BANGLADESH FLOOD ACTION PLAN

OPERATION AND MAINTENANCE STUDY

FINAL REPORT

VOLUME 2
Case Studies

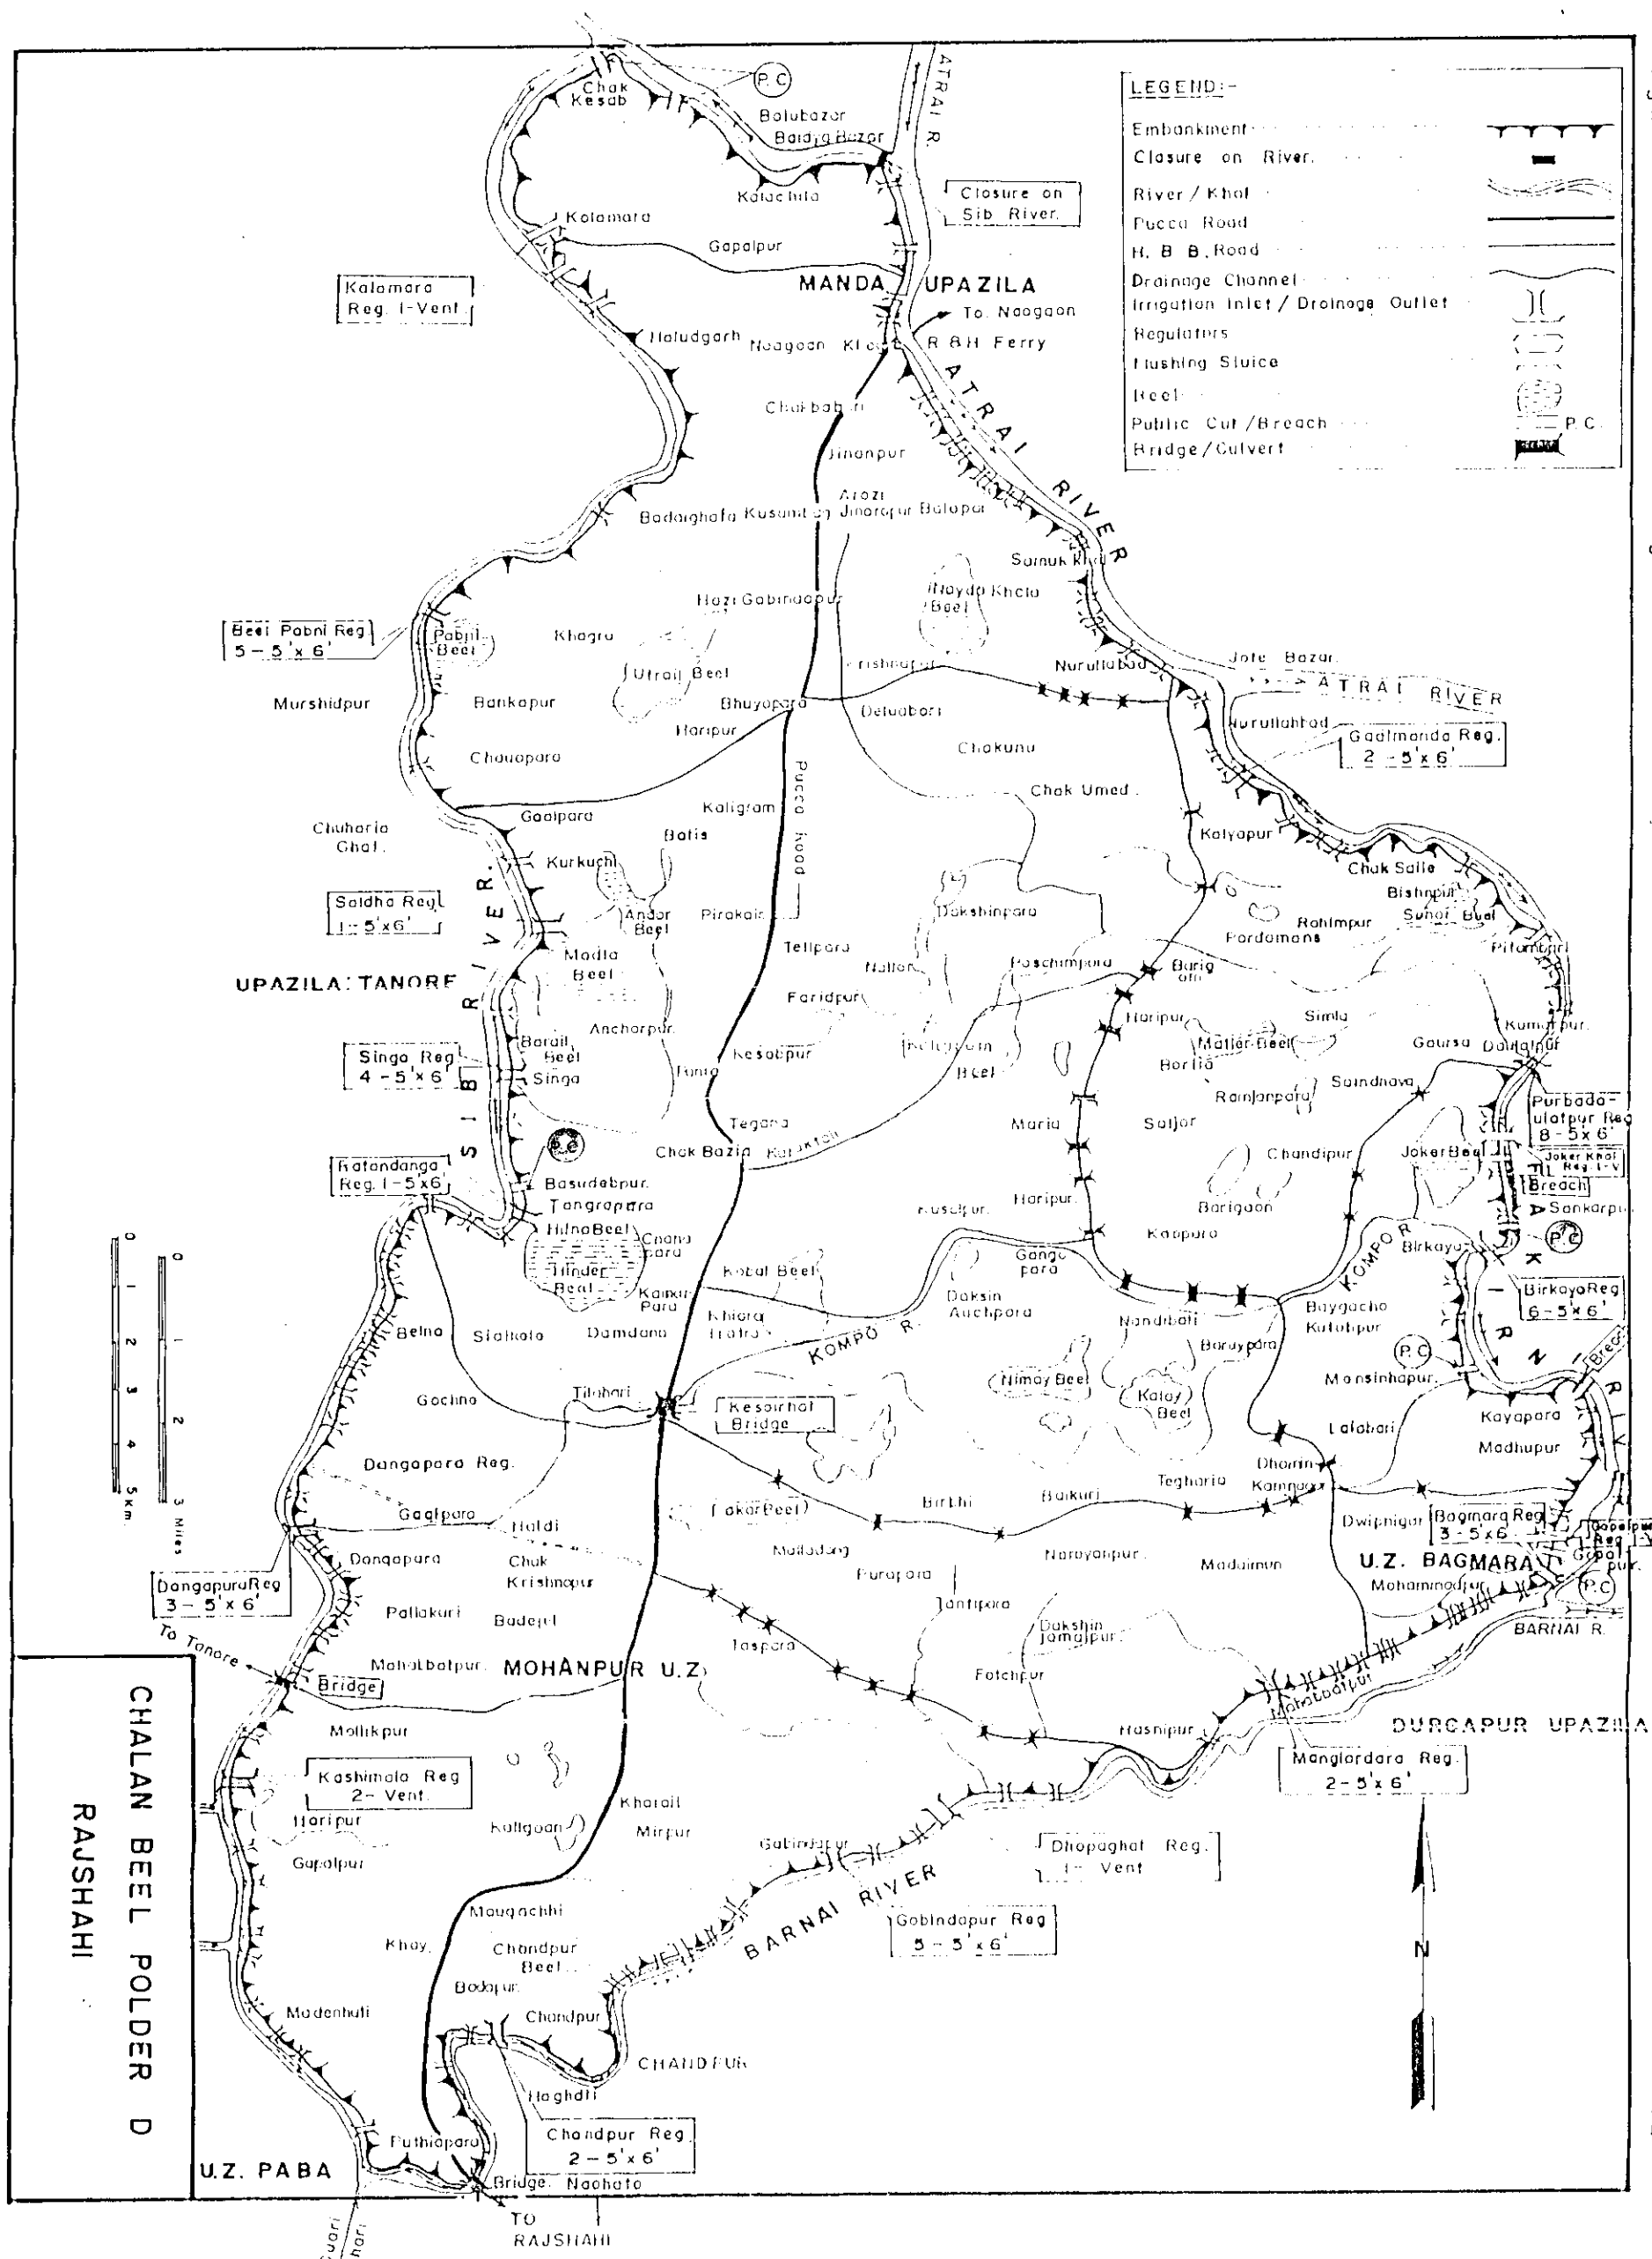
Figure 1.1 Chalan Beel Polder D showing locations visited and key features

Discussion with the BWDB staff, interviews with local people and on-site observations indicated that about 40 per cent of the whole embankment length is damaged - for example due to raincuts, and needs to be repaired or rehabilitated by resectioning.

All the irrigation inlets are in good condition, except two which need to be reconstructed as these fell into disrepair due to public cuts in the embankment.

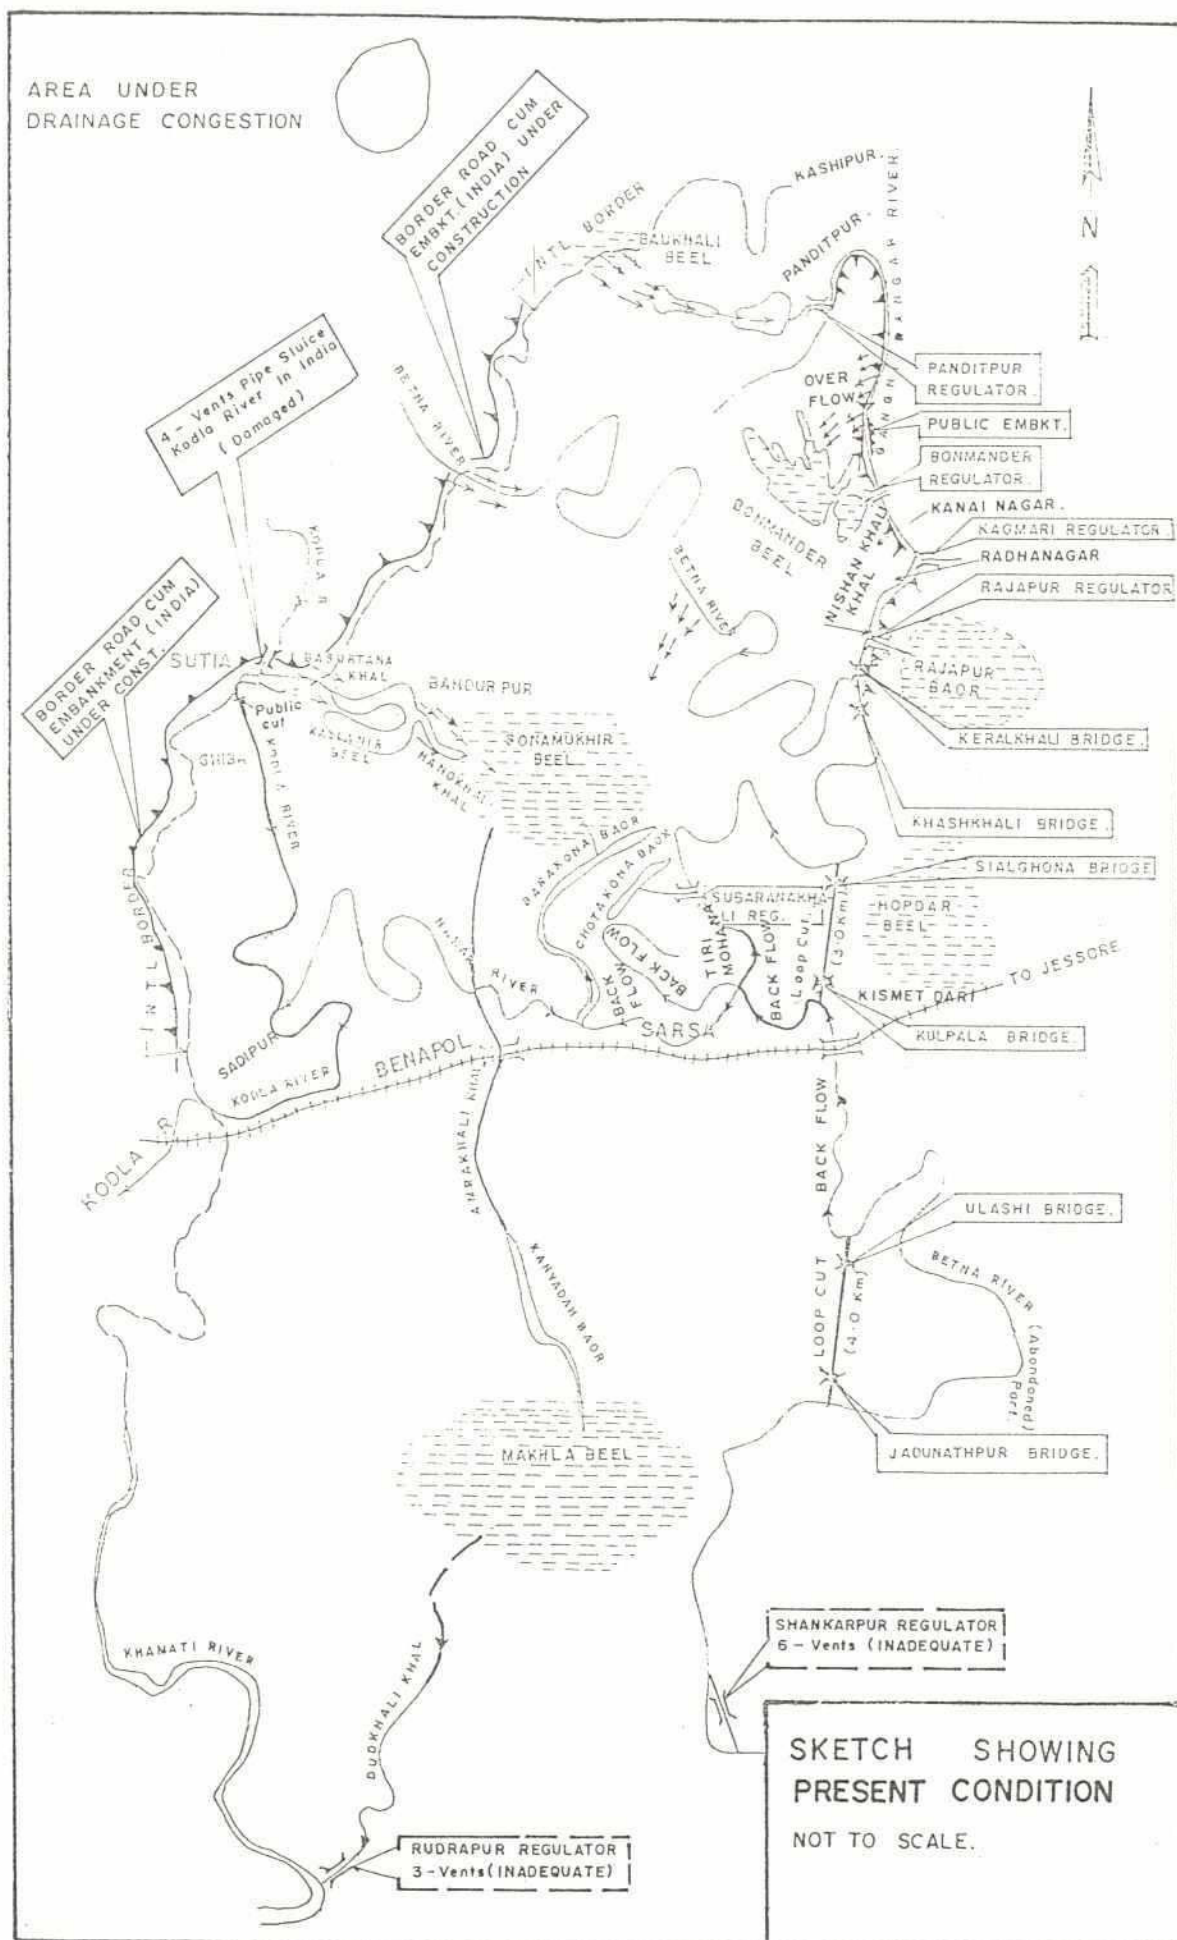
Figure 8.5 Sonamukhi Bonmender Beel Drainage Project.

overcome this situation the local people are now constructing a dwarf embankment around the main depression between village Radhanagar and Gaursuti at their own cost, to stop the entry of early monsoon water inside the beel.

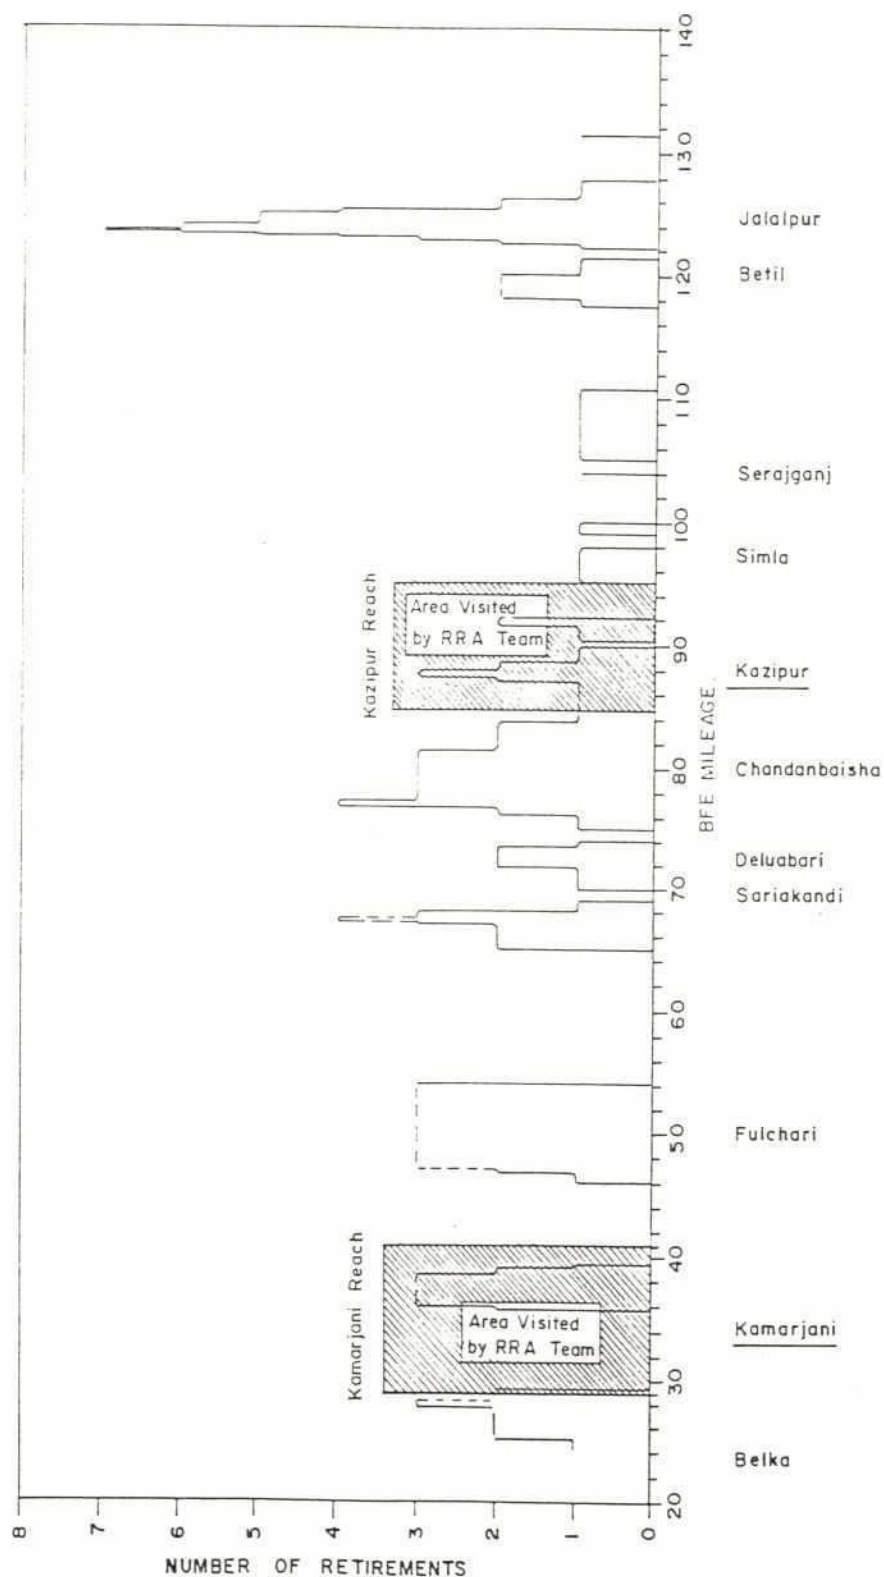
Figure 16-4

NUMBER OF RETIREMENTS ALONG BRE
