**BANK PROTECTION AND
RIVER TRAINING (AFPM)
PILOT PROJECT
FAP 21/22**

**EXTENDED STUDIES ON
RECURRENT MEASURES
(FAP 22)**

**KATLAMARI TEST SITE
IMPACT AND BEHAVIOUR
DURING MONSOON 1997**

AUGUST 1998

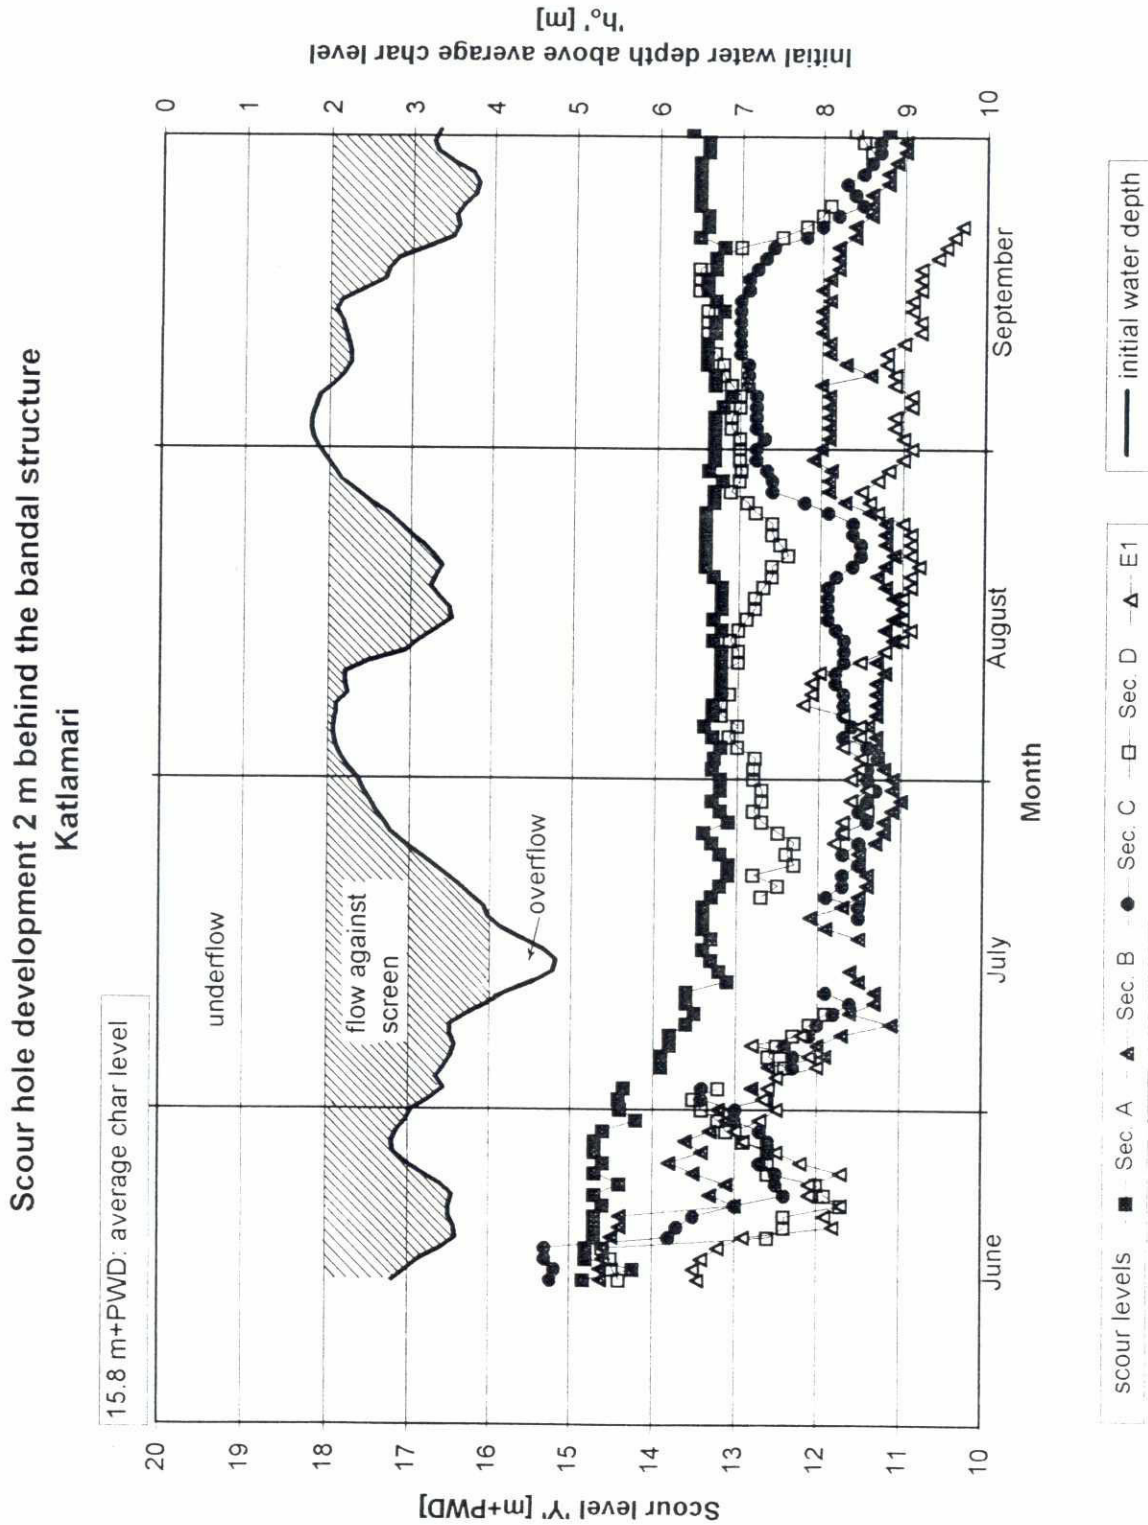
Fig. 6.1: Scour levels at 2m behind the bandals

The bandals survived the monsoon of 1997 in good condition. The maximum scour depth as measured between Sections B and C appeared more than expected viz. 5.1m instead of 4.2m (3.8m bandal scour plus 0.4m pile scour), but did not destabilise the structure (see next subsection). Minor damages occurred mainly to the screen matting (see Subsection 6.2.3). The deeper parts of the Fulchari channel approached the bandal site gradually. In September 1997 the channel came close to the tip of the bandals and Section E2 was washed away. During the last peak of the monsoon in the last week of September 1997, further erosion near the bandal tip took place and also Section E1 was washed away. Also some differences were noticed in the behaviour of the different types of bandals (see Subsection 6.2.2).

- The total different development of scour behind bandal Section A is most probably caused by the sheltered position near the high river bank.
- From the point of scour depth there is no clear preference for the design of Section B, C or D. Section D seems better but is less effective because of the shape of the screens.

Scour depth is a decisive parameter in view of the applicability of improved bandals. Too much scour endangers the stability of the structure. Long, safe piles are costly or not available above a certain length. For the improved bandals at Katlamari more than half of the construction costs were for the foundation. So, an improved understanding and predictability of the scouring process is essential for the optimization of the bandal design. Therefore, some further analysis of the scouring process follows hereafter.

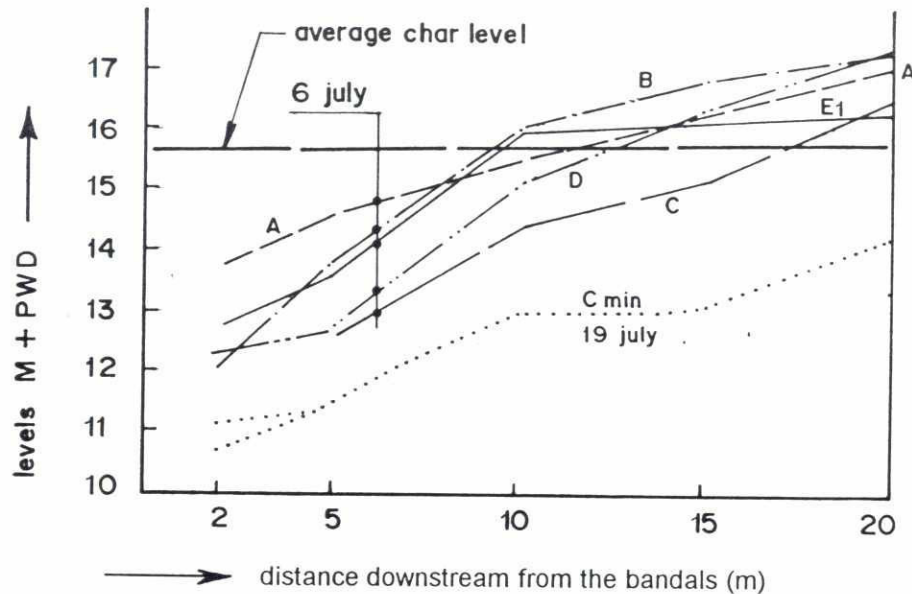
Fig. 6.2: Shape of scour hole downstream from the bandals

The shape on other dates remained about the same. In the first half of the 1997 monsoon, the deepest scour hole occurred on July 19, hence a couple of days after the high water peak. From the above Figure 6.2 it can be concluded that the maximum scour depth developed near the measuring line at 2m behind the bandals, see also the Figure 6.4 on the shape of the scour hole under the bandals. The length of the downstream part of the scour hole varied in place and time. Mostly the maximum dimensions were found behind bandal Section C. The downstream slope of the hole varied with time and along the bandals.

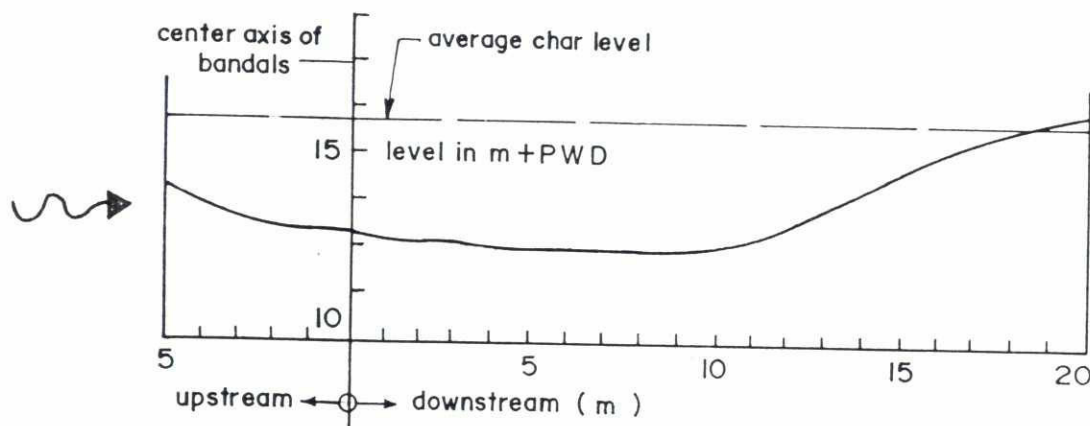
Fig. 6.4: Shape of scour hole under bandal (mid Section C)

Assuming that the shape did not change during erosion or siltation the maximum length upstream (during maximum erosion depth of 5.1m) is estimated to be about 30m. Hence, the total maximum length of the scour hole is 40 m, which is 8 times the scour depth. For the design a scour length of 20 to 30m was estimated.

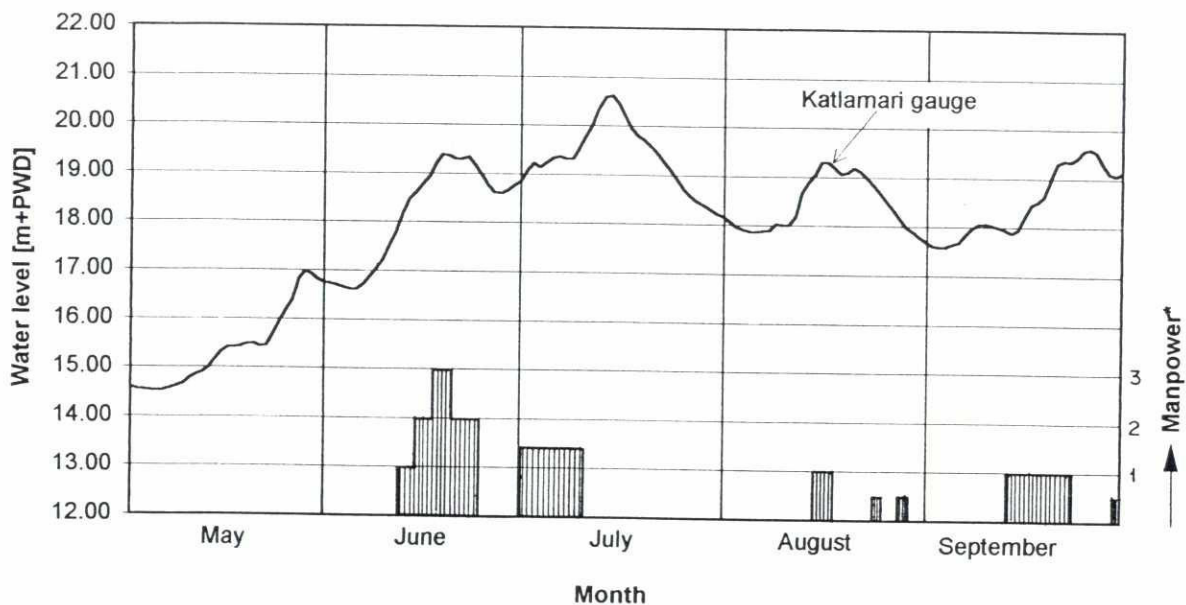
Fig. 6.9: Cleaning of bandals

- piles of floating debris will affect the hydraulic conditions around the screen obscuring the appropriate functioning of the bandals;
- debris will cause additional load on the structure. This will happen particularly on special parts such as the ropes of Section C, and
- the flow hitting the screens under an angle of about 45° will try to push the debris along the bandals. Especially at the irregular parts of the screen surface (for instance the connections between the various bandal sections). This may cause considerable forces in the longitudinal direction of the bandals. The shifting of the screen in Section C parallel to the axis is caused by floating debris pushing the ropes.

It is concluded that cleaning of the structure is important. Although the total period of cleaning appeared to be only about 1 month during the 1997 monsoon, the amount of work appeared to be considerable. The installation of a "floating rope" to divert the flow angle of the debris seems a sound one. More debris will bypass the structure and the remaining part can easier be removed. The strength of the locally made jute rope appeared insufficient. Some tests applying other material for the "floating rope" are recommended.

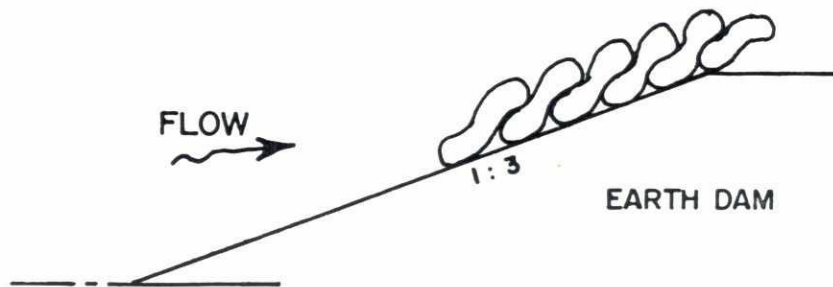
Fig. 6.15: Details earth dam

Initially, the dam crest was covered with a layer of 0.2 m of sand to protect the dam crest against damage. In June, however, this protecting layer appeared to be eroded and some damage of the gunny bags was noticed, especially along the upstream water line, probably caused by cattles. Due to moderate wave action the damaged bags were partly emptied and bags started shifting. From this it is concluded that the positioning of the bags need to be changed. The positioning was based upon the idea to lay the bags roof-tile wise in the current (see sketch).

A horizontal positioning of the bags with the length in the flow direction will probably be more stable.

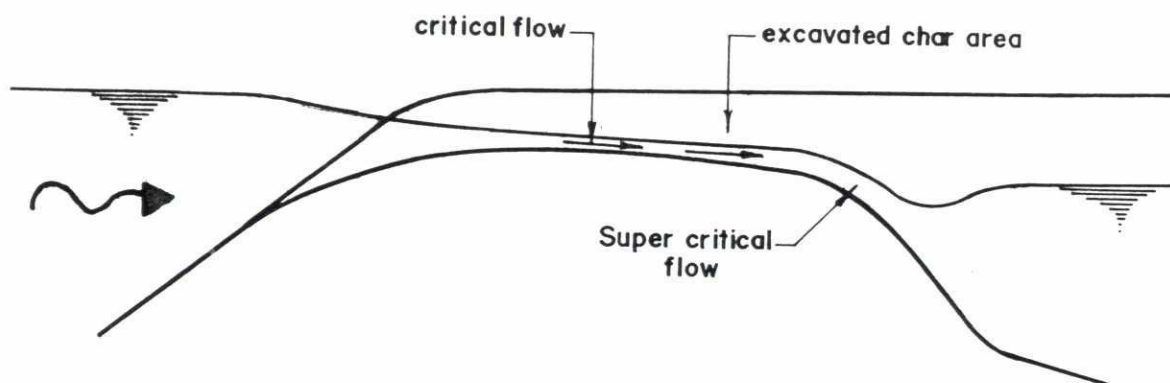
Fig. 6.16: Sheet flow overtopping char

The water levels continued their sharp rise of the last days (of about 0.2 to 0.3 m/day) overtopping the flattened char area adjacent to the dam. At that moment the head over the dam was 0.3 m. So sheet flow occurred (as usual when a char is overtopped).

The flow velocities on the char were rapidly increasing, becoming much higher than the critical flow velocities (say 0.4 m/s), which means, that erosion started soon after overtopping. A new channel bypassing the dam developed rapidly. This means in fact that the light sill of two layers of gunny bags had no effect.

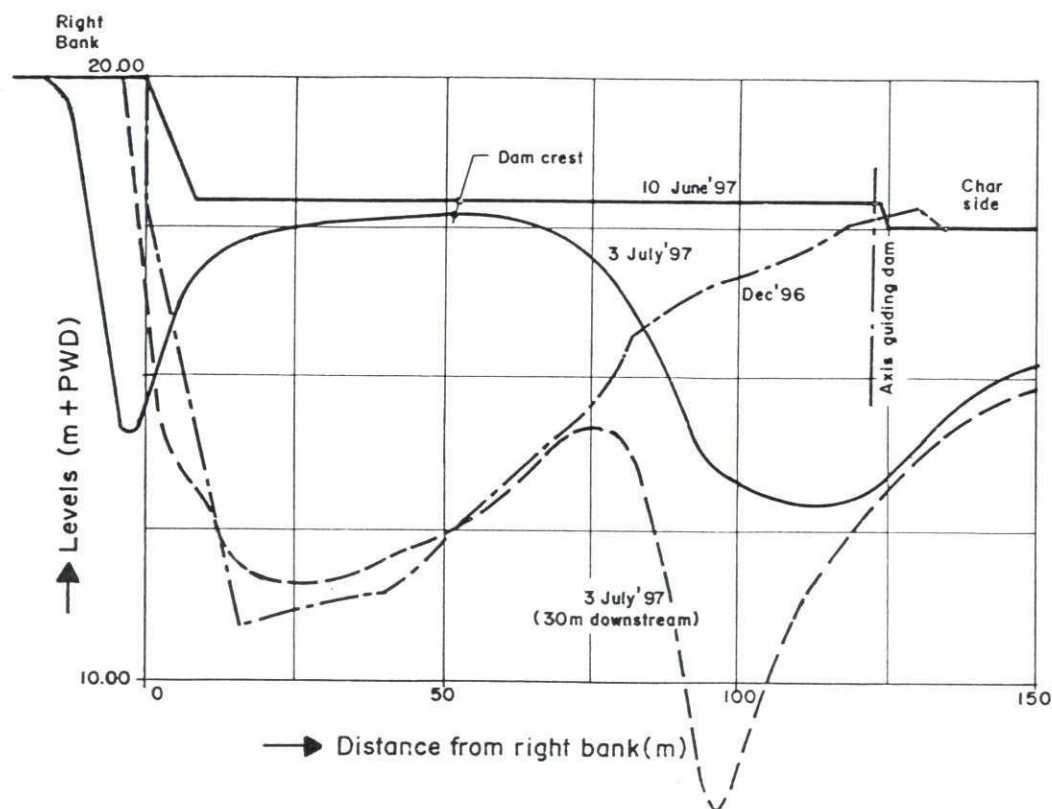
Fig. 6.17: Cross-sections dam site

The figure also includes the cross-section of the Katlamari channel before starting the construction in December 1996 and the levels after construction (June 10, 1997). The figure shows that the main body of the dam, closing the deeper parts of the channel, is still in place. Only some settlement occurred by which the dam crest lowered 0.2 to 0.5 m. At the right bank the dam was starting to be disconnected by erosion. The shallow part of the main dam and the guiding dam disappeared and at that location the new bypassing channel had fully developed. This channel was curling around the main dam, which acted as a kind of groyne. About 30 m downstream from the groyne head the deepest scour hole (8.00 m+PWD) was located. Therefore, a cross-section through the scour hole, parallel to the dam has been added to the previous figure. This cross-section clearly shows that the differences in the main part of the Katlamari channel were small (compare December 1996 section with the July 03, 1997 section at 30 m).

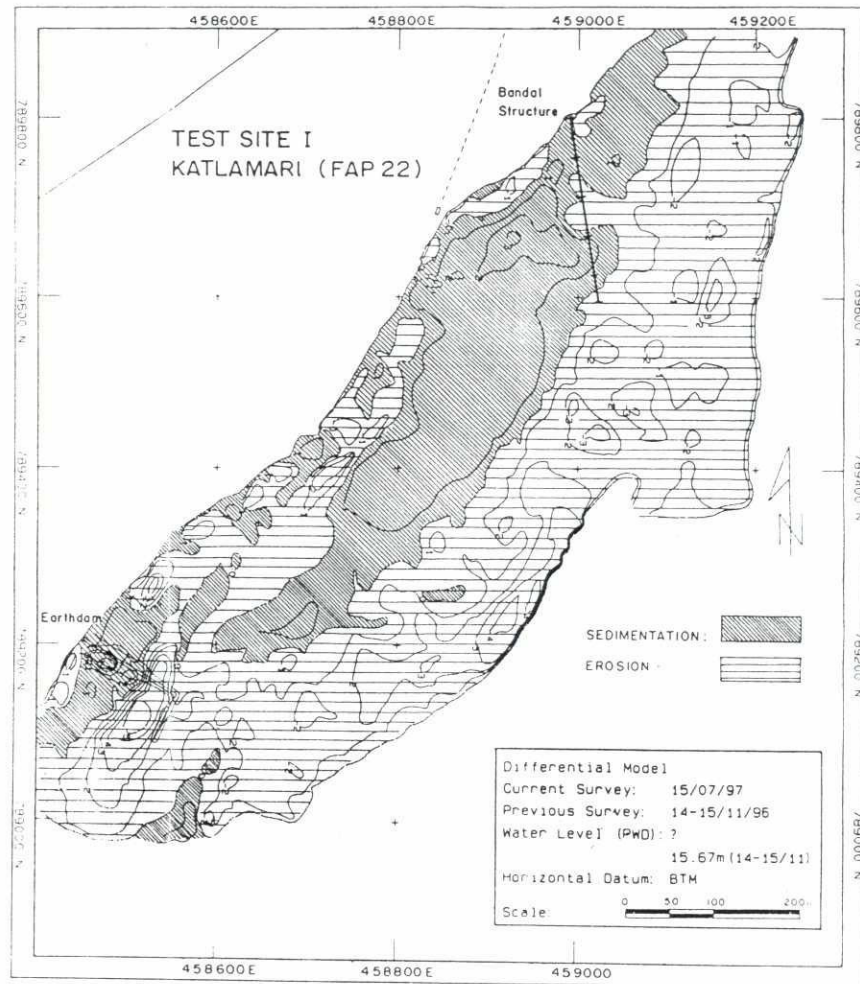
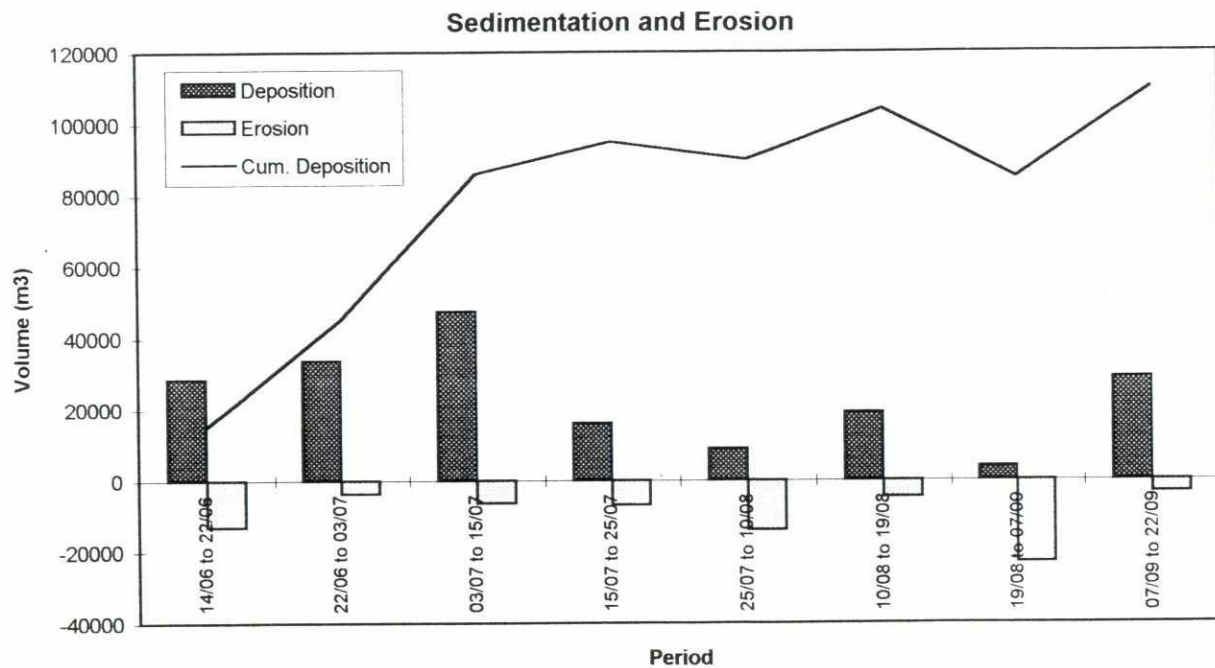
Fig. 7.1: Sedimentation behind bandals

- Due to the horizontal shifting of part of the screen of Section C an opening occurred between the B and C screens. The considerable velocities through such an opening generated probably additional scour. It was there that the maximum scour was measured.
