**BANK PROTECTION AND
RIVER TRAINING (AFPM)
PILOT PROJECT
FAP 21/22**

**TEST
AND
IMPLEMENTATION
PHASE
FAP 21**

**REPORT ON
MONITORING AND ADAPTATION
AT
BAHADURABAD TEST SITE**

MONSOON 1997

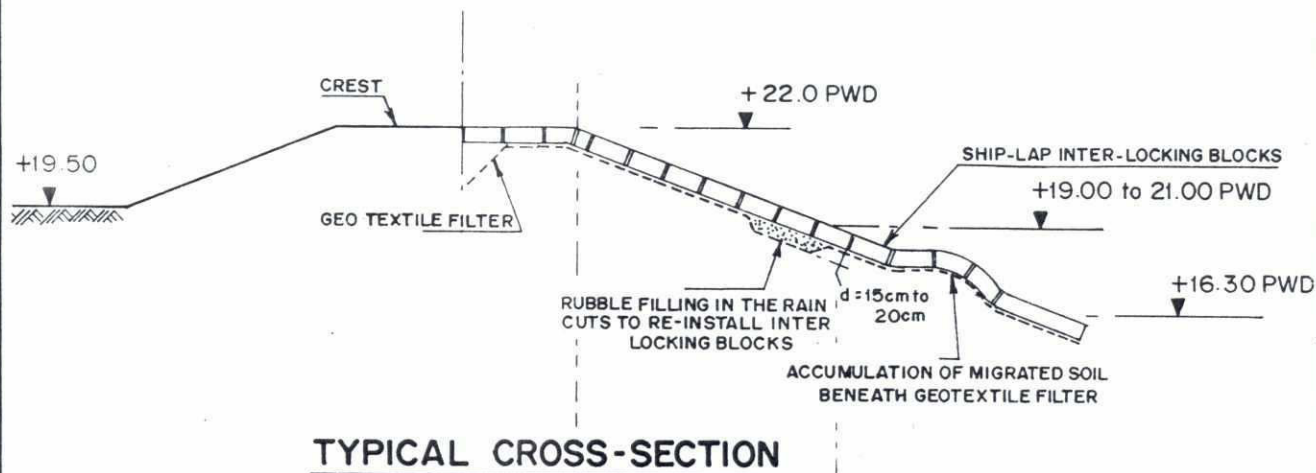
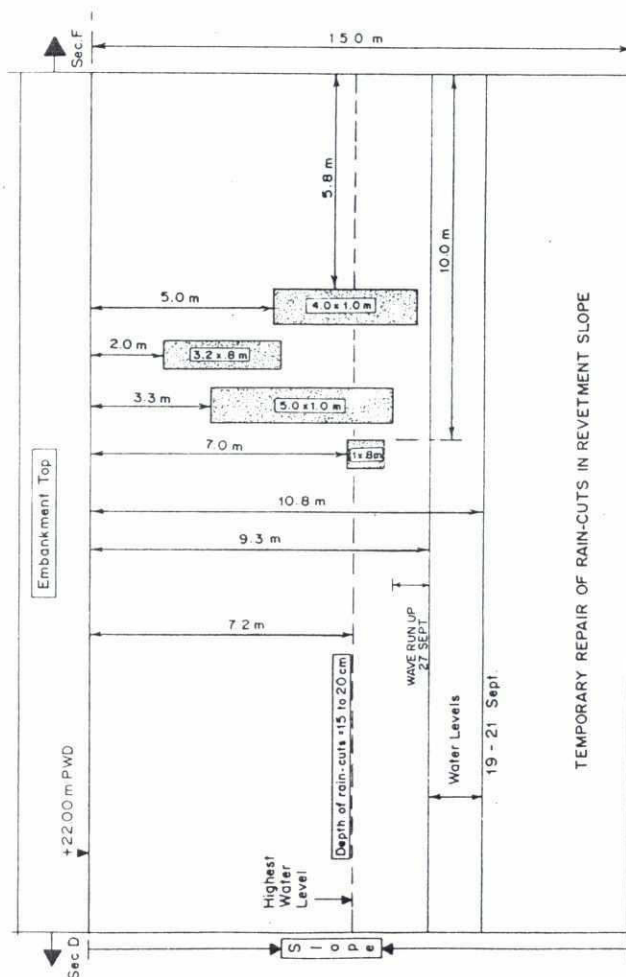
FIG. 4.15

The monitoring team reported some repair in Section E on September 22, where cuts had been observed and bulging of the ship-lap interlocking concrete slabs near the water level because of accumulation of migrated sand at about 2 to 3 m below the water level. The depths of the cuts were 0.15 to 0.2 m (see sketch in Fig. 4.15).

The site report mentioned heavy rainfall in Bahadurabad on June 15 as well as on September 19 and 20 (65 and 51 mm rainfall respectively). After this rainfall some settlements have been observed in the upper revetment in Sections E and F above the water level line (see sketches in Fig. 4.15). The ship-lap interlocking slabs have a variable shape regarding roundness of their corners, thickness of the slabs, and variable gabs between the slabs.

The hypothesis is that rainfall entered through the gaps between the blocks and ran down, transporting some of the subsoil. Just below the water level the subsoil material has been deposited. Bulging of the surface has been observed at several places. The contact between the blocks and the geotextile might have been low on several places because of 'beam action' between several blocks.

The flow along the revetment slope had a gradient of about 0.3. The results of the filter test investigation show that a small and un-equal distributed weight from the toplayer on the geotextile reduces the critical gradient from 0.5 to 0.2 in case of subsoil A (see Table 4.4). Beam action between the concrete slabs has probably reduced locally the weight pressure by the concrete slabs on the geotextile to zero. This might have reduced the critical gradient below the actual gradient. This explains the observed damage in Section E.

BAHADURABAD TEST SITE
Rain cuts under top layer of
concrete slabs, Section E

- In Section E rain-cuts have been detected underneath the geotextile. In the course of the investigations it was found out that the geotextile was wrongly placed (upside down). The rain-cuts could also be caused by wave action and because the weight of the blocks (ship-lap type) was too low. Beam-action between the slabs had reduced the pressure by the slabs on the geotextile. According to the results of the filter test investigation this low pressure causes rain-cuts damage under the geotextile.

To stabilize the slope of the revetment above the berm in Section E-2 the cover layer and filter layer had to be removed. The rain-cuts were filled up and the composite geotextile filter, which had been placed with the wrong side up during the construction phase, was replaced now with the right dark / coarse side down. On that a 5 cm thick filter layer of khoa was placed and finally the cc-slabs.

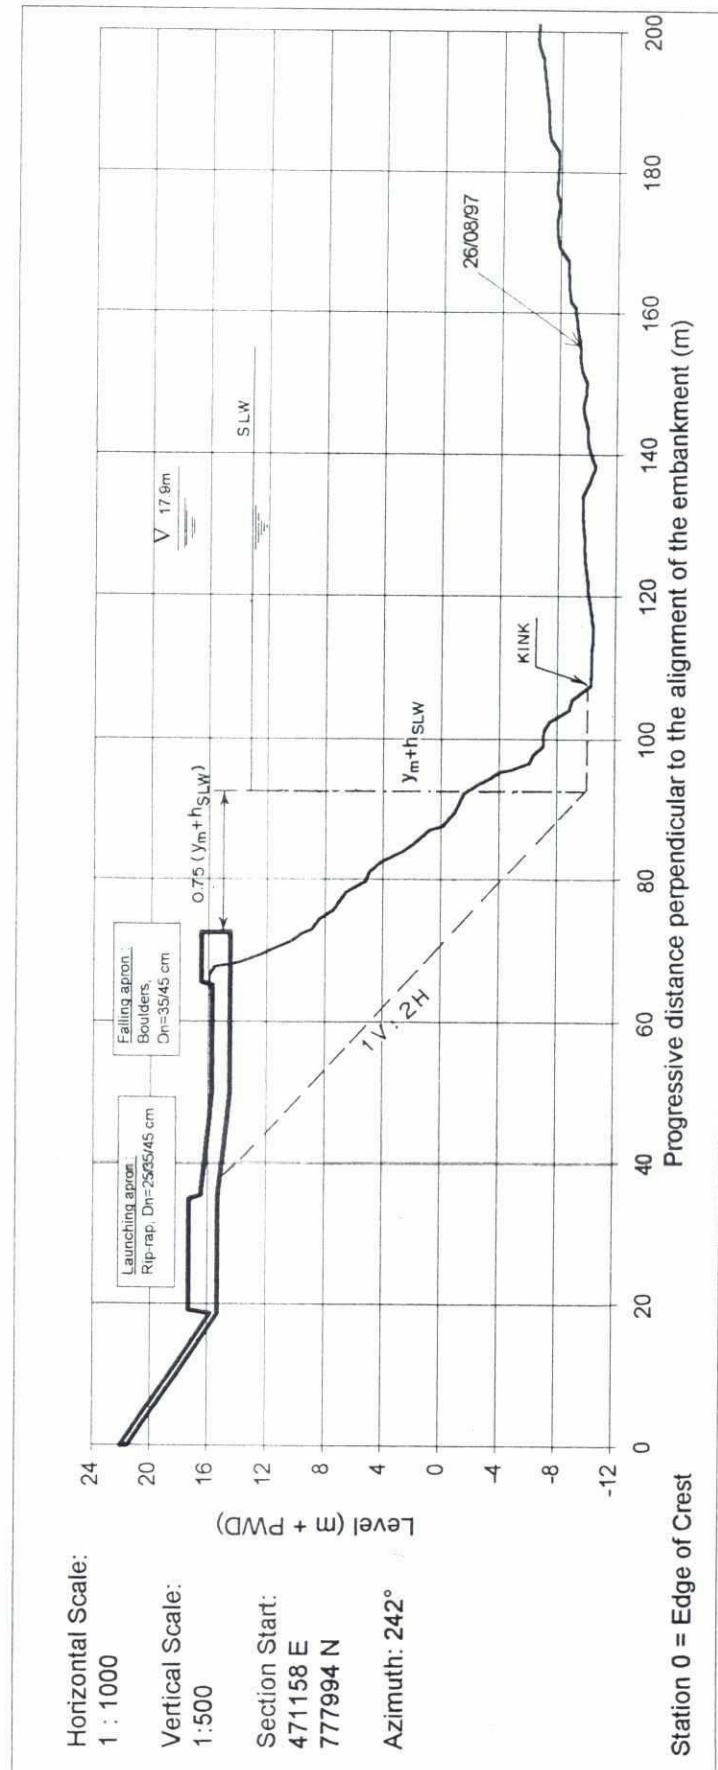
FIG. 4.18

A kink in the depth measured in cross-section surveys indicates a certain coverage down to this kink, (see example in Fig. 4.18). This bend has been caused by the slowly eroding surface formed of the falling elements. Also Spring (1903) mentioned this phenomena from field observations on the large rivers in the Indian sub-continent (see his sketch in Fig. 4.19).

Cross-section H-1, on August 26, 1997

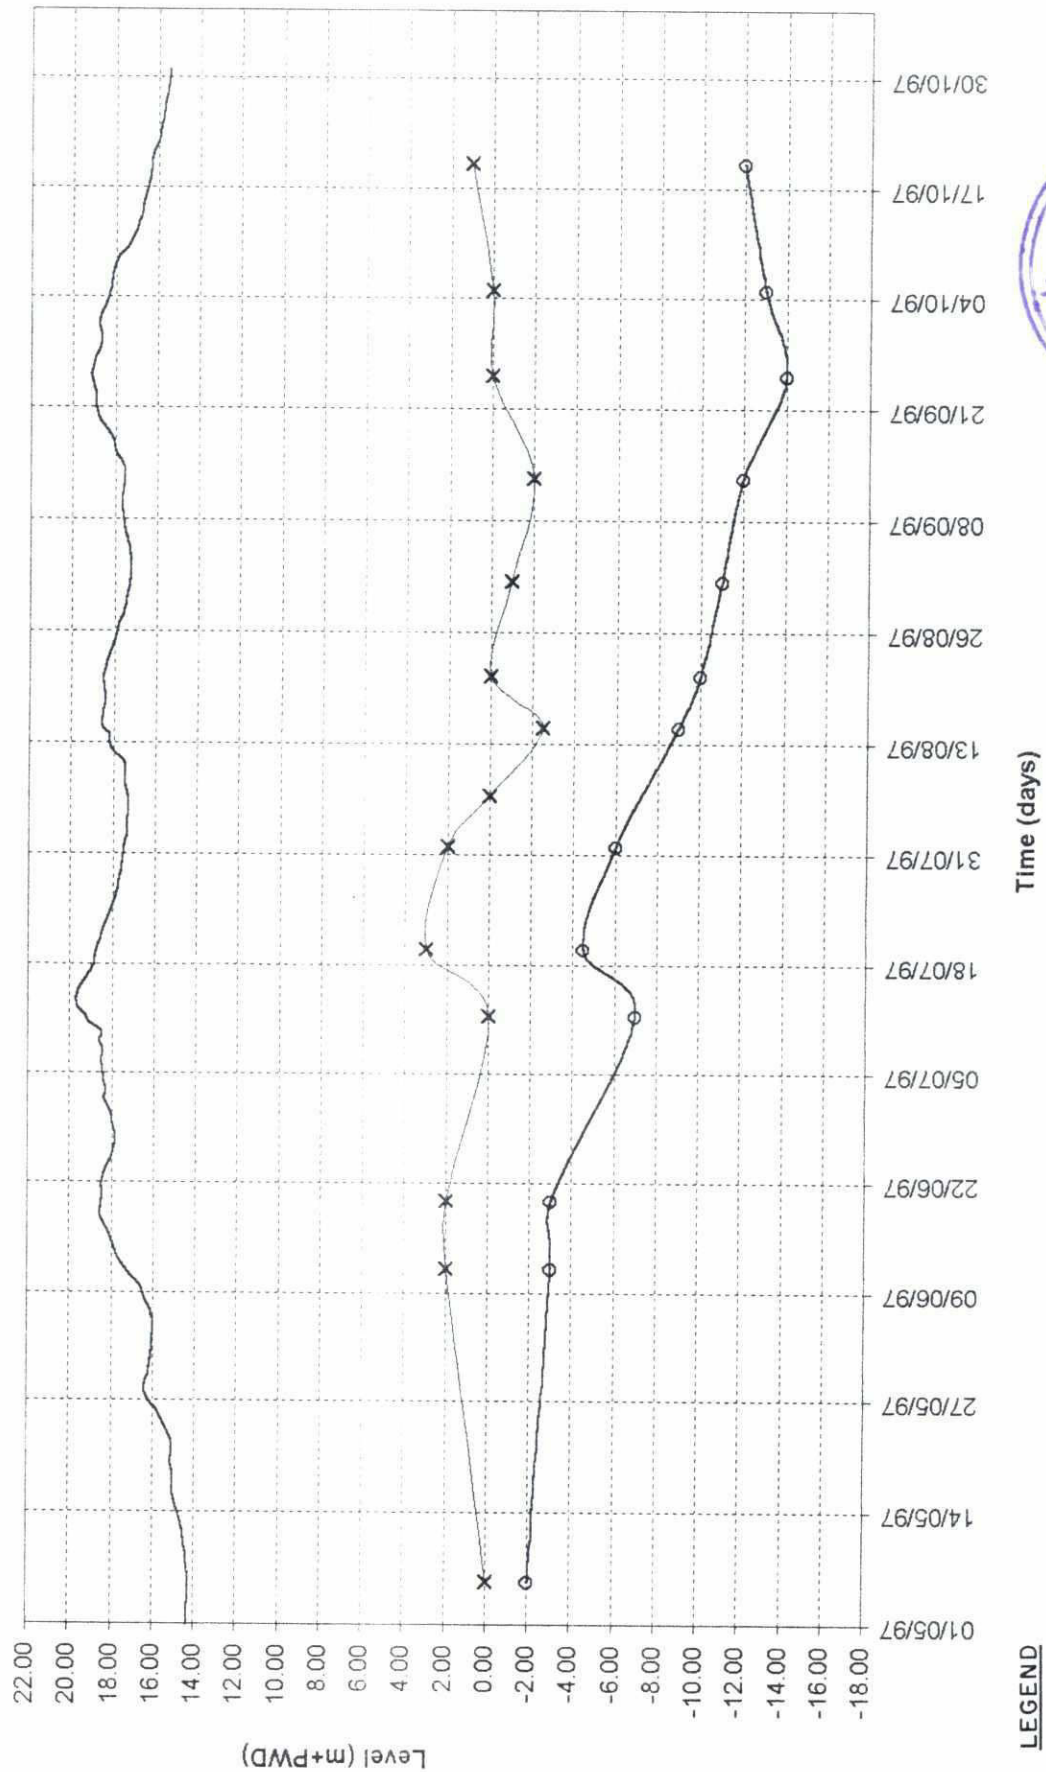
FIG. 4.20

The depth of the scour hole gradually increased from 2 m in May to 14 m end of September at an average rate of 0.1 m/day. This erosion rate is similar to the falling rate of the falling apron in Section F (see Sub-Section 4.6.3). This gradually increasing scour depth is different from the quick development of the local scour holes near Kamarjani groynes in the 1995 monsoon: 0.25 m/day near groyne G-1, 0.3 m/day in the scour hole near G-2 and 0.4 m/day in the scour hole near G-3. An erosion rate of 0.3 m/day or more is one factor which increases the risk of large slides as observed near G-2 and G-3. Fortunately, the slow erosion rate of the scour hole near the revetment structure has reduced considerably the risk of large slides damaging this new test structure.

BAHADURABAD TEST SITE
The bed level of approach channel and
Maximum scour depth as function of time

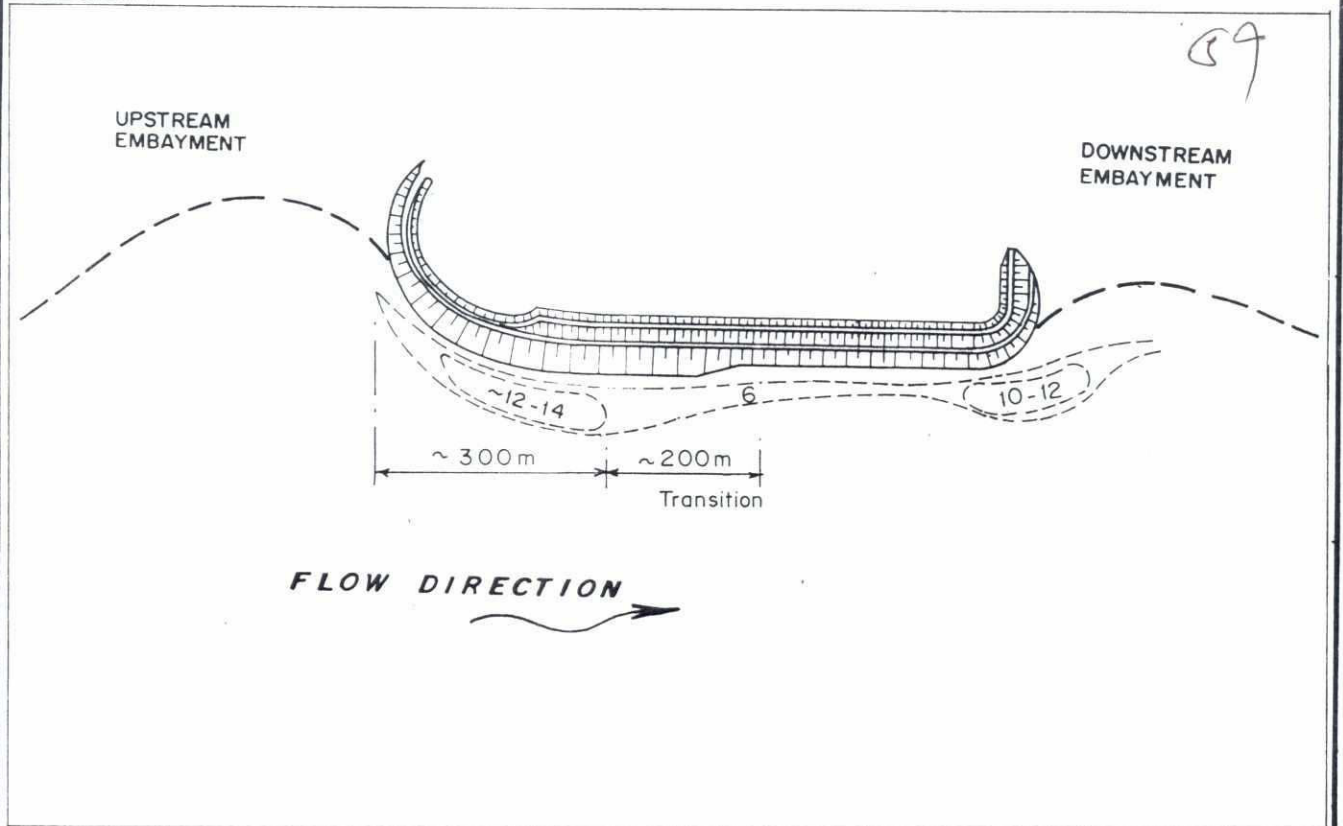
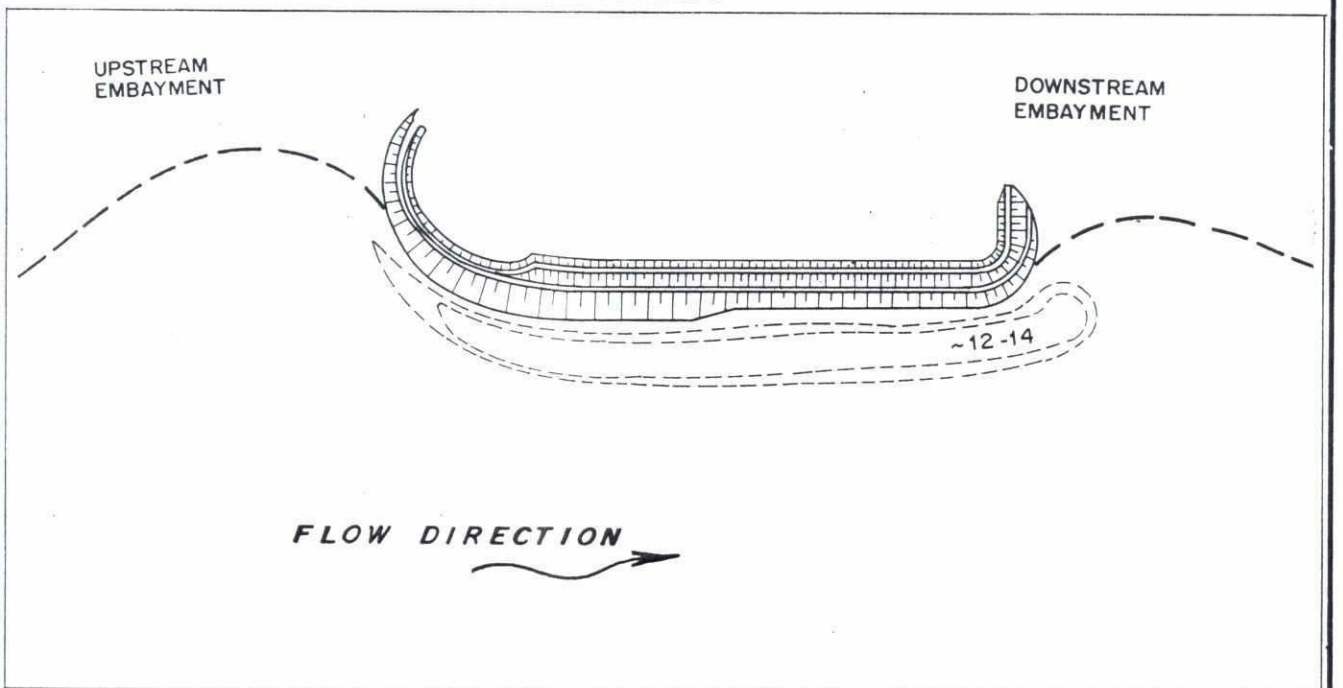
FIG. 4.21

Design scour pattern and bankline
