BANK PROTECTION AND  
RIVER TRAINING (AFPM)  
PILOT PROJECT  
FAP 21/22

CURRENT MEASUREMENTS  
AT KAMARJANI AND BAHADURABAD  
JULY AND AUGUST 1996

DECEMBER 1996

JAMUNA TEST WORKS CONSULTANTS, JOINT VENTURE  
CONSULTING CONSORTIUM FAP 21/22

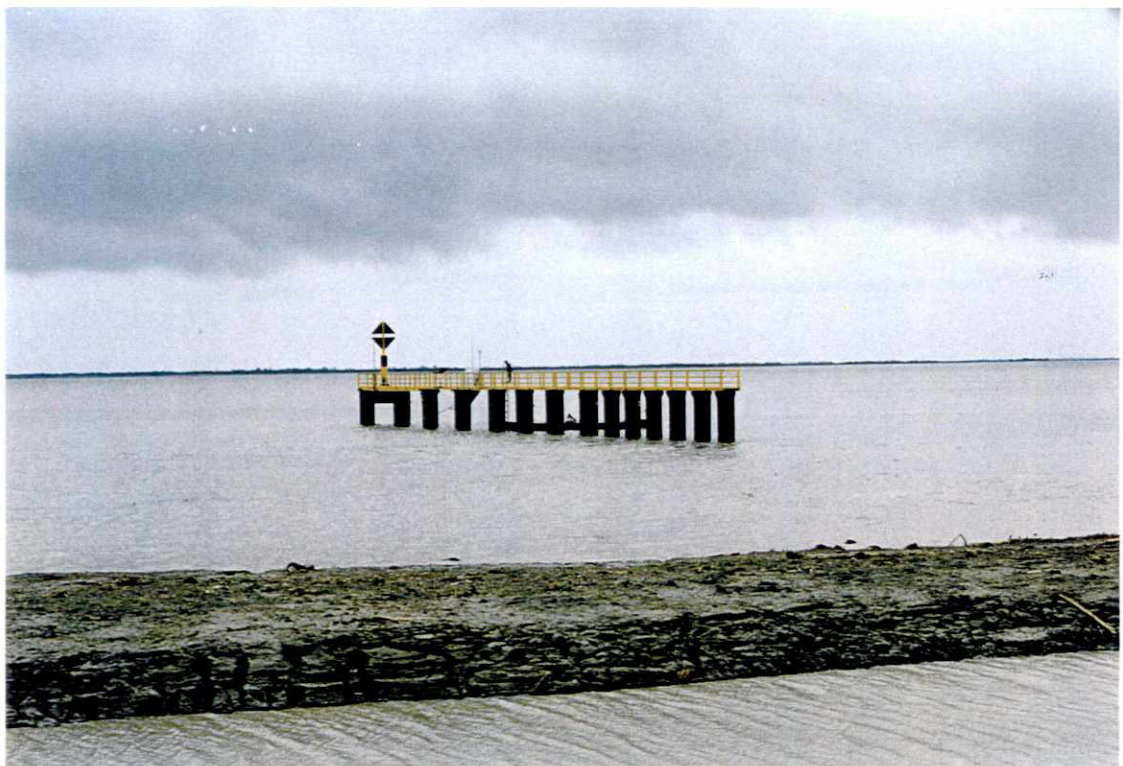
During the high flow season in 1995 the test structures suffered damages. In early July 1995 (09/07/95) the impermeable part of G-2 broke shortly followed by the embankment downstream of G-2. About a month later the same happened to the impermeable part of G-3 and some of the inner piles were lost.

Fig. 9: View of G-2 with the Remains of the old Embankment in the Foreground

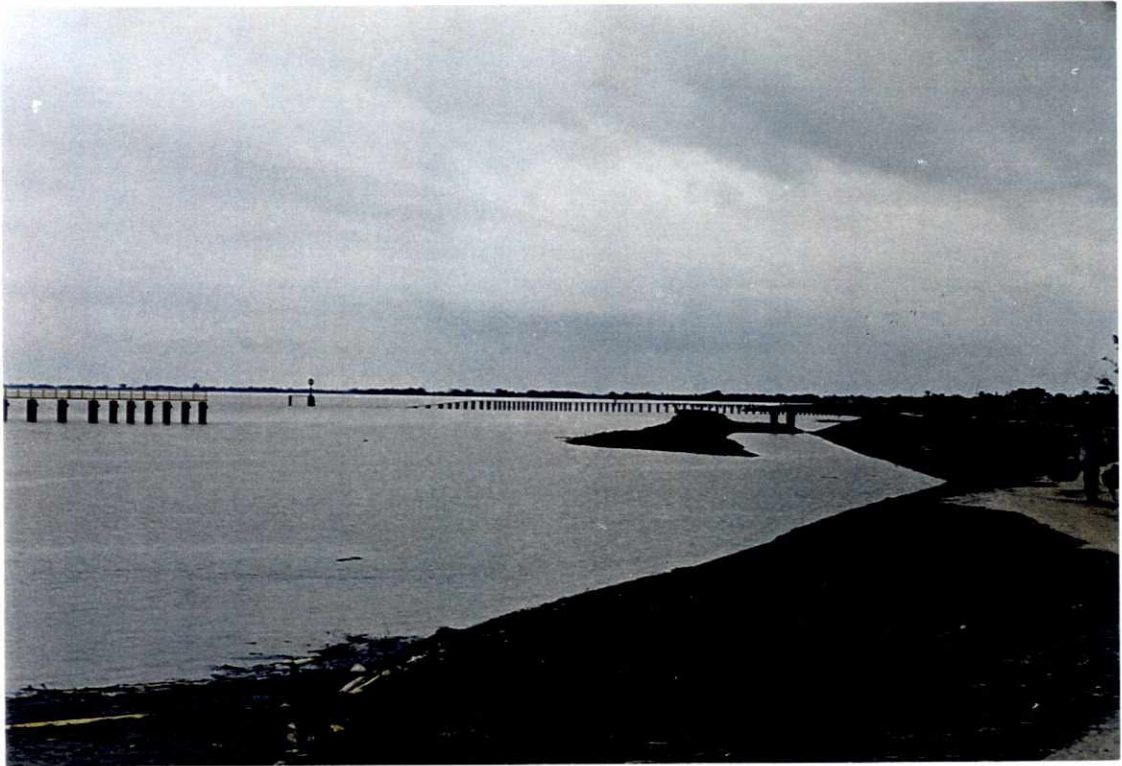
Fig. 10: View of Groyne G-3 and Remains of the old Embankment

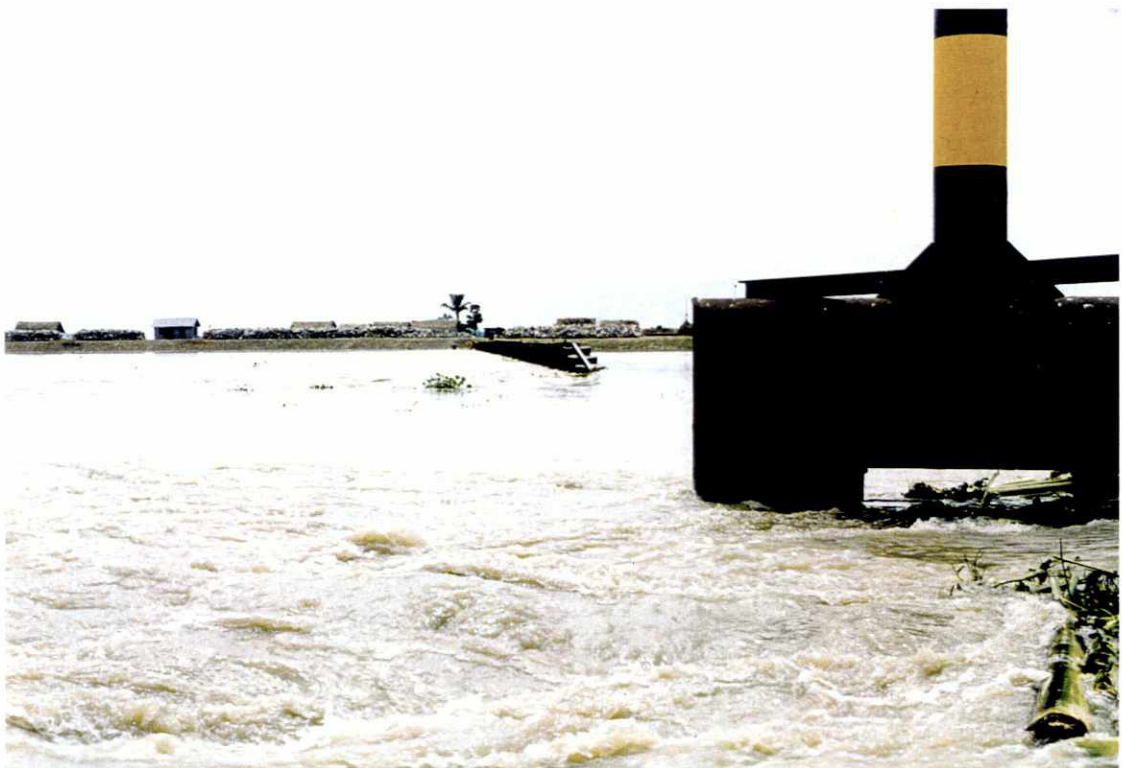
Fig. 11: Photo of the Head of Groyne G-3

by the intersecting flow tracks and by the varying velocities in each track. These distinctive intersecting vortex trails leading away from the head of G-3 can be observed on location.

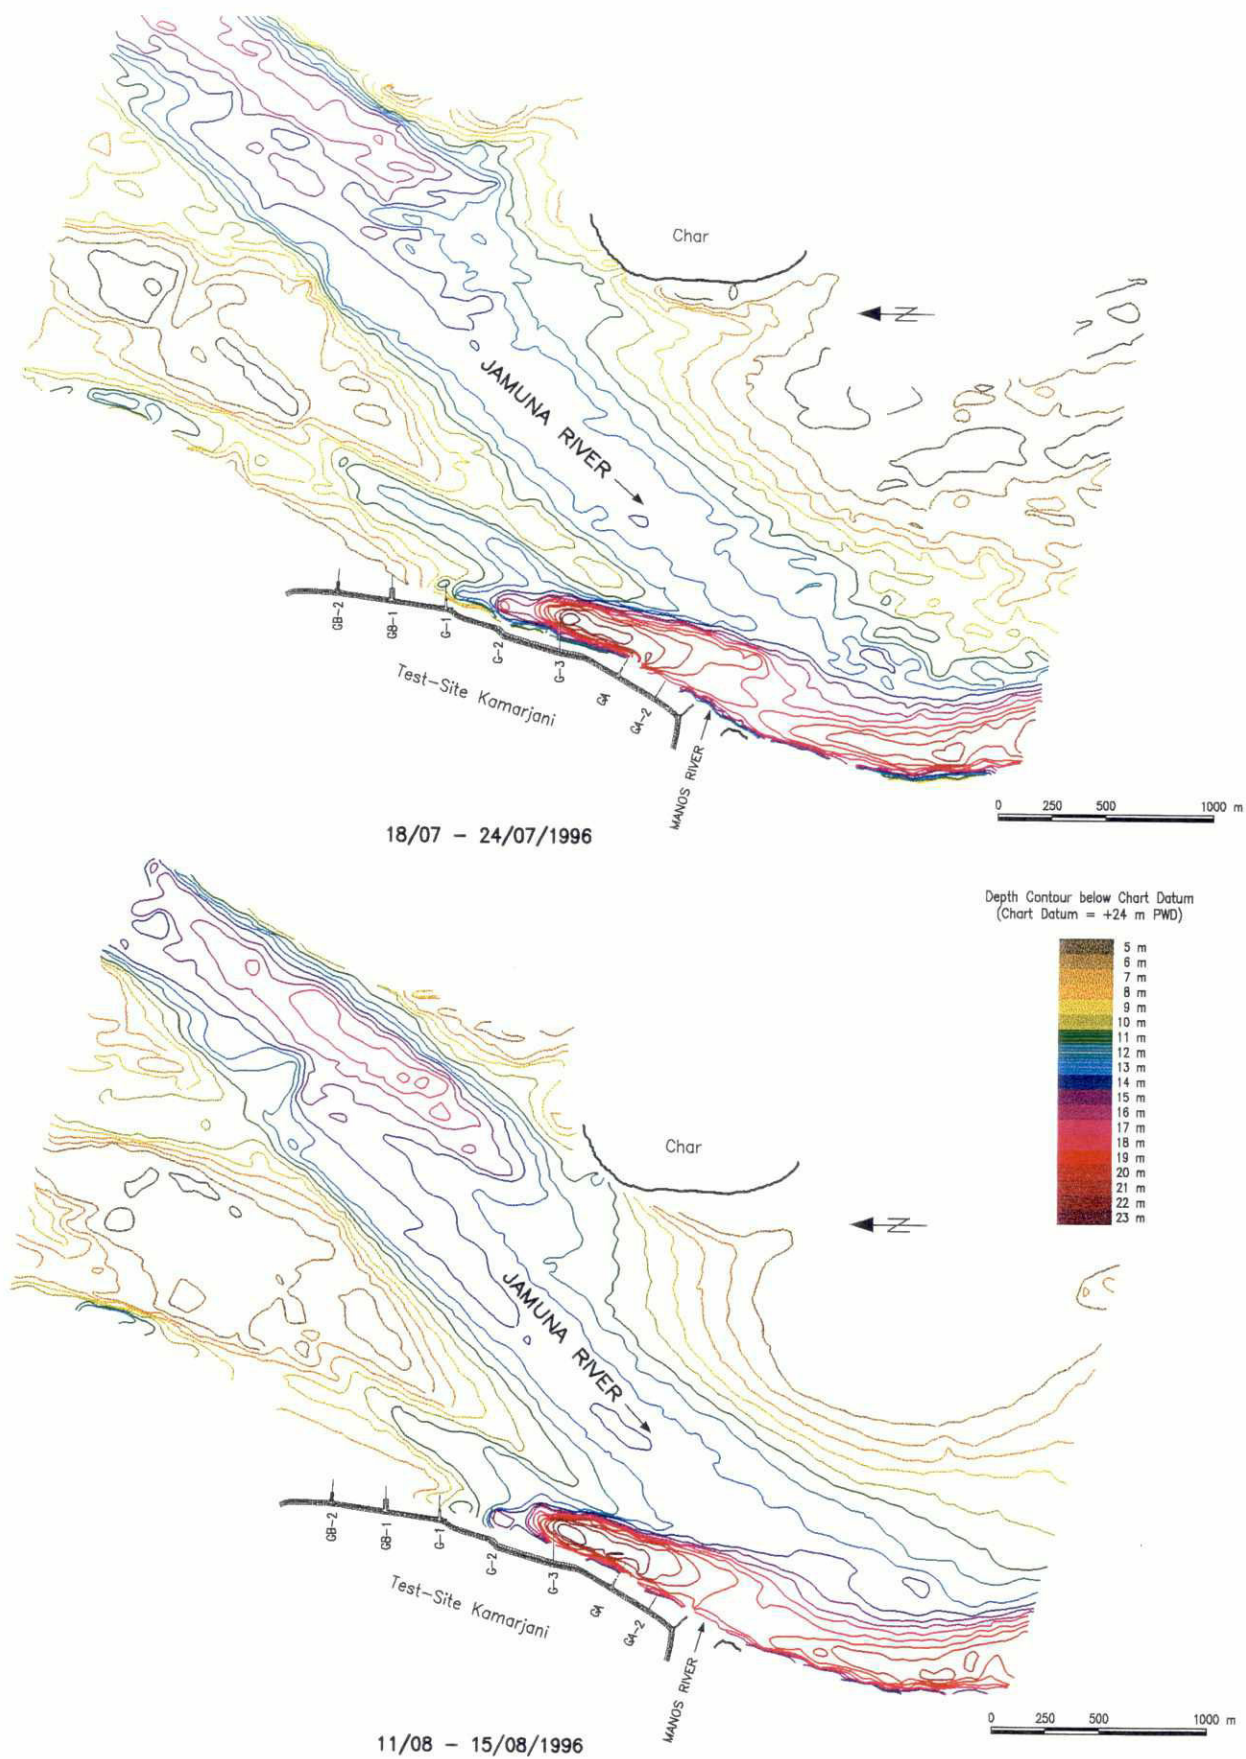
have on the flow directions in the river. In connection with this, it is interesting to note the changing morphology as shown in fig. 13. The deep water region due west of GB-1 and GB-2 and north of the char has extended itself southward in the period between late July and mid August. A comparison of the two bathymetric surveys shows how the main channel (margined by the blue 13 metre depth contours) has continued to scour from the deeper area north of the char across towards the right bank south of the Manos River. The erosion on the east side and the accretion on the west side upstream of the test site may be an indication whether the channel will move further eastwards pushing the escarpment south of the Manos River further downstream.

Fig. 13: Morphology at Kamarjani; Bathymetry Surveys from 18/07- 24/07/96 and 11/08 - 15/08/96

The concentration of the stream lines towards the groynes has caused the scour to extend as far as to the mouth of the Manos River (see also fig. 13, p. 13). This scour, caused by the test structure adjoins the natural scour on the undercut right bank. It can be assumed that if the course of the river does not change drastically, the main attack will in future be further south.

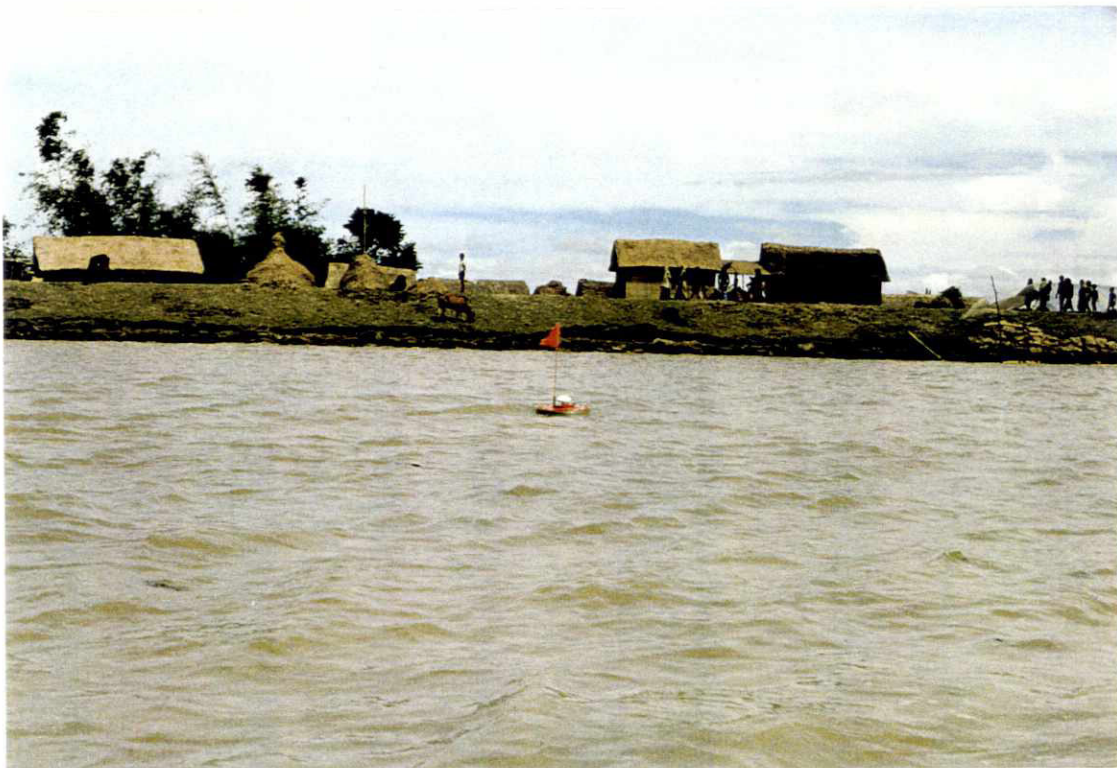
Return currents and scour are not the only responsible factors for the damages caused on the embankment. Owing to the vast breadth of the Jamuna, long wind fetches can cause wave heights of up to 1 metre. On the 26/07/96 winds of up to 11 m/s coming from east caused severe exudations on unprotected parts of the embankment. The damaged sections had to be hurriedly repaired with sand sacks. If immediate action is not taken accordingly during stormy periods the risk is too high that the embankment will take such damage that it will eventually burst. Figure 15, a photo taken on the 02/08/96 shows damages caused by wave erosion and figure 16, taken on 12/08/96 shows the extent of the damage to the unprotected slope.

Fig. 15: Photo from the 02/08/96 of Wave Erosion on the Embankment after the Storm on the 26/07/96

During the measurements it was observed that wind generated waves over long fetches can cause severe damages to unprotected earth dams. The wind velocities on the 26/07/96 reached 11 m/s and generated wave heights of up to 1 metre, which caused severe bank erosions which had to be secured with sand sacks.

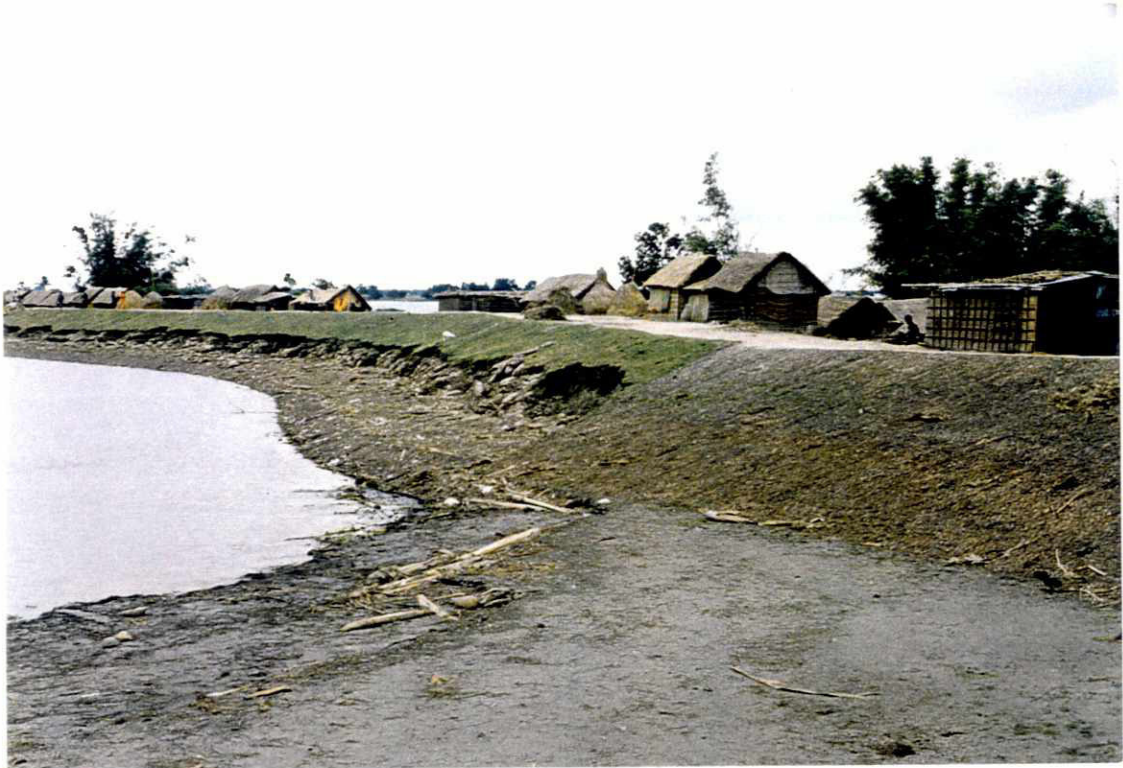
Fig. 16: Photo taken on the 12/08/96 showing the Damage to the unprotected Embankment

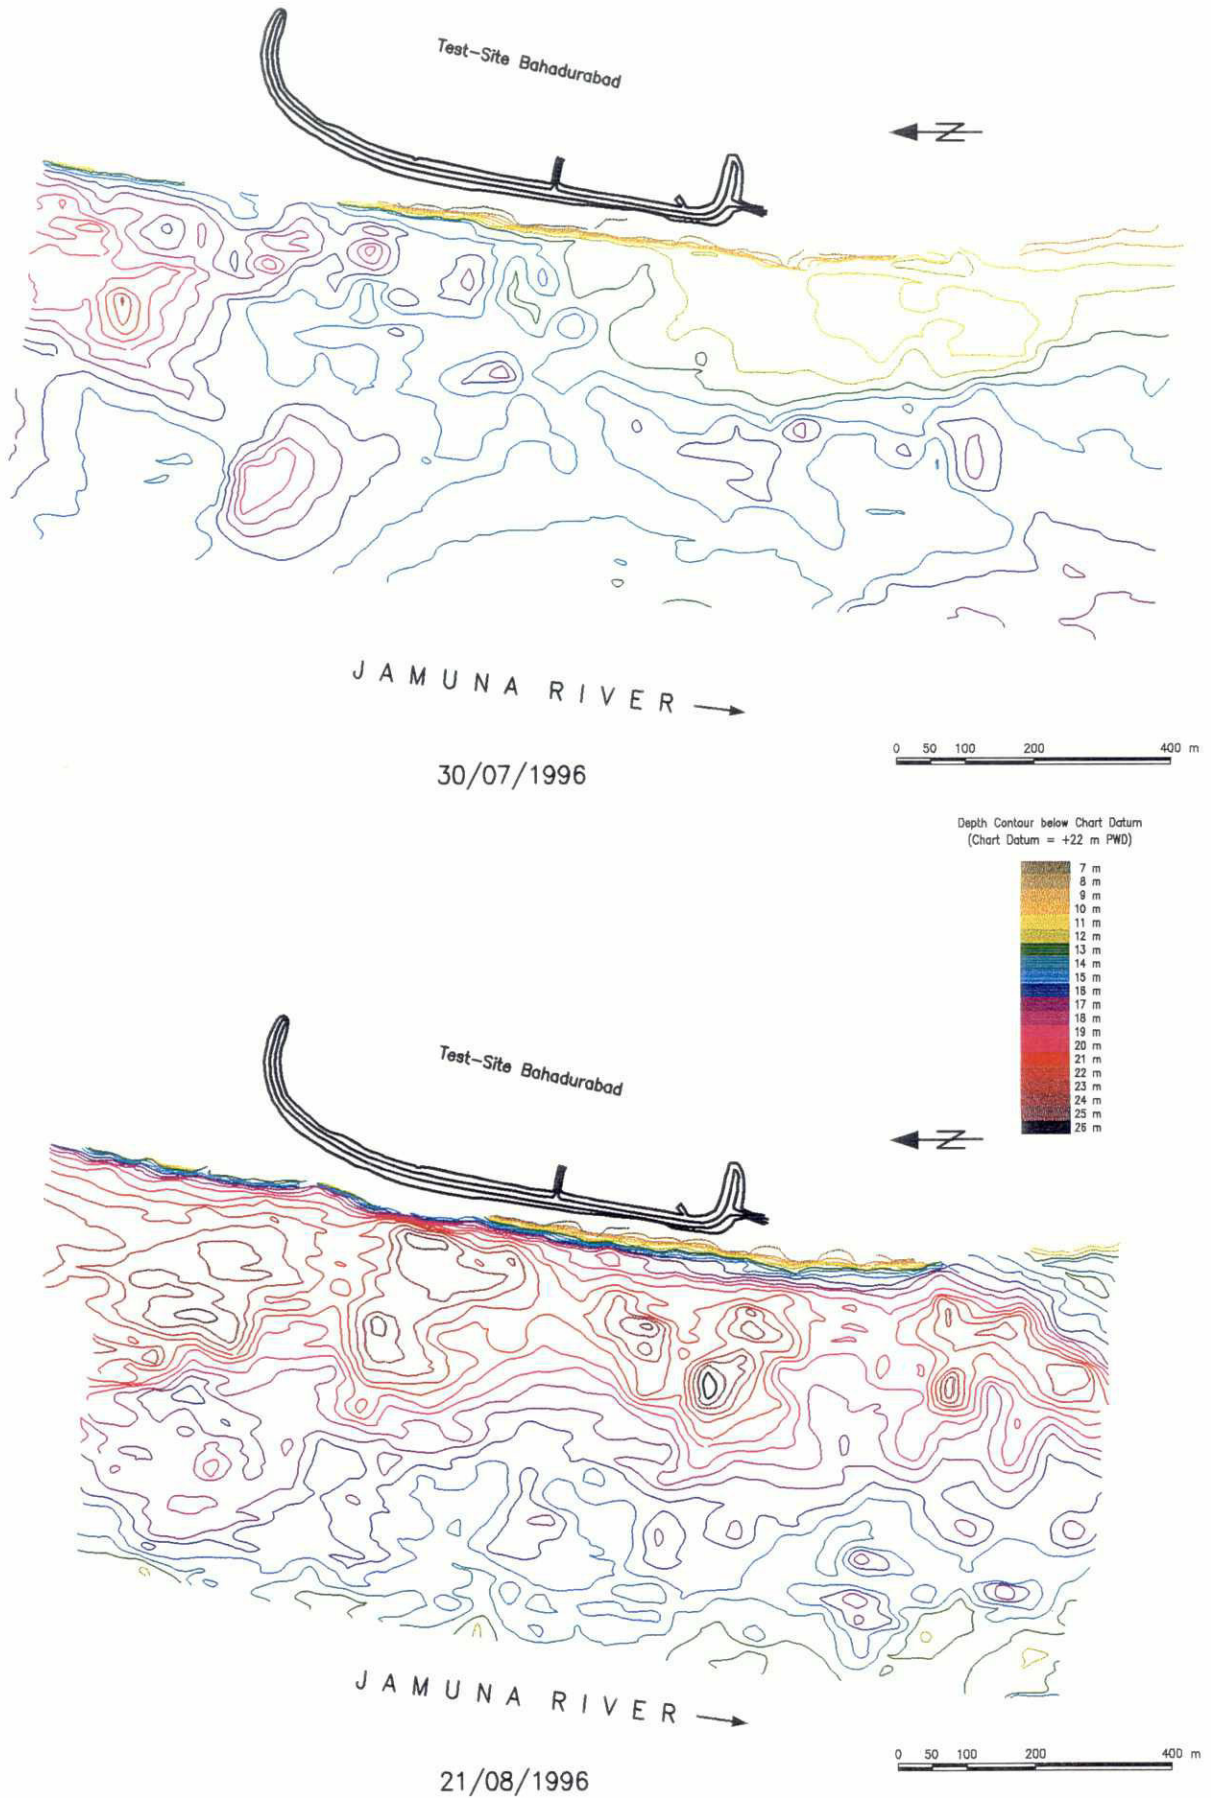
The Jamuna was very active at Bahadurabad also after the high water on the 15/07/1996. The bathymetric surveys carried out by the Consulting Consortium from the 30/07/96 and from the 21/08/96 show how the progressive bed and bank erosions have extended further south within just three weeks (fig. 20). The bed was deepened by more than 10 metres in front of the test site caused by the strong flow attack. This is demonstrated by the flow tracks described in the following.

Fig. 20: Morphology at Test Site Bahadurabad; Bathymetry Surveys from 30/07/96 and 21/08/96

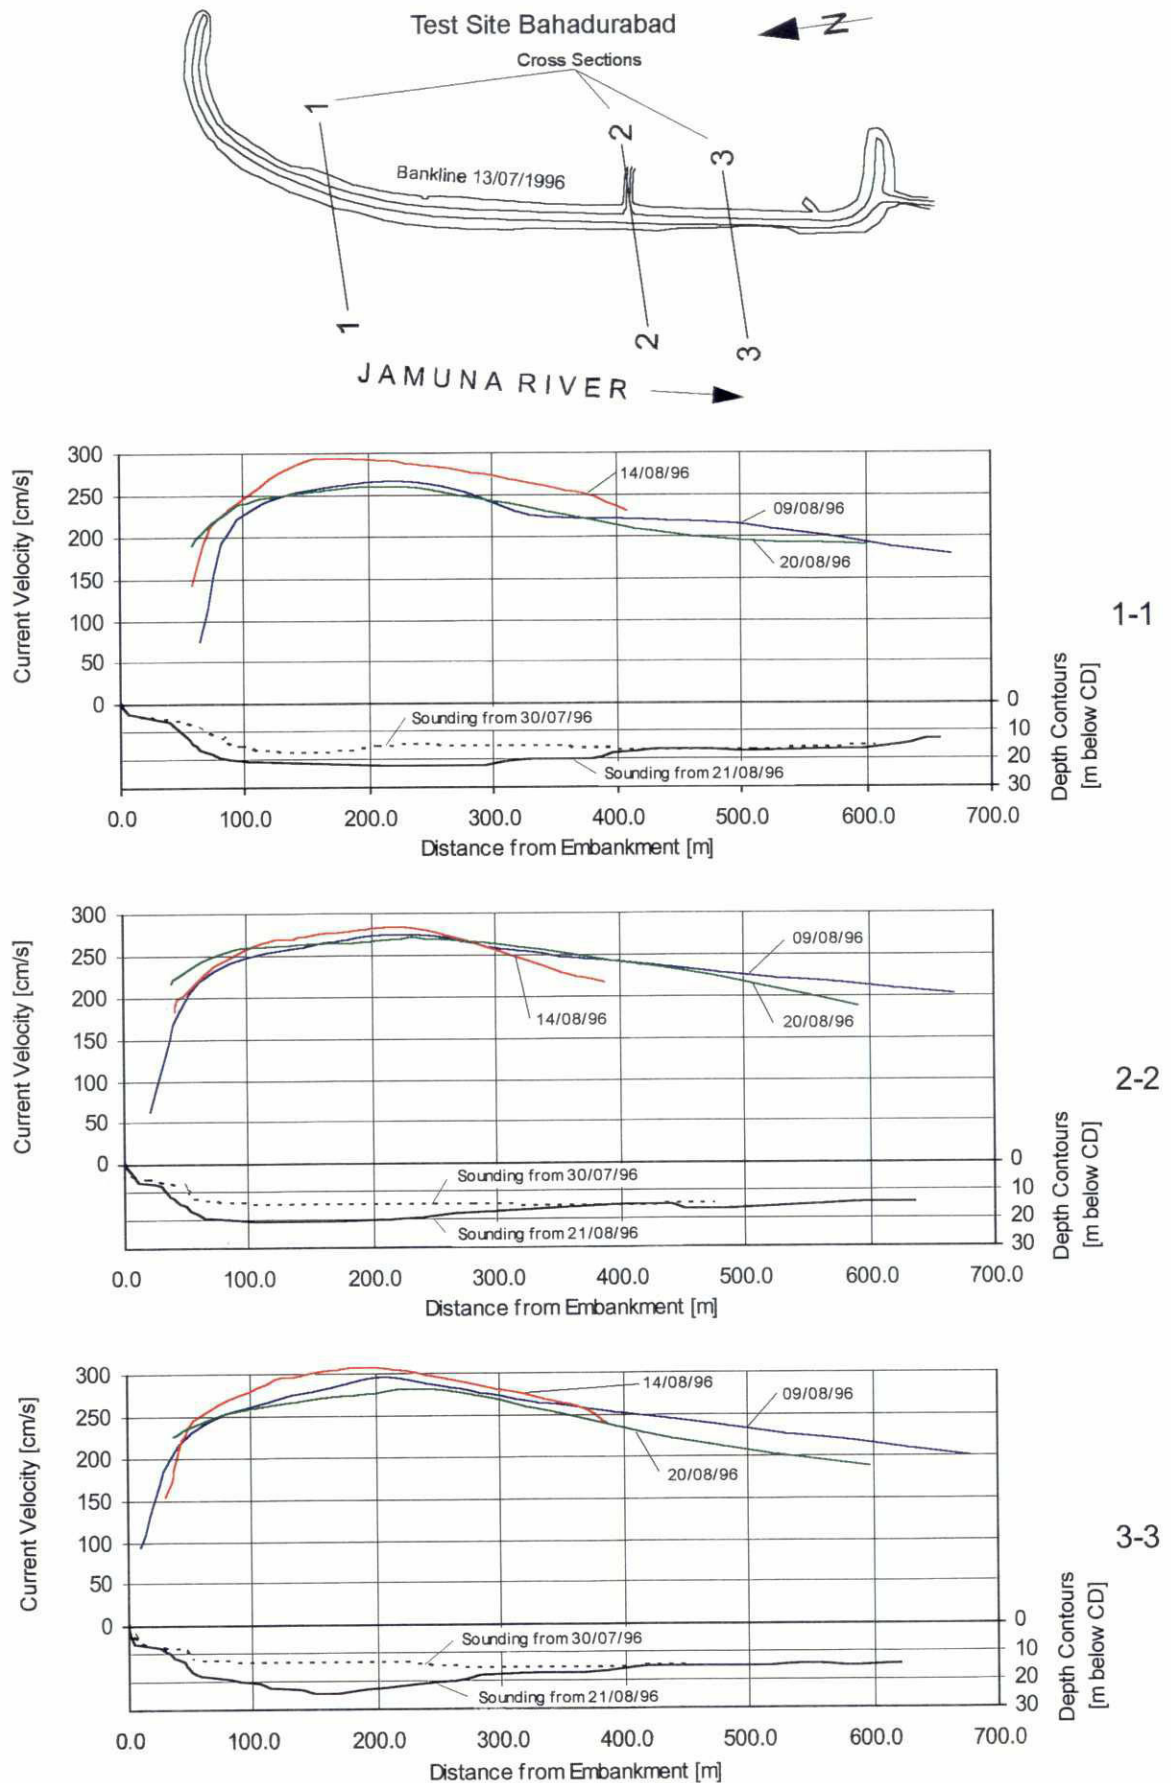
The comparison of the cross sections from the soundings from the 30/07/96 and 21/08/96 documents the extremely high bed erosions on the left bank. The highest vertical erosions reached over 10 metres at the profile 3-3 through the lower stretch of the test site. The highest horizontal erosions of about 30 metres within three weeks were encountered at cross section 1-1.

Fig. 21: Distribution of Current Velocities through Cross Sections 1-1, 2-2 and 3-3
