**BANK PROTECTION AND
RIVER TRAINING (AFPM)
PILOT PROJECT
FAP 21/22**

**REPORTS ON SUB-WATER INVESTIGATIONS
OF FALLING AND LAUNCHING APRONS:
A. VISUAL INSPECTION BY DIVING, AND
B. SIDE SCAN SONAR SURVEY
AT
TEST SITE II - BAHADURABAD**

FEBRUARY AND MARCH, 1999

JAMUNA TEST WORKS CONSULTANTS, JOINT VENTURE
CONSULTING CONSORTIUM FAP 21/22

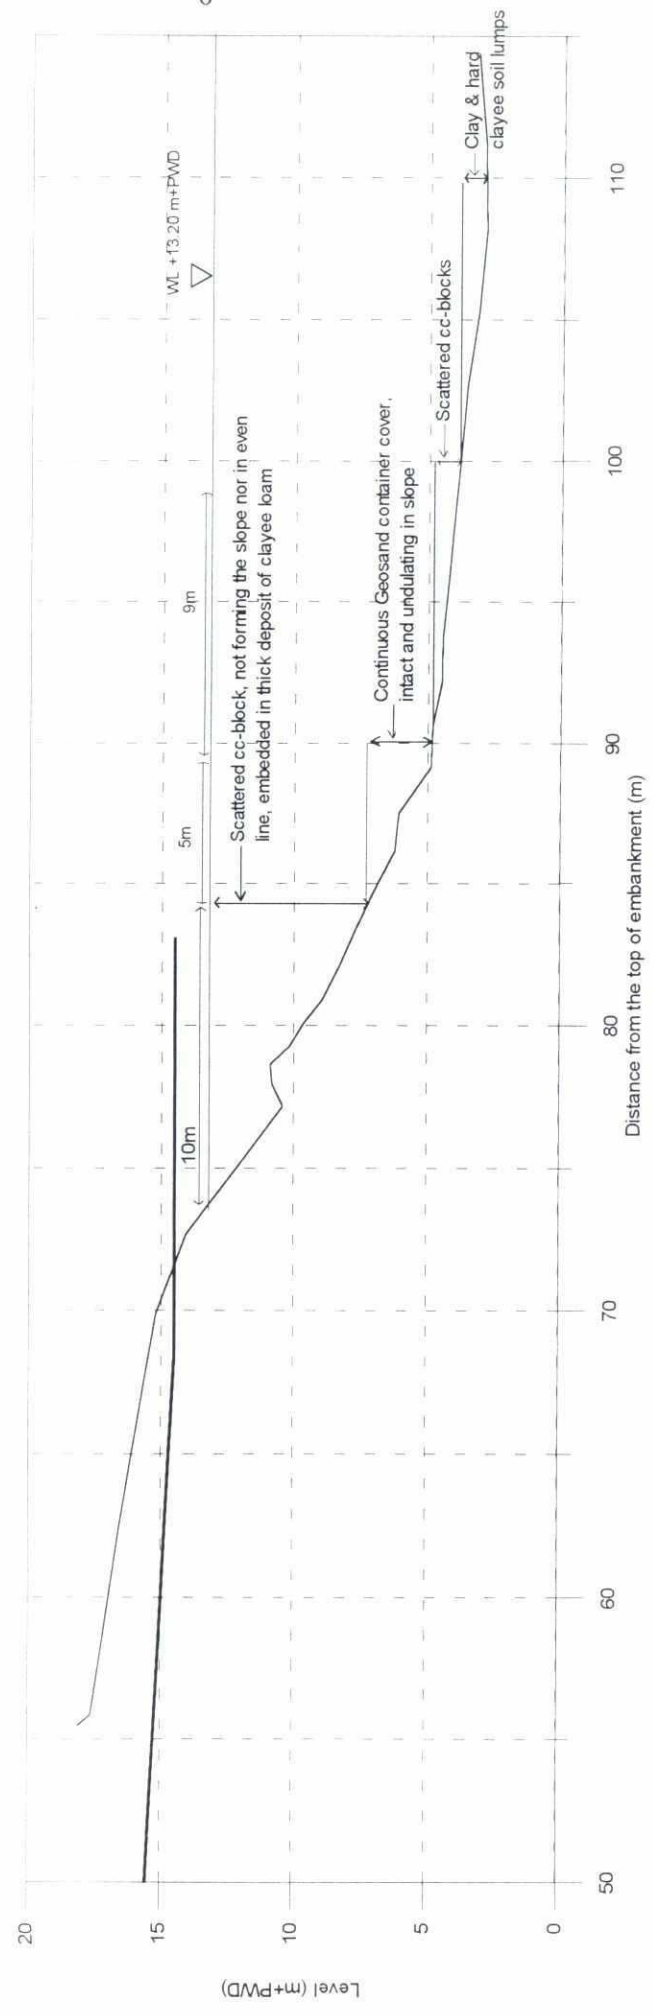
Results of Inspection by Diving
Bahadurabad Test Site
Upstream Transition of X_sec: B [16/02/99]

Existence of cc-blocks was found approx. 10 m from waterline. The blocks were scattered and did not form the slope, also nor in evenline. The slope is covered by thick deposit of clayee loam at the beginning of section B. Slightly upstream of the section start of a scour hole was located. Approximately the hole is 3 m x 3 m x 1.5 m in size at water depth of 4 m.

Geo-sand container was found in Section B as continuous cover over bed material up to 15 m from waterline. The bags were intact, undulating in slope. Scattered cc-blocks were also found in this section up to 24 m from waterline. Rest of the slope was composed of soil and hard clayee soil lumps.

REMARKS: The scattered cc-blocks found at the bottom of the slope are the remaining ones in the stack yard at natural cofferdam after the structure section. With the first disappearance of the cofferdam by erosion of the river, probably the blocks settled directly at that location.

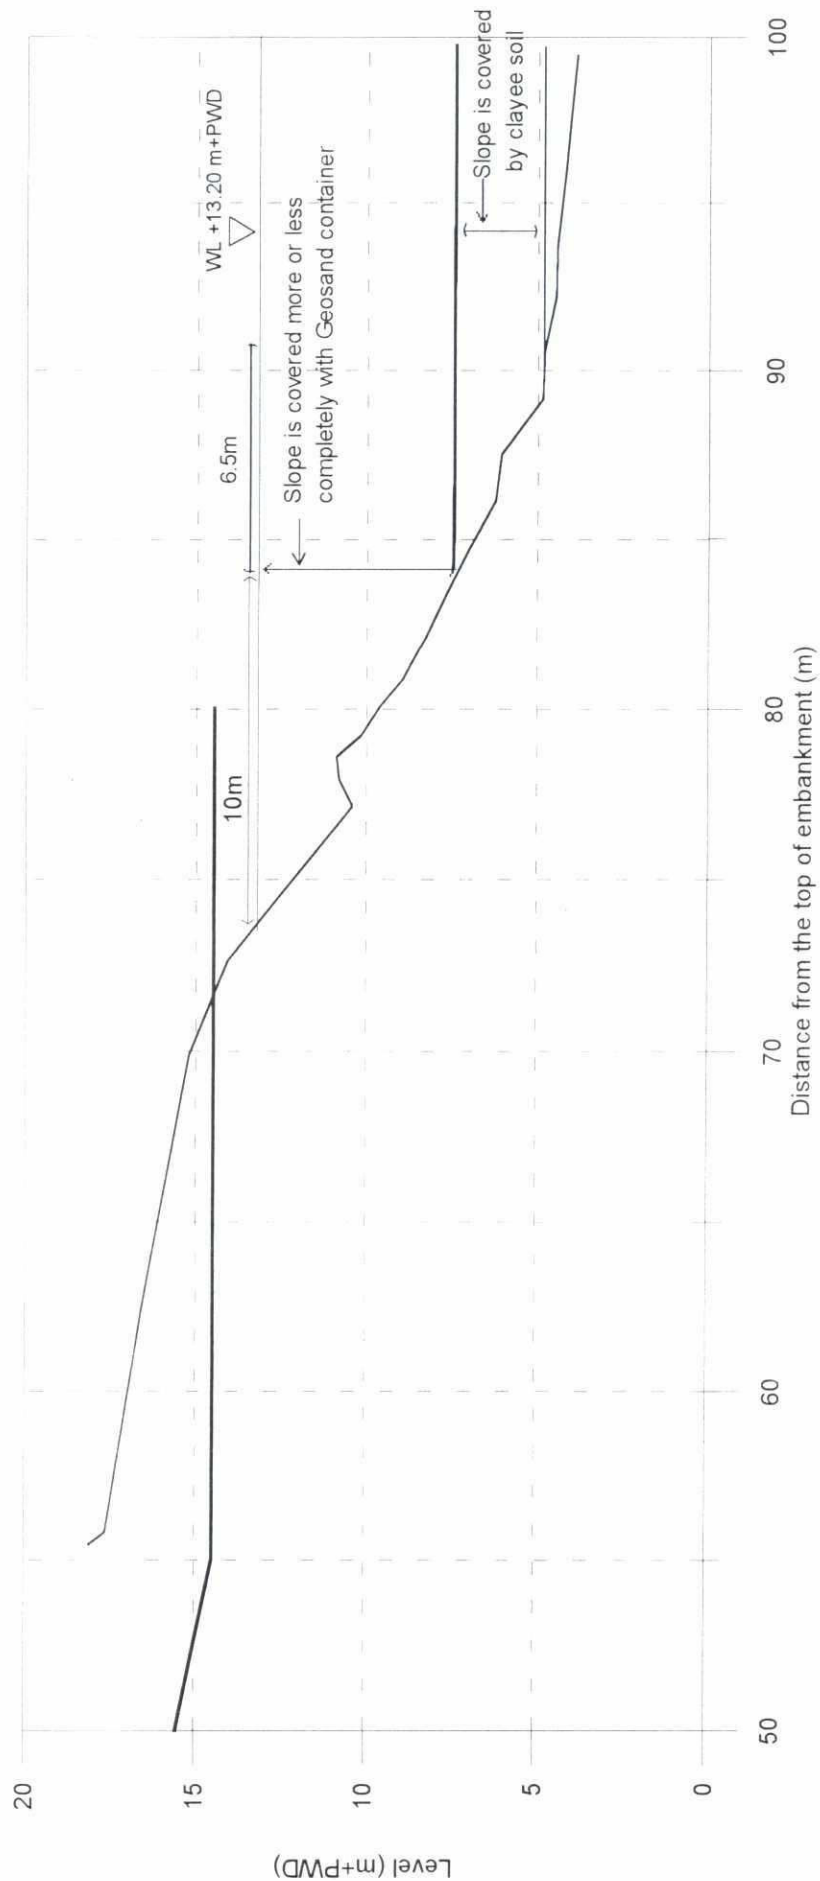
Results of Inspection by Diving
Bahadurabad Test Site
Mid of X_sec: B [17/02/99]

Approx. 12 m from waterline the bed was found in uniform gentle slope and then a sudden drop, then again uniform slope. Up to 12 m, the slope is covered by Geo-sand container covering the bed material more or less completely. After the drop, no more geo-sand container – the slope is covered by clayee soil.

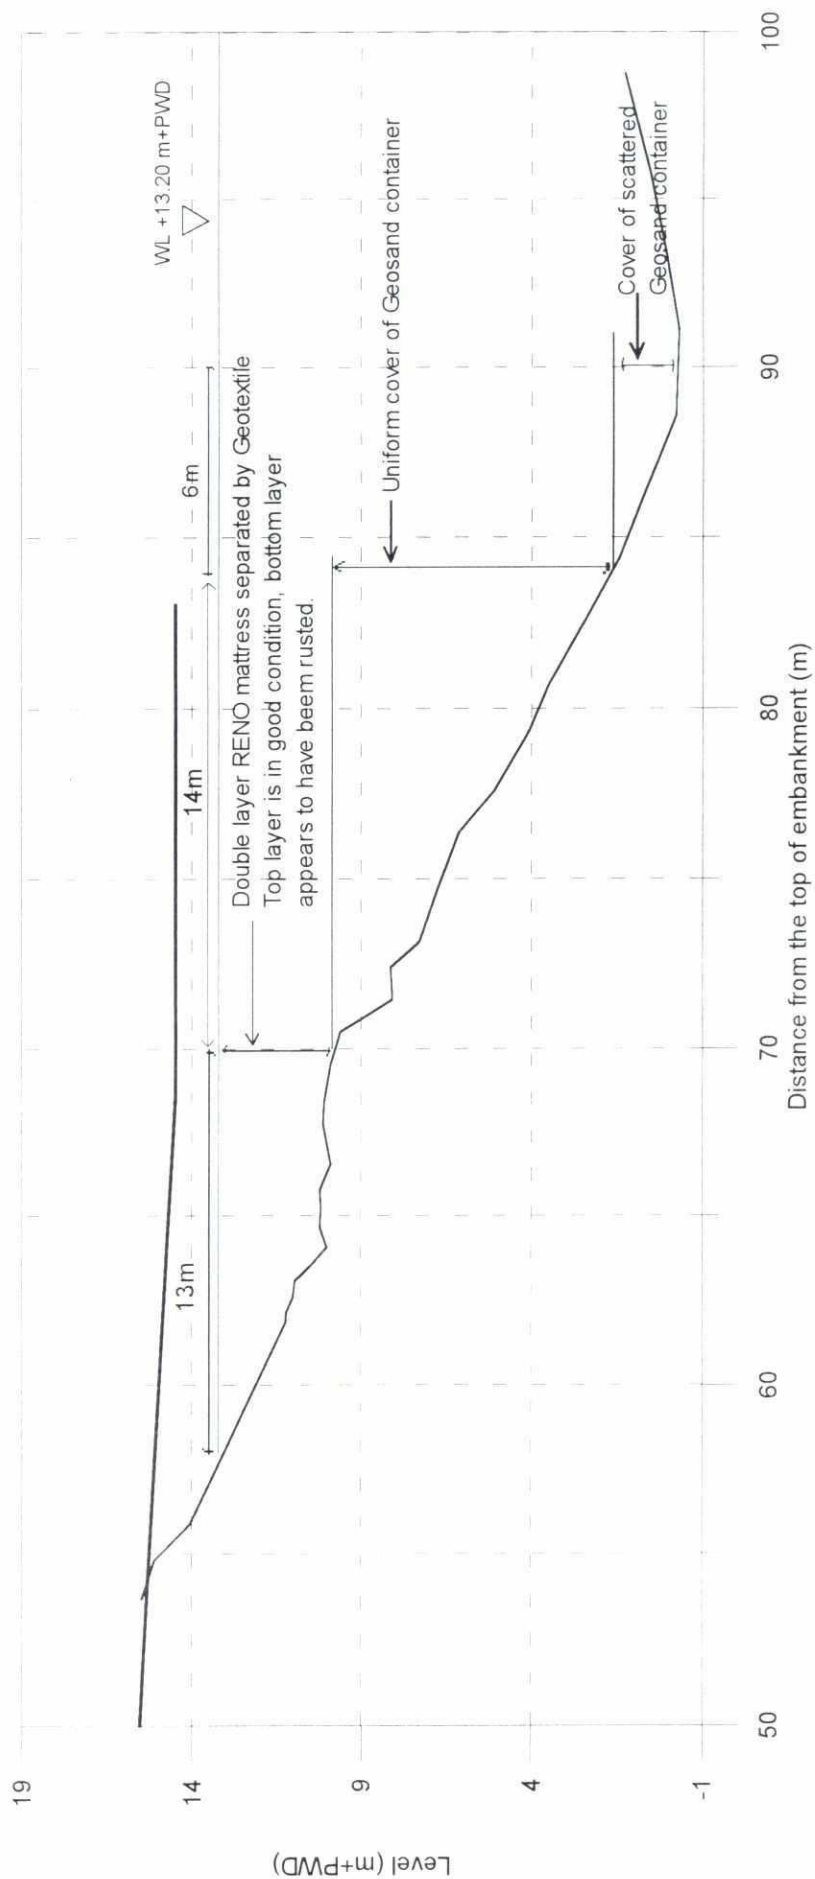
Results of Inspection by Diving Bahadurabad Test Site Transition of X_sec: B & C [16/02/99]

Close to the transition and up to 10 m upstream in section B, the slope is covered by random cc-blocks and sand bags – scattered and few in numbers.

From transition to downstream in Section C, RENO-mattress in double layers was found. Geotextile sheet separating two layers of Reno-Mattress and top layer RENO-mattress were found in good condition. Bottom layer appeared to have been rusted. Beneath RENO-mattress Geo-sand containers were found. This was up to 14 m in slope from waterline.

After this 14 m, further 16 m of slope was covered by geo-sand container in uniform slope and then scattered geo-sand container.

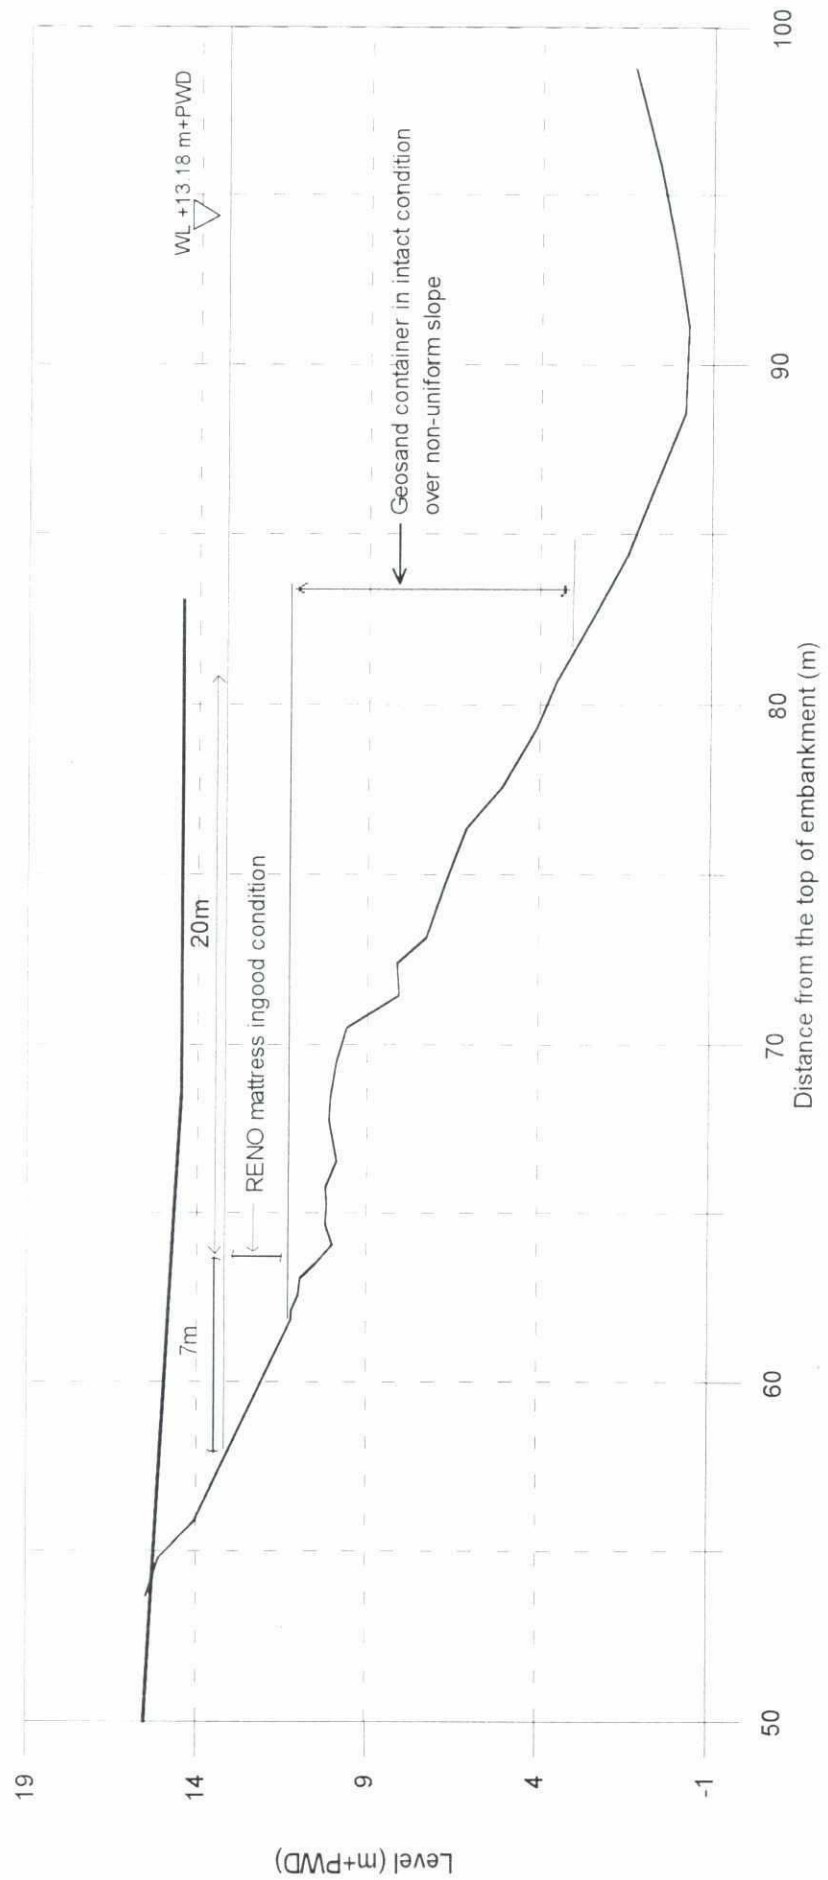
Results of Inspection by Diving
Bahadurabad Test Site
Transition of X_sec: C [17/02/99]

Slope was covered by RENO-Mattress up to distance of 12 m from the waterline. The connecting wire between adjacent first and second RENO compartment at a distance of about 3 m from waterline was torn away and the mattress rolled upward. Few gravels were lost from the top.

Geo-sand container covered the slope from 12 m to 36 m. These were not in uniform thickness, rather were found in single, double or even in triple layer. Between geo-sand containers, free soil surface was encountered, but this gap of free soil surface were small. Deposit of silty loam type soil in dense layer was found after the end of geo-sand container to the bottom of the slope. Over the geo-sand container no soil deposit was encountered, but algae type growth was detected.

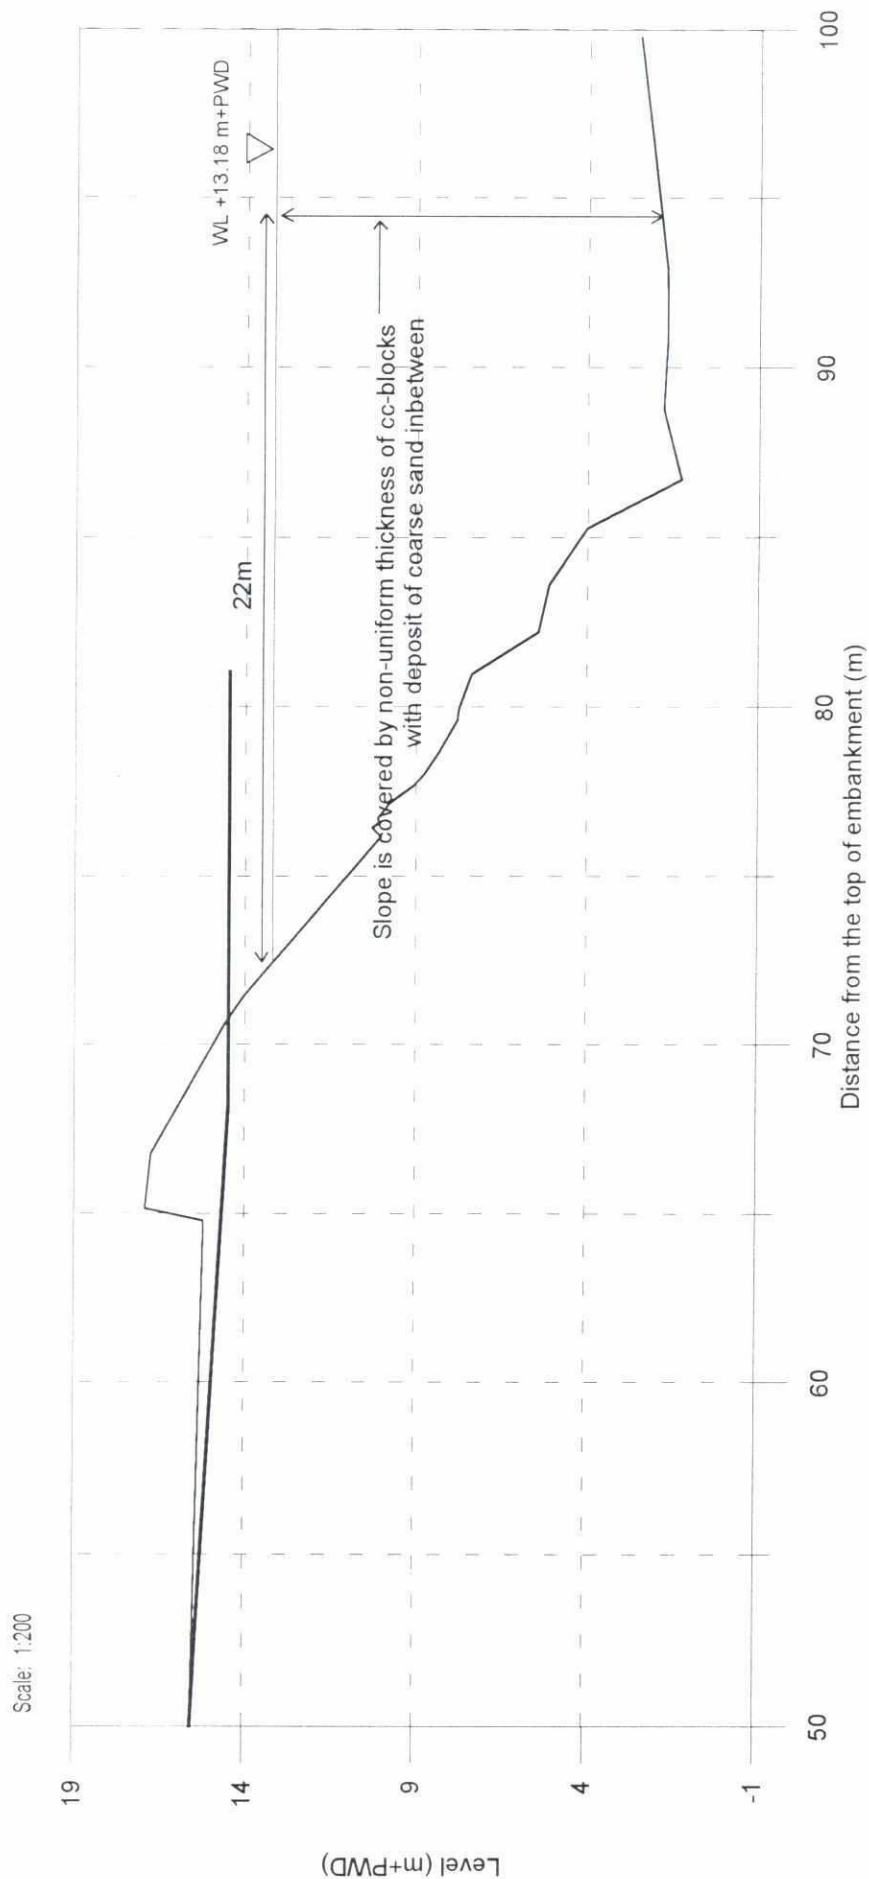
Results of Inspection by Diving Bahadurabad Test Site X_sec: D [17/02/99]

Section D: End of Falling Apron was detected at a distance of 24 m from waterline. Falling apron cc-blocks has taken non-uniform slope up to the end and between these coarse sand deposit was found. A sunken country boat propelled by engine was found at the end of falling apron block. Falling pattern was the same as is seen above waterline.

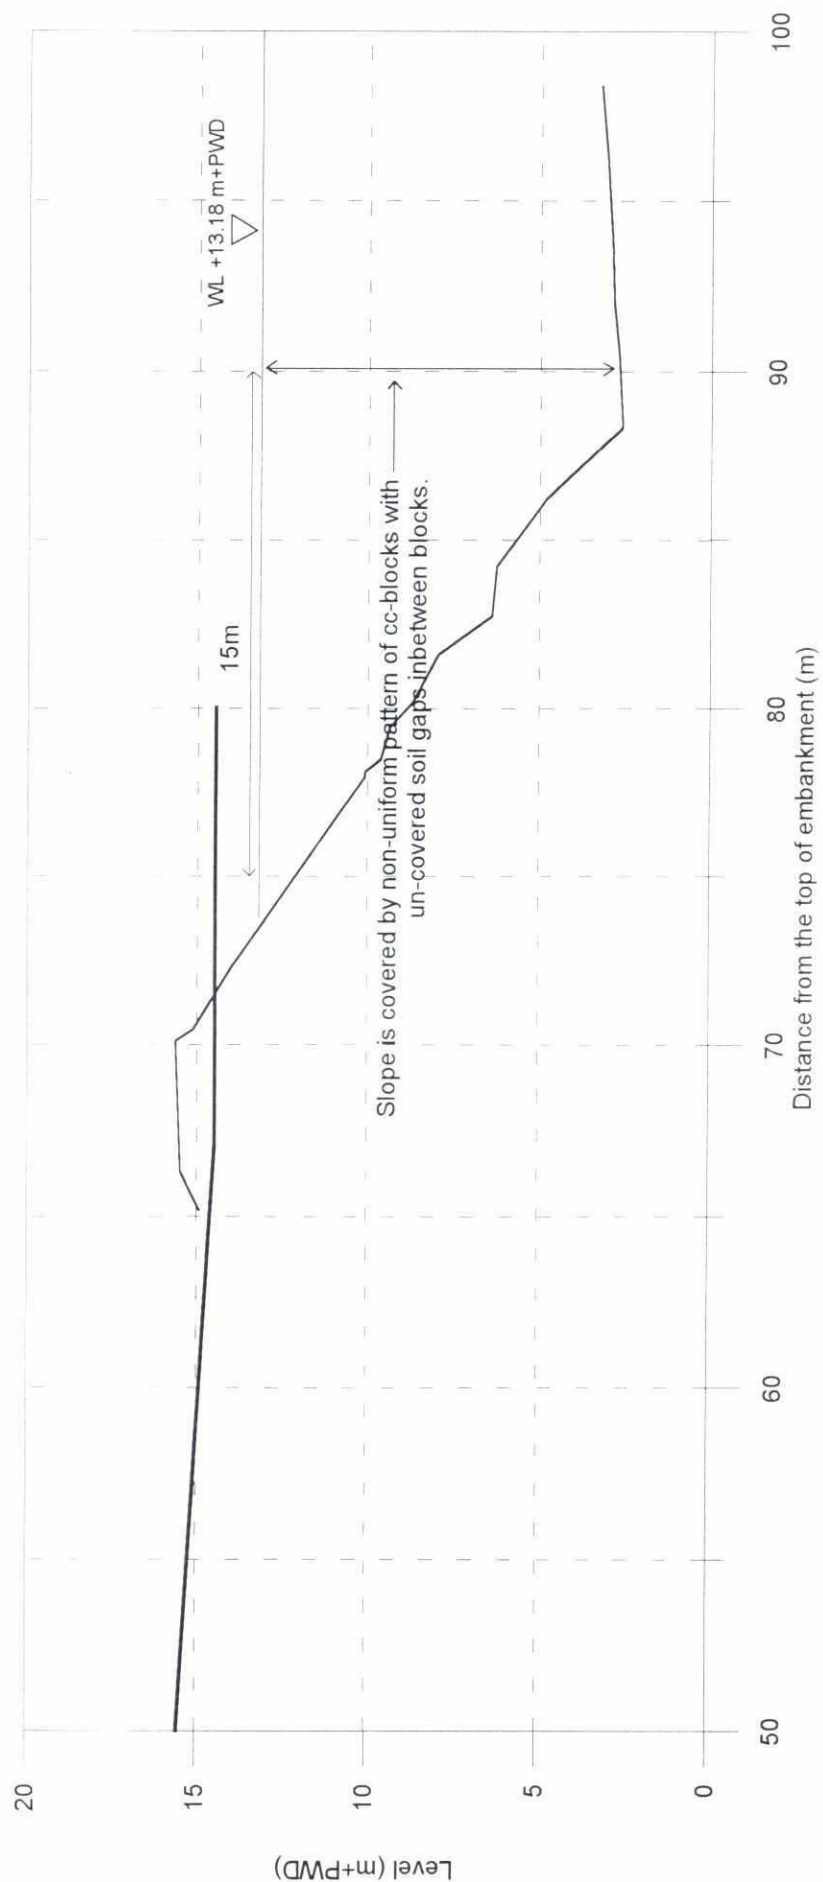
Results of Inspection by Diving
Bahadurabad Test Site
X_sec: E1 [17/02/99]

CC-blocks were found up to a distance of 12 to 15 m from waterline, but not in uniform pattern. Intermediate gaps were between 2 to 3 meters and uncovered soil was seen in these gaps. At the end, bed has raised slightly.

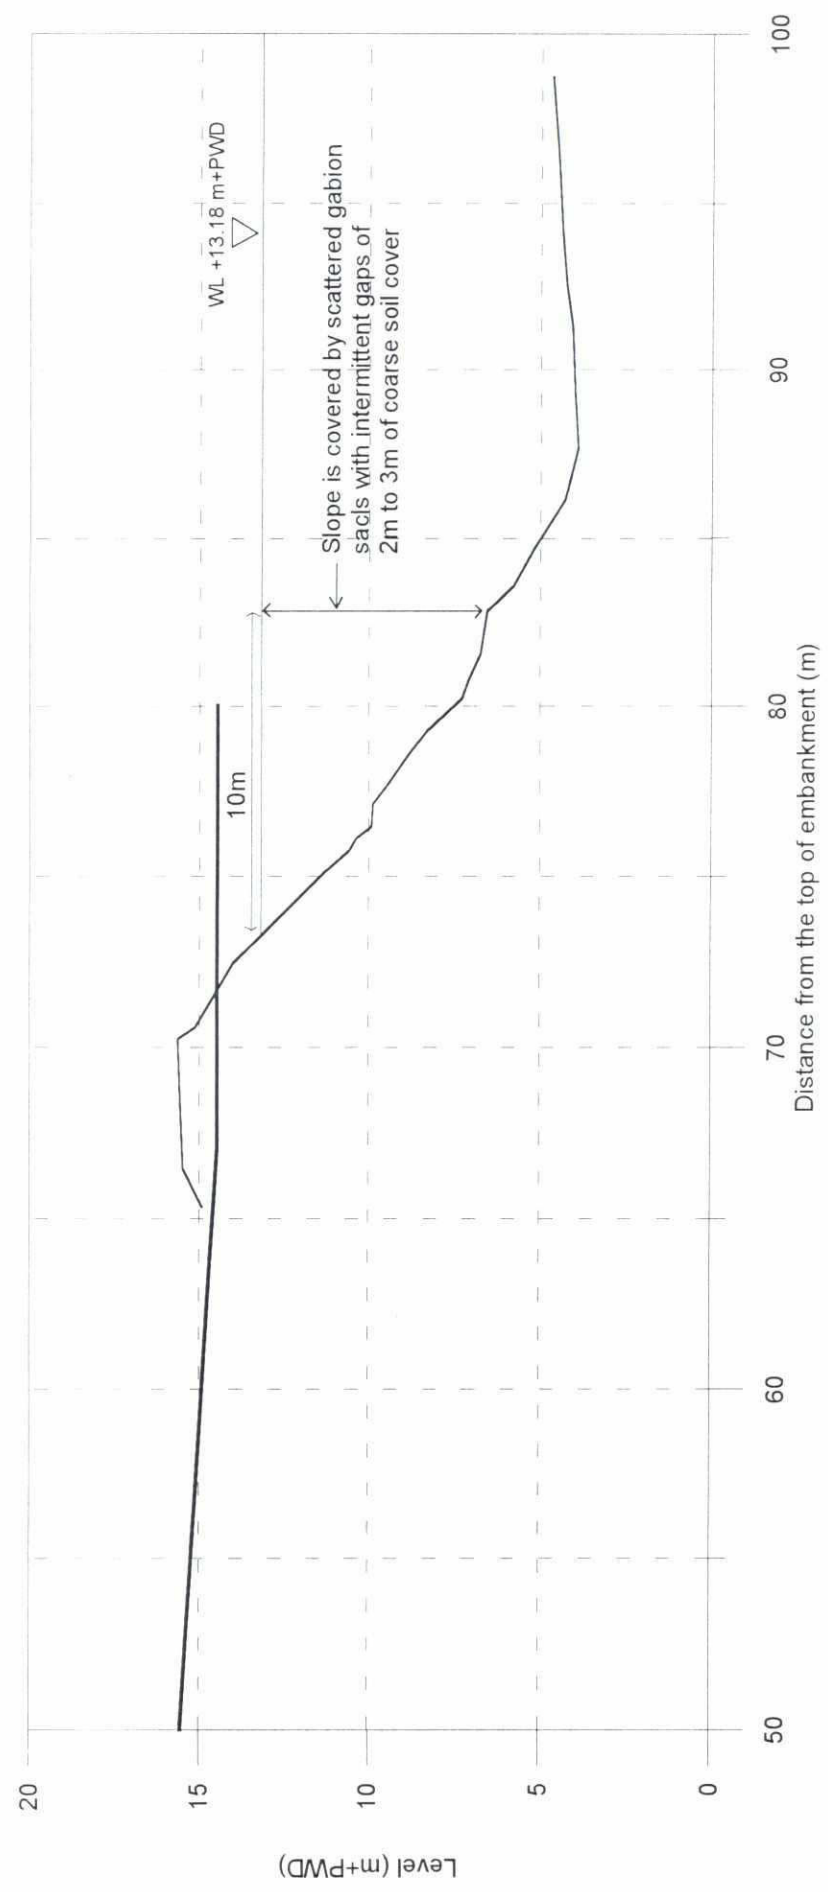
Results of Inspection by Diving
Bahadurabad Test Site
X_sec: E2 [17/02/99]

Scattered gabion sacks were found with intermittent gaps of 2 to 3 meters. In gaps, soil cover only with coarse sand deposit was found and extended up to 15 to 18 m from waterline. End raised slightly.

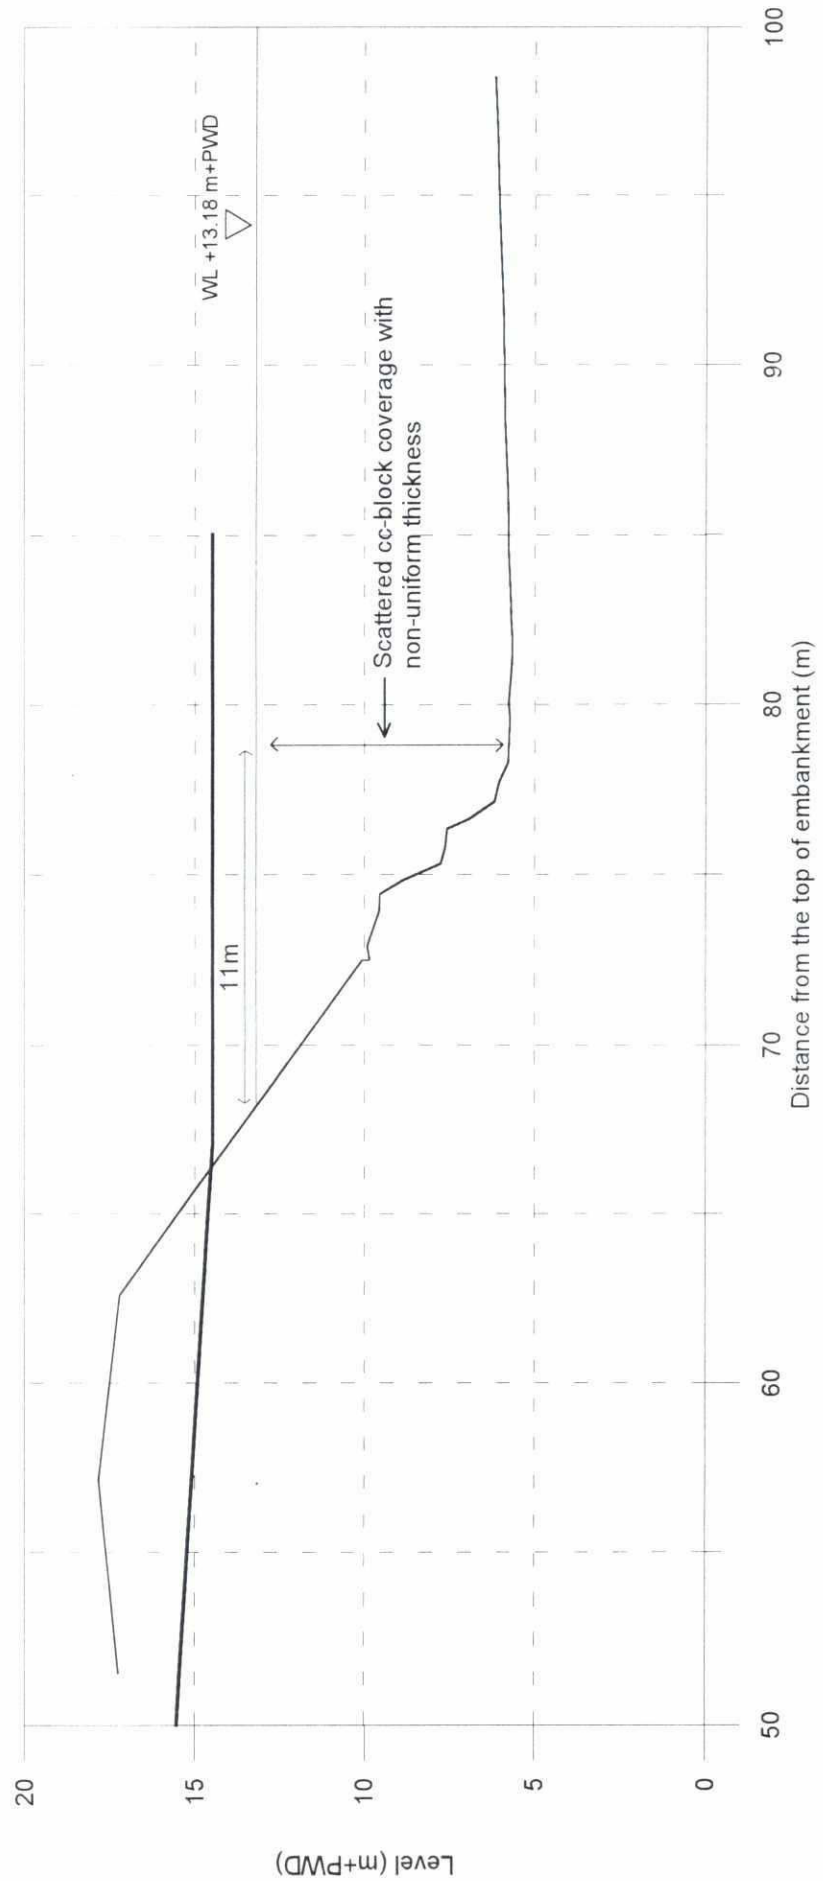
Results of Inspection by Diving
Bahadurabad Test Site
X_sec: F [17/02/99]

CC-blocks covered a length of 13 m in to the river. The total length has not been covered by blocks. In some place in this area, block was heaped together and in other place, no block at all. The heap is quite vertical and seemed that would collapse with small disturbance. Uniform channel like formation between blocks in longitudinal direction was found.

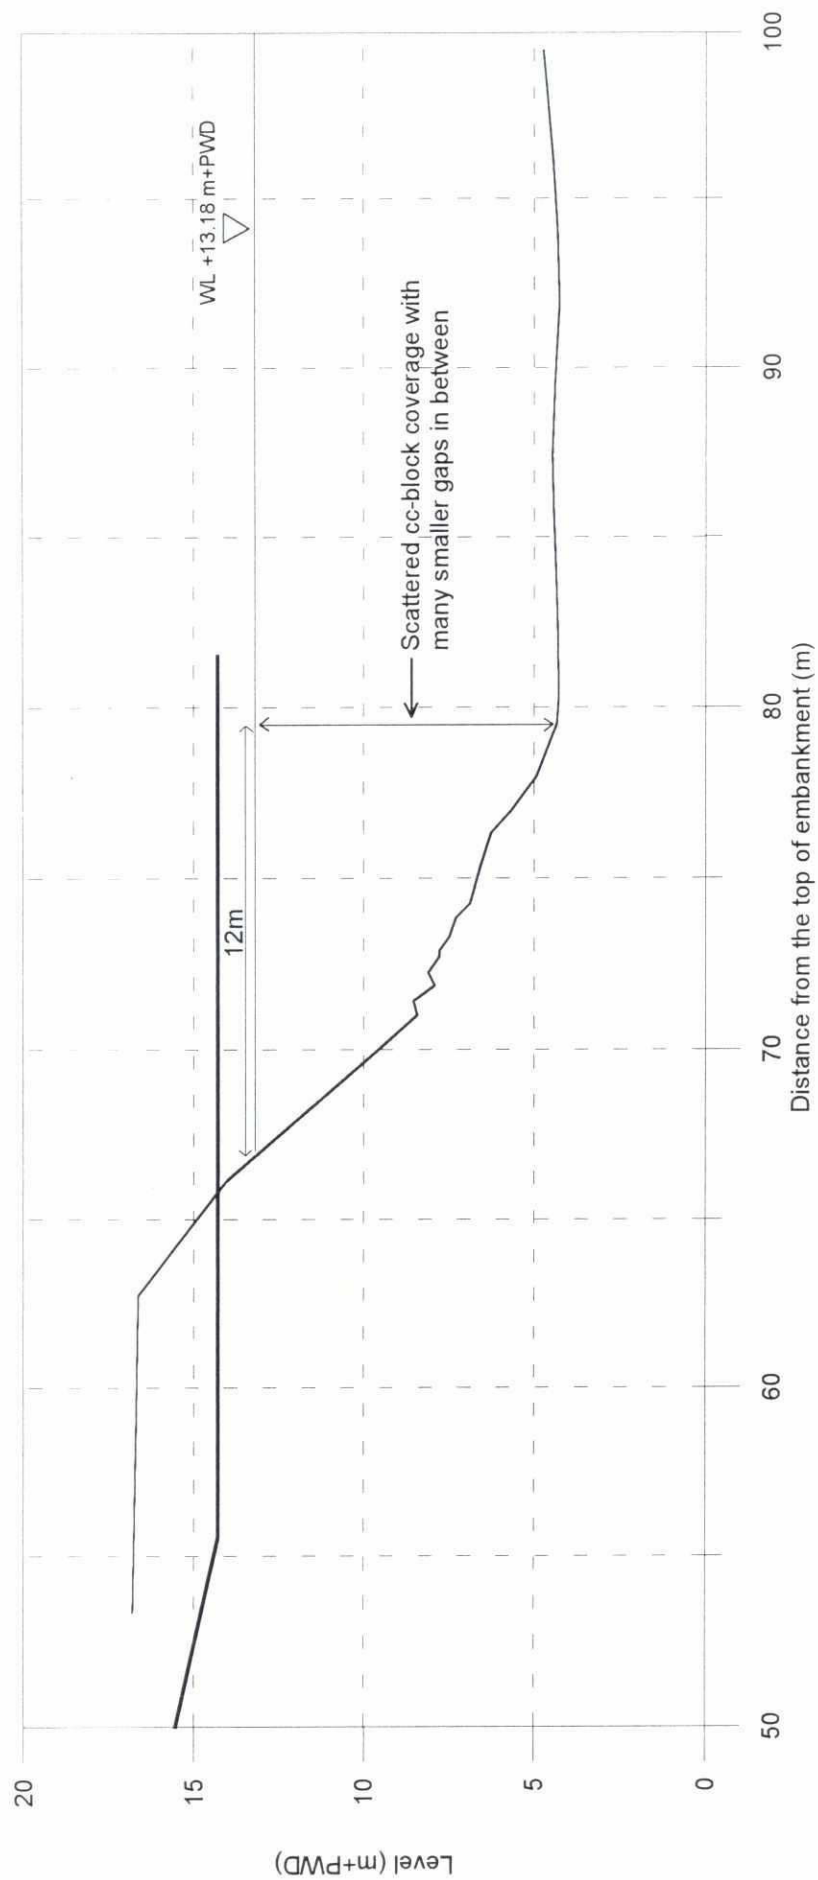
Results of Inspection by Diving
Bahadurabad Test Site
X_sec: G [17/02/99]

Scattered blocks with gaps in between but not very big was found up to a distance of 15 m from the waterline. Number of gaps were large. Raised sand of 1 m width in longitudinal direction in some part was found.

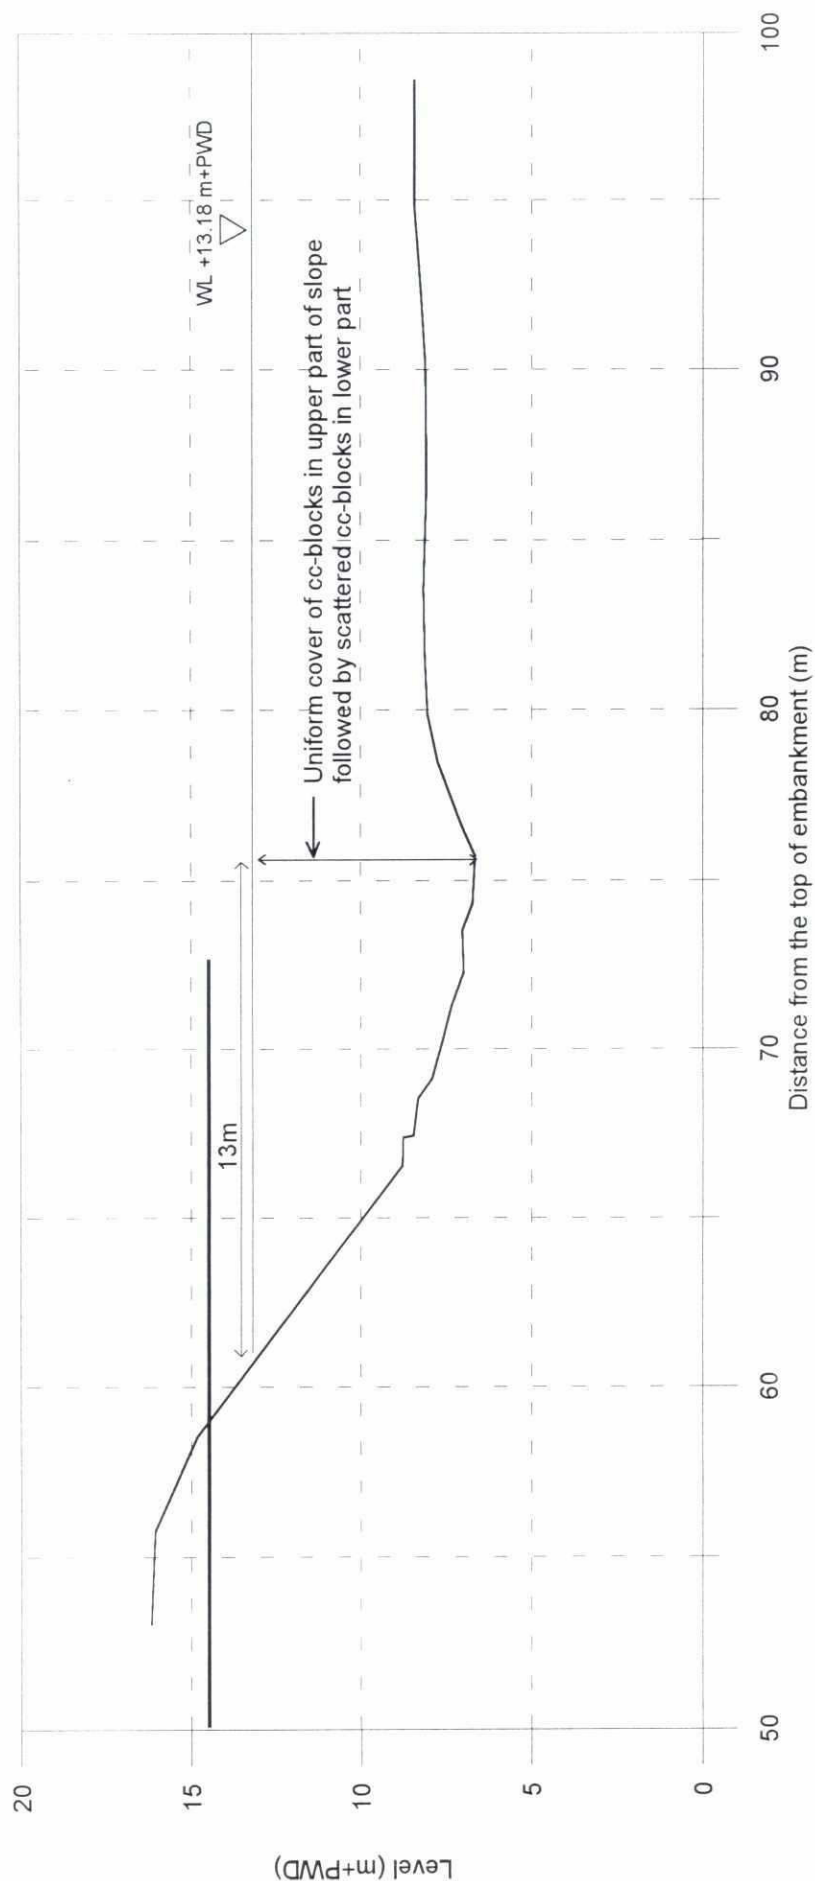
Results of Inspection by Diving
Bahadurabad Test Site
X_sec: H1 [17/02/99]

Scattered cc-blocks were found after the slopped cc-blocks extending more or less uniformly from a distance of 16 m to 8 m in upstream to downstream direction. Clay soil was encountered after cc-block. Bed is more or less uniform.

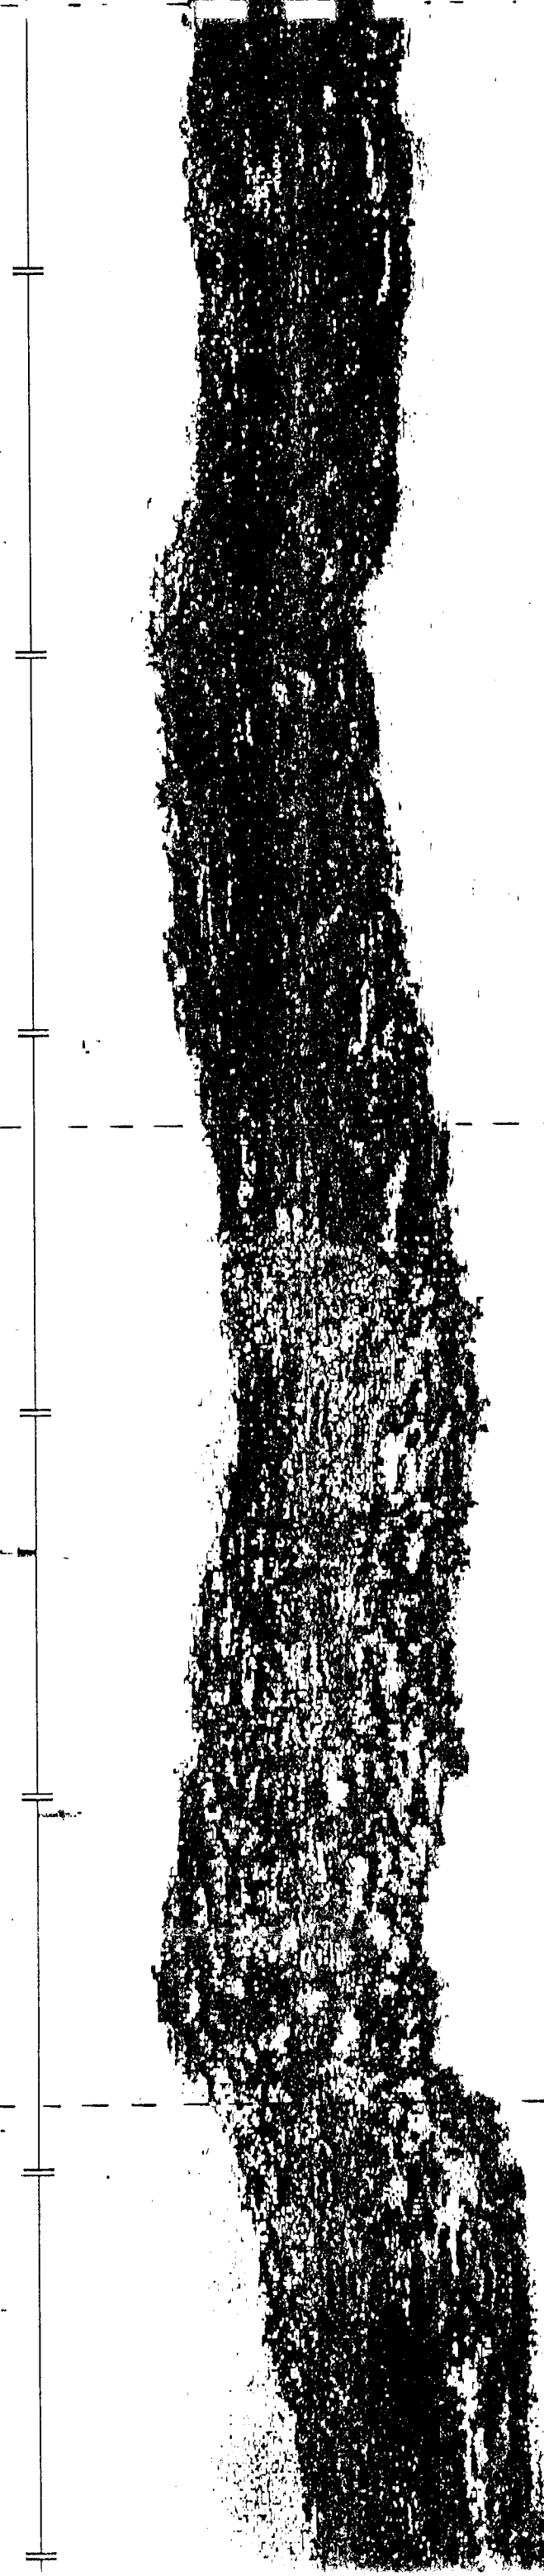
Fig. 6: Section D side scan sonar record

The submerged part of the falling apron of section D is completely covered by the side scan sonar profile 10m off from the original end of falling apron (Fig.6, Fix 349-354). The survey profile has been maintained 0-2m offline from the selected trackline. The corresponding Masterchart Filename is 10B02.LOG. A strip of more than 10m width is detected by the side scan sonar all over the section. The predominant darkness of the reflection in section D is characterized by the cc-blocks of the falling apron. Lighter areas in between should be caused by some sand deposition. In the area of fix number 352 the falling apron has moved farthest towards the river. The left side of the sonograph shows the contour of the western edge of the river channel.

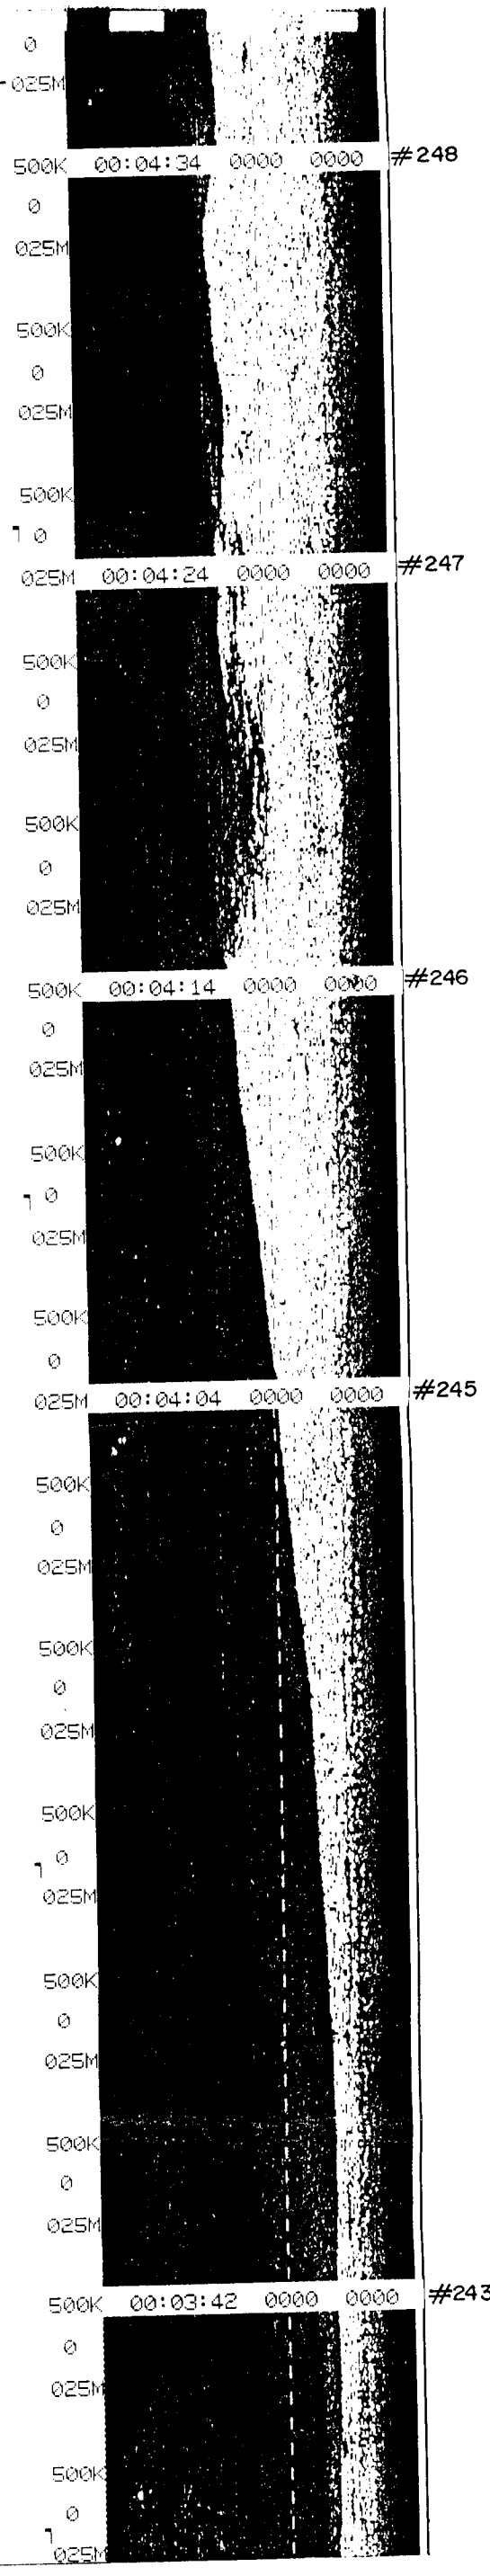
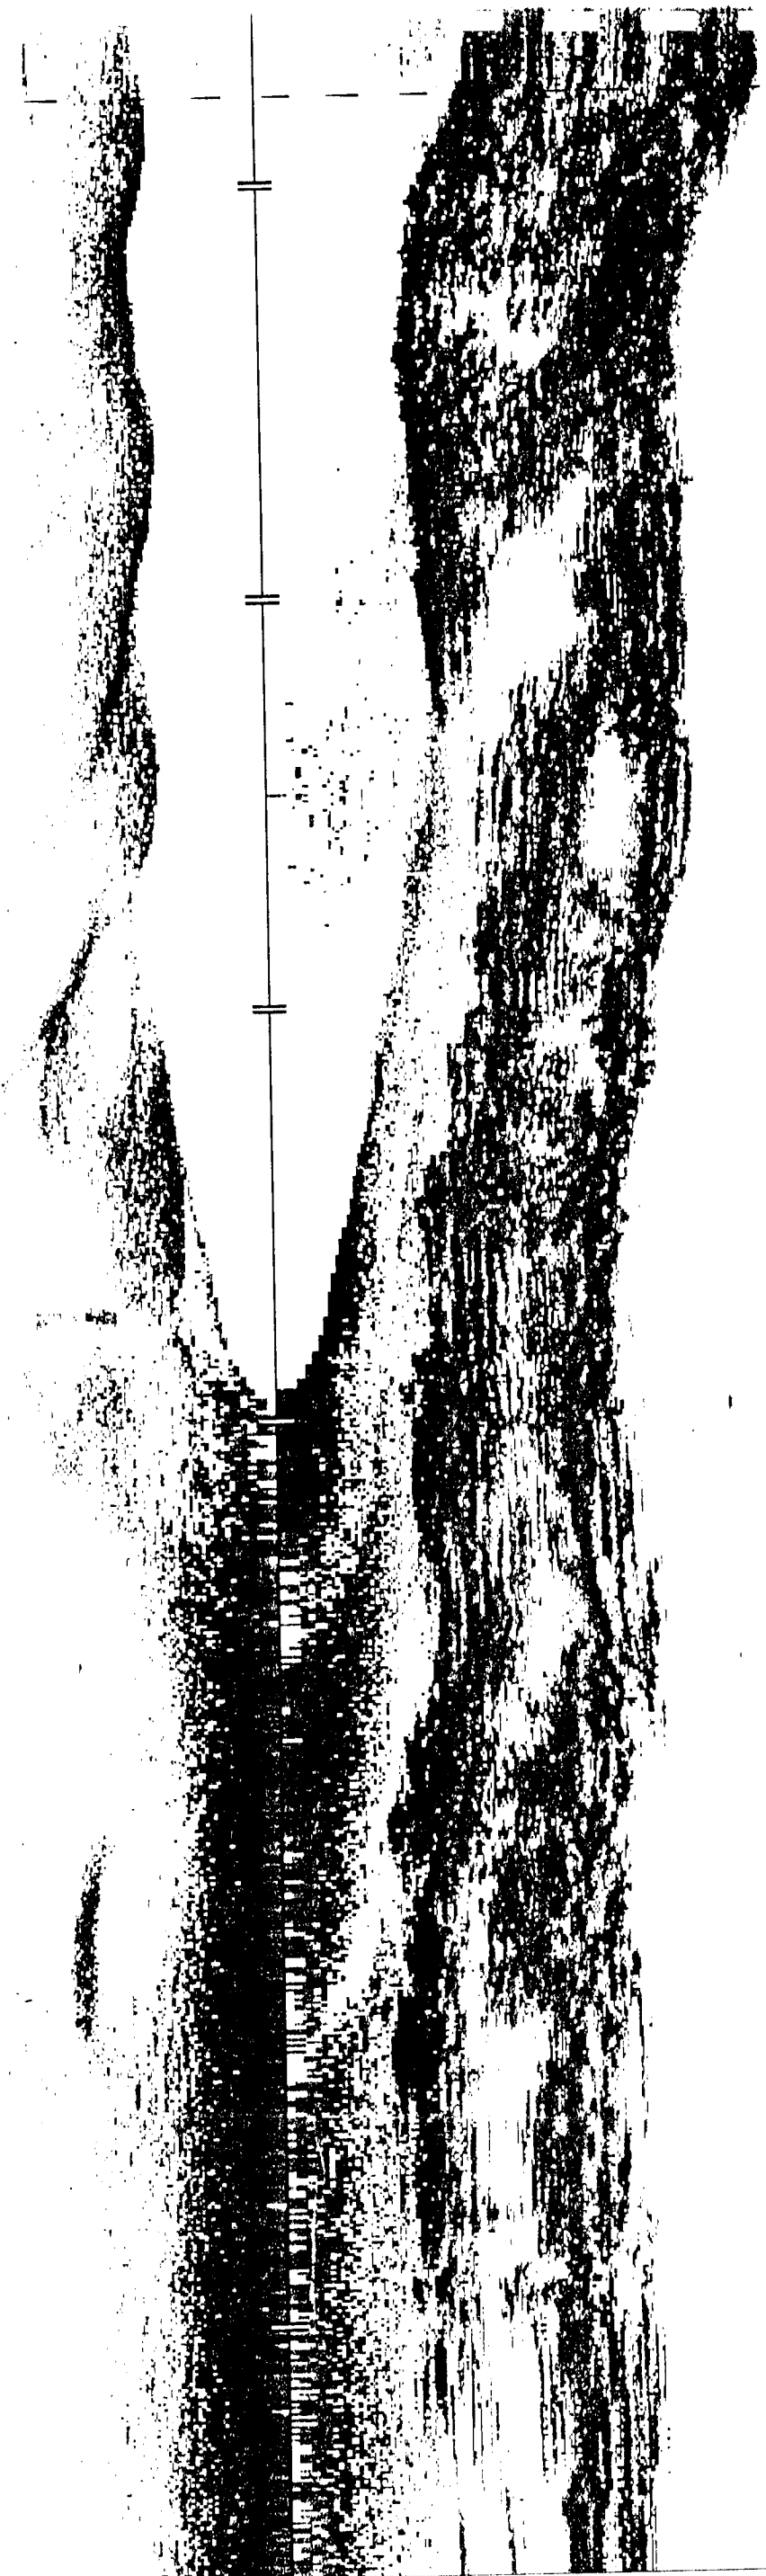
Fig. 8: Section F side scan sonar record

The sonograph (Fig.8, Fix 337-343) shows the submerged part of the falling apron at section F. The trackline has been selected 10m off from the original end of falling apron. The corresponding Masterchart Filename is 10B02.LOG. The survey profile has been maintained 0-1m offline from the selected trackline.

Remarkable is the point downstream of fix number 341, where the falling apron has move farthest towards the river. Further downstream the falling apron is characterized by more lighter areas, which indicates more sand deposition between the cc-blocks.

The spreaded irregular dots in front of the falling apron area resulted by noise. The left side of the sonograph shows the contour of the western edge of the river channel.
