**BANK PROTECTION AND
RIVER TRAINING (AFPM)
PILOT PROJECT
FAP 21/22**

**FINAL PROJECT
EVALUATION REPORT**

- Annex 10: The Revetment Test Structure; Monitoring Report**
- Annex 11: The Revetment Test Structure; Evaluation of Hydraulic Loads and River Response**

DECEMBER 2001

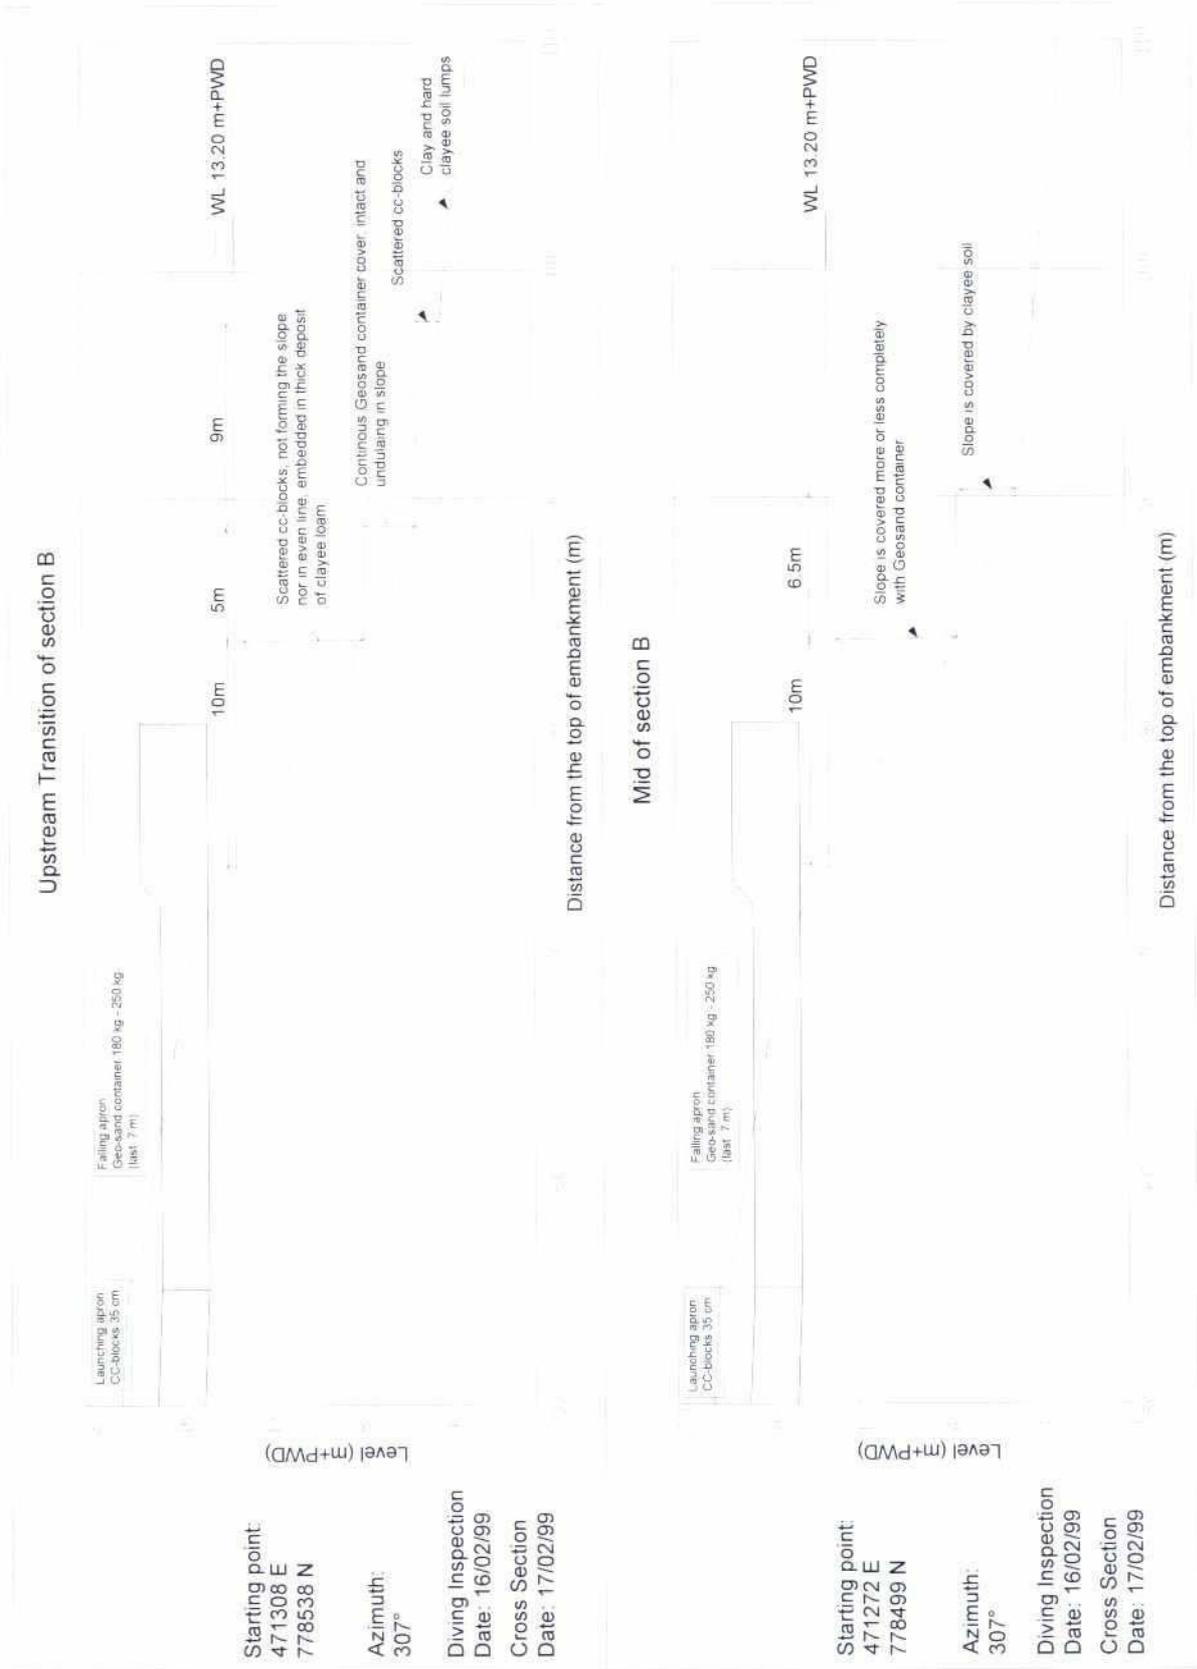
Fig. 5.3-1: Diving inspection at Section B

CC-blocks were found approx. 10 m from the waterline. The blocks were scattered and did not form the slope, nor in evenline. The slope was covered by thick deposit of clayey loam at the beginning of Section B. Slightly upstream from the section the beginning of a scour hole was located. The dimension of the hole was approximately 3 m x 3 m x 1.5 m at a water depth of 4 m.

Geo-sand containers were found in Section B completely covering the bed material up to 15 m from the waterline. The bags were intact, undulating in a slope. Scattered cc-blocks were also found in this section up to 24 m from waterline. The rest of the slope was composed of soil and hard clayey soil lumps.

Approx. 12 m from the waterline the bed was found in uniform gentle slope followed by a sudden drop, and then again uniform slope. Up to 12 m, Geo-sand container covered the slope more or less completely. After the drop, no more geo-sand container was found – the slope was covered here by clayey soil.

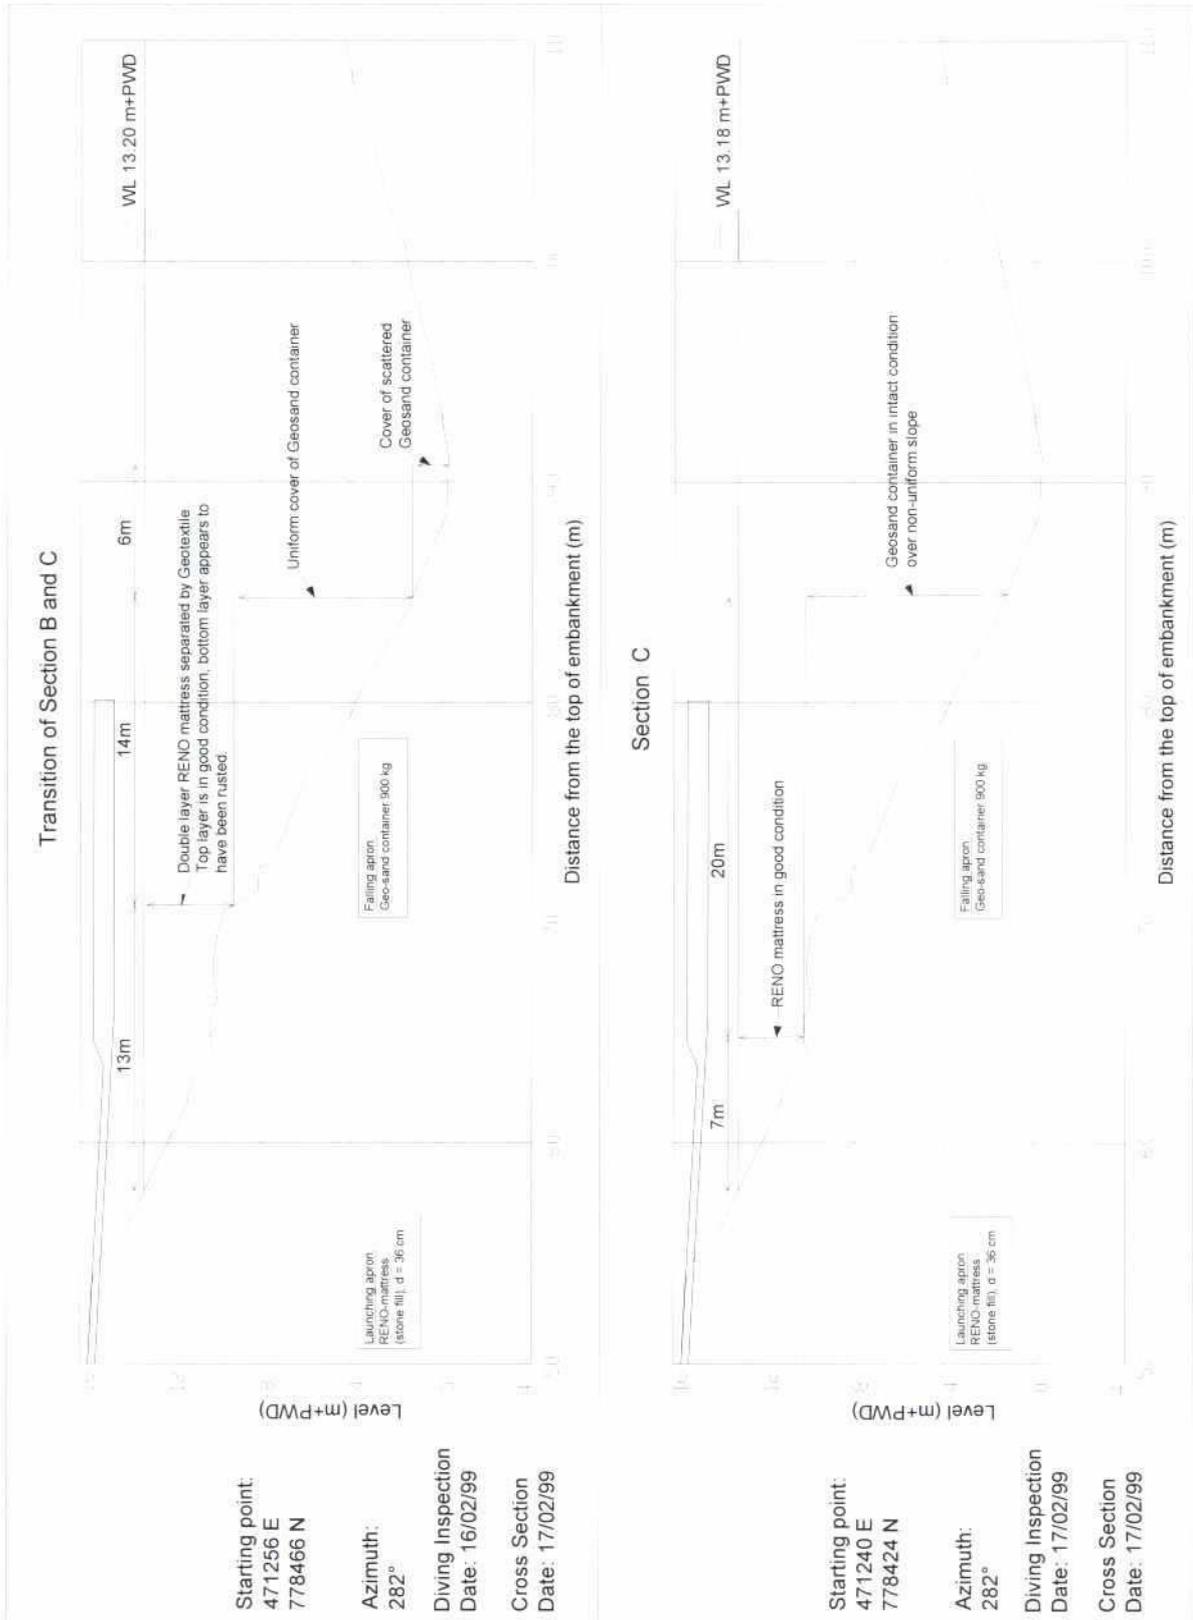
Fig. 5.3-2: Diving inspection at Section C

From transition to downstream in Section C, RENO-mattress in double layers was found. Geotextile sheet separating two layers of Reno-Mattress and top layer RENO-mattress were found in good condition. Bottom layer appeared rusted. Beneath RENO-mattress Geo-sand containers were found. This was located up to 14 m along the slope from the waterline.

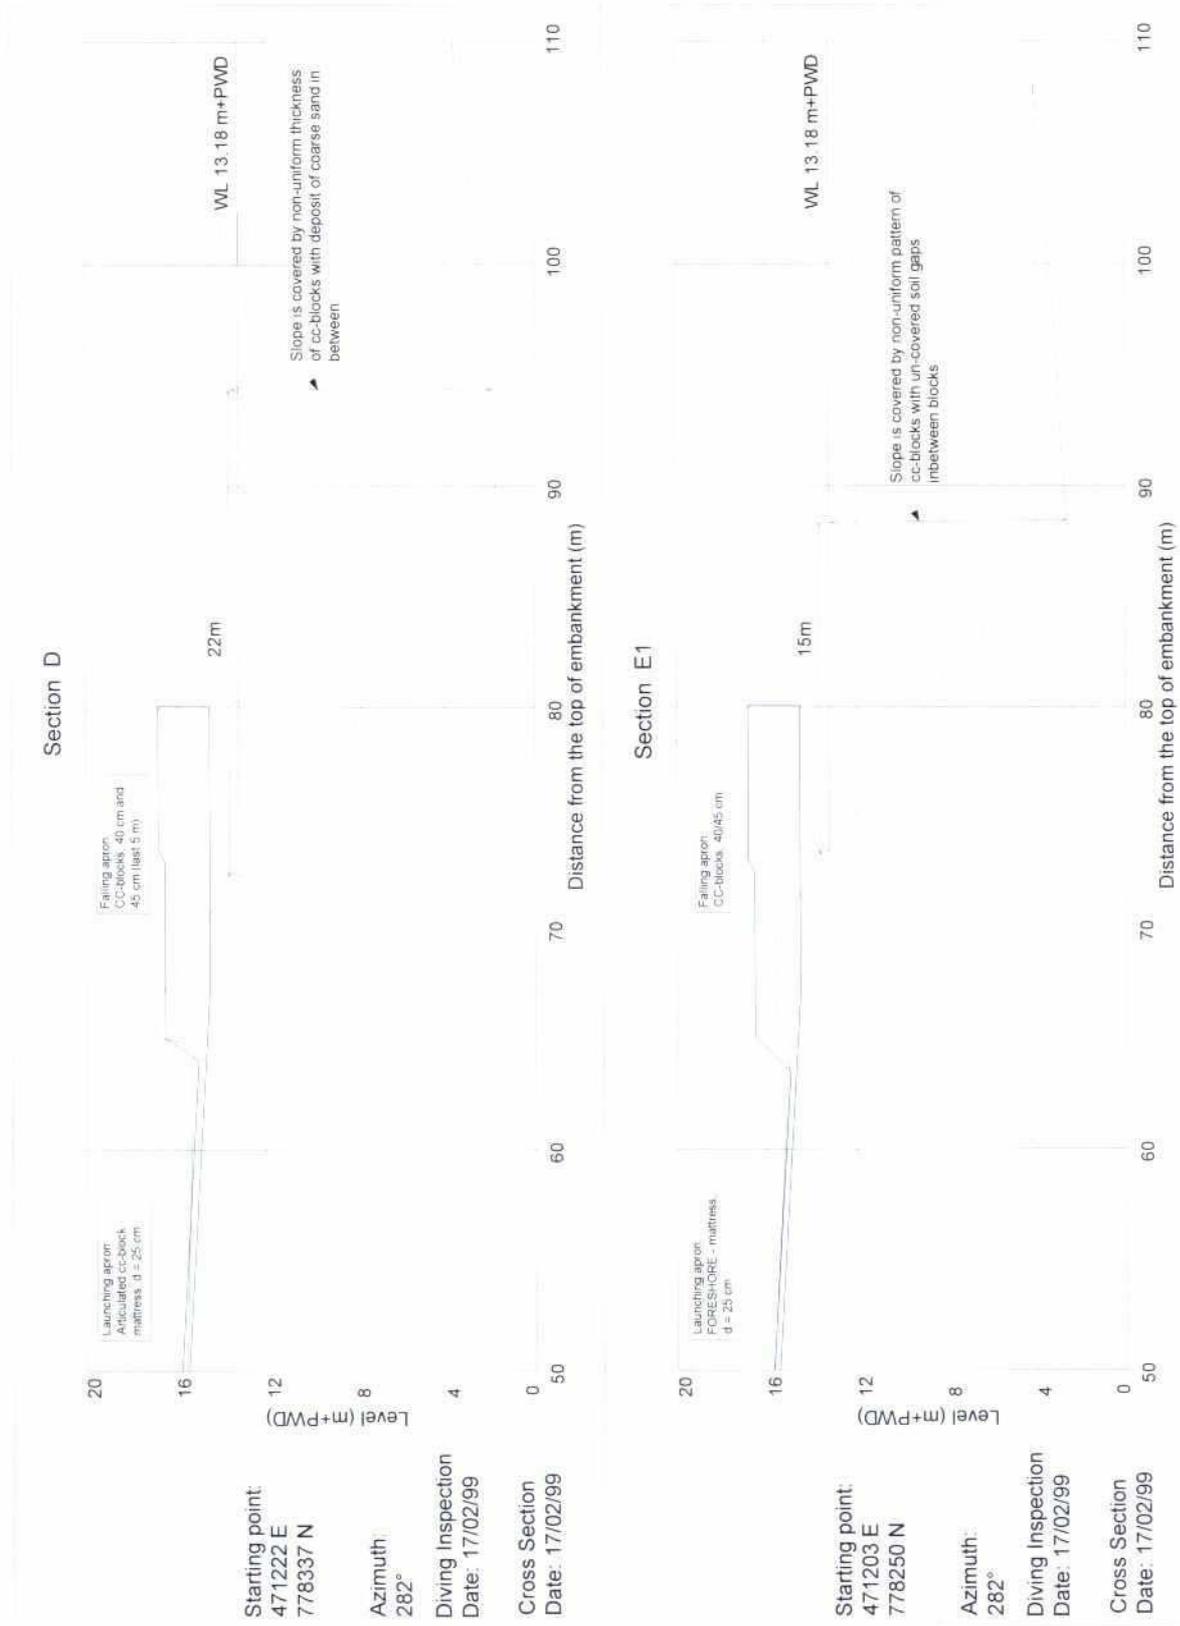
Fig. 5.3-3: Diving inspection at Sections D and E1

Geo-sand container covered the slope from 12 m to 36 m. They were not in uniform thickness, rather were found in single, double or even in triple layer. Between geo-sand containers, the soil surface was encountered, but these gaps were small. Deposit of silty loam type soil in dense layer was found behind the ending geo-sand container. No soil deposit was encountered over the geo-sand container, but algae type growth was detected.

RENO-mattresses covered extended from waterline to 7 m down along the slope and was in good condition. No rupture or damage was detected. No deposit of soil was encountered over RENO. Geo-sand containers were placed from 7 m to 25 m down along the slope. The slope was not uniform. At

the end of Geo-sand containers, a vertical trench like a formation in north-south direction for a short distance was found. All the containers were intact. Loose deposit of sand was found between gaps of the containers.

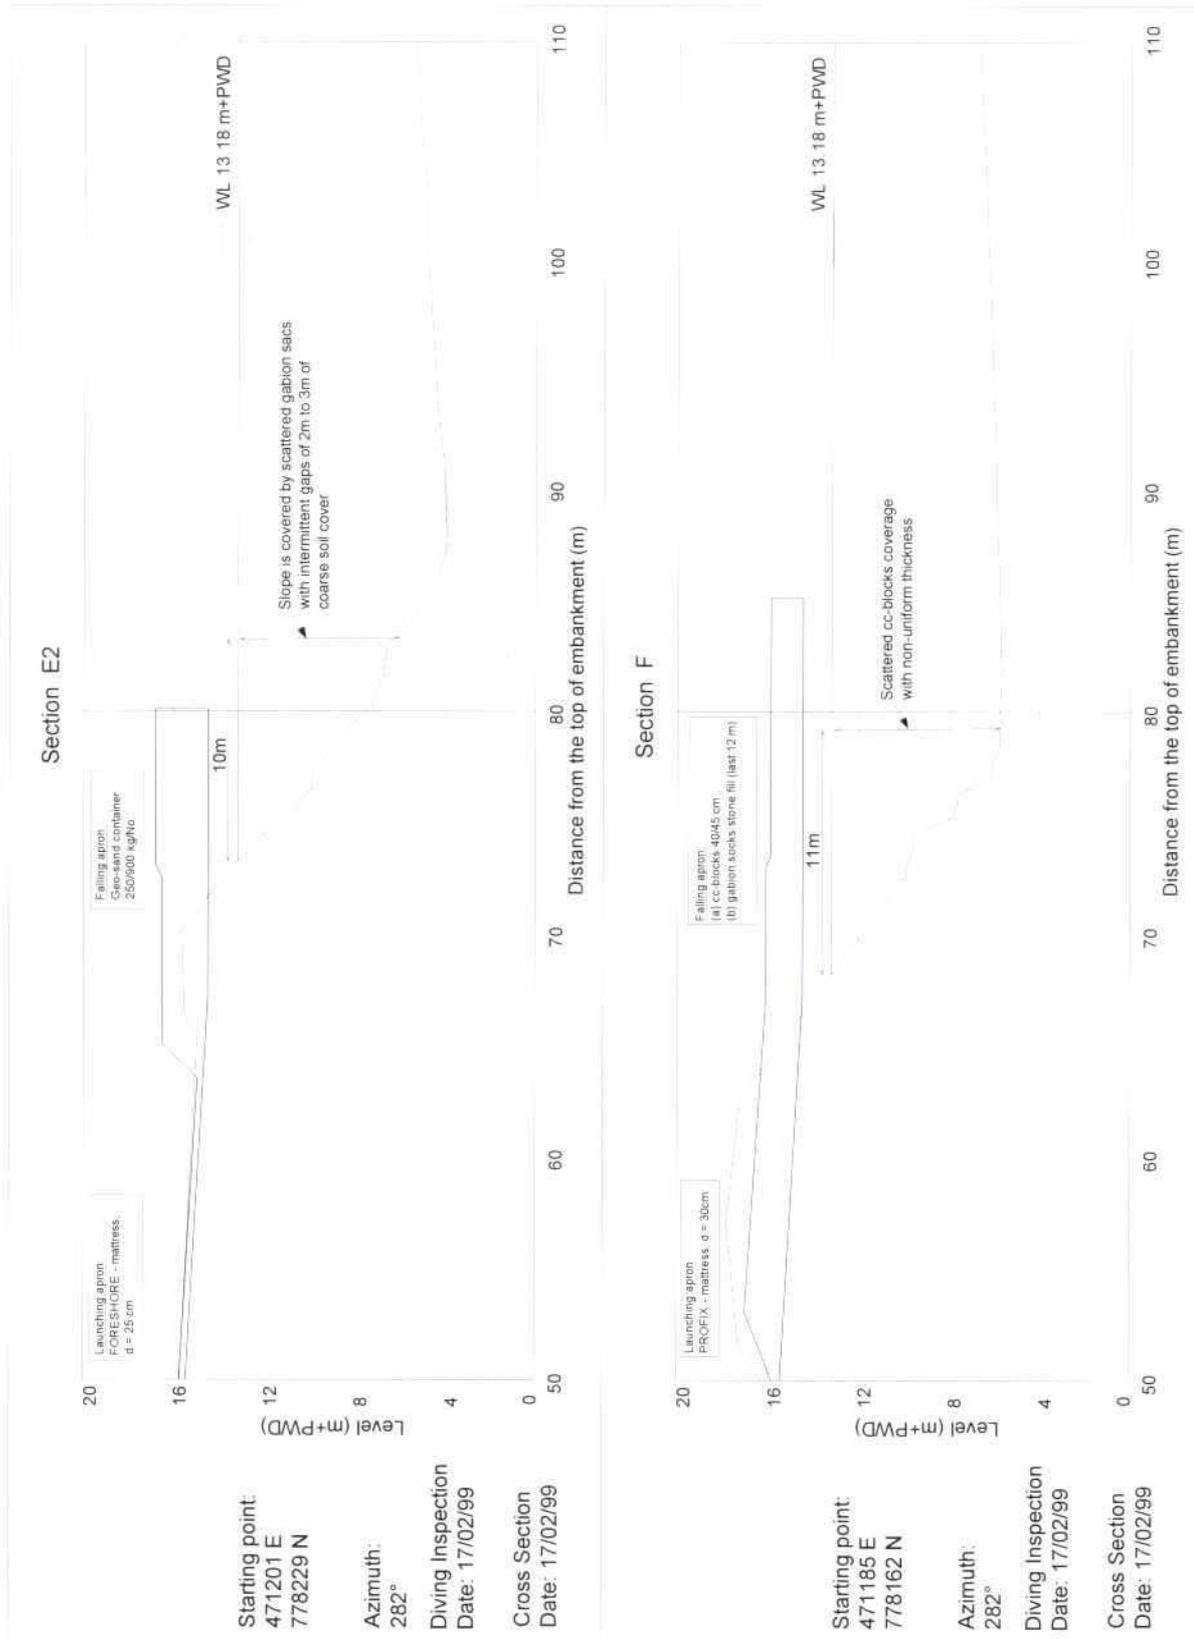
Fig. 5.3-4: Diving inspection at Sections E2 and F

The end of the falling apron was detected at a distance of 24 m from the waterline. The cc-blocks on the falling apron built a non-uniform slope up to the end and between them coarse sand deposit was found. A sunken engine country boat was found at the end of falling apron. The pattern of the cc-blocks was the same as it was visible above the waterline.

CC-blocks were found up to a distance of 12 to 15 m from the waterline, but not shown in a uniform pattern. Intermediate gaps in a distance of 2 to 3 meters were found and uncovered soil was seen in these gaps. At the end, the bed raised slightly.

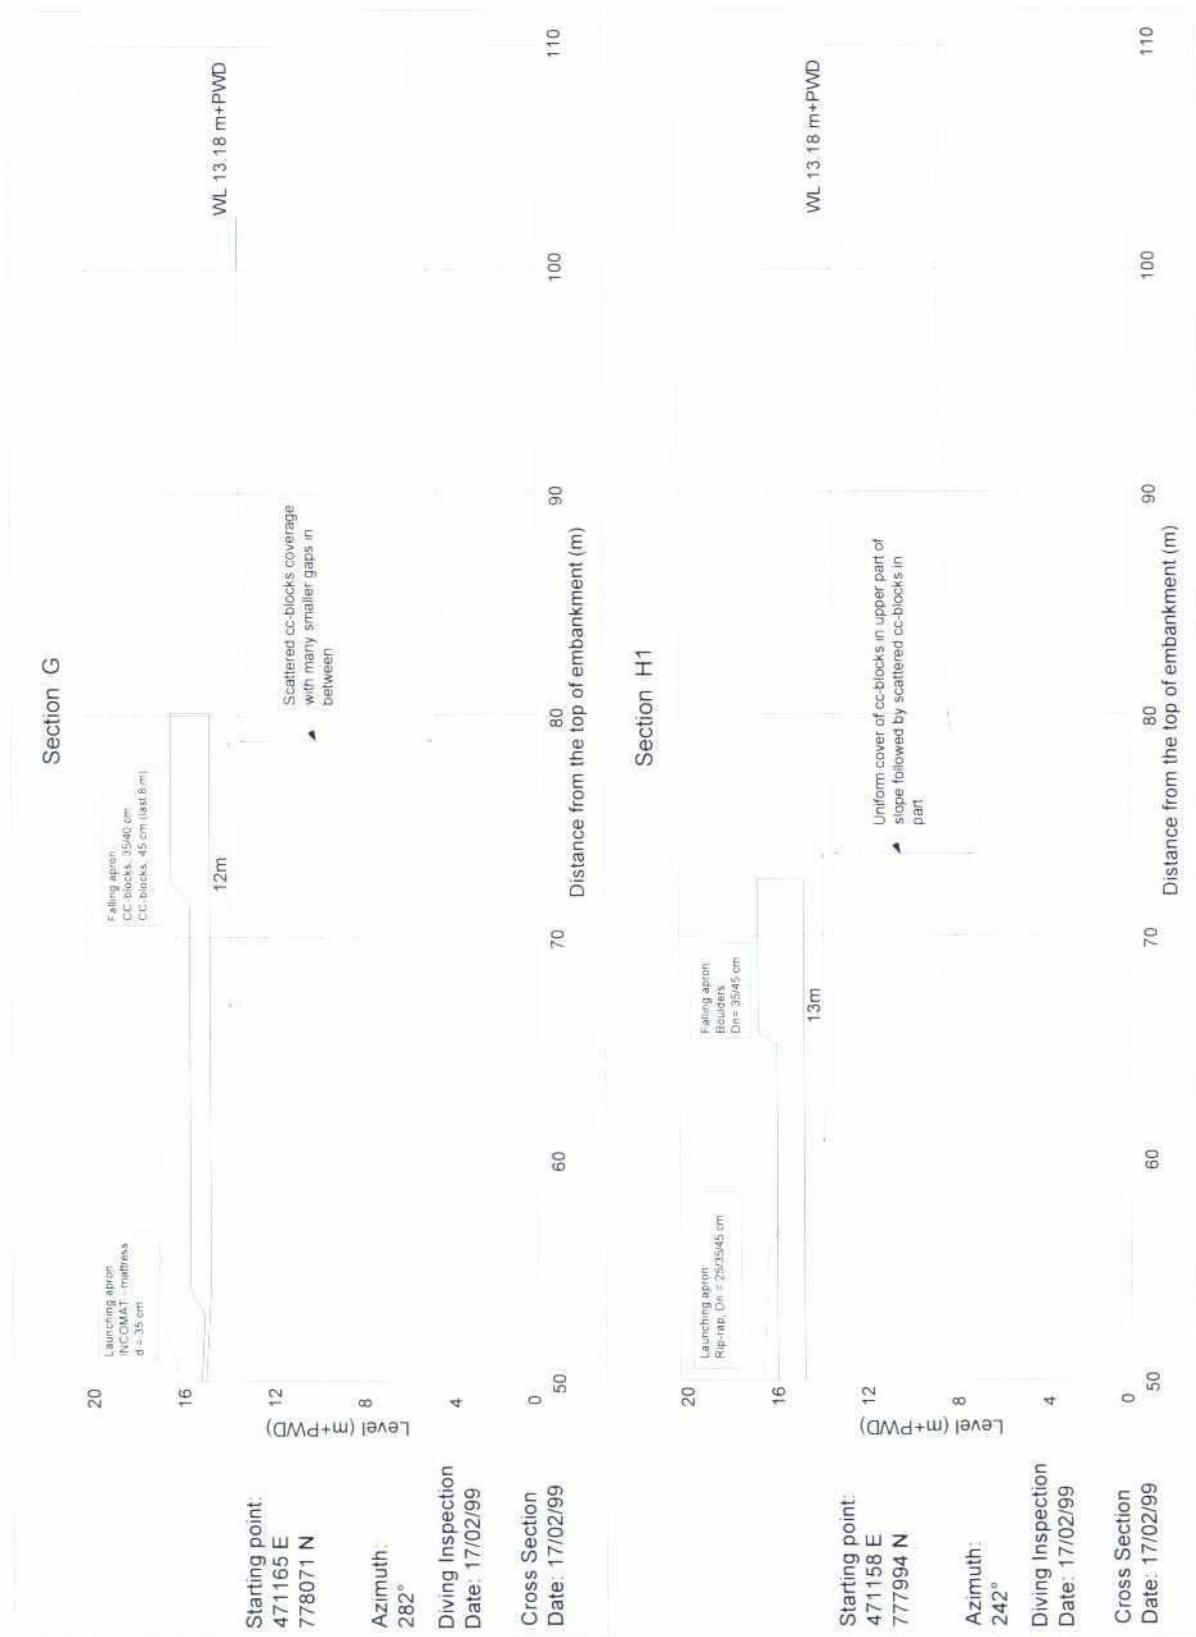
Fig. 5.3-5: Diving inspection at Sections G and H1

Scattered gabion sacks were found with intermittent gaps of 2 to 3 meters. The gaps soil cover showed only coarse sand deposit, which was extended up to 15 to 18 m from the waterline. The bed raised slightly at the end.

The cc-blocks of the falling apron extended towards the river in a more or less uniform pattern up to a distance of 16 m to 8 m in upstream to downstream direction. Further to the river they showed a more scattered pattern. Clay soil was encountered after cc-block.

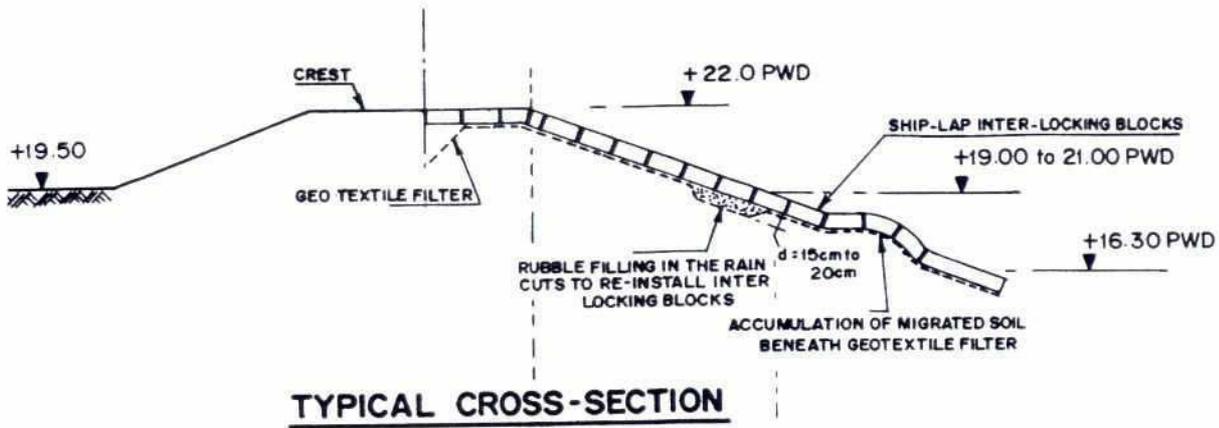
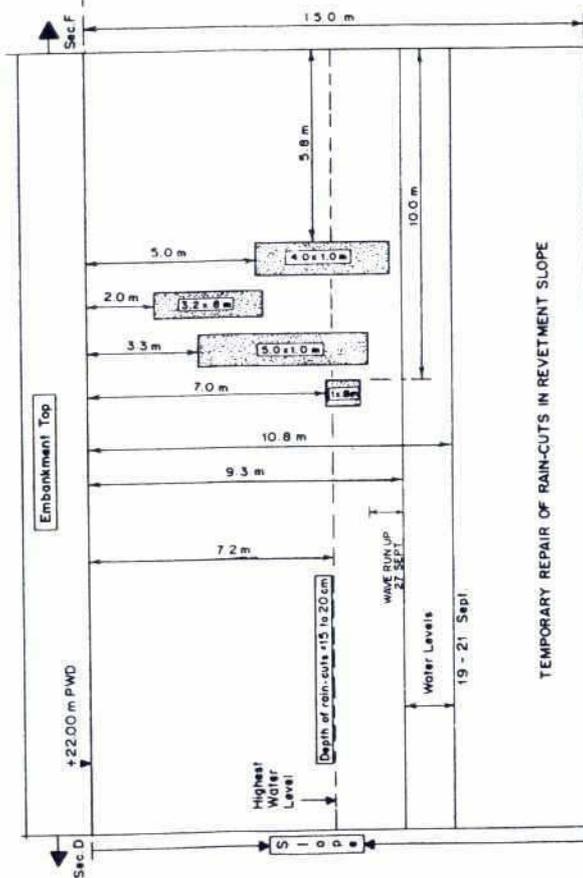
In subsoil A, which is sandy silt type ML to CL, pipes can develop until a complete failure takes place. Subsoil B, which is silty sand type MS, is characterised as a very dangerous soil because of its relatively low permeability, its relatively high compressibility and its low shear strength. In the filter test investigation, segregation of soil fractions and piping have been observed as the main failure mechanism. These pipes develop below the geotextile, where insufficient contact pressure exists between filter and protective layer.

Fig. 5.1-1: Rain cuts under layer of concrete slabs in Section E

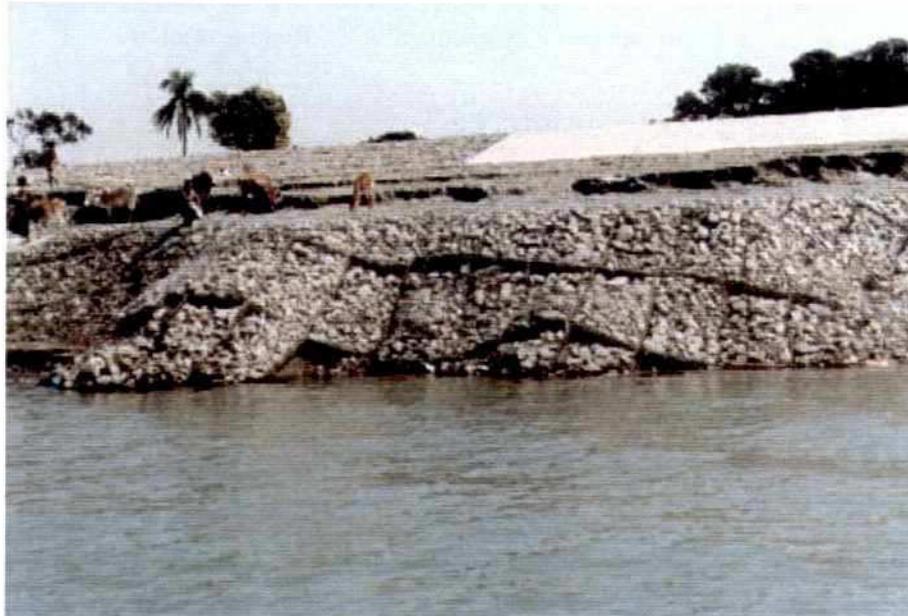
The flow velocities above the launching apron were analysed in Section 4.3. It can be concluded that all launching aprons have resisted a flow velocity of at least 2 m/s. The observed deformations are negligible as expected, because the design flow velocity for launching aprons was 2.8 m/s.

Photo 5.2-1: Section C: Launching apron on February 18, 1998; Water level at 13.00 m+PWD

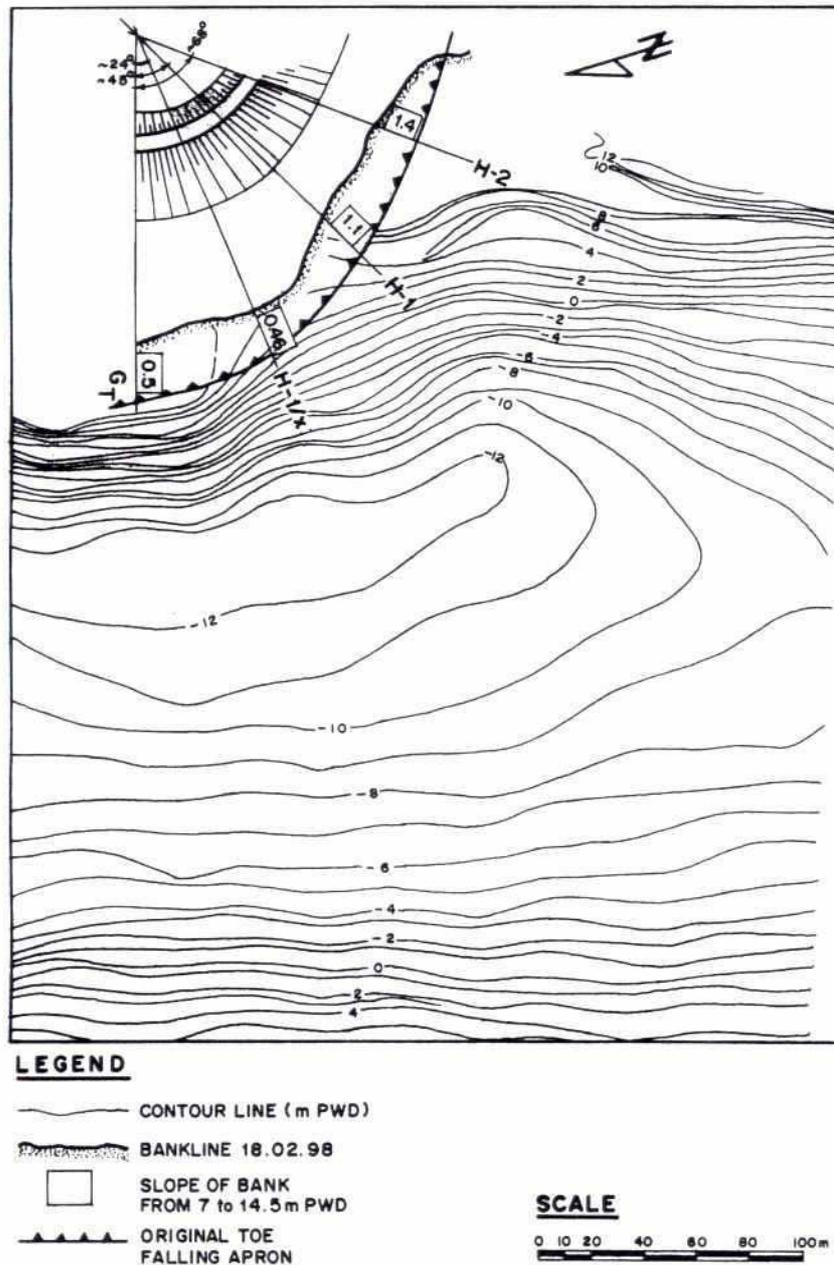
From photographs it can be seen that the boulders of the falling apron in Section H-1 had fallen and that the geotextile BIDIM S 390 was hanging on a steep slope of up to 1V:0.46H. After the flood season, the falling apron had been eroded over a distance of about 25 m. This erosion started when a scour hole had developed near the downstream termination (see Fig. 5.3-1).

Fig. 5.3-1: Steep slopes in front of the falling apron in Section H

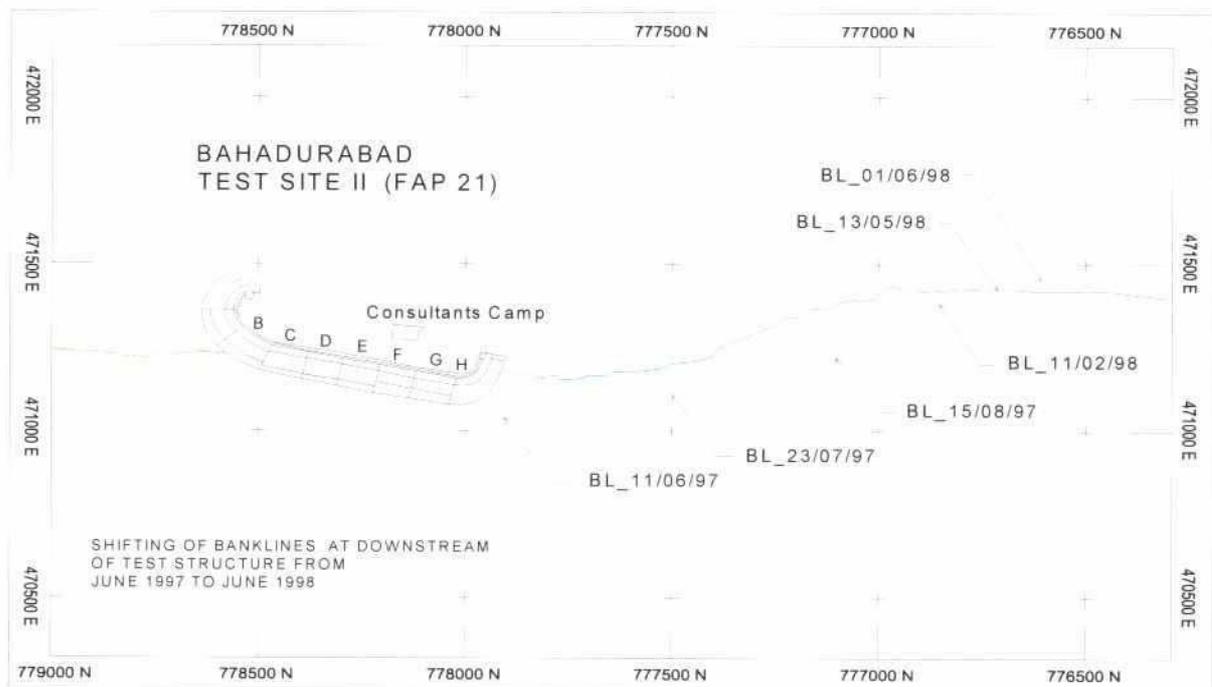
This erosion stopped on July 18 after the second flood peak. Between June 11 and July 23 the bank had been eroded over a distance of about 100 m at an average rate of about 2 m/day. Later it continued at a lower rate of 1 to 1.5 m/day up to September 17, then it stopped. The bank erosion shifted about one kilometre in downstream direction during September. The banklines in Fig. 6.1-1 show that the floods of 1997 and 1998 had eroded about 20 to 200 m/year of floodplain area.

Fig. 6.1-1: Bank erosion from June 1997 to June 1998
