**MES II  
MEGHNA ESTUARY STUDY**

TECHNICAL NOTE MES-039

**HAIMCHAR & KHORKI EROSION CONTROL PILOT SCHEMES**

June 2001

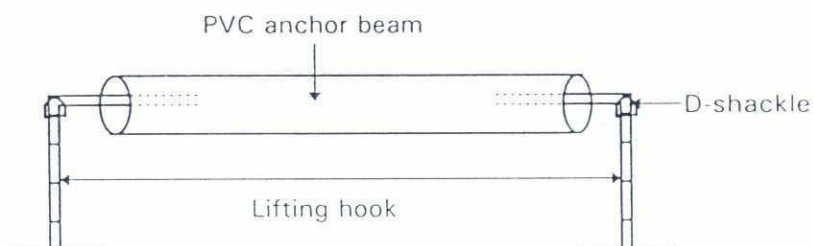
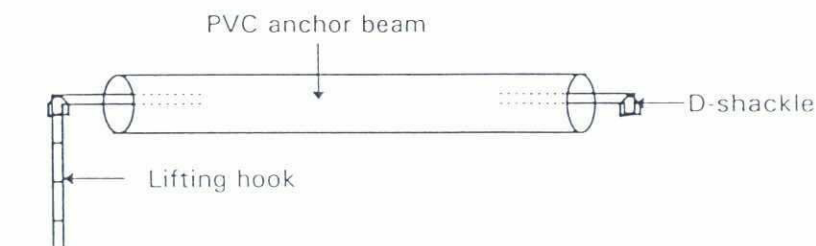
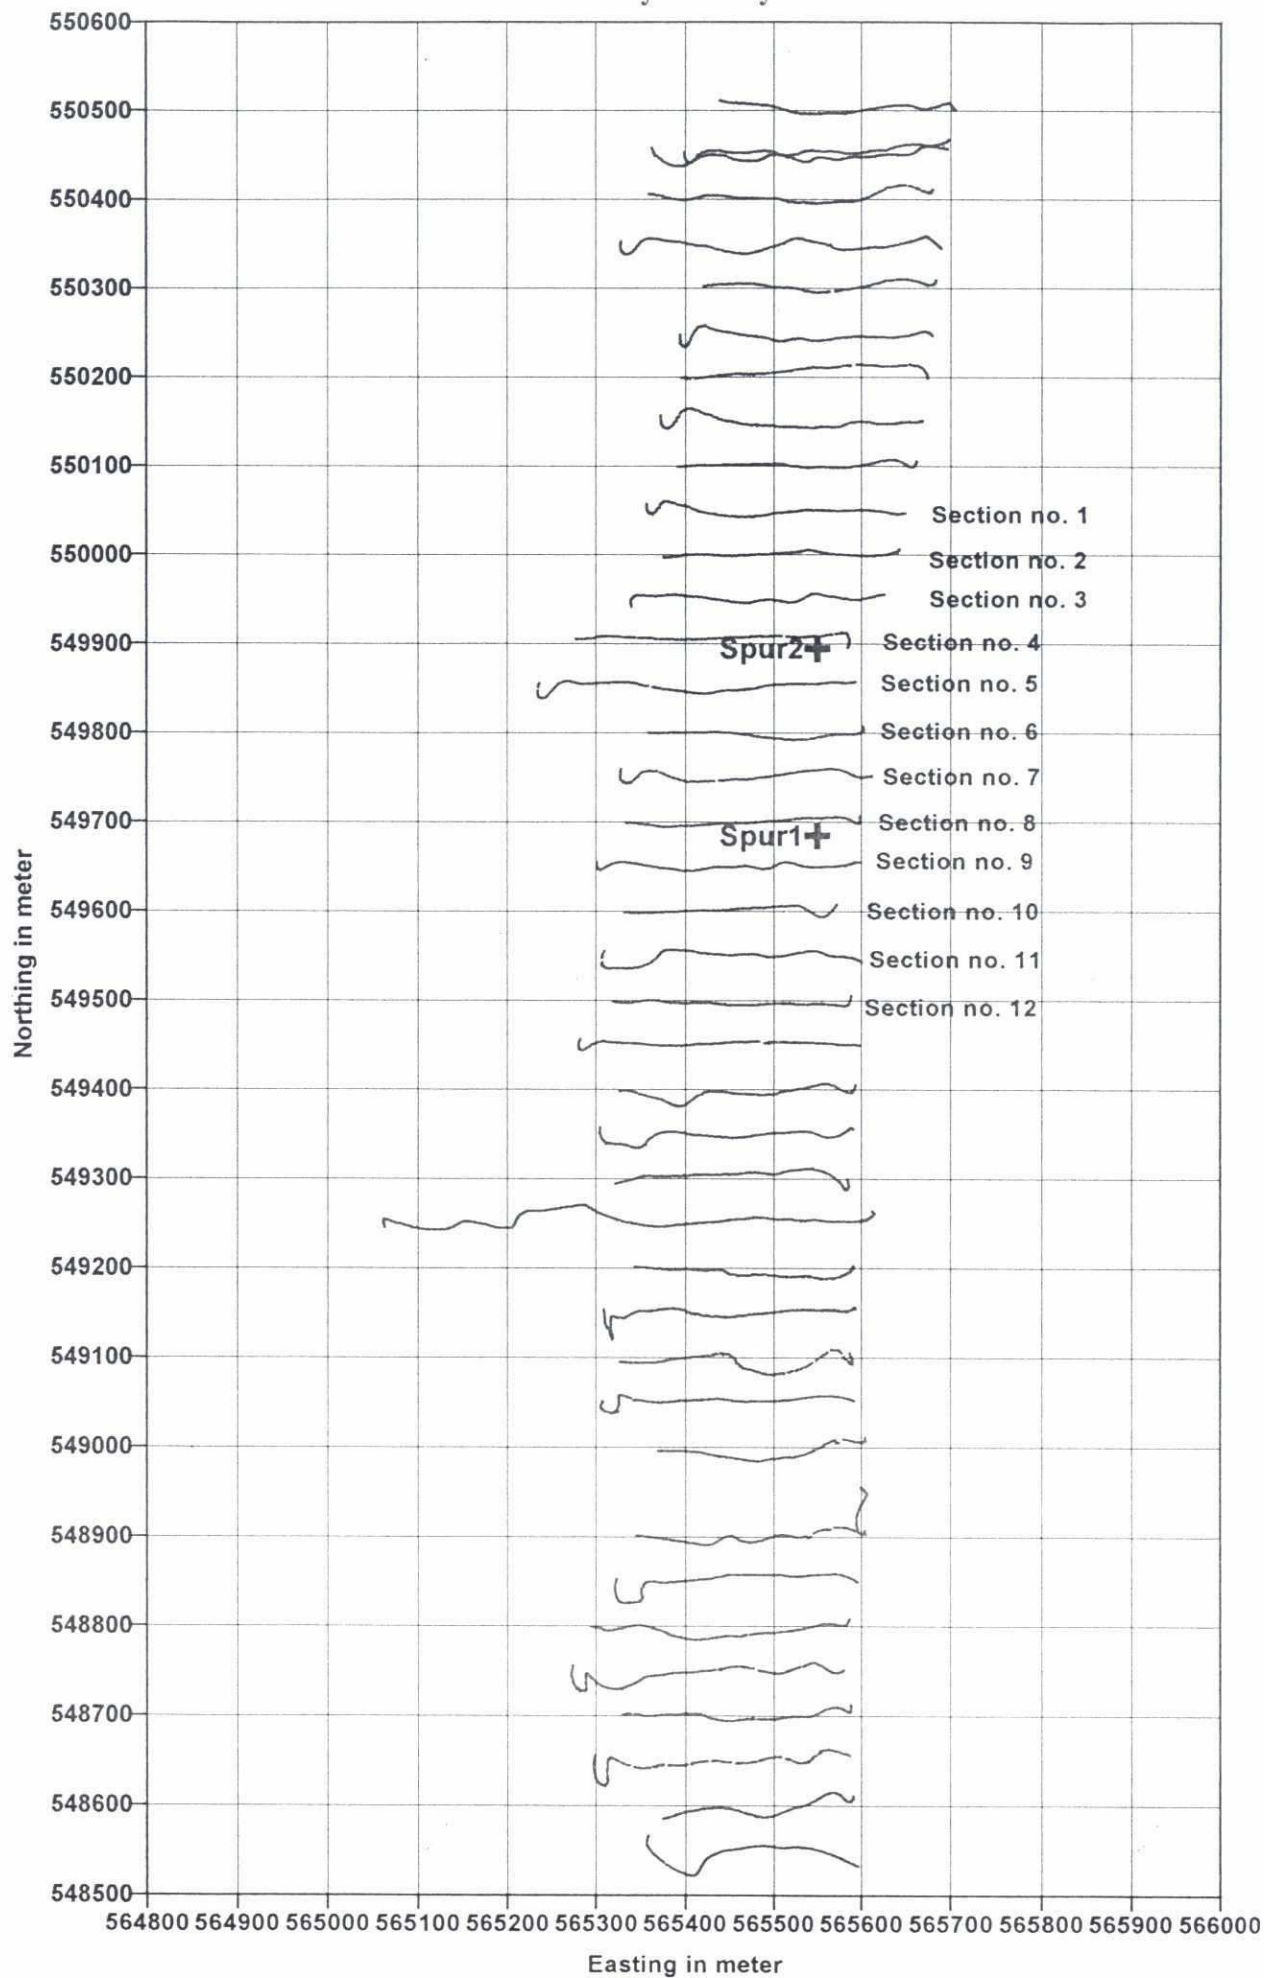
The flow velocity reached to about 2.0 m/sec. One of the 12 bottom vane screens was washed away due to a broken anchor hook at one end of the R.C.C. beam and a failing D-shackle at the other end (Fig-14). By outflanking the connecting dyke of spur 2 a secondary channel was formed in between the spur and riverbank through which a strong current force hit the bank angularly at South-East direction in between the spurs. Bank erosion started again and scour holes developed near the toe line of the embankment. Blocks pitched down near the toe of the embankment started sliding down and thus the Chandpur Irrigation Project was threatened.

- Out of 12 nos. of bottom vane screens installed upstream of the upstream spur (spur 2), one screen was washed away during the peak of the flood period. It was salvaged by an MES guard with the help of fishermen. Its anchor hook was broken at one end and at the other end the D-Shackle was missing.

Failures of the screens as observed in the ones rescued are shown in detail in Fig- 14.

1. The screen was disconnected on dt. 11.08.98 by disconnecting both the lifting hooks at bottom from the anchor slabs.

2. The screen was disconnected on dt. 23.09.98 by disconnecting the lifting hook from one anchor slab at bottom but on the other side the anchor beam hook was found with D-shackle.

3. The screen was disconnected on dt. 23.09.98, some fishermen has seen it being swept away but it could not be rescued.
4. The screen was disconnected on dt. 25.09.98 but D-shackles with the anchor beam hook of both sides were absent.
