# ASSESSMENT OF THE POSSIBILITY OF EROSION OF TANGAIL TOWN AND ITS ADJACENT AREA BY THE RIVER JAMUNA AND ITS PROBABLE REMEDIAL MEASURE

**RESEARCH REPORT**  
**REPORT NO. RES-4 (2001)**

**JUNE 2001**

**RIVER RESEARCH INSTITUTE, FARIDPUR**  
**Ministry of Water Resources**  
**Government of the People's Republic of Bangladesh**

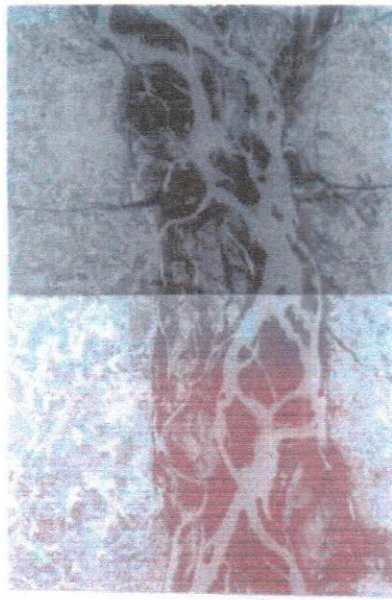
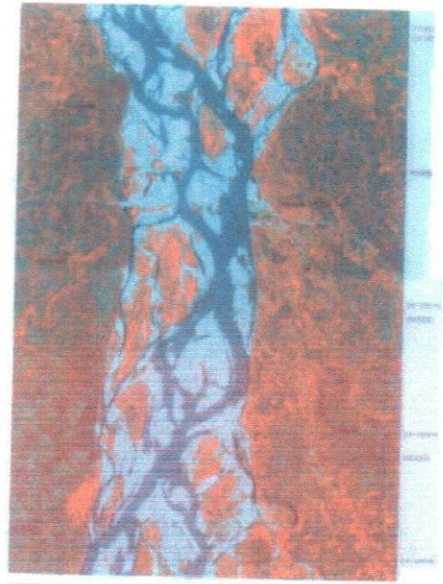
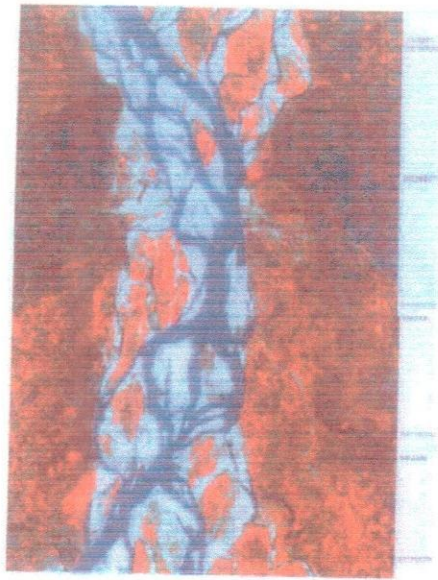
Fig.4.9 Planforms of the Jamuna river in 1999, 2000 & 2001

Fig.4.9 it is observed that the channel close to the East bank is still prominent. Yet from the standpoint of regular channel geometry it can be expected that in near future this channel close to the East bank will be abandoned and river may follow the mid channel as main channel.

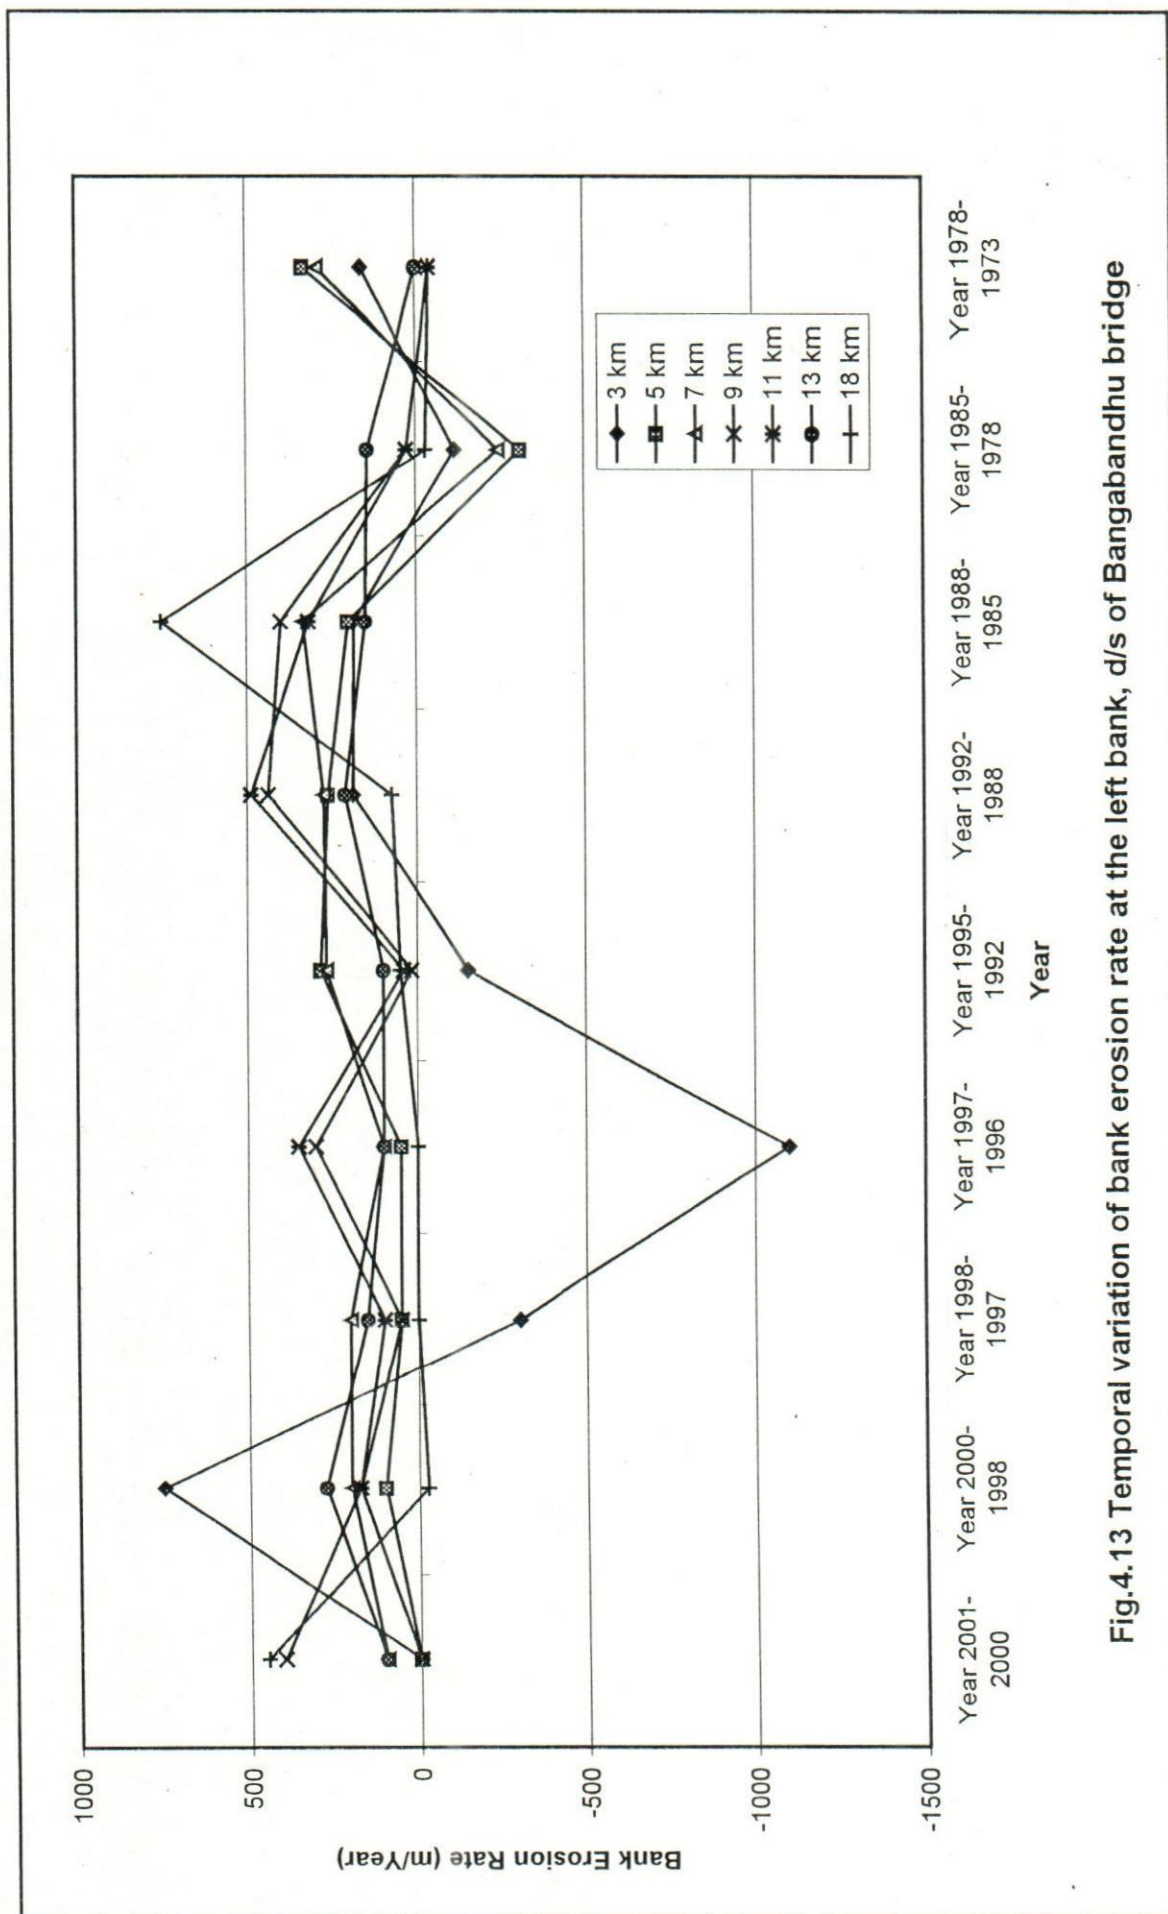
Fig.4.13 Temporal variation of bank erosion rate at the left bank, d/s of Bangabandhu bridge

From the analysis of bank erosion using the recent satellite images from EGIS-II for the period 1996-2001 it was found that along the left bank d/s of the Bangabandhu bridge the maximum bank erosion was 450 m in 2000-2001 (Fig.4.3 & Table-4.4). The maximum bank

erosion point was 18 km d/s from the bridge axis. Average bank erosion rate in 2000-2001 was in the order of 200 m/year. The analysis also shows that along the left bank the maximum bank erosion rates immediately u/s of Tangail town were about 400 m, 100 m, 225 m, and 500 m, in 1996-97, 1997-98, 1998-99 & 1999-2000 respectively (Fig.4.3 & Fig.4.4), whereas bank erosion in these years along the right bank found almost nil.

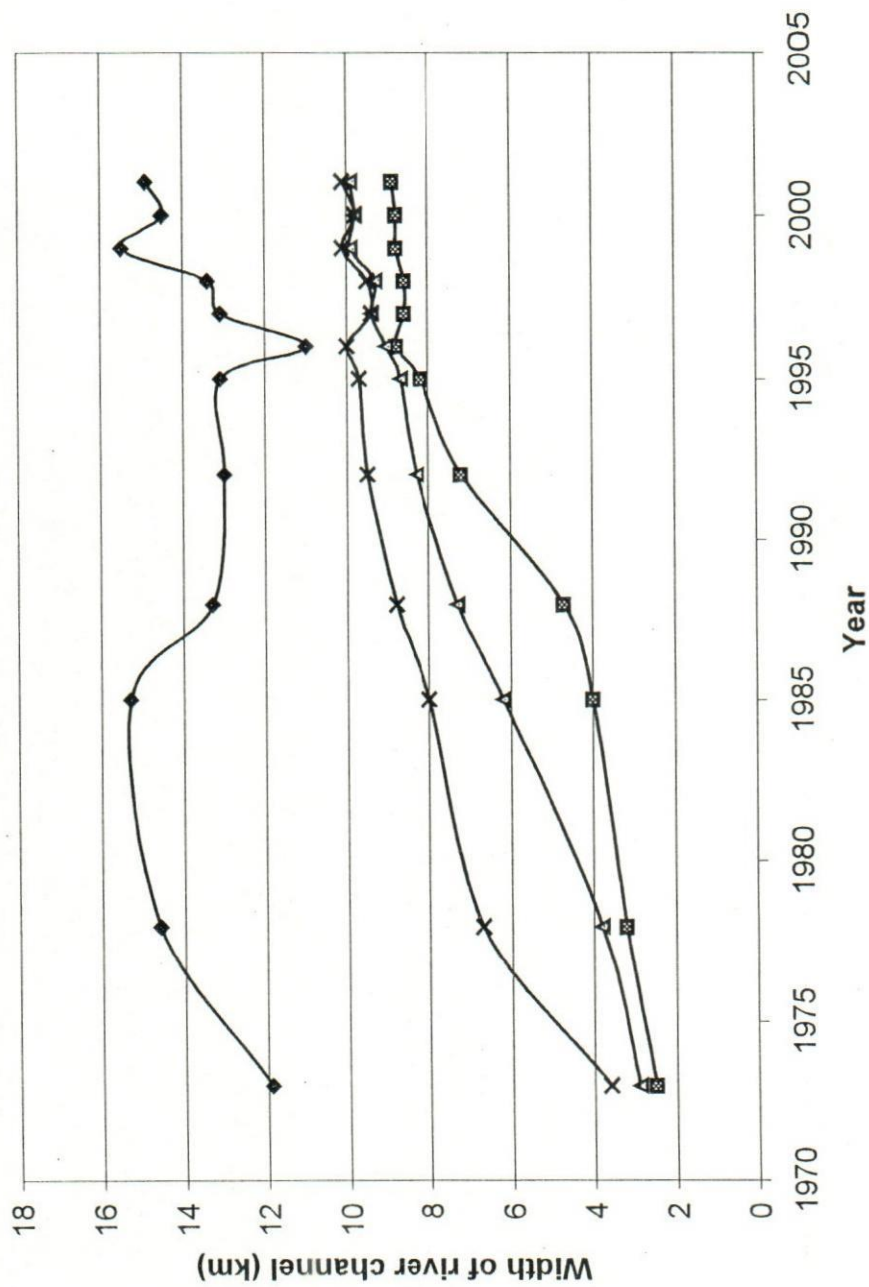
Figure 4.14 Temporal and spatial variation of channel width of the Jamuna river in study area

It indicates that the river is gradually widening and this widening is happening due to bank erosion towards the East. Widening pattern of the river channel for the study reach can be seen in Fig.4.14. From that figure it is observed there is a gradual trend of increase of width of channel both at u/s and d/s of the Bangabandhu bridge axis. The maximum bank erosion i.e., shifting of the left bank to Eastward direction is in the order of 500 m/year.

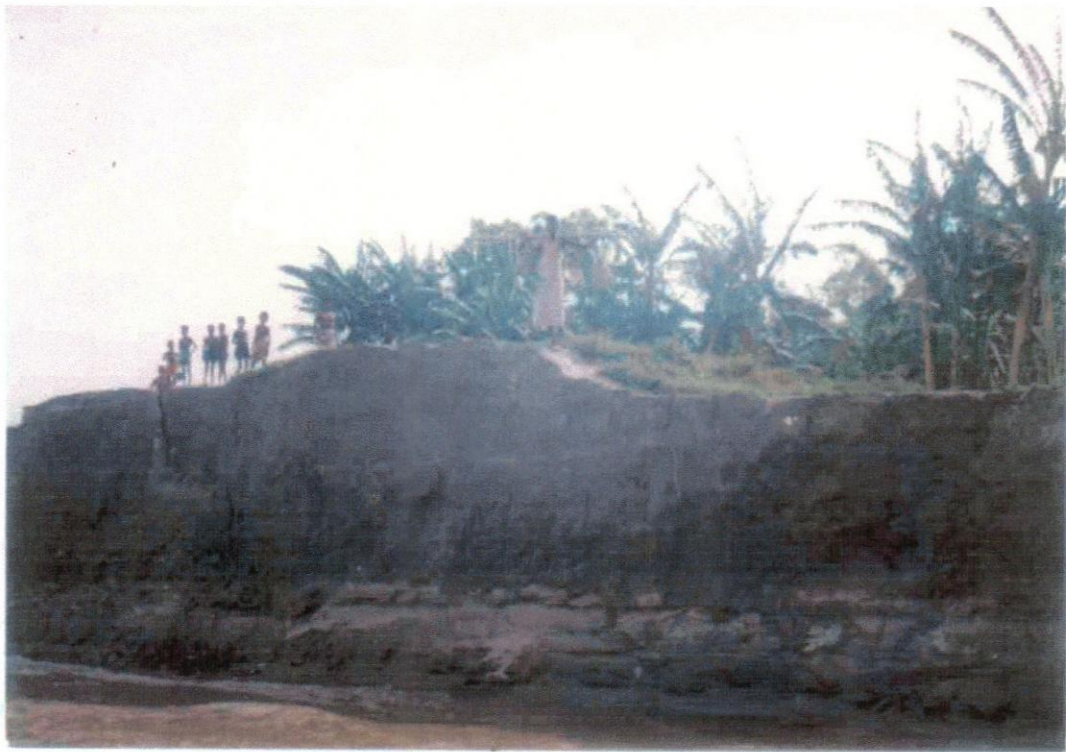
Plate-1: Bank erosion at the d/s of Bangabandhu bridge along the left bank

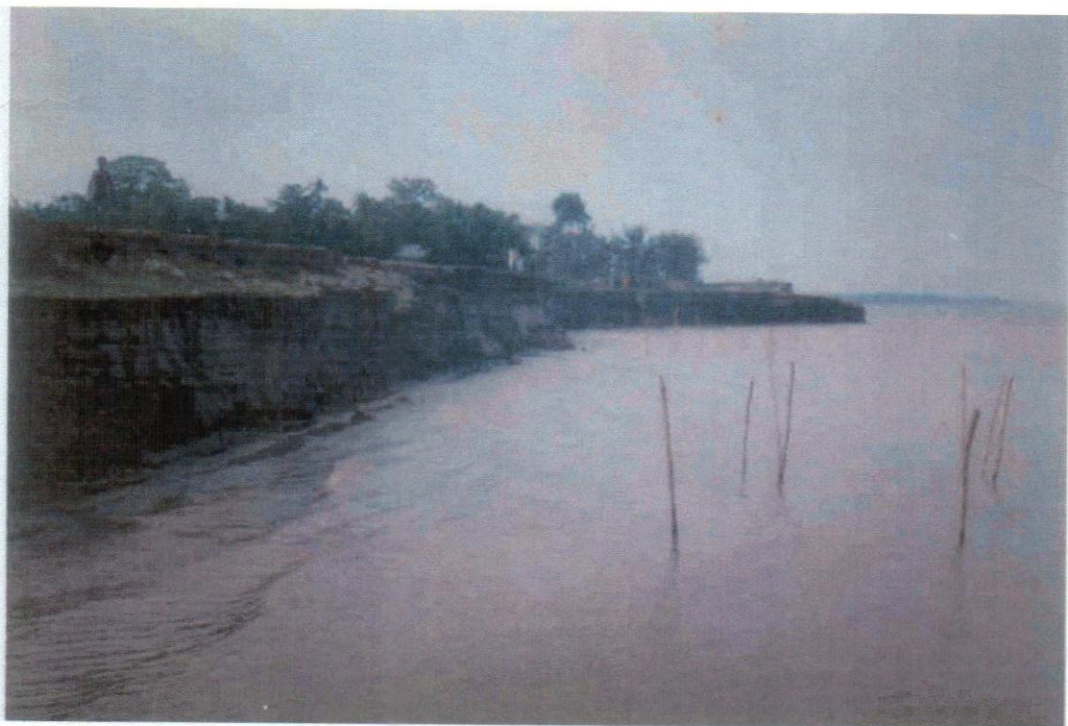
Plate-2: Bank erosion at the d/s of Bangabandhu bridge along the left bank

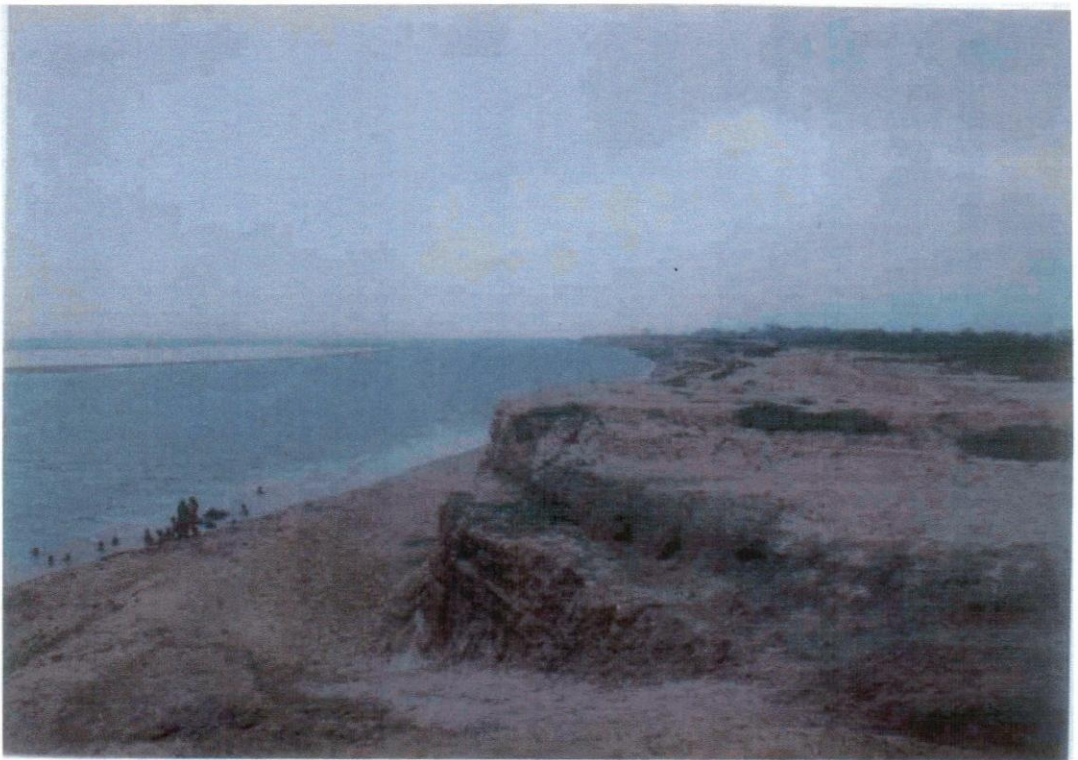
Plate-3: Bank condition at dry season along left bank

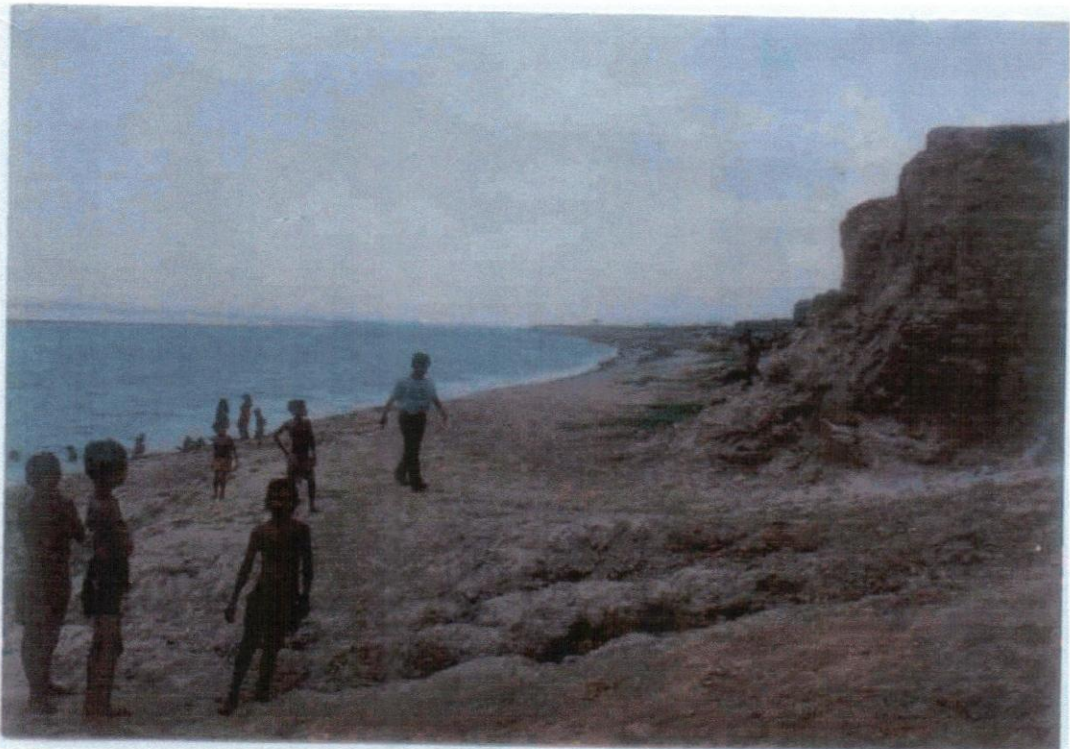
Plate-4: Bank condition at dry season along left bank
