**BANK PROTECTION AND
RIVER TRAINING (AFPM)
PILOT PROJECT
FAP 21/22**

**PROGRESS REPORT
NO. 25**

JULY TO SEPTEMBER 1999

**JAMUNA TEST WORKS CONSULTANTS, JOINT VENTURE
CONSULTING CONSORTIUM FAP 21/22**

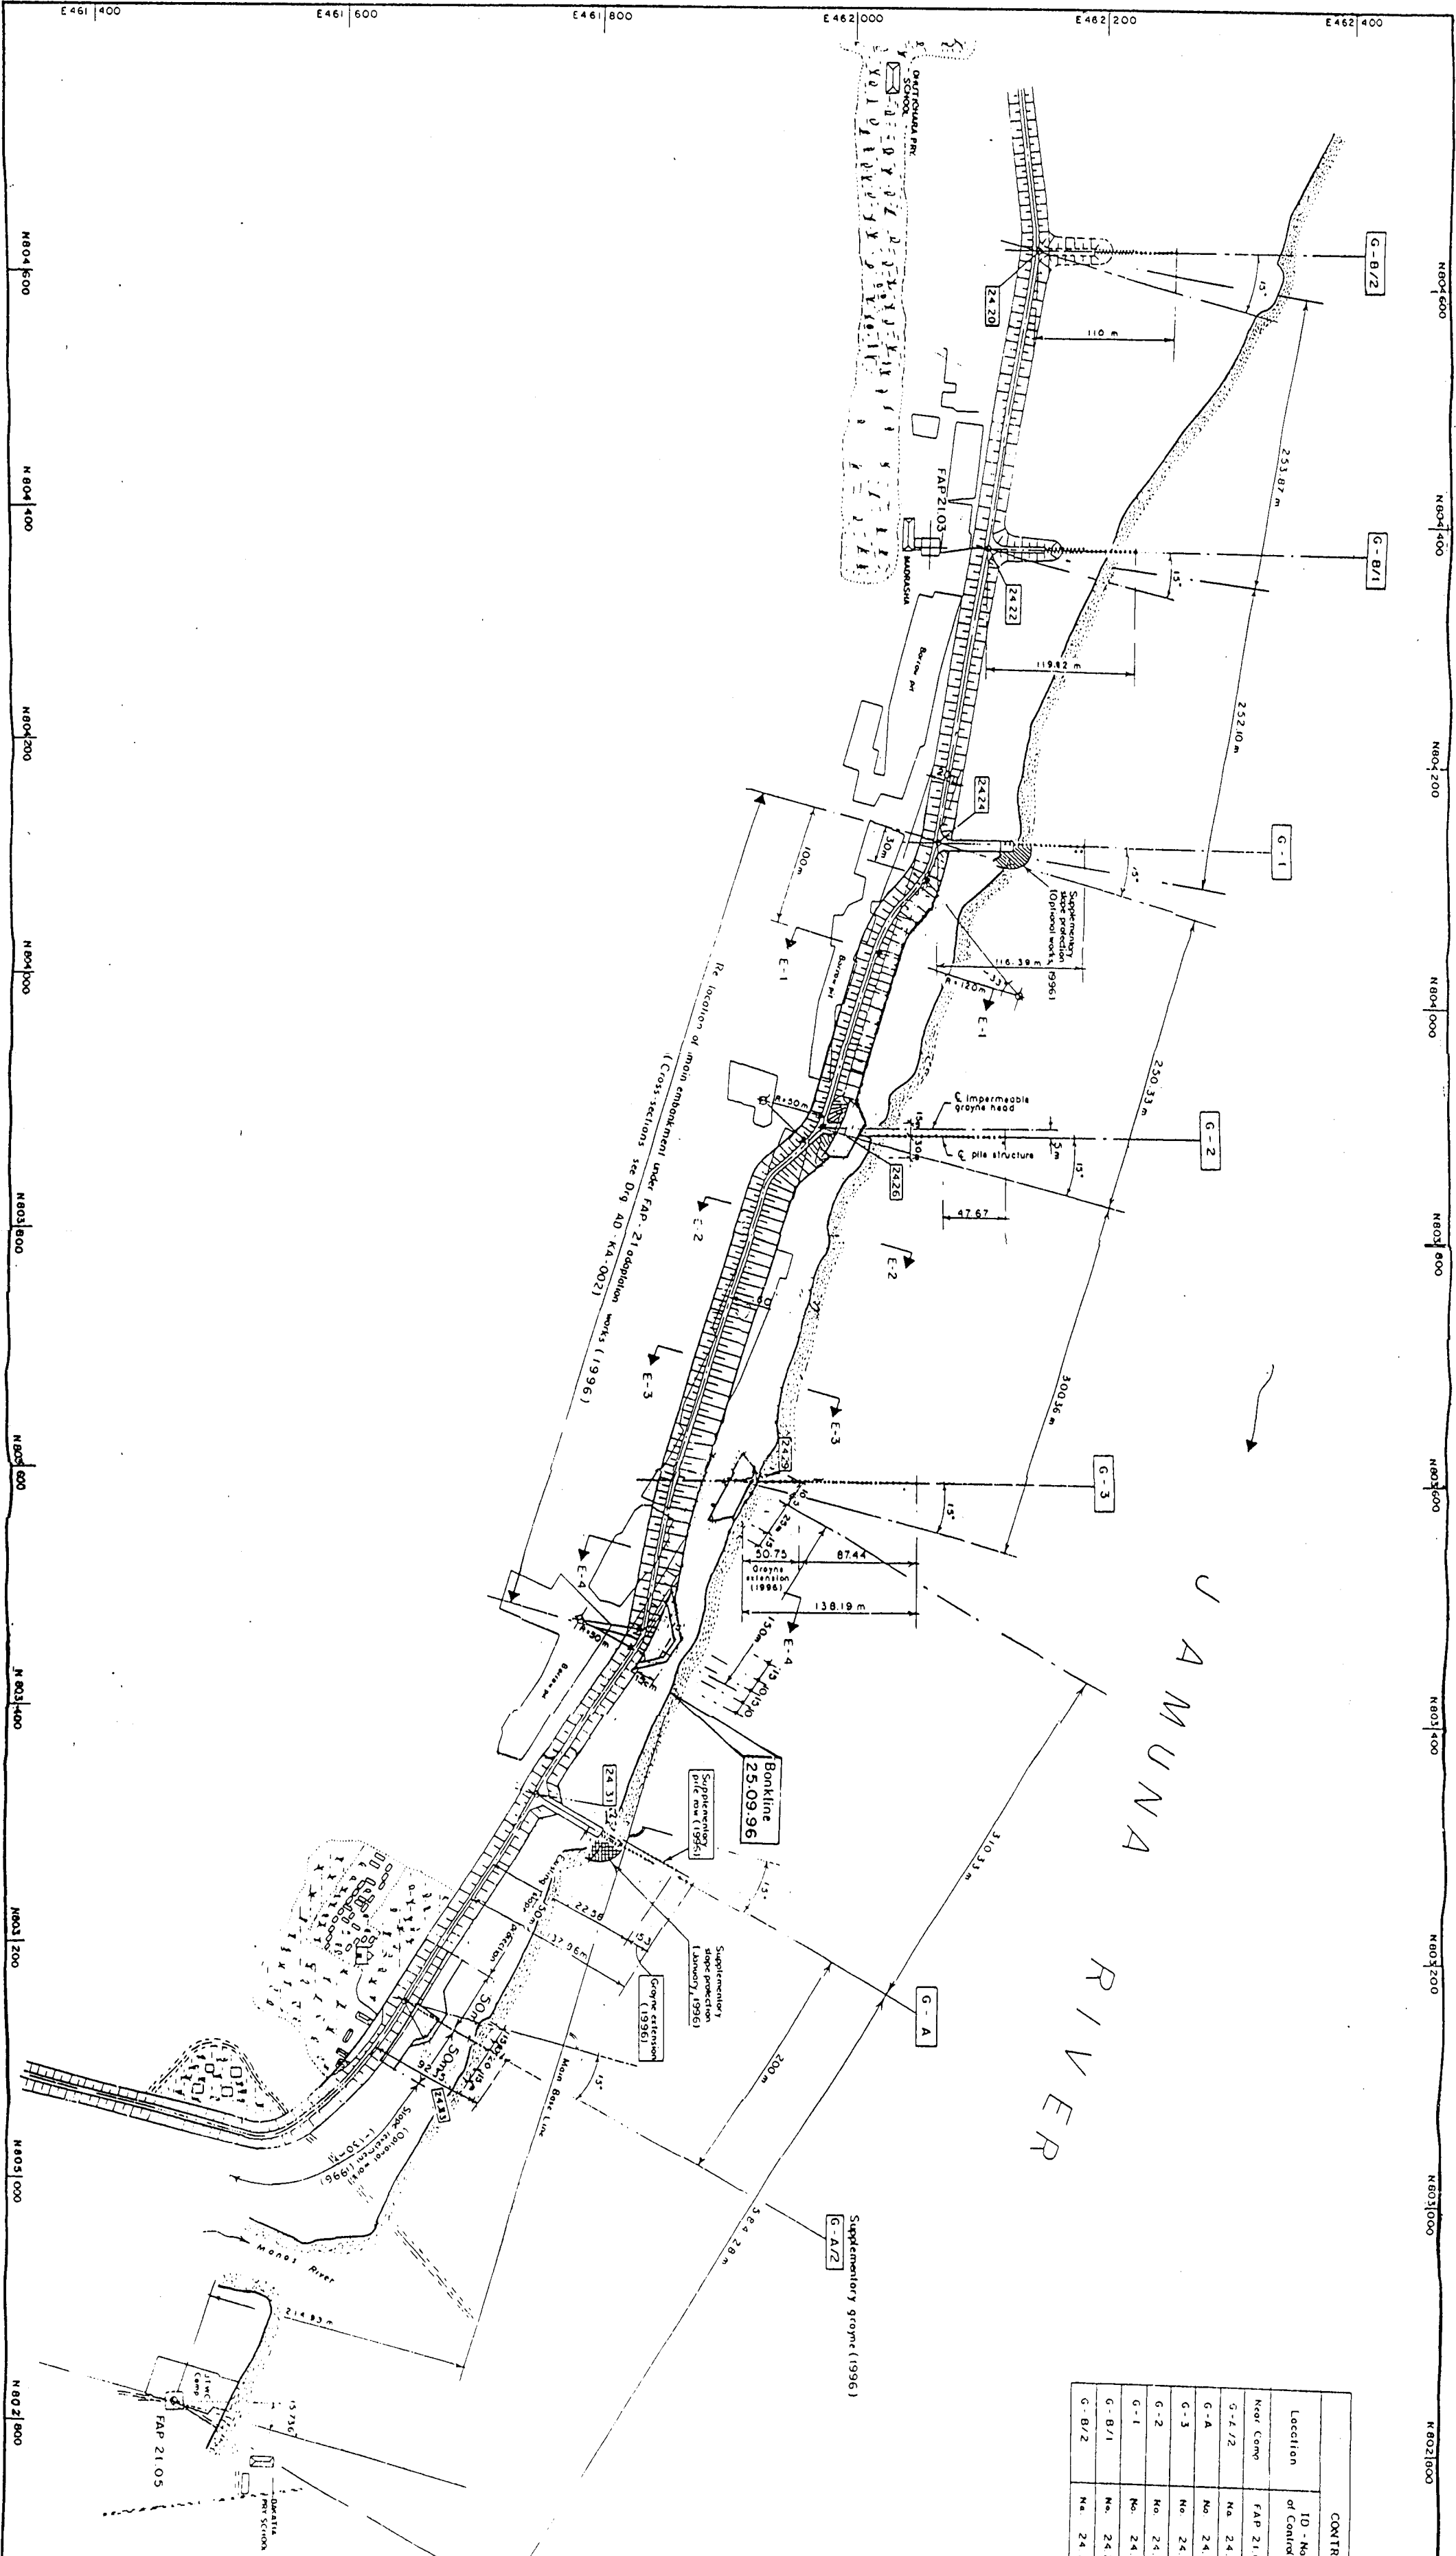
TEST SITE 1 - KAMARJANI
ADAPTATION OF TEST STRUCTURES
GENERAL PROJECT LAYOUT

The general layout of the test structure after the execution of adaptation and repair works is shown in Fig. 1.

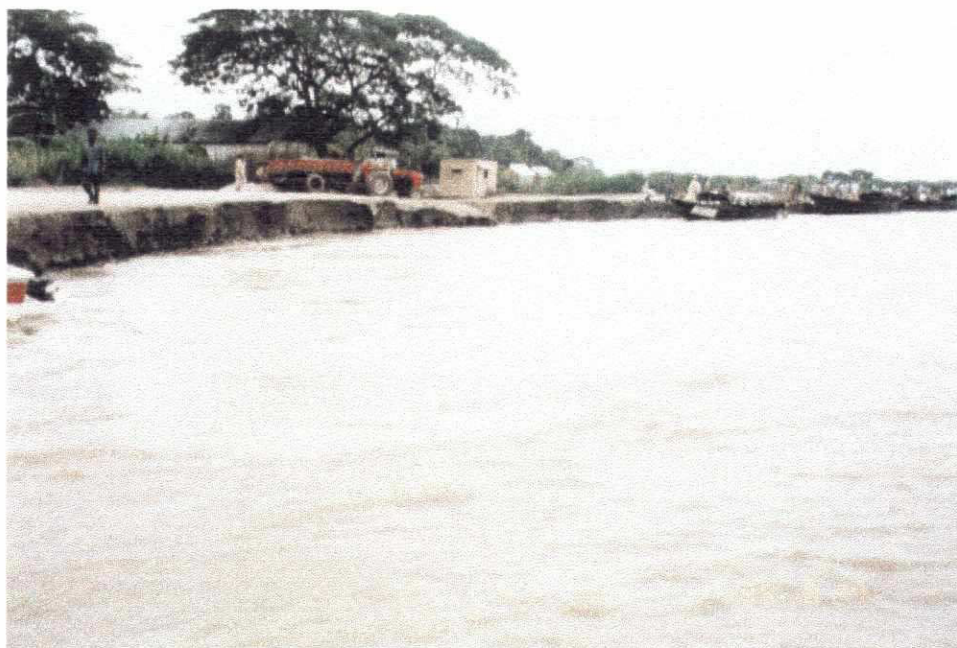
Photo 1: Situation in front of sugar cane building and FAP 21 container as on August 24, 1999;
Water level at 18.58 m+PWD

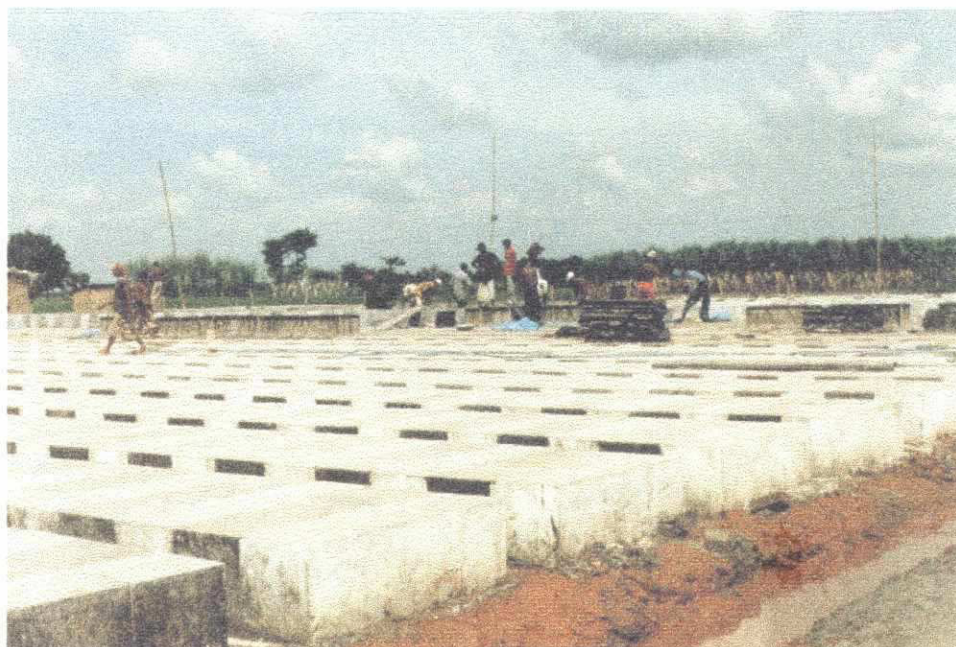
Photo 2: CC-block production in progress on September 20, 1999
