Investigation of Geotechnical Reasons for Bank Failure on Daulatdia and Paturia Side of Padma River of Bangladesh.

June 2020

RIVER RESEARCH INSTITUTE, FARIDPUR

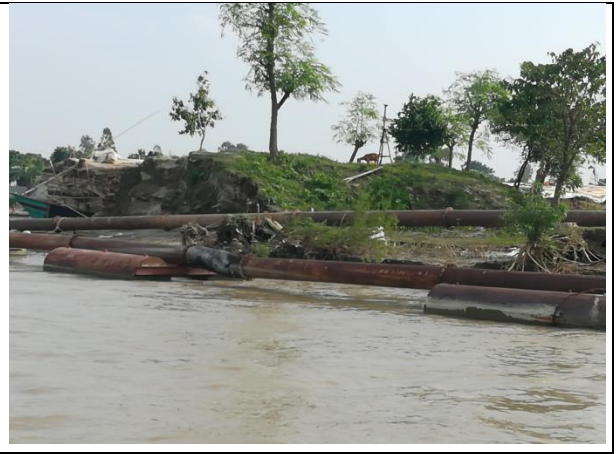
Bank failure at Afsarsheiker Para, Daulatdia, Rajbari

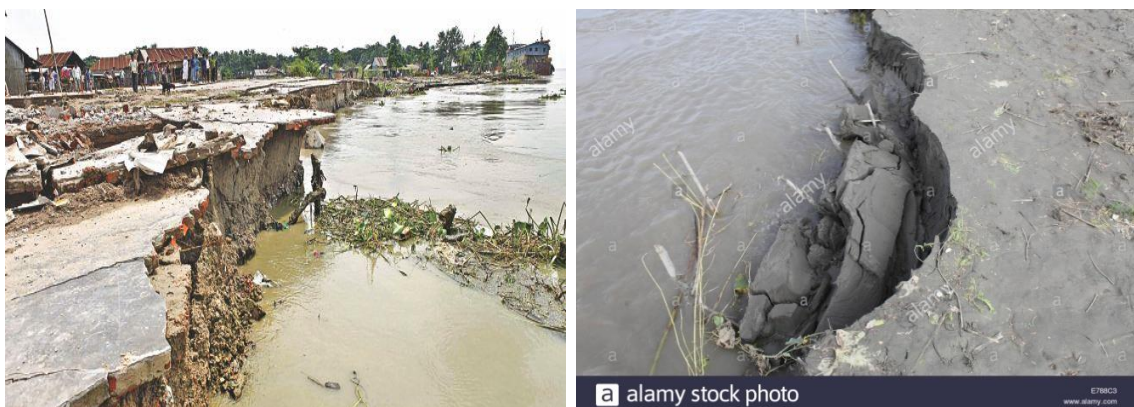
Figure1.1: Bank erosion at Daulatdia Ghat, Goaland

But the failure scenario of these figures also indicates that this failure has been occurred due to rise in water level and its stream which causes of geotechnical instability.

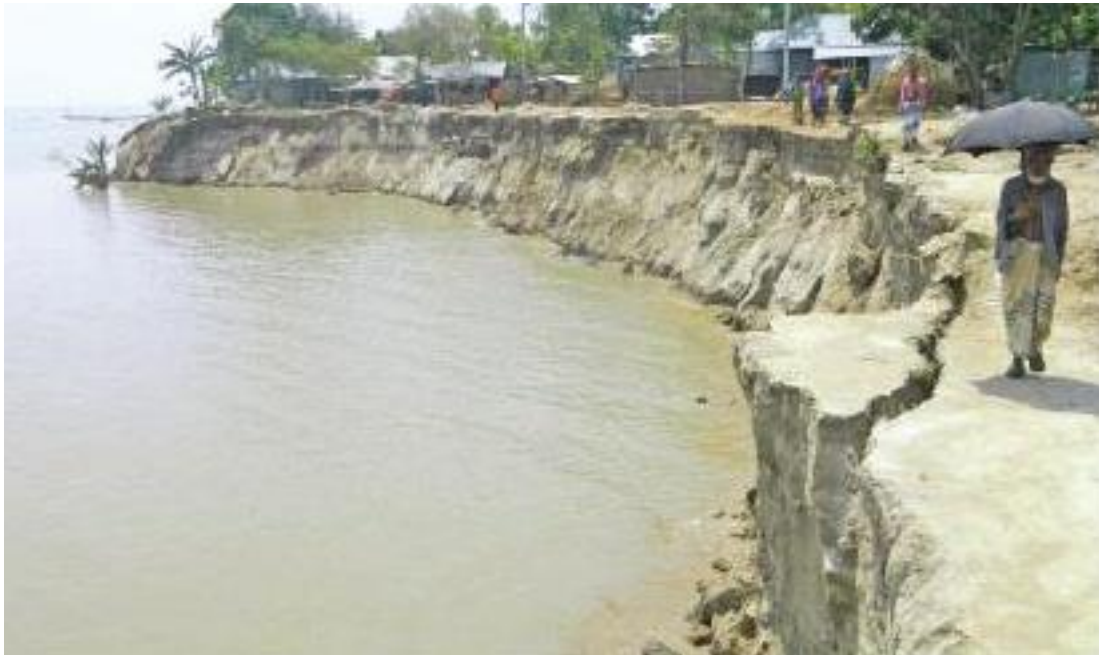
Figure 1.2: Daulatdia Ghat, Goalanda, Rajbari (Photo 6 May, 2017)

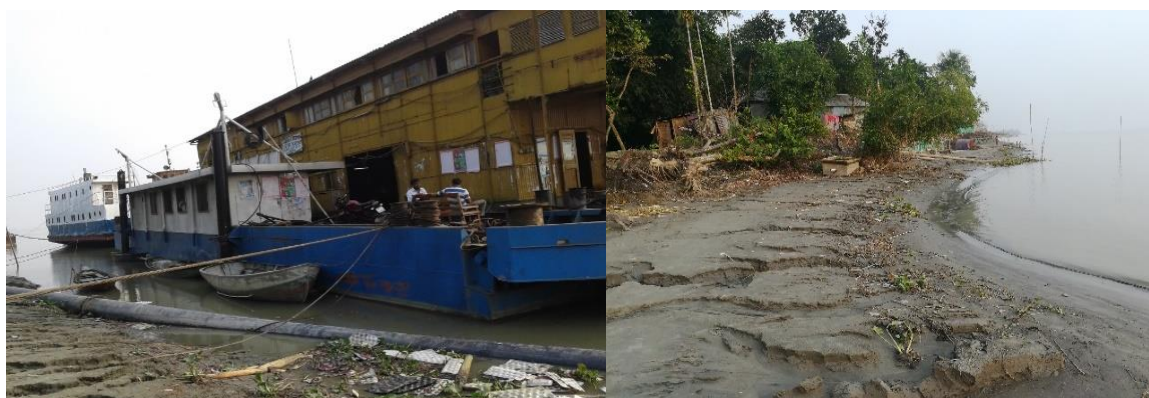
Figure 3.6: Floating Workshop of BIWTA and bank erosion at Arua (down of the Paturia ghat)

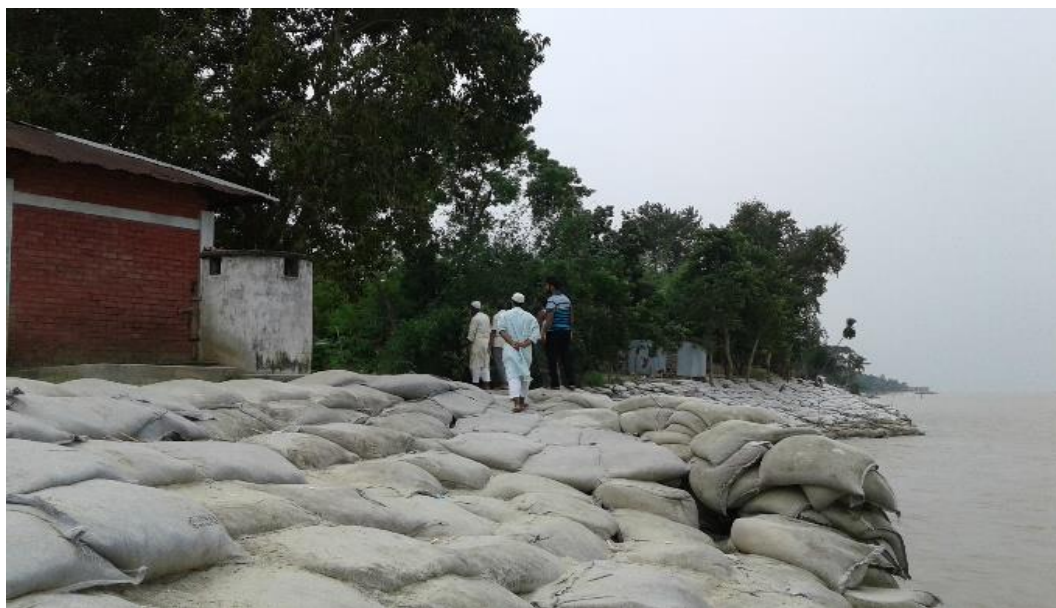
Figure 3.9: Bank protection work of BWDB at Urakandi Primary School, Rajbari, Rajbari

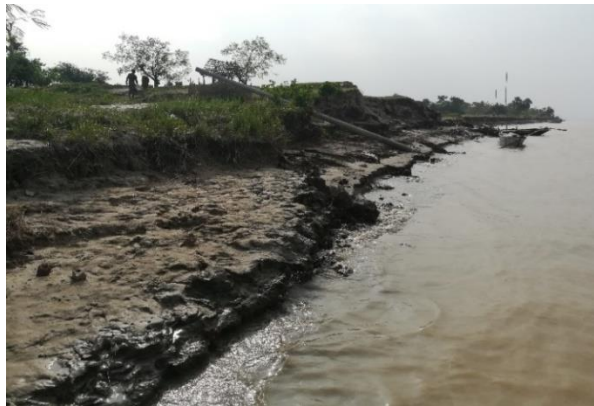
Figure 3.15: Bank line during the field visit September 2018 at Afsar Sheikher Char

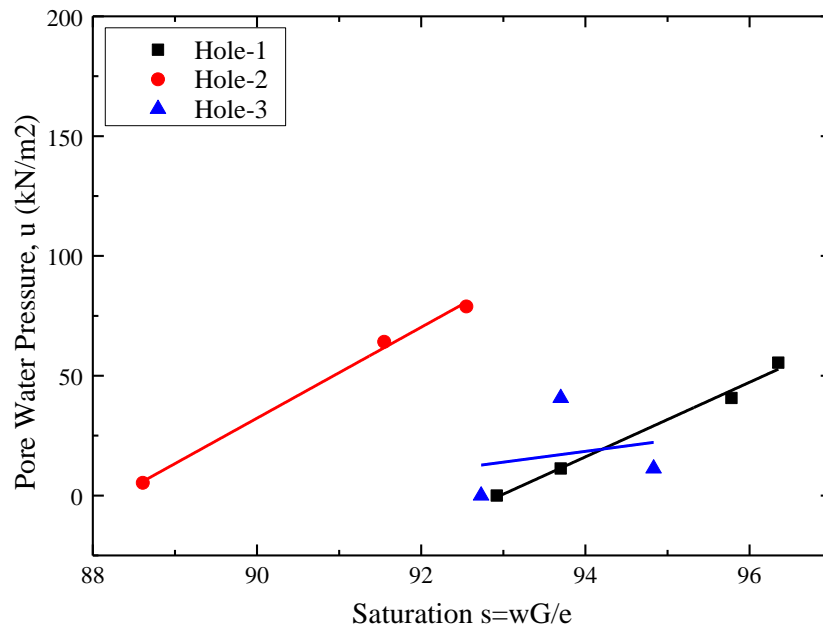
Figure 4.21: Graph showing the effect of saturation on pore pressure at Daskandi of Paturia side of Padma river

In Figure-4.21 the pore water pressure has been plotted with respect of its saturation. The data have been considered here on the month of February'18. From fig it is observed that the pore water pressure has been increased with the increases of saturation. It is mentionable that the data would become changed monthly as the location is situated on the river bank and the distance of the holes adjacent to the bank line. The saturation becomes full when the soil is submerged. The saturation has been increased I,e, from 85% to 97% in accordance with its soil properties as it depends on specific gravity as well as void ratio of the soils and its density. Their corresponding pore water pressures have been increased from 0 to 100kN/m² accordingly. However, the saturation at hole no.-3 of Daskandi site has not been changed significantly in comparison with other two holes. It has also been happened due to its soil layers and properties and its ground water level as well as coordinates. In here the ground water level has been changed in accordance with surface water level. Here it is remarkable that reduced level was not existed at the alike coordinate and ground level. That's why the soil layer was not homogeneous however, the location was identical.

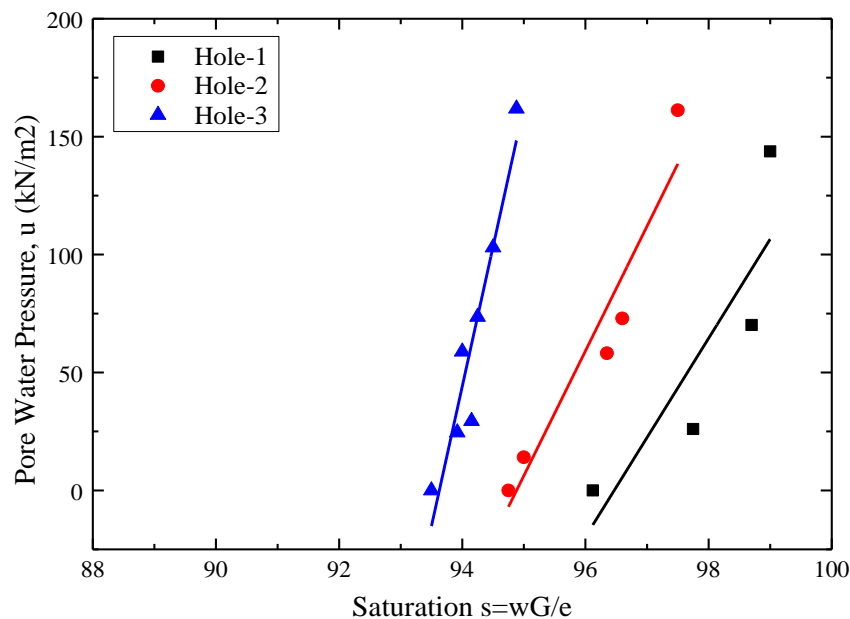
Figure 4.23: Graph showing the effect of saturation on pore pressure at CharBahirdia of Daulatdia side of Padma river

In Figure-4.23 the pore water pressure has been plotted with its respective saturation. The data have been considered here on the month of February'18. From figure it is observed that the pore water pressure has been increased with the increases of saturation. It is mentionable that the data would become changed monthly as the location is situated on the river bank and the distance of the holes adjacent to the bank line. The saturation becomes full when the soil is submerged. The saturation has been increased I,e from 93% to 99% in accordance with its soil properties as it depends on specific gravity as well as void ratio of the soils and its density. Their corresponding pore water pressures have been increased from 0 to 177kN/m² accordingly. Here the small variation of saturation has been occurred due to its soil layers and properties and its ground water level as well as coordinate. In here the ground water level has been changed in accordance with surface water level. Here it is remarkable that reduced level was not existed at the alike coordinate and ground level. That's why the soil layer was not homogeneous however, the location was identical.
