**BANK PROTECTION AND
RIVER TRAINING (AFPM)
PILOT PROJECT
FAP 21/22**

**REPORT ON
MONITORING AND ADAPTATION
AT
BAHADURABAD TEST SITE**

ANNEXES

MARCH 1999

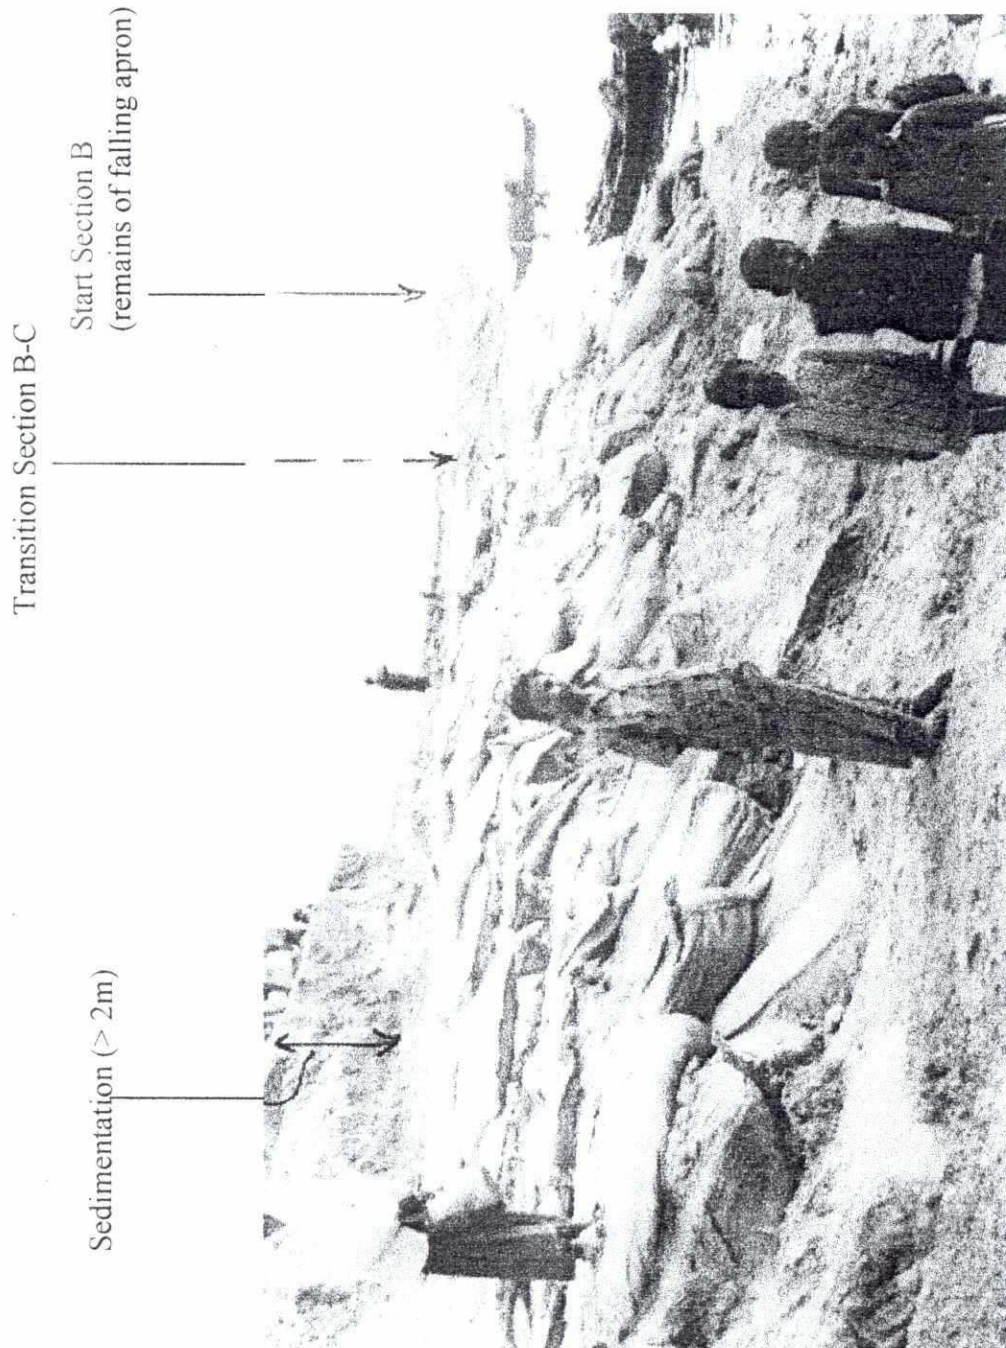
36 View from Section B towards South (downstream)
In front exposed falling apron of geo-sand containers (180/250 kg/

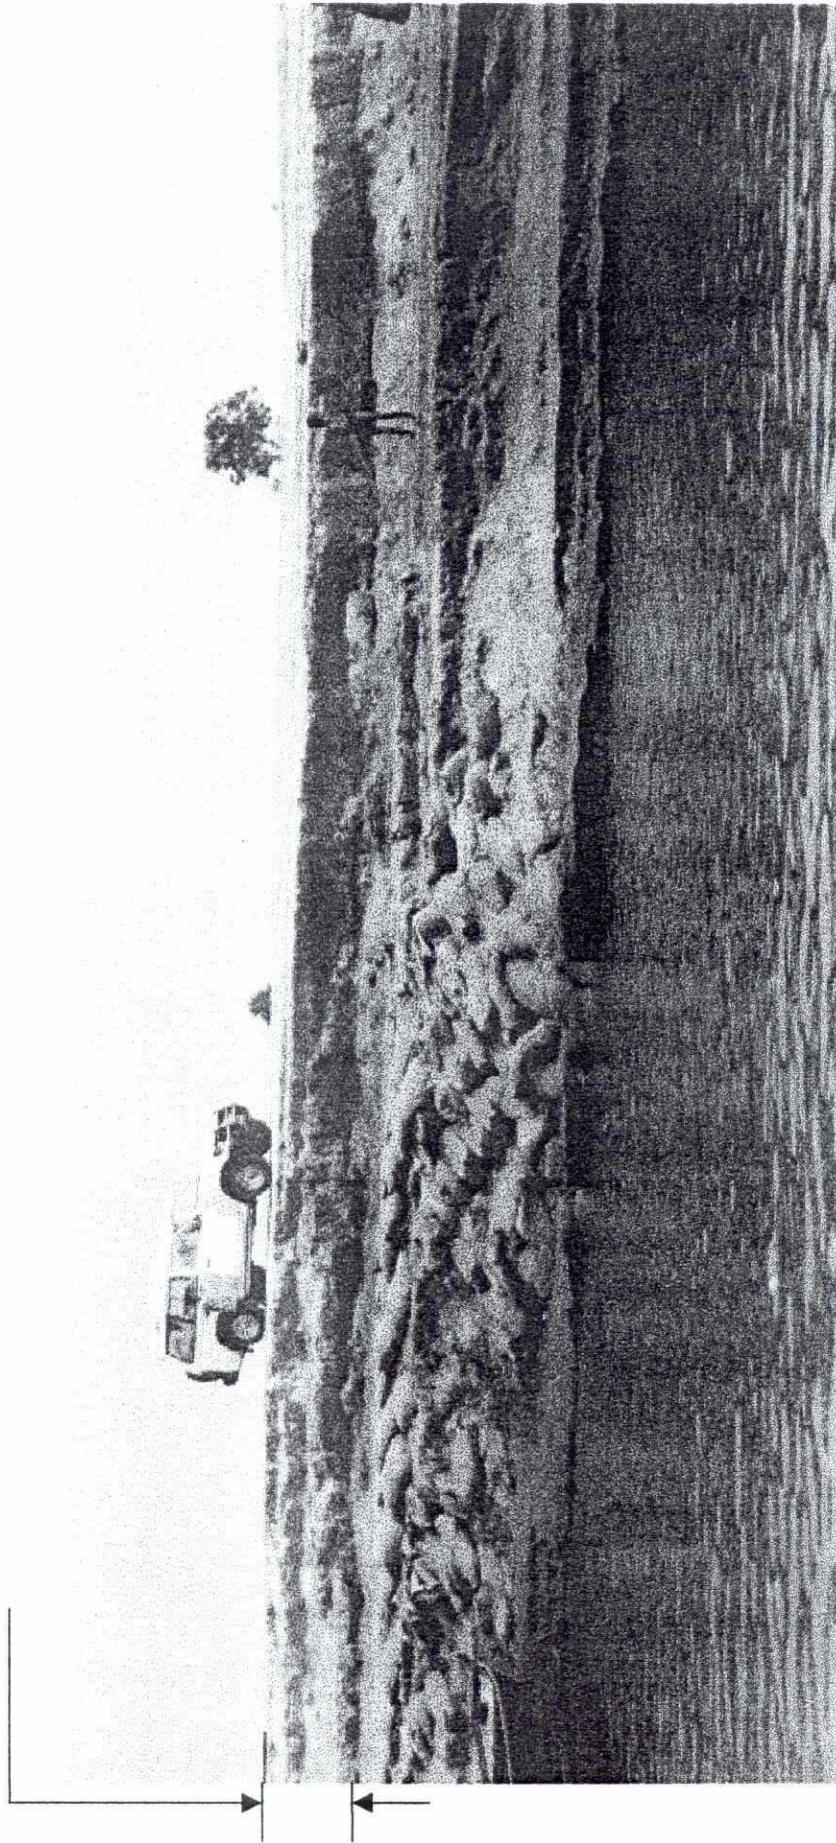
35 Section B:
Exposed falling apron of geo-sand containers (180/250 kg/No.)

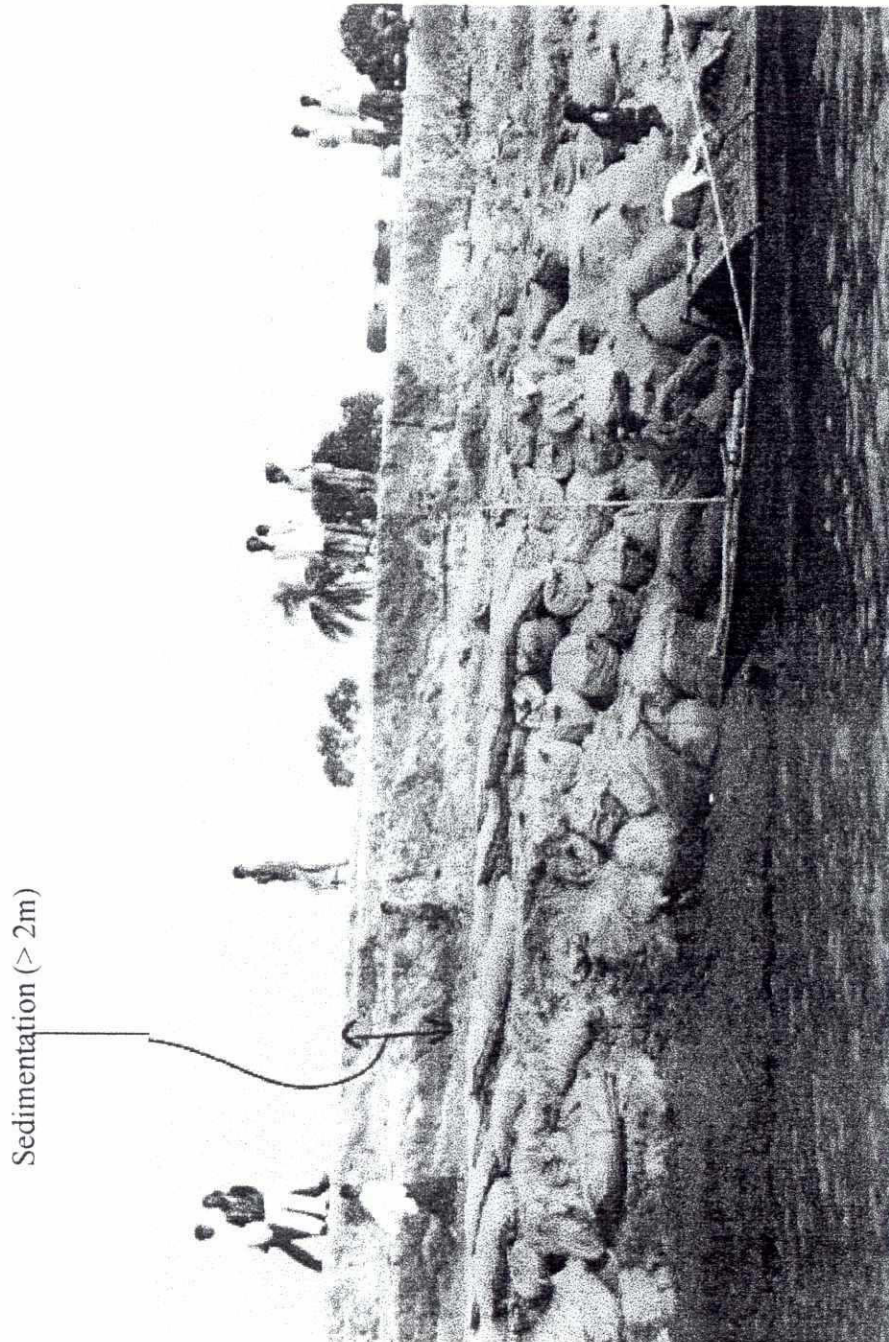
37 Section B:
Exposed falling apron of geo-sand containers (180/250 Kg/No.)
(15.02.98; WL~+13.0M)

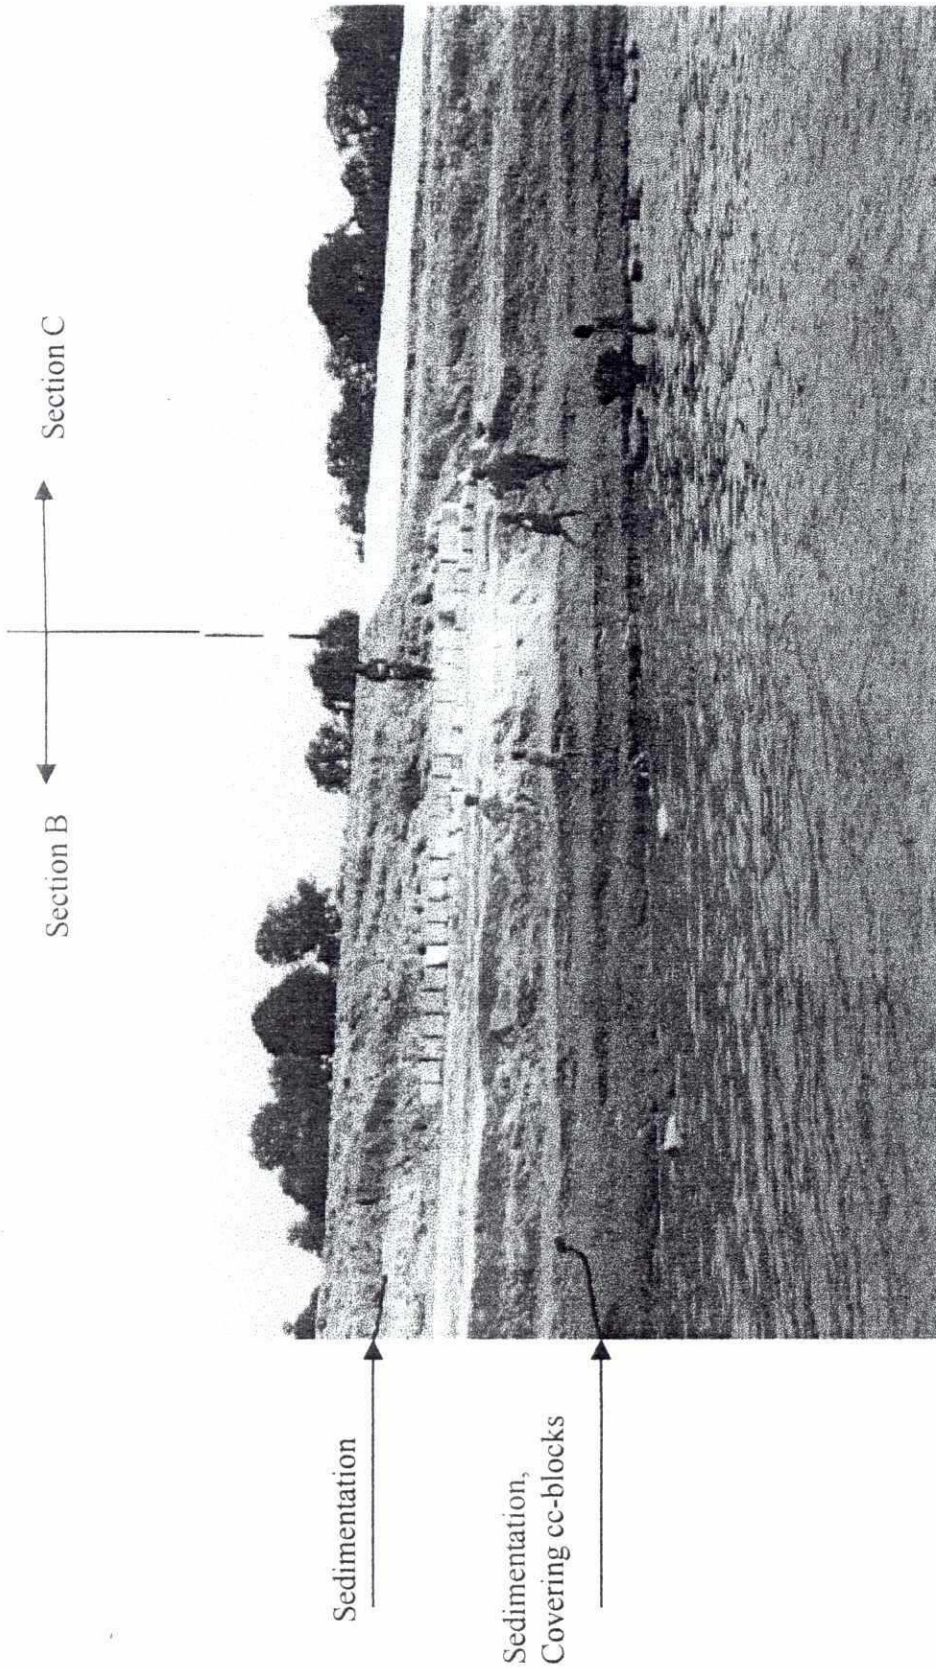
- 38 Section B: (15.02.98; WL+13.0m)
 Launching apron of cc-blocks exposed due to severe local erosion
 (trial excavation proved existence of cc-blocks also between waterline
 and visible blocks, well buried under sedimentation layers)

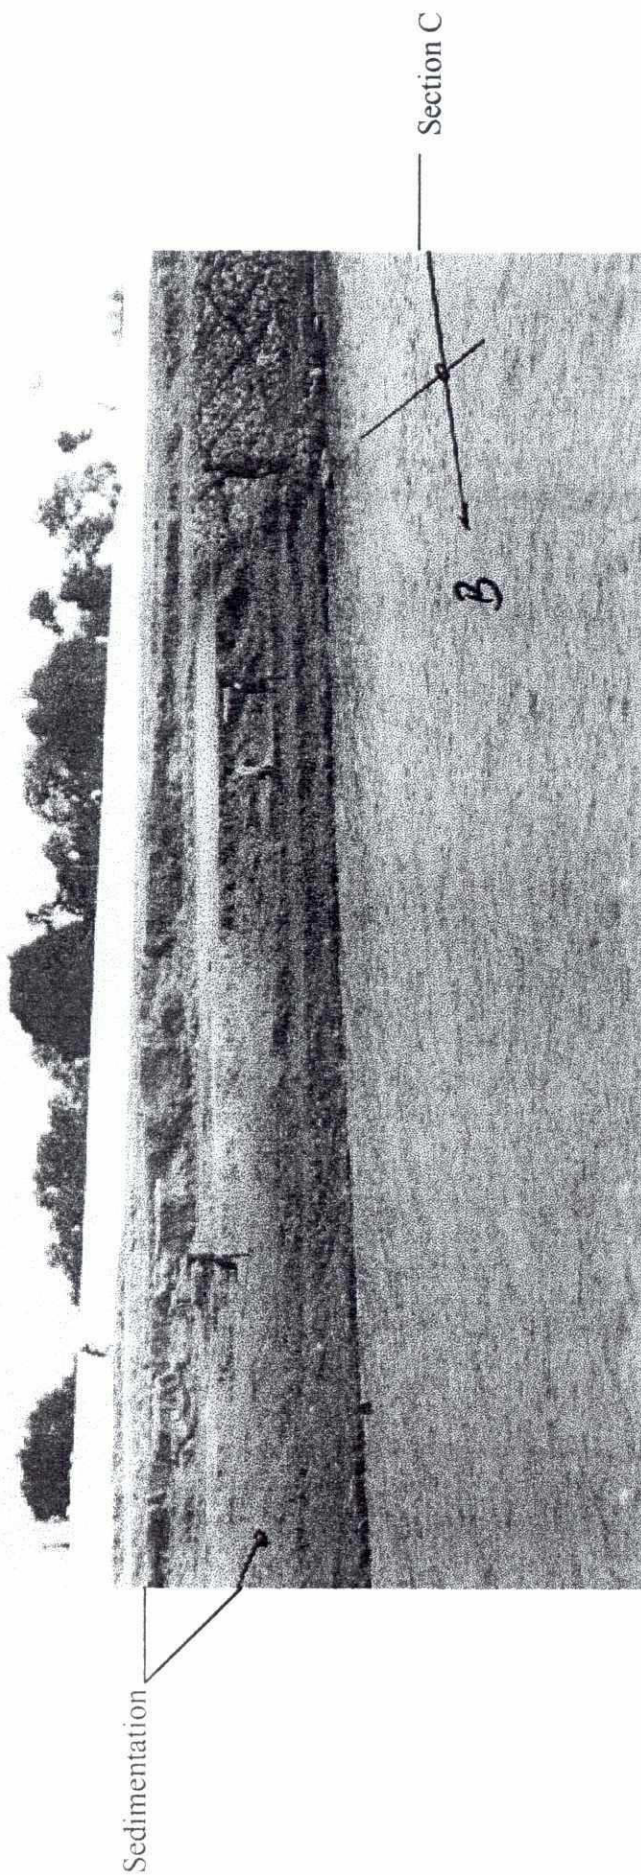
- 39 Exposed launching aprons in Sections B-C
 In Section B heavily covered by sediments (trial pits produced evidence of cc-blocks)
 (15.02.98; WL~+13.0m)

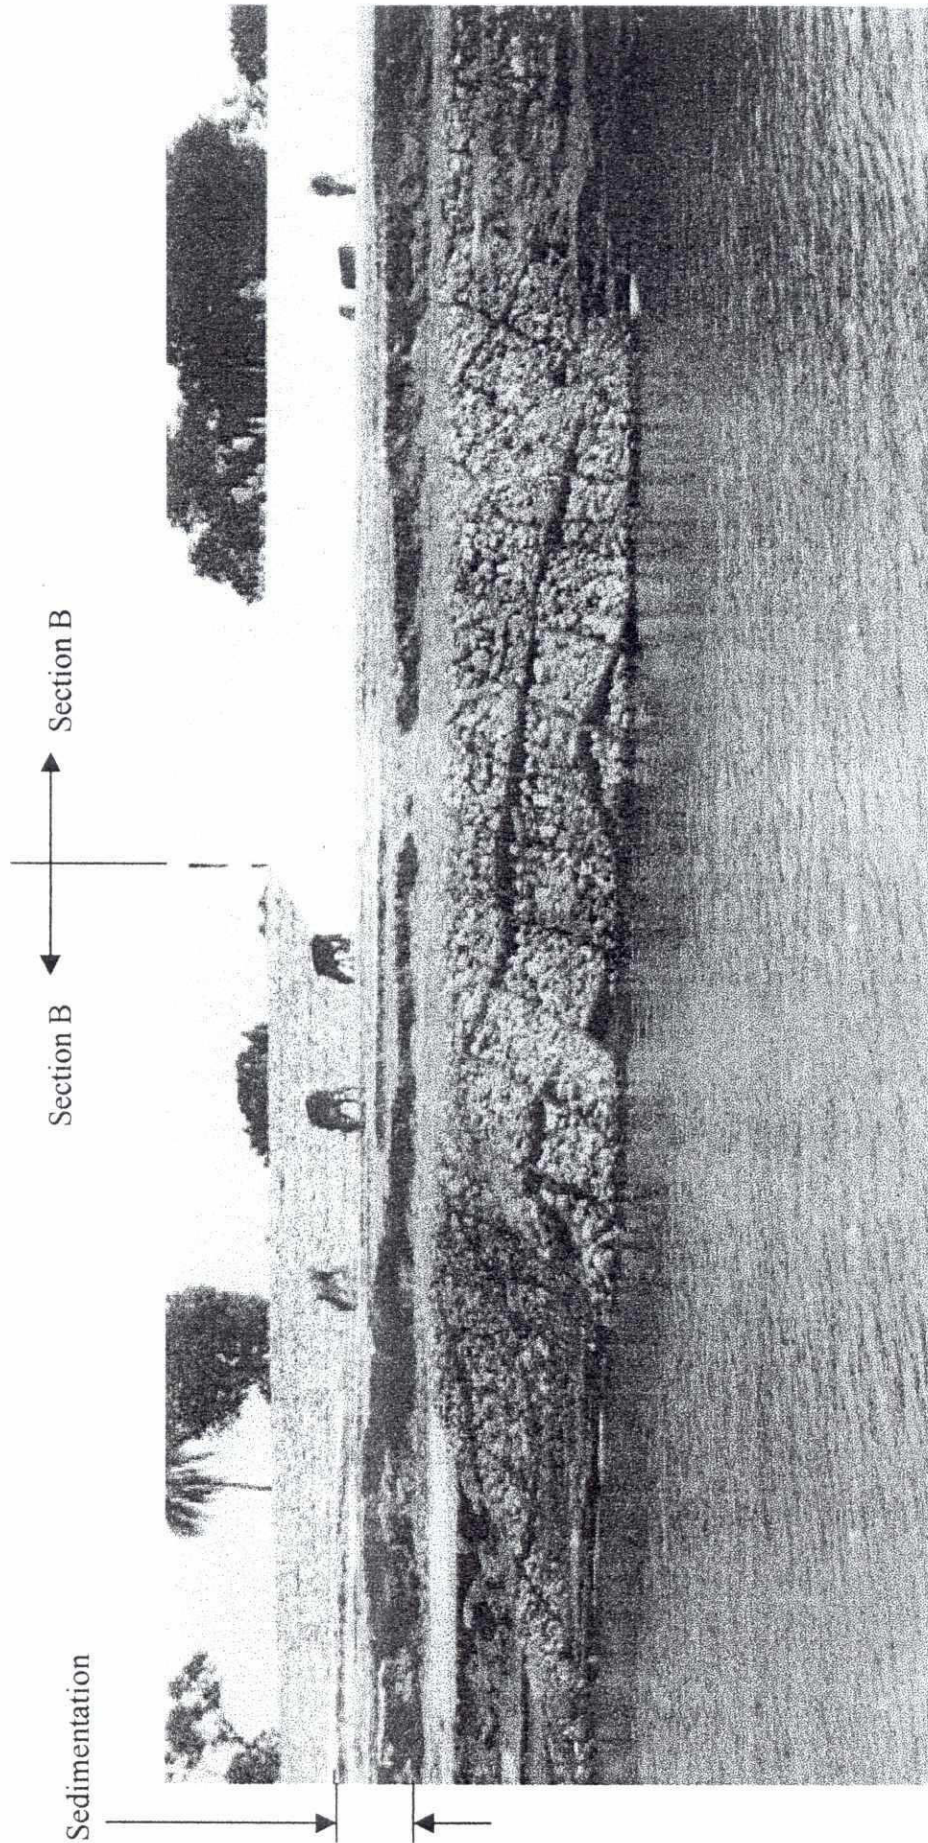
34 Exposed launching apron in Section C:

(articulated RENO-mattresses have well adjusted to eroding bank; some RENO-boxes disintegrated (possibly due to inadequate closing of box cover). Falling apron of geo-sand containers (900 kg/No.) completely eroded away.

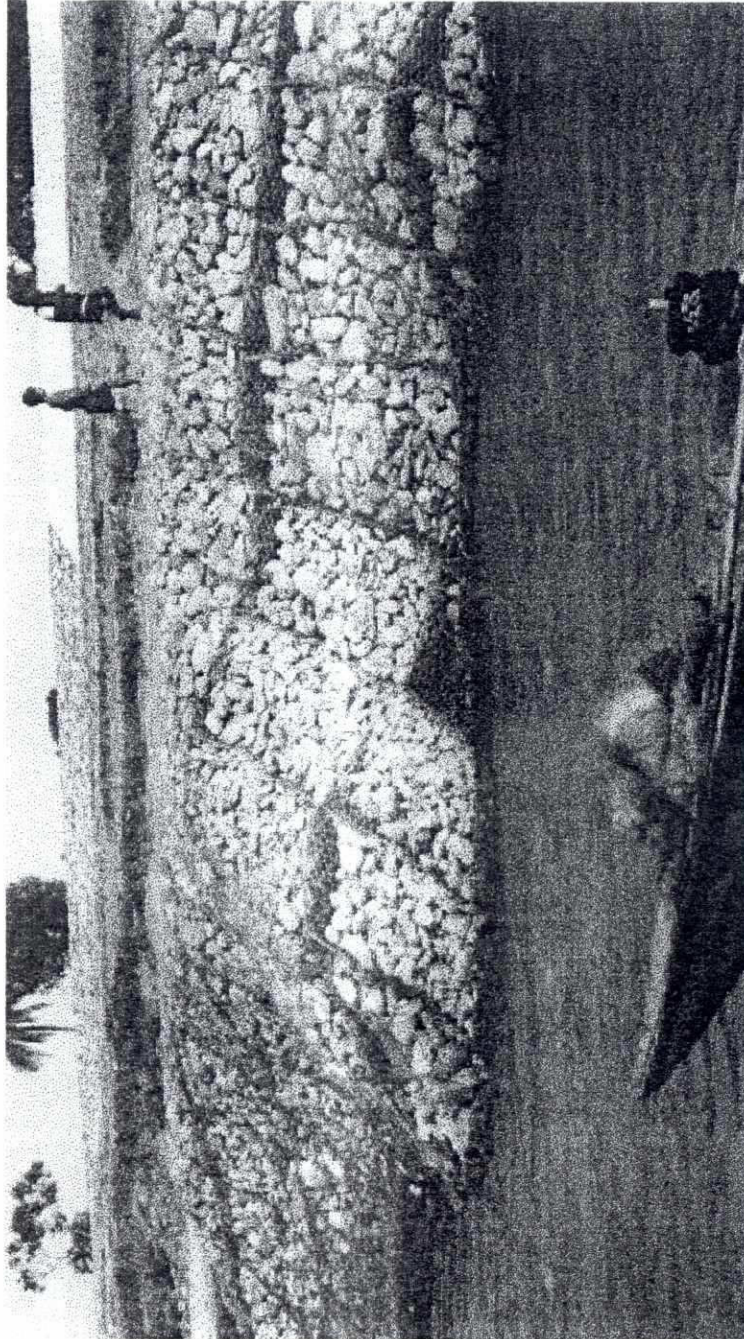
40 Section B: Launching apron of RENO-mattresses (15.02.98, WL~+13.0 m)
Articulated mattress system fully integrated, only a few box covers opened
Due to excessive deformation (likely due to inadequate wiring/tying of box
covers after placing the stone fill)

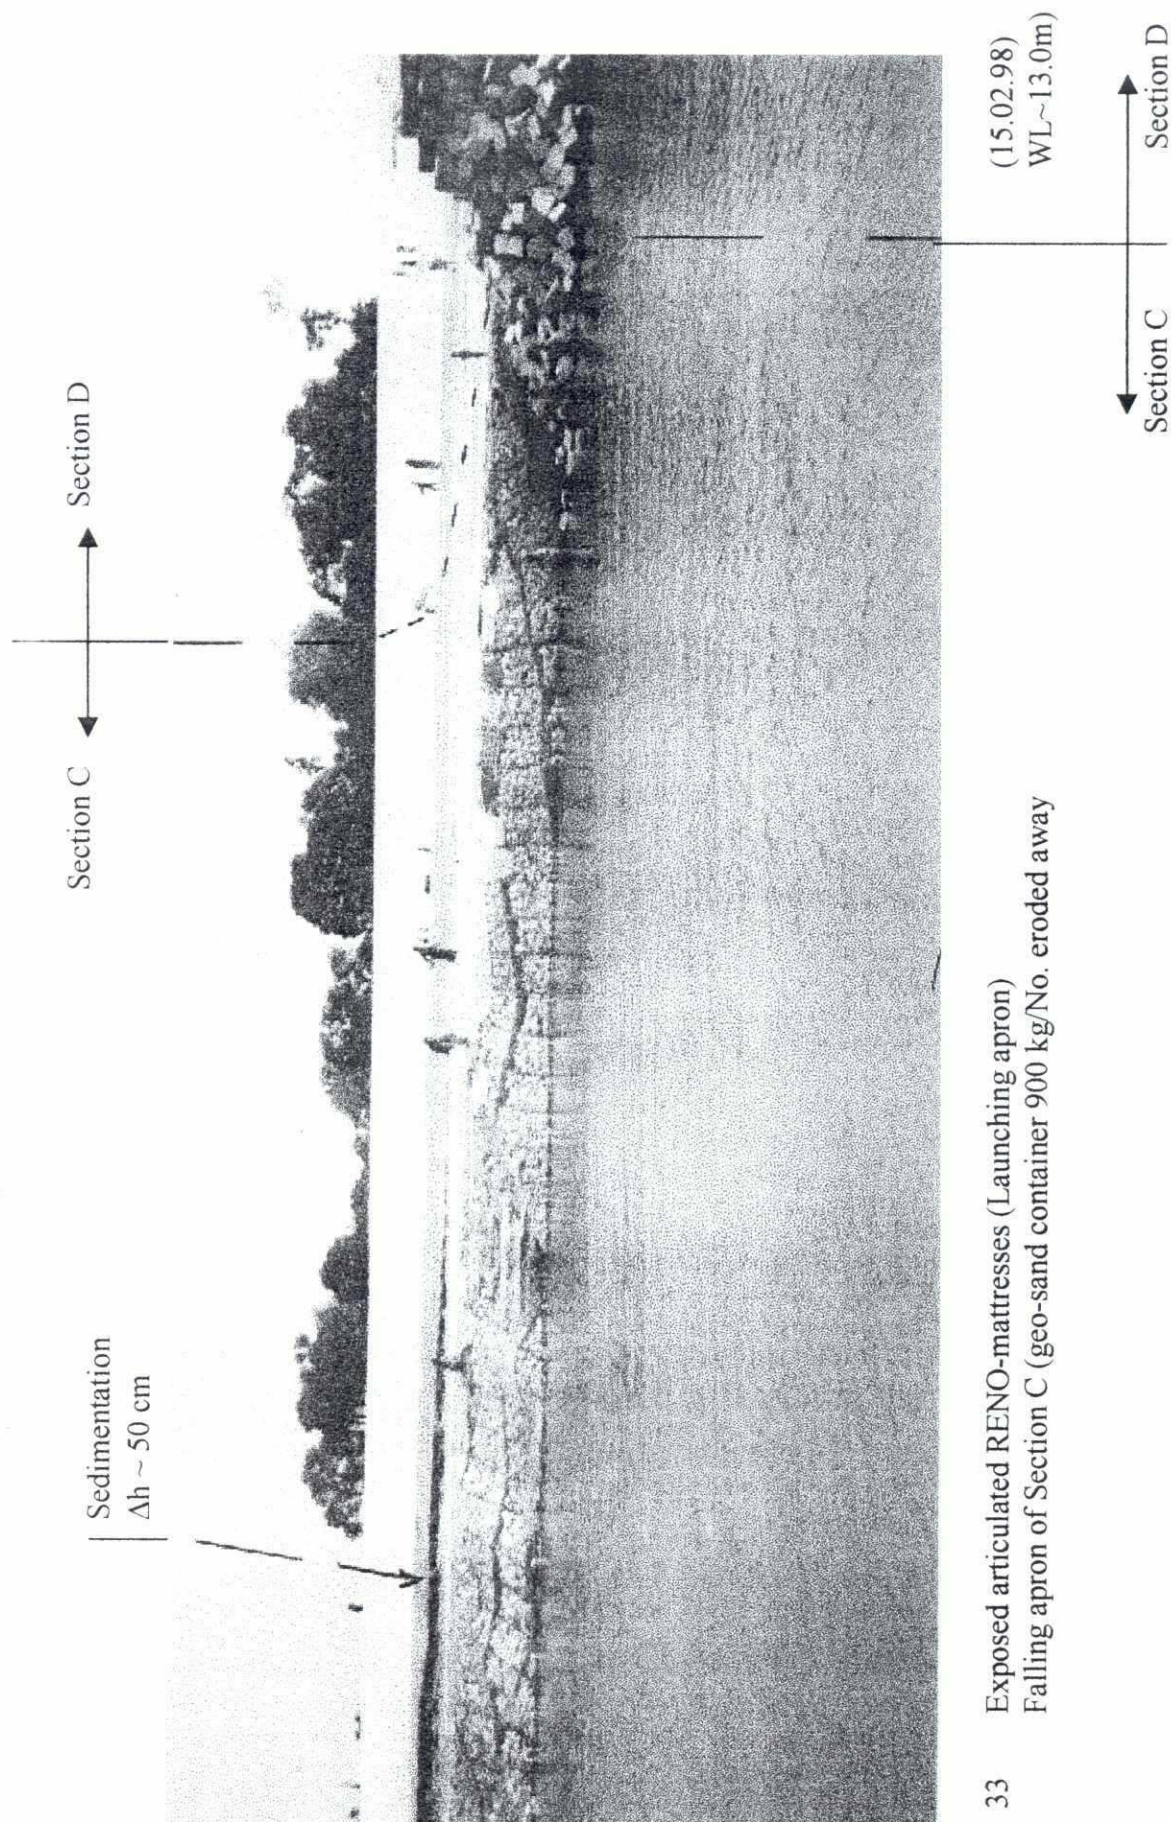
33 Exposed articulated RENO-mattresses (Launching apron)
Falling apron of Section C (geo-sand container 900 kg/No. eroded away)

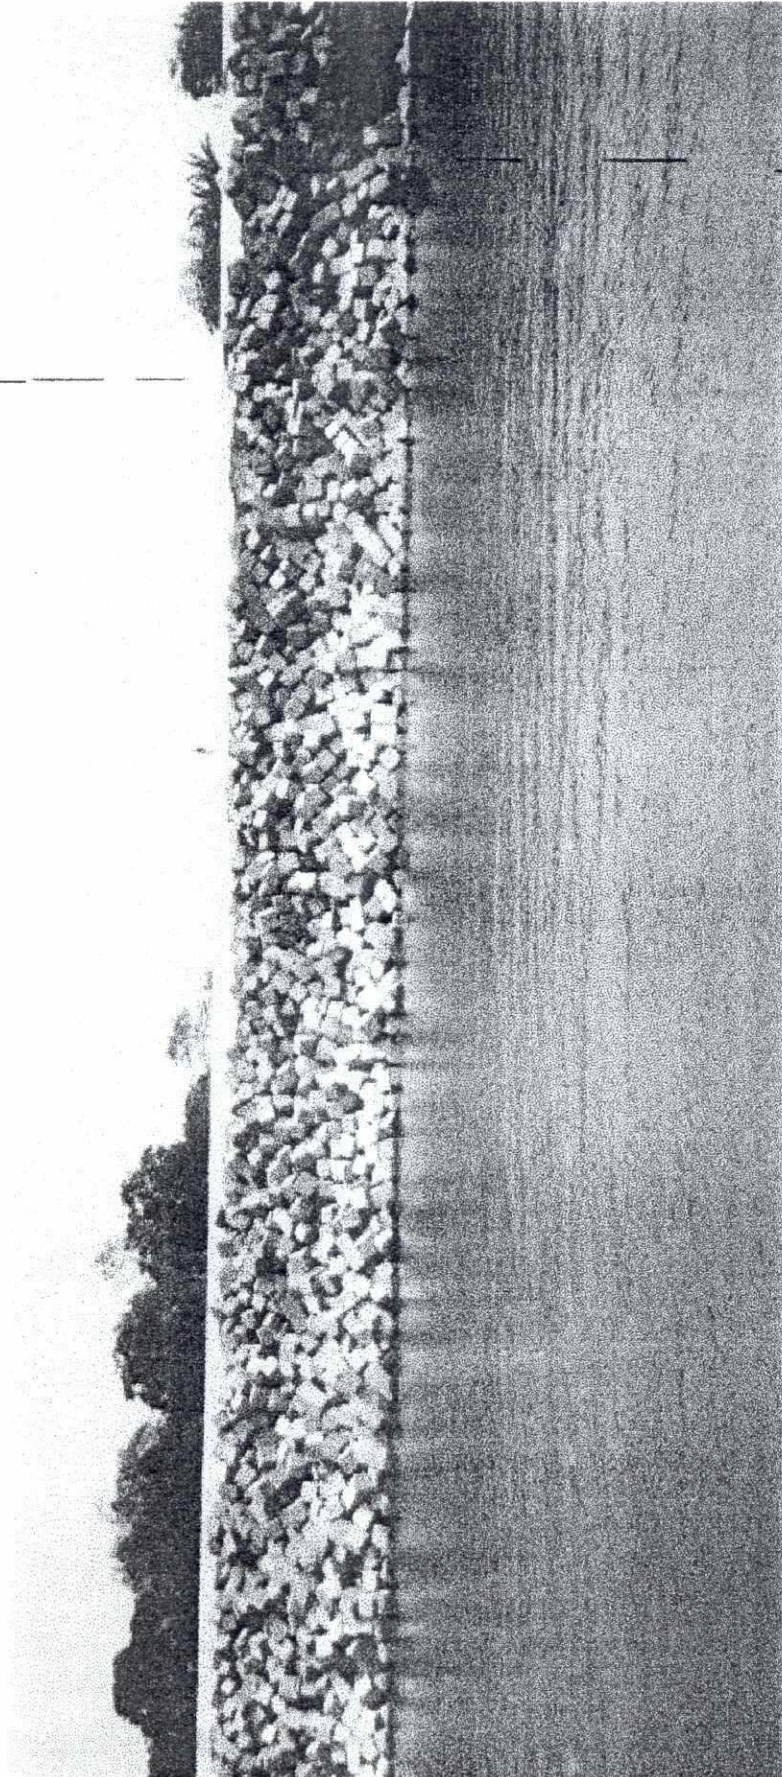
32 Exposed falling apron Section D / E-1 (cc-blocks size 40 * 40 * 40 cm)

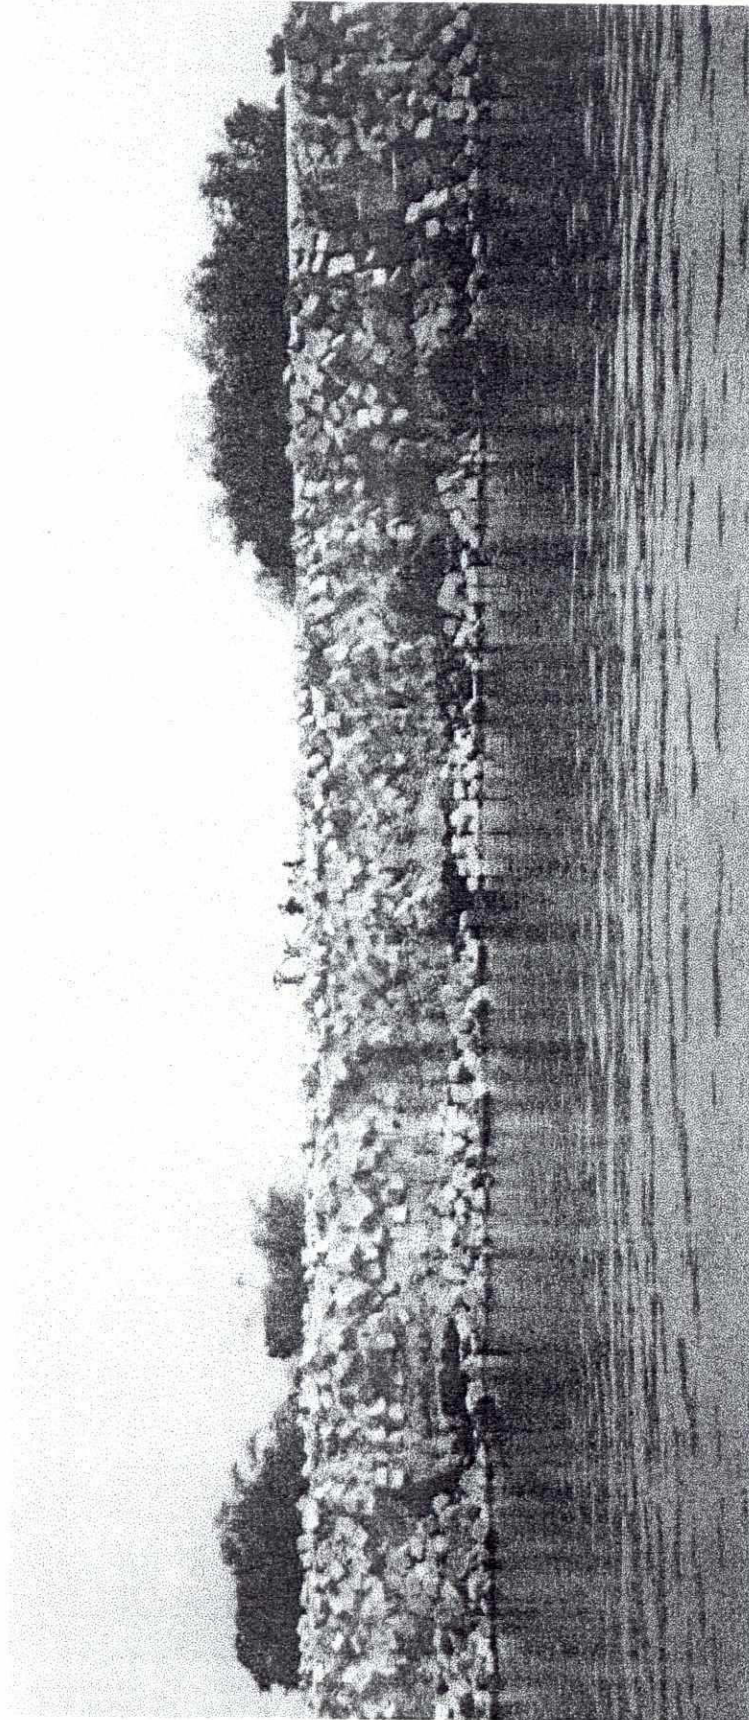
- 30 Section F:
- Exposed falling apron;
 - cc-blocks 40*40*40 cm and 45*45*45 mm;
 - upper part of bank less covered (as compared to Section G)

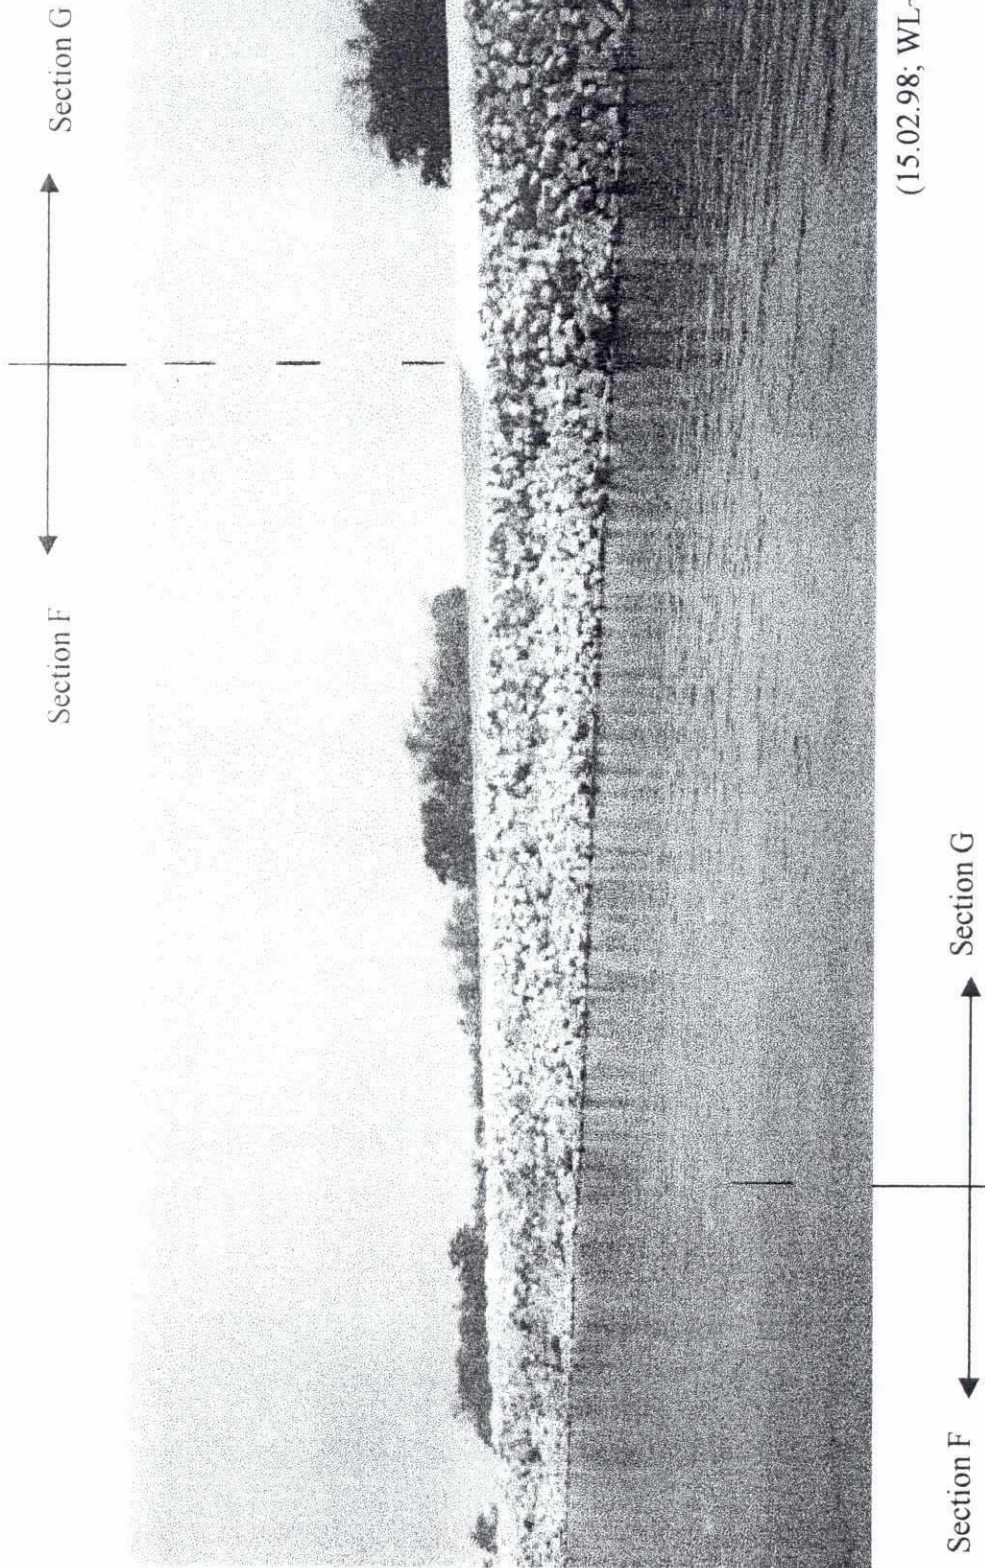
Exposed falling apron:

Section G: cc-blocks 35*35*35 cm and 40*40*40 cm (slope nicely covered)

Section F: cc-blocks 40*40*40 cm and 45*45*45 cm

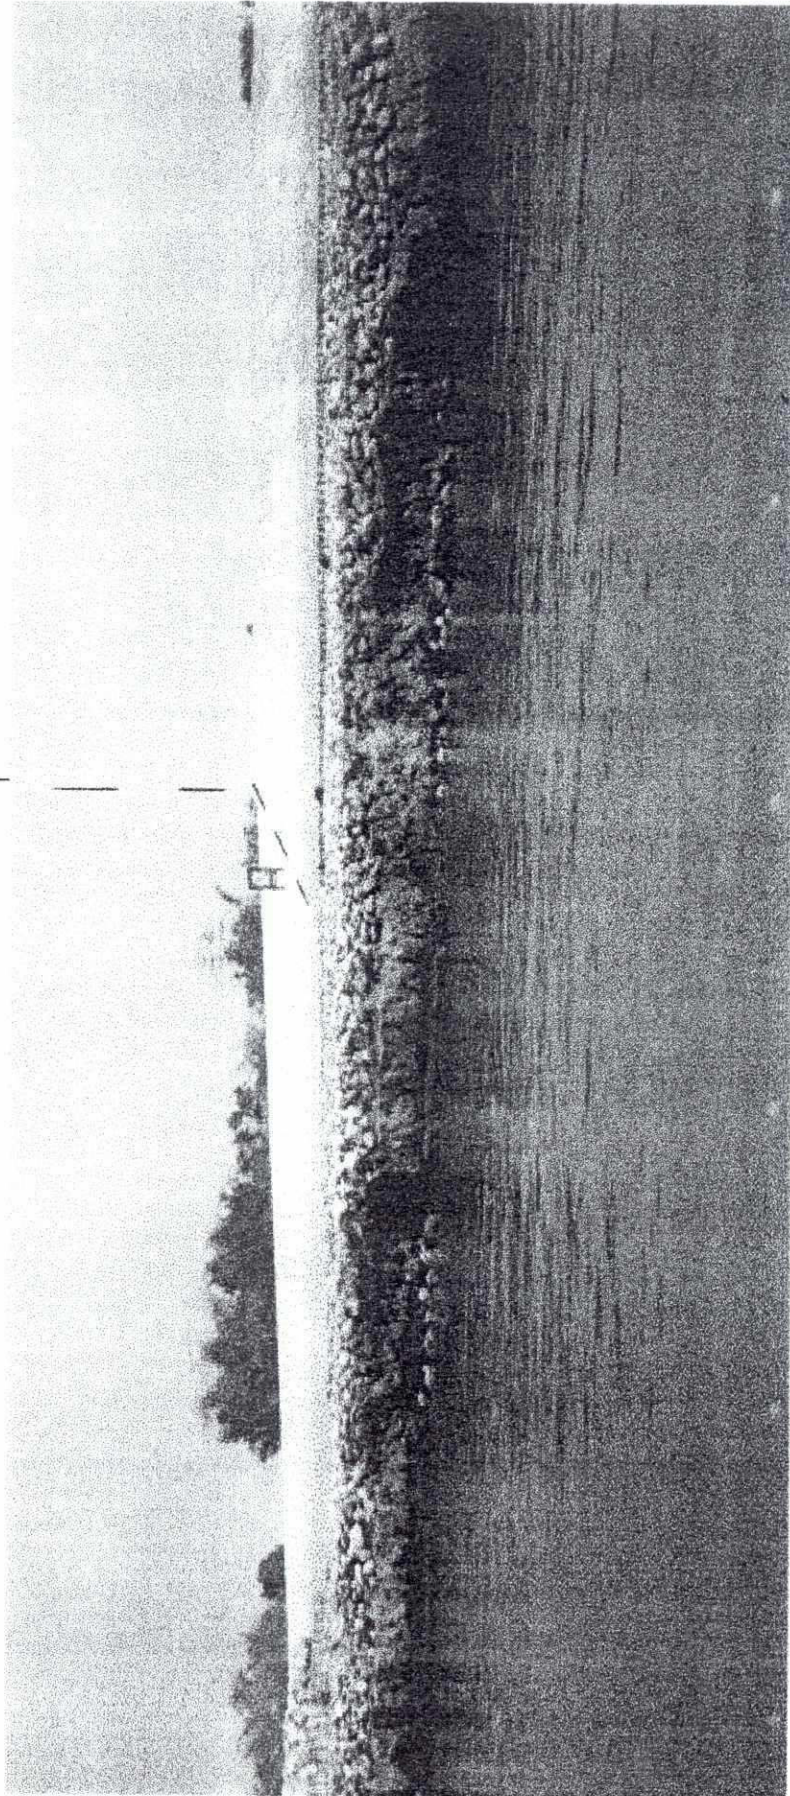
28 Section H-1: Transition of falling apron from G into H-1

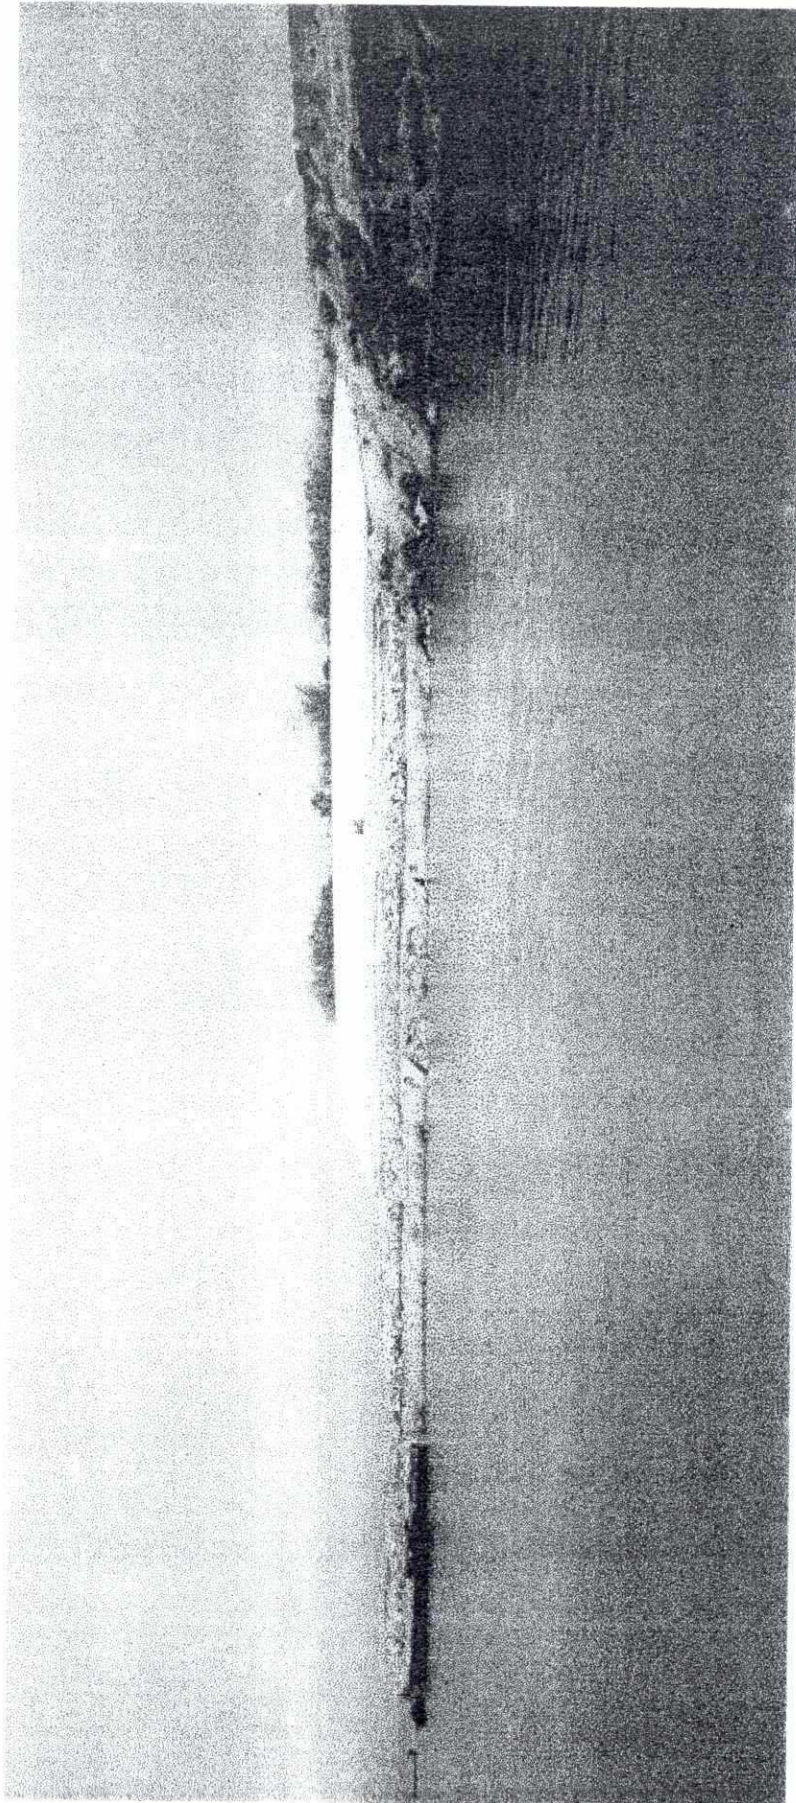
26 Downstream termination – Section H-1 / H-2 (view from south / downstream)

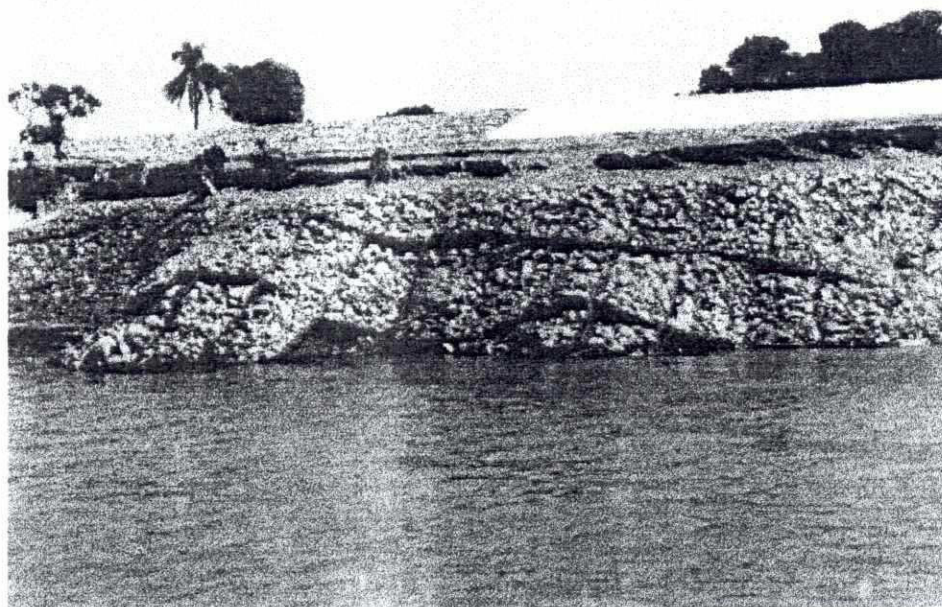
273/0A: View at bank-/ waterline of Sectin C (21.02.98; W.L. = 12.97 m PWD)

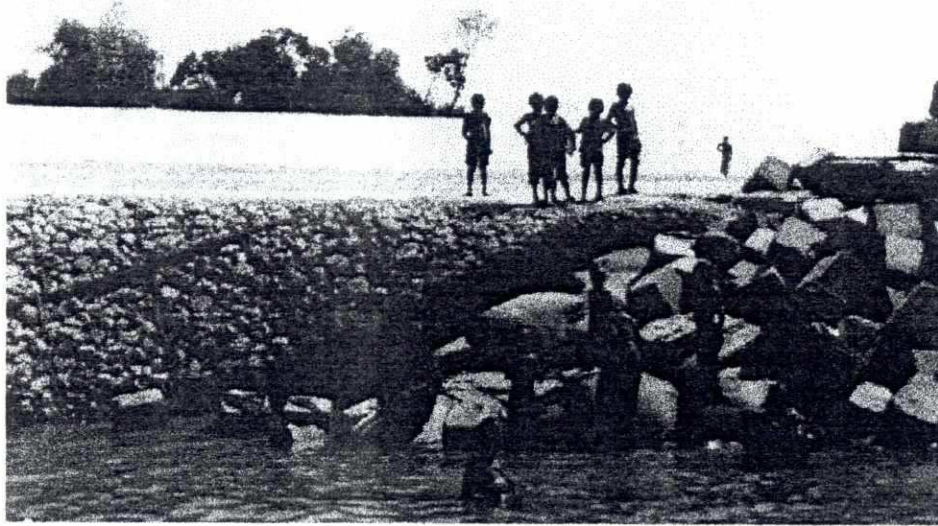
271/31: View at bank-/ waterline transition Section C/D (21.02.98; W.L. = 12.97 m PWD)

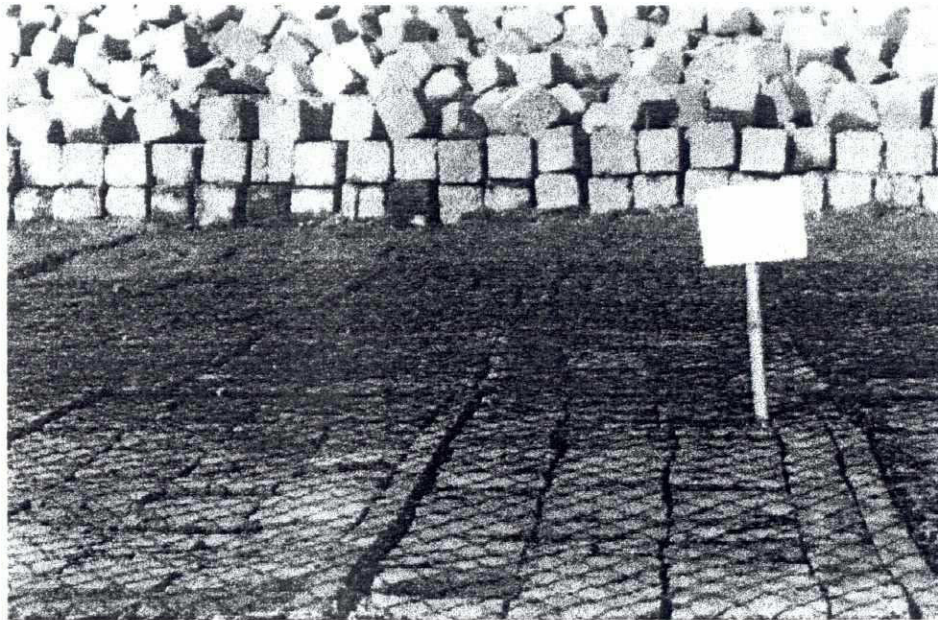
272/3: Sight on Section F before inspection (17.02.1998)

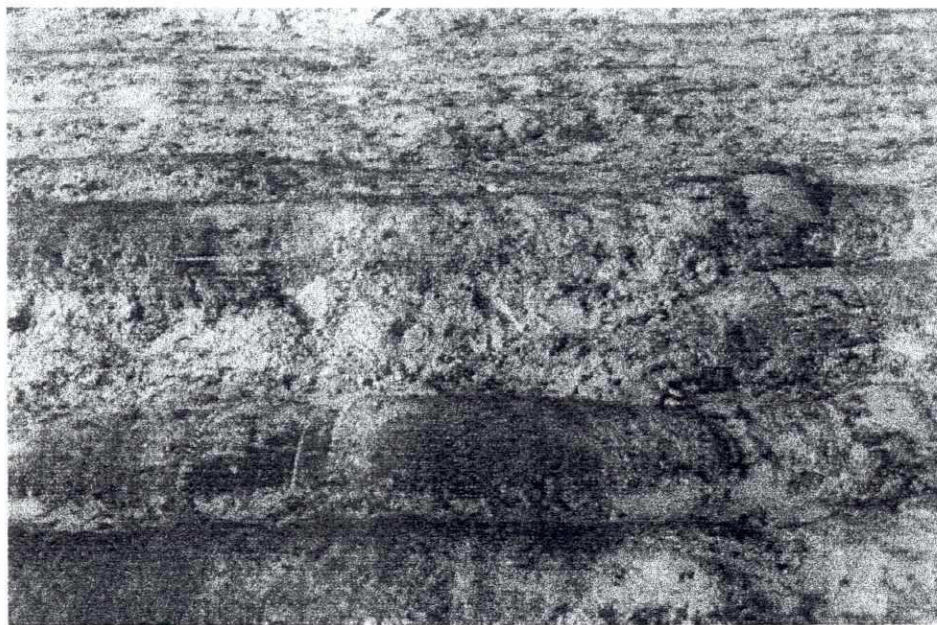
280/13A: View on repaired PROFIX-mattress of launching apron Section F (02.03.98)

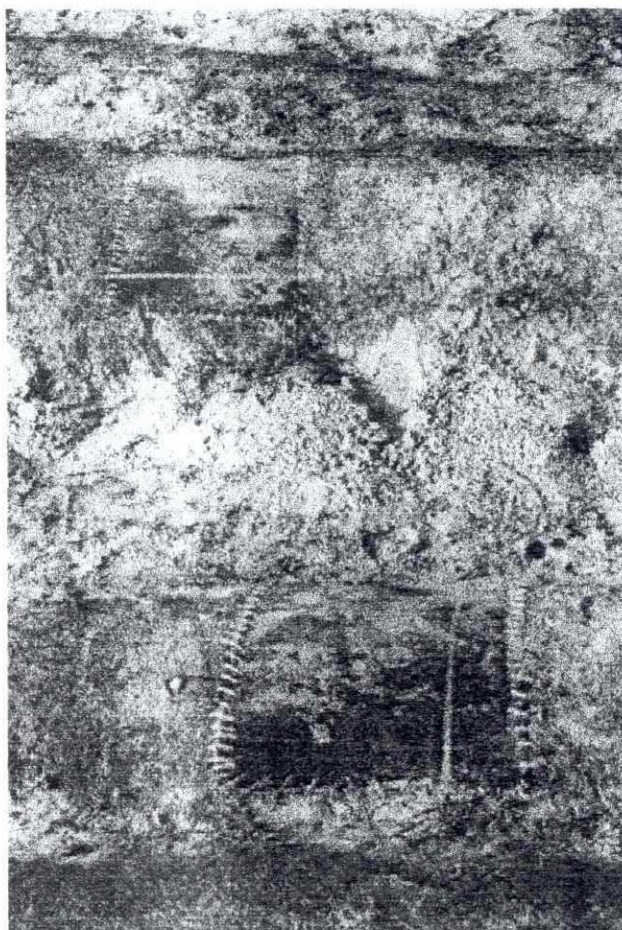
280/14A: View on repaired PROFIX-mattress of launching apron Section F (02.03.98)

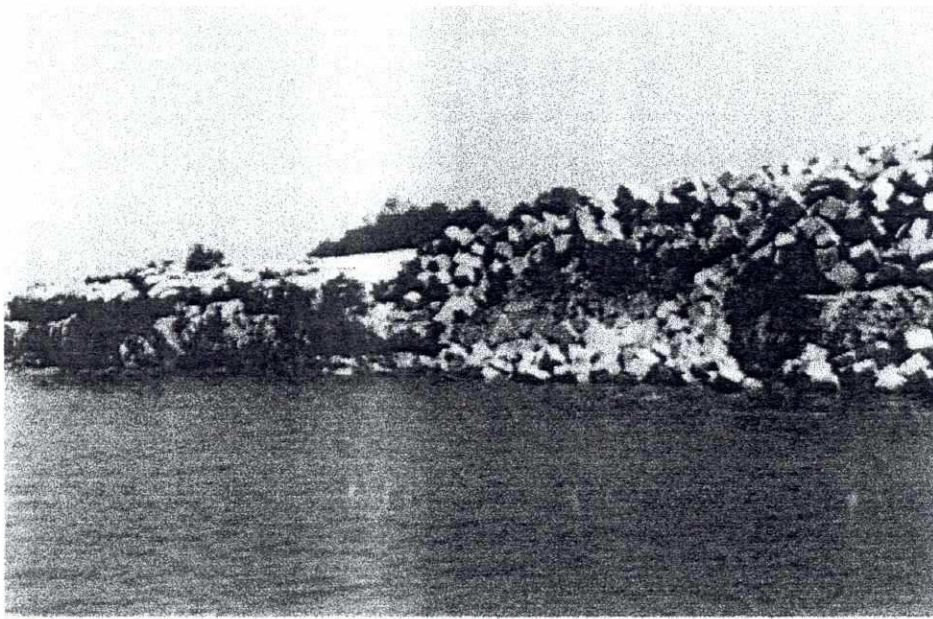
271/25: View at bank-/ waterline transition Section E-2/F (21.02.98; W.L. = 12.947 m PWD)
