MEGHNA ESTUARY STUDY

TECHNICAL NOTE MES-025

MONITORING OF HAIMCHAR EROSION CONTROL WORKS

MONITORING OF KHORKI EROSION CONTROL WORKS

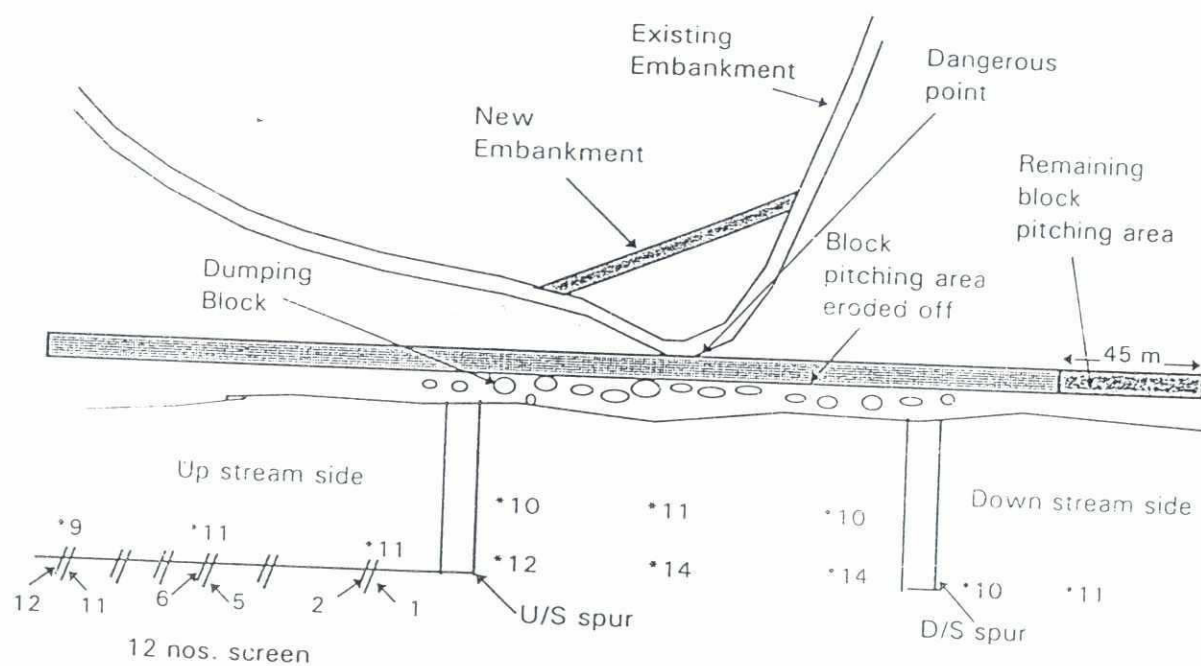
Figure 8

2. Out of the remaining 11 screens only 6 nos. were found at the river bed by the diver (figure 8). 5 screens are suspected to be washed away during the flood. In more detail:

- Screen no. 1 was in its original position at  $45^{\circ}$  angle to the flow, but the other one of the pair i.e. number 2 was displaced slightly in orientation to an angle of  $30^{\circ}$  to the flow.
- Screens nos. 5 & 6 were found lying flat on the river bed. The end seals of the PVC float pipes were missing. One top float pipe was found in bruised condition indicating a hit by a river vessel.
- Screens nos. 11 and 12 were found in place but in changed orientation from the installation angle of  $45^{\circ}$ , about perpendicular to the flow. One float pipe of screen no. 11 was open at both ends, but other float pipes were OK.
- Around the anchor slabs scouring was observed resulting in settlement of the slabs.
- Fishing nets were found inter winded with numerous screens.

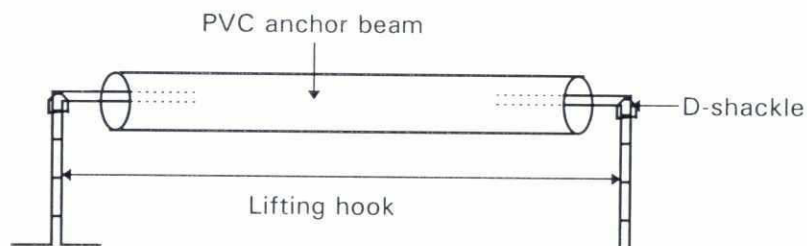
1. The screen was disconnected on dt. 11.08.98 by disconnecting both the lifting hooks at bottom from the anchor slabs.

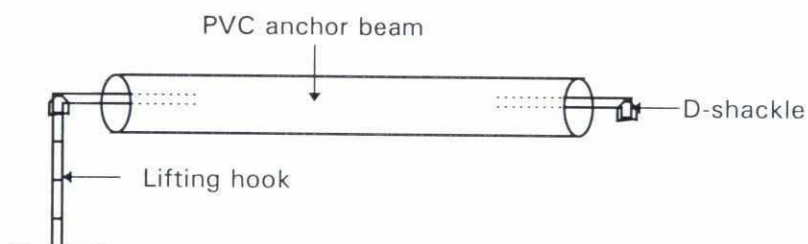
2. The screen was disconnected on dt. 23.09.98 by disconnecting the lifting hook from one anchor slab at bottom but on the other side the anchor beam hook was found with D-shackle.

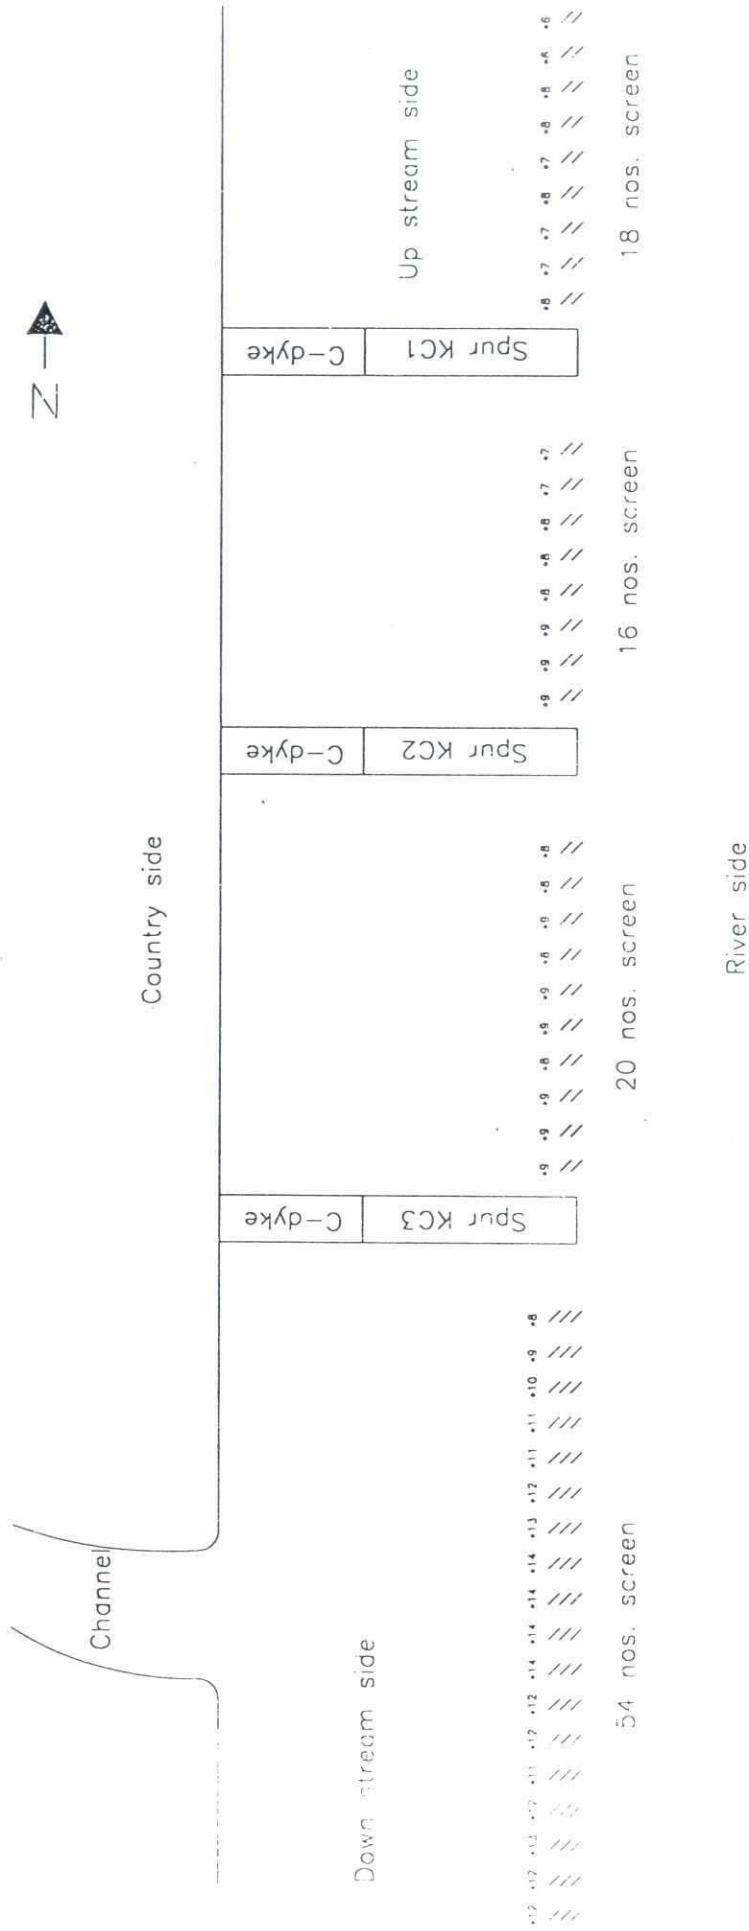
Figure 12

During high tide the water levels were recorded as shown in figure 12.

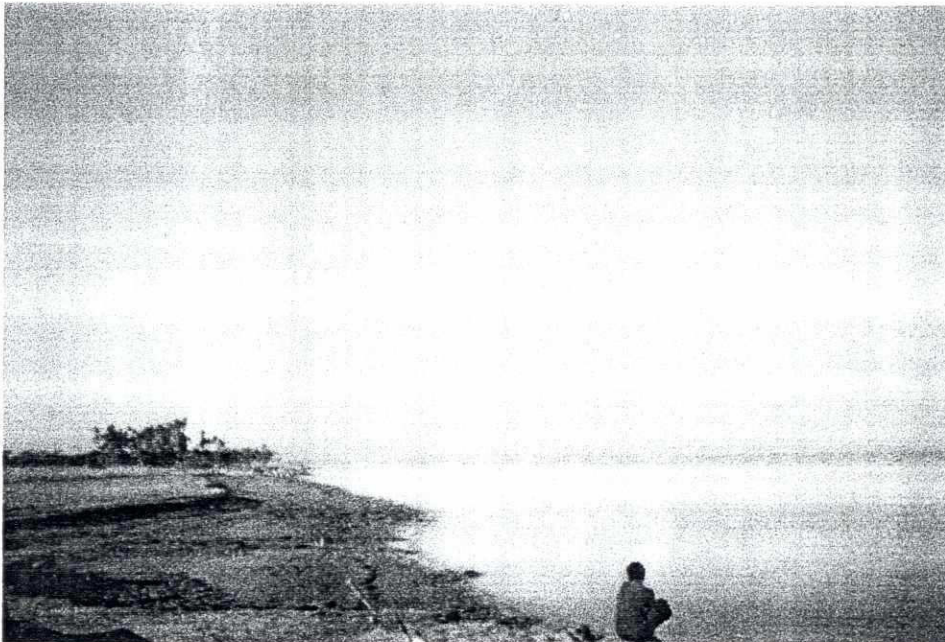
30 meters downstream of spur KC-3, 13 meters erosion was recorded (picture 13). No shoreline regression was observed in between the spurs KC-1, KC-2 and KC-3. In picture 14 the unharmed shoreline upstream of the upstream spur (KC-1) is shown. The siltation pattern at the upstream side of the middle spur (KC-2) can be seen in picture 15. Siltation is visible at the upstream side of the downstream spur (KC-3, picture 16).

Picture 16 Shoreline regression decreased and siltation is visible at the upstream side of the downstream spur (KC-3).

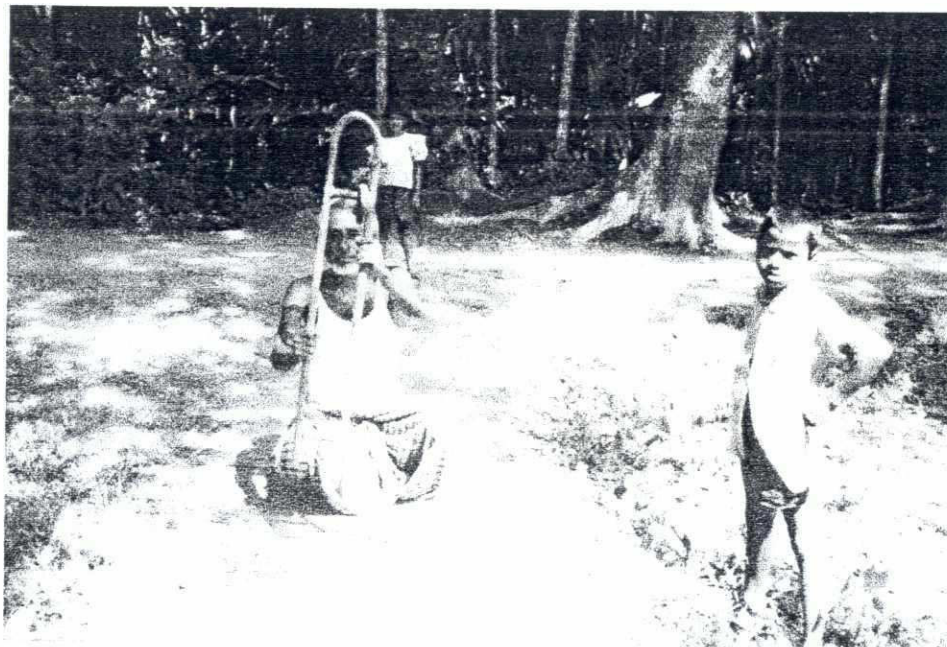
One screen was disconnected from the riverbed on November 15th 1998. The one meter long lifting hook was separated from the anchor slab (picture 17). The top float pipe was flattened. It might have been hit by a river vessel which might have dragged the screen causing failure of the lifting hook (picture 18).

Picture 17 A lifting hook has broken off the foundation of a bottom vane screen.

- k) The length of the lifting hook has to be reduced from 100 cm to 60 cm.
- l) The sealing method of the PVC float pipes needs improvement. The end seals were attached to the float pipes through double welding. The outer seal plate was reinforced through fiber-reinforced polyester resin (FRP) system. It is recommended that both the inner and outer end seal plates will be double welded and further reinforced by the FRP system to increase the strength of the float pipes.
