**BANK PROTECTION AND
RIVER TRAINING (AFPM)
PILOT PROJECT
FAP 21/22**

**TEST
AND
IMPLEMENTATION
PHASE
FAP 21**

**REPORT ON
MONITORING AND ADAPTATION
AT
KAMARJANI TEST SITE**

MONSOON 1999

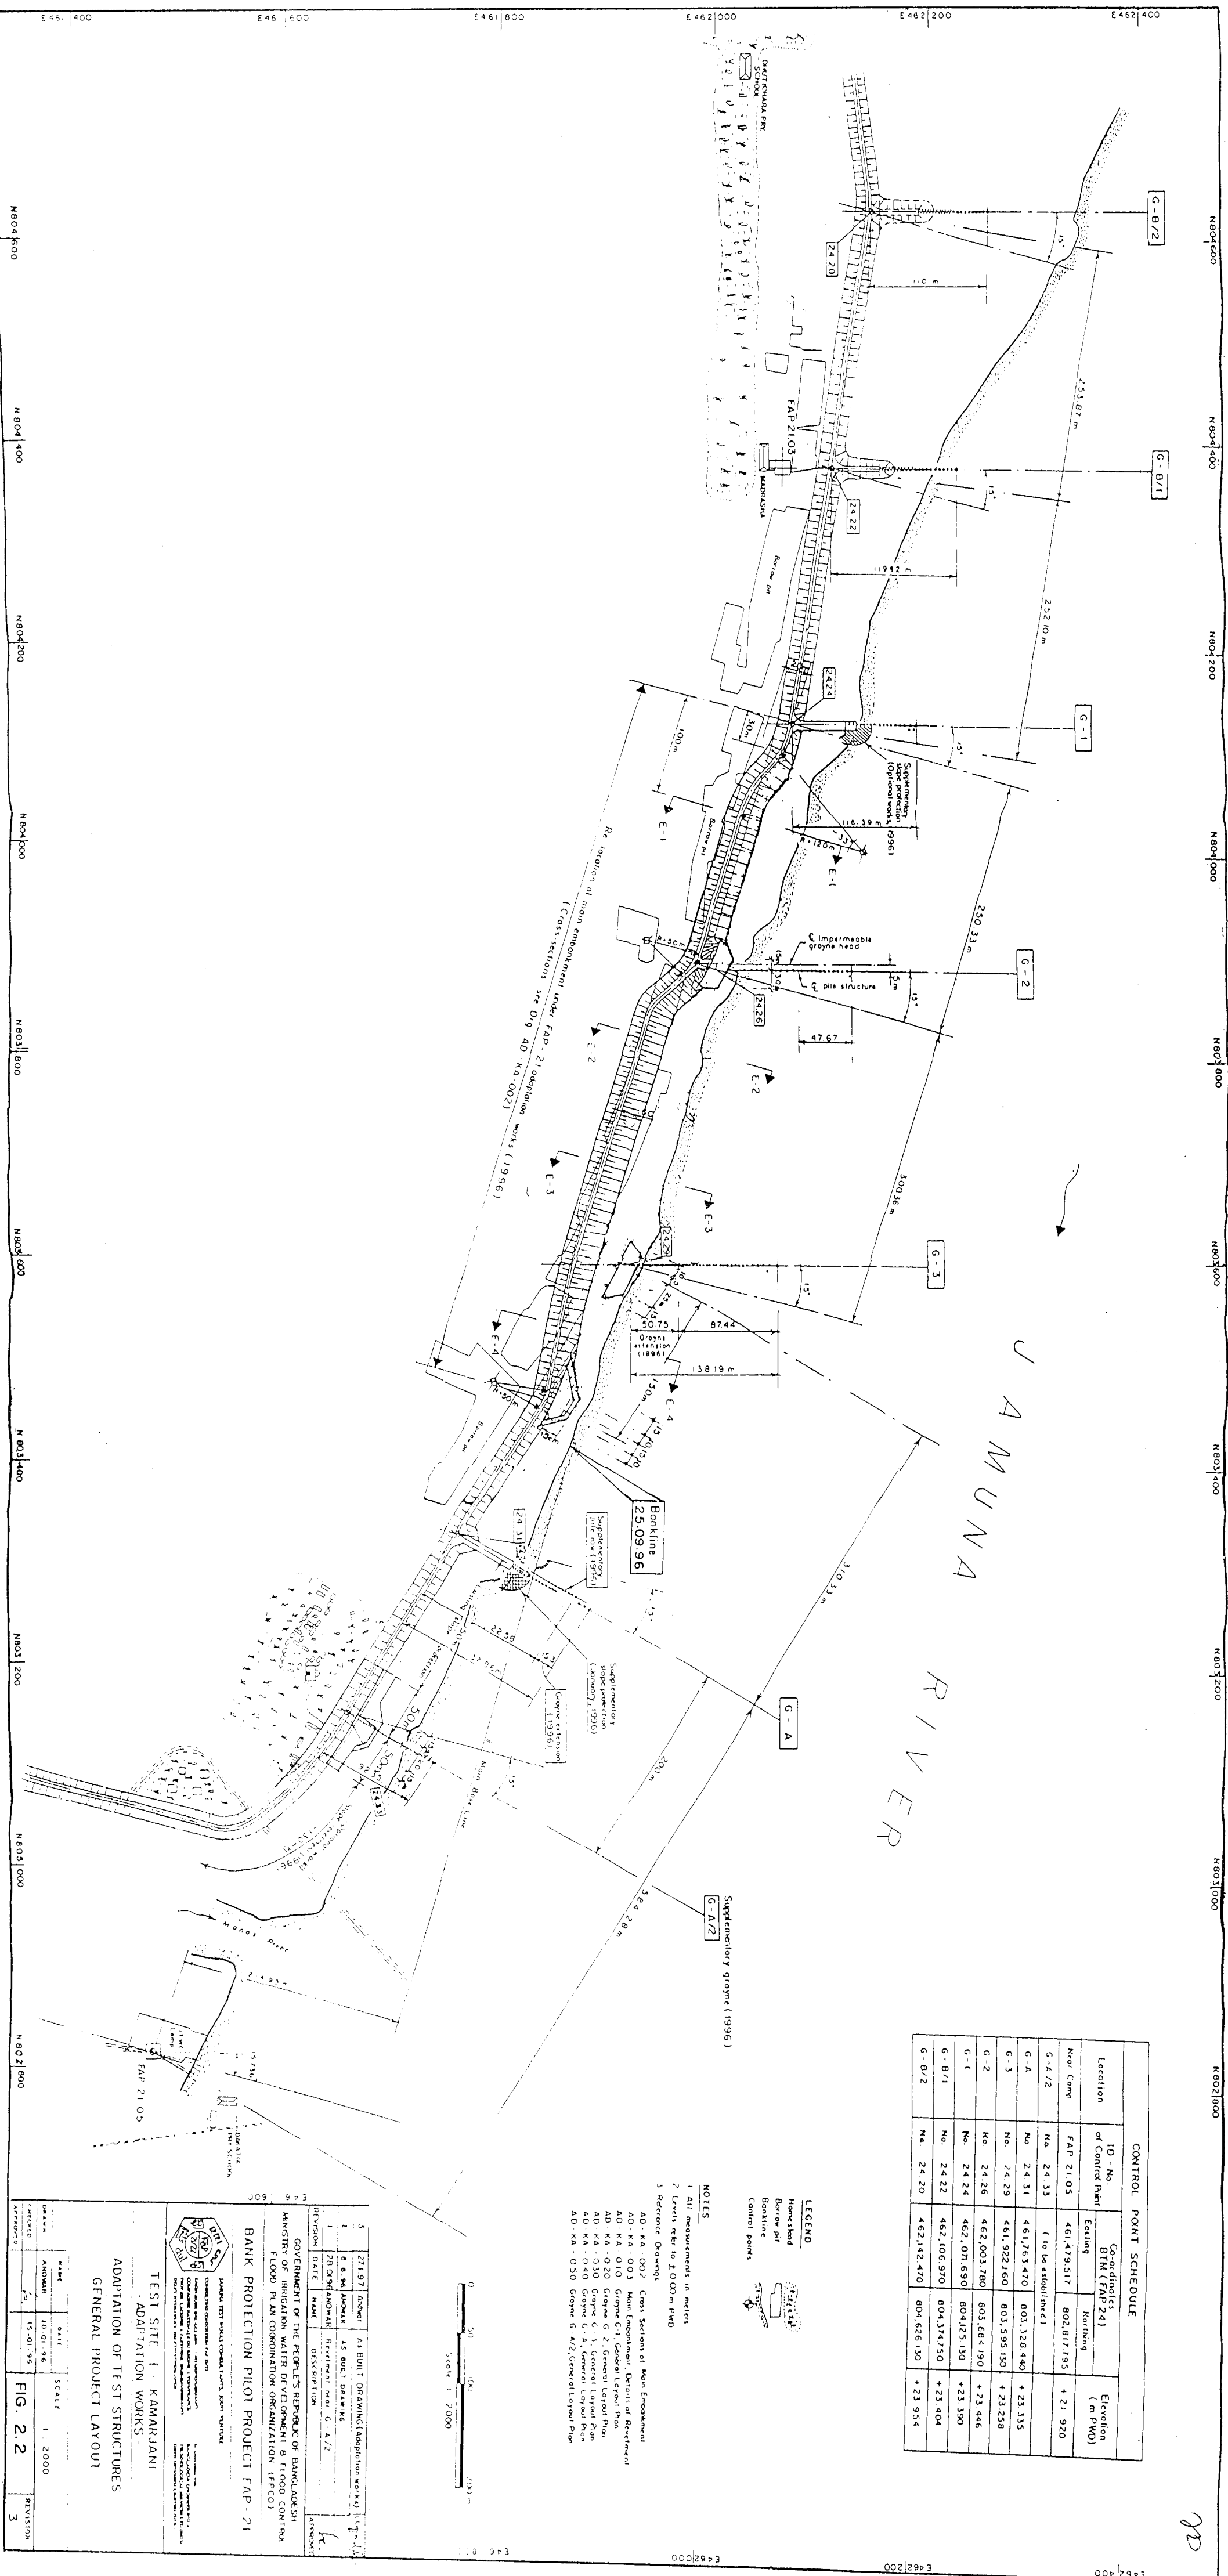
The general layout of the test structure after execution of adaptation and repair works is shown in Fig. 2.2.

- relocation of the main embankment starting about 30 m downstream from groyne G-1 up to about 150 m downstream from groyne G-3. The retired embankment is now 20 m behind the original one between groyne G-1 and G-2 and 50 m between groyne G-2 and G-3;

- slope protection by cc-blocks/boulders at the head of the steel sheet pile cofferdam of groyne G-1;
- driving of 44 Nos. tubular steel piles dia. 711 mm between the existing pile structure of groyne G-3 and the retired main embankment after removal of the remaining part of the impermeable groyne section;

- toe-protection of the retired embankment by cc-blocks upstream and downstream from the pile structure of groyne G-3;
- pile Nos. 21 to 24 (tubular steel piles Ø 711 mm) of groyne G-A were extended by 4.5 m and re-driven. Moreover, the pile structure was extended to the river side by 3 additional tubular steel piles Ø 1016 mm. Since 5 Nos. of totally 12 Nos. bored piles Ø 914 mm got lost during and after the monsoon season 1995 a row of additional 9 Nos. tubular steel piles Ø 711 mm have been installed 2.5 m upstream from the bored piles. The total length of the pile structure is now about 78 m;

- the new groyne G-A/2 consists of 20 Nos. bored piles Ø 914 mm and 14 Nos. tubular steel piles Ø 711 mm. The total length of the groyne is about 92 m from the centre of the main embankment;

- the river-sided slope of the retired embankment was protected between groyne G-1 and G-2 up to a level of 21.0 m+PWD by brick-mattresses and above up to the crest at 23.50 m+PWD by Durba grass sods on Geo-jute soil saver. The same holds for the section between groyne G-2 and G-3. Downstream from groyne G-3, between groyne G-A and G-A/2 as well as downstream from groyne G-A/2 the brick-mattresses are up to the crest of the embankment;

- replacement of grass sod protection in all areas by brick mattresses on geotextile filter up to the crest of the main embankment;
- repair of the crest and land sided slope of the main embankment, and
- driving of 23 Nos. steel piles Ø 711 mm and 32 m length at groyne G-2.

During the dry season 1997/98 the adaptation and repair works, which were required after the monsoon 1995, were completed by the construction of 12 Nos. reinforced in-situ concrete piles between the toe of the relocated main embankment and the pile structure of groyne G-2.

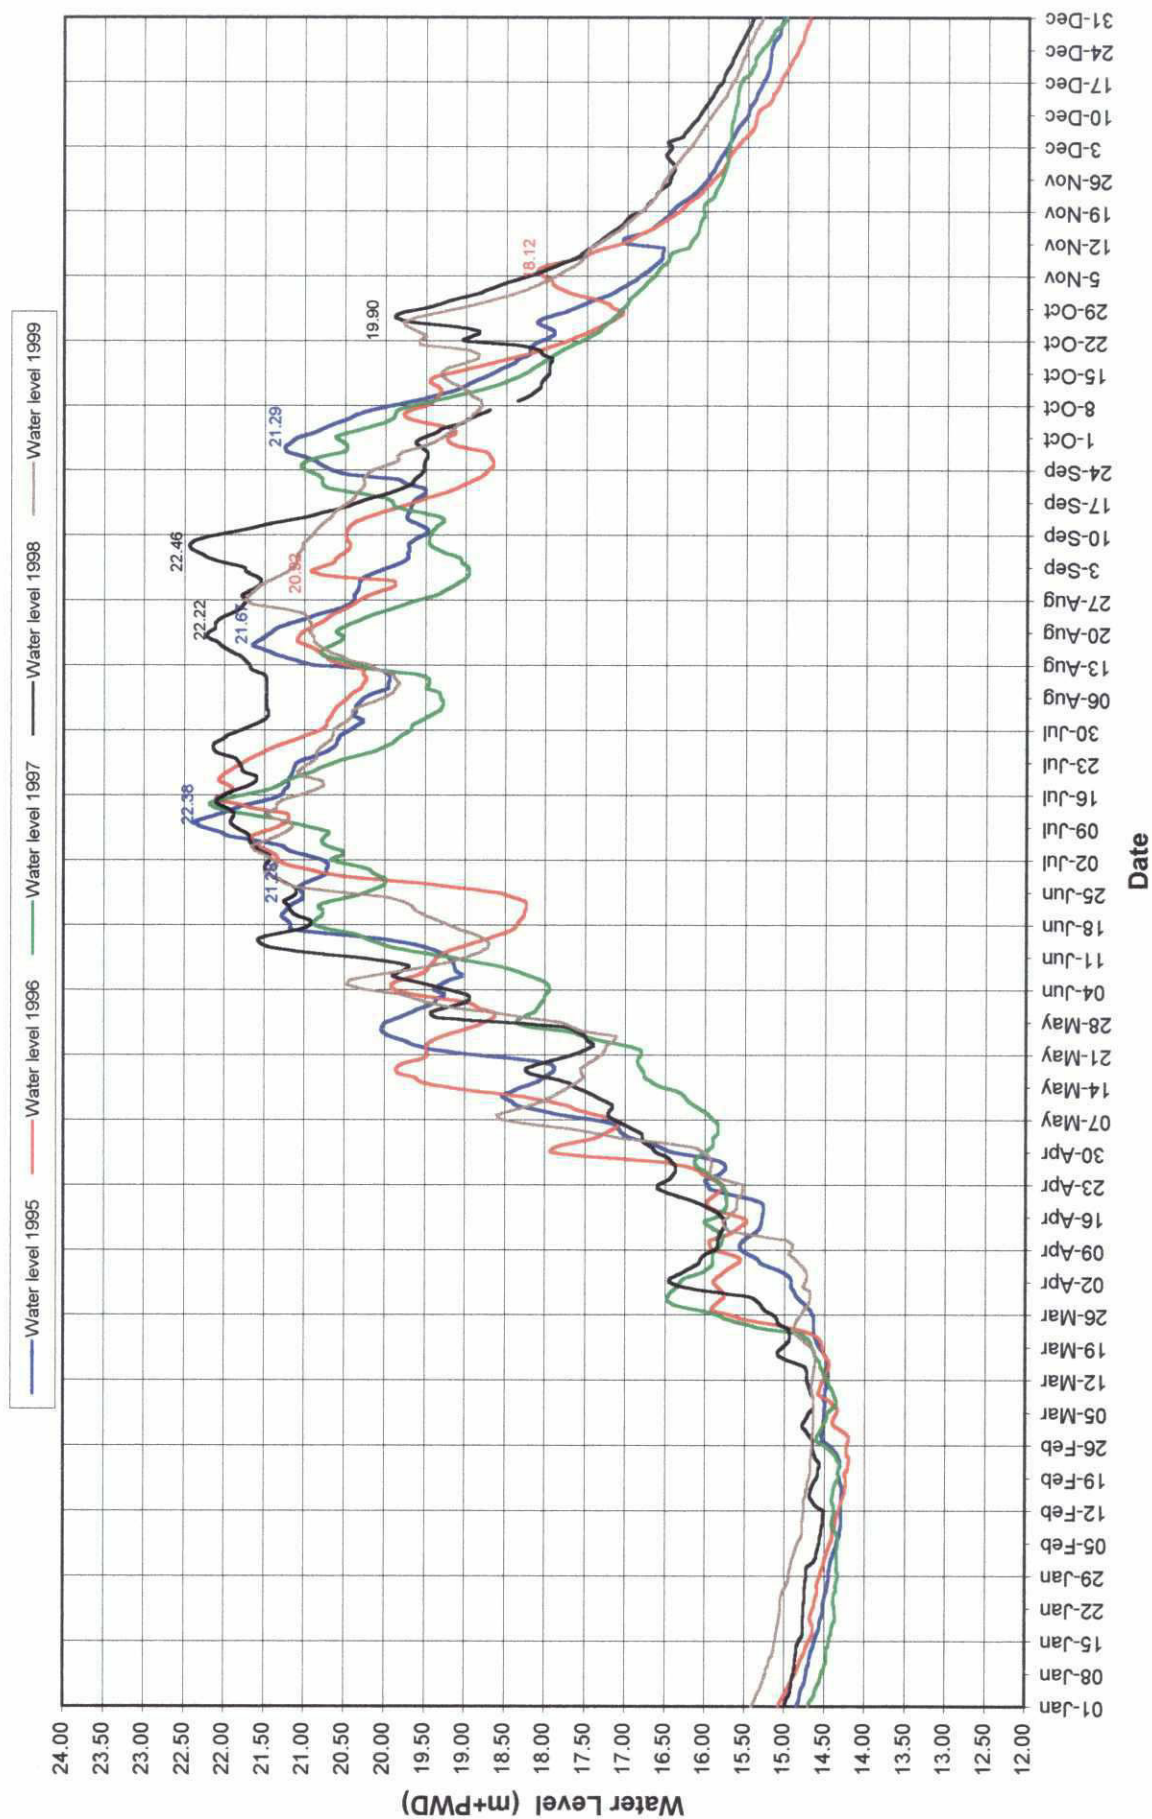
BANK PROTECTION TEST STRUCTURES - FAP 21 **WATER LEVEL AT KAMARJANI TEST SITE** **(January to December)**

At the beginning of 1999 the water level was measured at 15.41 m+PWD, but continued to drop till mid March. The minimum was recorded at 14.62 m+PWD on March 16 and 17. Till end of March the seasonal rise, which is usually expected to start at about March 20, did not appear. Only on April 10 the water level started significantly to rise and a first peak was recorded on May 08 at 18.61 m+PWD. After a drop of 1.5 m within a fortnight, a sharp rise of 3.36 m within 11 days was observed with a peak at 20.47 m+PWD on June 05.

The third peak water level in 1999 was measured on July 05 at 21.67 m+PWD. Thereafter the water level dropped for more than one month and the minimum was recorded on August 09 at 19.83 m+PWD, which was close to the minimum of the frequency curve for the period 1957 to 1997. The highest water level of the 1999 monsoon flood was observed on August 27 at 21.74 m+PWD followed by a fall of the water level till October 08, when a minimum of 18.81 m+PWD was measured. After that a continuous drop was observed and at the end of 1999 the water level was at 15.32 m+PWD.
