TECHNICAL JOURNAL

Vol. 08 No. 01 December 2001

RIVER RESEARCH INSTITUTE
FARIDPUR, BANGLADESH

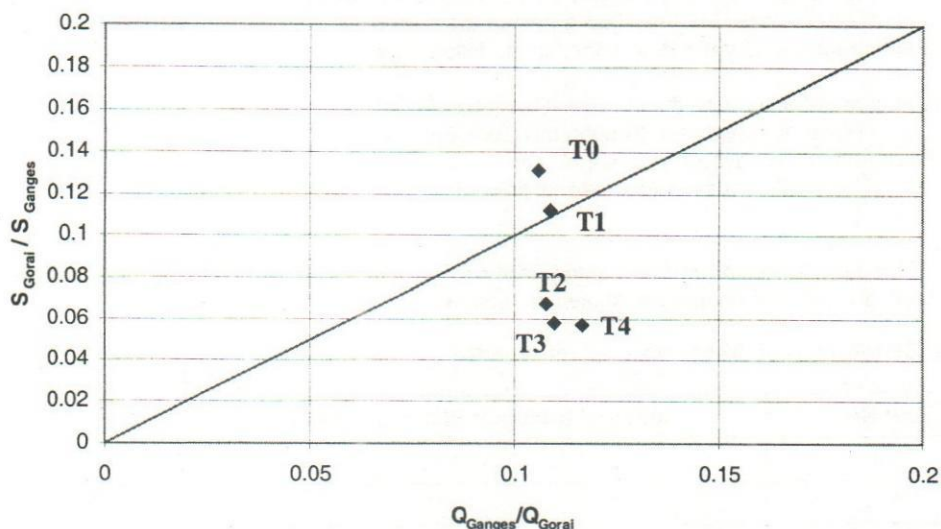
take. From the above analysis the distribution of discharge and sediment transport in the model is shown in Table-4 and Figure-3.

Figure-3: Discharge and sediment distribution for different Tests.

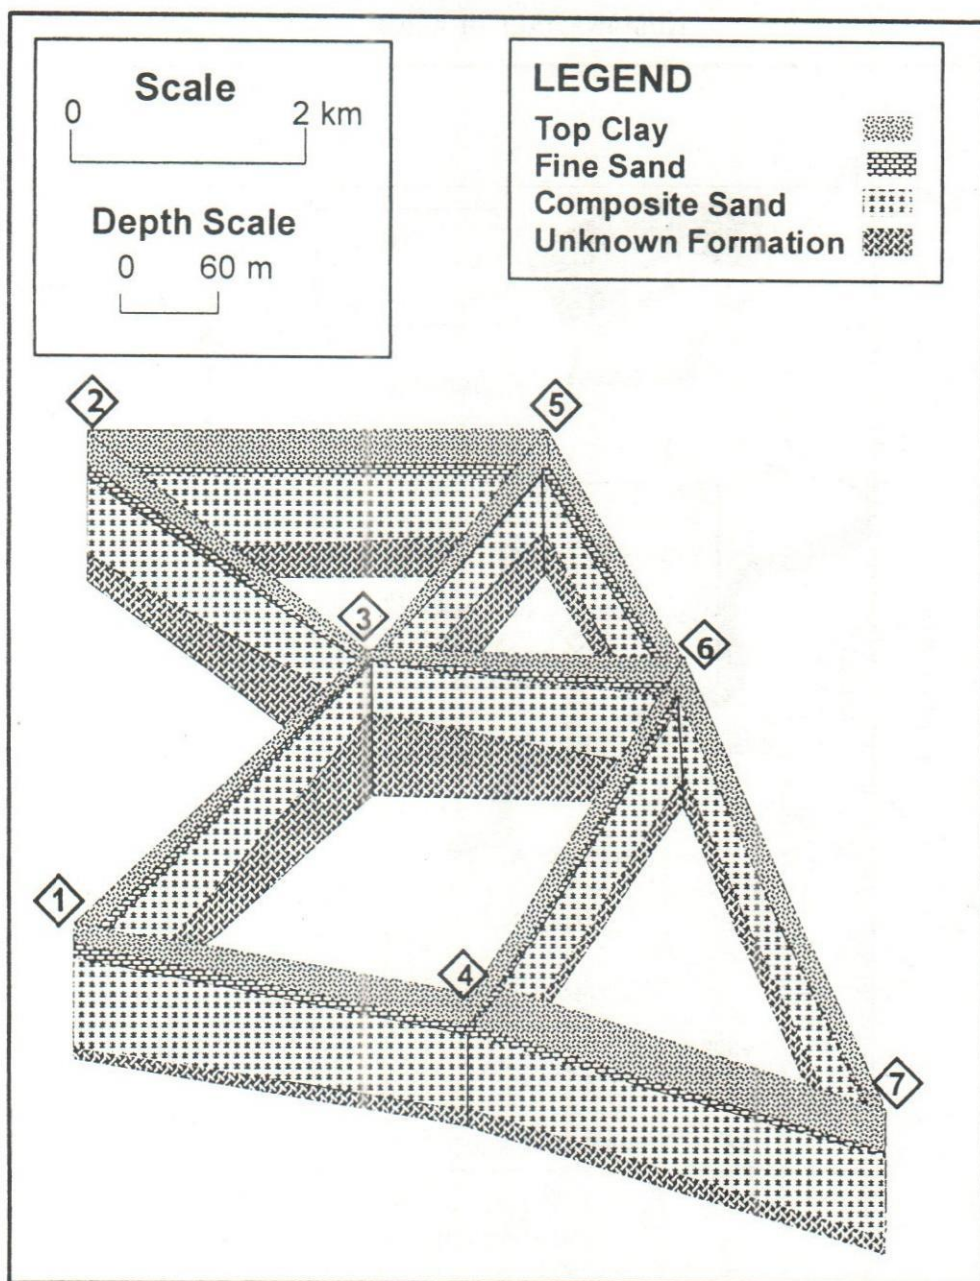
Fig.2 : Panel diagram of the effective study area.

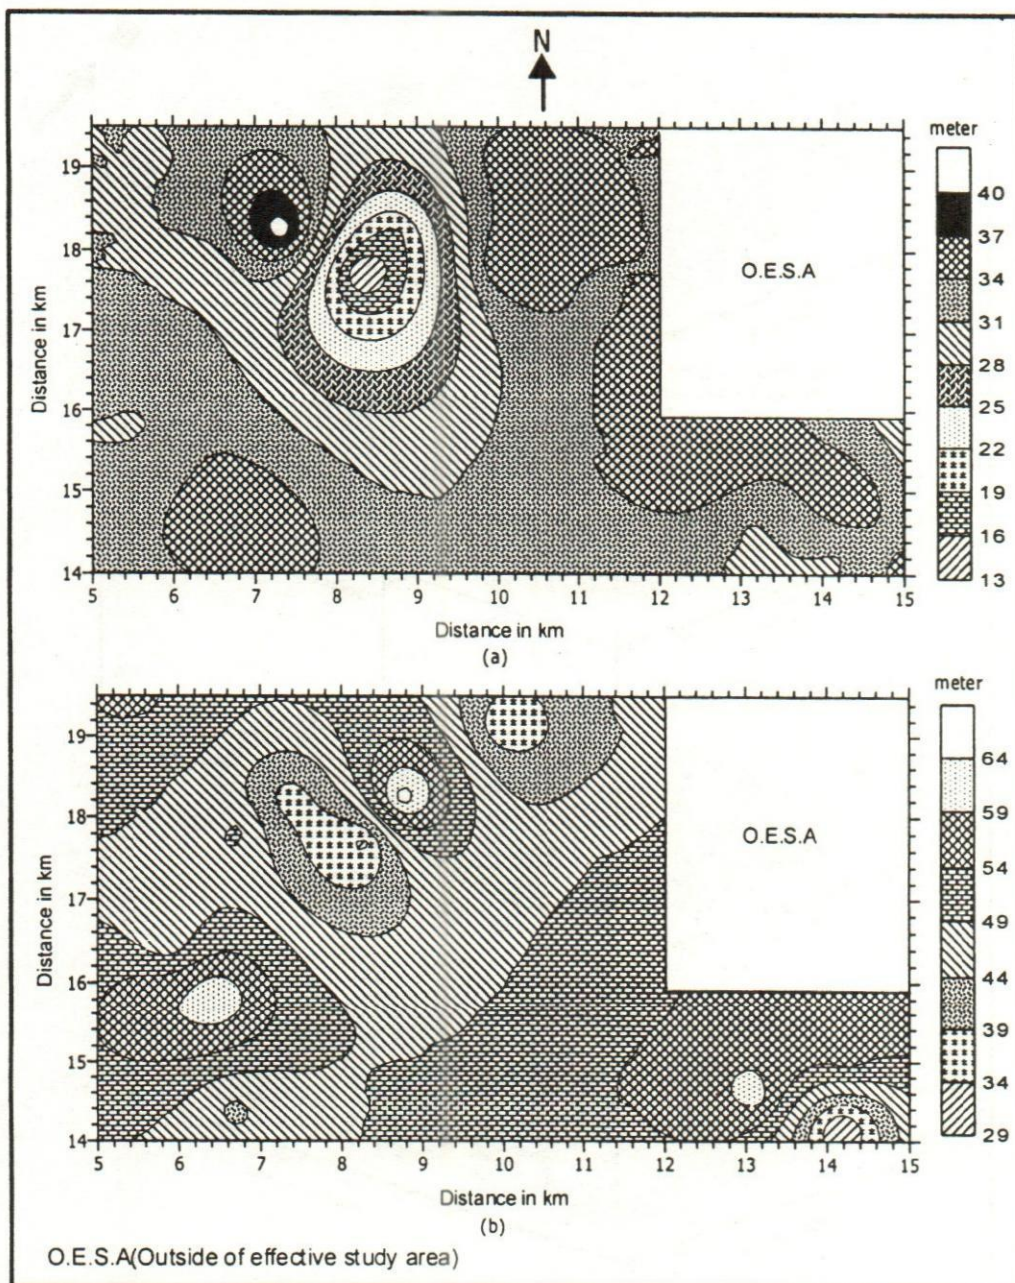
Fig.3 : Contour map with shade of the thickness of (a) Top clay-fine sand and (b) Composite sand.

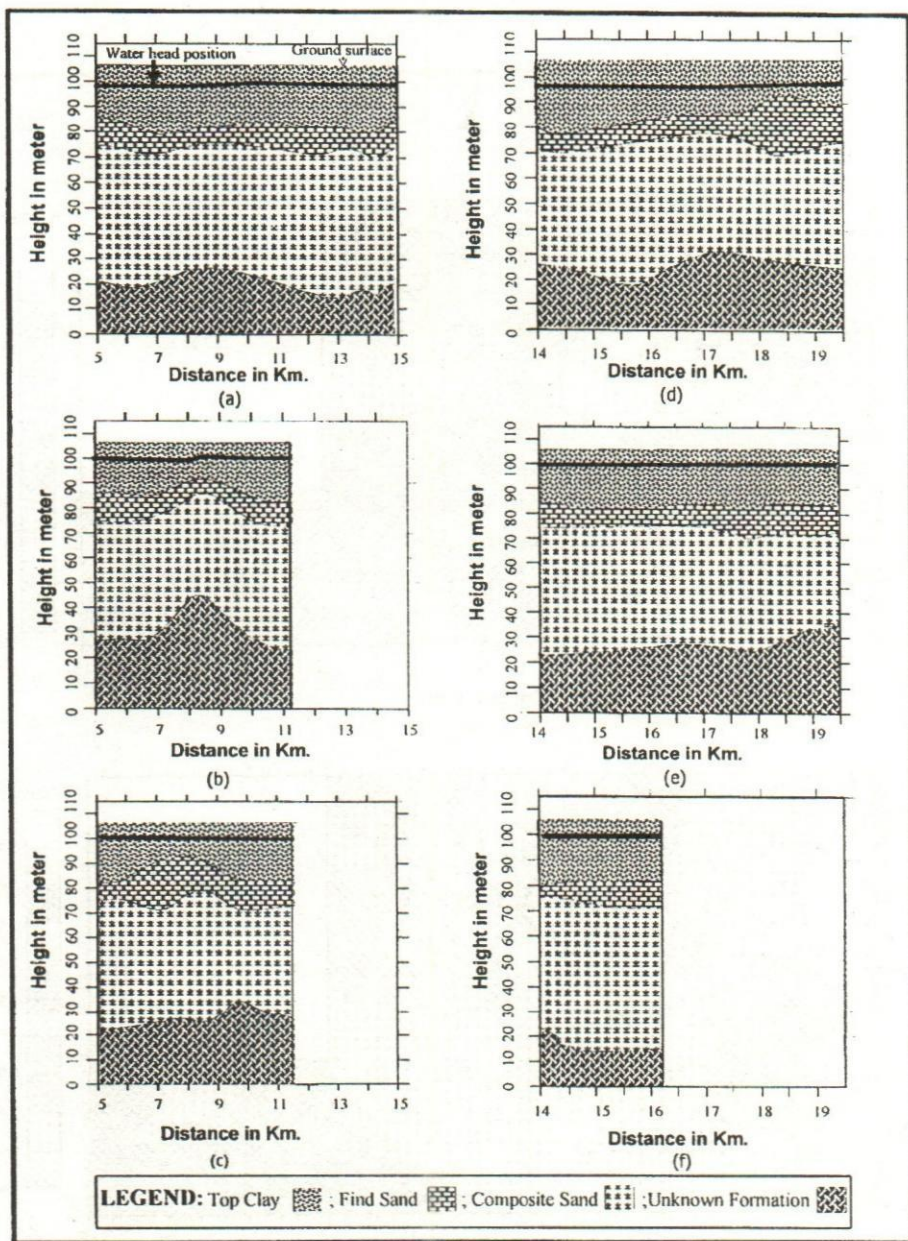
Fig.5 : Cross-sectional views at latitudinal distance of (a) 15 Km, (b) 17 Km, (c) 19 Km and at longitudinal distance of (d) 7 Km, (e) 10 Km, (f) 13 Km from the (0,0) origin.

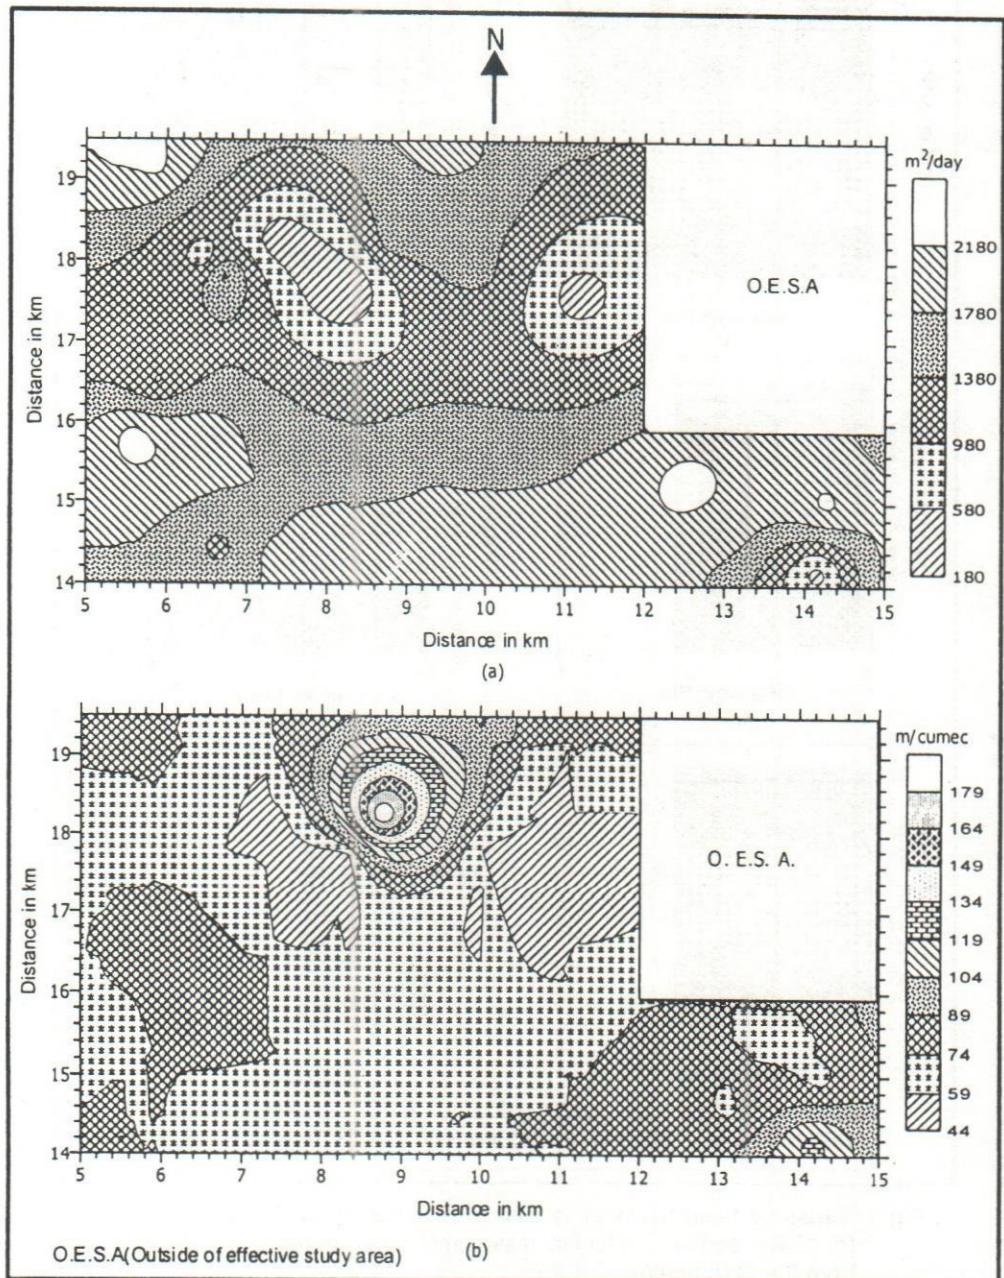
Fig.6 : Contour map with shade of (a) Transmissivity and (b) Specific Draw Down.

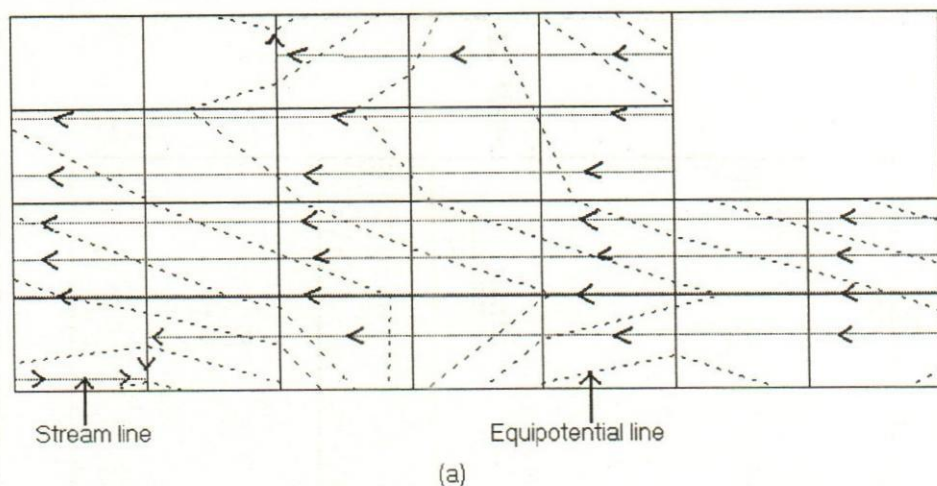
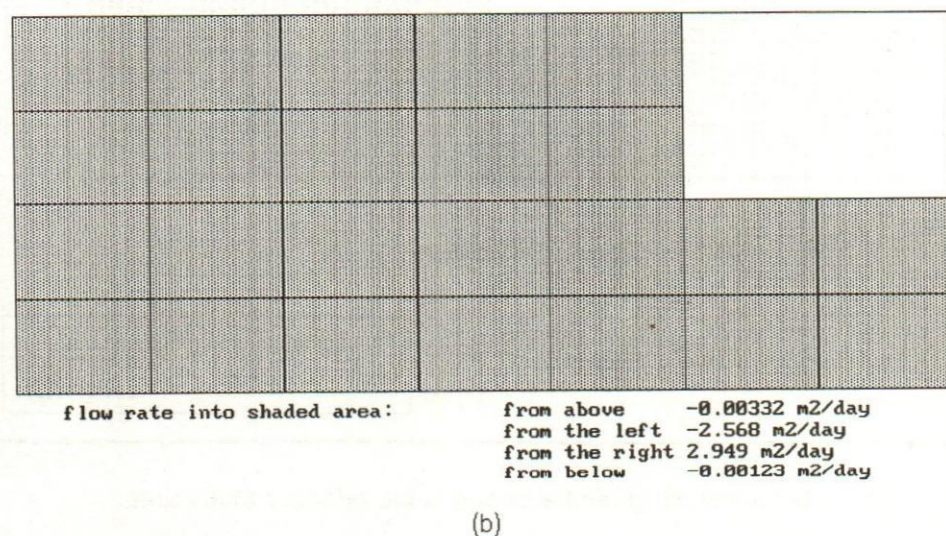
Fig.7: Groundwater (a) flow pattern and (b) flow rate of the study area in dry, 2000.

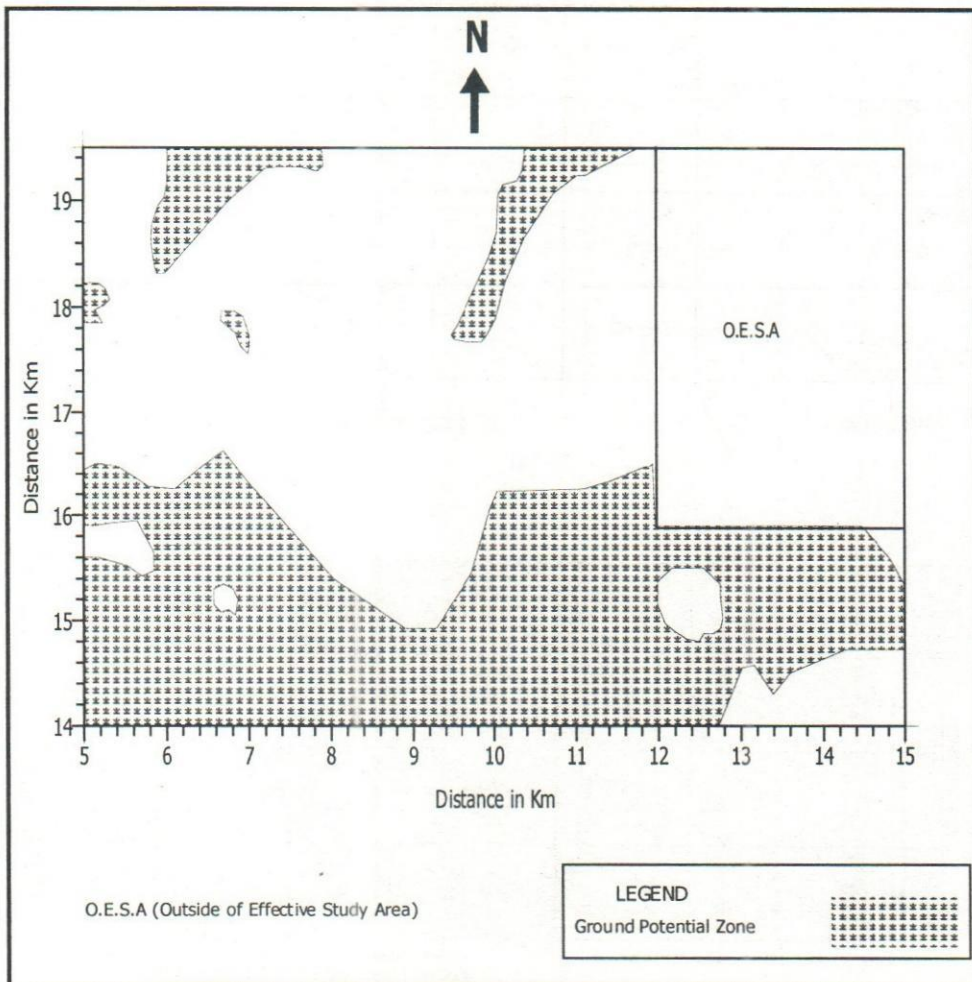
Fig.8 : Groundwater potential zones in the effective study area.

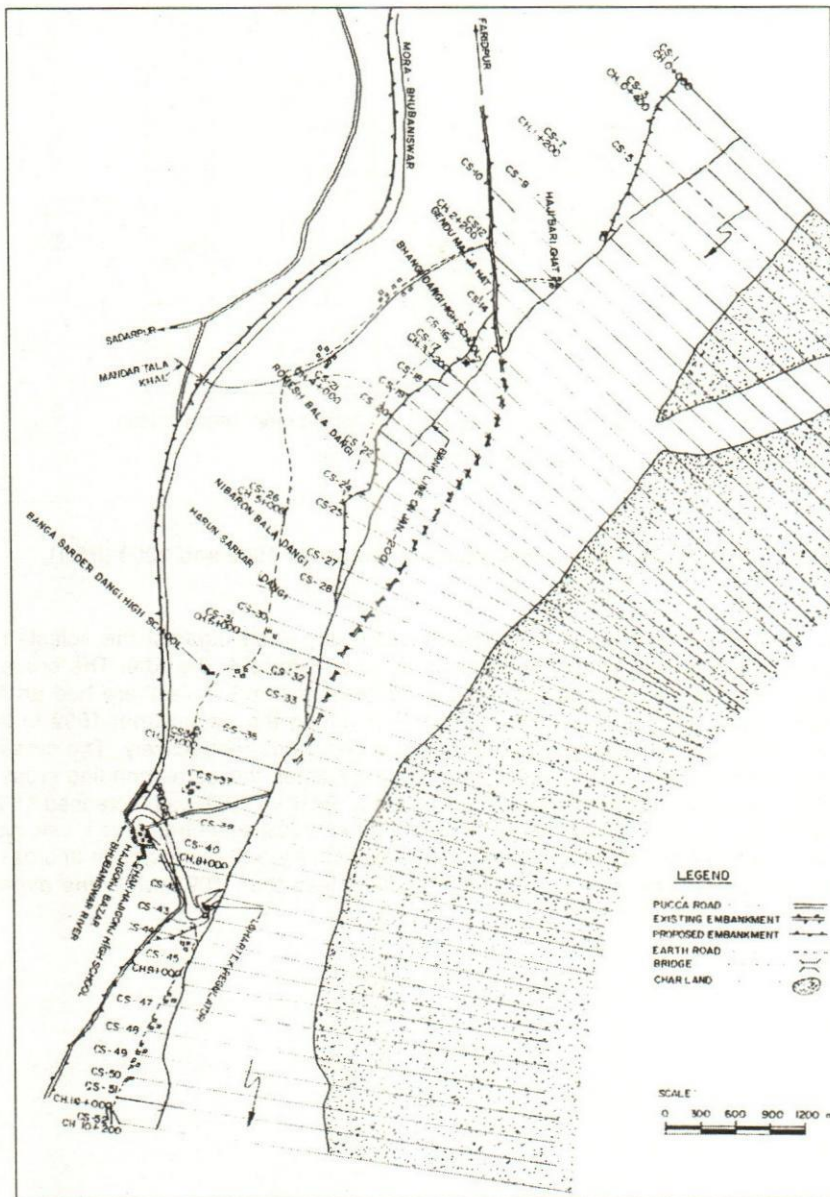
Figure 2 Present right bankline of Padma river with existing embankment

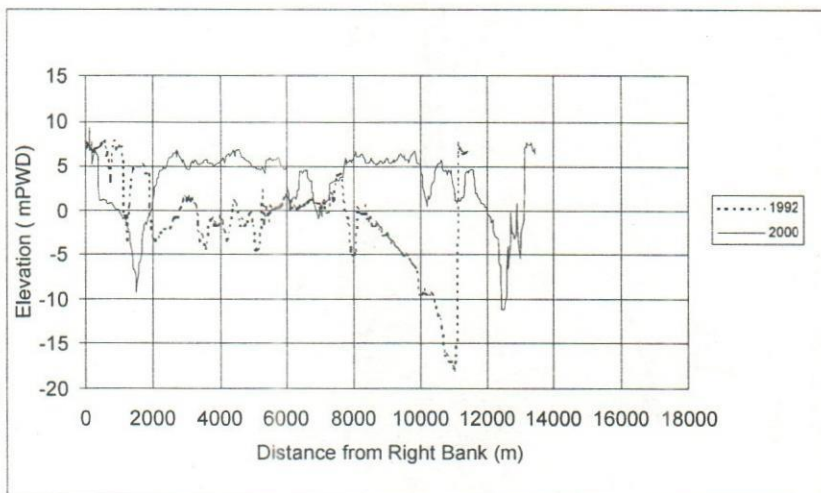
Each of the cross-sectional map was superimposed for the years 1992 and 2000 which clearly shows the shifting of thalweg, change of top width as well as the location of the deepest point. A typical plot is shown in Figure 3 (P5.1).

Figure 3 Superimposed cross-sectional maps for 1992 and 2000 (P5.1)

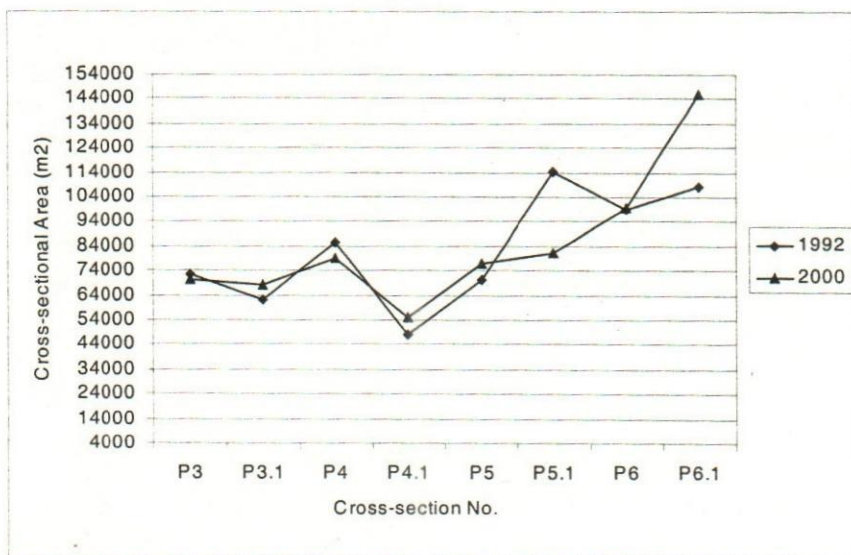
The variation of cross-sectional area, average depth, top width against the selected standard BWDB cross-section is also shown in graphical form in Figure 4, 5 and 6. The cross-sectional area at cross-sections P3, P4 and P5.1 had a decreasing trend while there had an increasing trend at cross-sections P3.1, P4.1, P5, P6 and P6.1 during the period from 1992 to 2000. This indicates aggradation and degradation of these cross-sections respectively. The cross-sectional area at cross-section P5.1 in 1992 was reduced to 0.7 times the corresponding cross-sectional area in 2000. The cross-sectional area at cross-section P6.1 in 1992 was increased to 1.34 times the corresponding cross-sectional area in 2000. The cross-sectional areas calculated were 660387.0 m^2 and 676235.0 m^2 in 1992 and 2000 respectively and the increase in cross-sectional area was about 2.4%. The average depth in 2000 is less than 1992 while the average width increases.

Figure 4 The variation of cross-sectional area

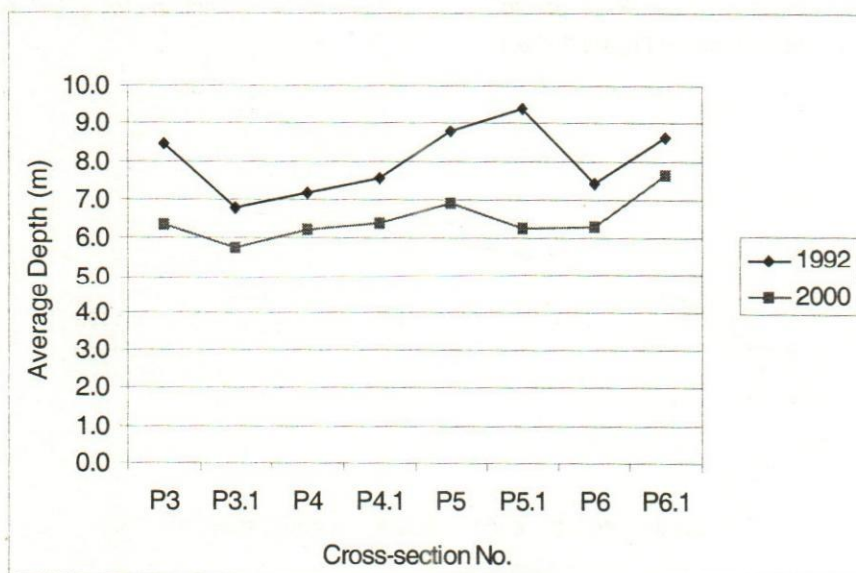
Figure 5 The variation of average depth

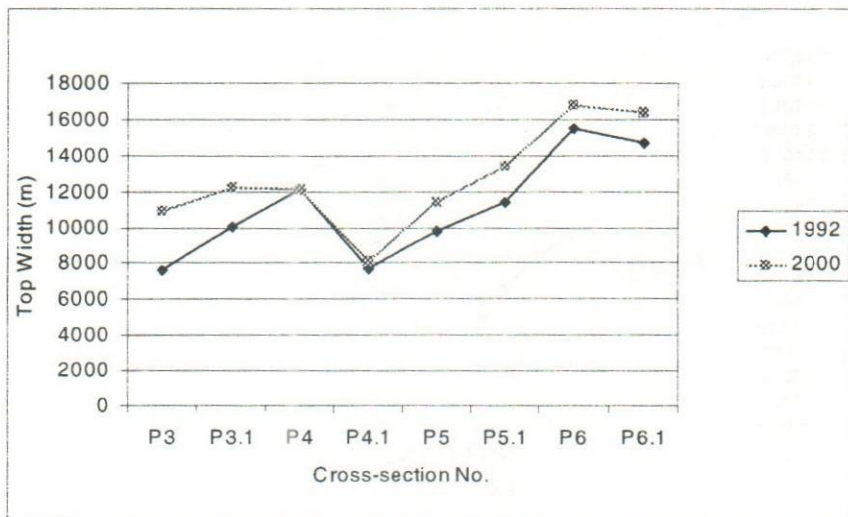
Figure 6 The variation of top width

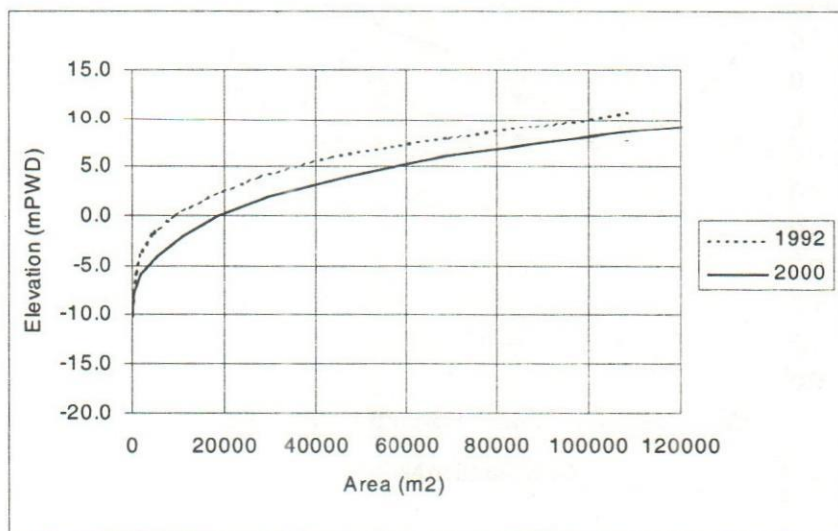
Area-elevation relationships showing the variation of cross-sectional area with elevation (with respect to PWD datum) were developed for various standard cross-sections for 1992 and 2000 and a typical plot is shown in **Figure 7 (P5.1)**.

Figure 7 Area-elevation relationship

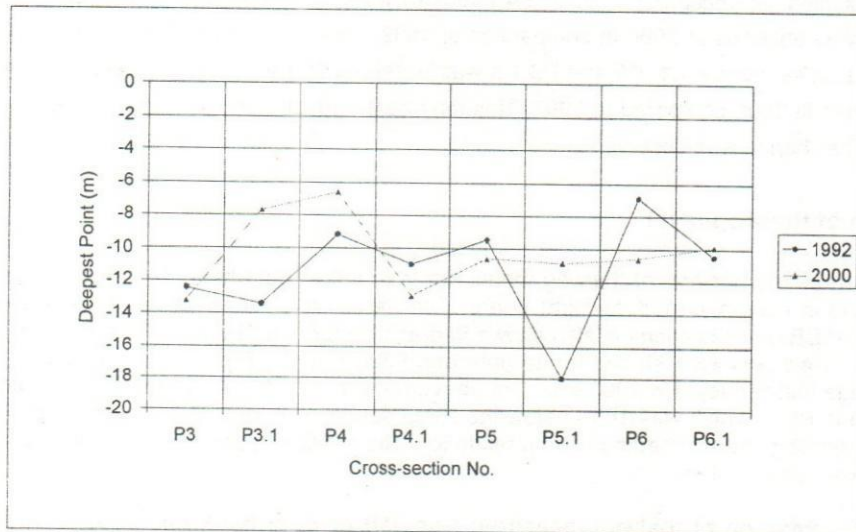
Figure 8 The variation of deepest point

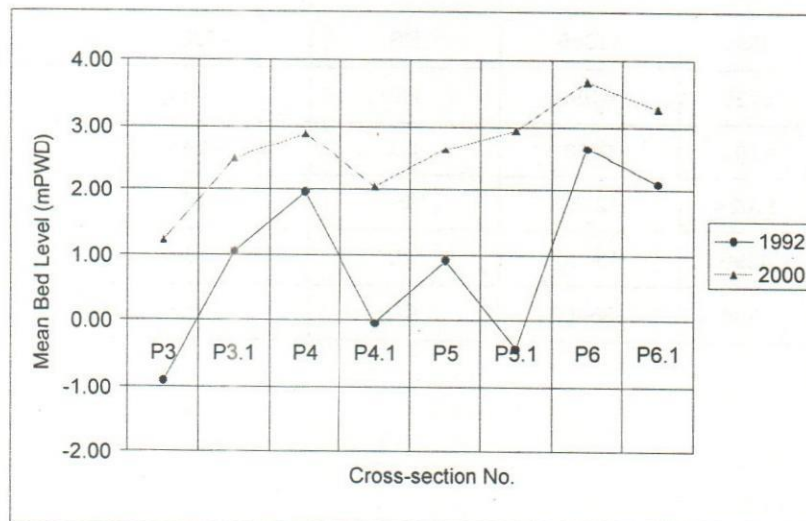
The variation of MBL for the selected standard BWDB cross-sections is also shown in graphical form in Figure 9. It was observed that at all the selected BWDB standard cross-sections considered in the present study reach, the MBL rises in 2000 relative to 1992 situation.

Figure 9 the variation of MBL

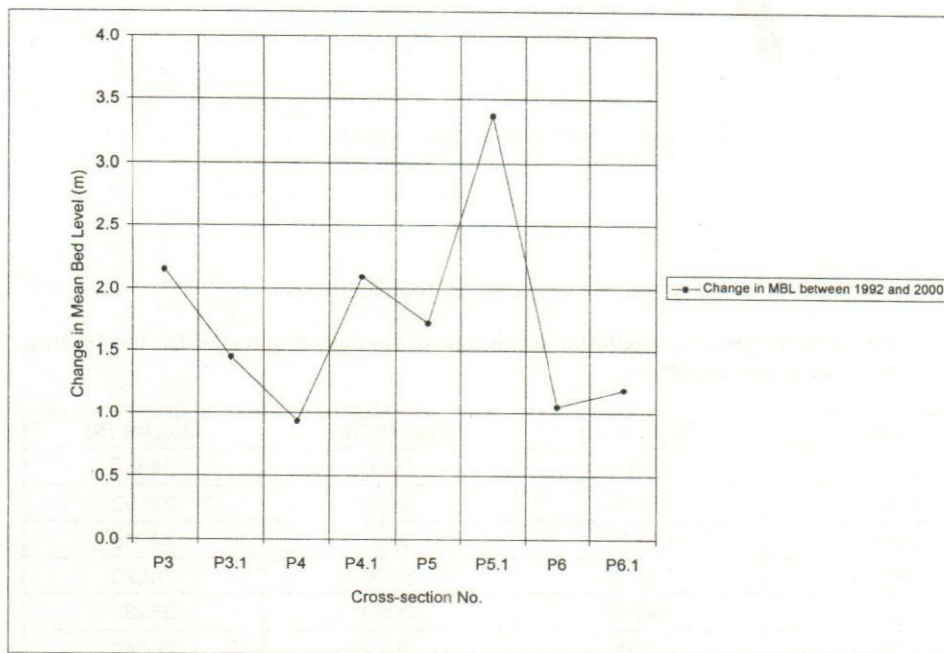
The variation of change in MBL was also shown in **Figure 10**. From this figure it was revealed that sediment was deposited at all cross-sections within the study reach. Assuming linear variation of change in MBL, the calculated net sediment deposition was found as $9.4 \times 10^8 \text{ m}^3$ during 1992 to 2000. It corresponds to about 22.0 cm sediment deposition each year throughout the study reach (P3 to P6.1) of Padma river during the period from 1992 to 2000.

Figure 10 The variation of change in MBL

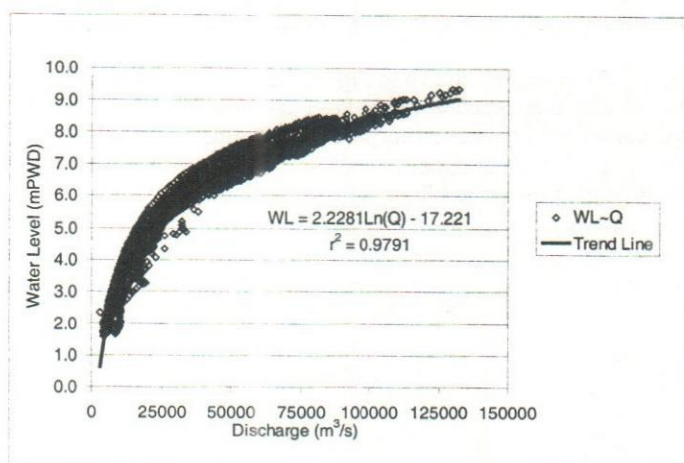
Figure 11 The rating curve at Baruria Transit Station

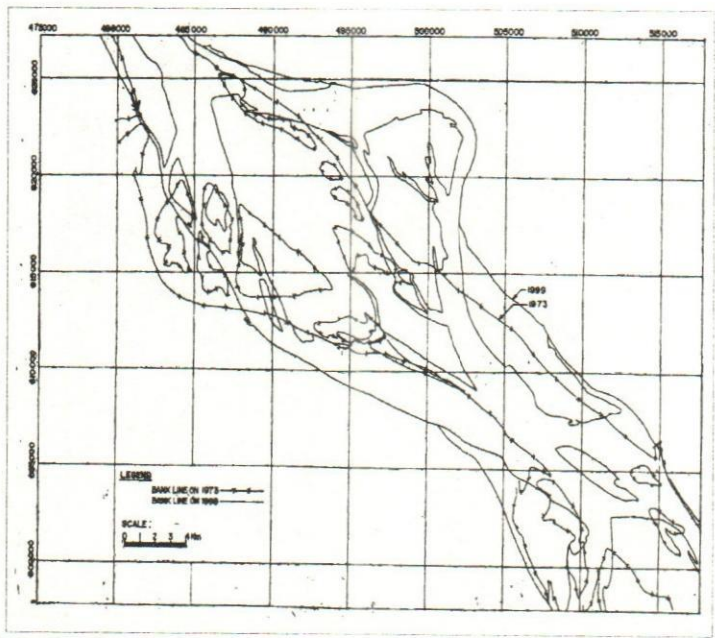
The bankline of Padma river from satellite image was plotted and superimposed on the same map for the years 1973 and 1999 as shown in **Figure 12**. From the superimposed plan maps it was seen that the river bankline at 1999 along the study reach became wider relative to bankline at 1973. **Table 3** shows lateral bankline shifting along grid lines (Easting) of Padma river at the study area. From the table it can be seen that the maximum left bank erosion was 9.15 km and the maximum right bank erosion was 3.95 km. Only upstream of study reach near C & B Ghat, 3.35-km deposition at the right bank was occurred. Especially near the Hazi Bari Ghat under Faridpur Sadar Thana, the right bank of river was shifted towards the right side, which causes unmitigable losses of properties and sufferings to the people.

Figure 12 Superimposed bankline from satellite imagery at the study area for the years 1973 and 1999

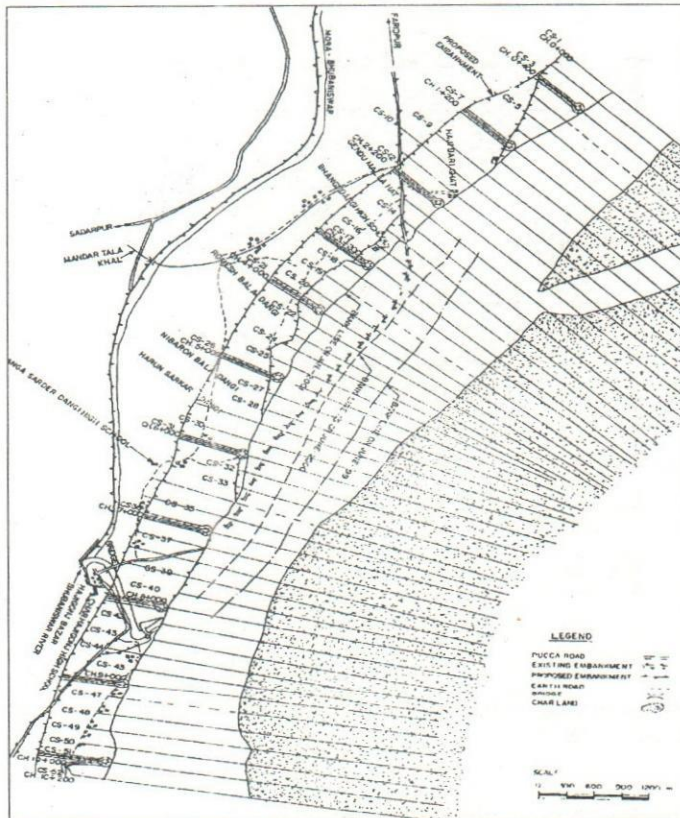
Figure 13 shows the bankline shifting of Padma river which cover some parts of Faridpur Sadar Upazila and some parts of Char Bhadrason Upazila for the period of 1999, 2000 and 2001 from which one can easily visualize the nature of devastation of bank erosion. The trend of right bank shifting is towards the right side. **Table 4** shows the amount of right bankline shifting of Padma river for various cross-sections (shown in index map) of the river. The maximum shifting was occurred along cross-section No. 21, which was about 1005 m for a period of only 2 years (from 1999 to 2000) so the maximum rate of bankline shifting is $1005/2=502.5$ m/year. This erosion was occurred at Romesh Bala Dangi under Char Bhadrason Upazila.

Figure 13 Bankline shifting of Padma river and location of proposed embankment and proposed spurs at the study area

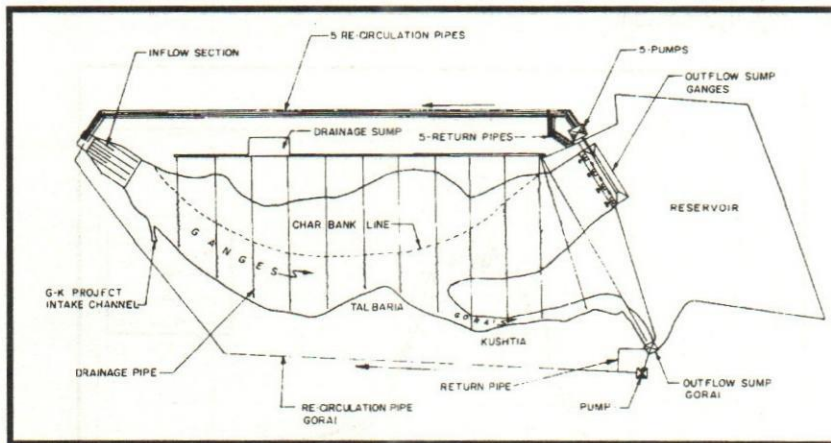
Figure 1 Layout of the model

The study area is located at about 55 km downstream of the India- Bangladesh boarder on the Ganges river. The latitude and longitude of the study area lies between $23^{\circ}52' N$ to $24^{\circ}7' N$ and $89^{\circ}2' E$ to $89^{\circ}12' E$. The Eastern part of the Ganges area is located under Sirajgang and Pabna district and Western part under Kushtia district. The area comprised of flood plain and unstable islands. Area reproduced in the model is about 25 km, which includes Hardinge Bridge in the upstream, 2 km downstream of Gorai Railway Bridge in the Gorai and up to 10 km downstream from the off-take in the Ganges downstream. The model layout can be seen in **Figure 1**.

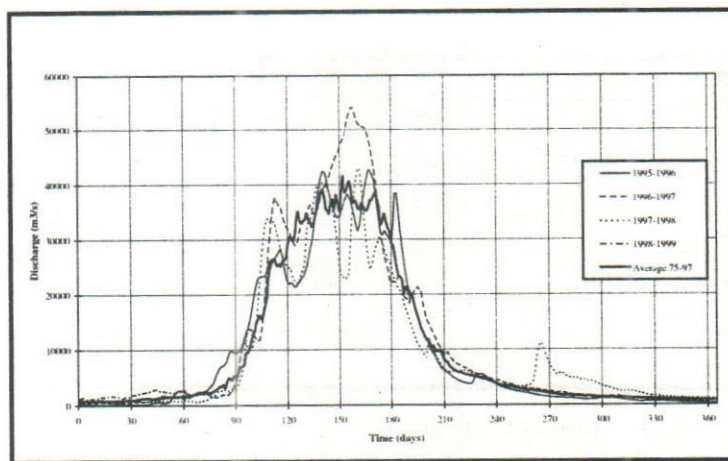
The starting date of the hydrographs is 1st April. As can be observed the differences between these specific years and the average hydrograph are only marginal and hence it can be proposed to use the average hydrograph.

Figure 2 Comparison of average 1977-1997 hydrograph with three specific years

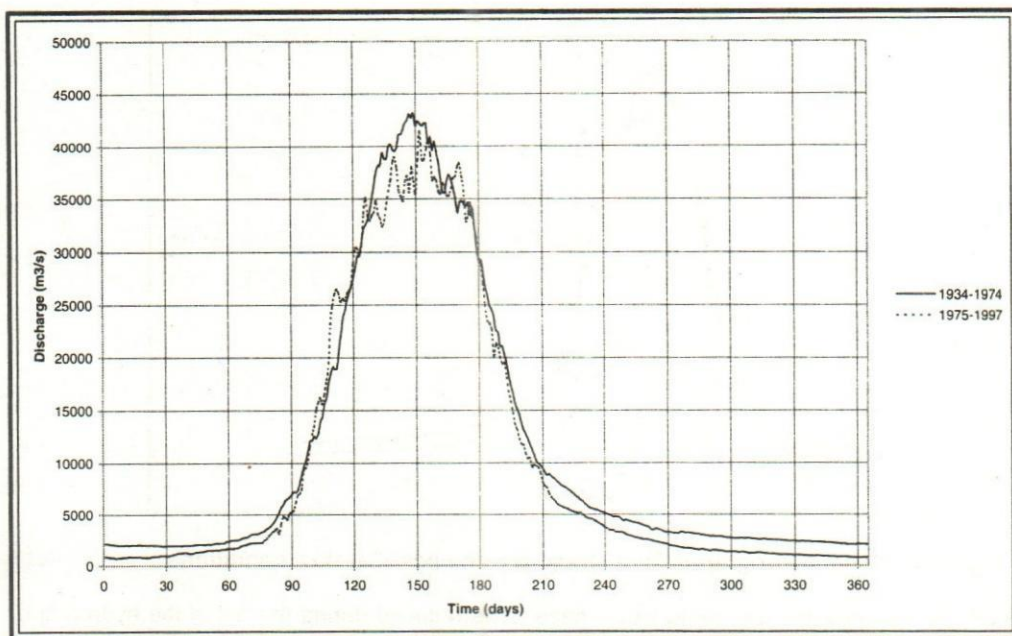
Regarding the choice between pre and post-Farakka hydrographs there are less doubts. In the post-Farakka period the fall of the hydrographs is quicker than in the pre-Farakka period (FAP-24,1996). Hence the post-Farakka hydrographs are preferred for the model simulation as these are more critical (less time for the retarded scour to develop) and as they are more realistic for the present conditions. **Figure 3** shows the average hydrographs for both the pre and post-Farakka period.

Figure 3 Average pre and post-Farakka hydrographs

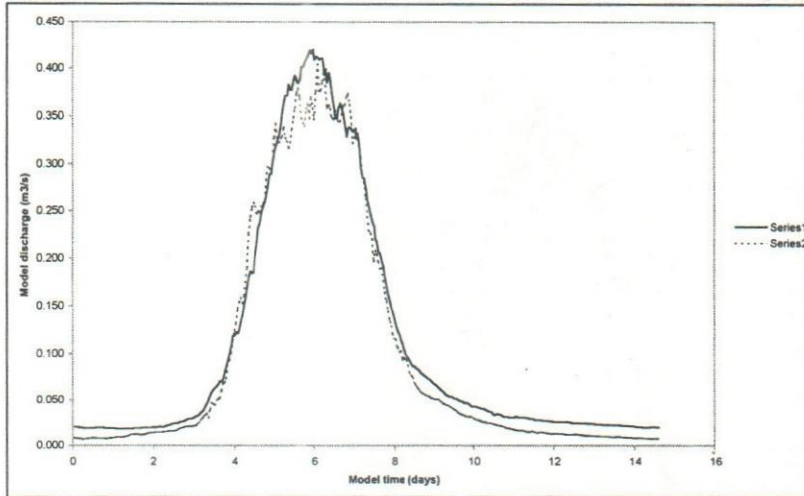
By applying the above scale factors for the discharge and the time, model hydrographs have been determined. These are given in **Figure 4**. Simulation of a whole year takes about 15 days, and the discharge in the model varies between 0.01 and 0.4 m³/s (10 to 400 l/s).

Figure 4 Model hydrographs for average pre and post-Farakka conditions

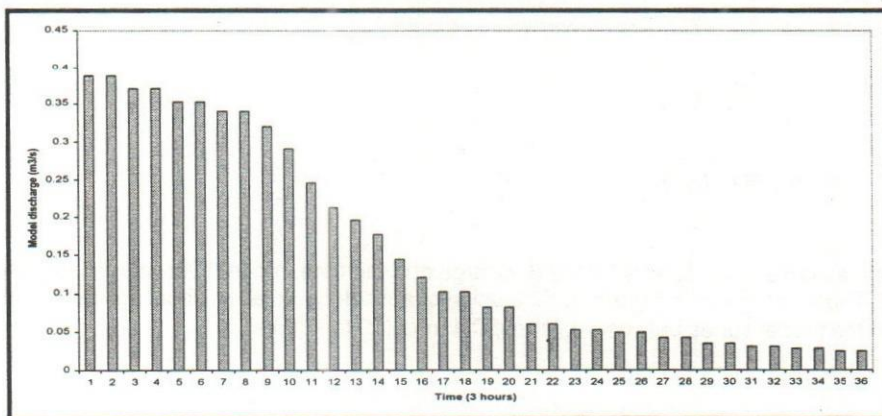
Only the recession part of the hydrograph was considered to be simulated in the model. Because only in that period retarded scour will occur. The recession hydrograph is made stepwise to apply in the model conveniently. The starting discharge of the simulation corresponds approximately to the peak of the flood. Some values were slightly adjusted to obtain a smoother hydrograph. The proposed hydrograph is shown in **Figure 5**.

Figure 5 Proposed recession hydrograph for the model

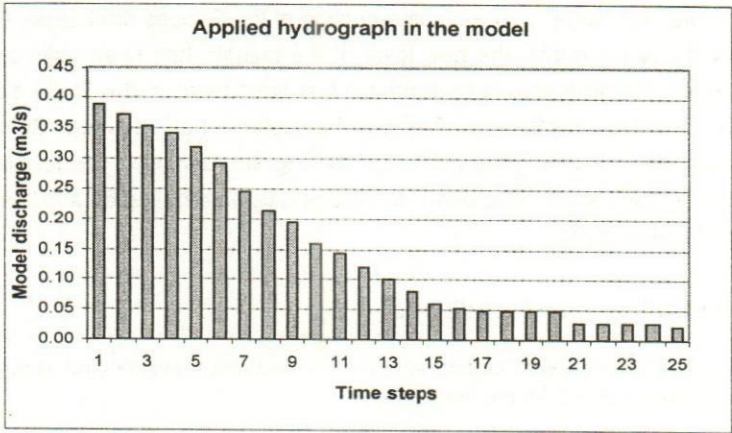
stepwise discharge in different time steps employed as an upstream boundary in presented in Figure 6.

Figure 6 Hydrograph applied in the model

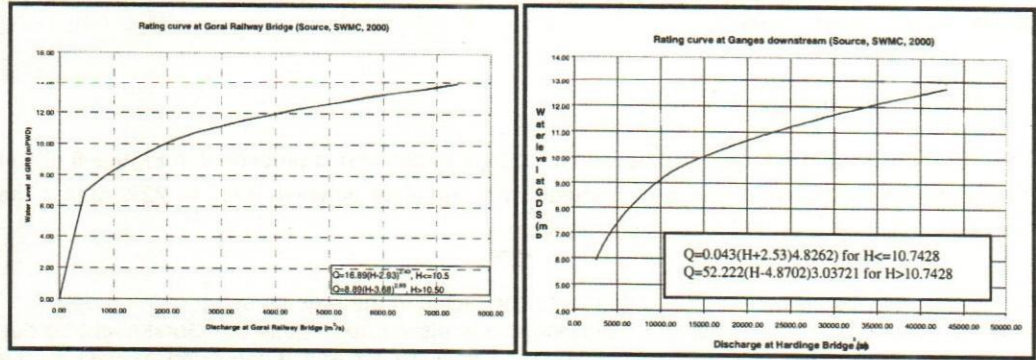
For the Gorai River this was the rating curve for Gorai Railway Bridge. For Gorai River rating curve produced by SWMC (Second Technical Report, SWMC, 2000) has been used. For the Ganges downstream boundary a prototype rating curve has been derived based on the rating curve produced by SWMC for the Hardinge Bridge. The rating curves derived for the downstream boundary conditions are shown in Figure 7.

Figure 7a. Ganges downstream rating curve

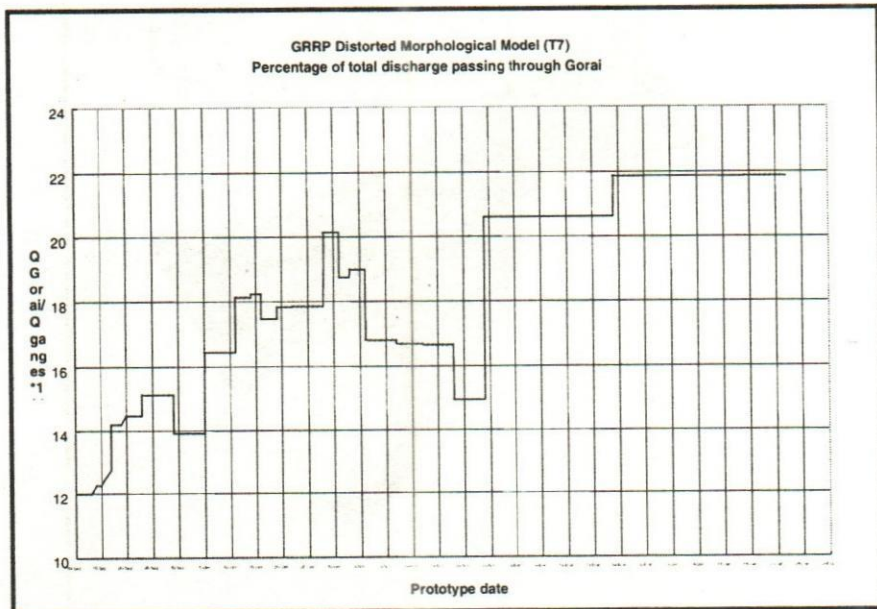
that a considerable discharge could be maintained in the Gorai in the present setup of the model (boundary conditions, bank lines and constructions tested).

Figure 8 Development of discharge distribution in hydrograph test

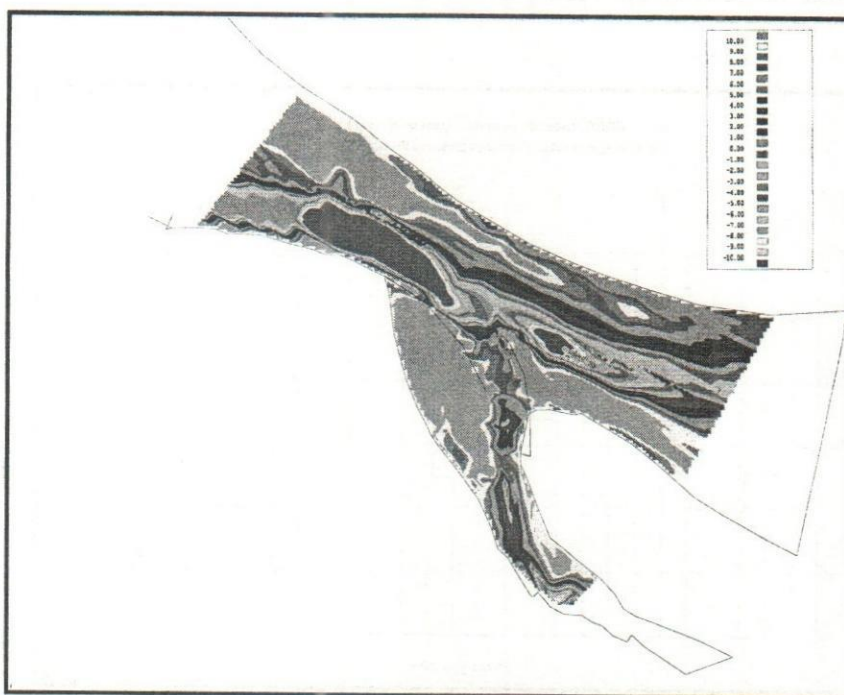
It was observed during model tests that a local scour hole developed at the head of the flow divider. In hydrograph test the local scour hole at the downstream of flow divider is observed to be diminished with the reduction of the discharge in the falling stage of the hydrograph, which is called as breathing of a local scour hole. This is due to the reduction of flow velocity resulting in the lowering of the sediment carrying capacity and consequently depositing in the scour hole.

Figure 9 : Simulated retarded scour in hydrograph test

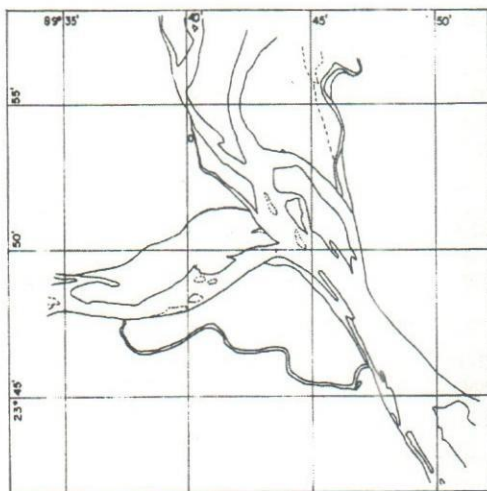
Figure 1 Planform of Notakhola, Aricha and Daulatdia area, 1991

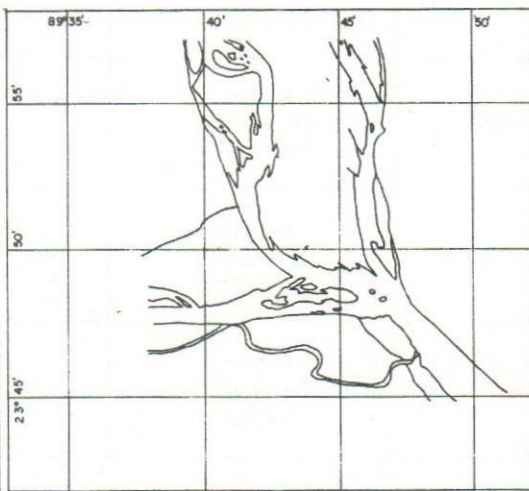
Figure 2. Plan form of Notakhola, Aricha and Daulatdia area, 2000

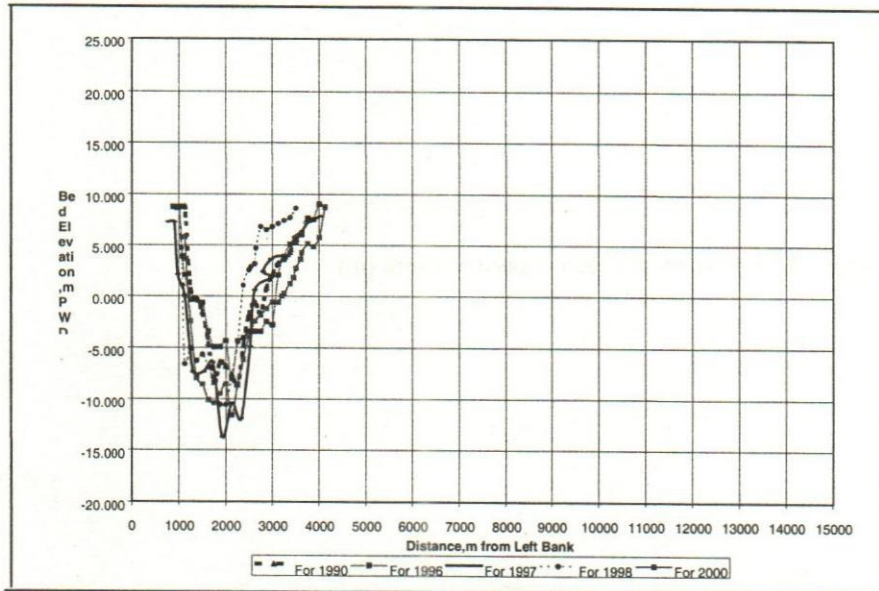
The hydrographic chart collected from the BIWTA was analyzed and some selected sections were plotted. But, the problem faced during the analysis of hydrographic charts is that, the soundings are not taken along the full width of the river. As a result, it is not possible to analyze the data for the estimation of erosion or siltation purposes. However, it can be visualized from the bathymetric plotting about the variation of the cross sectional geometry. Therefore, it can be stated here that the cross-sectional geometry of the river is changing randomly with time, which indicates that the river is very active and unstable.

Figure .3 Bed profile from hydrographic chart

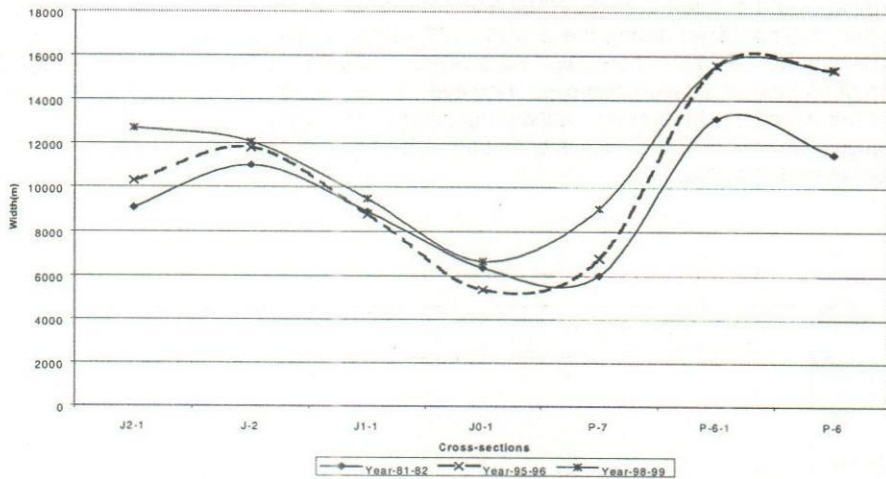
Figure 4 Variation of cross sectional width (m)

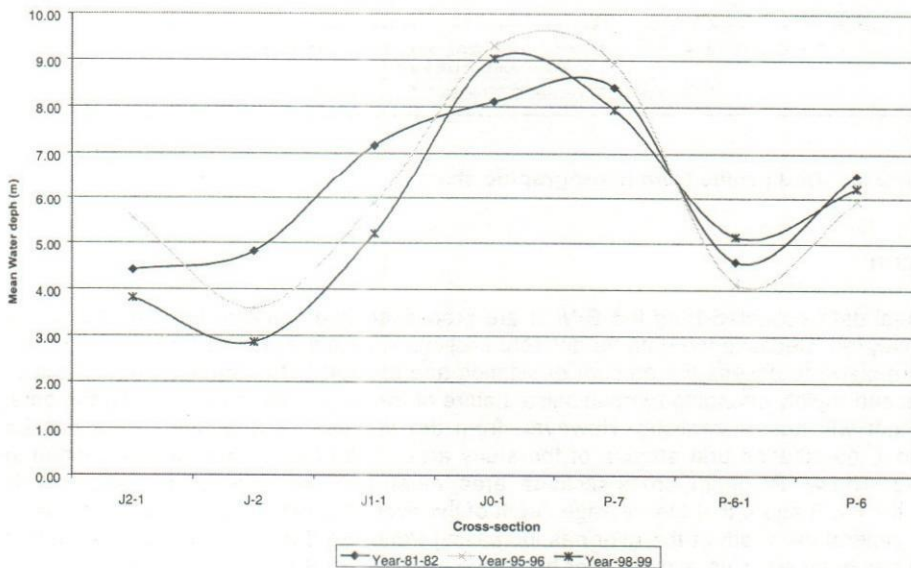
Figure 5 Variation of mean water depth (m)

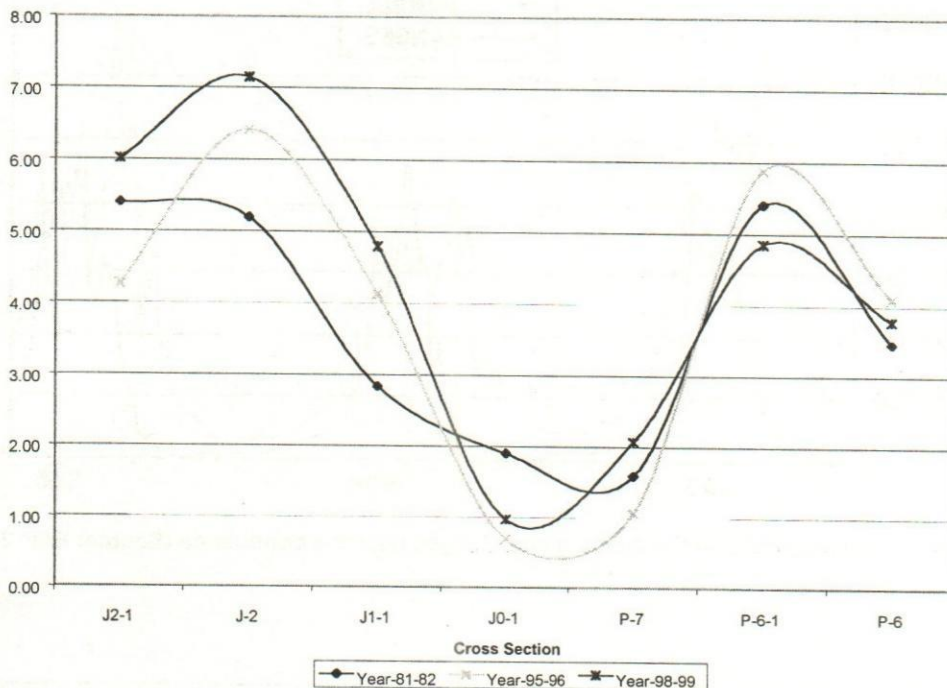
Figure 6 Variation of mean bed level (m)
