TECHNICAL JOURNAL

Vol. 08 No. 01 December 2001

RIVER RESEARCH INSTITUTE
FARIDPUR, BANGLADESH

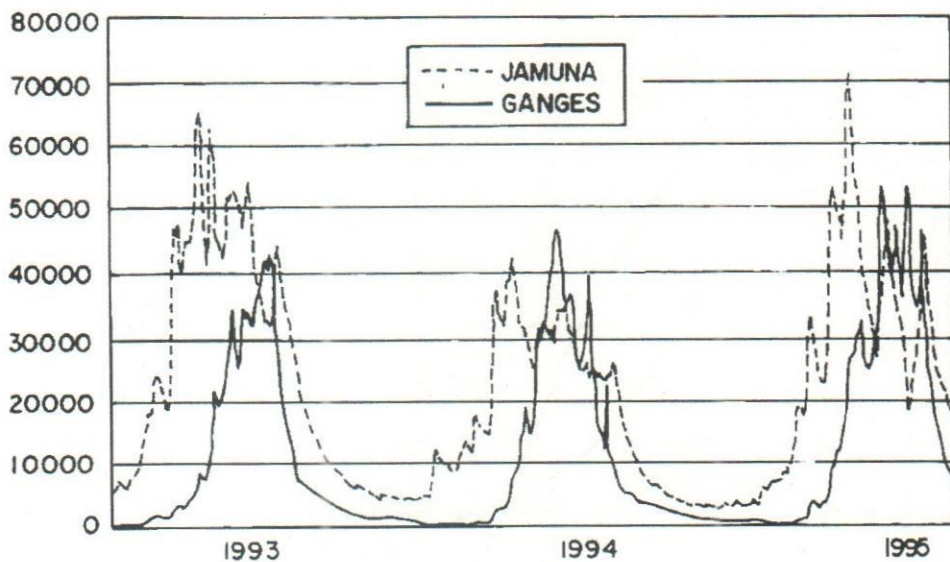
- The rise of the Jamuna river discharge is earlier than the Ganges river. But the fall of the Ganges discharge is usually earlier than the Jamuna
- The rise of the Jamuna river discharge is earlier than the Ganges river. But the fall of the Ganges discharge is usually earlier than the Jamuna
- The discharge ratio (Q_{Gan}/Q_{Jam}) of the Ganges is normally below 1, except in some cases during the flood and falling season. It means that the flow in the Ganges is much smaller than that of the Jamuna both for maximum, minimum and annual average flow.
- Deposition dominates during the recession of the flood in the Ganges, where as in the Jamuna the picture is more complex. Both deposition and scour occurs, and there is no real dominance of either of the two.

Figure 7 Hydrographs of the Jamuna and Ganges near the confluence (Source: FAP-24)

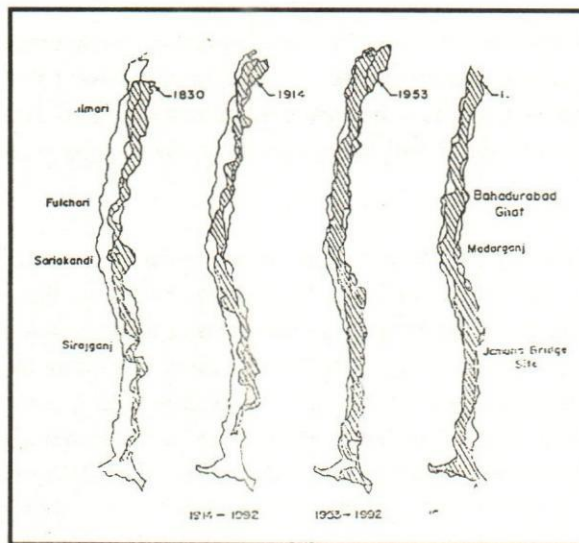
Although in the report on the Jamuna Bridge Study, Phase 2 (1989) it is still stated that no significant changes can be observed based on an analysis of the BWDB cross-sections which are surveyed every year, in the mean time the evidence is piling up that suggests that the 1st order channel is subject to major changes.

Figure-1: Historical bank line position of Jamuna river.

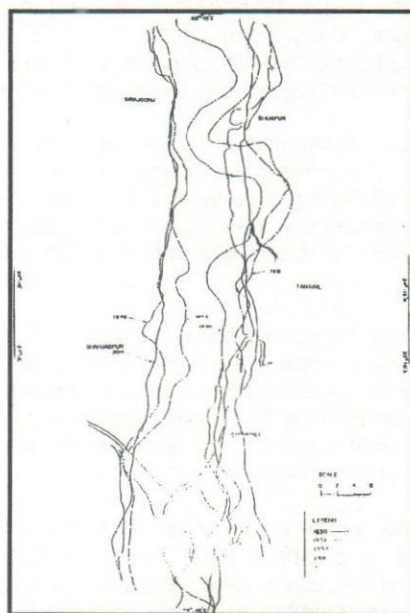
line maps in Figure-2 it was seen that the river course is gradually shifting towards the West. Shifting of the river course from 1830 to 1951 is not that much especially for the reach downstream of Bhuapur. But overall river course shifting from 1951 to 1989 was significant. Immediately downstream of Bhuapur this shifting was almost 3.8 km in 38 years. On the other hand river course shifting from 1830 to 1951 i.e., in 121 years was maximum 1.4 km at downstream of Tangail town and at immediately downstream of Bhuapur this shifting was only 200 m towards the west. Historical river course shifting trend also can be seen in Figure-1. From Figure-1 it is seen that the river course had been shifting towards west from 1830 to 1953. But after 1973 shifting trend of the river course especially of the reach downstream of Bhuapur had been reversed. The river started to shift towards the East.

Figure-2: Historical bank line position of Jamuna river

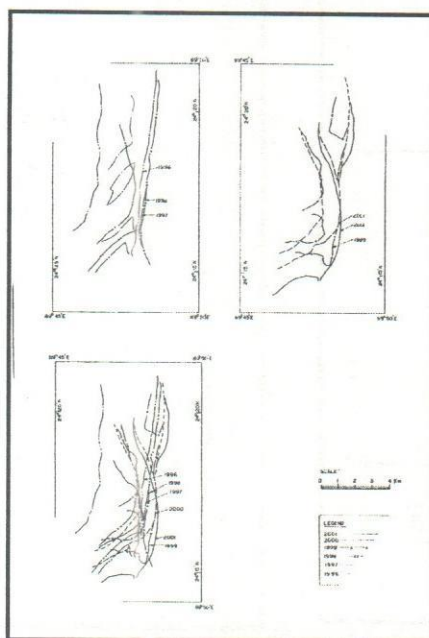
Figure-9: Typical bend evolution in the Jamuna river at the d/s of Bangabandhu bridge(along left bank)

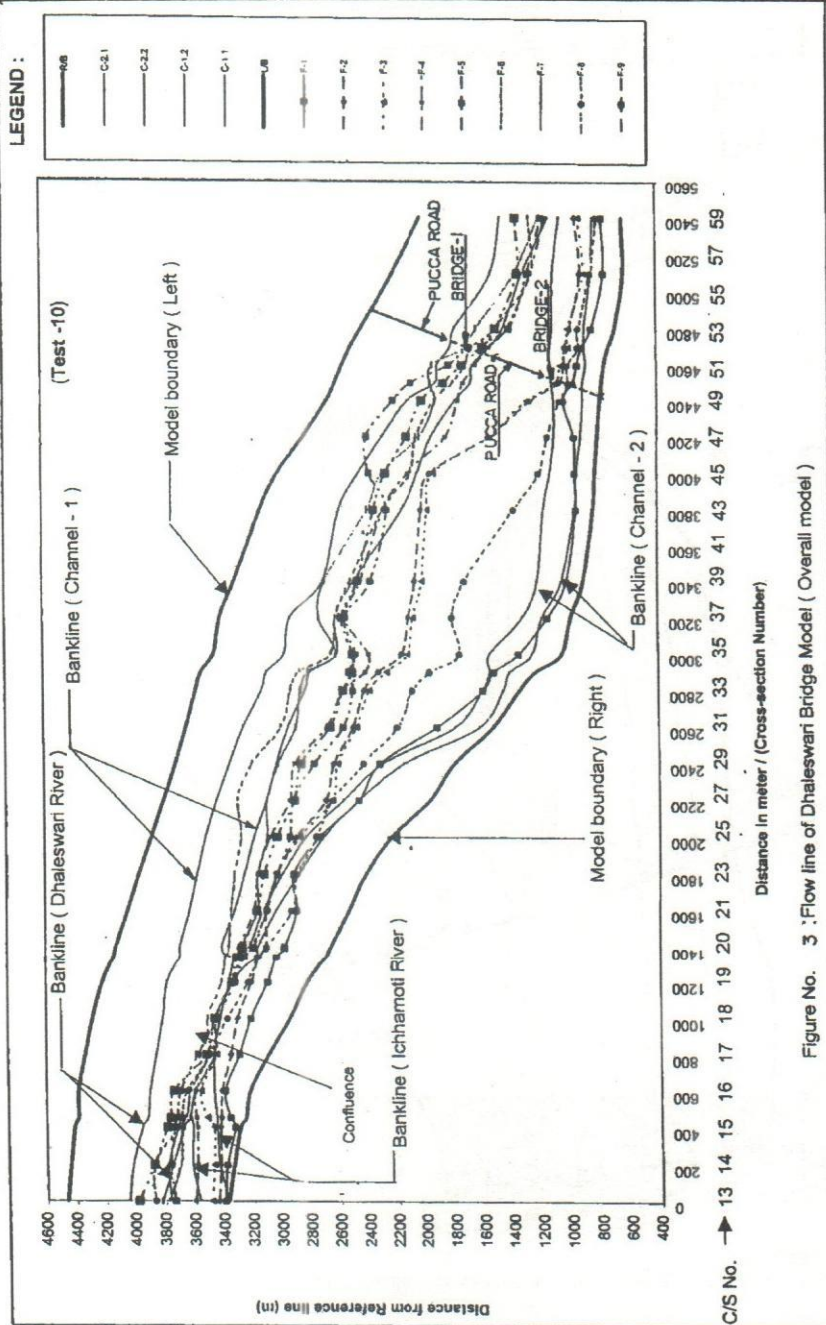
Figure No. 3 : Flow line of Dhaleswari Bridge Model (Overall model)

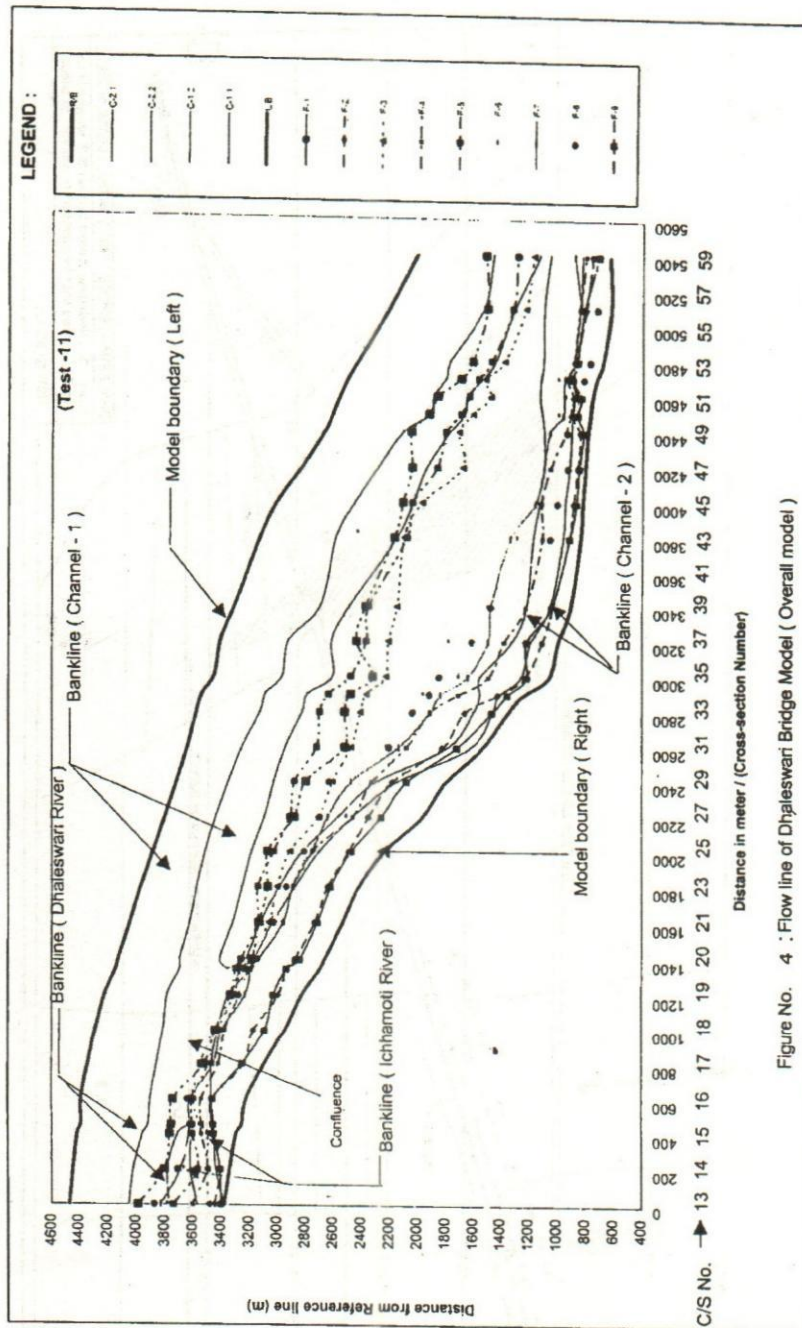
Figure No. 4 : Flow line of Dhaleswari Bridge Model (Overall model)

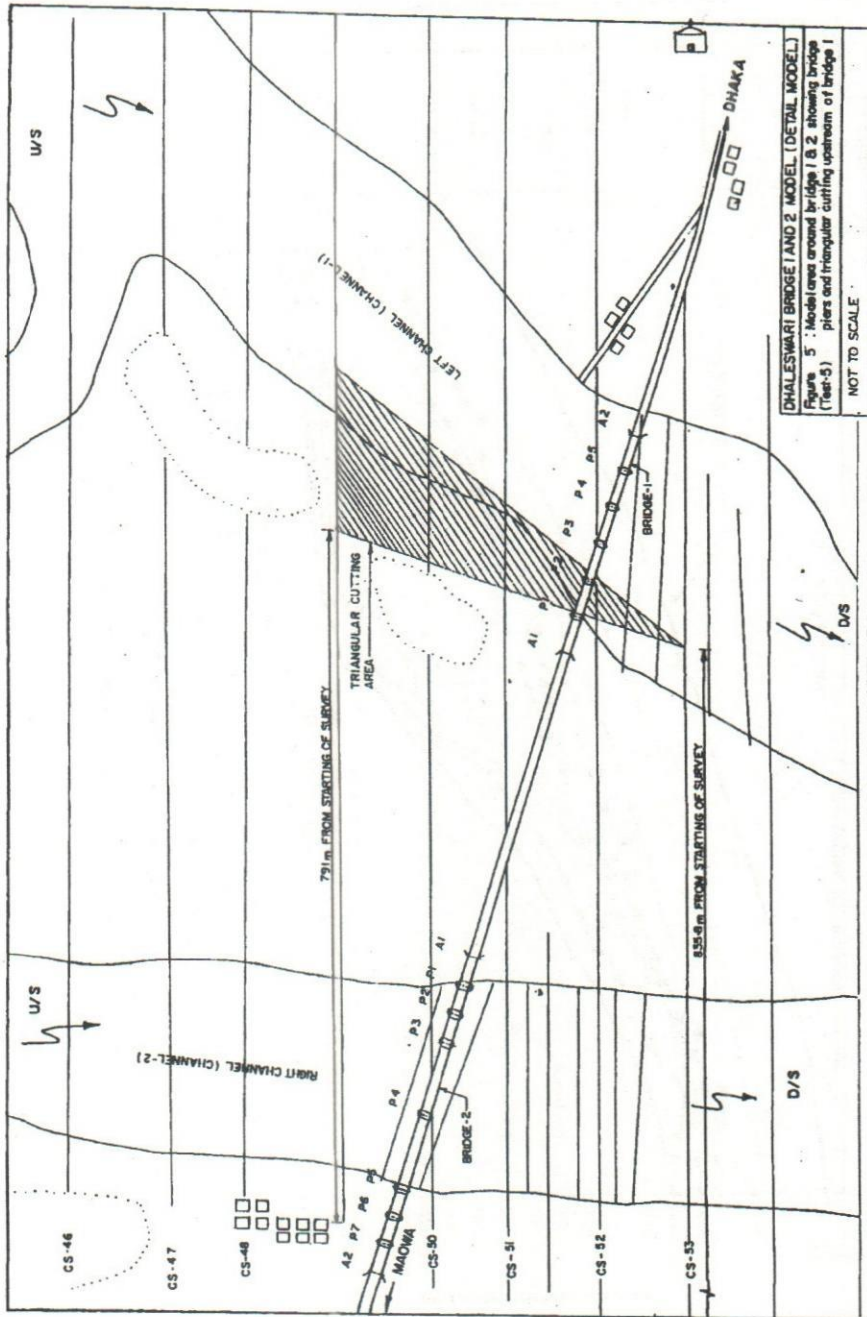
DHALESWARI BRIDGE 1 AND 2 MODEL (DETAIL MODEL)
 Figure 5 : Model area around Bridge 1 & 2 showing Bridge (Tier-5) piers and triangular cutting upstream of Bridge 1

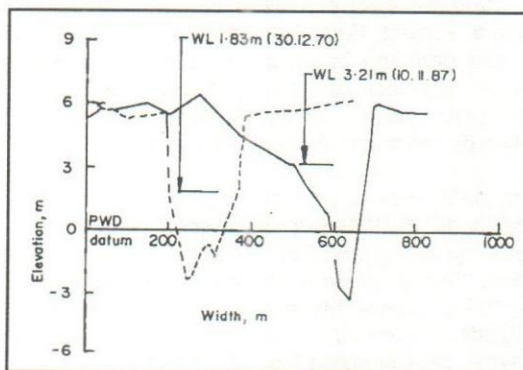
Figure 2 Cross-section for the Arial Khan Upper (AKU-3)

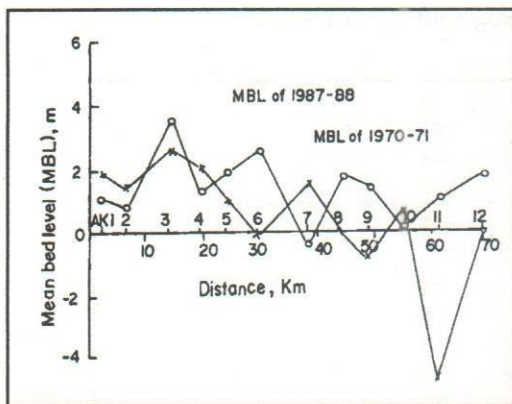
Fig. 3 Variation of mean bed level (MBL) for the Arial Khan Upper

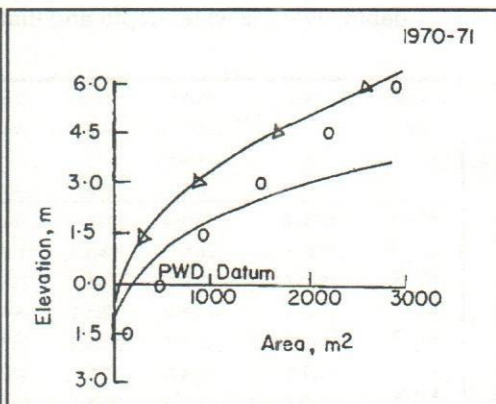
Fig. 4 Area-elevation relationship (AKU-4)

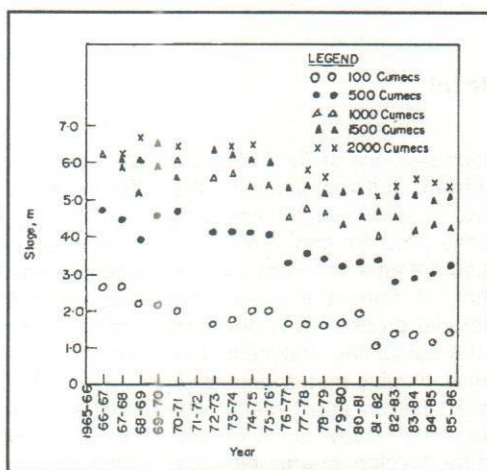
Figure 5 Variation of stage of the Arial Khan Upper at Chowdhury Char at different discharge level

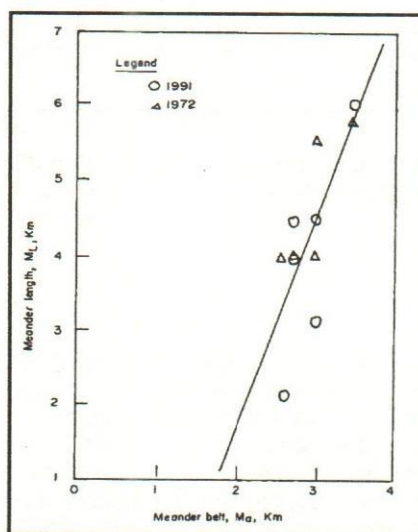
Figure 6 Relation between meander length (M_L) and meander belt (M_B)
