## MEGHNA RIVER BANK PROTECTION SHORT TERM STUDY

FINAL REPORT

ANNEX: C GEOTECHNICAL INVESTIGATIONS

February 1992

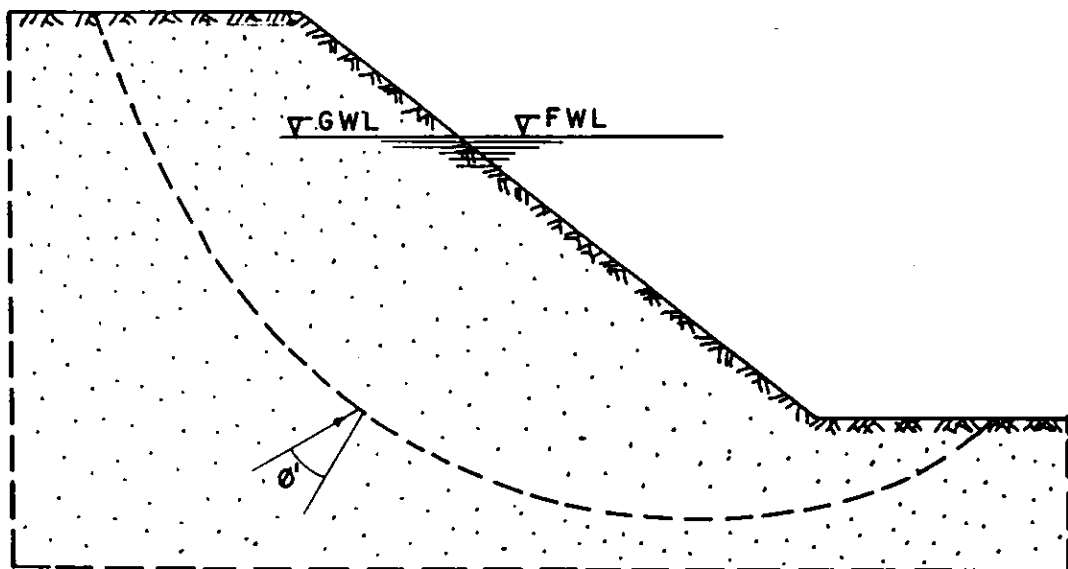
FIGURE NO. C. 4.1

Oversteep slope

Exceeding angle of friction ( $\phi'$ )

MACRO - STABILITY IN SINGLE LAYERED SOIL

Without any ground water flow between ground and free water the hydraulic gradient equals zero (Figs. C.4.1 and C.4.2). Overburden stresses only will govern shear resistance. An in- or outwardly directed gradient perpendicular to the slope face will increase or reduce the overburden stress level. Allowing for loading conditions above and the consistency of fine and silty fine sand layers, a potential failure plane will have an approximately circular shape.

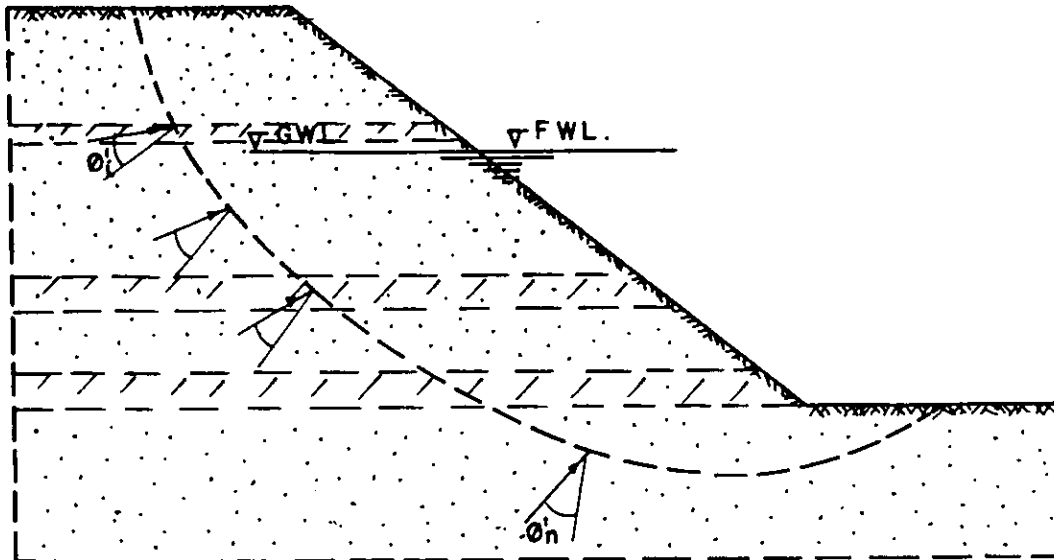
FIGURE NO. C. 4. 2

Oversteep slope

Exceeding angle of friction ( $\phi'_1$ )

MACRO - STABILITY IN MULTI LAYEREO SOIL

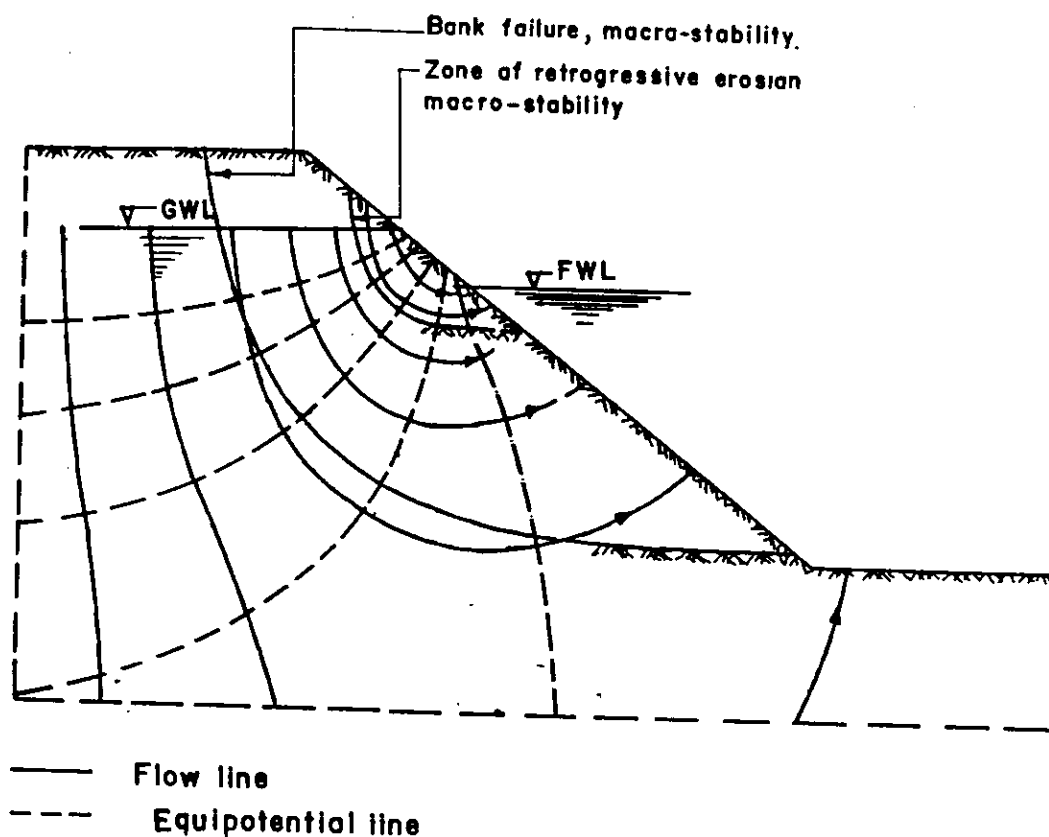
FIGURE NO. C. 4.3

Loss of macro-stability inside =

Combined phenomenon

MACRO AND MICRO - STABILITY IN SINGLE LAYERED SOIL

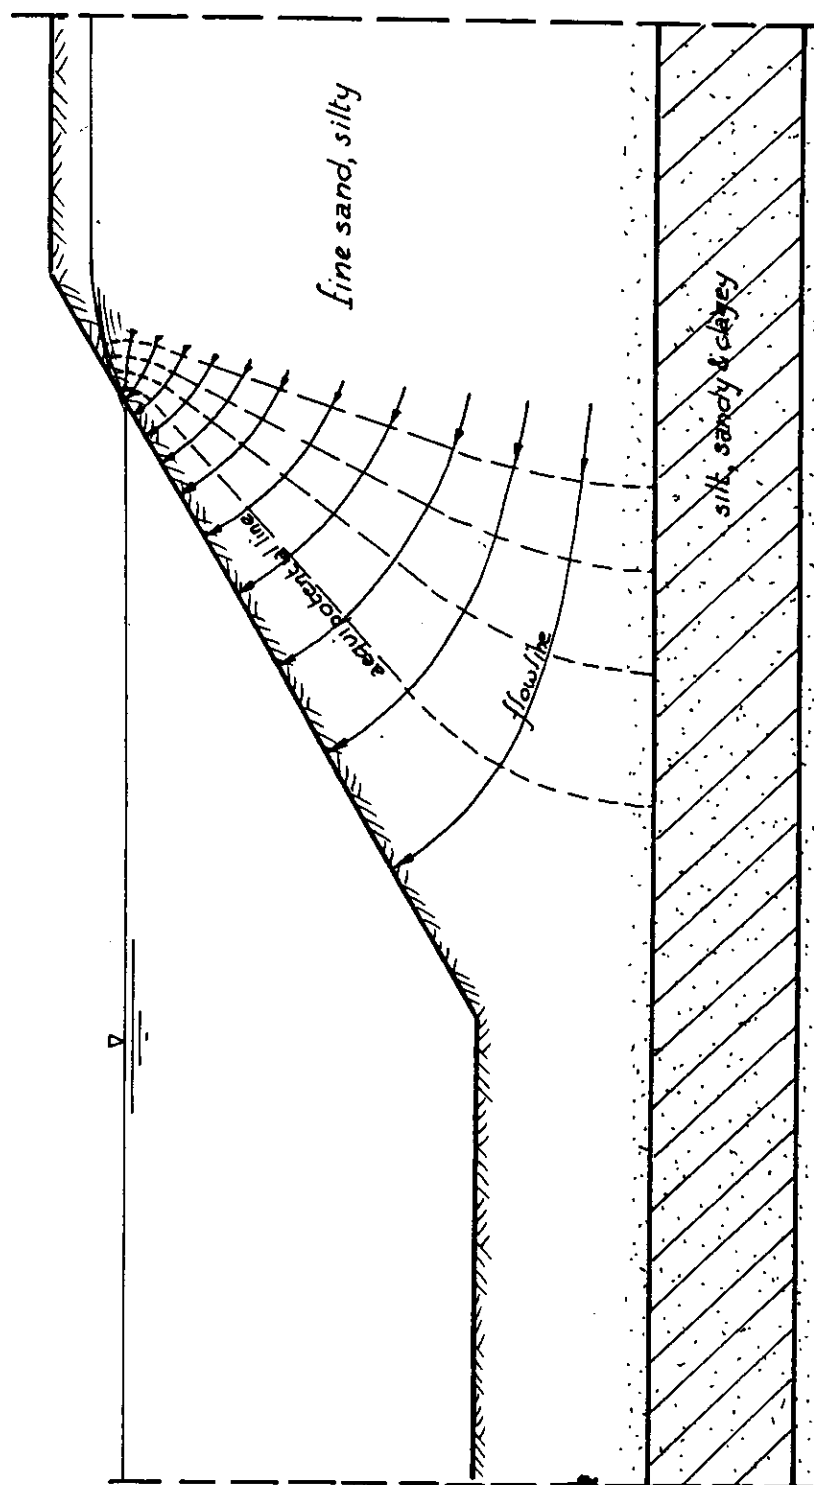
FIGURE NO. C. 4.5

TYPICAL CROSS SECTION AT BHAIRAB BAZAR

GROUND WATER FLOW CONDITIONS AT  
BHAIRAB BAZAR

An analysis to this effect indeed confirms that soil layering and piezometric levels at this location, after a very high water, provided the critical conditions resulting in a slope failure.

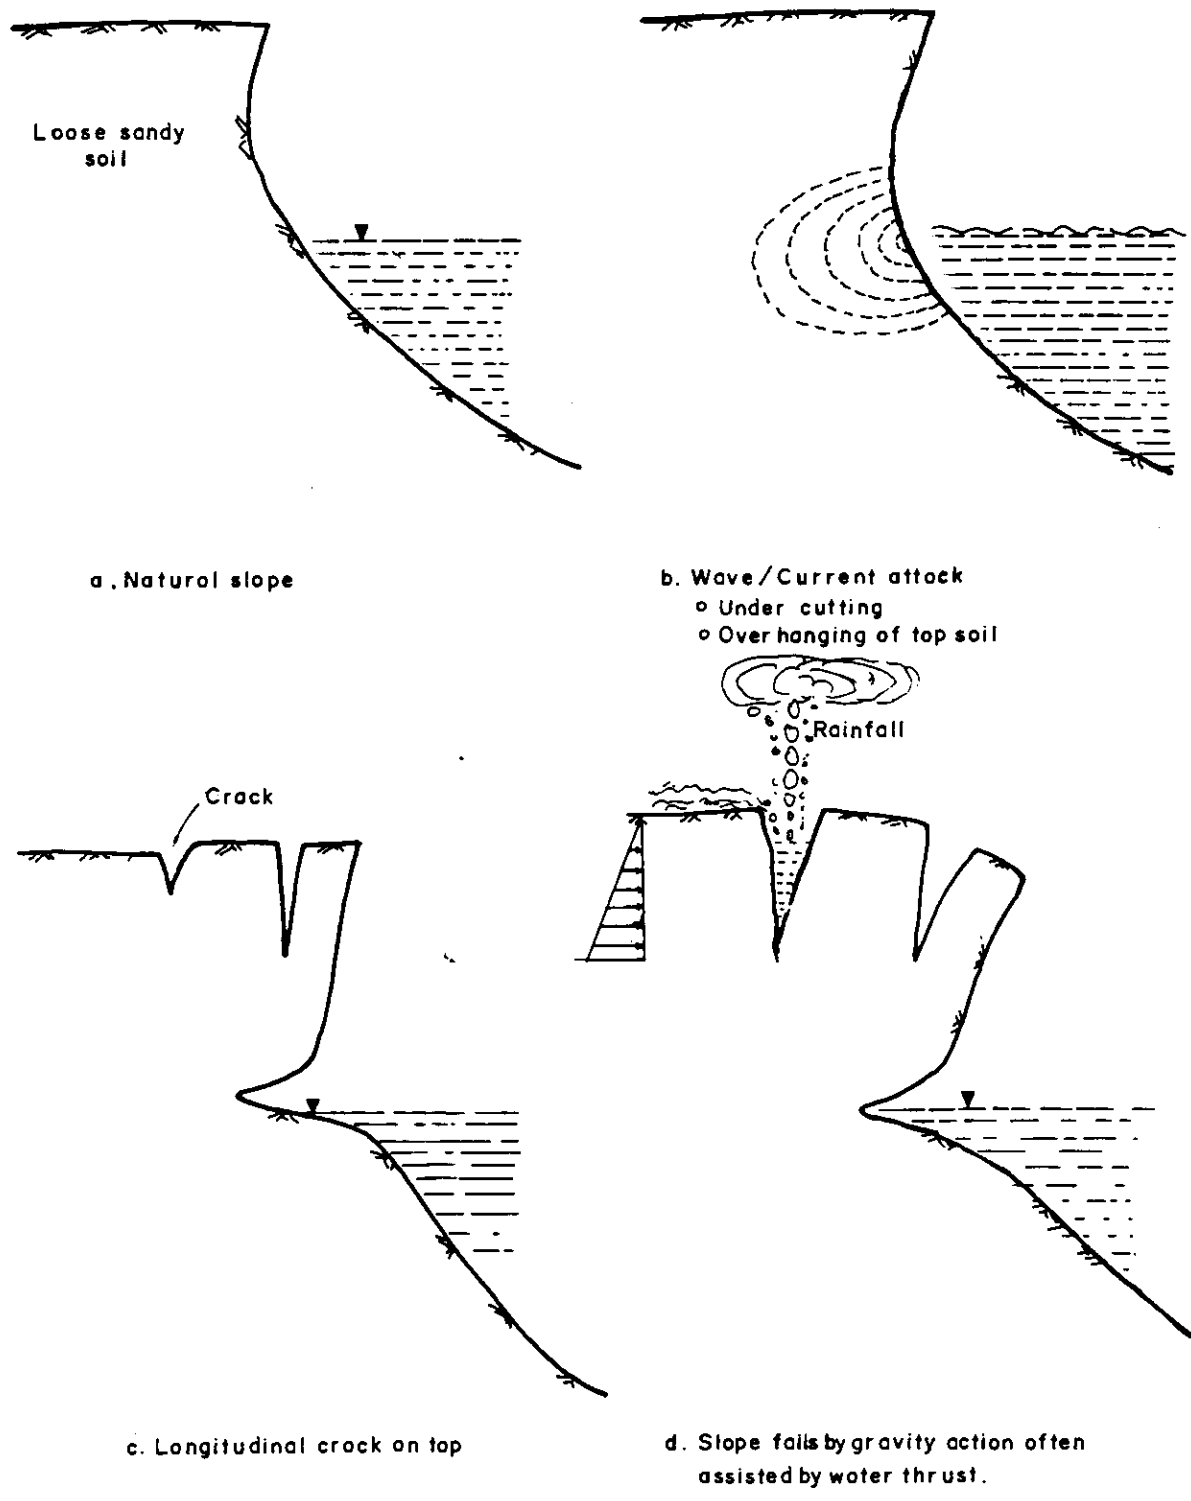
**FIGURE NO.C.4.6**

**Micro to Macro mode failure cycle**

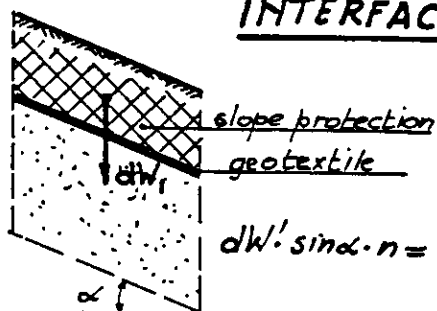
## INTERFACE GEOTEXTILE-SOIL

$$dw' \sin \alpha \cdot n = dw' \cos \alpha \cdot \tan \beta$$

$$\therefore n = \frac{\tan \beta}{\tan \alpha}$$

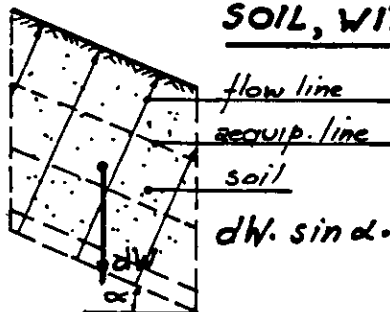
## SOIL, WITH GROUND WATER GRADIENT

$$dw' \sin \alpha \cdot n = dw' \cos \alpha \cdot (1-i) \cdot \tan \phi'$$

$$\therefore n = (1-i) \cdot \frac{\tan \phi'}{\tan \alpha}$$

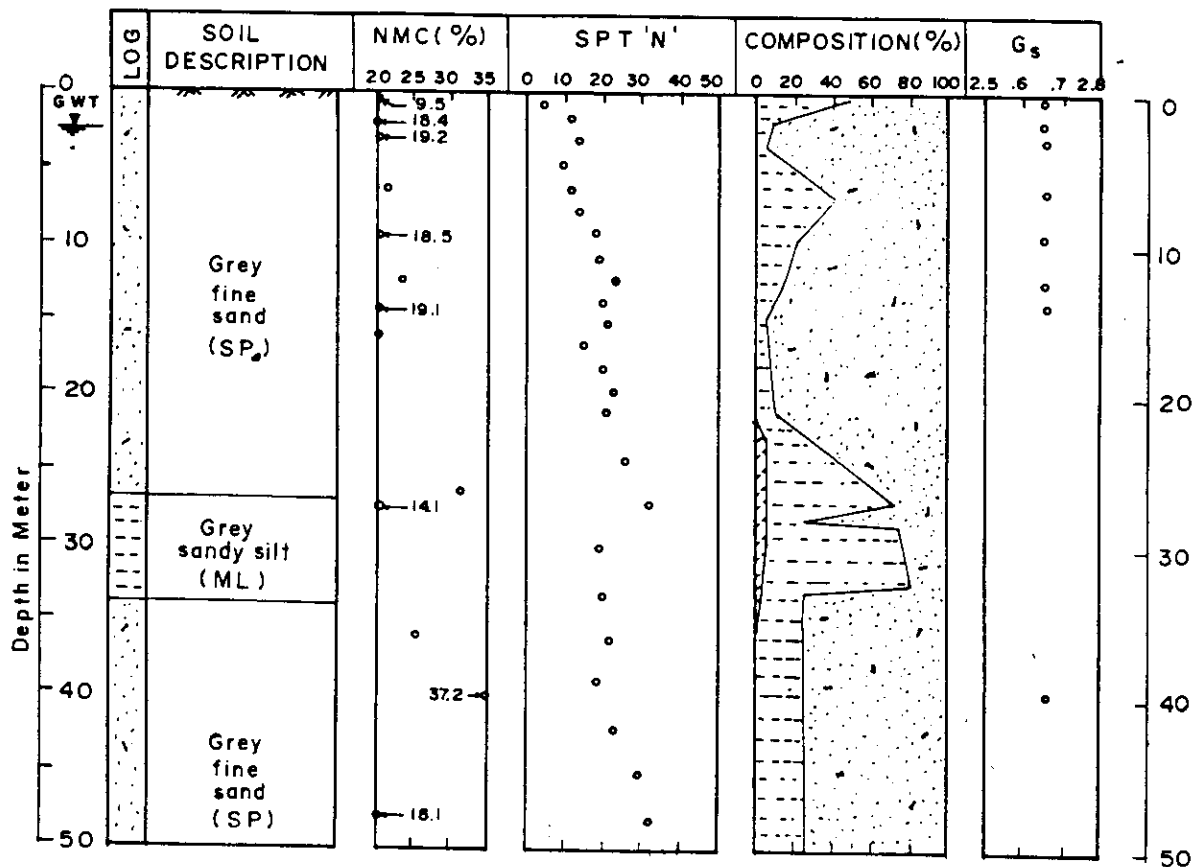
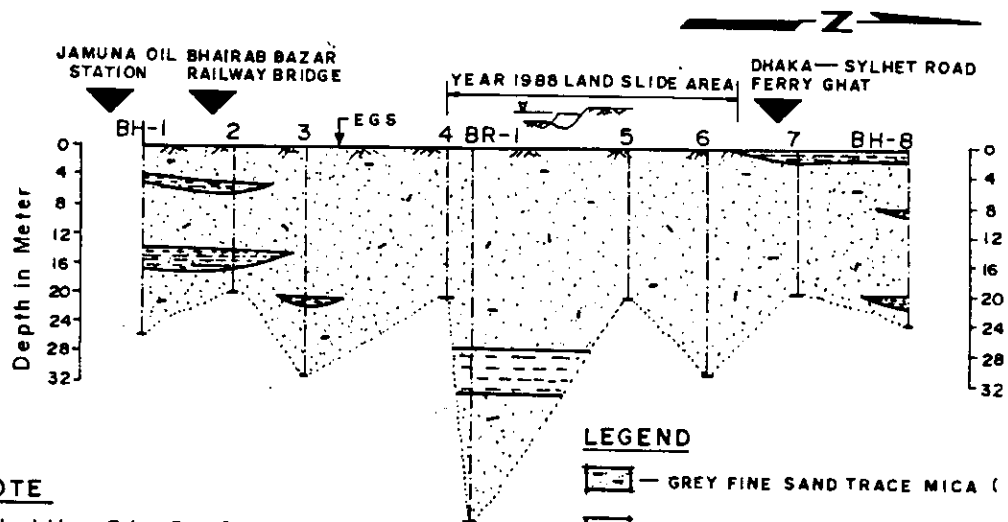
FIGURE NO. C.6.1 + C.6.2

a) TEST RESULT FROM BR-1 AT BHAIRABBAZAR RLY. BRIDGE SITE  
b) STRATIGRAPHY AT WEST BANK OF THE MEGHNA RIVER AT BR-1

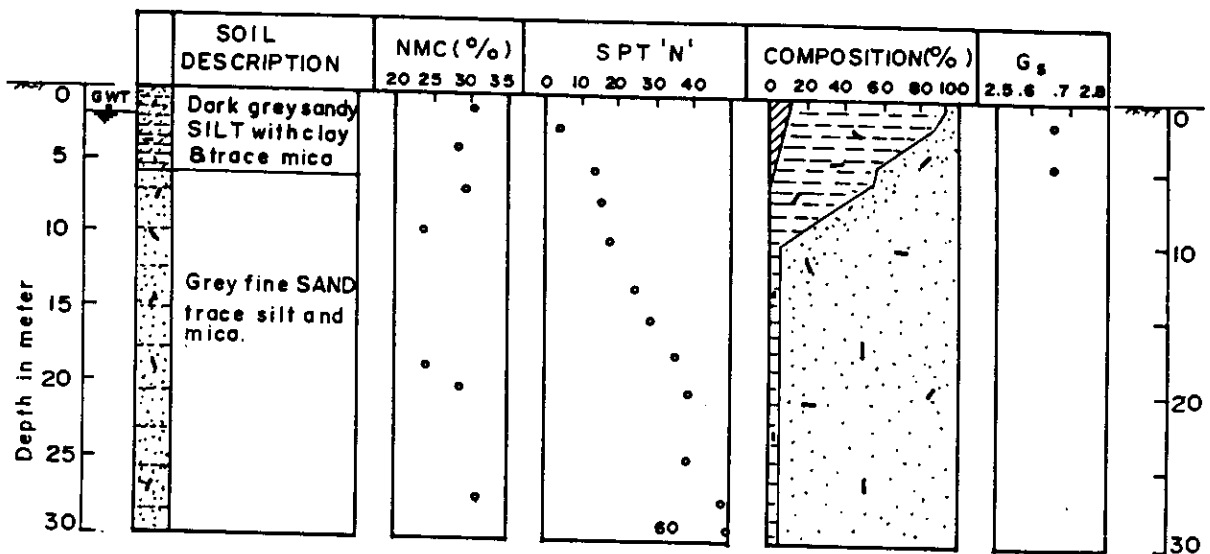
FIGURE NO. C.6.5

TEST RESULTS FROM  
MG-2 AT MEGHNA R & H BRIDGE SITE

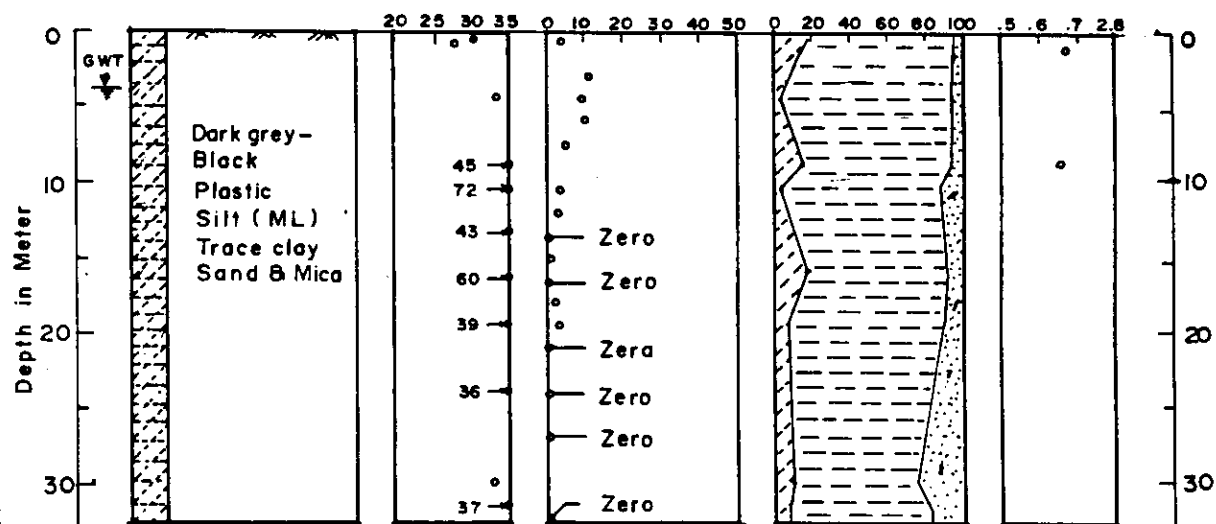
FIGURE NO. C.6.6

a) TEST RESULTS FROM MN-1 AT MUNSHIGANJ

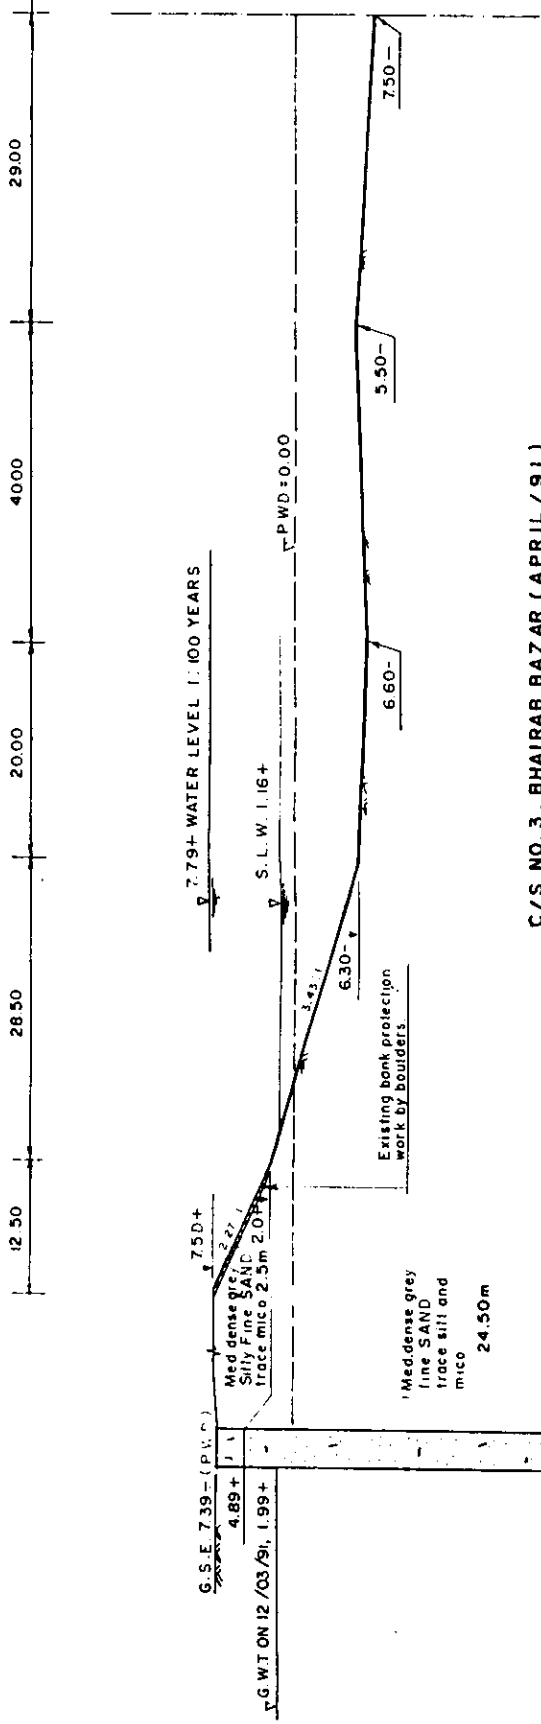
BORE LOG BR-1 AND CROSS SECTION  
C/S NO. 3 OF MEGHNA RIVER AT BHAIKAB BAZAR

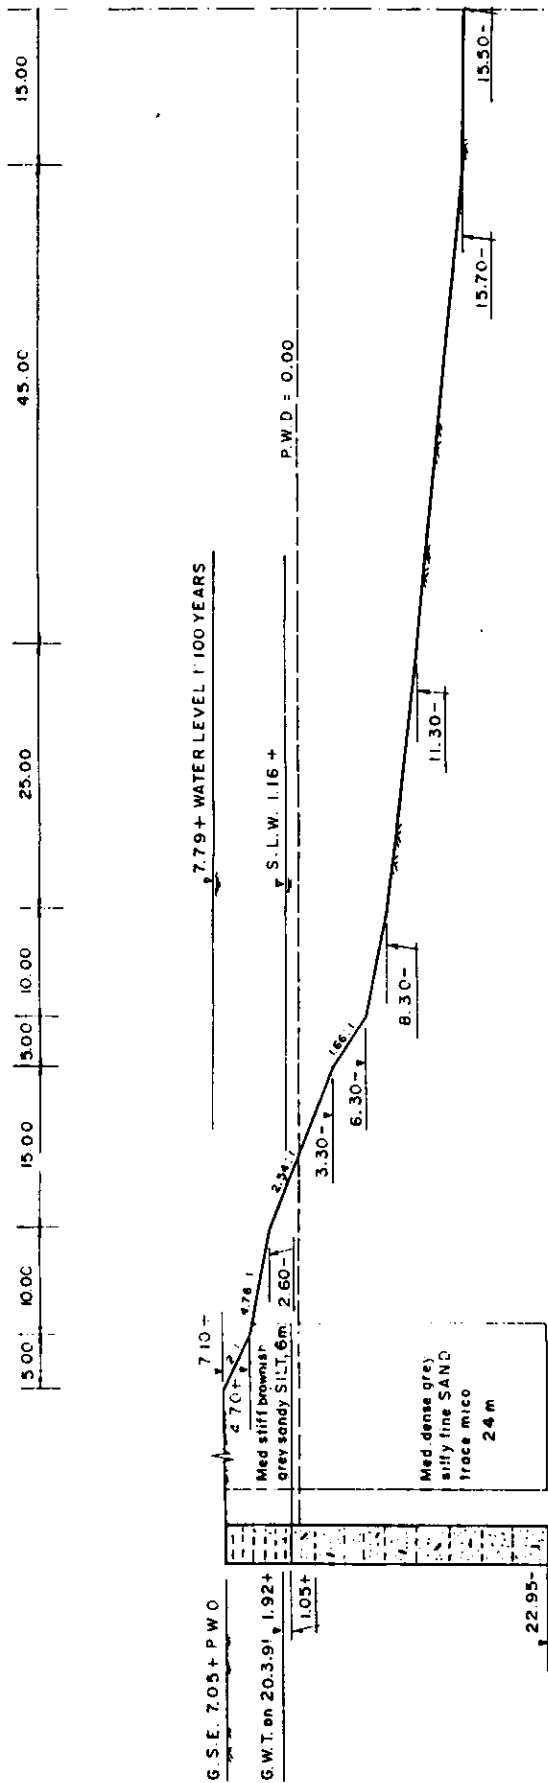
APPENDIX - 5  
FIGURE NO. C/5.2

BORE LOG BR-2 AND CROSS SECTION C/S NO. 22  
OF MEGHNA RIVER AT BHAIRAB BAZAR

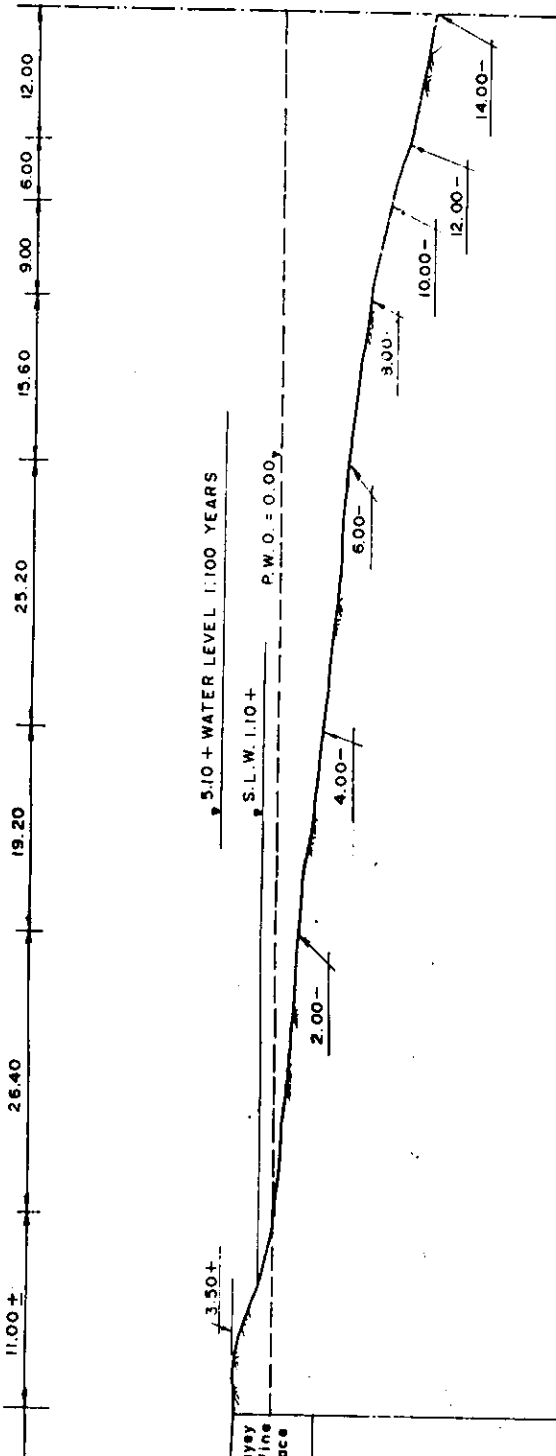
C/5-8

BDRE LOG MG-1 AND RIVER CROSS SECTION  
NEAR R & H BRIDGE ON MEGHNA

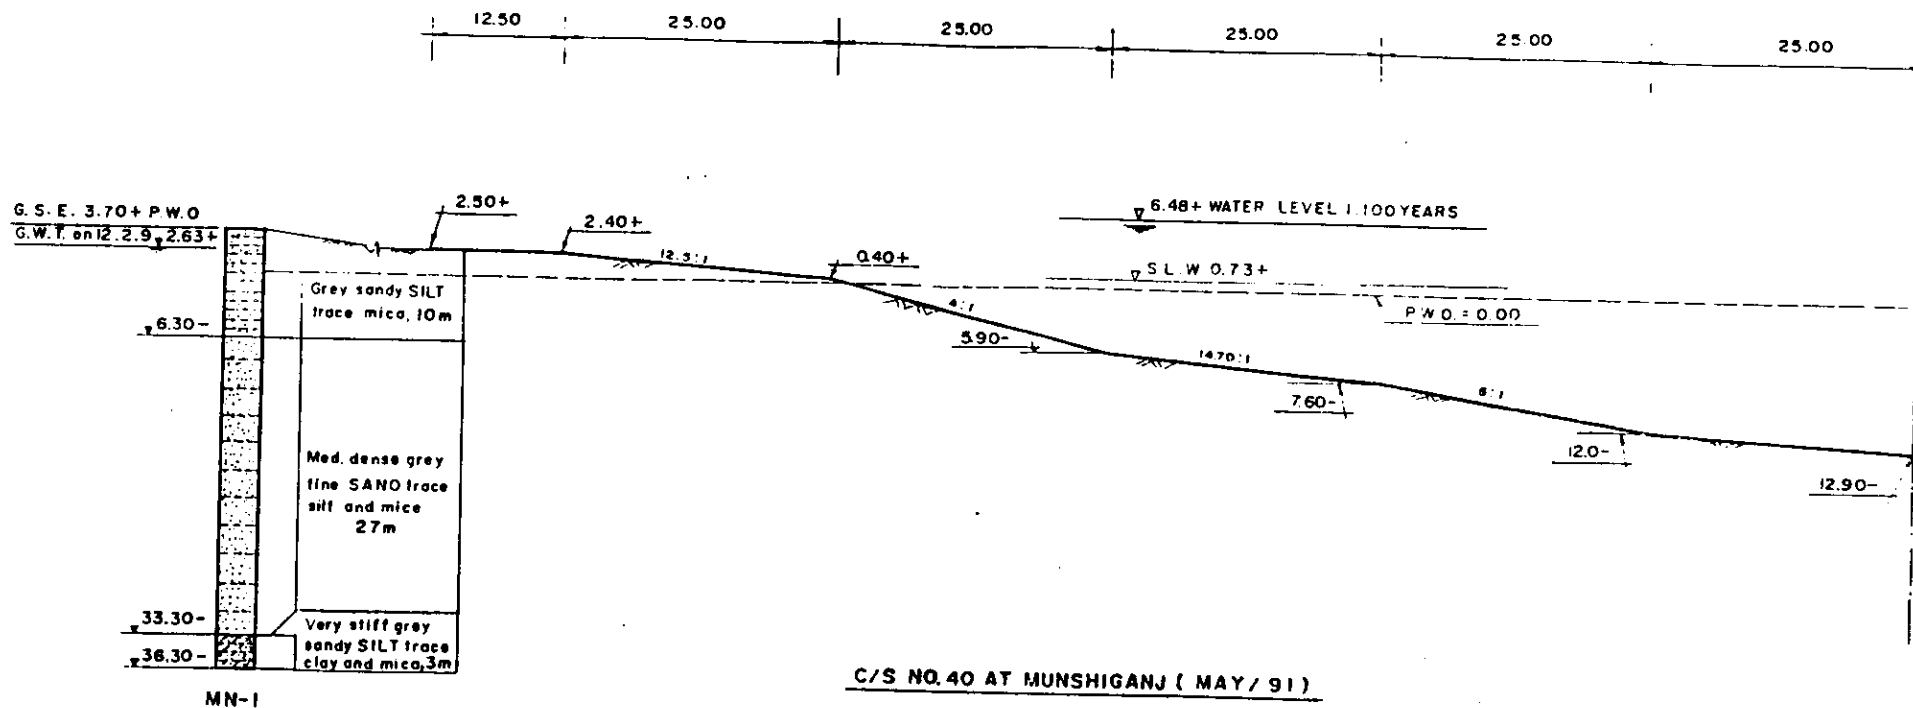
APPENDIX - 5  
FIGURE NO. C/5.4

BORE LOG MN-1 AND CROSS SECTION C/S NO.40  
OF DHALESWARI RIVER AT MUNSHIGANJ

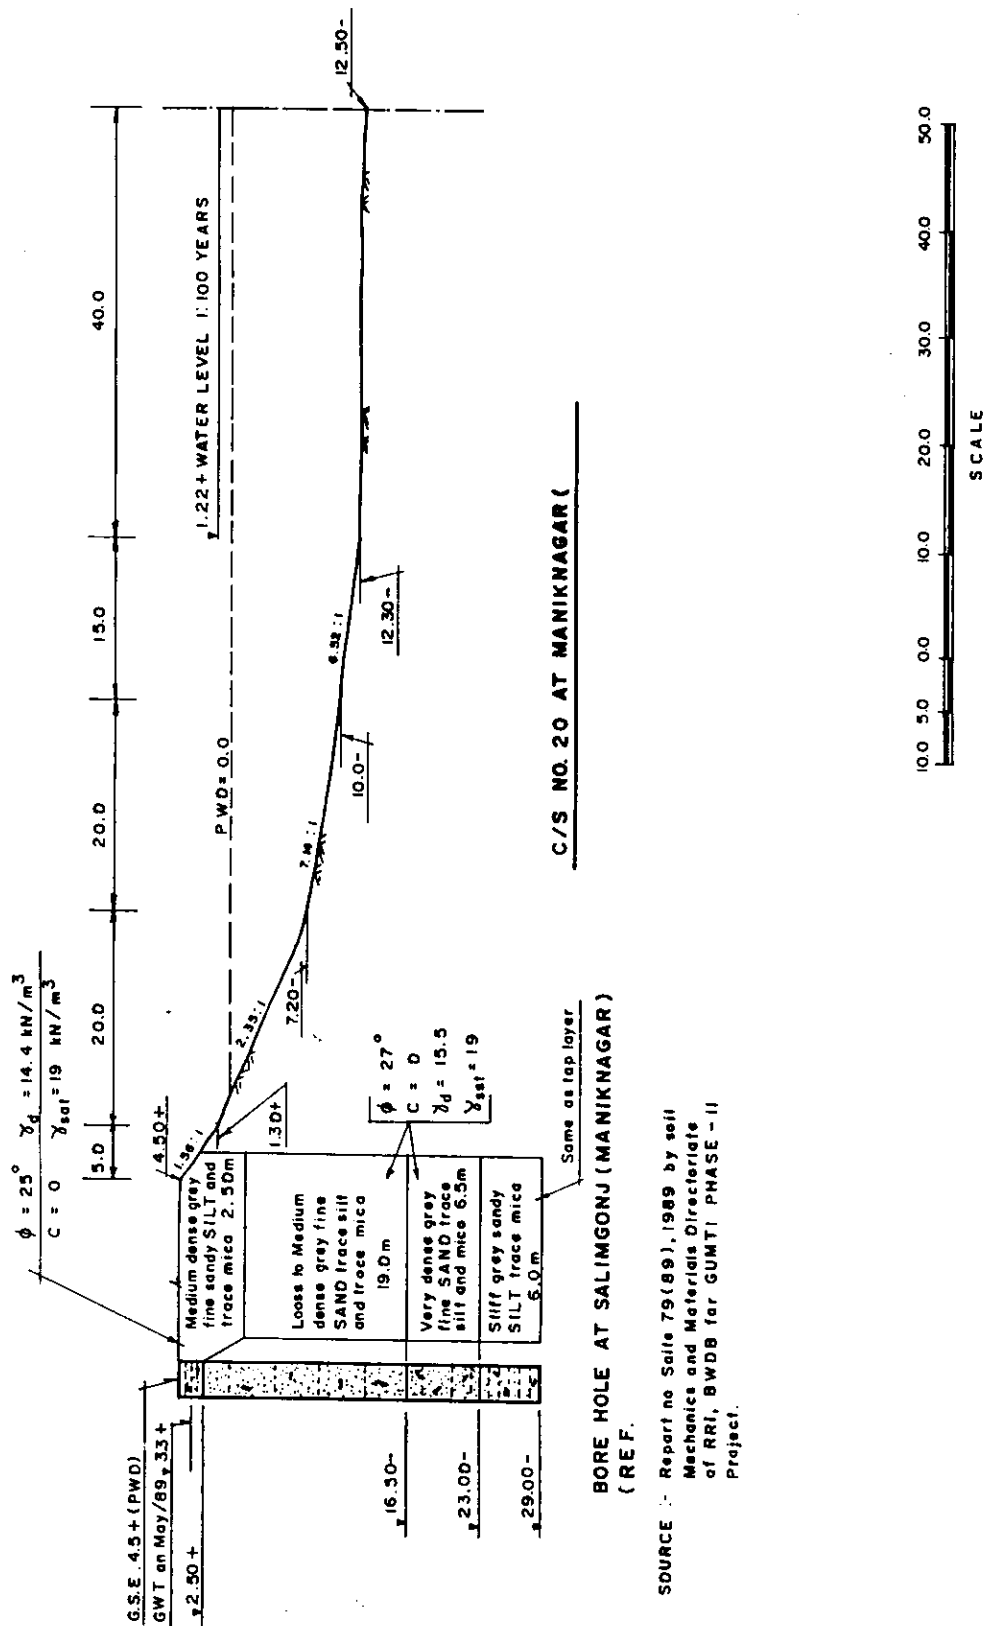
FIGURE NO. C/5.7

BORE HOLE AT SALIMGANJ (MANIKNAGAR) AND CROSS SECTION ON C/S NO. 20 OF MEGHNA RIVER AT MANIKNAGAR

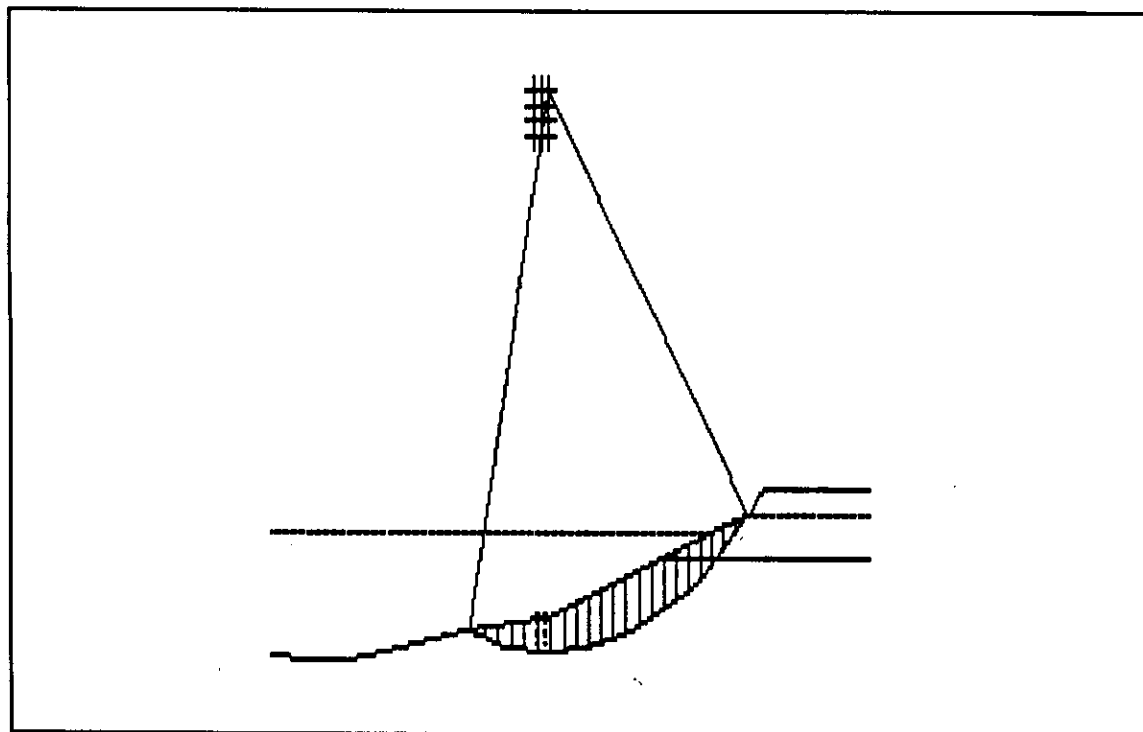
DRIVING MOMENT : 130546  
COUNTER-ACTING MOMENT : 106817  
MOMENT WATER ON SLOPE : 53746

FIGURE 1. Slope Stability Analysis. Munshiganj Town. Slope 1 to 3.5  
Calculation with HASKONING/BISEIS Model.

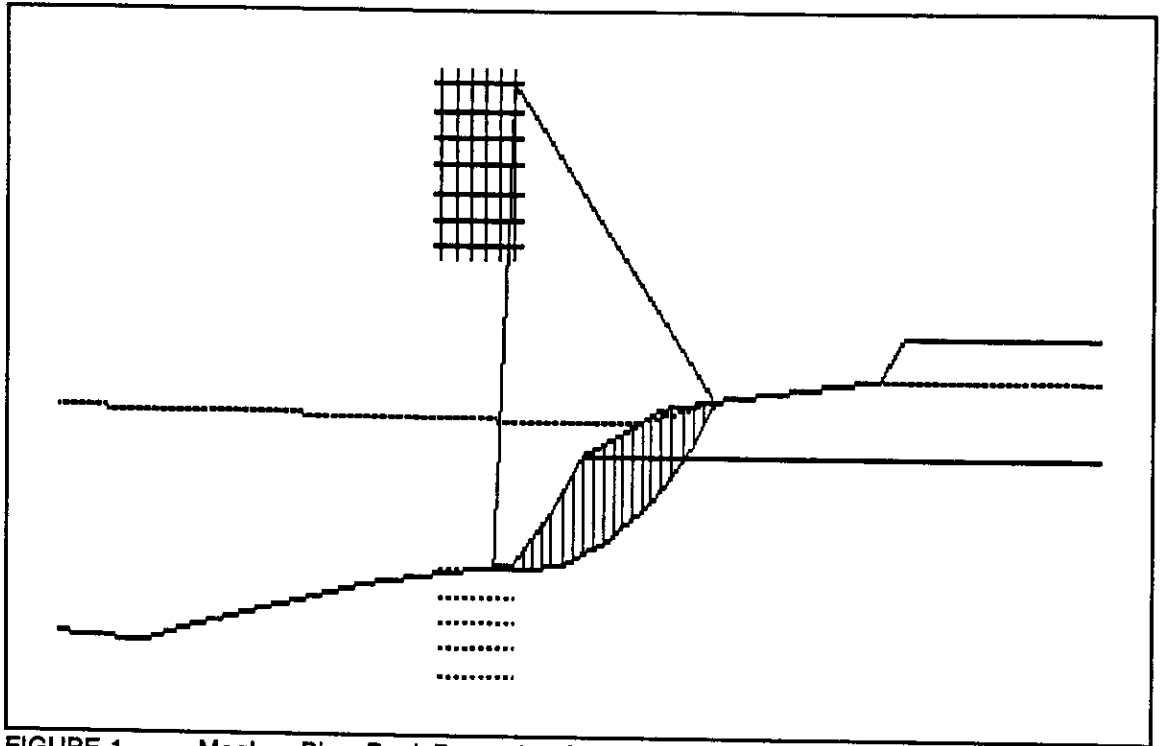
DRIVING MOMENT : 38102  
COUNTER-ACTING MOMENT : 20365  
MOMENT WATER ON SLOPE : 16367

FIGURE 1. Meghna River Bank Protection Study. Munshiganj Town. Slope Stability Analysis. Present Situation Cross Section 22.

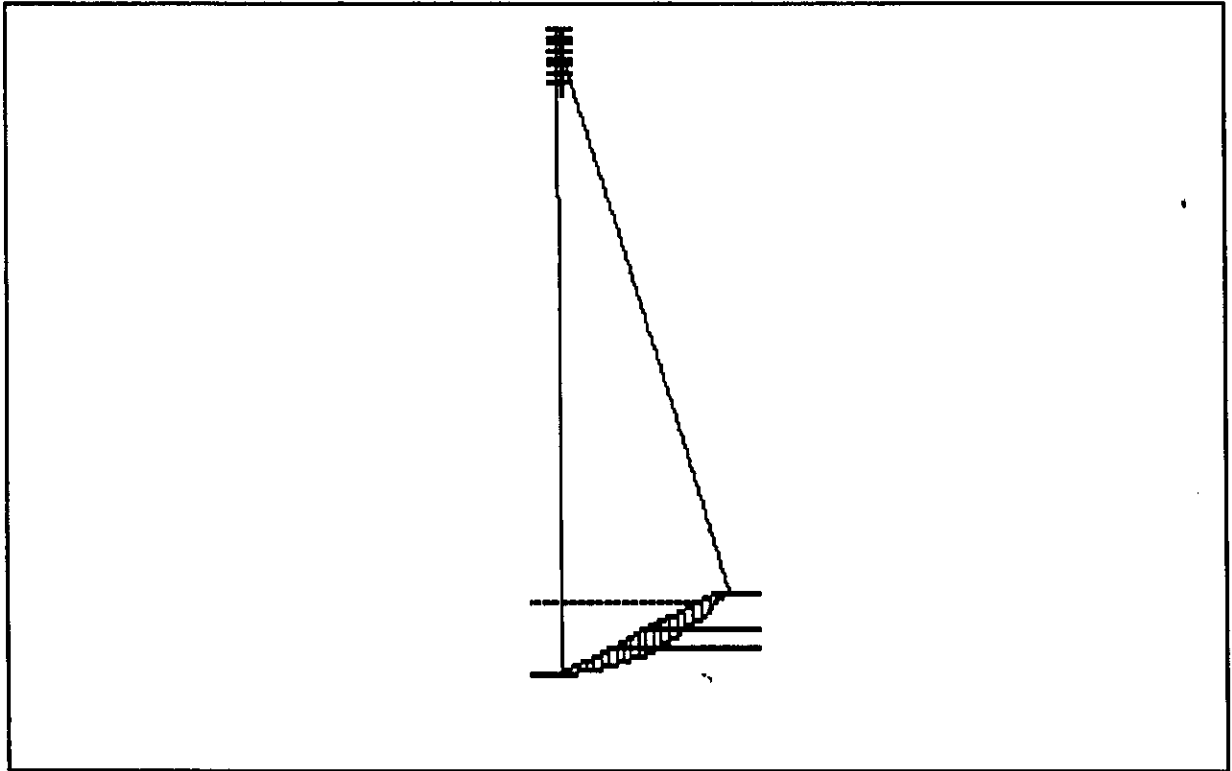
DRIVING MOMENT : 5880723  
COUNTER-ACTING MOMENT : 4219498  
MOMENT WATER ON SLOPE : 2351582

FIGURE . Slope Stability Analysis. Slope 1:3.5  
Chandpur Town Protection.

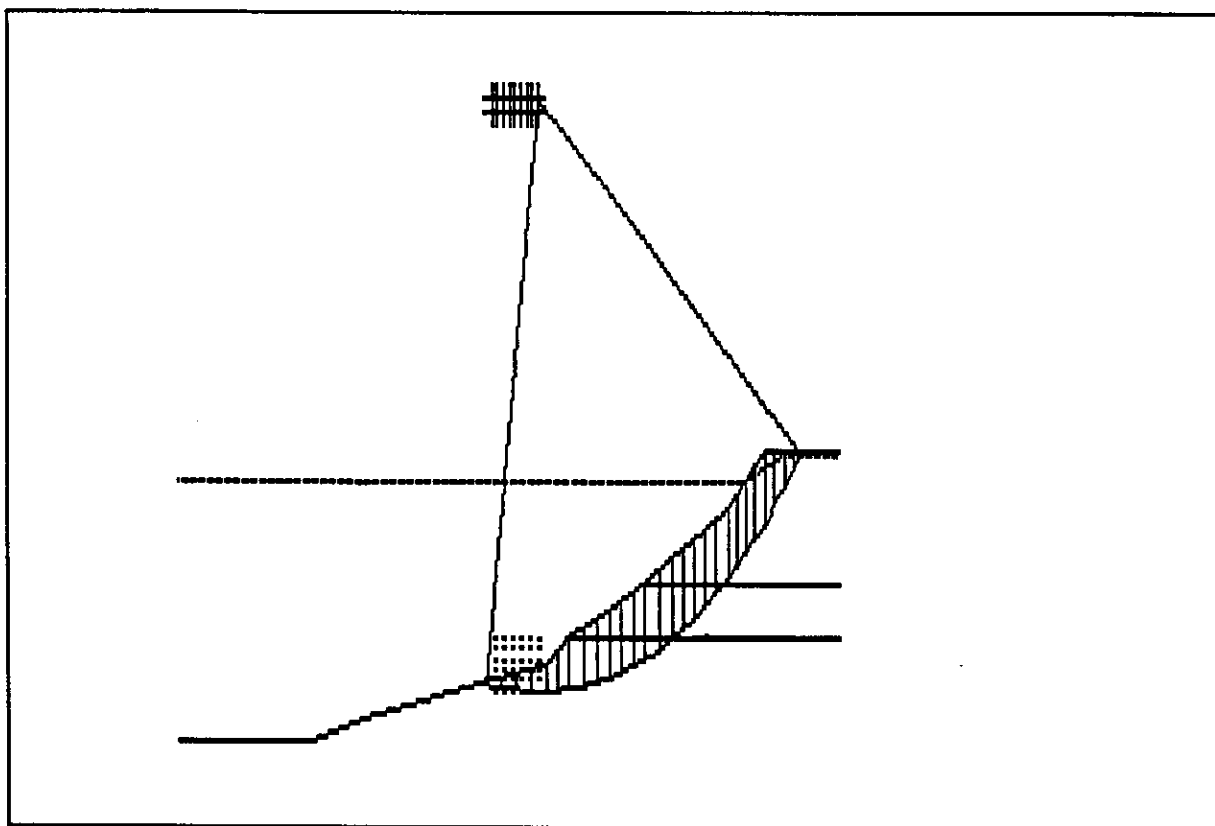
FIGURE . Slope Stability Analysis  
Chandpur Town Protection. Cross Section 21 (Present Situation).
