**BANK PROTECTION AND  
RIVER TRAINING (AFPM)  
PILOT PROJECT  
FAP 21/22**

**TEST  
AND  
IMPLEMENTATION  
PHASE**

**PROGRESS REPORT  
NO. 29**

JULY TO SEPTEMBER 2000

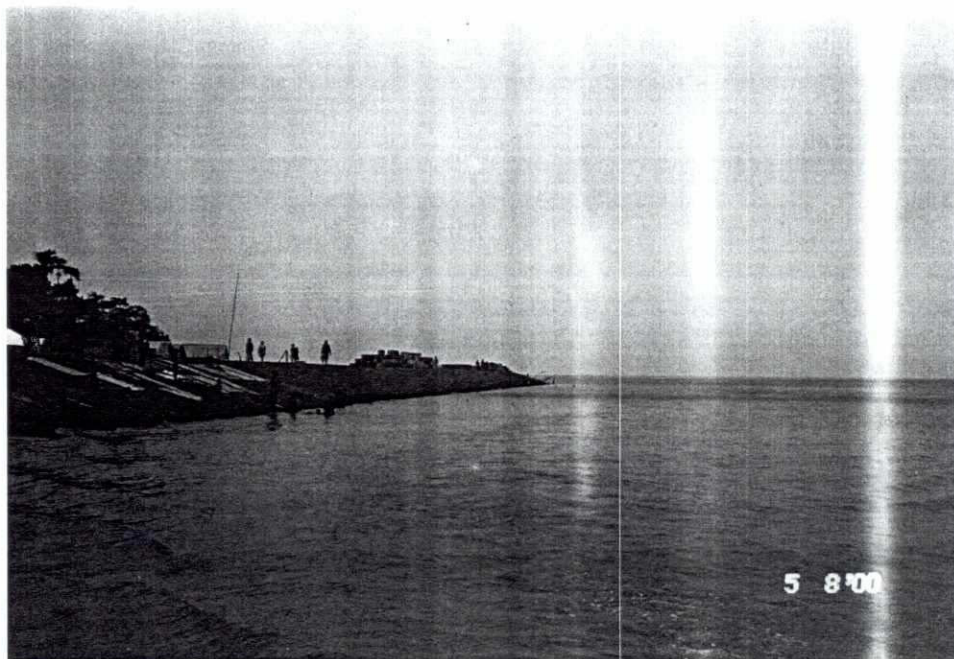
Photo 7: Test Site III – Ghutail;  
Test structure at Ghutail on August 05, 2000;  
Water level at 19.40 m+PWD

The average flow velocity along the Revetment Test Structure was 1.2 m/s in July, but 0.8 m/s only in September. Sedimentation along the test structure was observed during the period under review. Only downstream from the structure erosion continued.

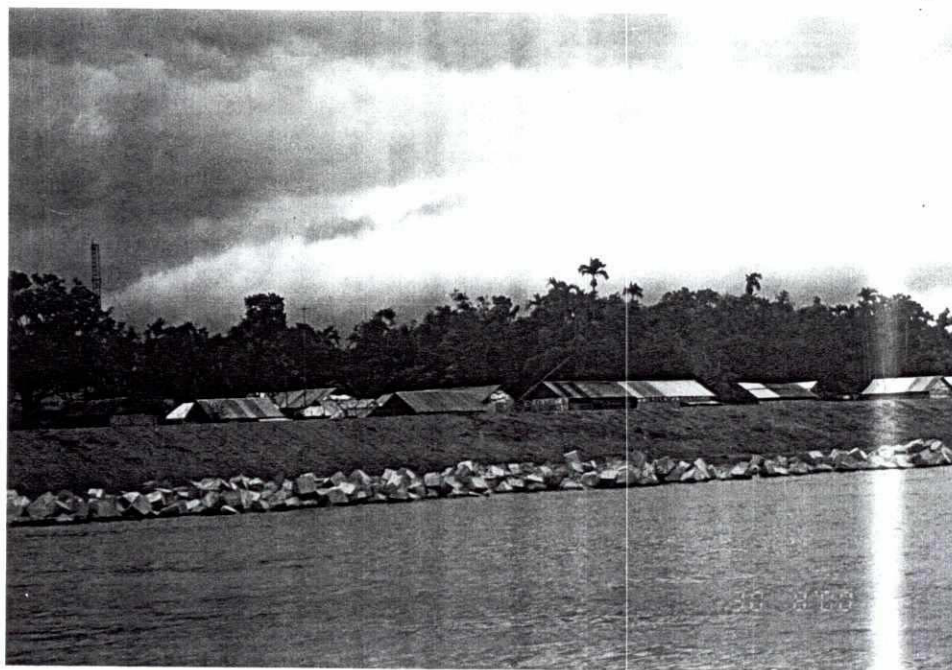
Photo 8: Test Site III – Ghutail;  
Test structure at Ghutail on August 30, 2000;  
Water level at 18.56 m+PWD
