**BANK PROTECTION AND
RIVER TRAINING (AFPM)
PILOT PROJECT
FAP 21/22**

**FINAL PROJECT
EVALUATION REPORT**

**Annex 6: The Groyne Test Structure;
Monitoring Report**

**Annex 7: The Groyne Test Structure;
Evaluation of Hydraulic
Loads and River Response**

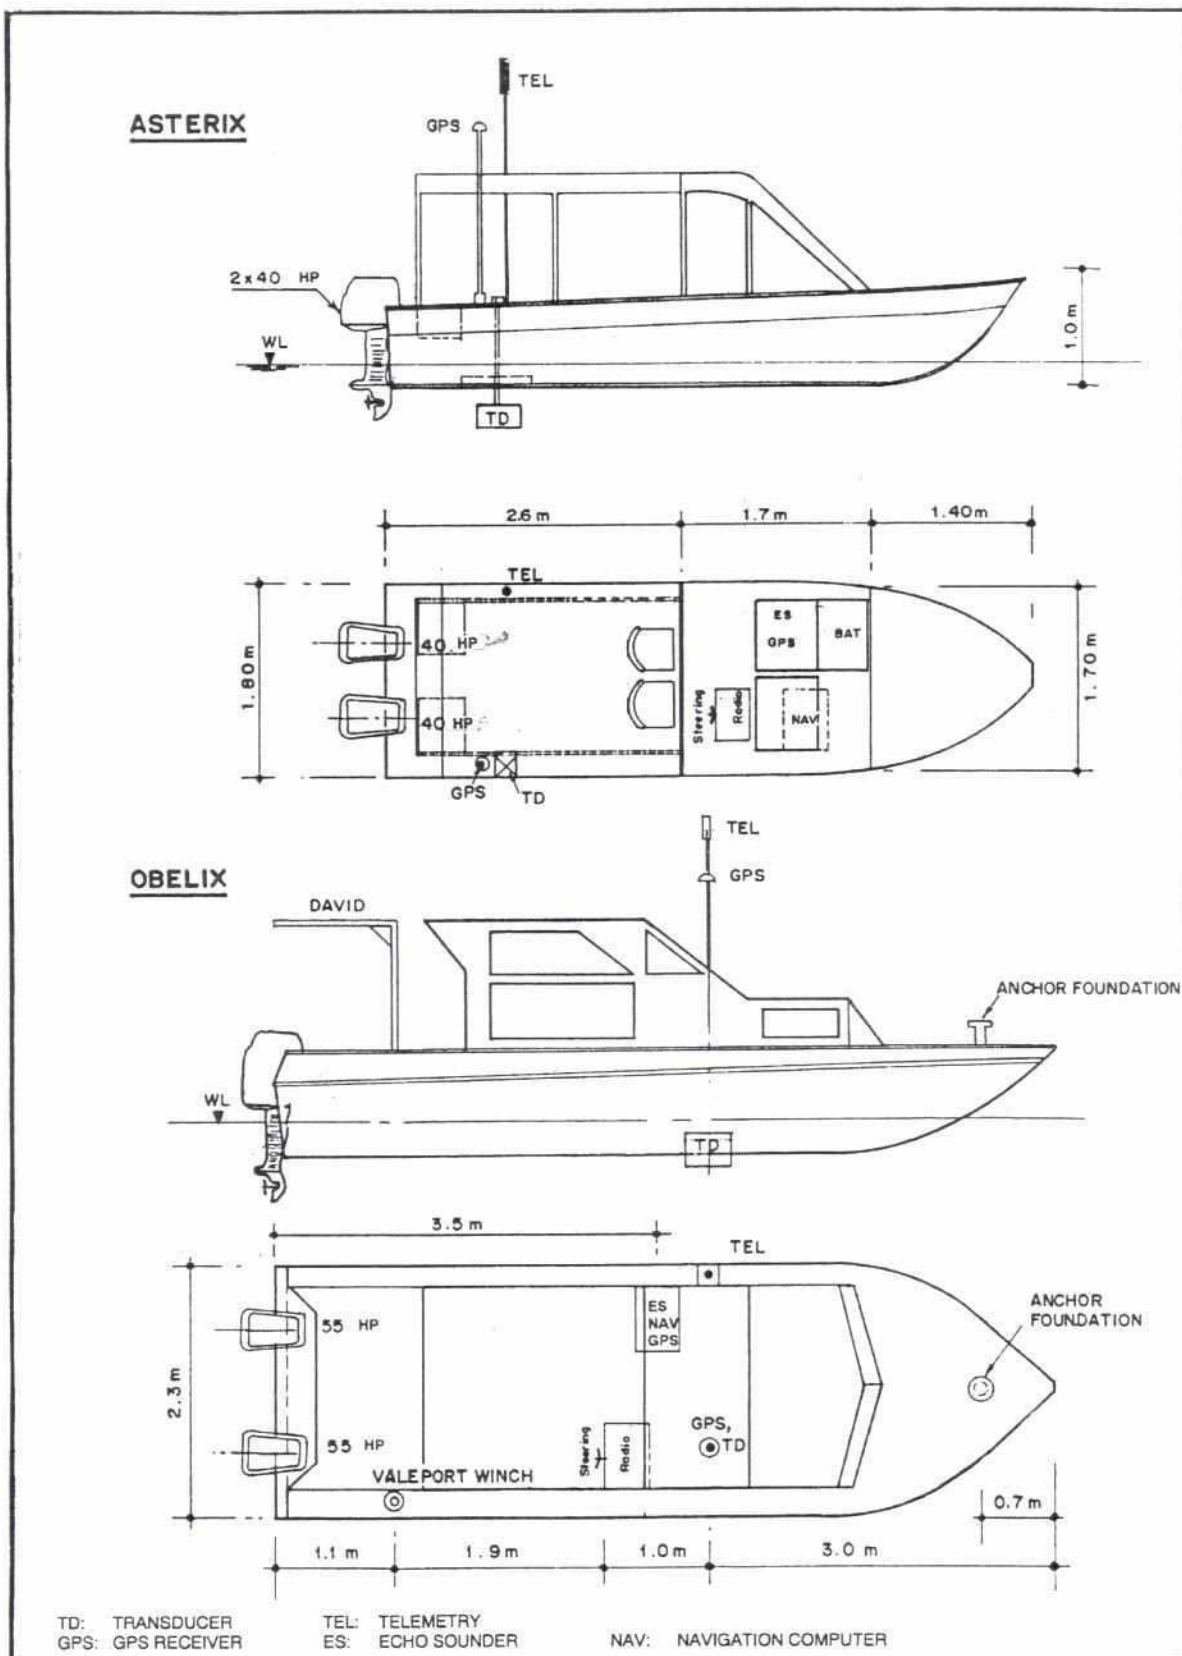
Fig. 2.5-2: Survey boat Asterix

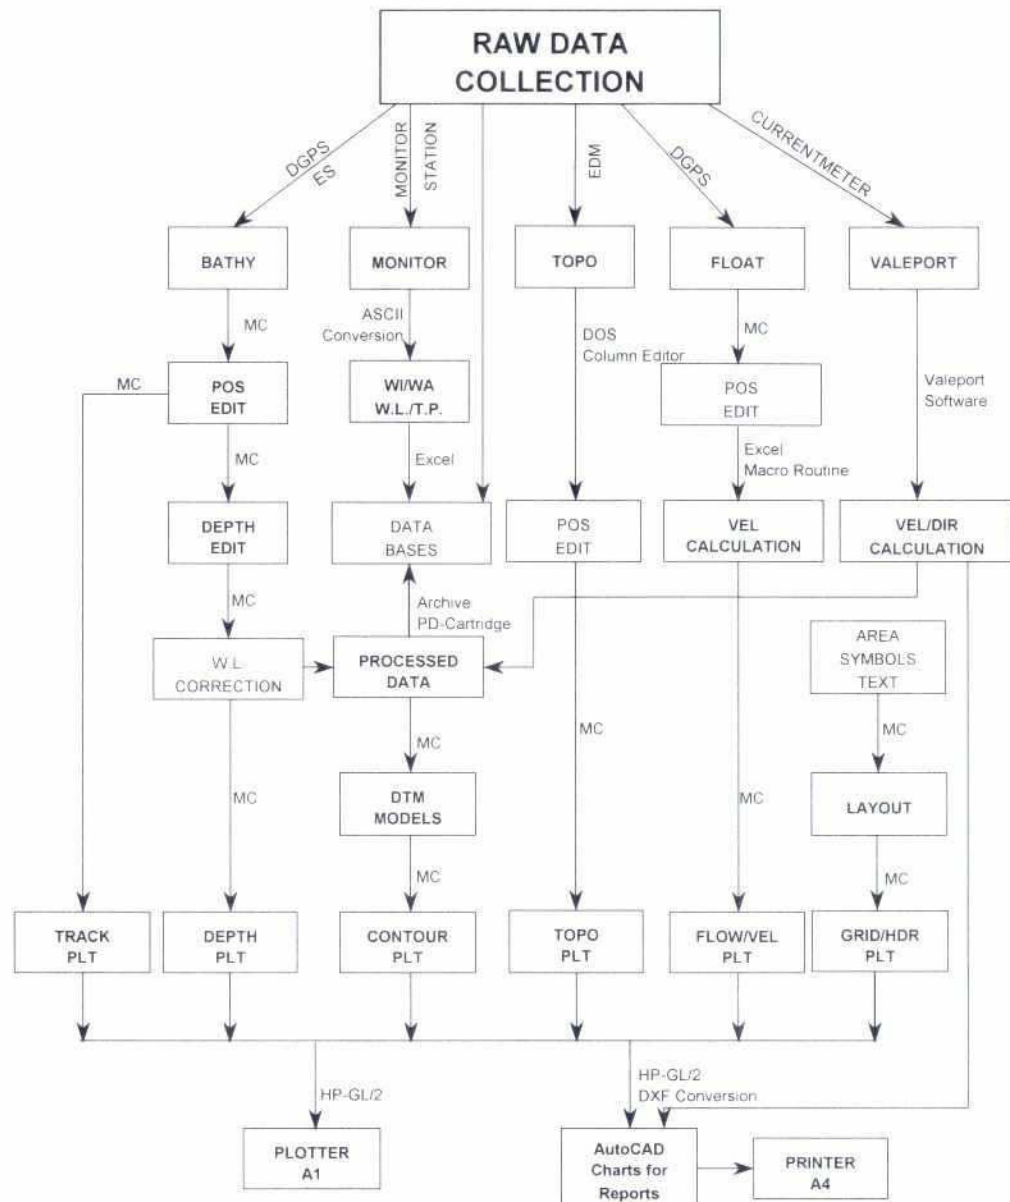
MC	Masterchart	Topo	Topography data	W.L.	Water level
ES	Echo sounder	Bathy	Bathymetry data	DTM	Digital Terrain Model
Float	Float track data	WA	Wave Height	WI	Wind direction/speed
T.P.	Test Pile	EDM	Electronic Distance Measurement unit	HP-GL/2	Hewlett-Packard Graphics Language

Fig. 4.1-1: Flowchart – Processing of digital monitoring data

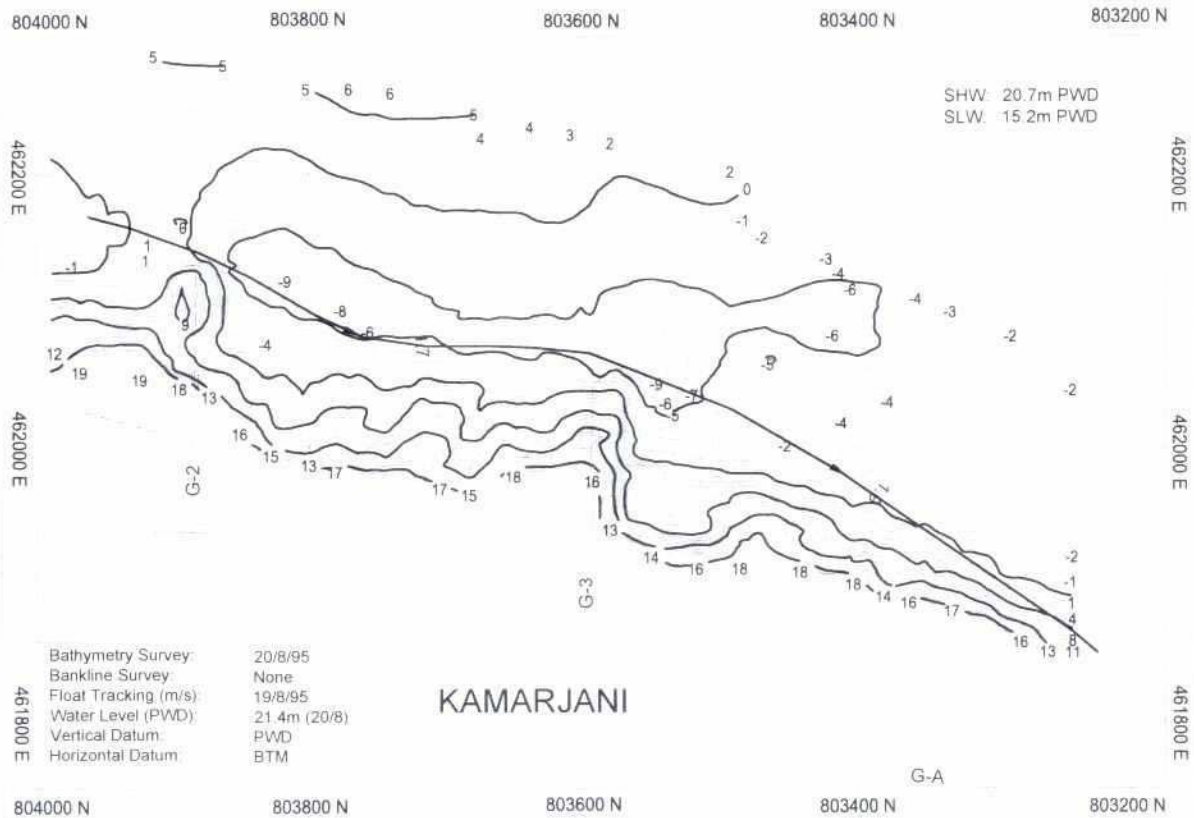
Fig. 5.3-12: Bathymetry and flow at the test site area on August 20, 1995

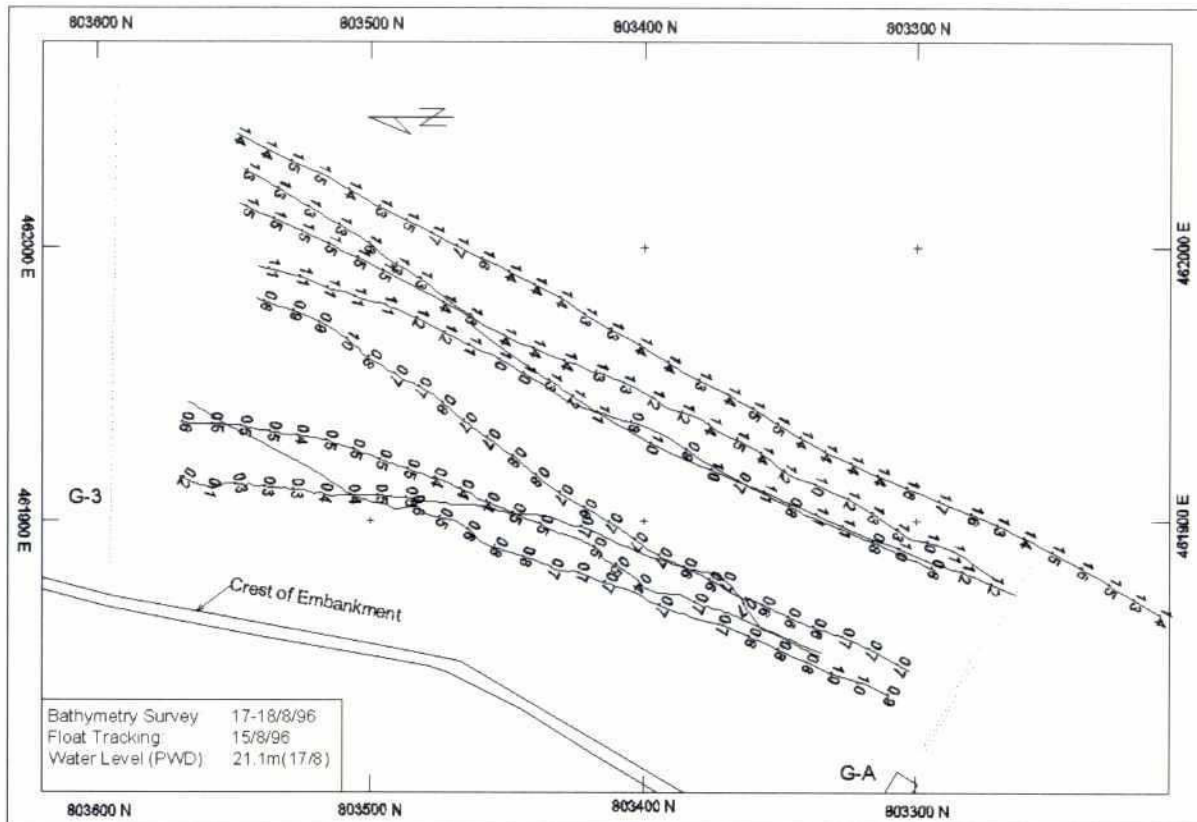
Fig. 5.3-25: Float tracking d/s of G-3 in August 1996

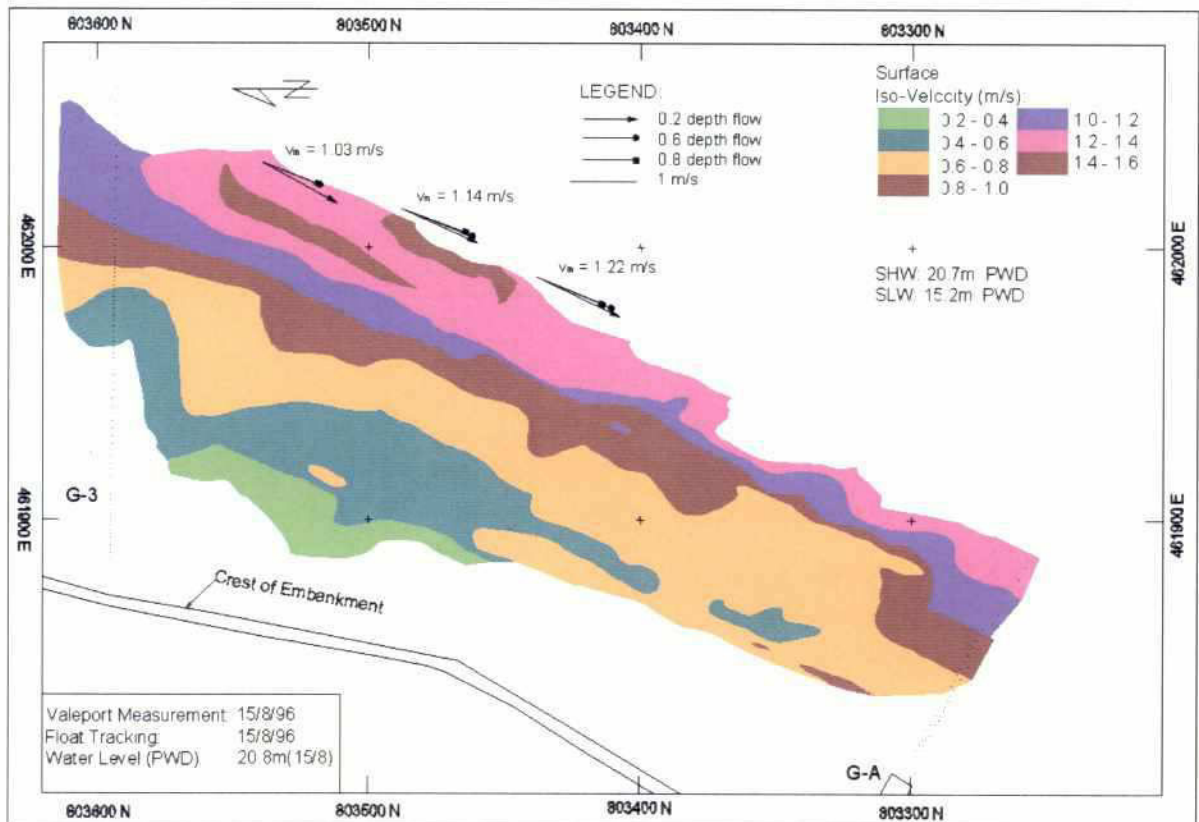
Fig. 5.3-26: Iso-velocities evaluated from float tracks in August 1996

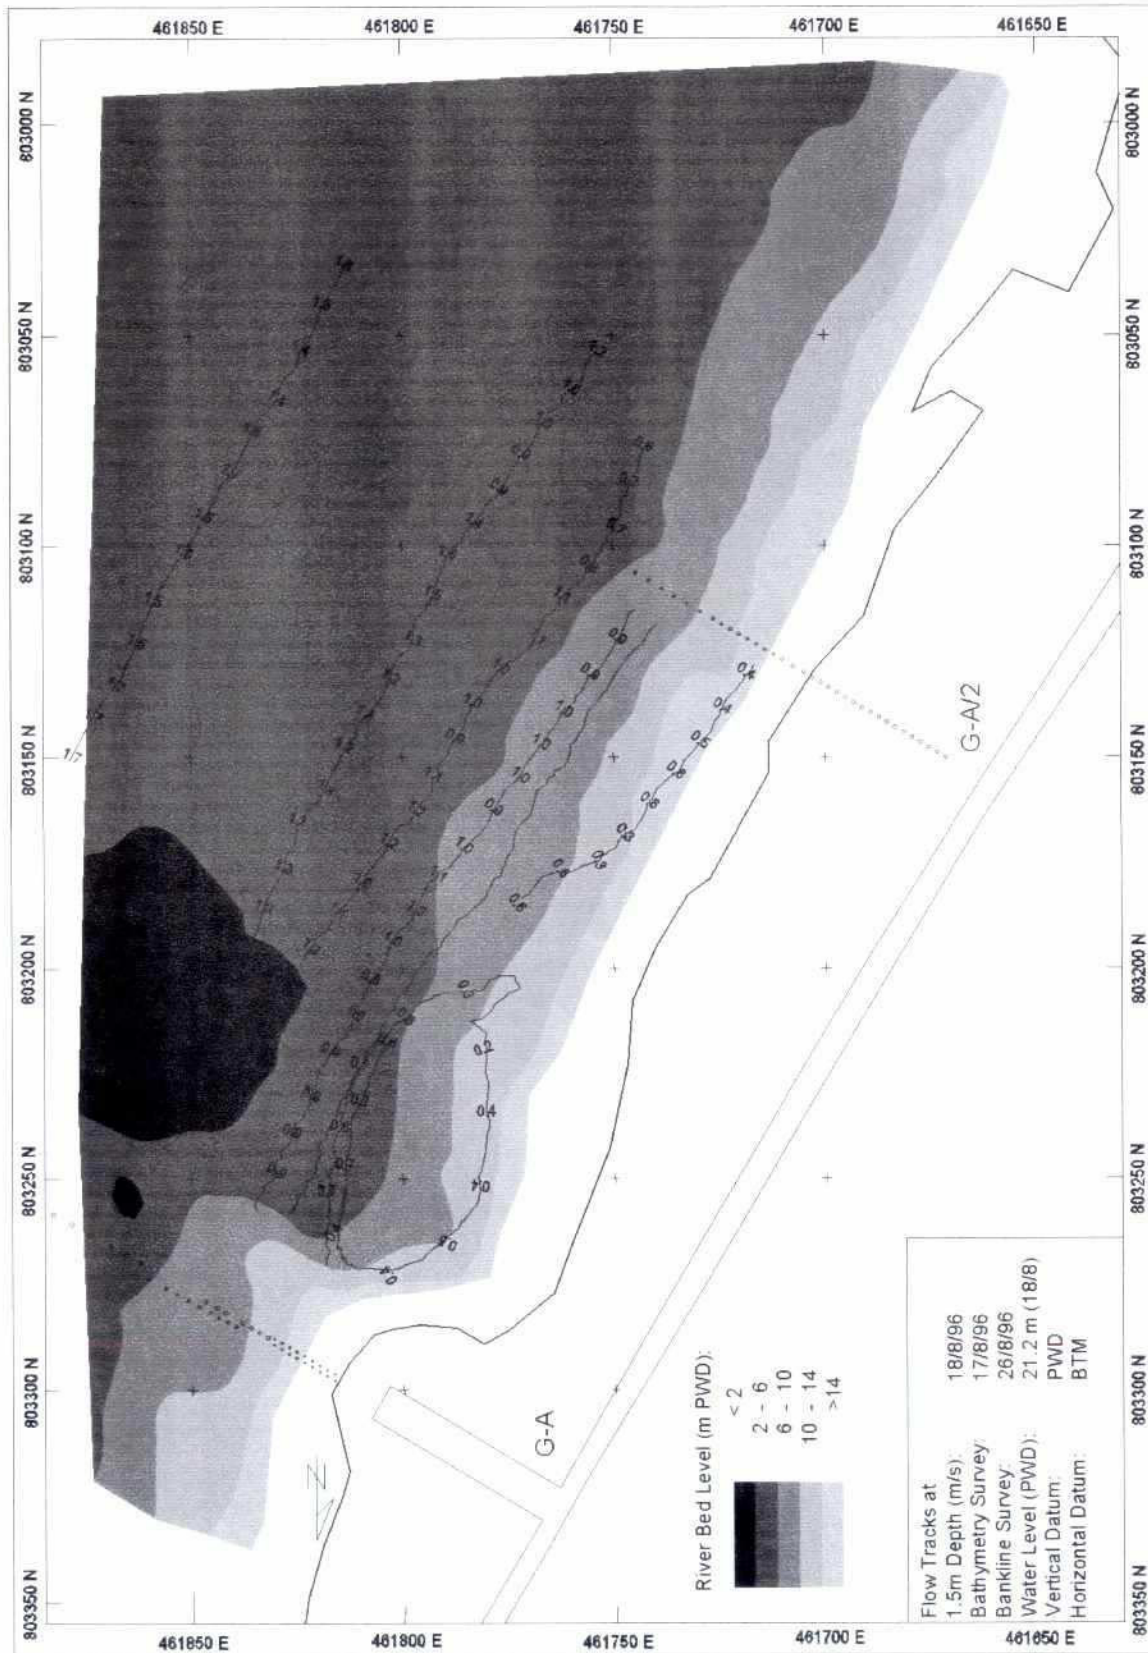
Fig. 5.3-27: Flow pattern d/s from G-A in August 1996

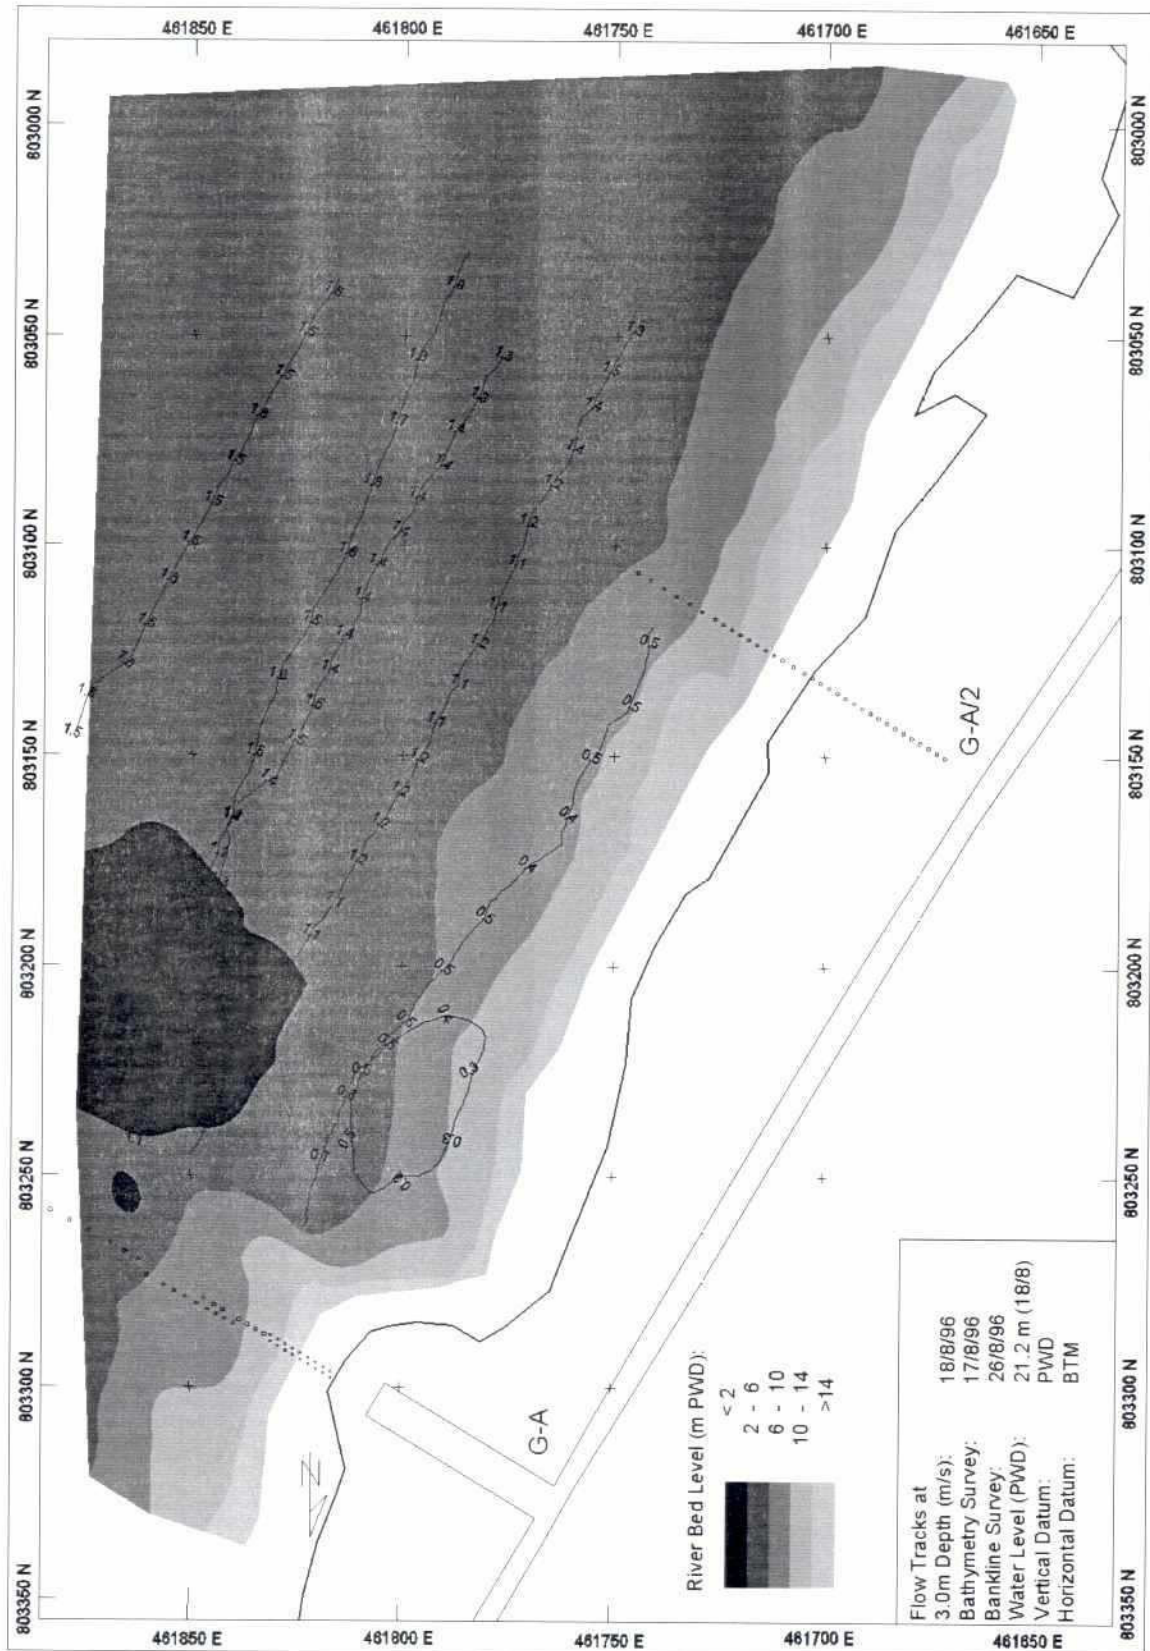
Fig. 5.3-28: Flow pattern d/s from G-A in August 1996

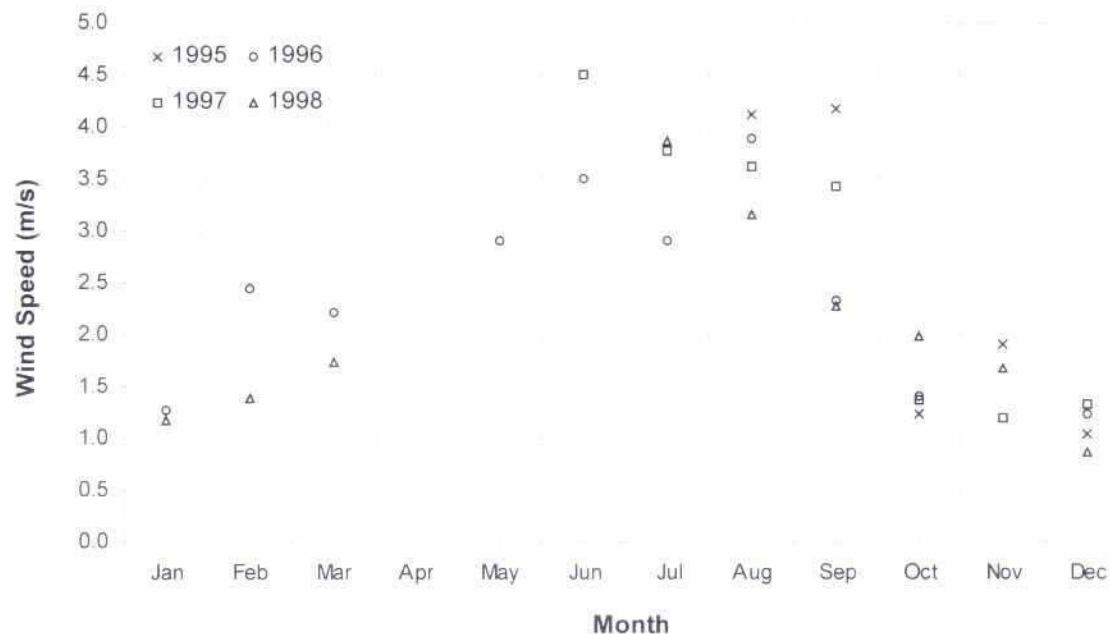
The monitoring station (see Section 3.6) recorded wind and wave data every 10 minutes. The monthly mean wind speed is presented in Fig. 6.2-1. If sufficient data has been available, the monthly average wind has been calculated for this analysis. During the monsoon seasons from 1995 to 1998 higher wind speed has been recorded than during the other months.

Fig. 6.2-1: The Groyne Test Structure
Monthly mean wind speed measured at G-2

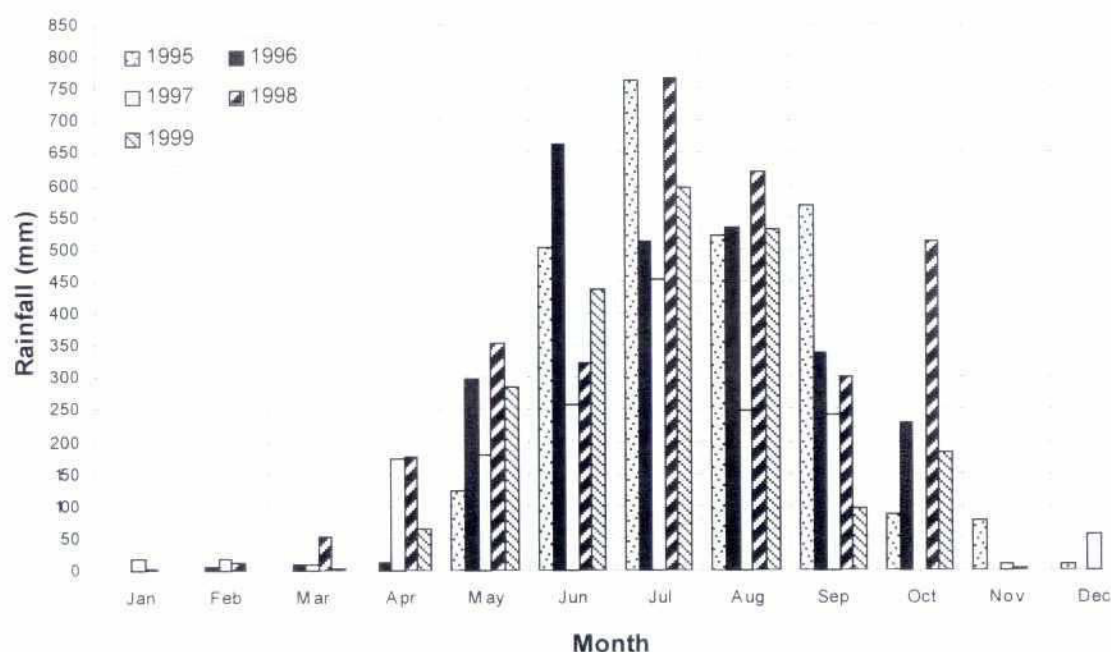
Fig. 6.3-1: The Groyne Test Structure
Comparison of monthly rainfall

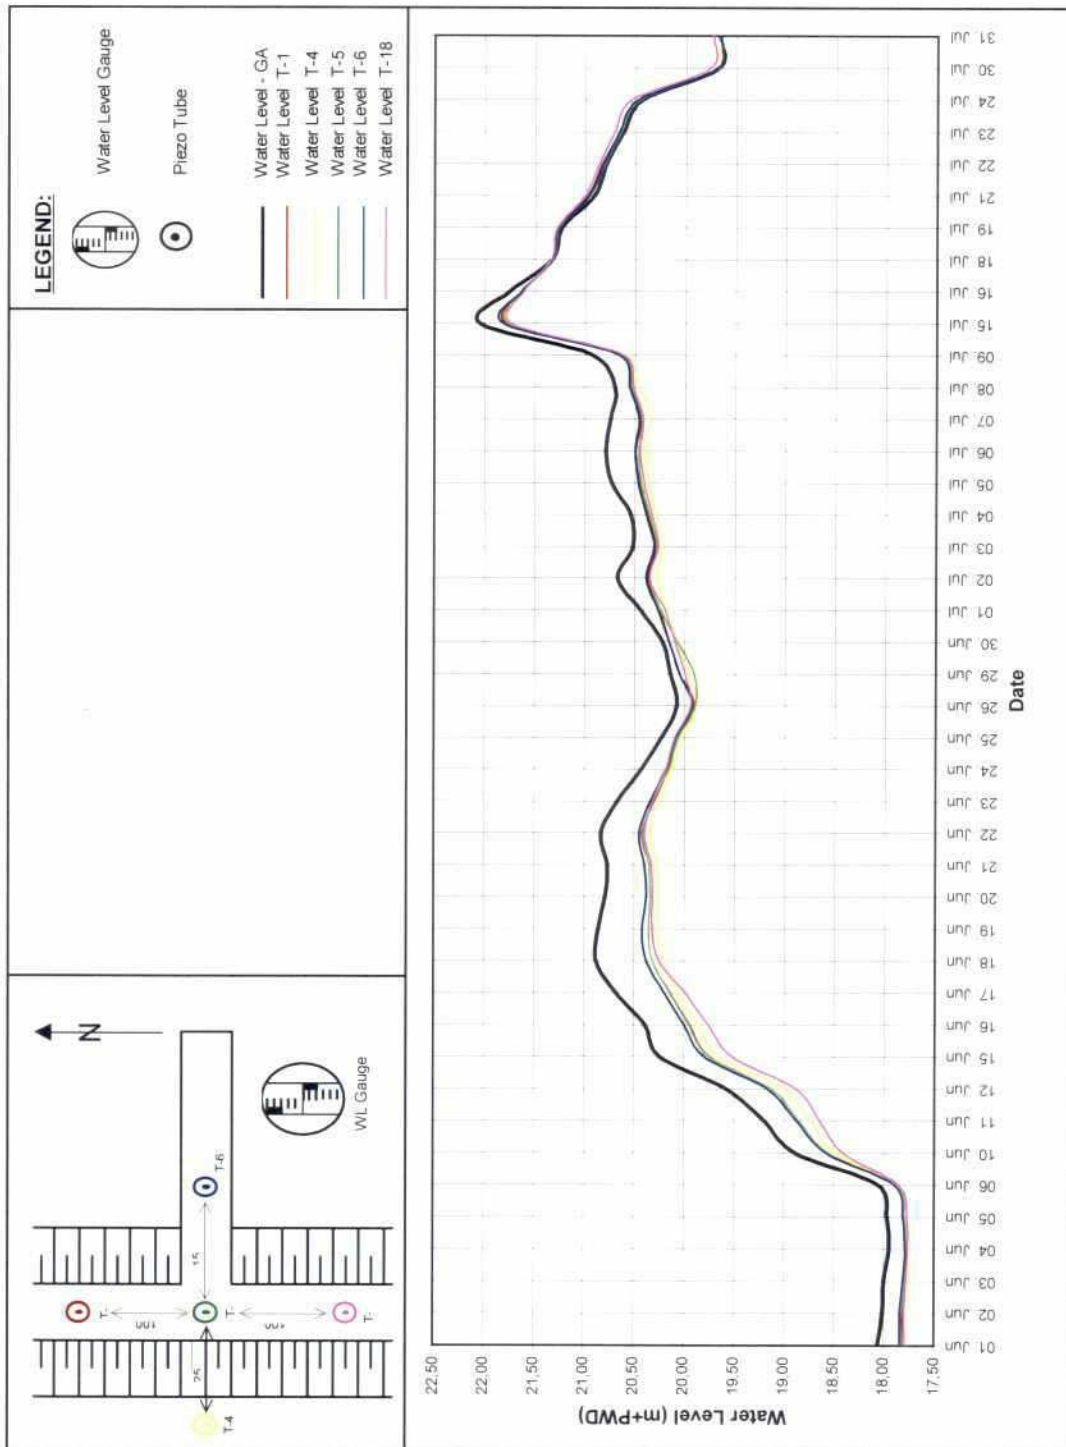
Piezometer tubes were installed surrounding the embankment at G-A. Measurements were made from July 1996 onwards. A comparison of the groundwater level with the surface water level of June to July 1997 is given in Fig. 6.5-1.

Fig. 6.5-1: Ground water and surface water level at G-A, June to July 1997

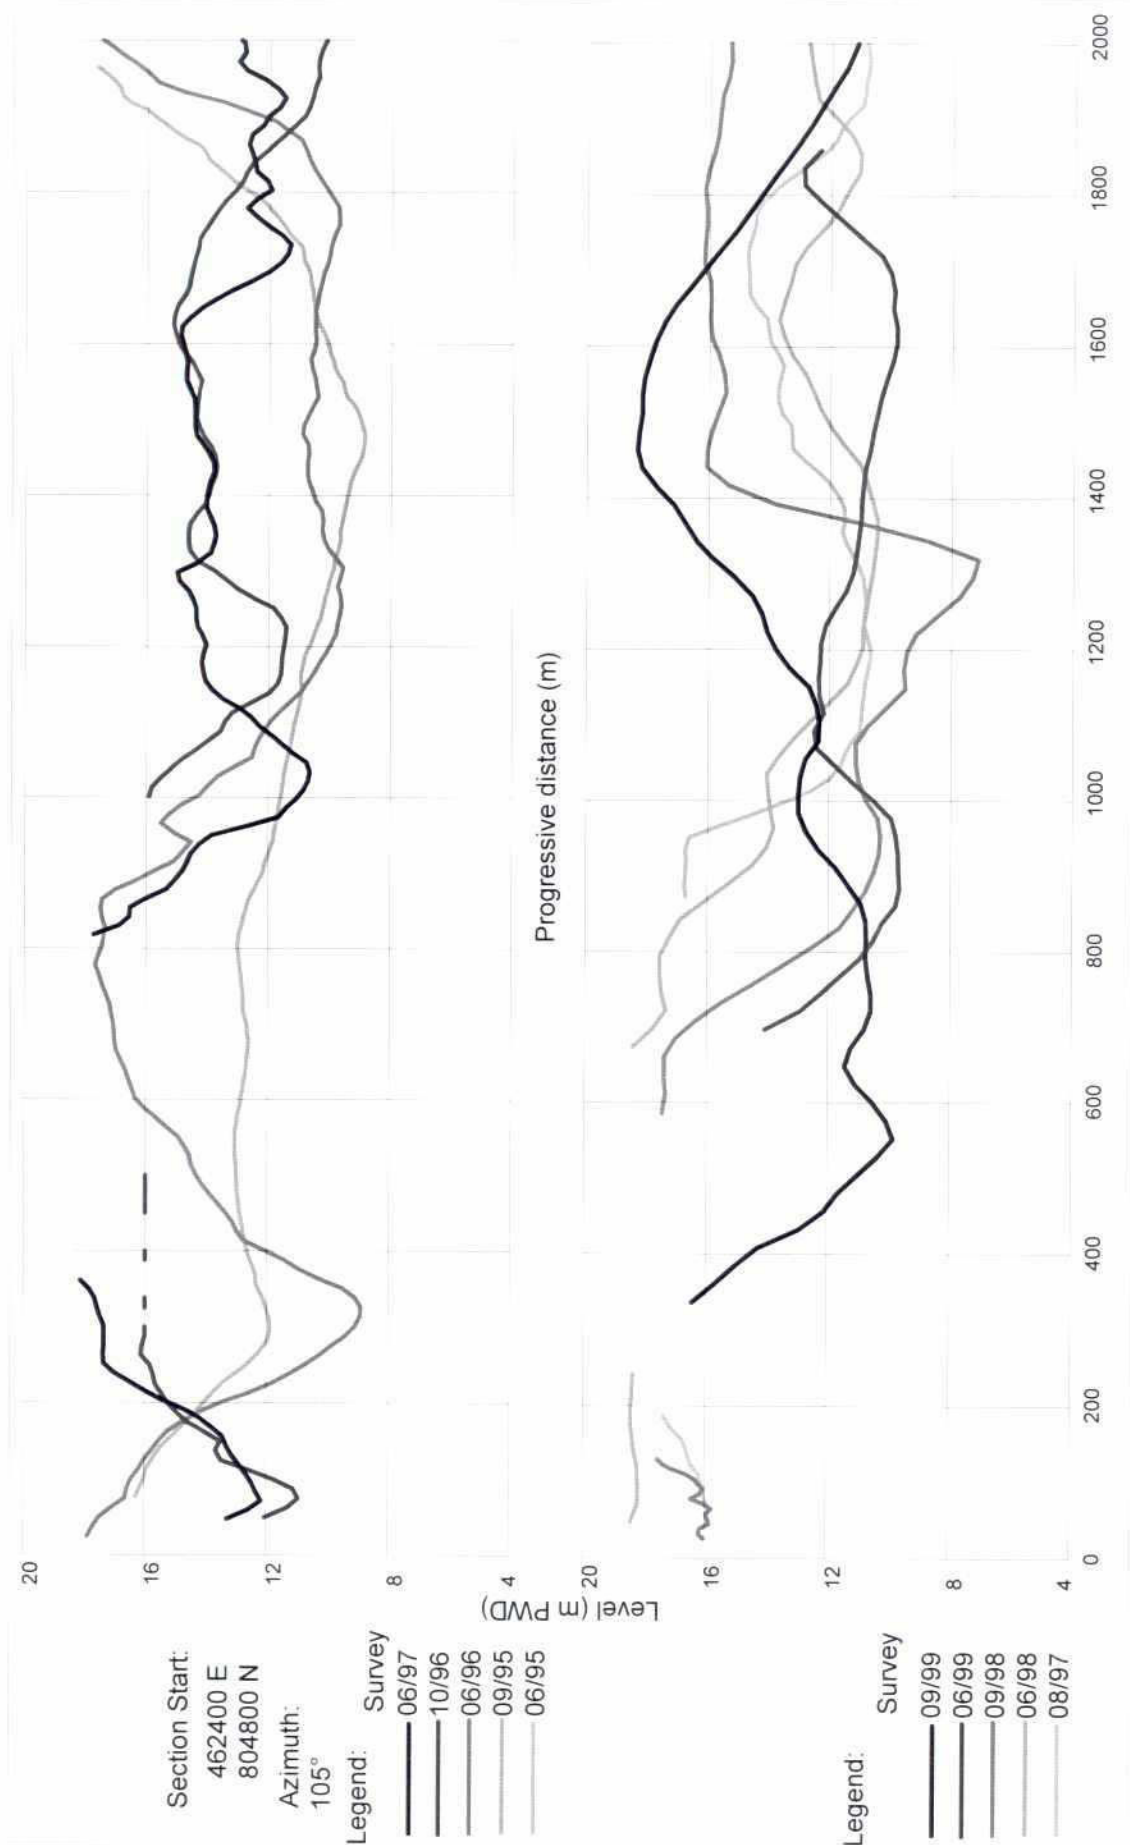
The cross sections upstream from G-B/2 (Fig. 7.2-1) show a similar channel development as at groyne G-2. No bank erosion has taken place at this place.

Fig. 7.2-1: Cross-section Kamarjani channel starting from 150 m upstream of G-B/2

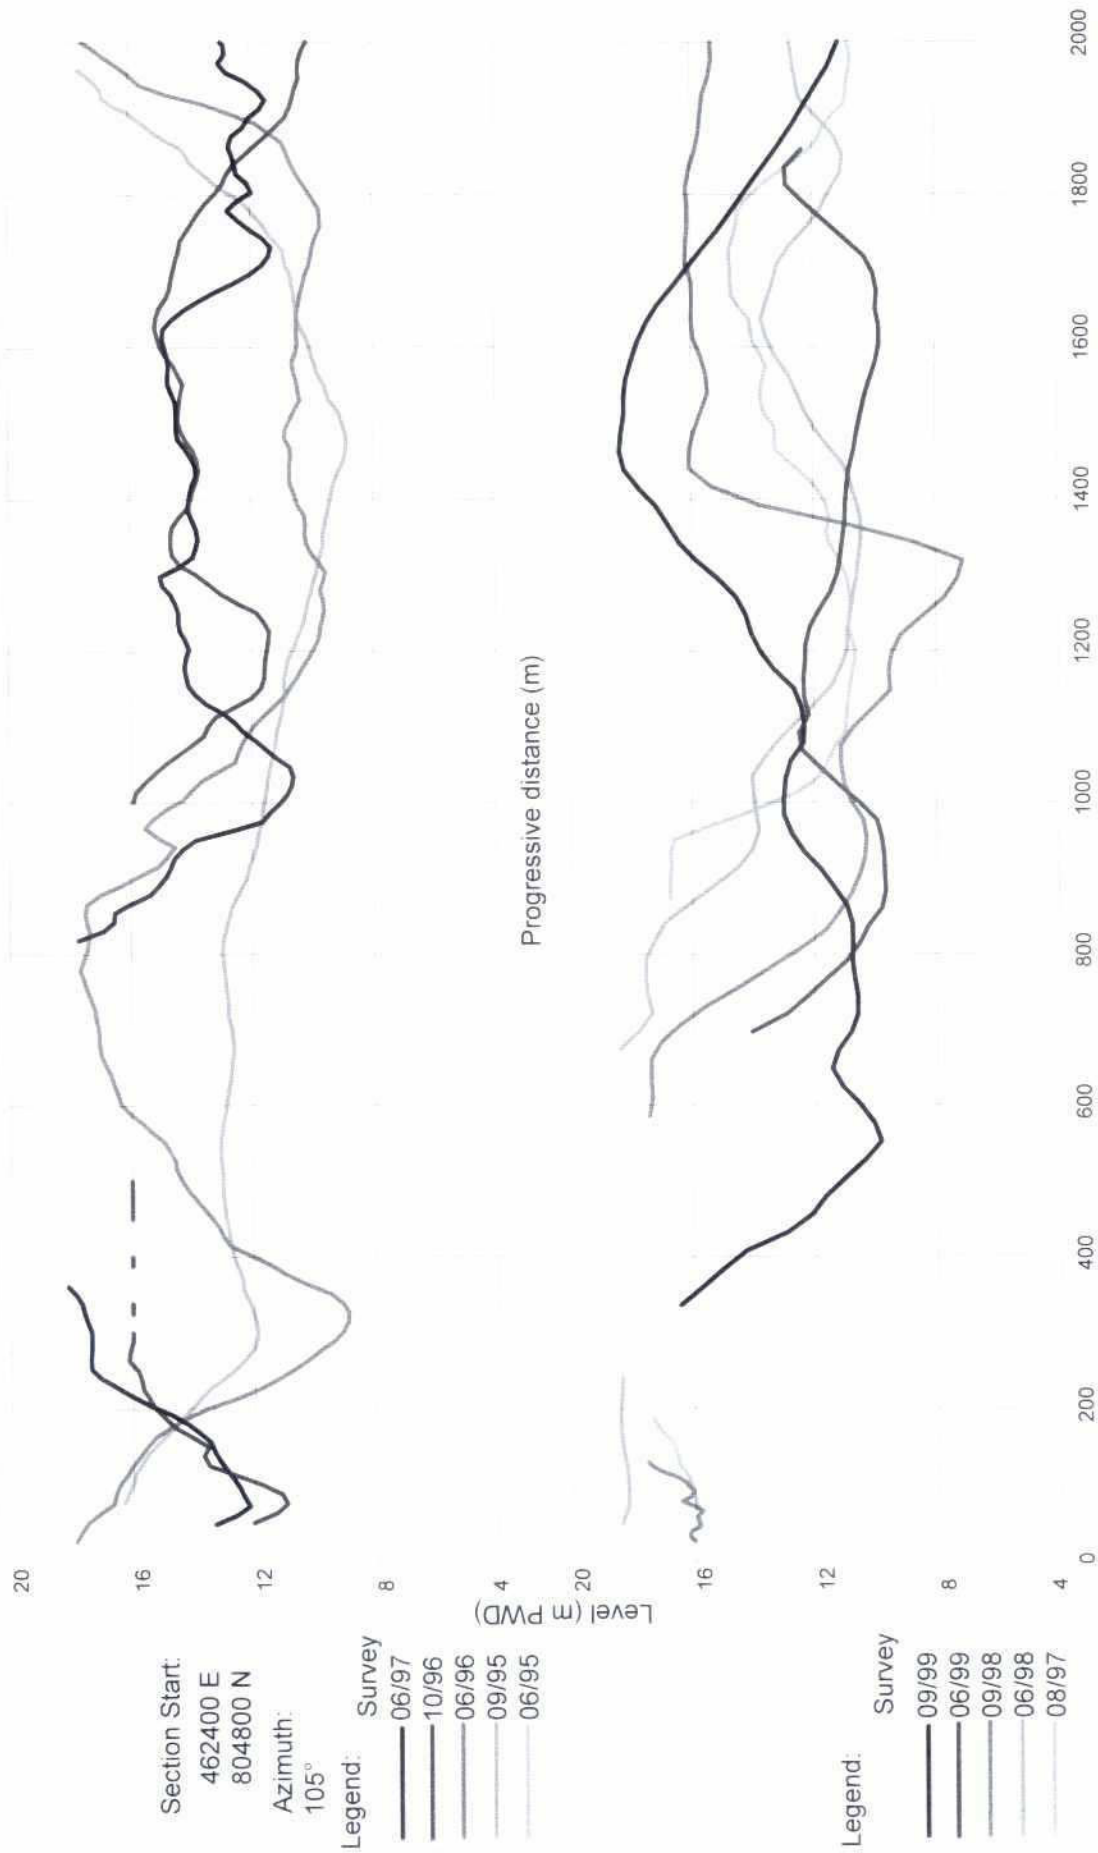
Fig. 7.2-2: Cross-section Kamarjani channel starting from G-2

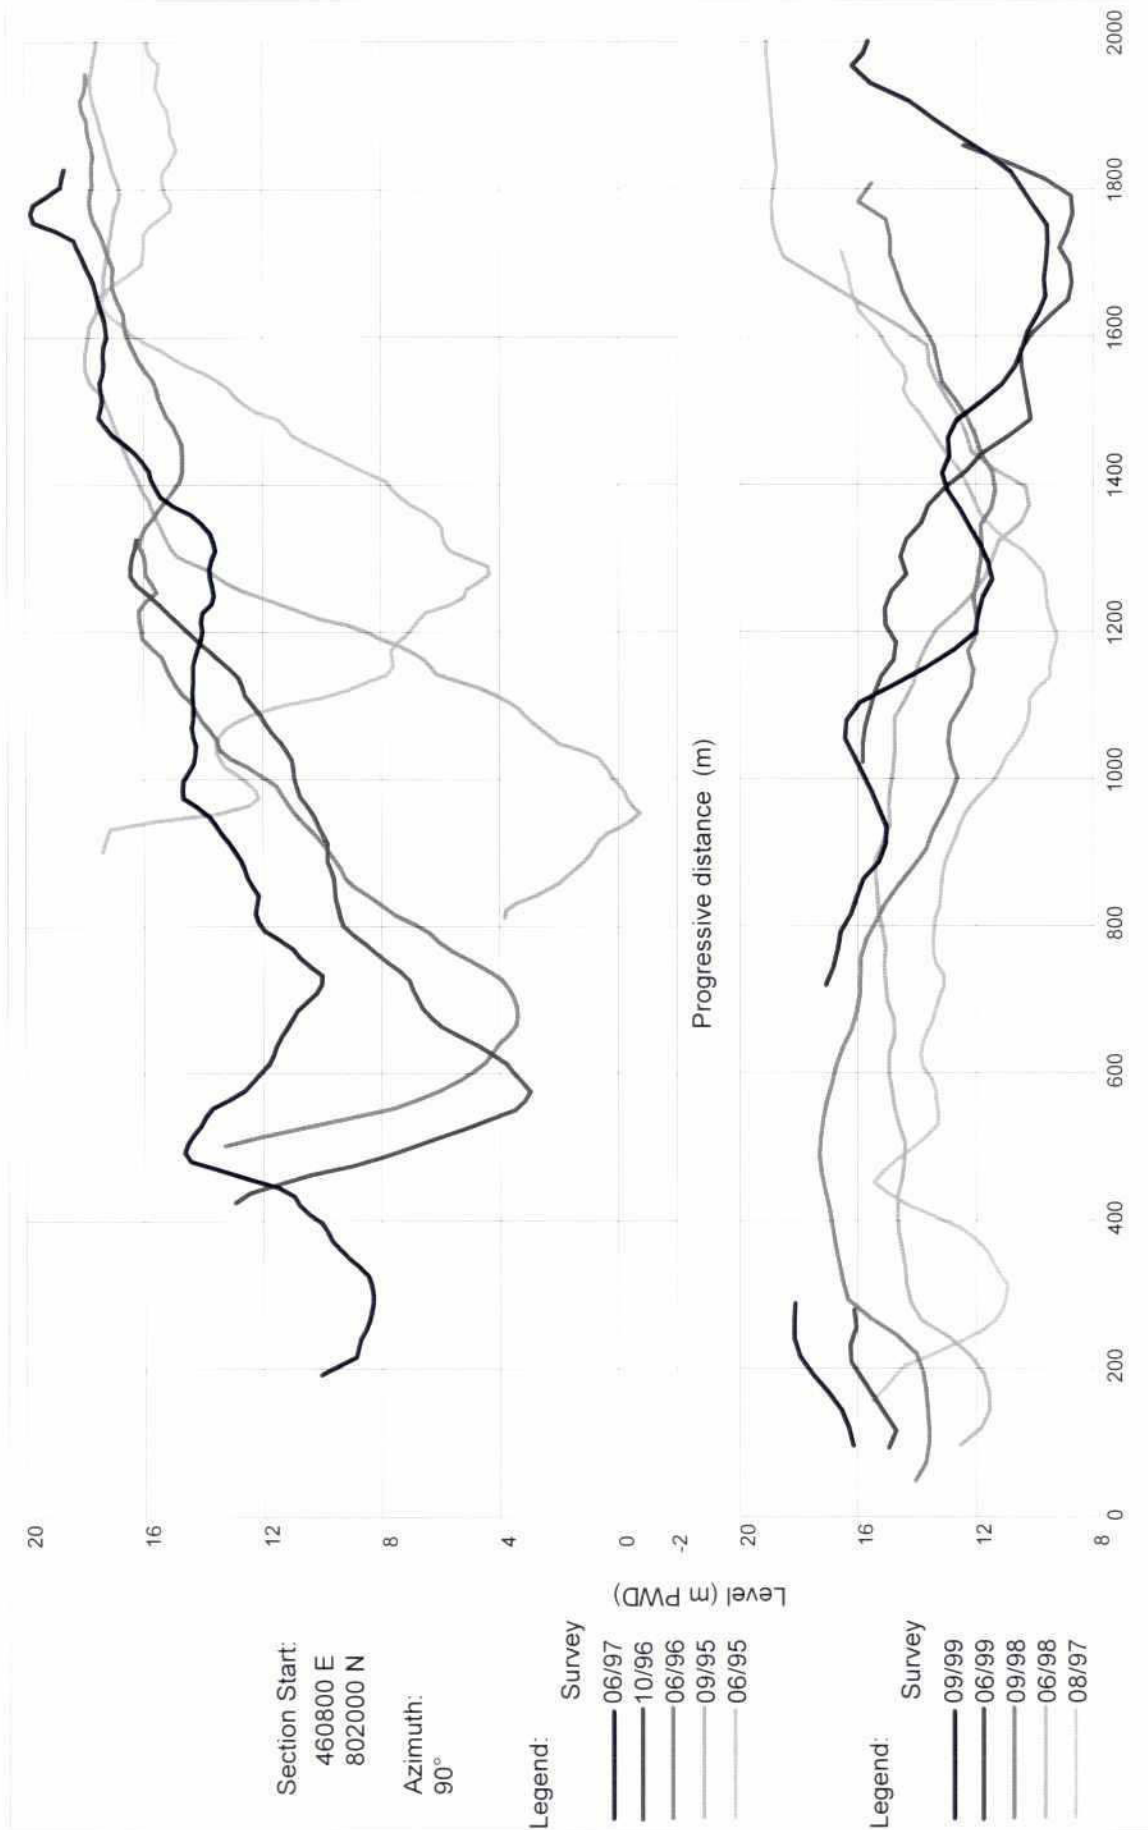
Fig. 7.2-3: Cross-section Kamarjani channel starting from Syedpur

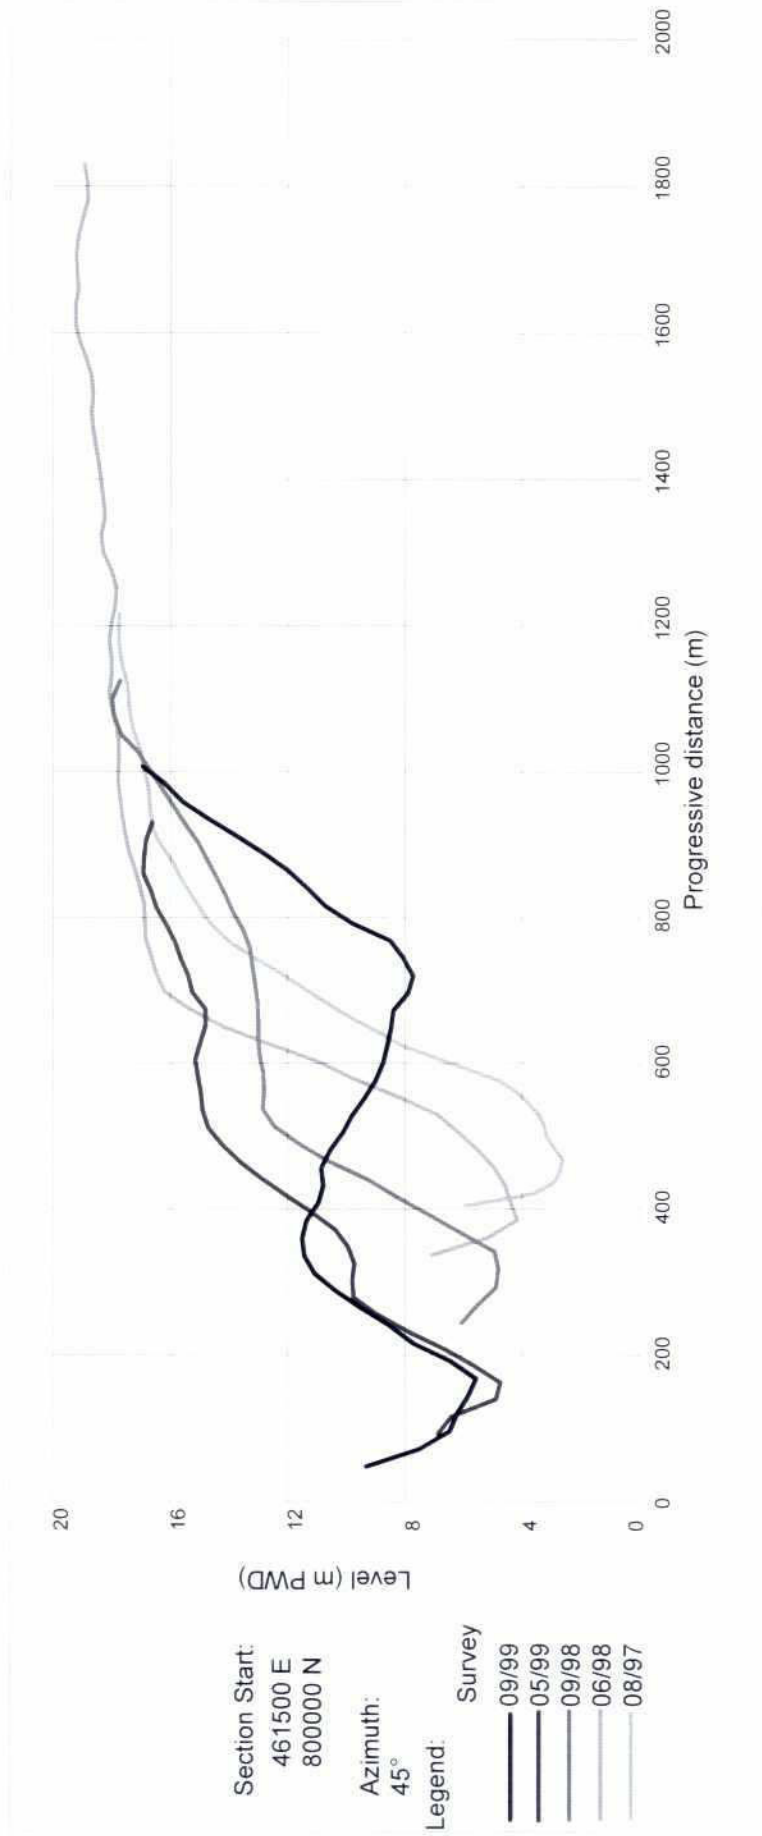
Fig. 7.2-4: Cross-section Kamarjani channel starting from Rasulpur

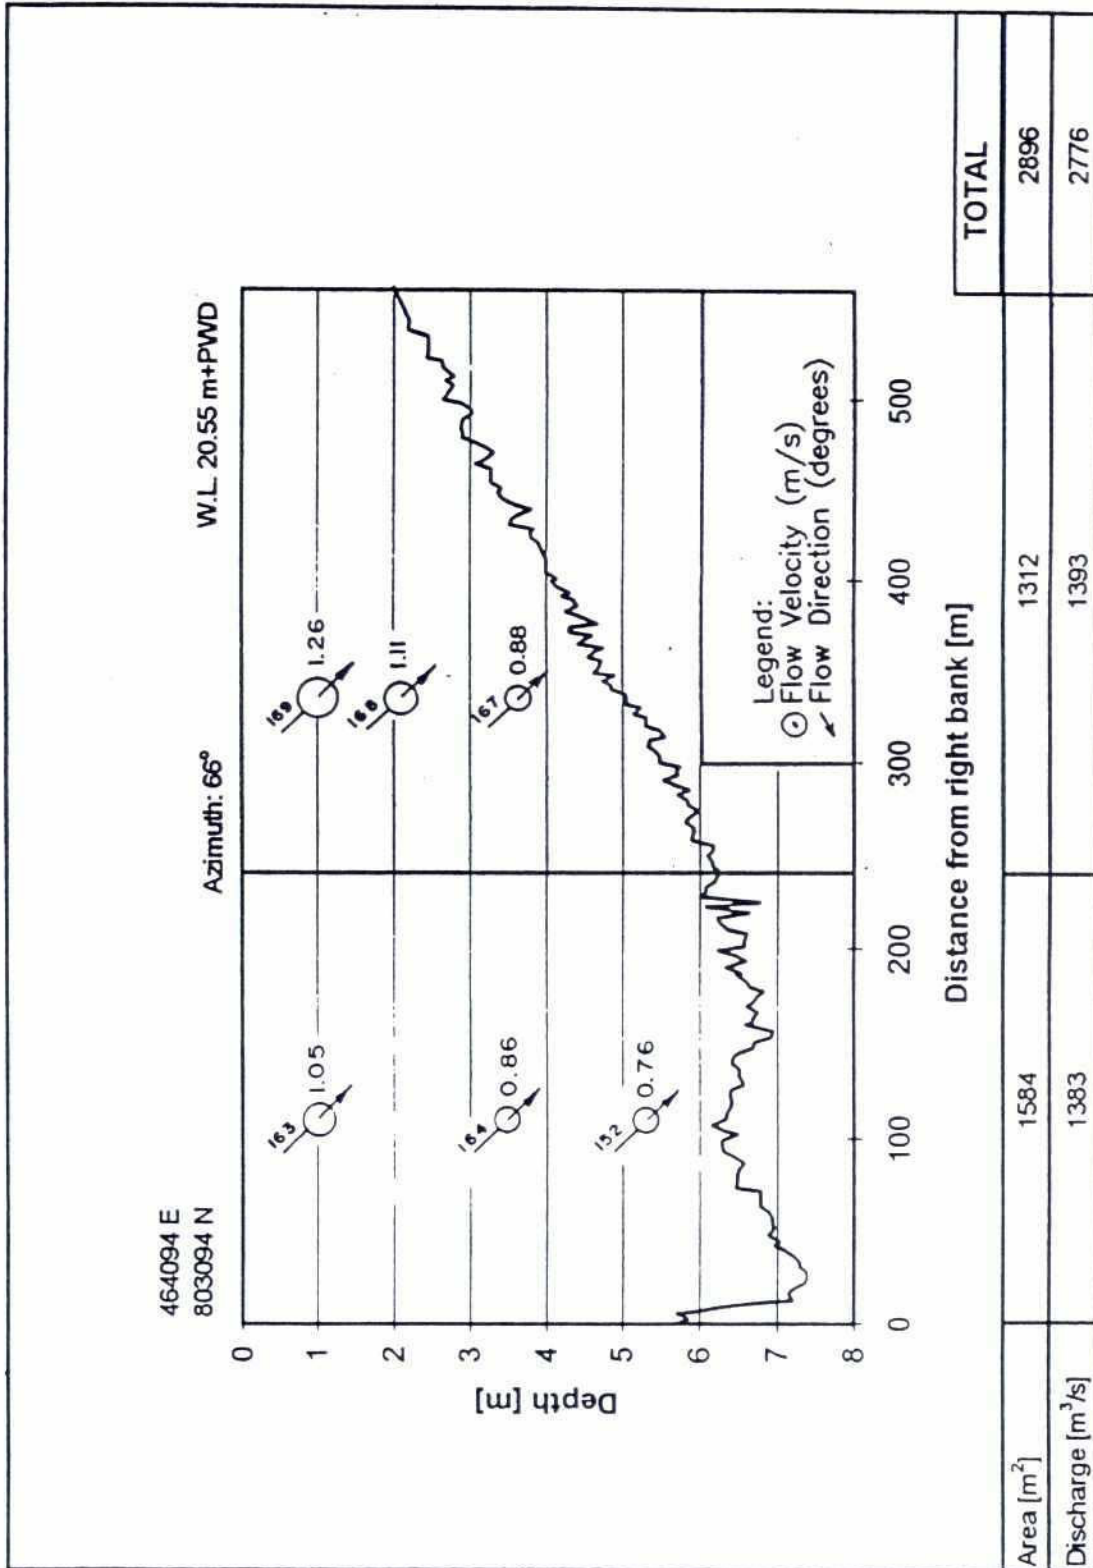
Fig. 7.3-1: Discharge measurement Kundarapara channel on August 19, 1997
