**BANK PROTECTION AND
RIVER TRAINING (AFPM)
PILOT PROJECT
FAP 21/22**

**FINAL PROJECT
EVALUATION REPORT**

**Annex 6: The Groyne Test Structure;
Monitoring Report**

**Annex 7: The Groyne Test Structure;
Evaluation of Hydraulic
Loads and River Response**

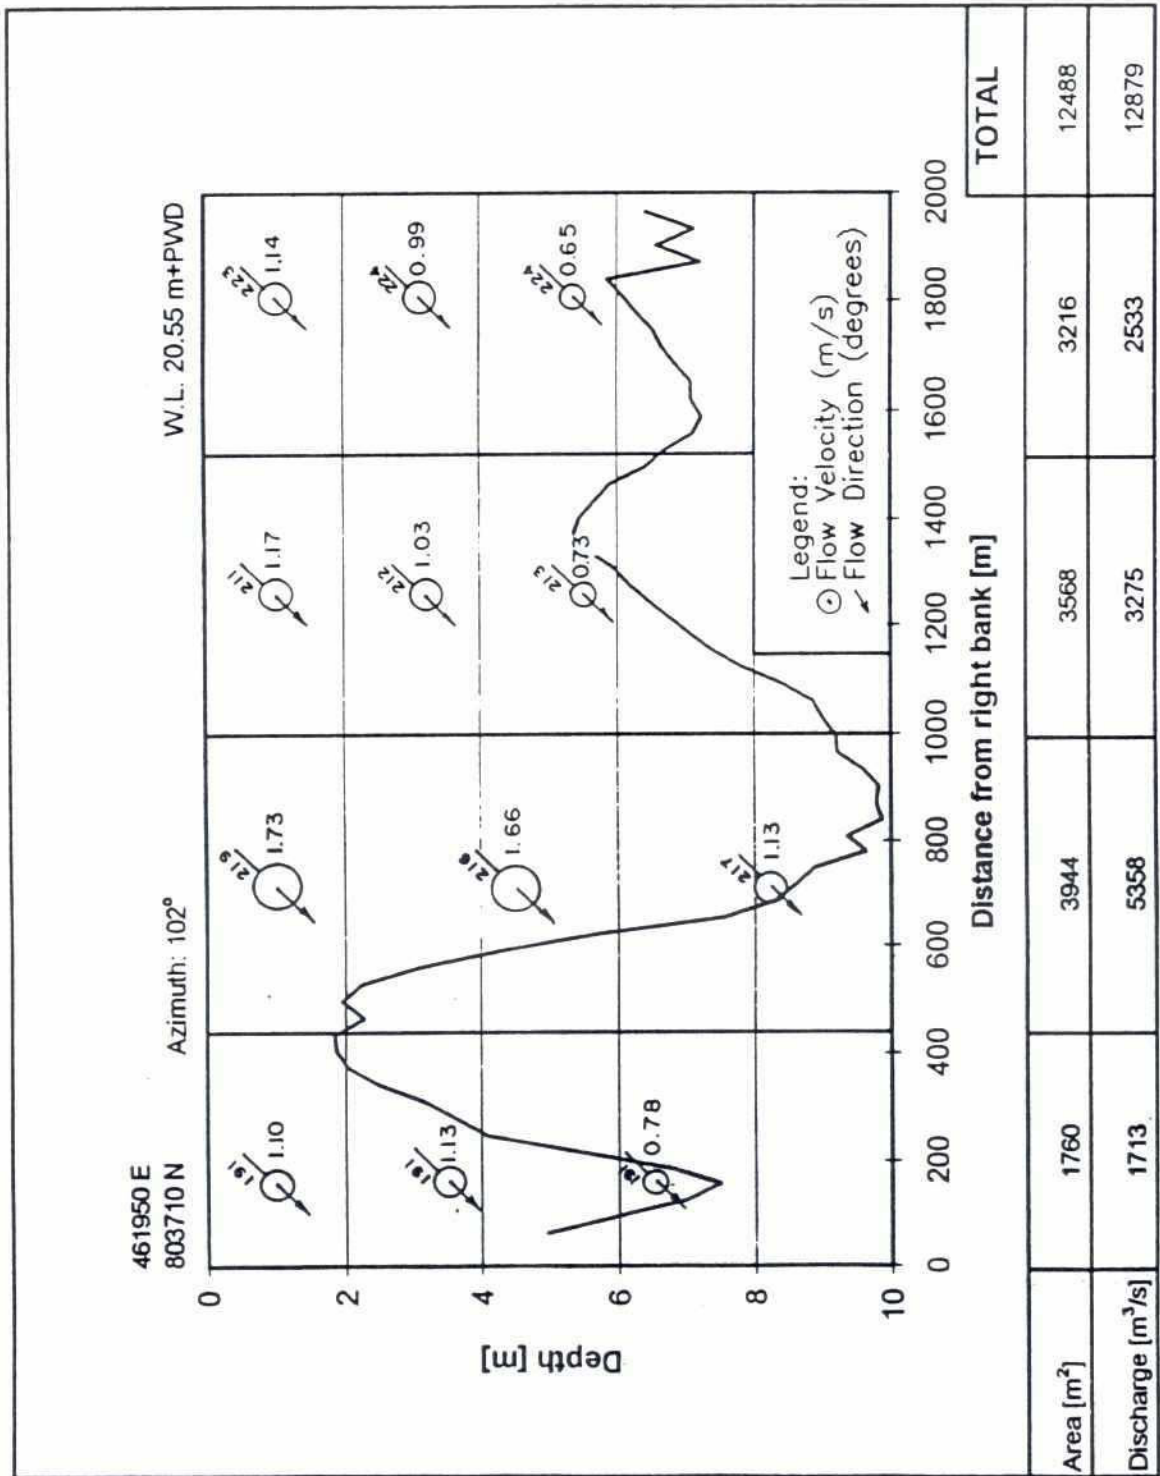
Fig. 7.3-2: Discharge measurement Kamarjani channel on August 19, 1997

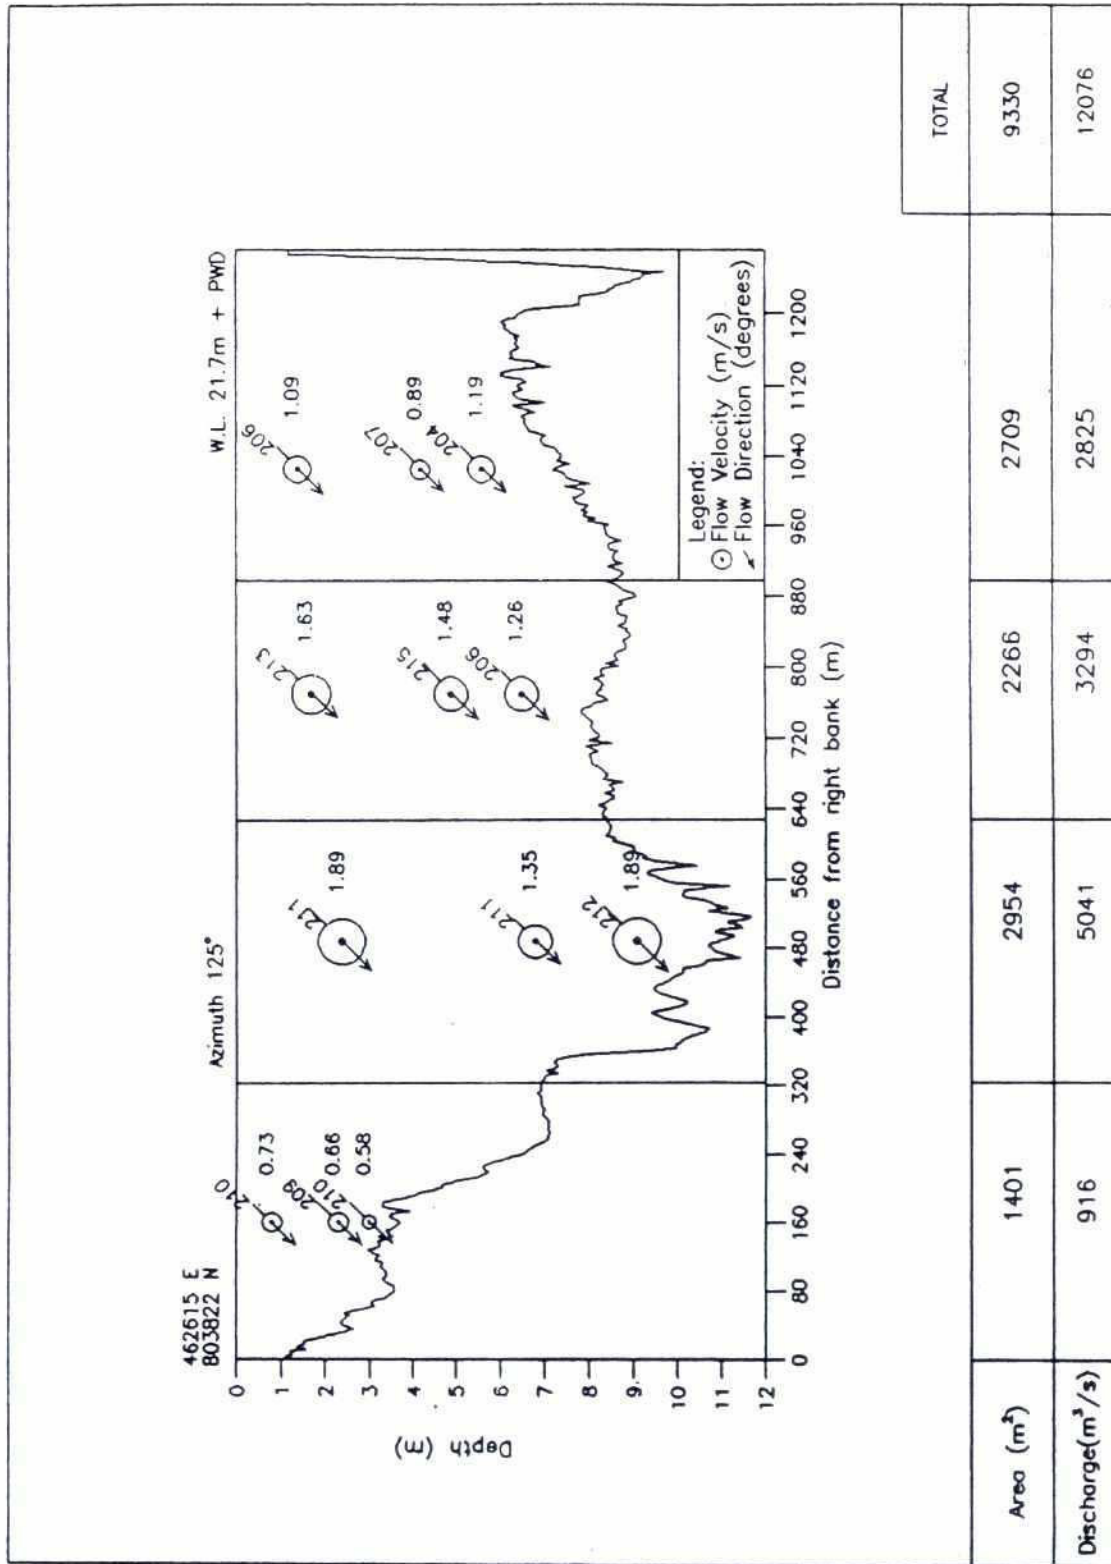
Fig. 7.3-3: Discharge measurement Kamarjani channel on July 31, 1998

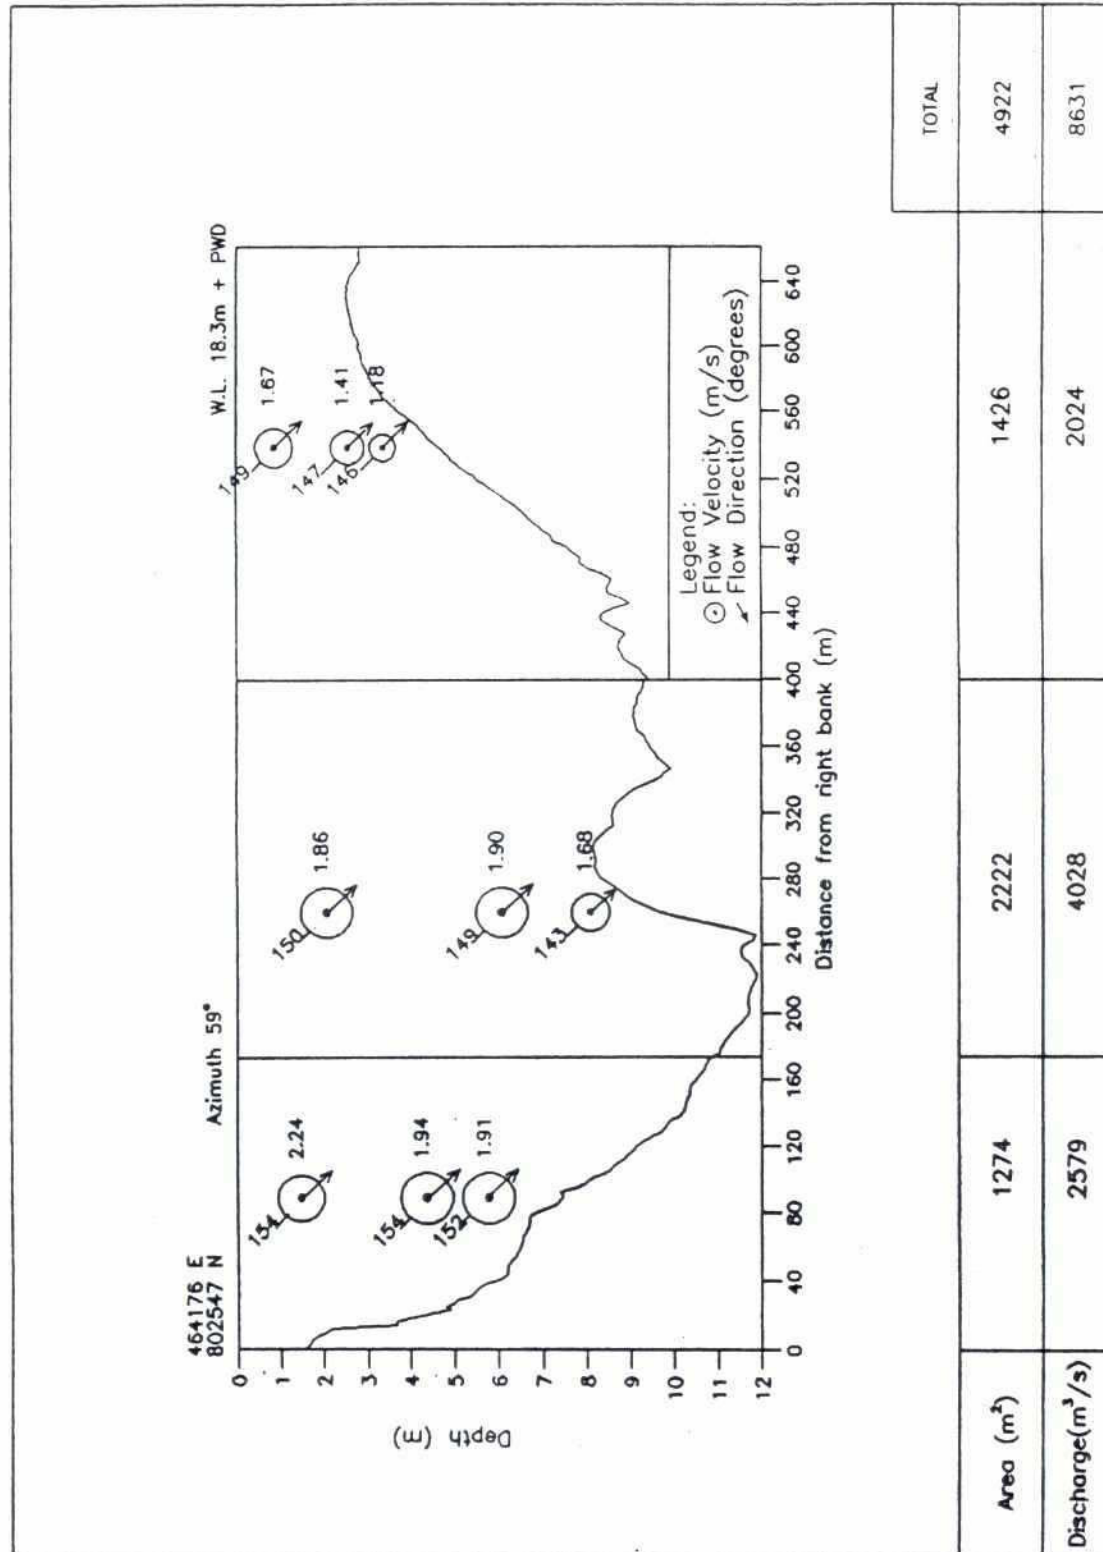
Fig. 7.3-4: Discharge measurement Kundarapara channel on July 31, 1998

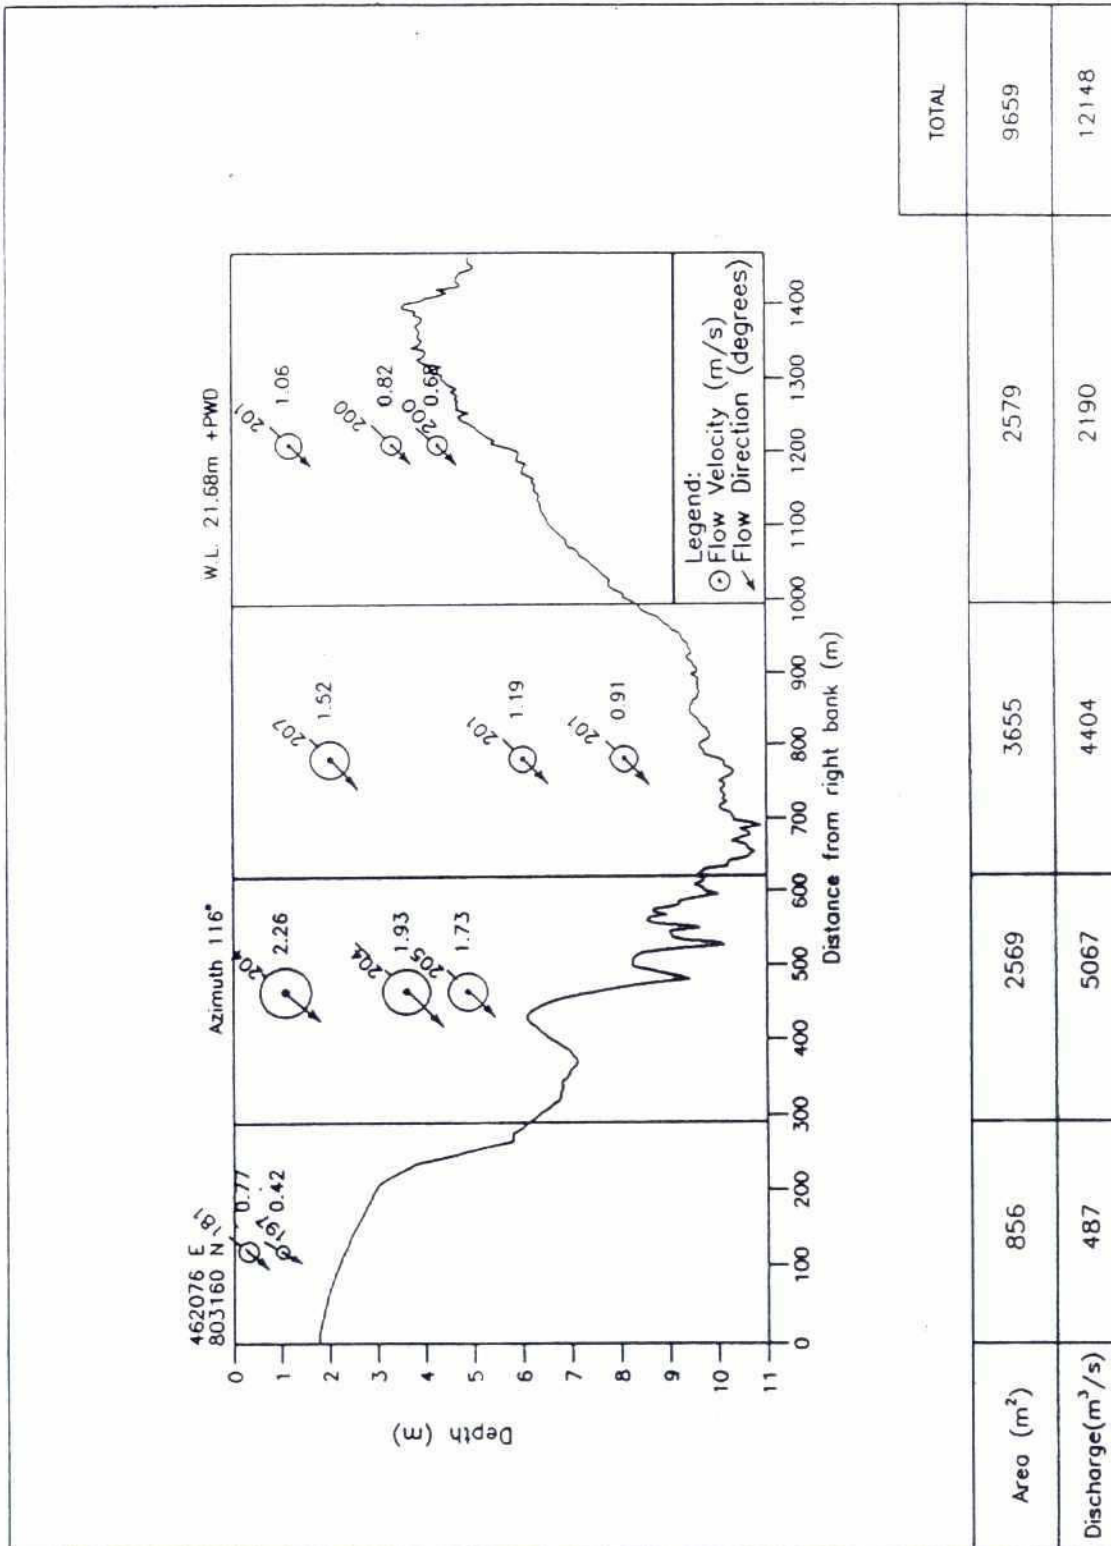
Fig. 7.3-5: Discharge measurement Kamarjani channel on August 26, 1999

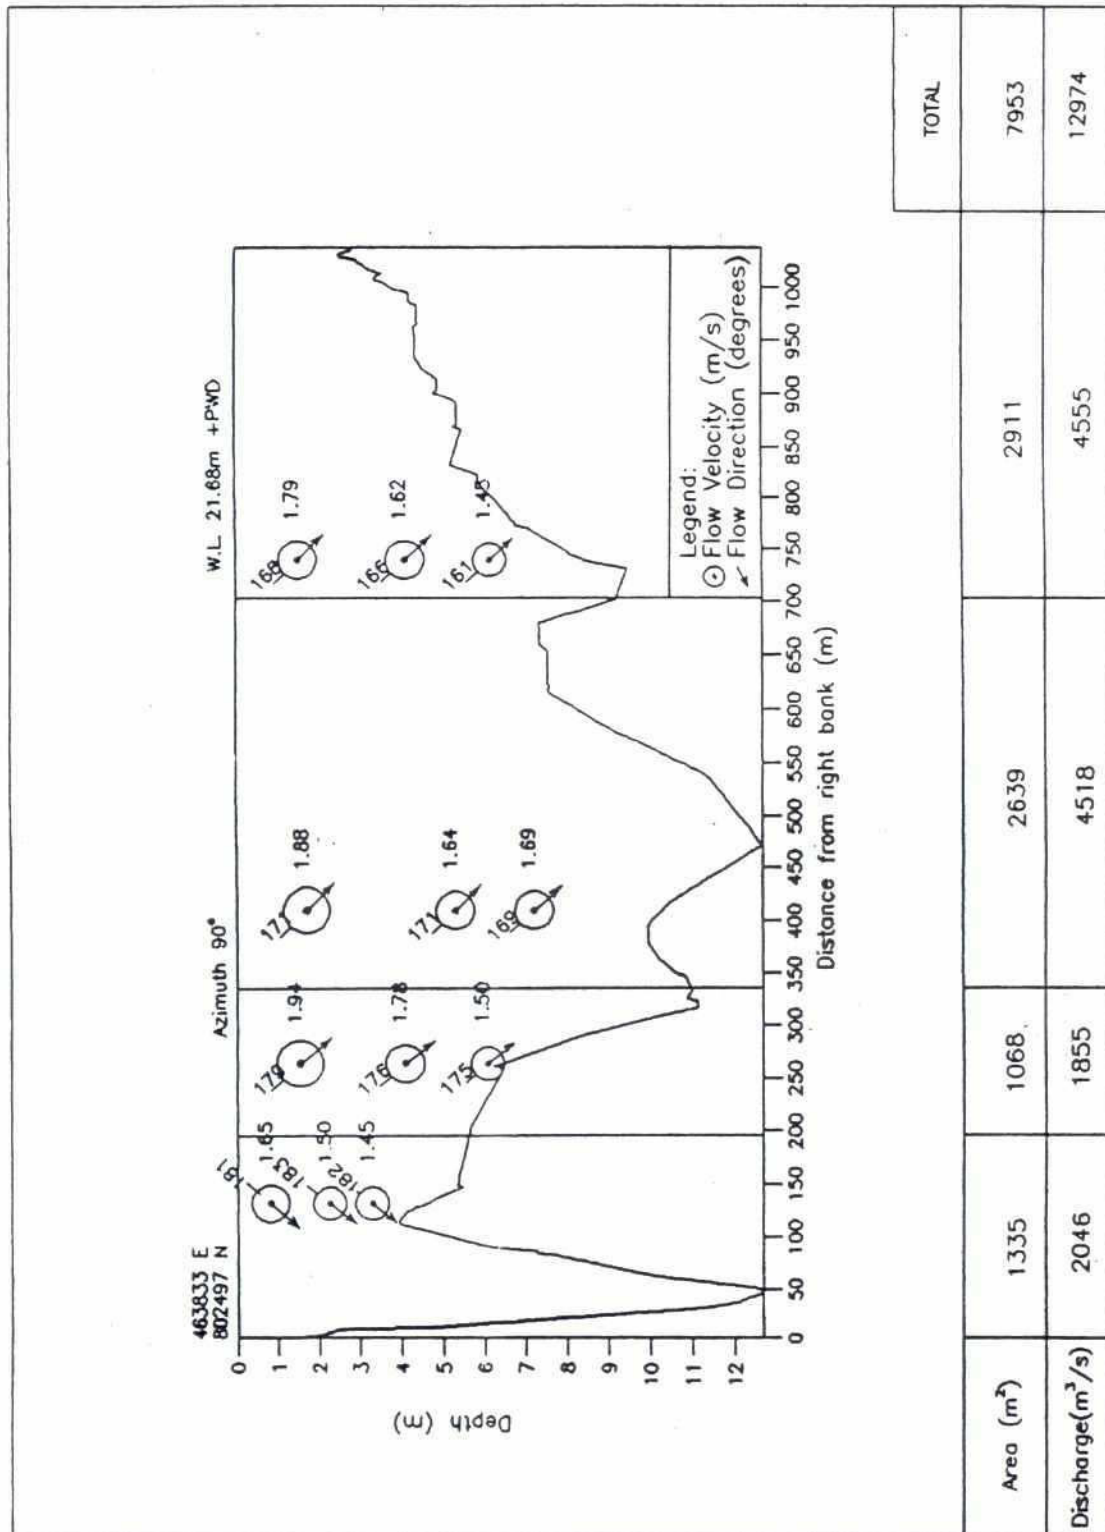
Fig. 7.3-6: Discharge measurement Kunderapara channel on August 26, 1999

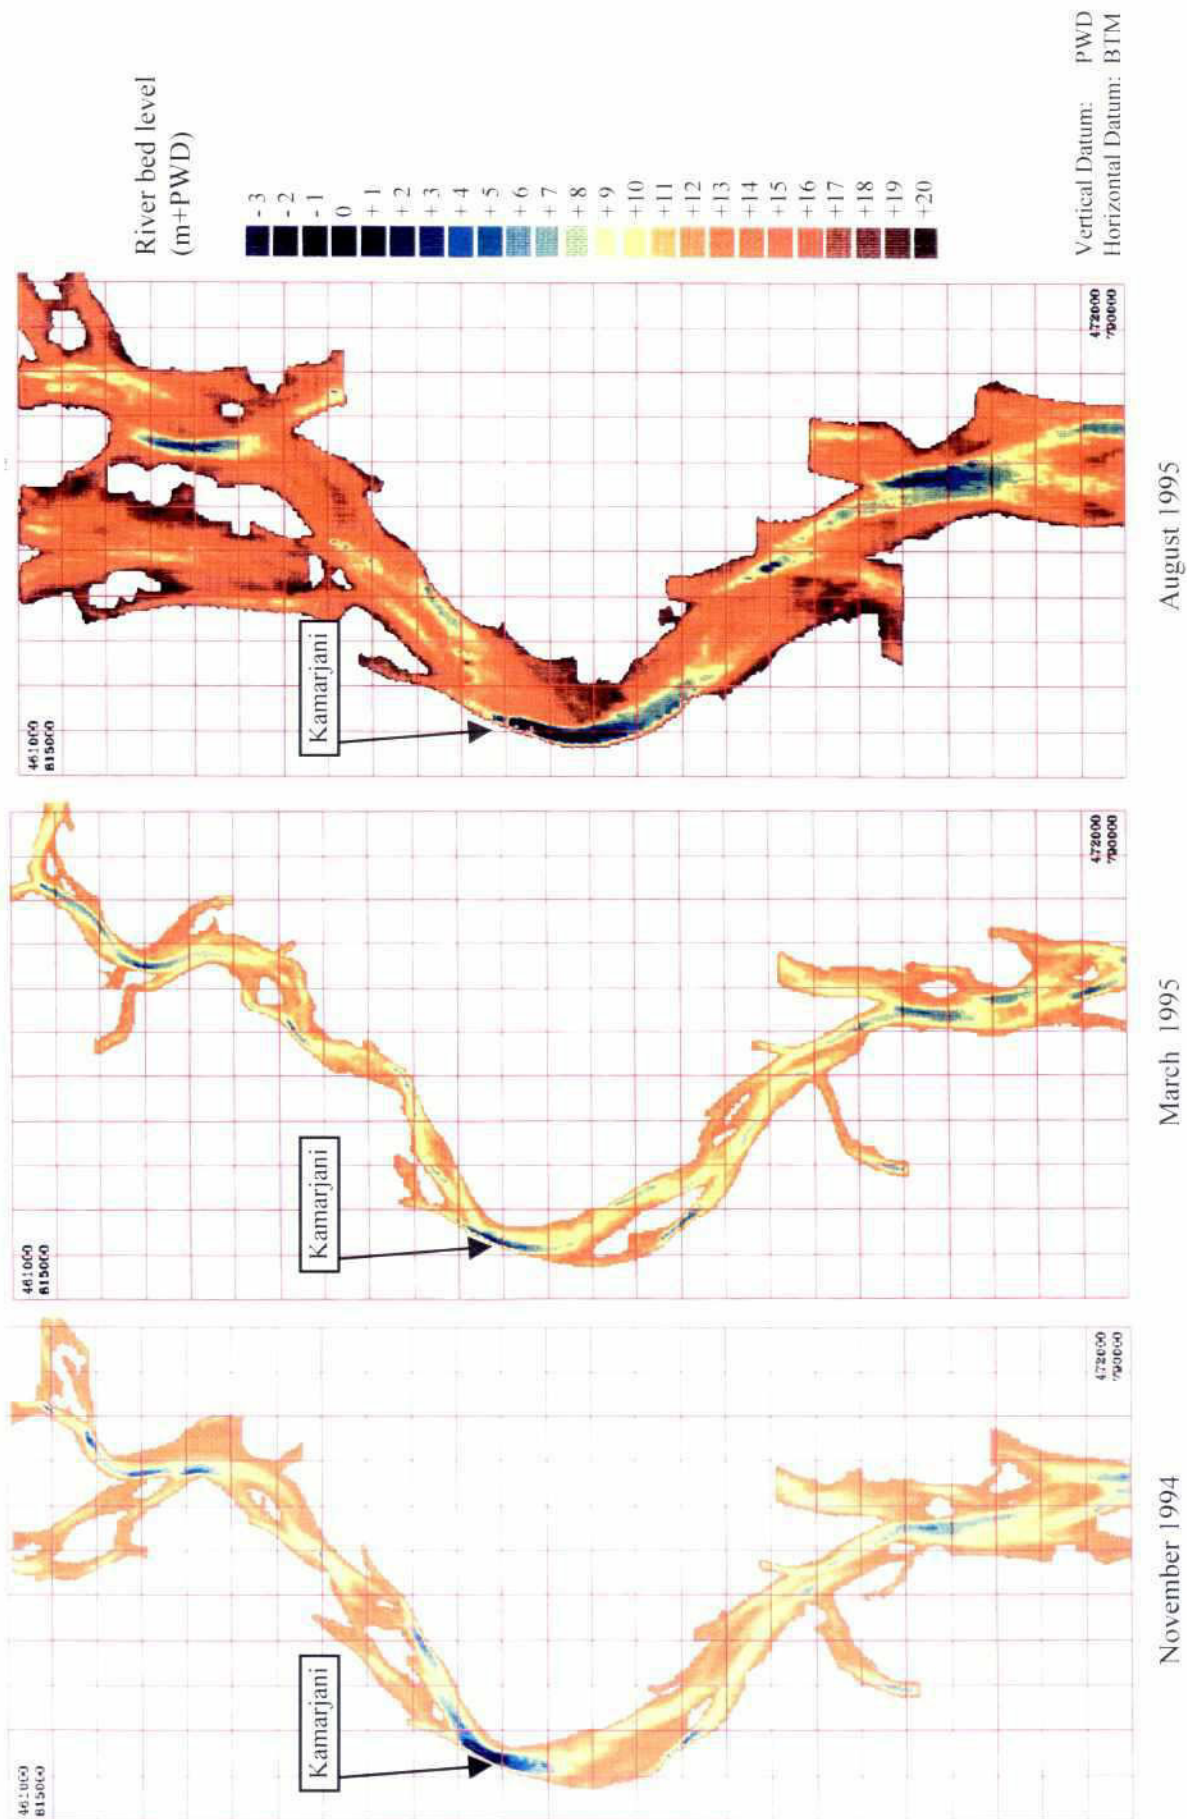
Fig. 4.4-1: Plan view of the Jamuna with bathymetry at Kamarjani
(Surveyed by FAP 24 and processed by EGIS)

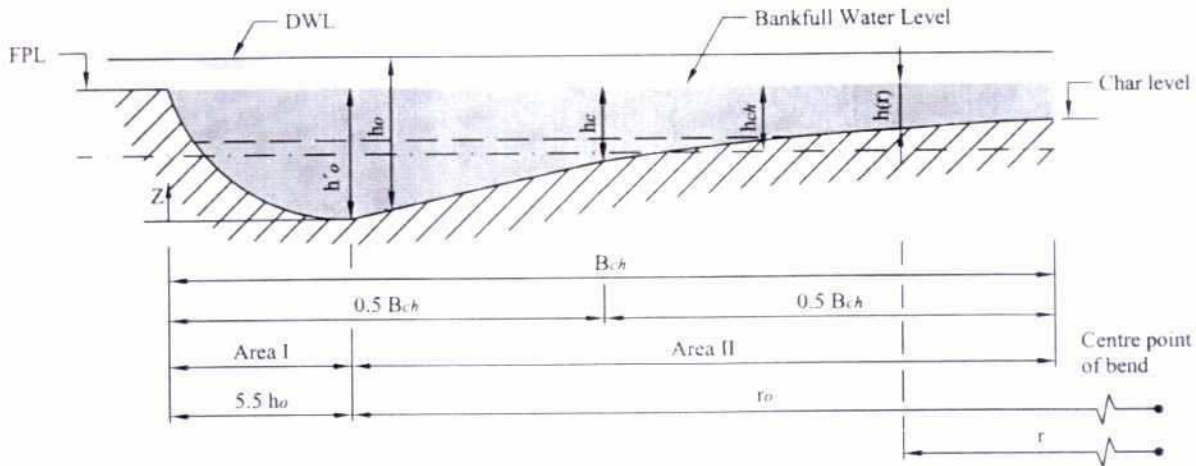
The above parameters determine a simple rectangular cross section of the design channel and serve therefore only as a first approach. For more accurate calculation, the cross-section is separated in two parts: one part with the inner bend profile (area II) and a part with the outer bend profile (area I), see sketch in Fig. 4.4-2. The centre line of the cross section is defined by half the width B_{ch} .

Fig. 4.4-2: Sketch of a cross-section of an axi-symmetrical bend

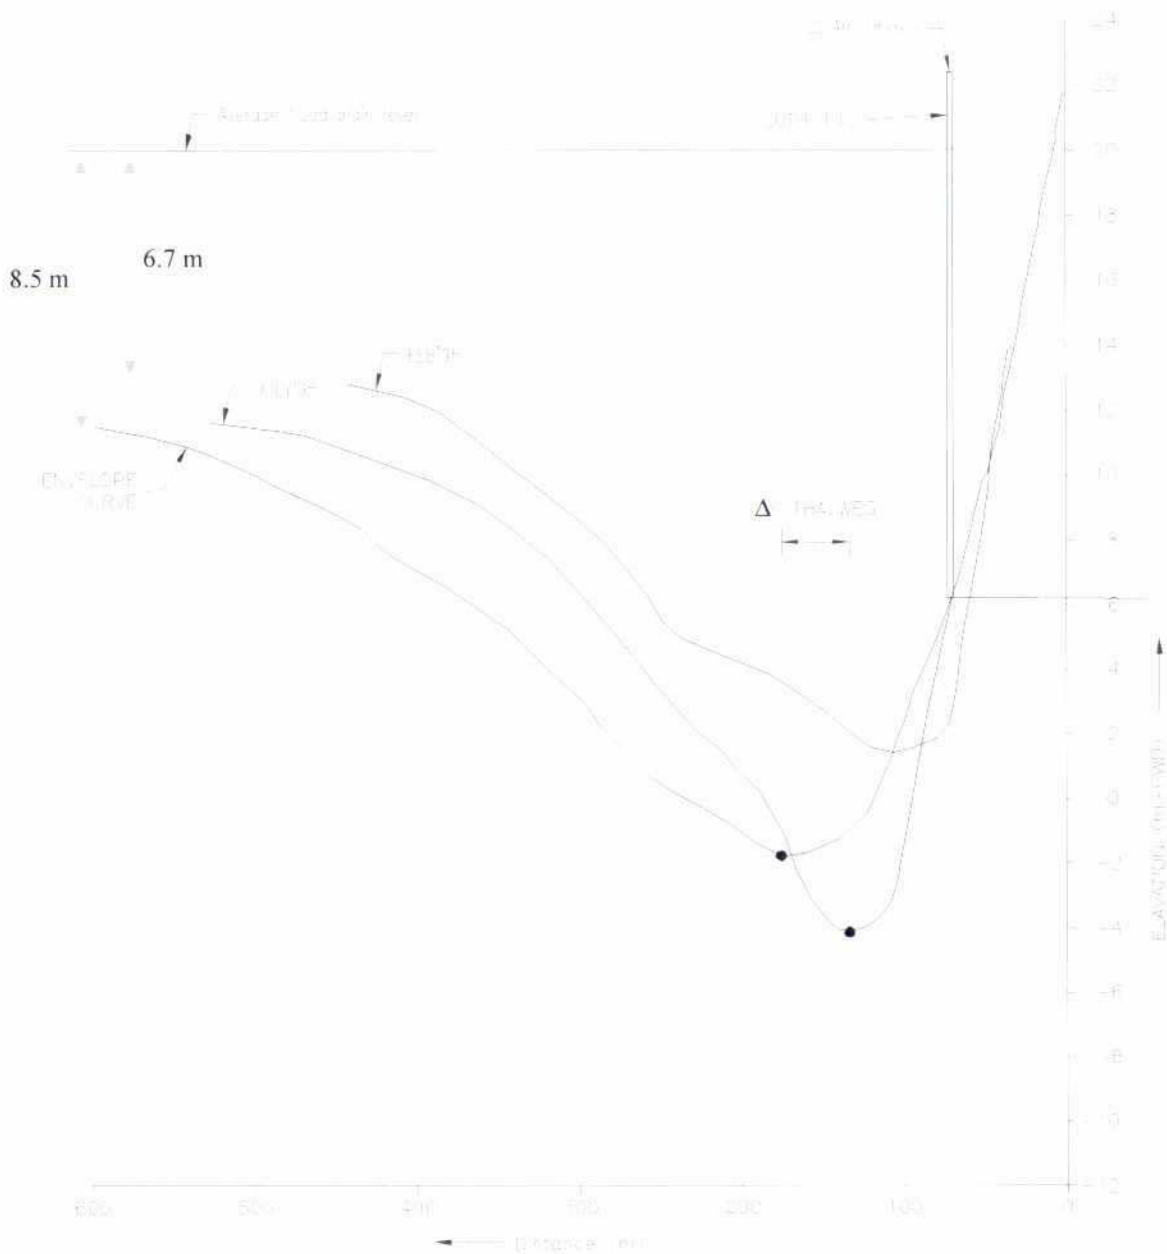
Fig. 4.4-3 Comparison between calculated and observed inner bend profile, Kamarjani during 1995 flood

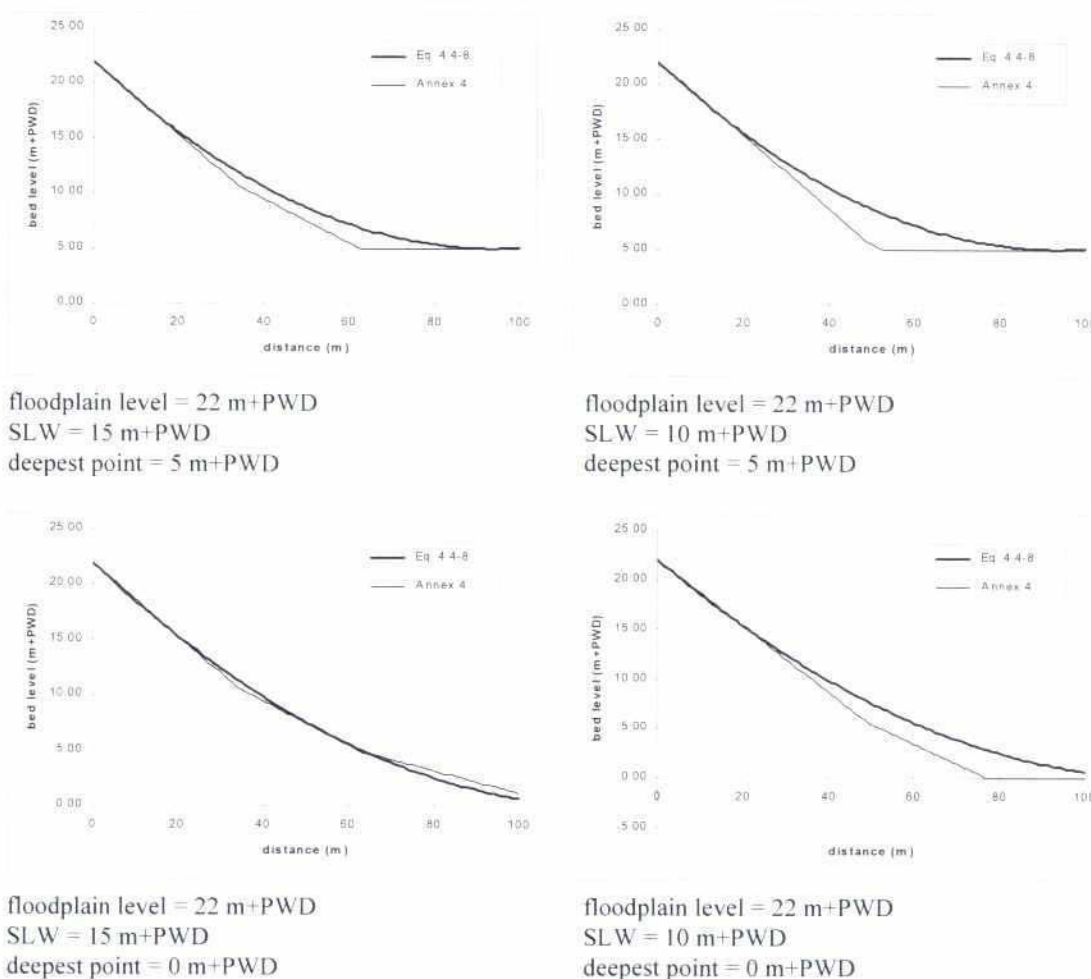
Fig. 4.4-5: Comparison of design outer bend profiles according to Formula (4.4-8) and Annex 4

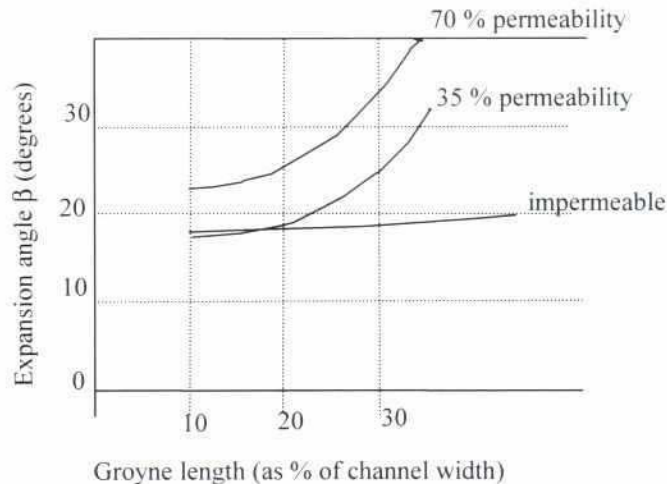
Fig. 4.6-2 shows Brown's (1985) graph for the expansion angles at permeable groynes (Lagasse et al, 1995).

Fig. 4.6-2: Relationship between groyne length and expansion angle for several groyne permeabilities

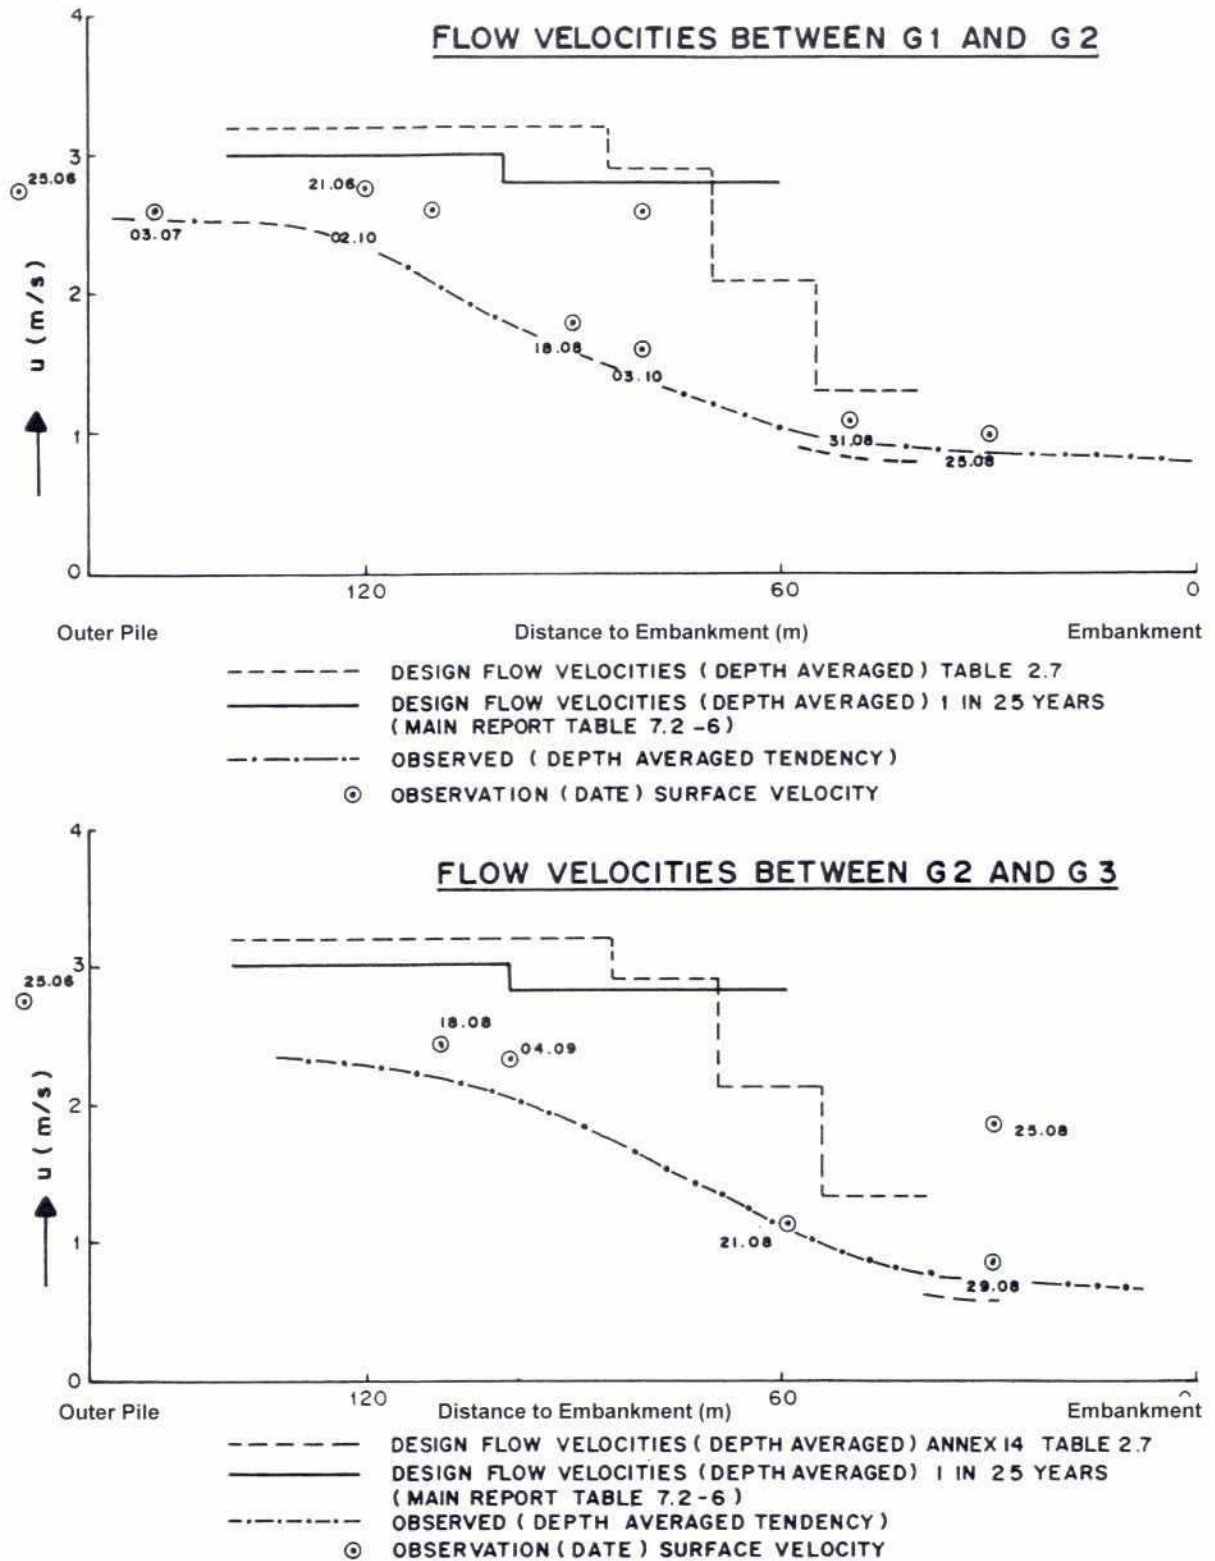
Fig 4.7-1: Flow velocities between G-1 and G-2 and between G-2 and G-3 during the 1995 flood

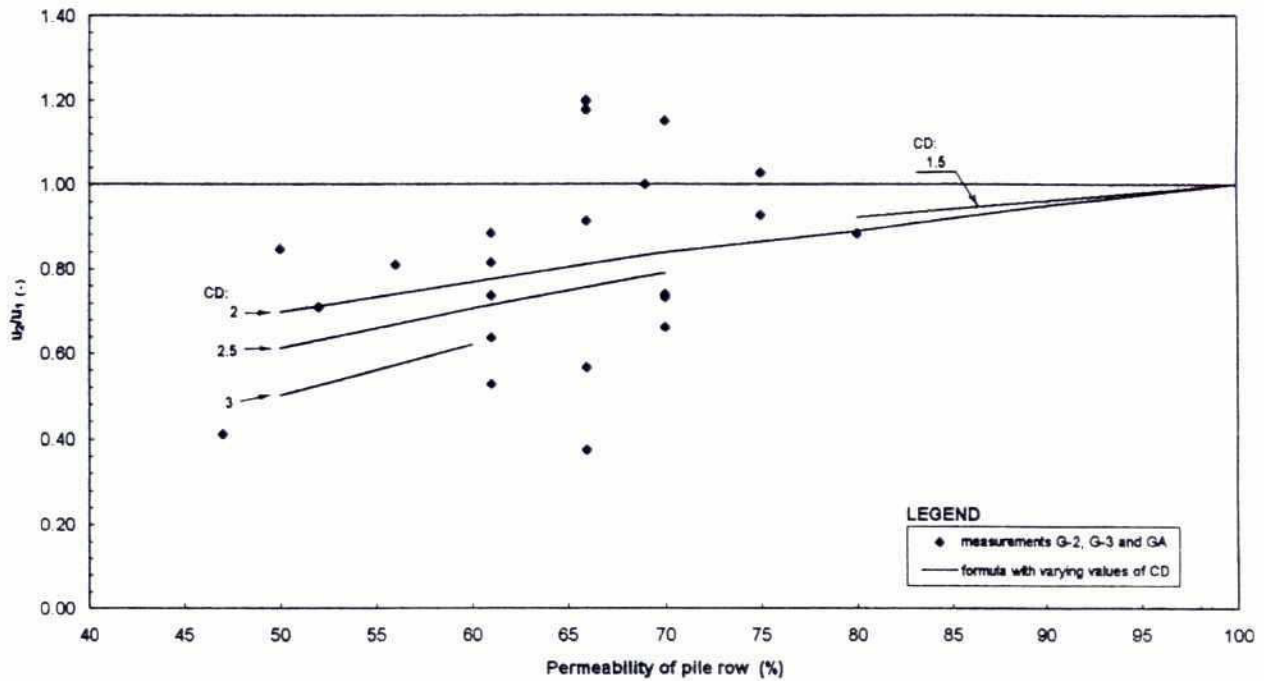
Fig. 4.7-3: The drag coefficient determined from float observations during 1995 flood

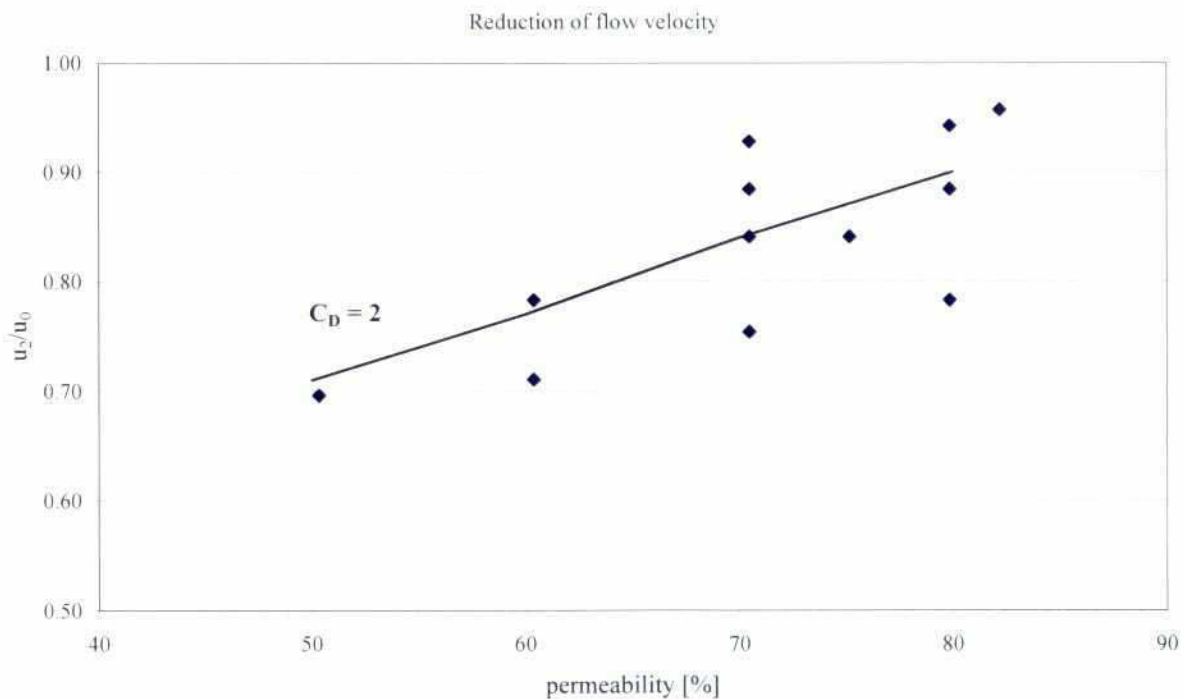
Fig. 4.7-4: The drag coefficient determined from accurate float observations during 1998 flood.

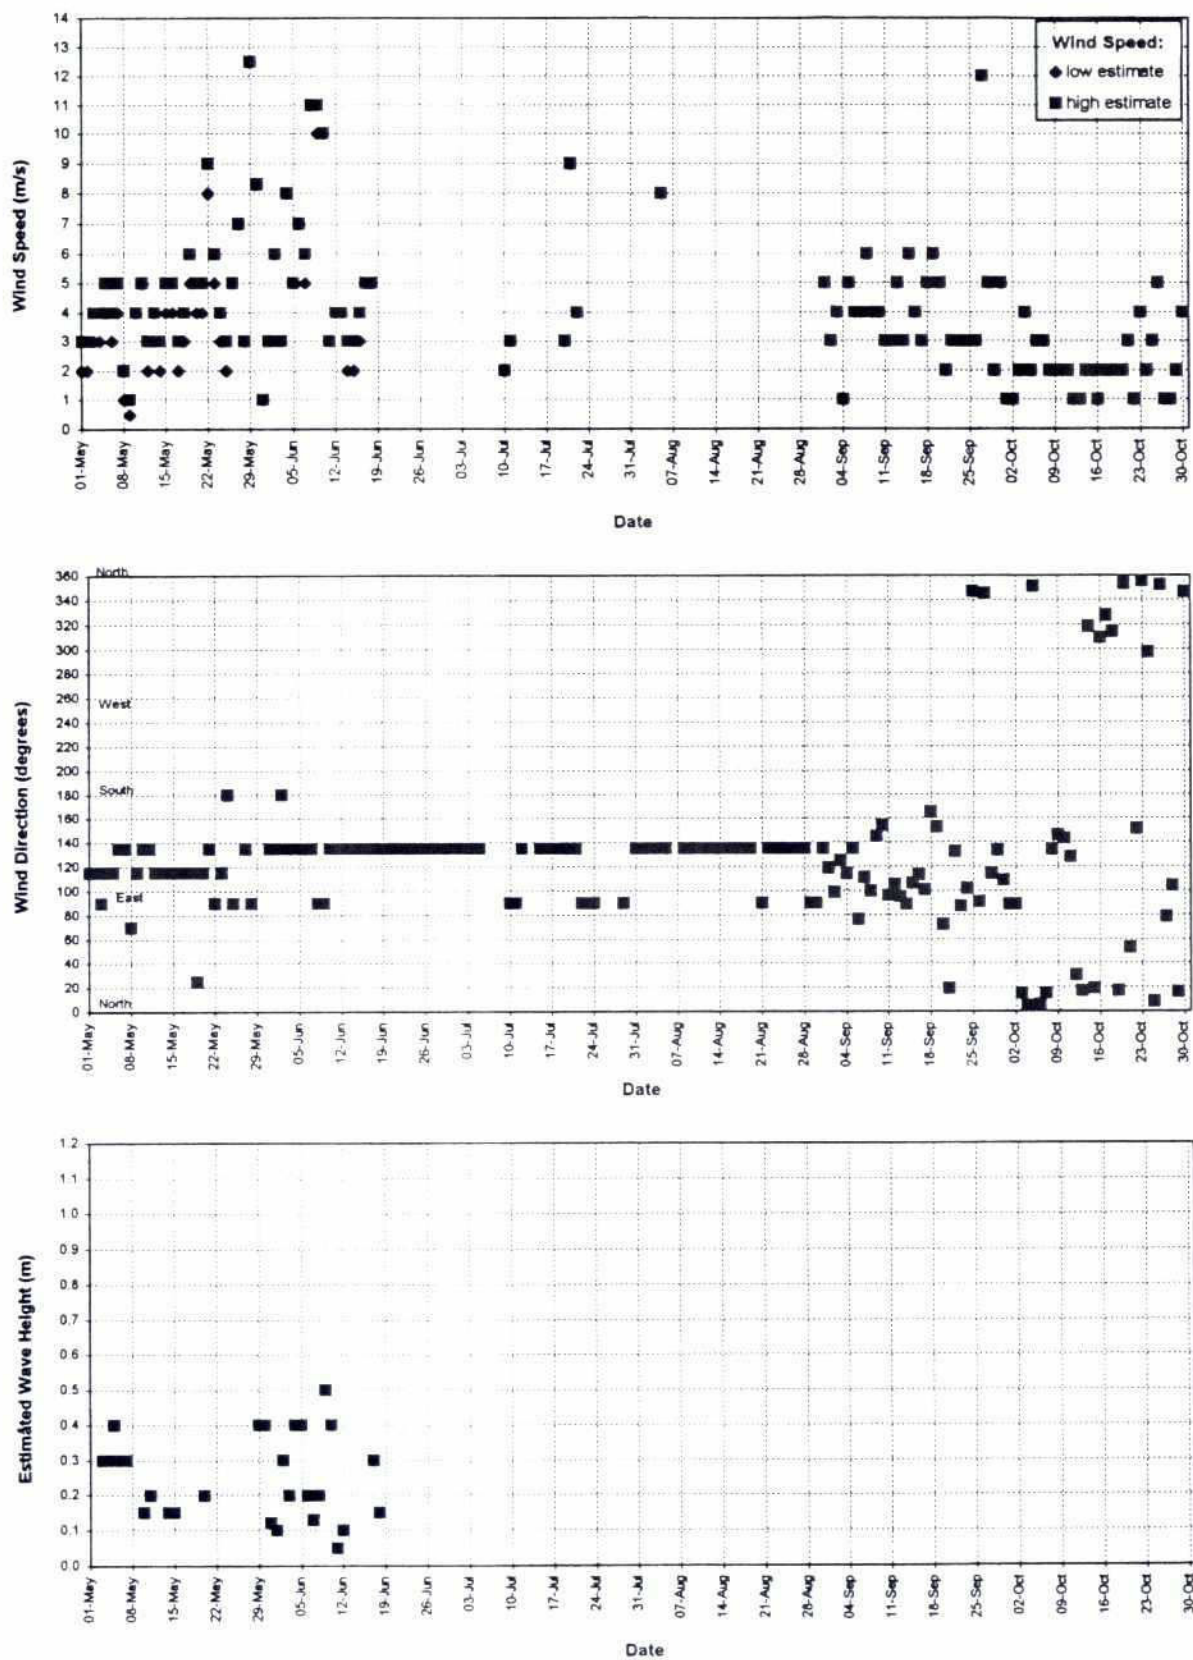
The wind direction and the wind speed had been observed at the monitoring station (see Annex 6). A maximum wind speed of 12 to 16 m/s has been measured at the test structure during some moderate storms, see Fig. 5.1-1 showing the measurements during the monsoon 1997 and an example of wind speed measurements during a storm on September 12, 1996, see Fig. 5.1-2. In the year before a few observations are available, indicating an estimated maximum wind speed of 8 Beaufort, see Fig. 5.1-3. The maximum wind during extreme storms is most probably higher than these measured speeds. The maximum wind speed occurs during storms, most probably the storms which are called Northwesters (Rashid, 1991). During these storms the wind can change to all possible directions, but these storms occur mainly in the period from October to May, when the water level is below flood plain level. During the monsoon the dominant wind direction is SE, see Fig. 5.1-1.

Fig. 5.1-1: Measured wind speed and direction, wave heights during monsoon 1997

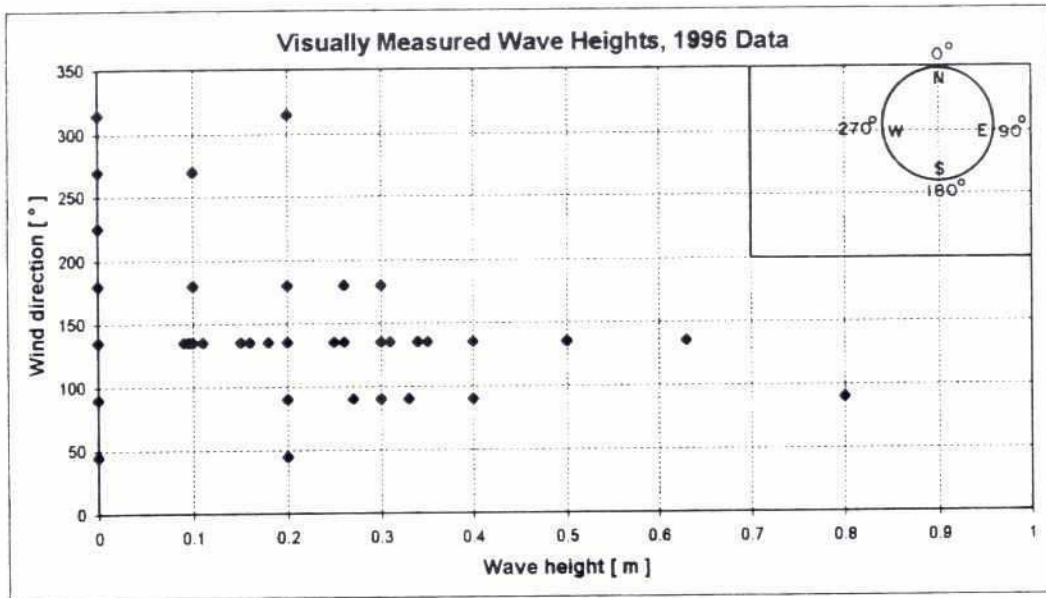
Fig. 5.2-1: Visually measured wave heights as function of wind direction, 1996 data

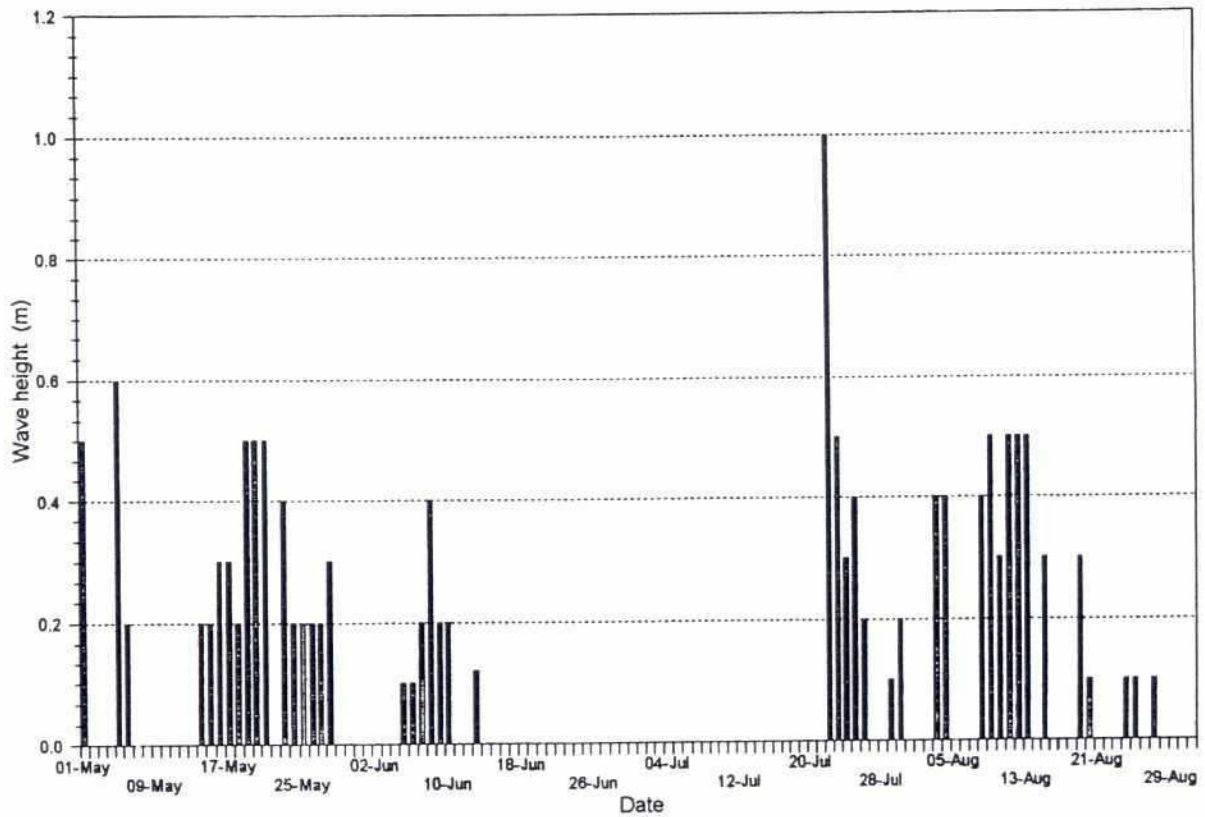
Fig. 5.2-2: Preliminary analysis of some observations made in 1995

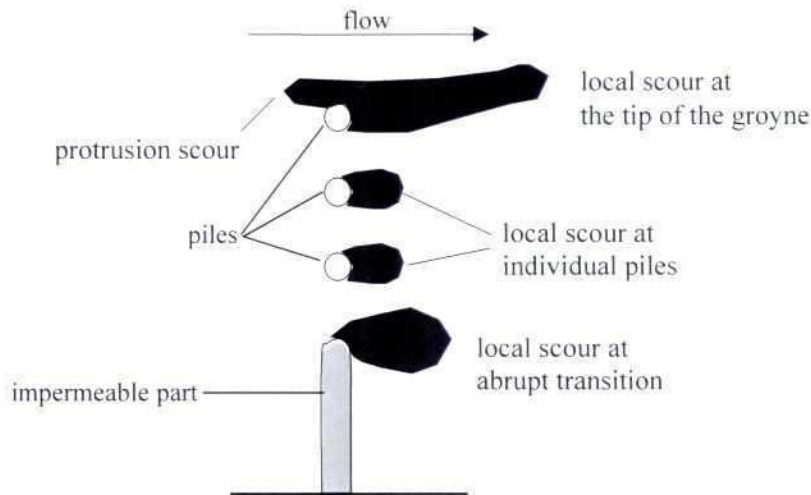
Fig. 6.1-1: Scour pattern at groynes with an impermeable and a permeable part
