**BANK PROTECTION AND
RIVER TRAINING (AFPM)
PILOT PROJECT
FAP 21/22**

**FINAL PROJECT
EVALUATION REPORT**

**Annex 6: The Groyne Test Structure;
Monitoring Report**

**Annex 7: The Groyne Test Structure;
Evaluation of Hydraulic
Loads and River Response**

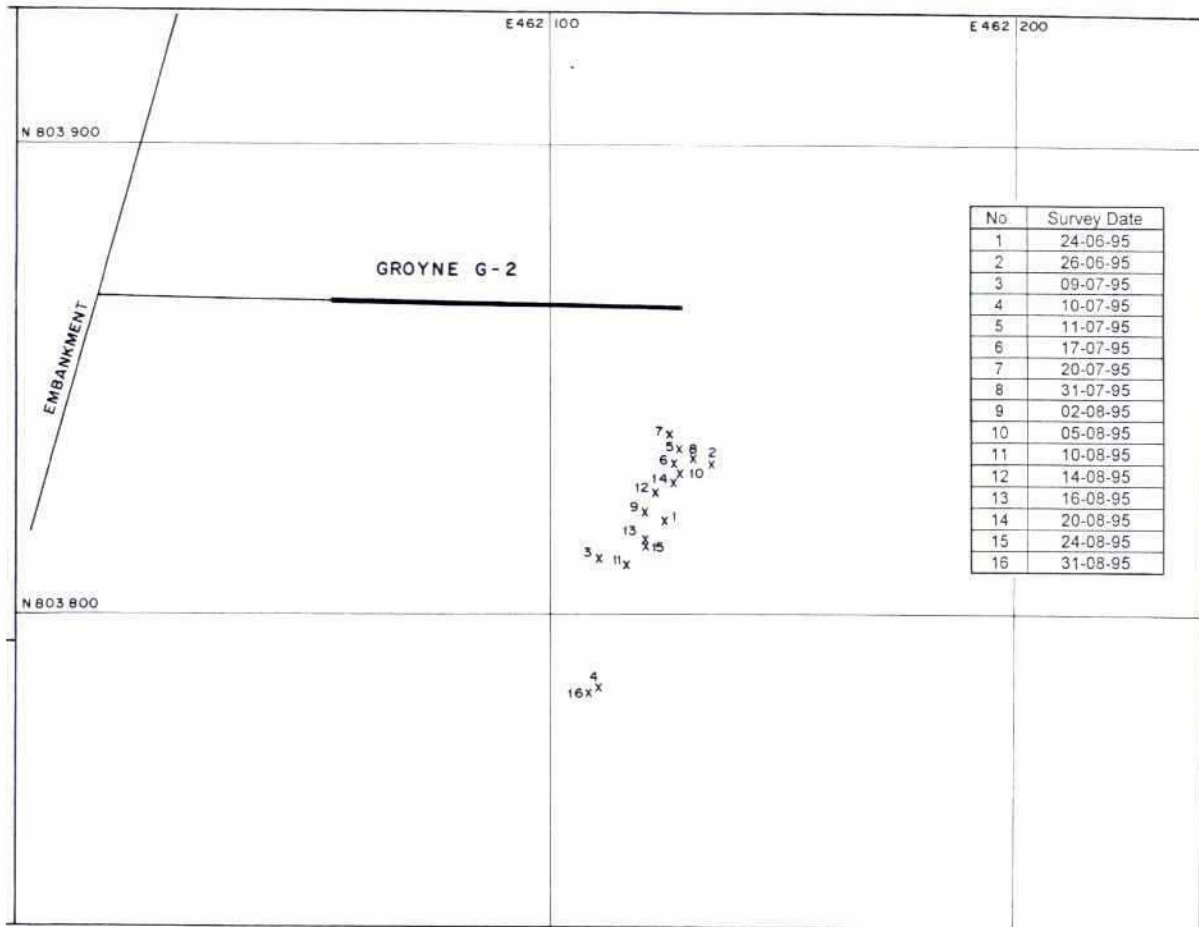
Fig. 6.3-1: Location of the maximum local scour depth downstream from G-2 during 1995 monsoon

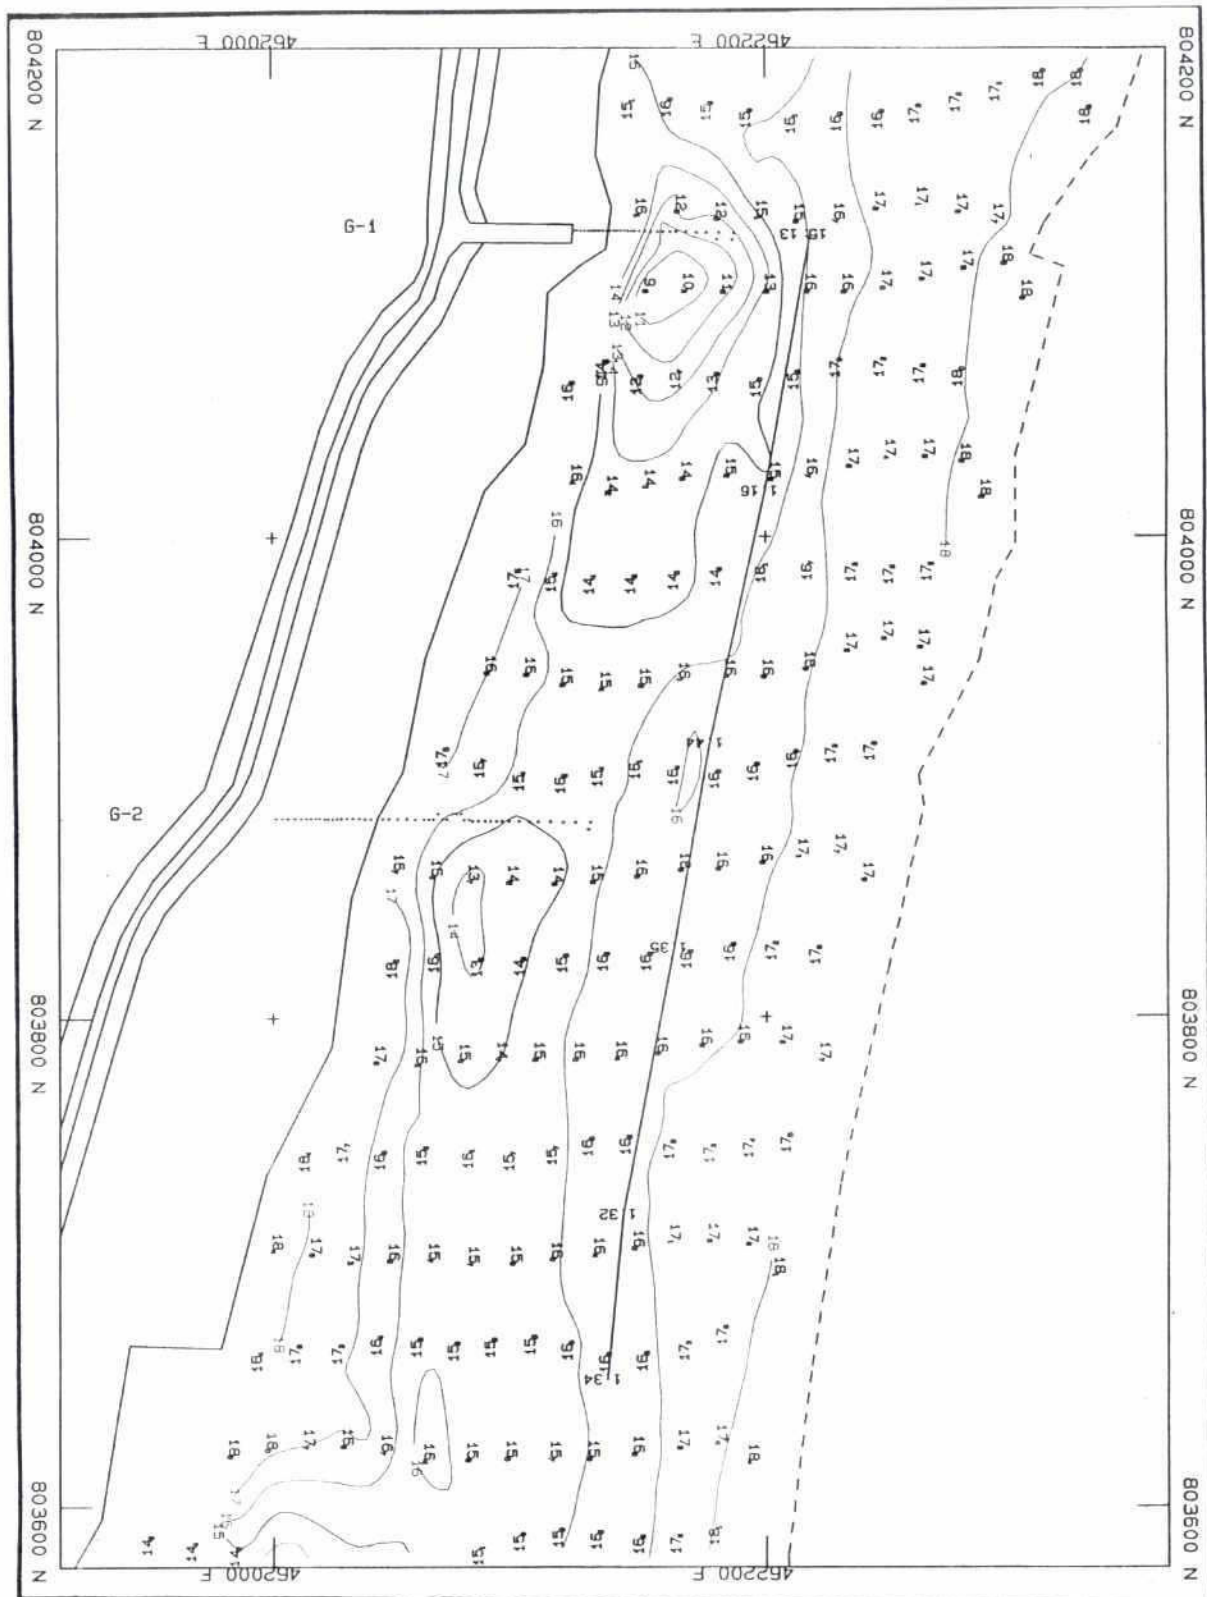
Fig. 6.3-2: Location of the maximum local scour depth downstream from G-1 and G-2 during 1998 monsoon

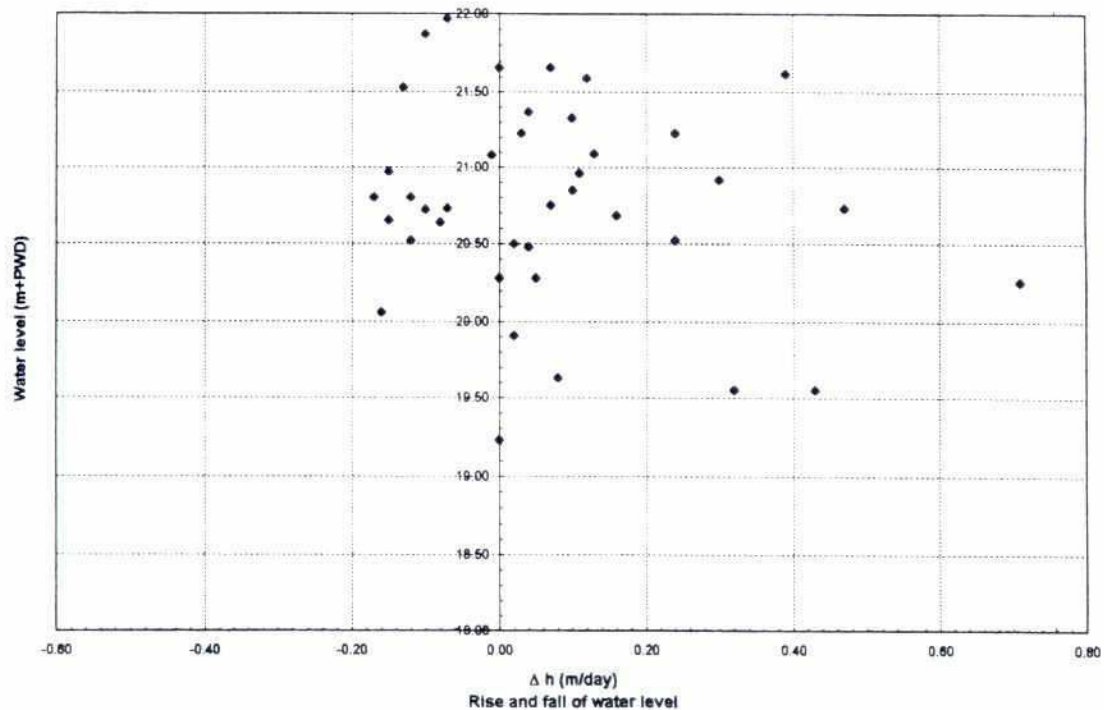
Fig. 6.4-3 The rise or fall of the water level as function of the water level on days floating debris had been observed during 1996 monsoon

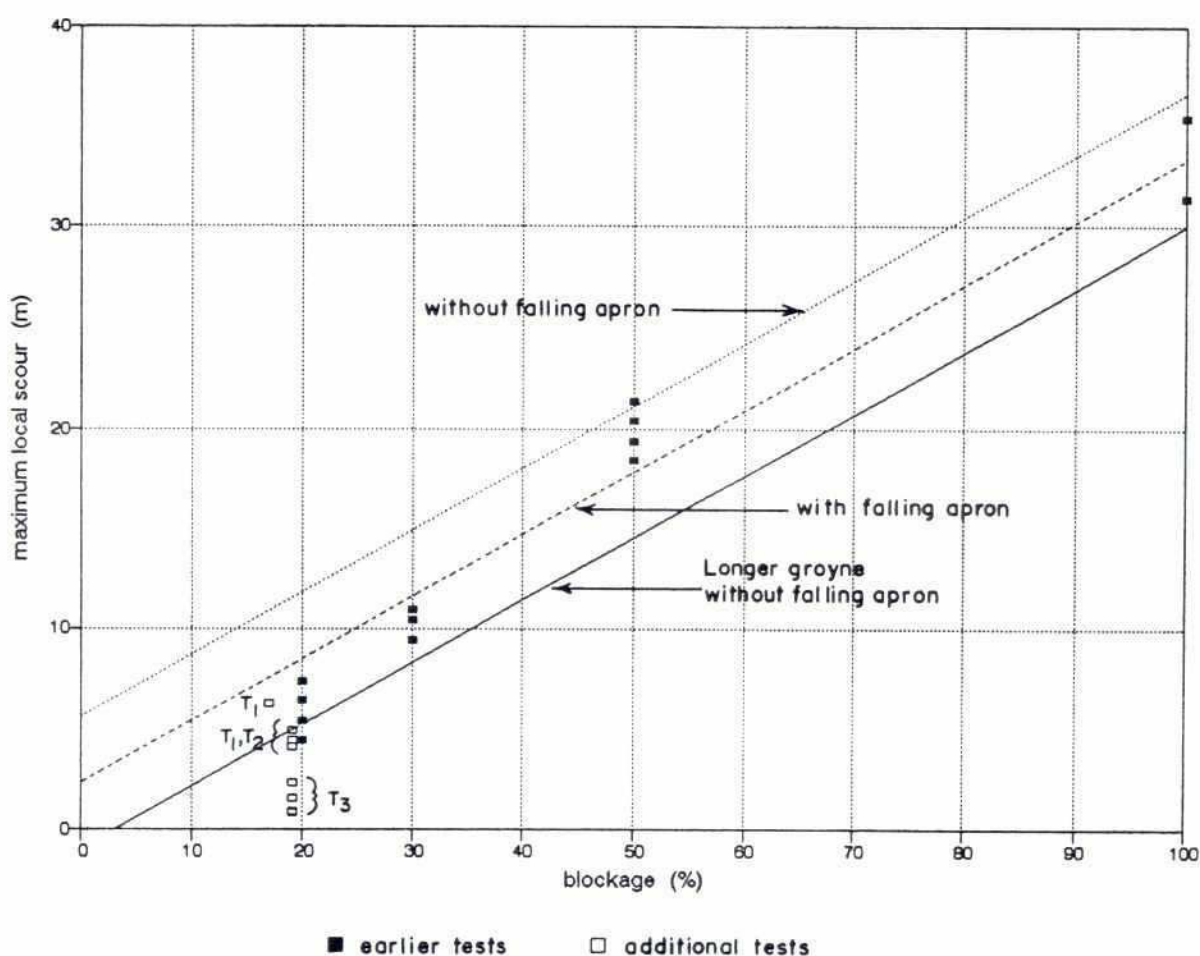
The minimum value of p is 0 for an impermeable groyne and the maximum value is 1 when no groyne is present. An impermeable groyne has $k_b = 1$ and a groyne with 20 % blockage has $k_b = 0.2$.

Fig. 6.4-4 Reduction of scour depth by increasing blockage of the groyne

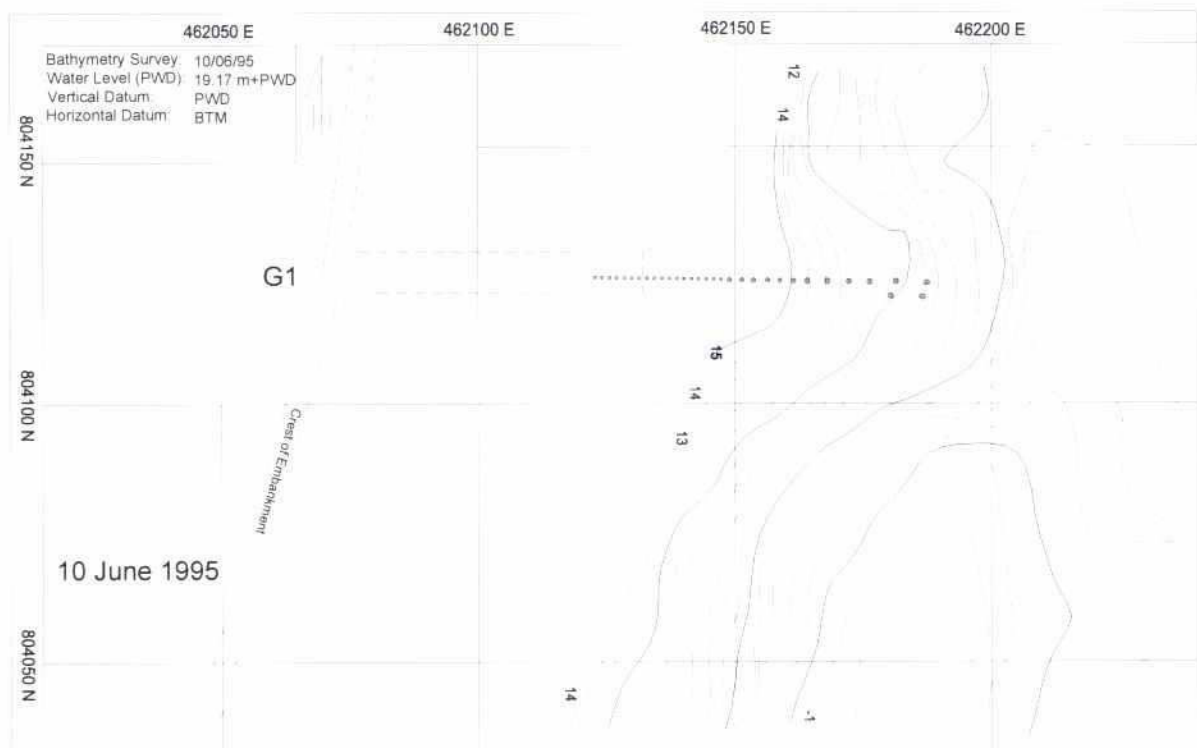
The bathymetric survey on June 10, 1995 shows smooth bank profiles upstream and downstream from G-1 (see Fig. 6.8-1). A small slide near the head of the impermeable part of the groyne occurred on June 17, 1995 as the water level raised quickly to the first peak flow. In the period from June 13 to 20, a lot of floating debris had piled up against G-1. This floating debris may have caused a sudden increase of flow velocities and a small increase of the local scour depth, thereby triggering some small slides. The bathymetric surveys of the same area on June 24 and 26, 1995 show 3 to 4 small slides just downstream from the bed protection (see Figures 6.8-2 and 6.8-3). At that time the water level had started to recede just after the first peak flow.

Fig. 6.8-1: Bathymetry around groyne G-1 on June 10, 1995

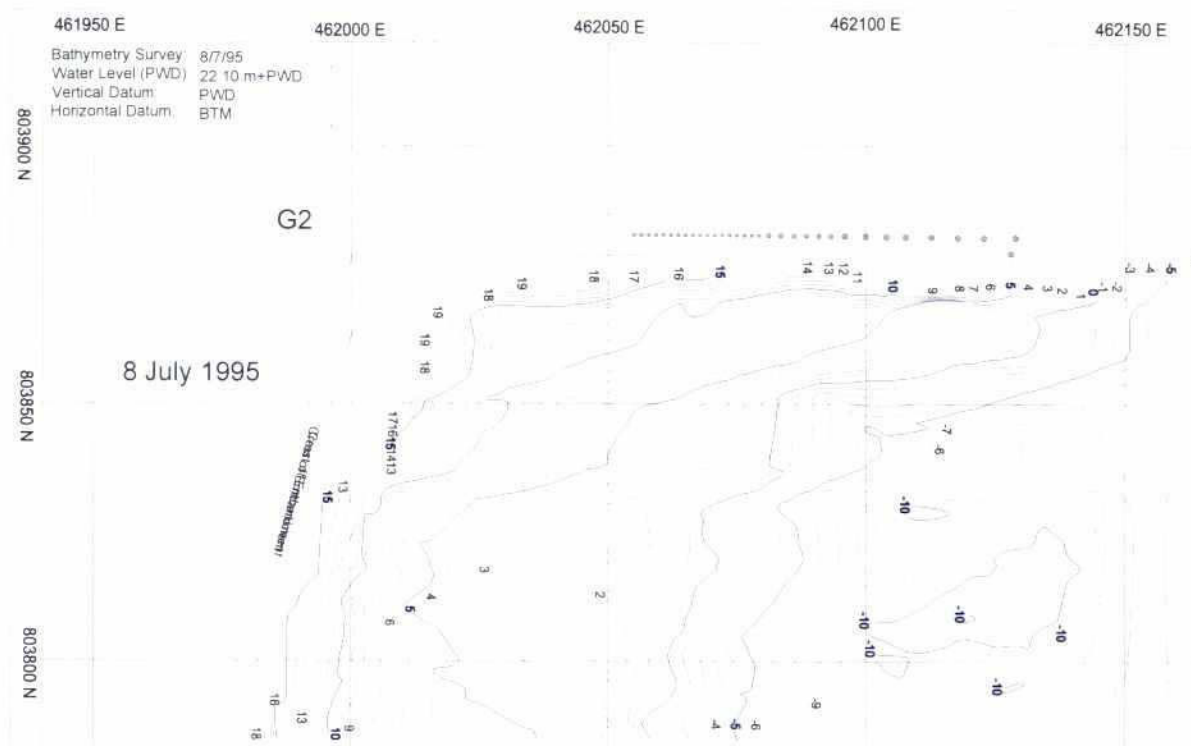
Just before the slide, the maximum scour depth downstream from the groyne increased from 7 m on June 26 to 11 m on July 08/09, 1995. This increase of the local scour depth had also increased the side slopes. Local steep side slopes can result in over-steepening, which can trigger a slide.

Fig. 6.8-5: Bathymetry around groyne G-2 on July 08, 1995

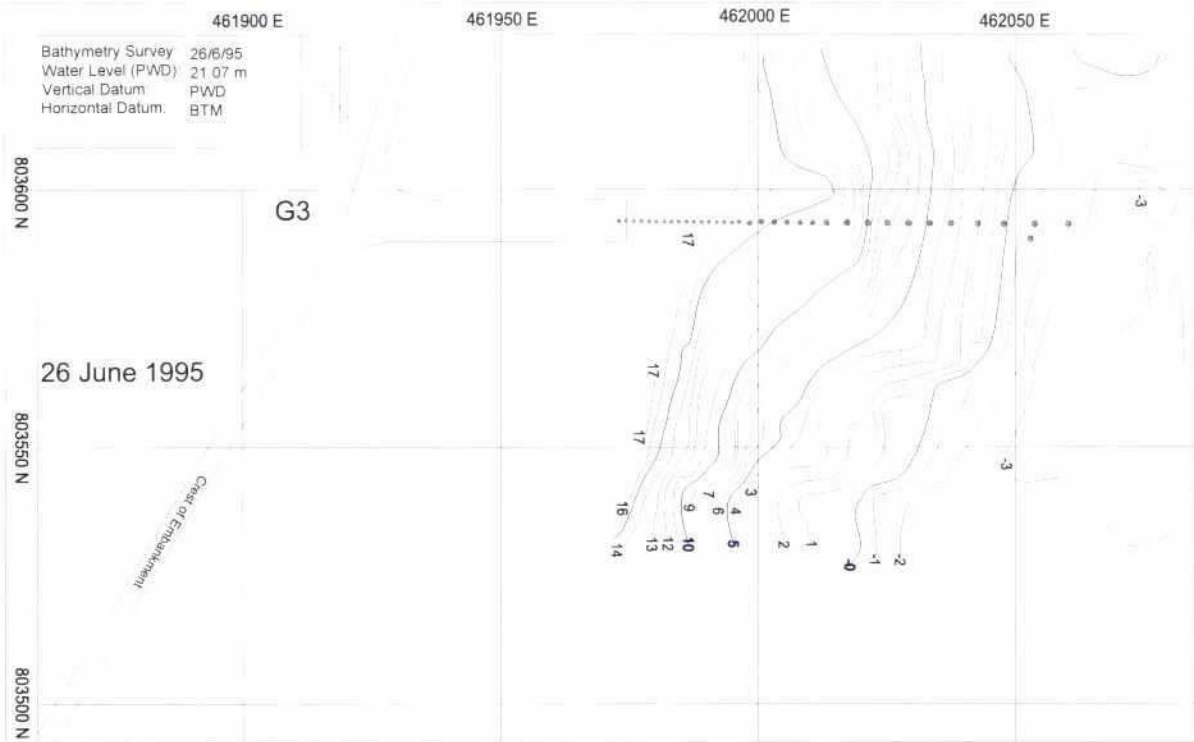
Fig. 6.8-6: Bathymetry around groyne G-3 on June 26, 1995

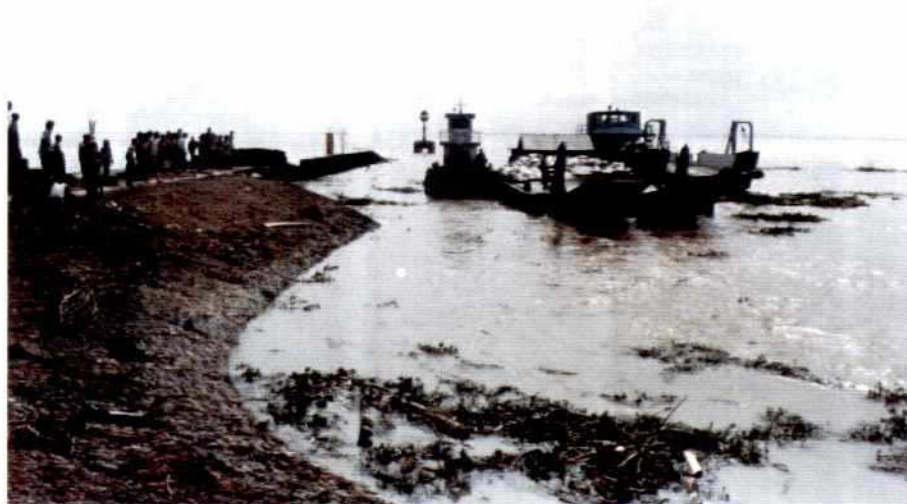
An impressive big slide occurred near G-3 during day time on August 19 after an extremely quick rise of the water level of 0.8 m on August 12 as the water level started to rise for the third peak flow, which reached its maximum water level on August 17. The slide started in the morning at 9 hours when boulders slipped down and immediately a long straight crack parallel to the groyne axis developed in the middle of the impermeable part of G-3 (see Photographs 6.8-1 to 6.8-7). The head of the impermeable part started to disappear under the water surface at around 12 hours. The slide was completed several hours later in the afternoon. The next day some small erosion near the water line was observed near the remaining head of the impermeable part, which was more or less the part upstream from the initial crack. This indicates that the equilibrium was lost along one single slide plane rather than along a series of several slide planes during that event. However, the soil did not move in one large chunk as often observed along the Mississippi river (Torrey, 1995), but in smaller pieces. The bathymetric surveys of August 17 and 31, 1995 show that about 34,000 m³ eroded just downstream from the impermeable part of the groyne in an area of approximately 100 m by 75 m (see Fig. 6.8-8 and Fig. 6.8-9). The location of the maximum erosion depth in the slide was about 30 m downstream from the groyne axis. The falling apron around the impermeable part was made of concrete blocks with 0.15 and 0.2 m sides. The width of the falling apron was only 25 m from the axis of the groyne. This part was not able at all to resist a slide of that size and disappeared completely, together with a part of the impermeable groyne protected by brick mattresses. Based on the experience with earlier slides no actions were taken to repair the groyne by dumping materials (stones and cc-blocks).

Photo 6.8-1: Development of a crack in groyne G-3, August 1995

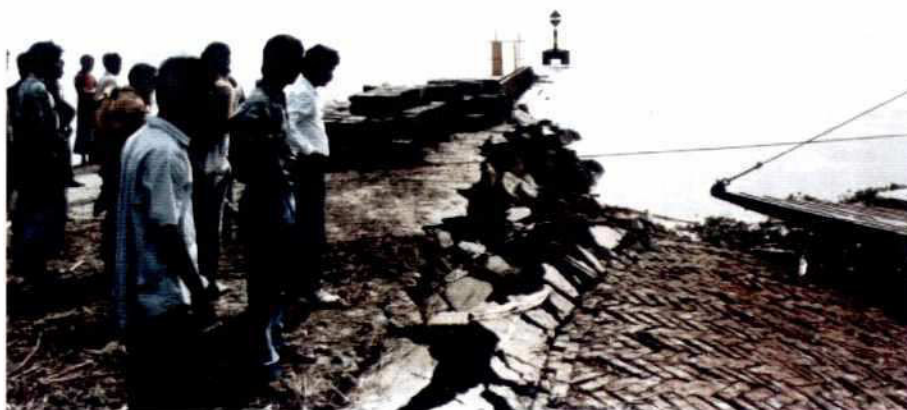
Photo 6.8-2: Development of a crack in groyne G-3, August 1995

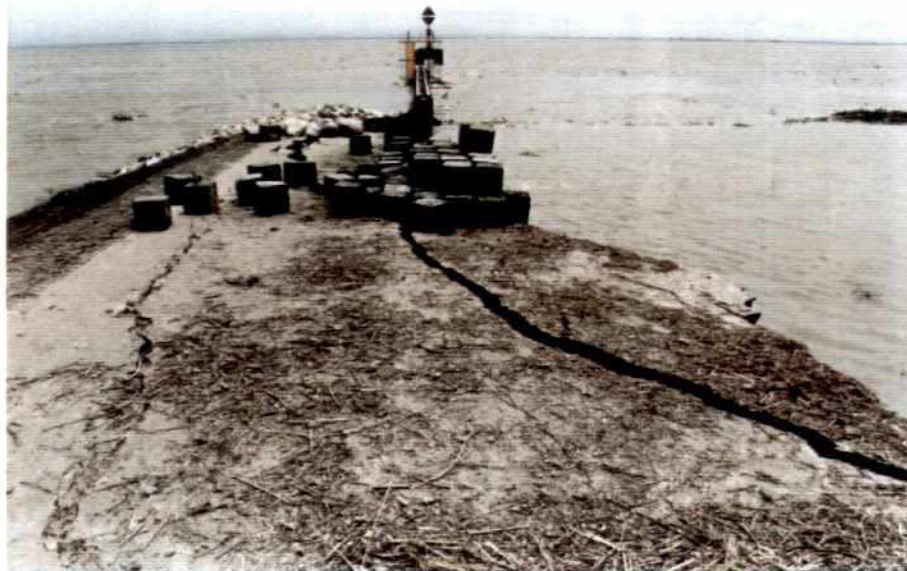
Photo 6.8-3: Erosion process during slide at groyne G-3, August 1995

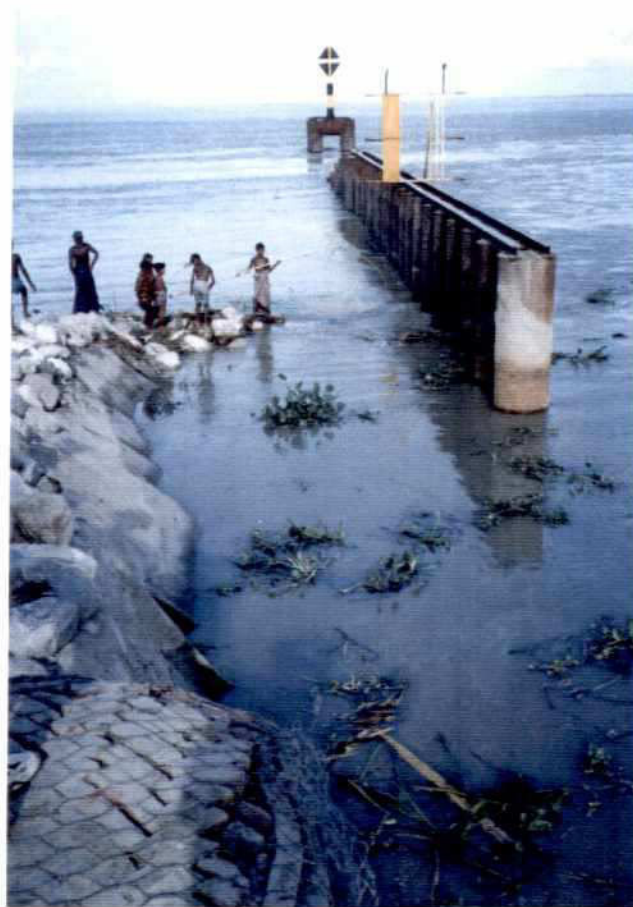
Photo 6.8-7: Transition between permeable pile row and earth dam after slide at groyne G-3, August 1995

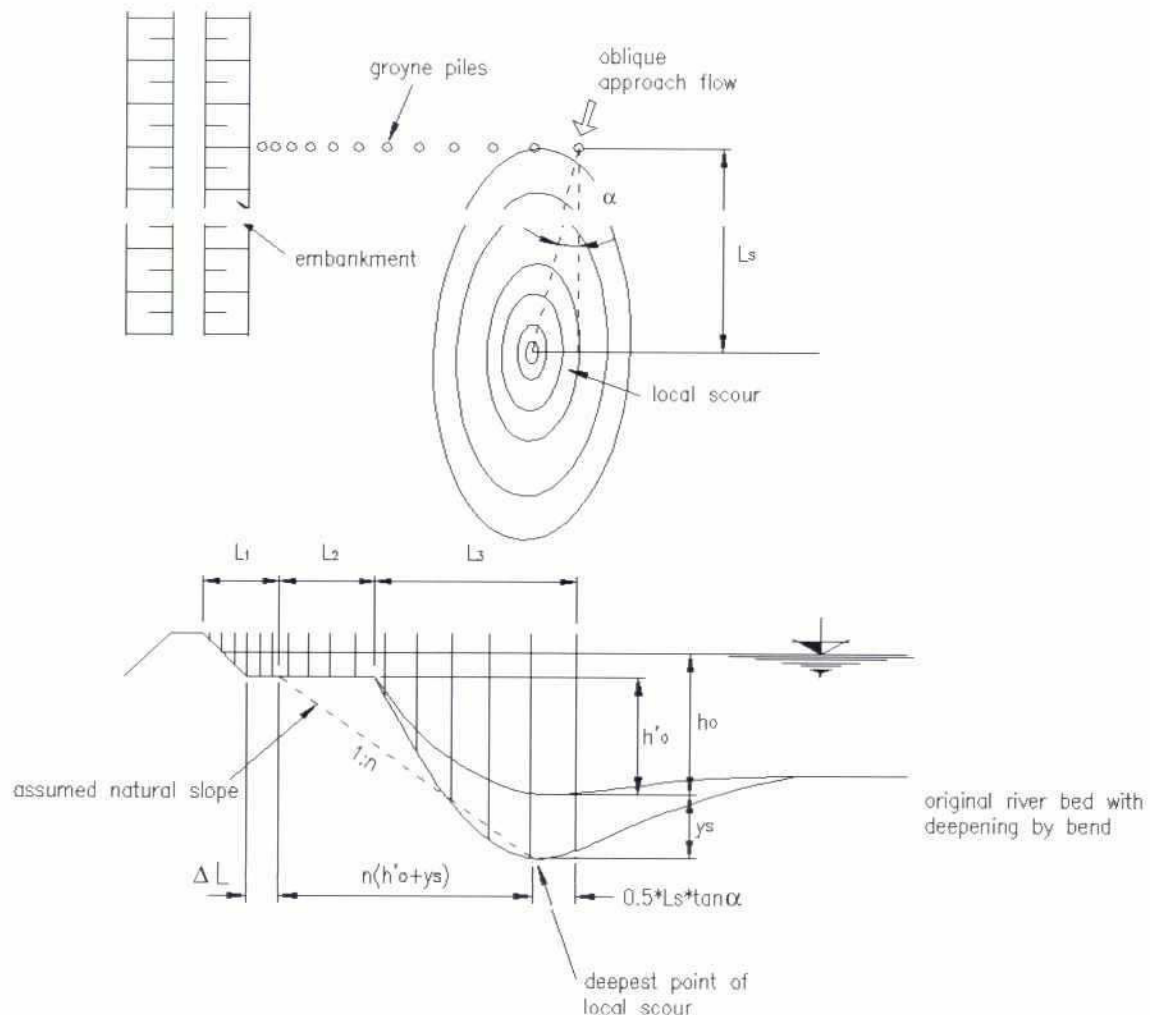
To the estimated length of the permeable groyne L_g another safety margin and the length of the groyne on the floodplain has to be added according to Fig. 7.3-1. For the latter, the minimum length is the expected bank erosion during the construction phase.

Fig. 7.3-1: Design projected total length of a groyne
