**BANK PROTECTION AND  
RIVER TRAINING (AFPM)  
PILOT PROJECT  
FAP 21/22**

**FINAL PROJECT  
EVALUATION REPORT**

**Main Report**

DECEMBER 2001

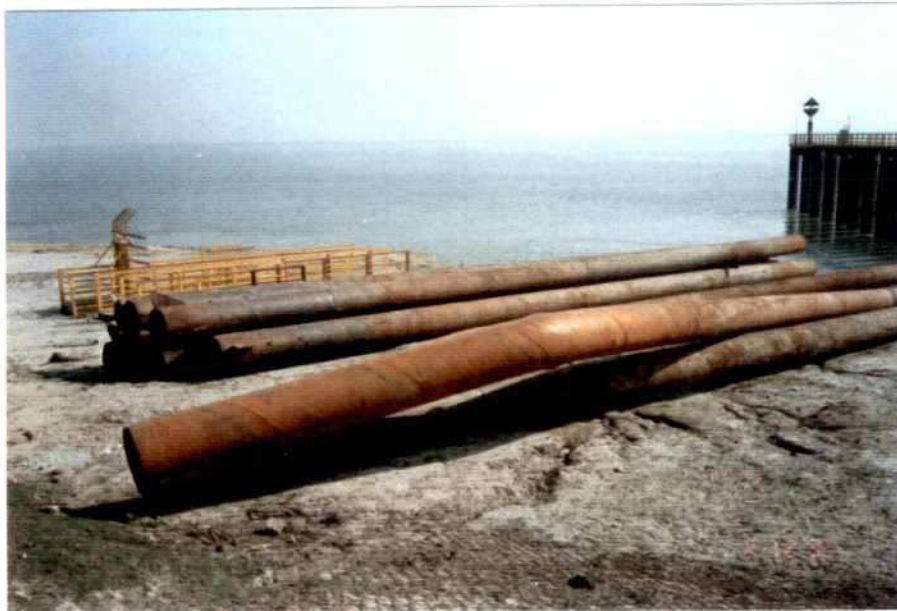
**Photo 3.7-2: Recovered tubular steel piles of groyne G-2**

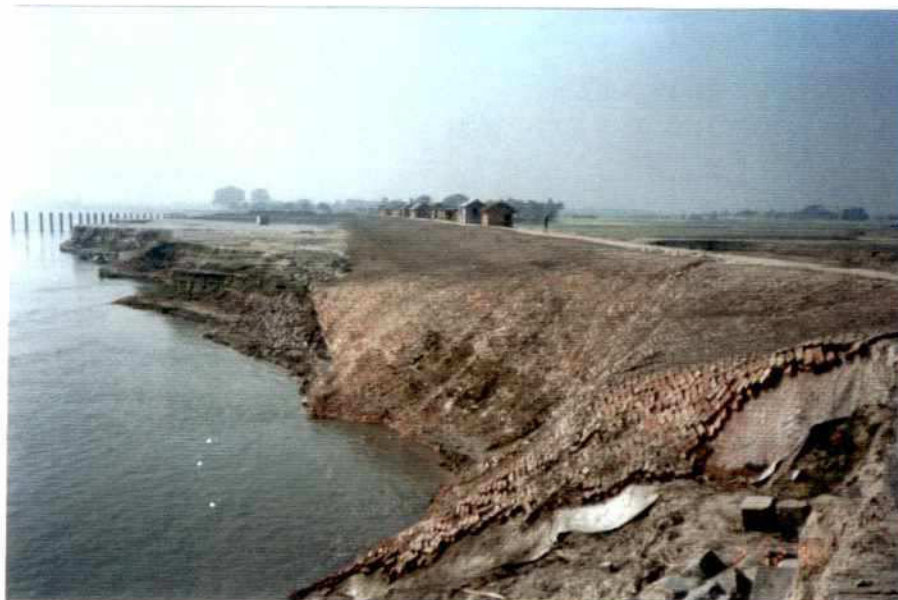
**Photo 3.7-4: Main embankment downstream from groyne G-3 after monsoon flood**

Between the groynes G-1 and G-2 minor erosion along the embankment occurred, however, not threatening its stability. Between the groynes G-2 and G-3 the local erosion of the floodplain extended up to the embankment which was undermined and finally failed (Photo 3.7-1). Similarly, the brick mattress of the main embankment downstream from groyne G-3 was undermined by erosion but maintained its integrity and followed the slope of the developed scour (Photo 3.7-4). The anchorage of the brick mattress at the top of the main embankment remained intact.

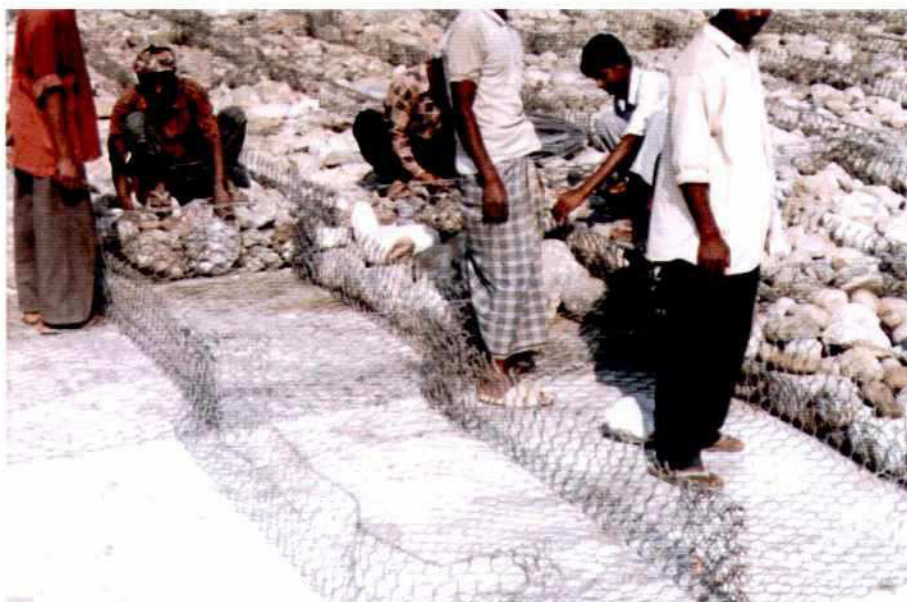
**Photo 4.4-3: Reno<sup>®</sup>-mattress placed on geo-textile (stone filled cages to be closed by wire mesh)**

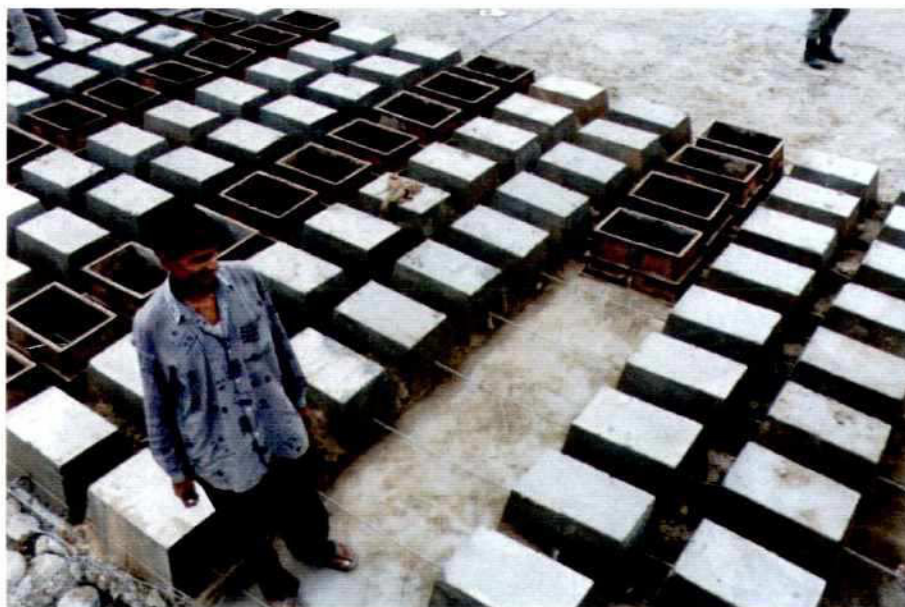
**Photo 4.4-4: Casting of articulating CC-blocks, interconnected by steel cables**

For the implementation of articulating CC-block mattresses (Section D), the in-situ cast concrete blocks were anchored by steel needles in the geotextile material. The steel needles as well as the anchor cables were installed prior to concreting to allow for a good connection between filter mat and articulating CC-blocks (Photo 4.4-4). The installation of the articulated CC-block mattress was time consuming but caused no specific problems.

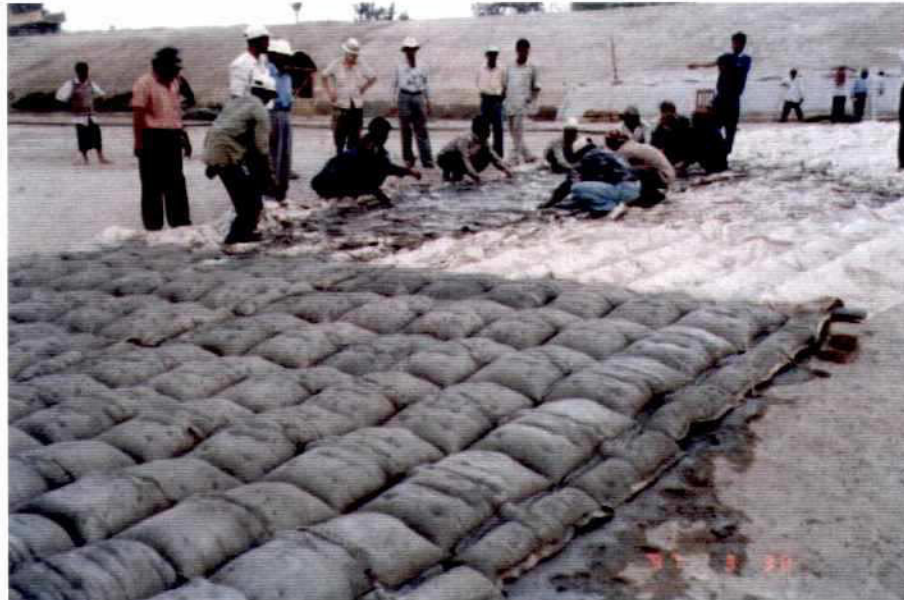
**Photo 4.4-5: Filling of the Foreshore<sup>®</sup> collapsible mattress with cement grout**

Placing of the Foreshore<sup>®</sup> collapsible block mattresses (Section E) and inserting the slope cables was carried out by hand without problems. Difficulties occurred when the mattresses had to be filled with concrete (grouting) using a special colcrete mixer pump to achieve the design filling level ( $d=25$  cm). The matter was solved by using additional filling holes to reduce the filling length and additional pressure by “foot stamping” (Photo 4.4-5).

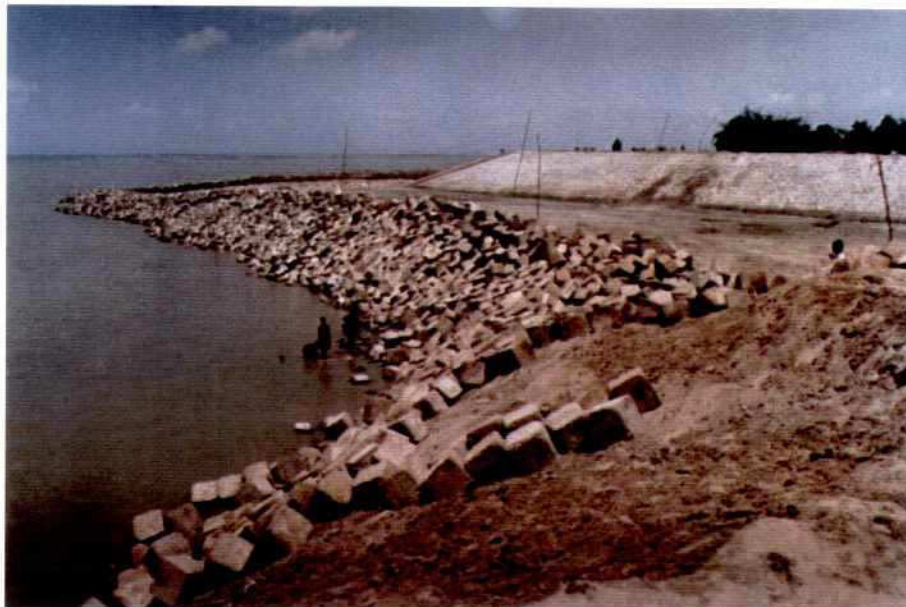
**Photo 4.5-2: Exposed sub-layers after severe erosion during monsoon 1997  
in front of Section H**

The protruding downstream part of the structure experienced the strongest flow attack and the main erosion in depth (Fig. 4.5-9, below), but taking into account the comparatively steep scour slope, the horizontal development of the scour hole was rather small. The good functioning of the CC-blocks prevented from more severe scouring so that the launching apron did not become exposed. Nevertheless, some repair was necessary in test Section H-1, where the falling apron was placed on geotextile filter materials which led to sliding of the protection material. Thus, parts of the area were exposed but without endangering the overall stability of the test section (Photo 4.5-2).

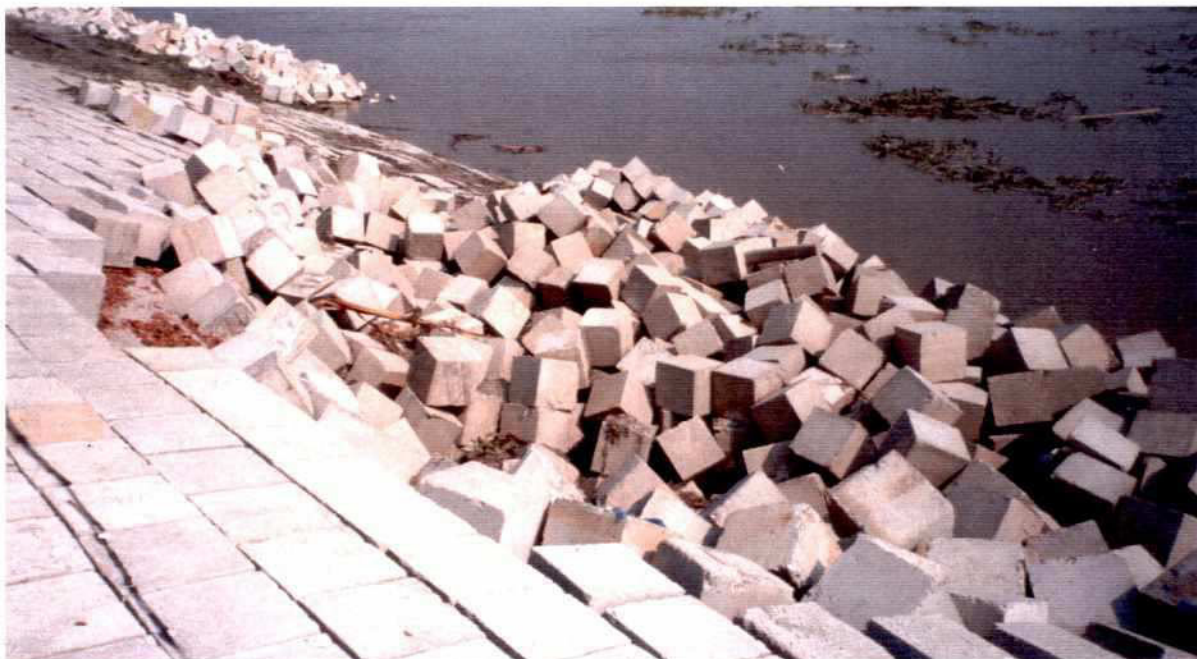
**Photo 8.2-1: Damaged revetment at Sirajganj with dumped concrete blocks (situation in October 1998)**

Monitoring during the 1999 flood showed a new scour at the downstream end of these mattresses which caused minor damages to the bed protection.

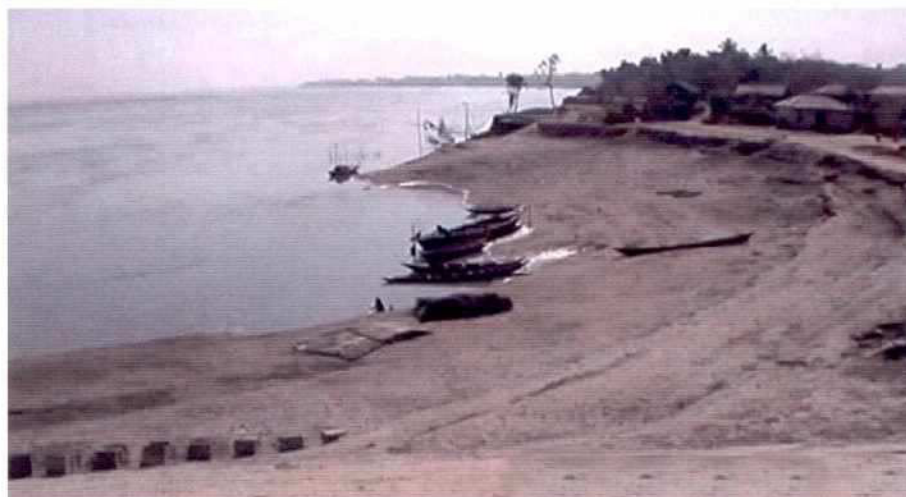
**Photo 8.2-3: Erosion downstream from "hard point" No. 3 at Mathurapara**  
(situation in December 1999)

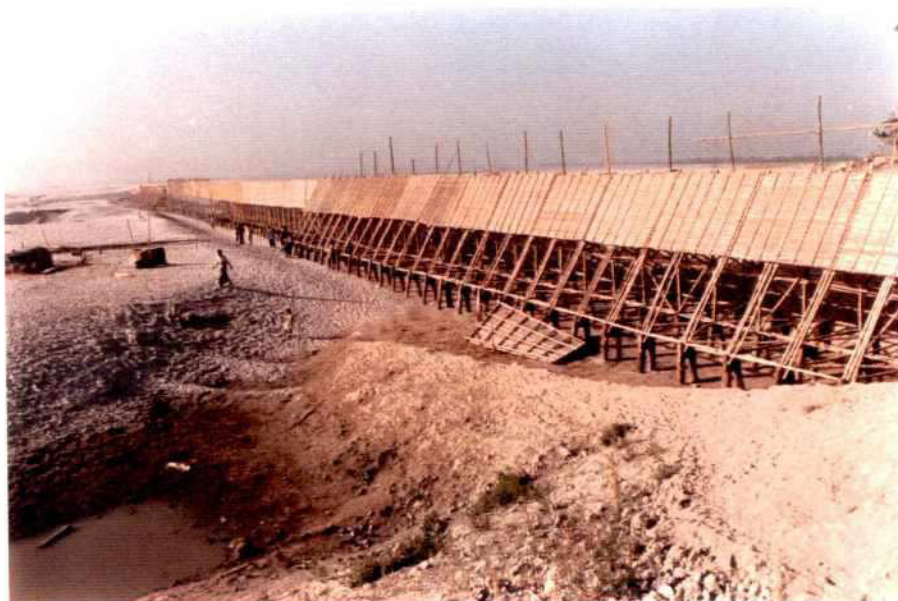
**Photo 4.2-1: Improved bandal structure after construction at Katlamari in March 1997**

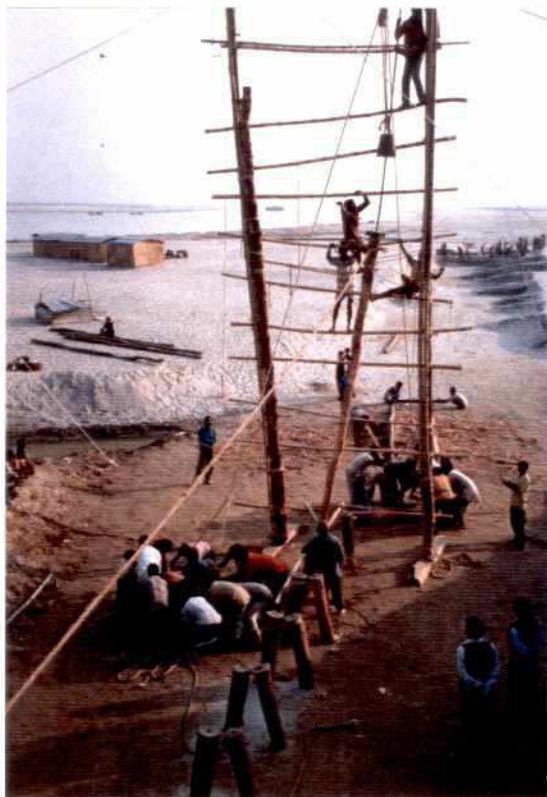
**Photo 4.2-3: Pile driving for the foundation of the bandals in January 1997**

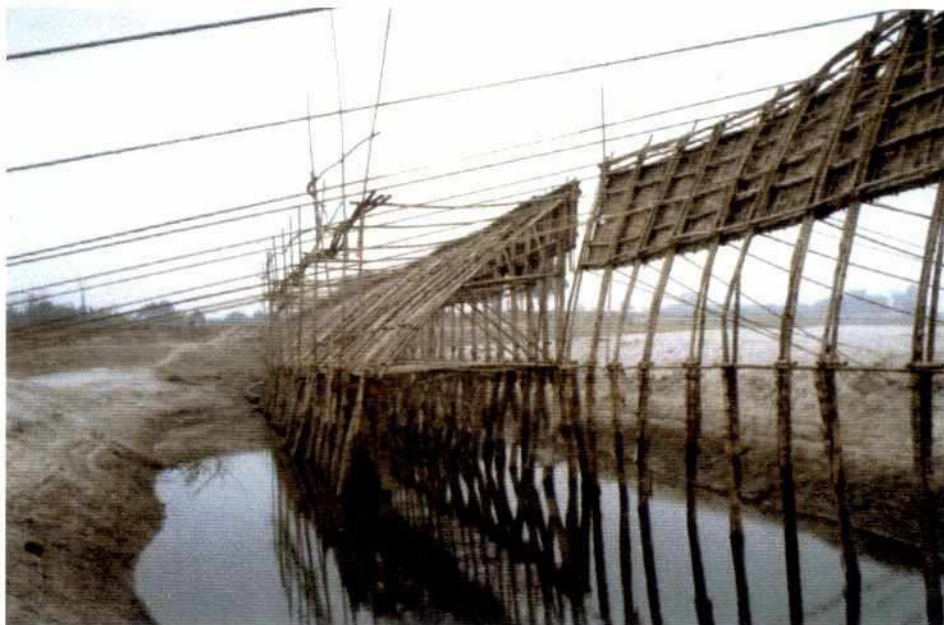
**Photo 4.2-8: Scour below the bandal structure Type B and C in January 1998**

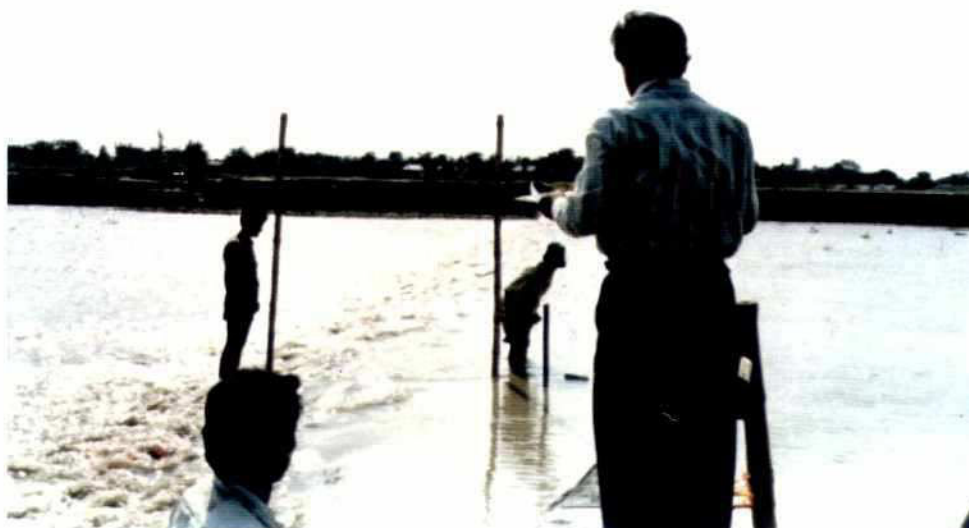
**Photo 4.2-9: Flow measurements at the overtopped earth dam in June 1997**

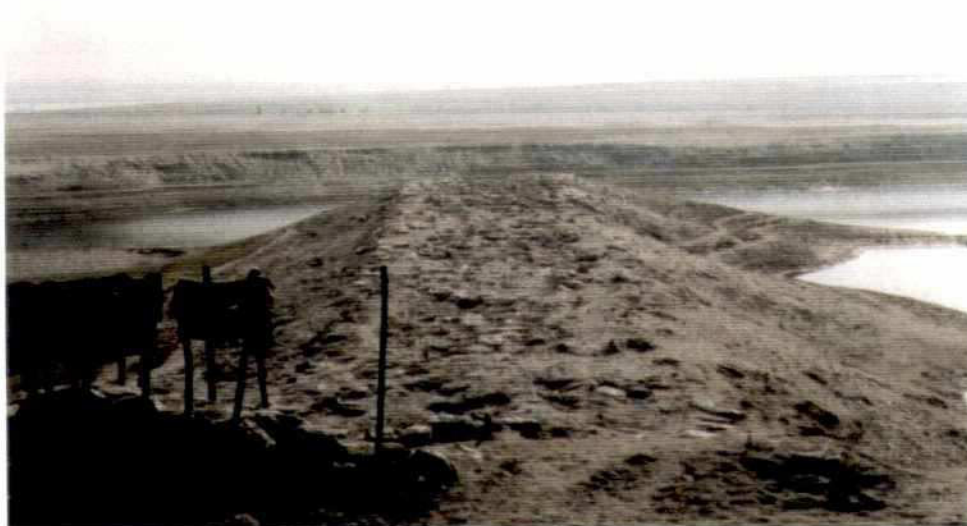
**Photo 4.2-10: Earth dam after the flood in January 1998**
