MEGHNA ESTUARY STUDY

DRAFT DEVELOPMENT PLAN

VOLUME 2 : PART 2
INITIAL ENVIRONMENTAL EXAMINATION
HAIMCHAR EROSION CONTROL PROJECT

DHV CONSULTANTS BV

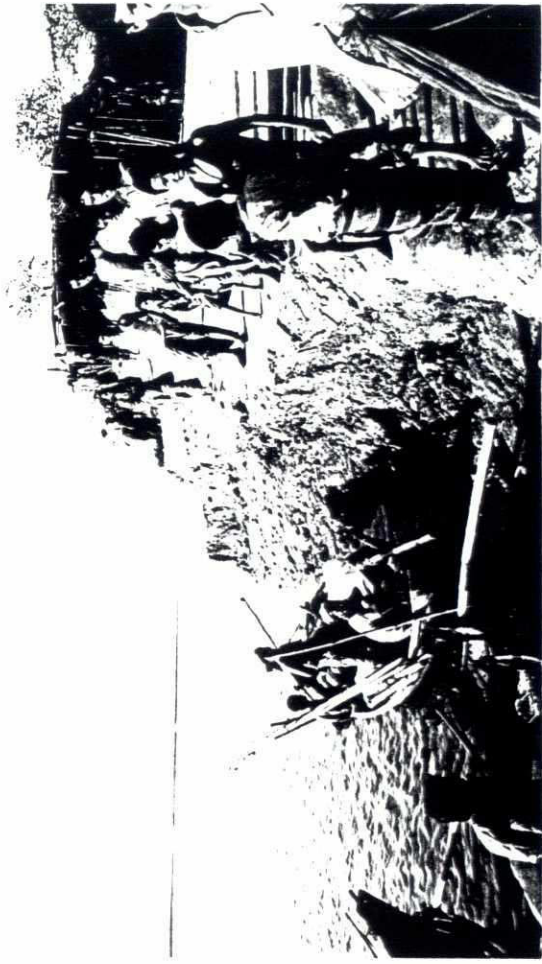
Plate 1: Bank erosion Hanar Char, looking north, eroded end of CIP embankment, March 1998.

The nature of the bank erosion can be seen in Plates 1 to 6. It can be seen that there are land areas now on the western side of the main river channel that in 1914 lay on the eastern side. However the Rennall's map of 1776 indicates that the left bank of the Meghna was in approximately in the same place as it is now for the reach 10 km downstream of Chandpur. Without maps of the intervening years it is difficult to make any interpretation except to say that the western part of the project area has probably accreted since 1776 and is now being rapidly eroded.

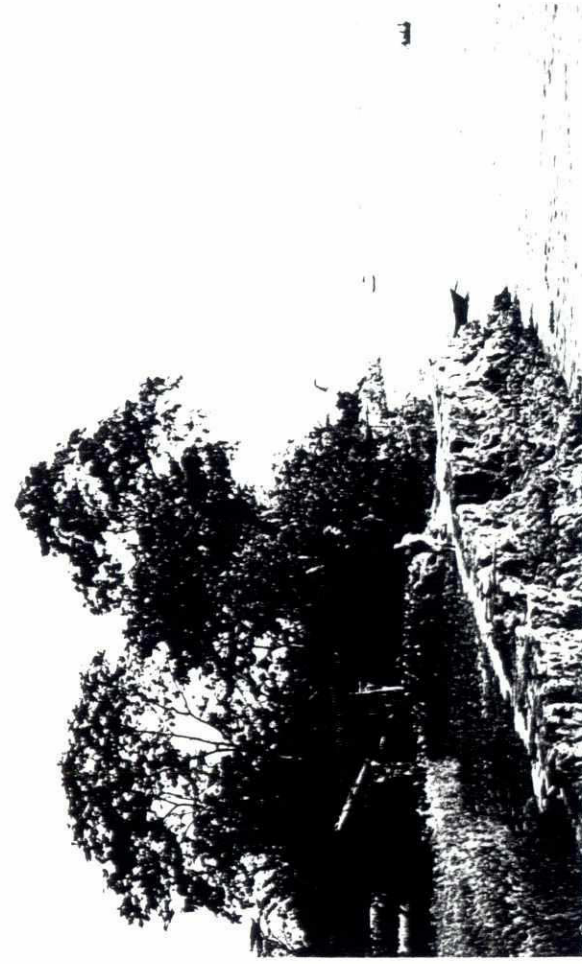
Plate 2: Bank erosion Hanar Char, looking south, March 1998.
