Volume II: Main Report

Final Report

Preparation of Flood Management Plan for Paro Dzongkhag

June 2020

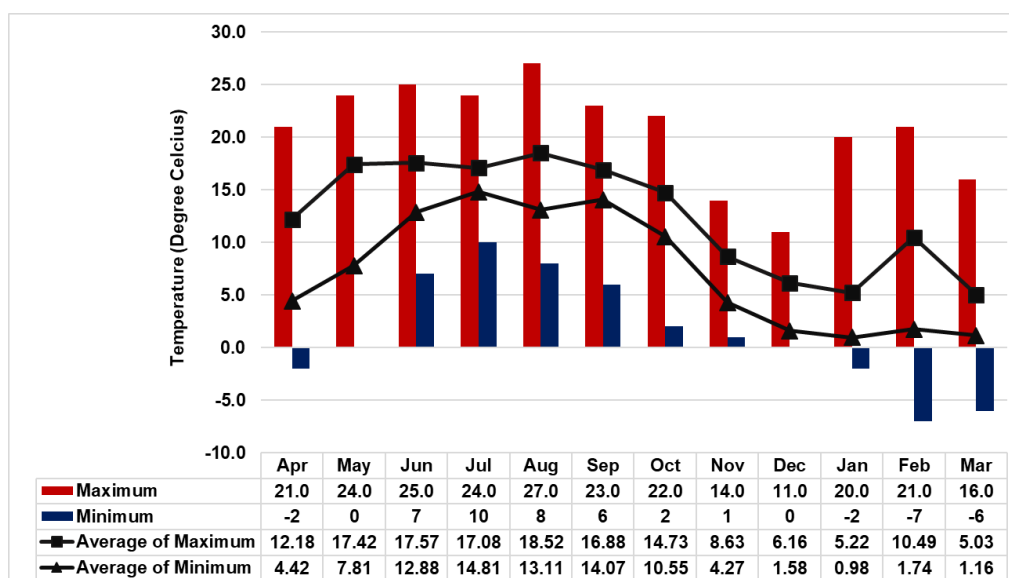
In the Gunitsawa Station, the temperature data from 2011 to 2017 was analyzed. It has been observed that the average maximum annual temperature varies between 5.03°C to 18.52°C at this station. While the average minimum annual temperature varied from -7°C to 10°C. From the analysis of maximum and minimum monthly temperature data, it has been also observed that the average temperature falls during the months of November to March. During this season snowfall in this region is also a major reason for the falling down of temperature. The maximum temperature was in the month of August (27°C) and the minimum temperature was (-7°C) in February.

Figure 2.3: Monthly Maximum and Minimum Temperatures Gunitsawa Station (2011-2017)

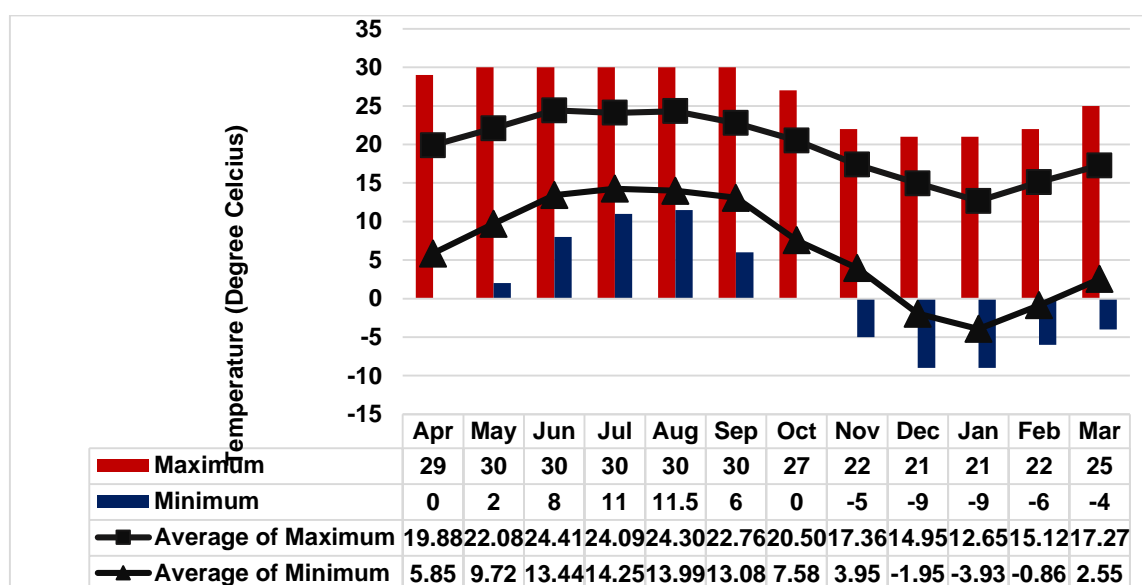
In the ParoDSC Station, the temperature data from 2011 to 2018 was analyzed. It has been observed that the average maximum annual temperature varies between 12.65°C to 24.41°C at this station. While the average minimum annual temperature varied from -3.93°C to 13.99°C. From the temperature analysis, it has been also observed that the average temperature falls down during the months of November to March. During this season snowfall in this region is also a major reason for the falling down of temperature. The maximum temperature is in the month of May-August (30°C) and the minimum temperature was (-9°C) in December and January.

Figure 2.4: Monthly Maximum and Minimum Temperatures ParoDSC Station (2011-2018)

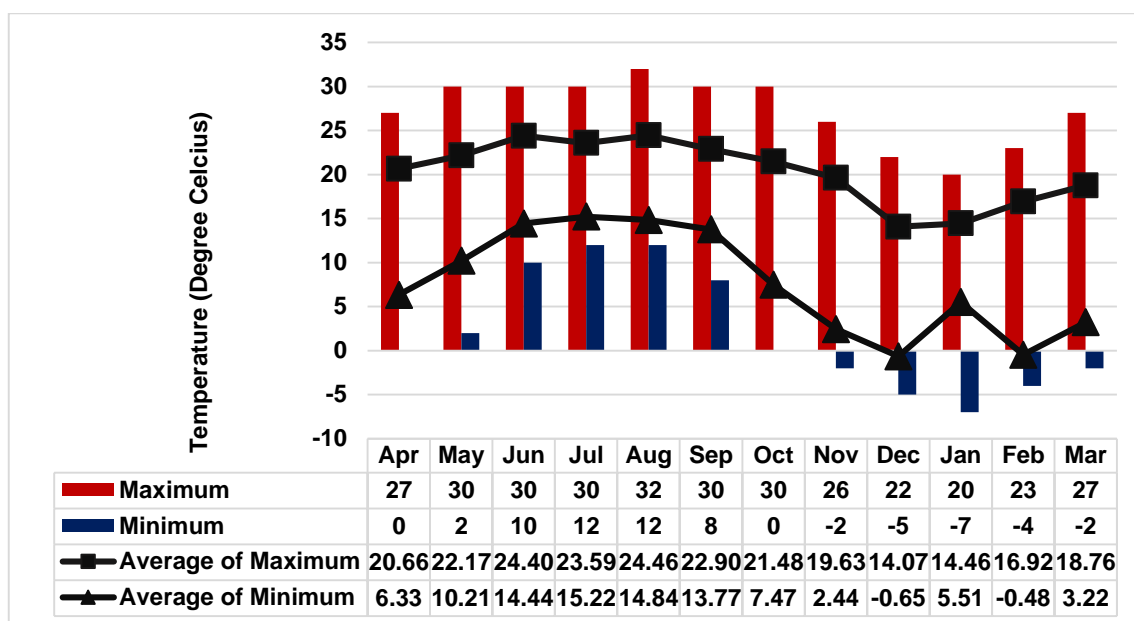
In the Drukgyel Station, the temperature data from 2011 to 2017 was analyzed. It has been observed that the average maximum annual temperature varies between 14.07°C to 24.46°C at this station. While the average minimum annual temperature varied from -0.48°C to 15.22°C. From the temperature

analysis, it has been also observed that the average temperature falls down during the months of November to March. During this season snowfall in this region is also a major reason for the falling down of temperature. The maximum temperature is in the month of August (32°C) and the minimum temperature was (-7°C) in January.

Figure 2.5: Monthly Maximum and Minimum Temperatures Drukgyel Station (2011-2017)

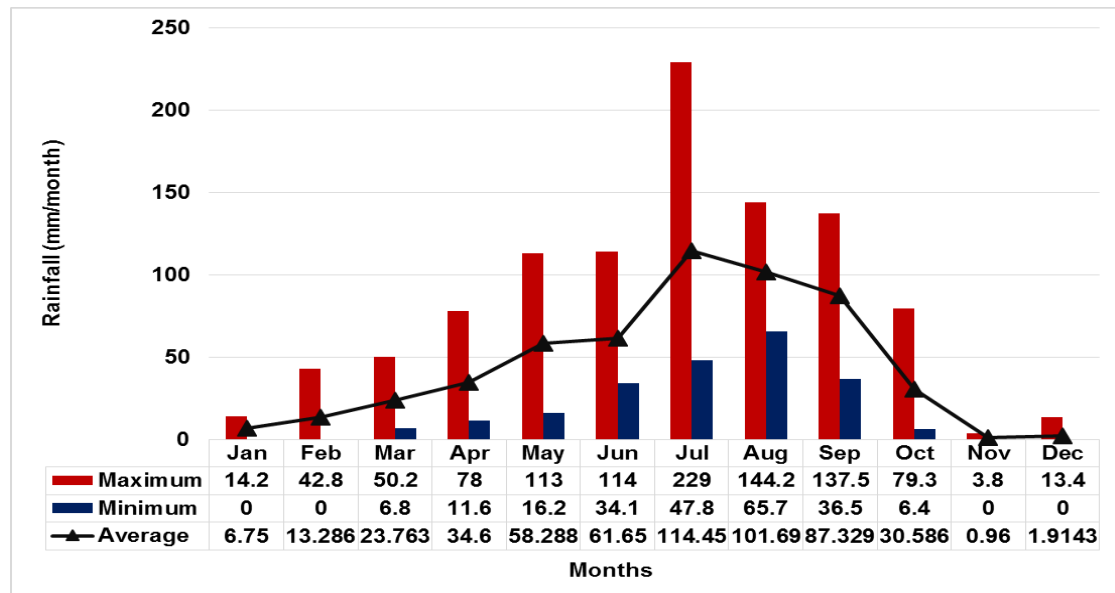
In the ParoDSC Station, the rainfall data from 2011 to 2018 was analyzed (**Figure 2.6**). It has been observed that the average maximum annual rainfall varies between 3.8 (mm/month) in November to 229 (mm/month) in July at this station. While the average minimum annual rainfall varied from 0 (mm/month) in the winter season to 65.7 (mm/month) in May. From the rainfall data analysis, it has been also observed that the average rainfall varies throughout the year. The highest average rainfall was 114.45 (mm/month) in July and the lowest average rainfall was 0.96 (mm/month) in November. From the data analysis, it is also observed that rainfall events start in late April and peaks in the month of July. After this period of time, rainfall starts to decrease. From November to February, the amount of rainfall decreases on a rapid scale.

Figure 2.6: Monthly Maximum and Minimum Rainfall ParoDSC Station (2011-2018)

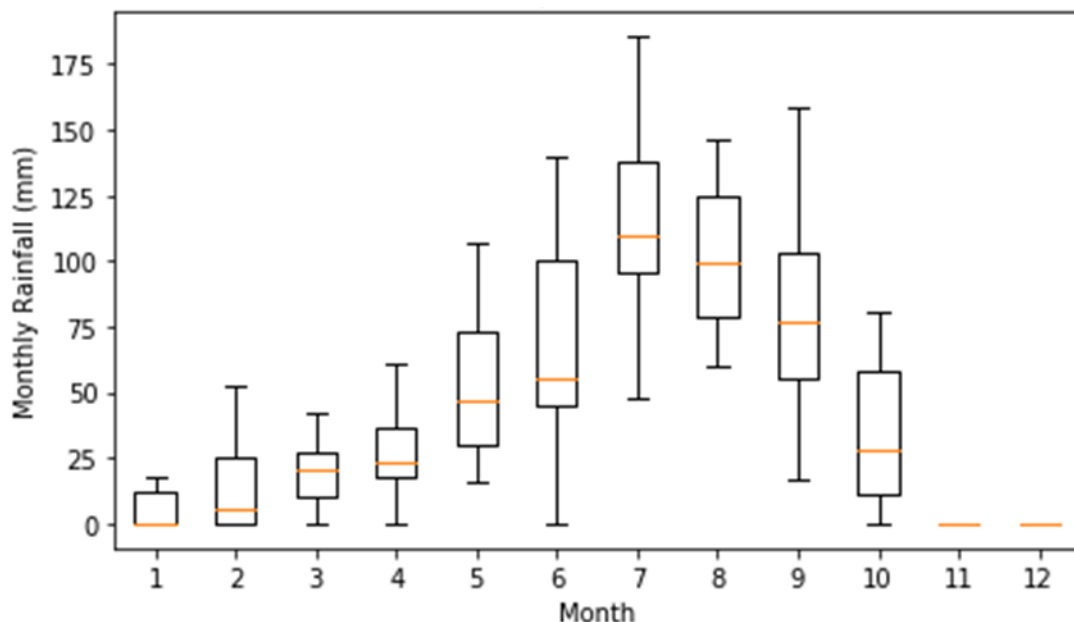
Monthly rainfall distribution analysis is done for 1996-2019 at Paro DSC Station which represents the variance of monthly rainfall increase with the increase of rainfall amount (**Figure 2.7**). The rainfall is noticed from May to October. In June, July and August a large Inter-Quartile Range (IQR) indicate clustering rainfall distribution near the 25th and 75th percentile and large whiskers indicate how markedly the extremes are from the remaining sample. The highest maximum is observed in July which is 180 mm. From January to April the rainfall is comparatively low but these months represent a different distribution of rainfall. There is no rainfall from November to December. From January to April the rainfall is distributed about the median but in February the long tail of maximum extreme indicates large dispersion of the relative outliers.

Figure 2.7: Distribution of monthly rainfall at Paro DSC Station

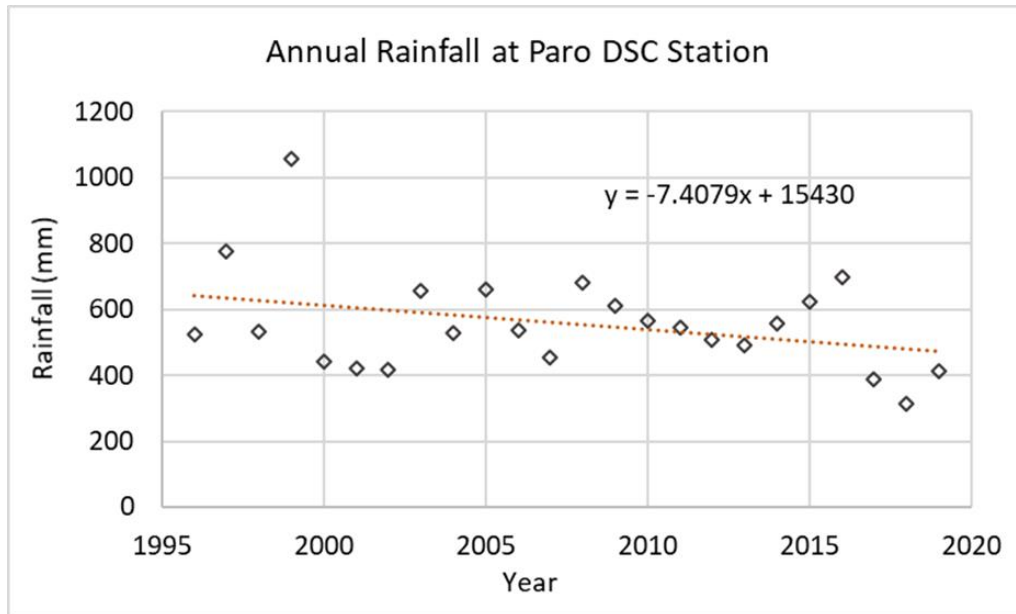
Figure 2.8: Annual rainfall trend at Paro DSC Station

The annual rainfall trend of at Paro DSC Station is shown in **Figure 2.8**. It has been observed that the rainfall is in a decreasing trend. From the rainfall data analysis, annually around 7.41 mm rainfall is being decreased. The average annual rainfall is 560 mm and the annual rainfall varies from 313 to 1058 mm.

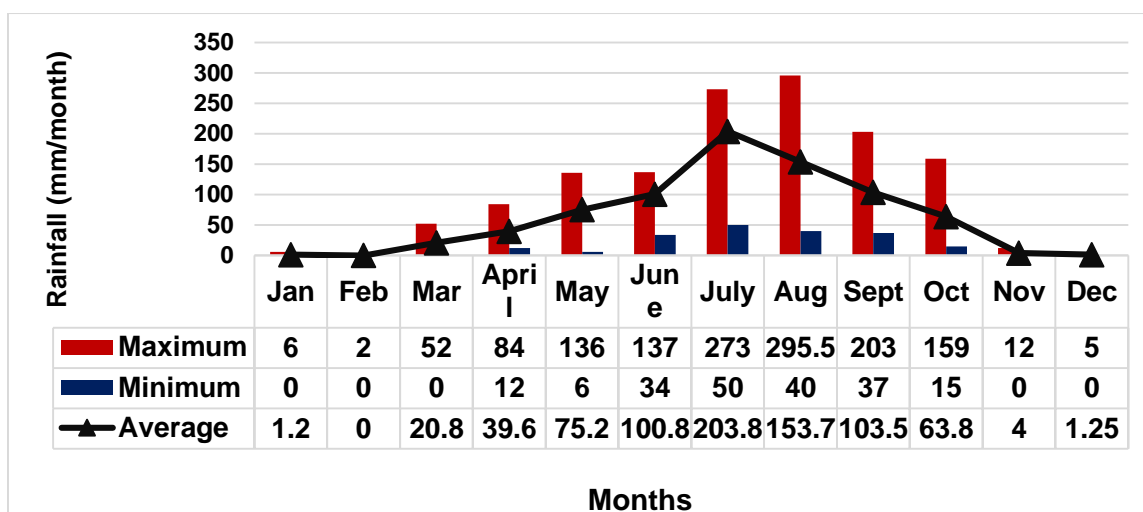
In the Drukgyel Station, the rainfall data from 2011 to 2017 was analyzed (**Figure 2.9**). It has been observed that the average maximum annual rainfall varies between 2 (mm/month) in February to 295.5 (mm/month) in August at this station. While the average minimum annual rainfall varied from 0 (mm/month) in the winter season to 50 (mm/month) in July. From the rainfall data analysis, it has been also observed that the average rainfall varies throughout the year. The highest average rainfall was 203.8 (mm/month) in July and the lowest average rainfall was 0 (mm/month) in February. From the data analysis, it is also observed that the rainfall event starts in late April and peaks during the month of July and August. From November to February, the amount of rainfall is negligible at this station.

Figure 2.9: Monthly Maximum and Minimum Rainfall Drukgyel Station (2011-2017)

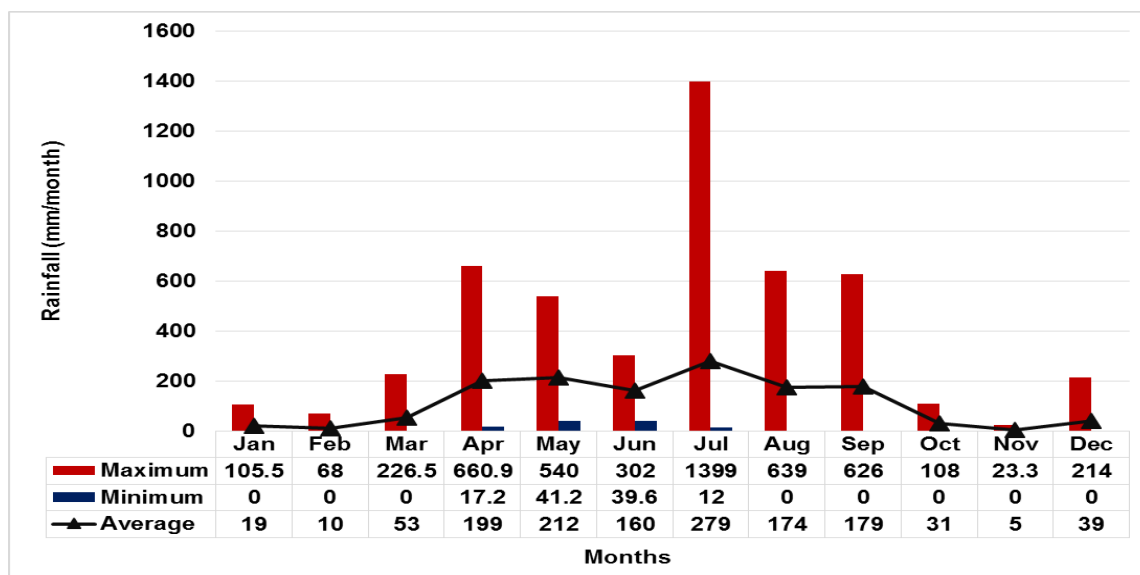
In the Gunitsawa Station, the rainfall data from 2011 to 2018 was analyzed (**Figure 2.10**). It has been observed that the average maximum annual rainfall varies between 23.3 (mm/month) in November to 1399 (mm/month) in July at this station. While the average minimum annual rainfall varied from 0(mm/month) in the winter season to 41.2 (mm/month) in May. From the rainfall data analysis, it has been also observed that the average rainfall varies throughout the year. The highest average rainfall was 279 (mm/month) in July and the lowest average rainfall was 5 (mm/month) in November. From the data analysis, it is also observed that rainfall events start in late April and peaks during the month of July and August. After this period of time, rainfall starts to decrease. From November to February, the amount of rainfall decreases tremendously.

Figure 2.10: Monthly Max and Min Rainfall Gunitsawa Station (2011-2018)

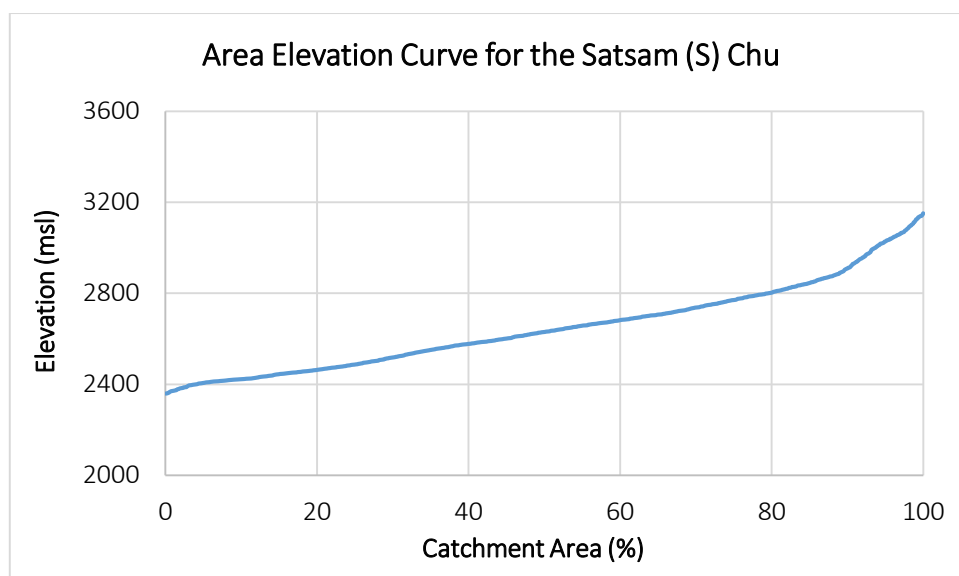
Figure 2.12 shows the area elevation curve for the Satsam (S) Chu. It is observed that overall elevation in this catchment ranges between 2400 to 2800 m maintaining slight variation in altitudes.

Figure 2.12: Area Elevation Curve for the Satsam (S) Chu

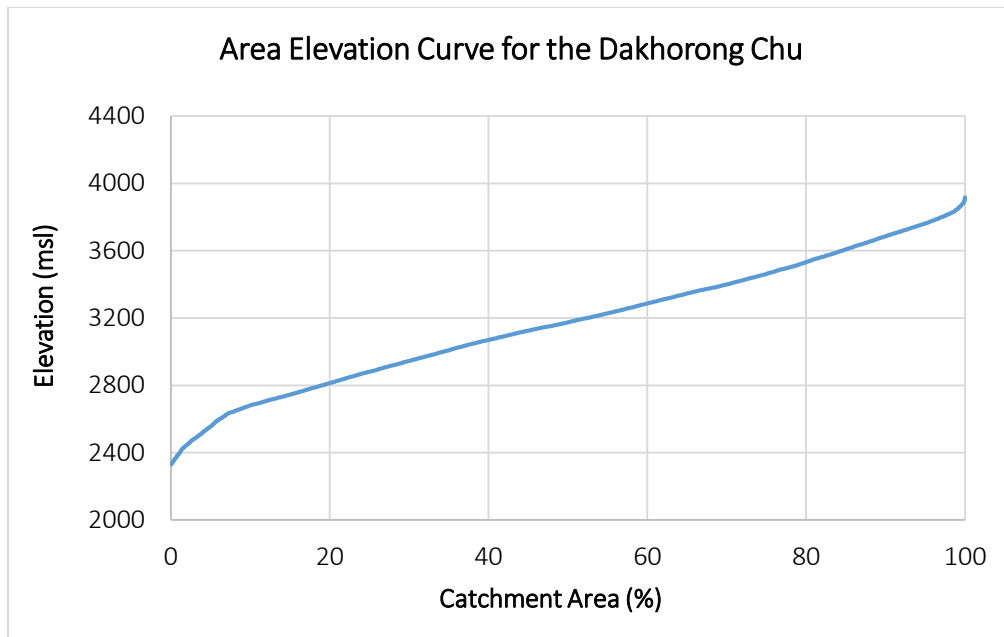
Figure 2.18 shows an Area Elevation Curve for the Dakhorong Chu. According to **Figure 2.16**, it is observed that a dominant percentage of the area contains an elevation ranges between 2800 to 3600 by maintaining a steep slope. **Figure 2.19** shows the longitudinal profile of Dakhorong Chu which illustrates a steep profile of stream.

Figure 2.18: Area Elevation Curve for the Dakhorong Chu

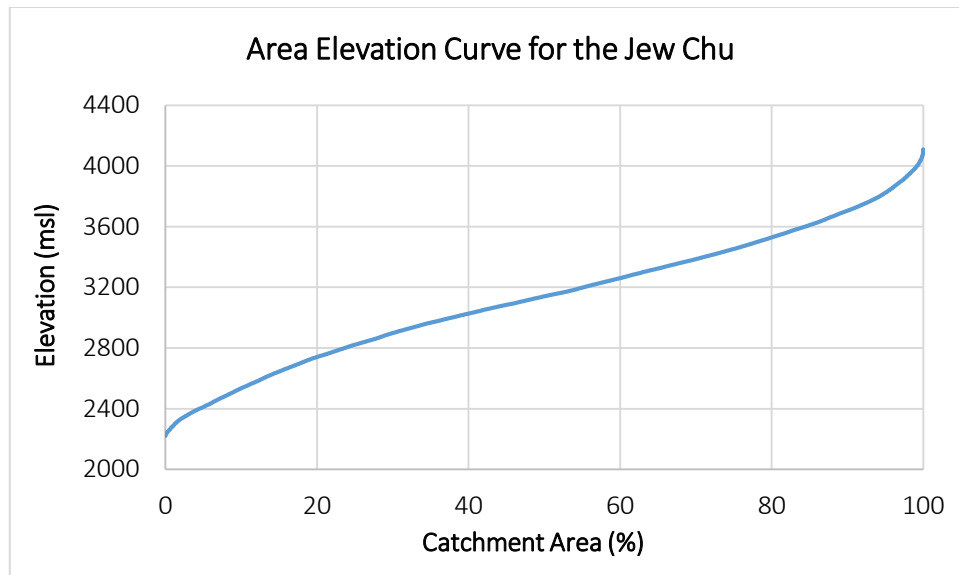
The line graph of **Figure 2.27** gives information about elevation concerning the catchment area of the Jew Chu. The overall elevation of surrounding regions varied from 2200 m to 3800 m in between more than 70% of the area lies in the elevation ranges from 2600 to 3400 m. Besides, about 20% area lies in between elevation ranges from 2200 to 2600 m, and the rest one-tenth portion of the total area lies in higher altitude, ranges from 3400 to 3800m. Overall the area obtained a dominant altitude of 3000m to 3600m where the overall slight variation of altitude is observed from the curve.

Figure 2.27: Area Elevation Curve for Jew Chu

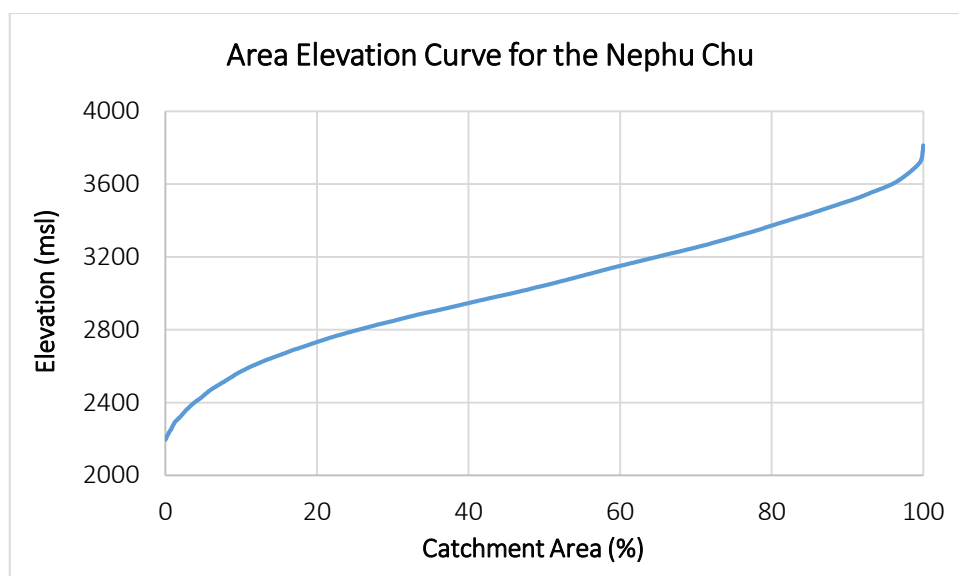
The line graph of **Figure 2.33** shows the area elevation curve for the area of the Nephu Chu. According to the curve, it is observed that the overall elevation of the catchment varied from 2200 m to 3800 m where more than 70% of the area lies in the elevation ranges from 2600 to 3400 m. Besides, about 20% area lies in between elevation ranges from 2200 to 2600 m, and the rest one-tenth portion of the total area lies in higher altitude, ranges from 3400 to 3800m.

Figure 2.33: Area Elevation Curve for the Nephu Chu

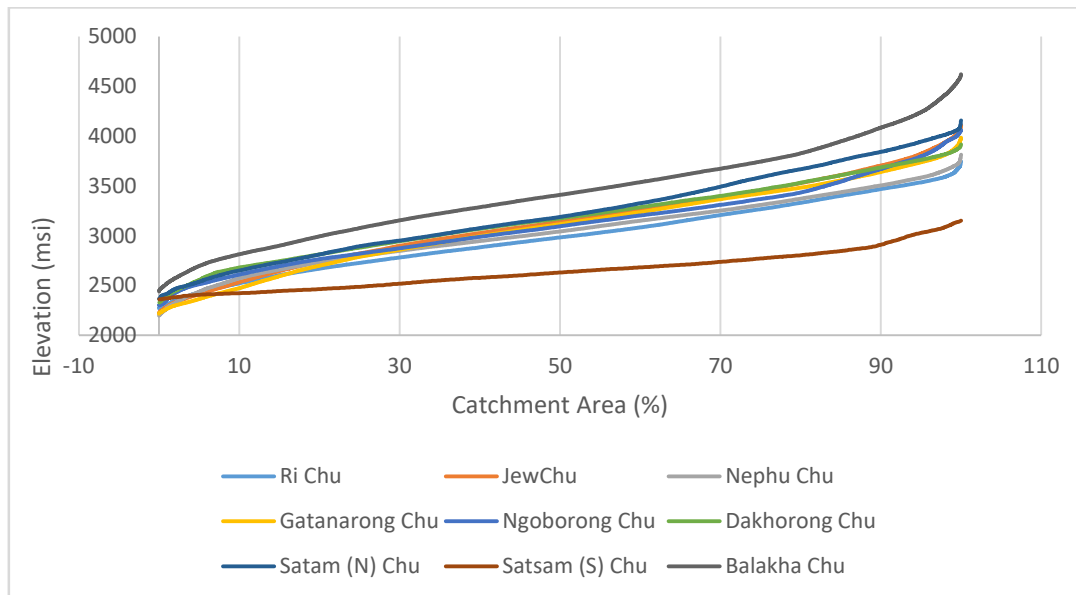
The line graph of **Figure 2.36** illustrates the area elevation curves of the eight streams. All the streams except Balaka Chu and Satsam (South) Chu represent a steady steep slope where a gentle variation of altitude is observed with respect to the percentage of area. But soaring of Balaka Chu is observed in the graph. Balaka Chu also experienced a wide range of altitude varieties compared to other streams while Satsam (South) illustrated a very steady slope and gentle variation of altitude over the catchment area.

Figure 2.36: Area Elevation Curves of Streams

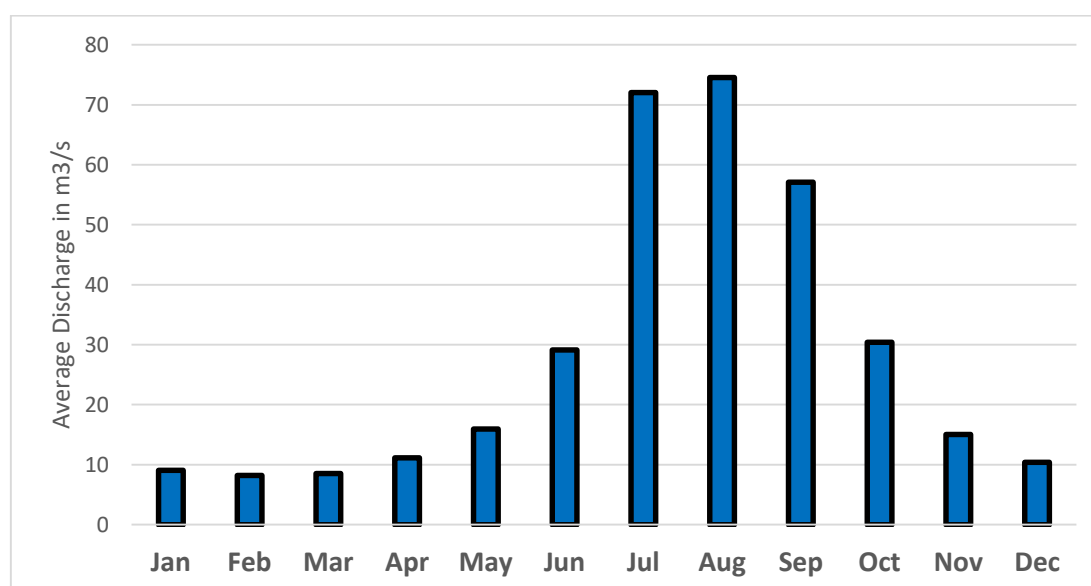
Figure 2.38 illustrates the average monthly discharge of Paro Bondey for the year 2014 to 2019. In Bhutan, dry season is considered from October to April whereas the wet season is considered from May to August. Paro Bondey Station recorded about 50 m³/s of flow during the wet season with a maximum of 74.5 m³/s while in the dry season, about 13.5 m³/s of flow with a maximum of 28 m³/s. In the month of July and August, Paro Bondey recorded the maximum discharge of 72-75 m³/s.

Figure 2.38: Average Monthly Discharge of Paro Bondey (2014-2019)

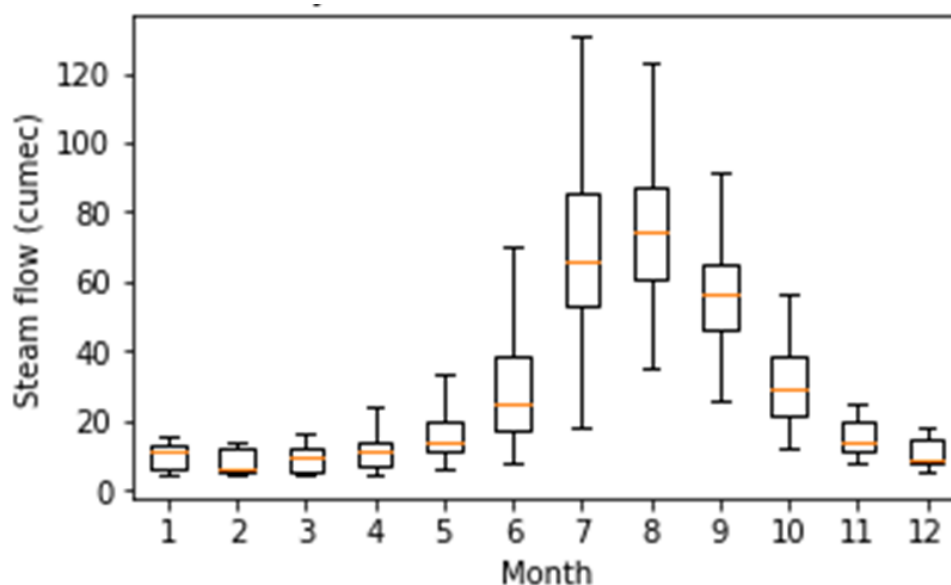
The Box and Whisker plot of the monthly flow distribution of Pa Chu is shown in **Figure 2.39**. The boxes are bound by the 25th and 75th percentiles of the datasets, while the heavy mid-line displays the median value. The graph indicates that streamflow is high from July to October as the streamflow is above the median level during these months. The maximum streamflow is observed from July to August which are above 120 cumec. During the month from November to February the dispersion of stream is small also the maximum and minimum stream flow lies close to where the whisker ends, whereas April to May shows that despite the smaller dispersion of stream values where the maximum value is far away from the whisker end. The month of May to June also indicates that the streamflow data is clustered about the median where the long tails represent a large dispersion of the relative outliers which includes the maximum and minimum streamflow.

Figure 2.39: Variability of streamflow at Paro station (Bondey) during 2014-2019

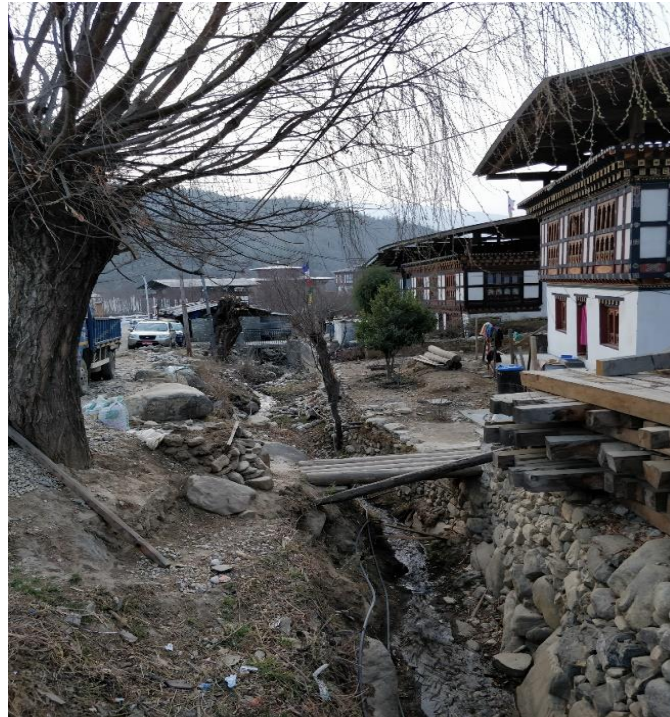
Encroachment in lake shorelands usually is comprised of residential development and associated vegetation removal; it can also include roads, parks and beaches and urban areas. Recent development patterns on lakeshores have seen replacement of small "camps" with larger houses suitable for year-round use. This new development generally is accompanied by substantial lot clearing, lakeshore bank armoring and an overall increase in lawn coverage and impervious surface. Research in Vermont and nationally has shown this land conversion and development results in degraded shallow water habitat and increased phosphorus and sediment runoff. Encroachments into the lake itself include docks, retaining walls, bridges, fill and dredging. The table below documents the effects of encroachment upon surface waters. Figure 4 and 5 illustrates the typical and schematic diagram of river encorachment.

Figure 3.3: Typical Encroachment at Nephu Chu

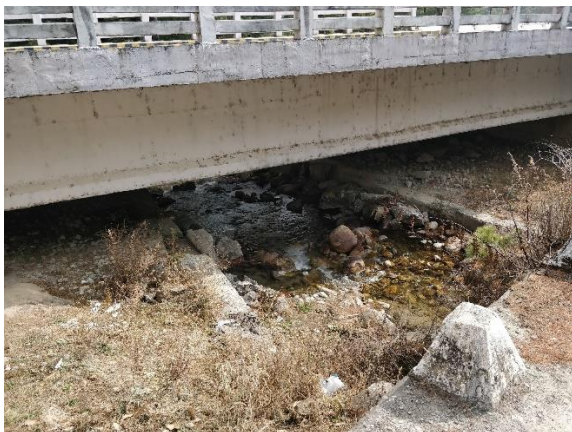
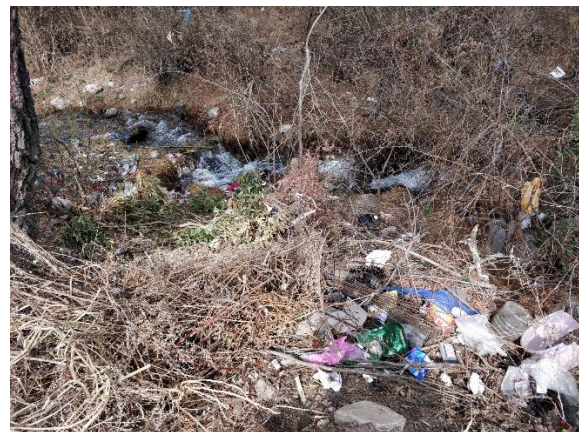
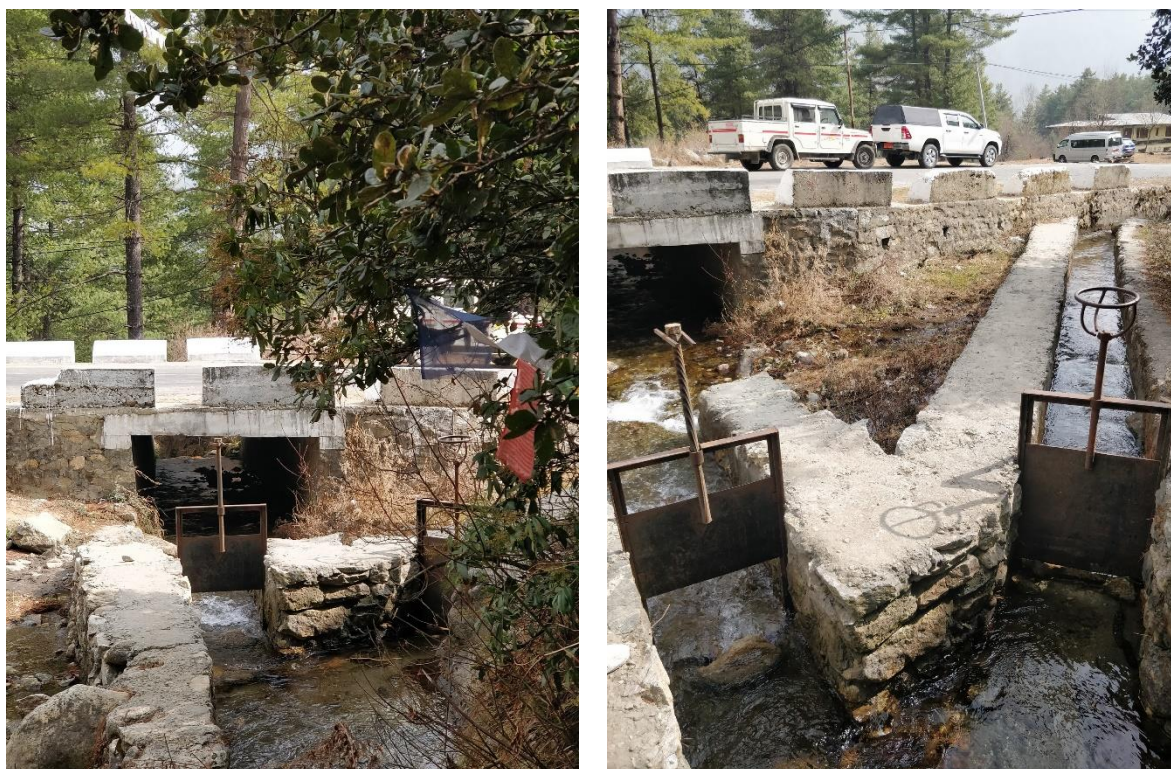
Balaka Chu originated from relatively uphill terrain which outfalls at Pa Chu. Traverse steep slope has been observed before it discharges into Pa Chu. An old bridge with inadequate opening constricted the flow in the upstream. Monsoon water comes to the bridge level often. Substantial flow has been diverted via irrigation canals which can reduce flood risk. Vegetation around both the banks included forest trees and bushes need to be cleared. Boulders need to be removed from the flow path to increase conveyance capacity.

Figure 3.5: Balakha Chu

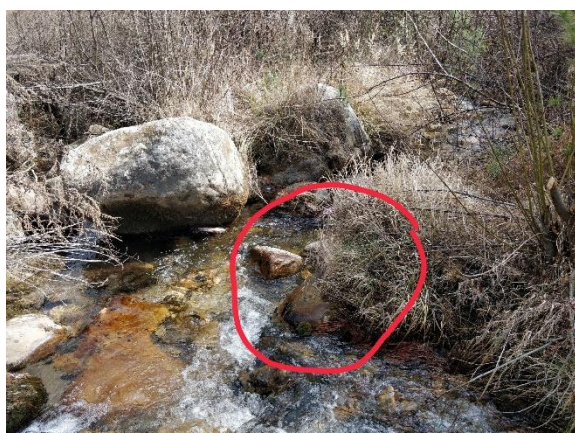
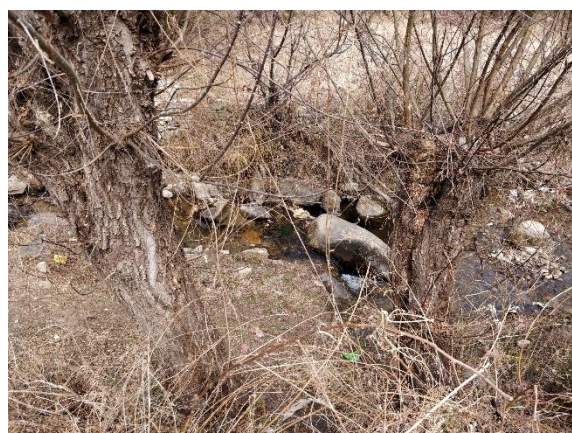
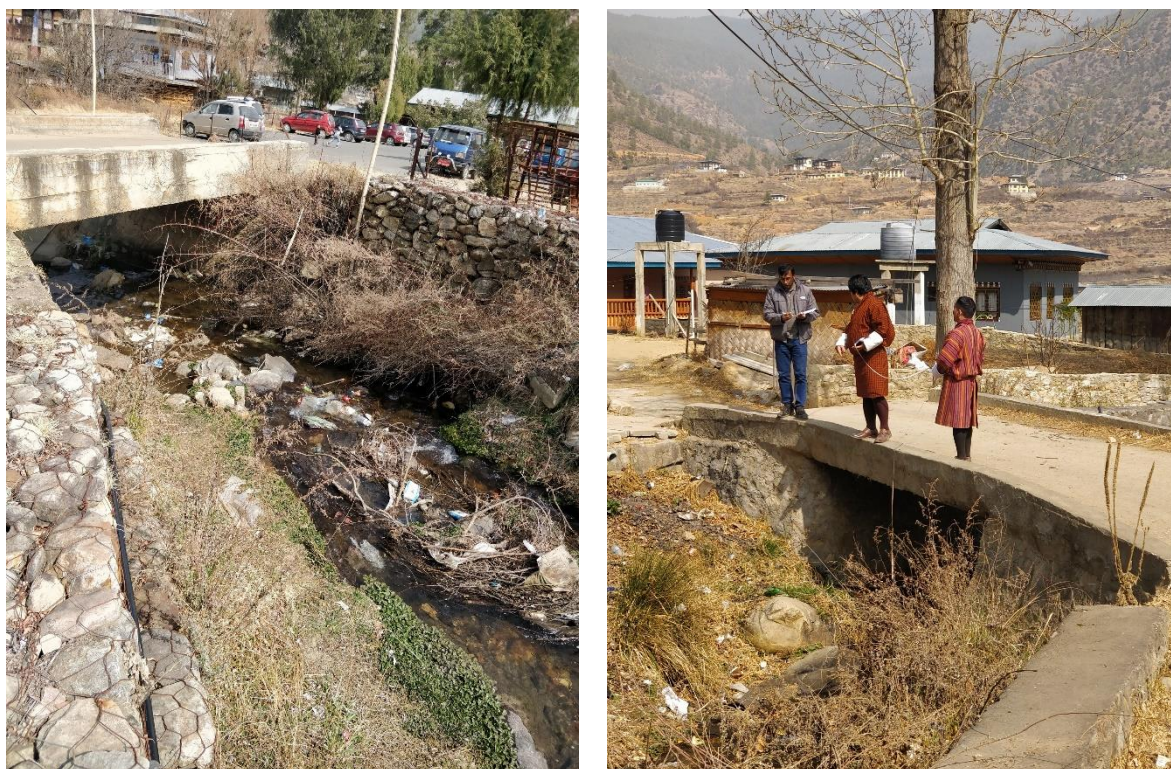
The flow of Jew Chu is obstructed due to unplanned settlements, regular farming practices and heavy sediment depositions. Passage of flow has been constricted due to abutments and pipes with inadequate diameter. Clearing of boulders may provide some immediate solution for smooth flow passage. Roads need to be elevated in designated portion. Impact of erosion results in failure of right-bank gabion in the u/s and d/s of the structure. Streams seemed to be widened up substantially in the d/s. Clearing of dense vegetation and bushes need to be done. It is recommended to construct a box culvert with guide wall at designated portion. Furthermore, adequacy of channel section will be checked via hydro dynamic model simulations.

Figure 3.6: Jew Chu

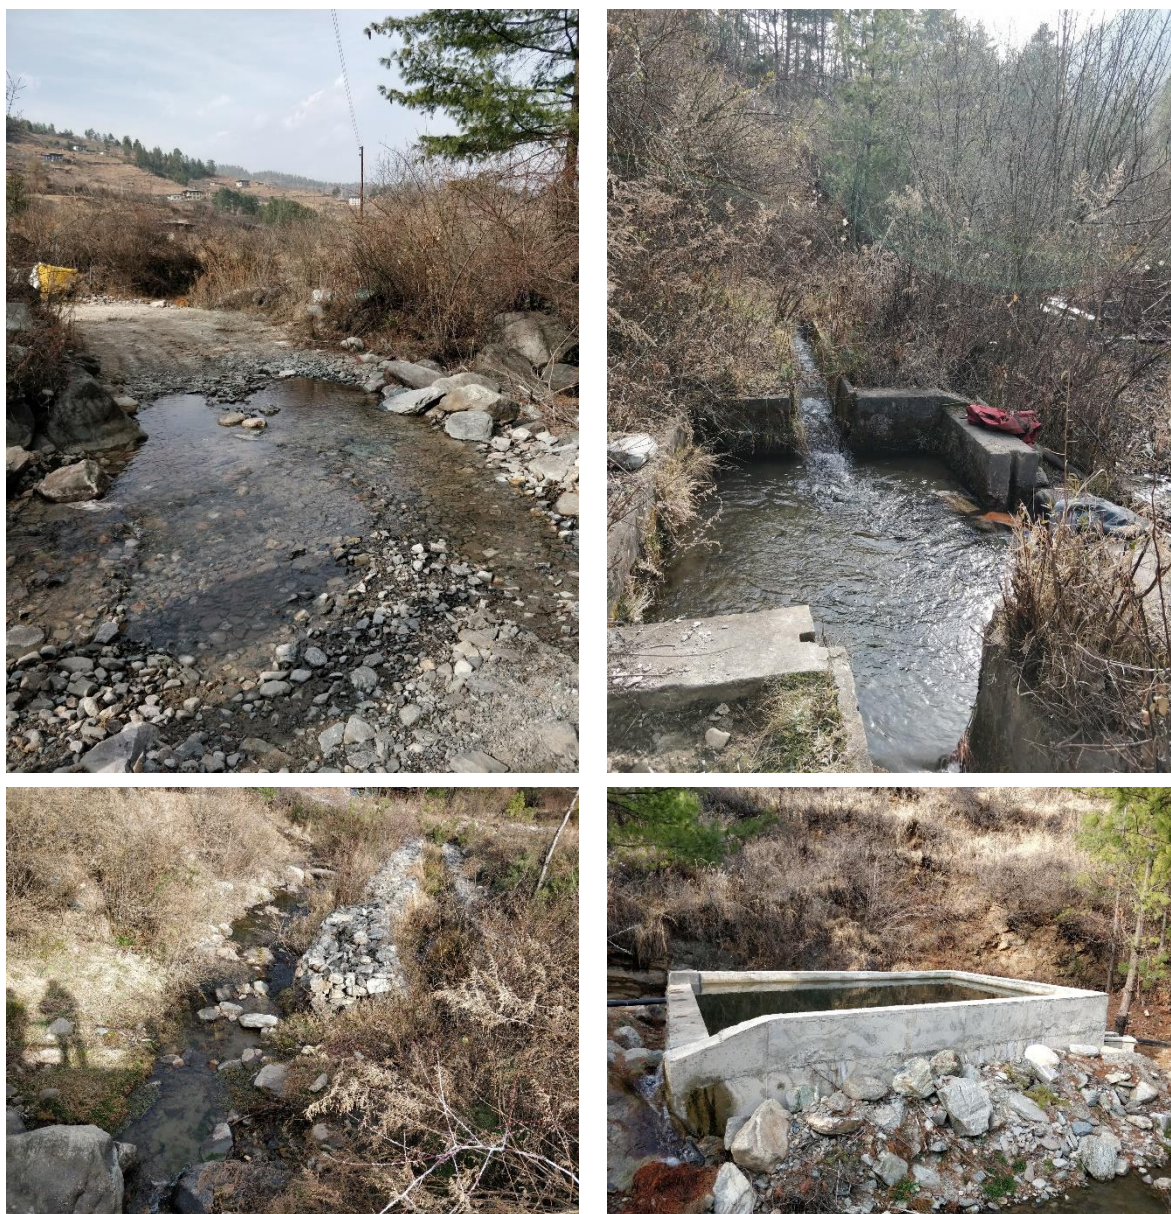
Flow of Upstream portion of Gatanarong Chu is being constricted due to heavy siltation and random landslides. In some portion intentionally bed filling to accommodate vehicular and pedestrian crossing is observed which is highly recommended to be replaced by bridges or culverts. Box culvert is recommended at some places. An irrigation canal is observed at d/s portion which helps to reduce the vulnerabilities of flood. Some bridges with no railing has been observed and recommended to repair. Near d/s approximate 150 m to 200m of channel should be guided with retaining wall on both banks for protection against encroachment. Downstream portion is covered by dense bushes which are recommended to be cleared for reducing increased roughness co efficient.

Figure 3.7: Gatandarong Chu

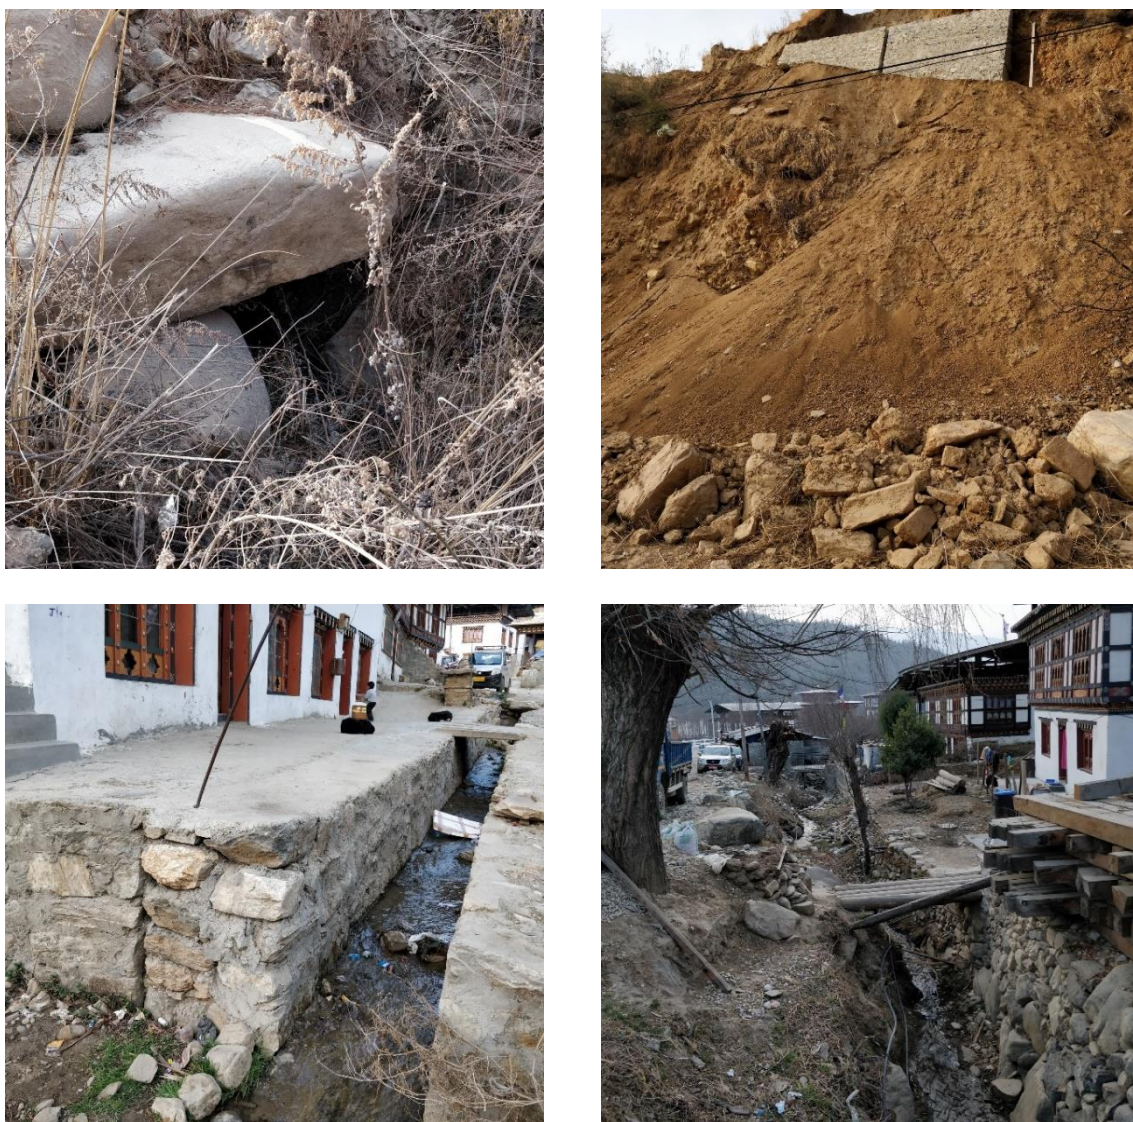
The streams started with the combination of wild vegetation and settlements which causes severe narrowing of flow passage at the up streams. Steep slopes have been observed. Unplanned development in association with unsafe hill cuts for construction works causing imminent landslide risks. Encroachment along d/s right-bank from unplanned settlements severely constricting flow passage which is recommended to demolish to increase the conveyance capacity. Stream is observed narrowed in d/s, which is incapable of conveying design discharge. Debris near outfall where stream traverses highway bridge need to be cleared.

Figure 3.8: Nephu Chu

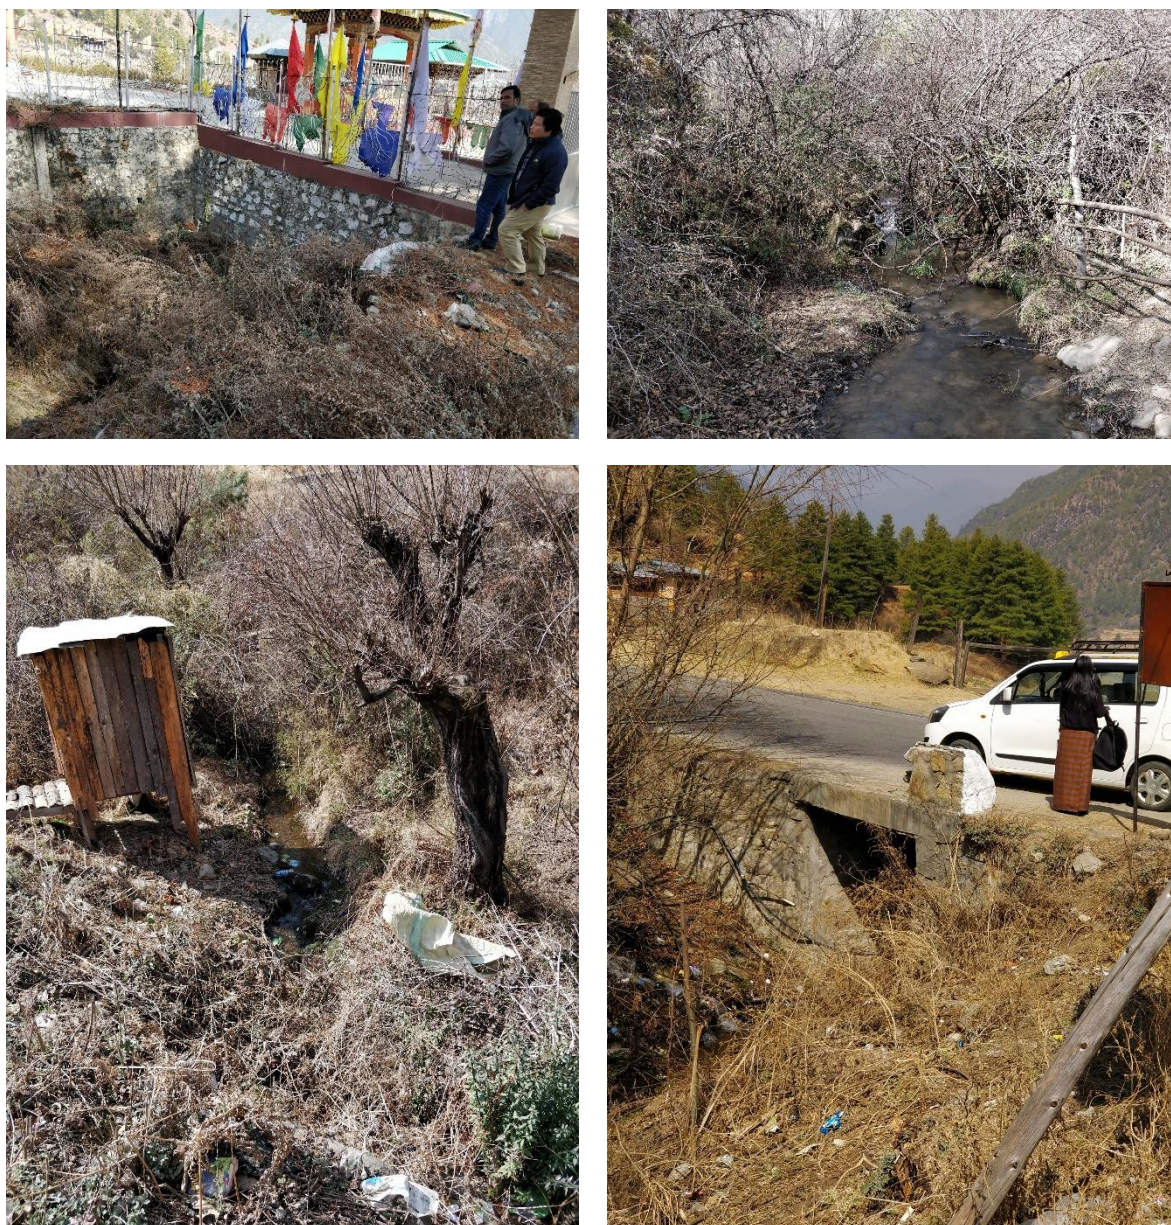
Upstream of Satsam (North) Chu is being generated debris from temporary stone grinding site which causes siltation of stream bed and banks. This portion is crisscrossed across road where flow is accommodated via pipe culverts. Cross drainage structures reduced the cross section of streams which results in constricted flow passage. Some construction site obstructed the flow via filling up bed for vehicle passage which is recommended to be re-sectioned. A local resort block entirely of flow passage via illegal expansion of property is recommended to demolish immediately. Dense bushes in d/s are recommended to be cleared. Narrow highway culvert at out fall is recommended to be widened.

Figure 3.9: Satsam (North) Chu

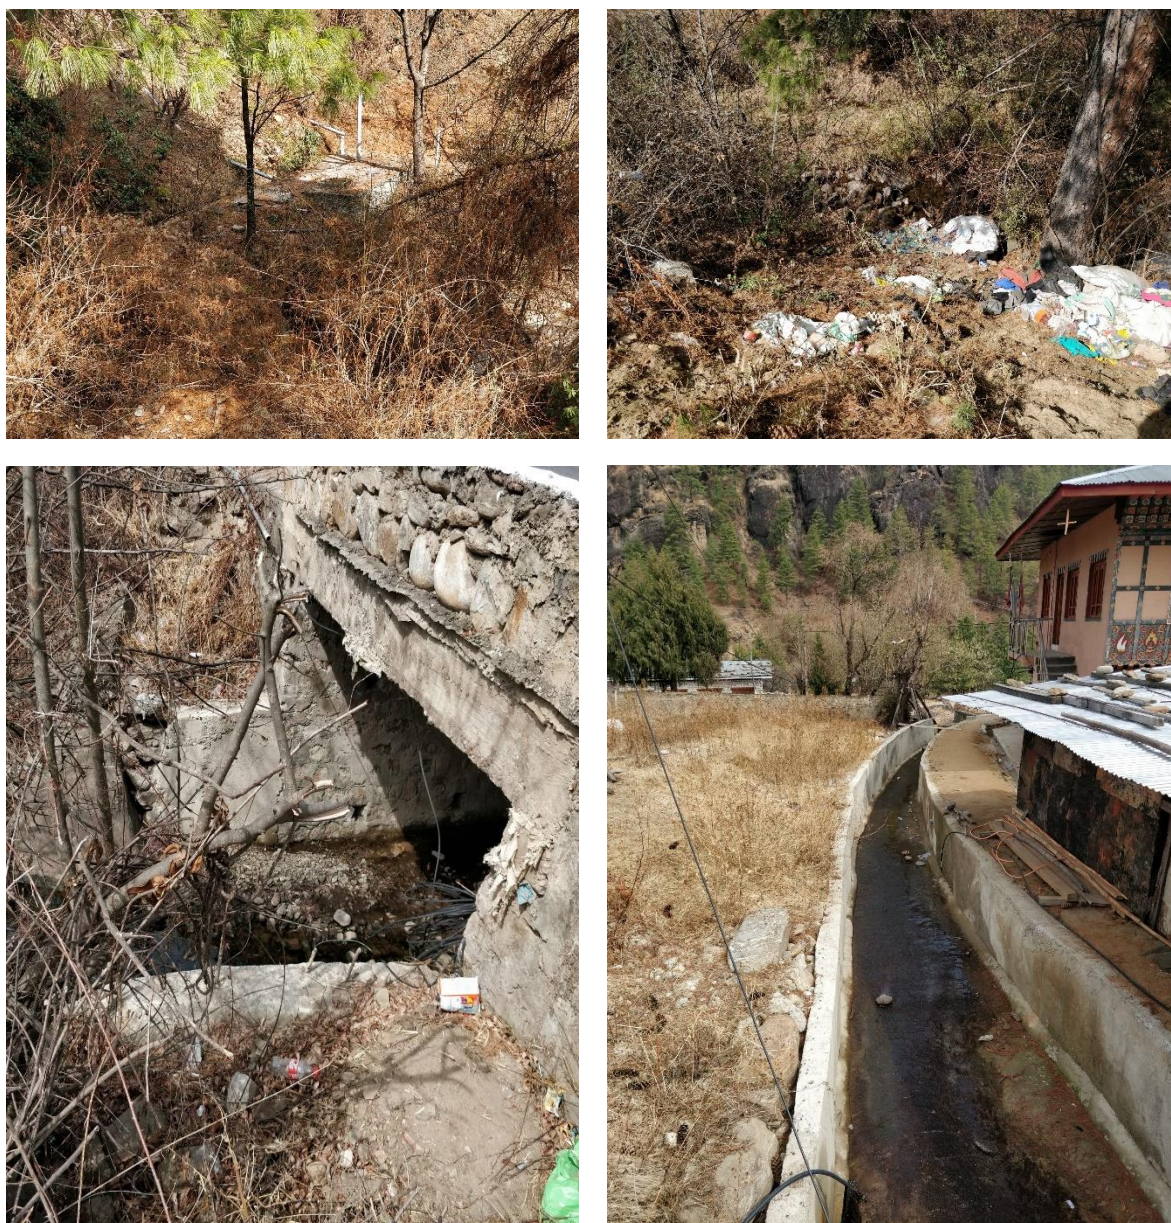
Upstream portion were inaccessible due to dense vegetation and forest and is becoming narrow as it traverses across hill-side road through a narrow culvert, restricting flow passage near which bed is at road level. Culvert with adequate capacity is recommended here. Unplanned waste disposal observed which obstructs the flow passage. A septic tank in very close quarters along the left bank is observed which is recommended to be removed. Regular cleaning of bushes are required for ensuring the flow in d/s. Heavy downpour cause severe flooding at the d/s most portion due to narrow flow passage. In the d/s portion a highway culvert is recommended to be widened up.

Figure 3.10: Satsam (South) Chu
