Volume II: Main Report

Final Report

Preparation of Flood Management Plan for Paro Dzongkhag

June 2020

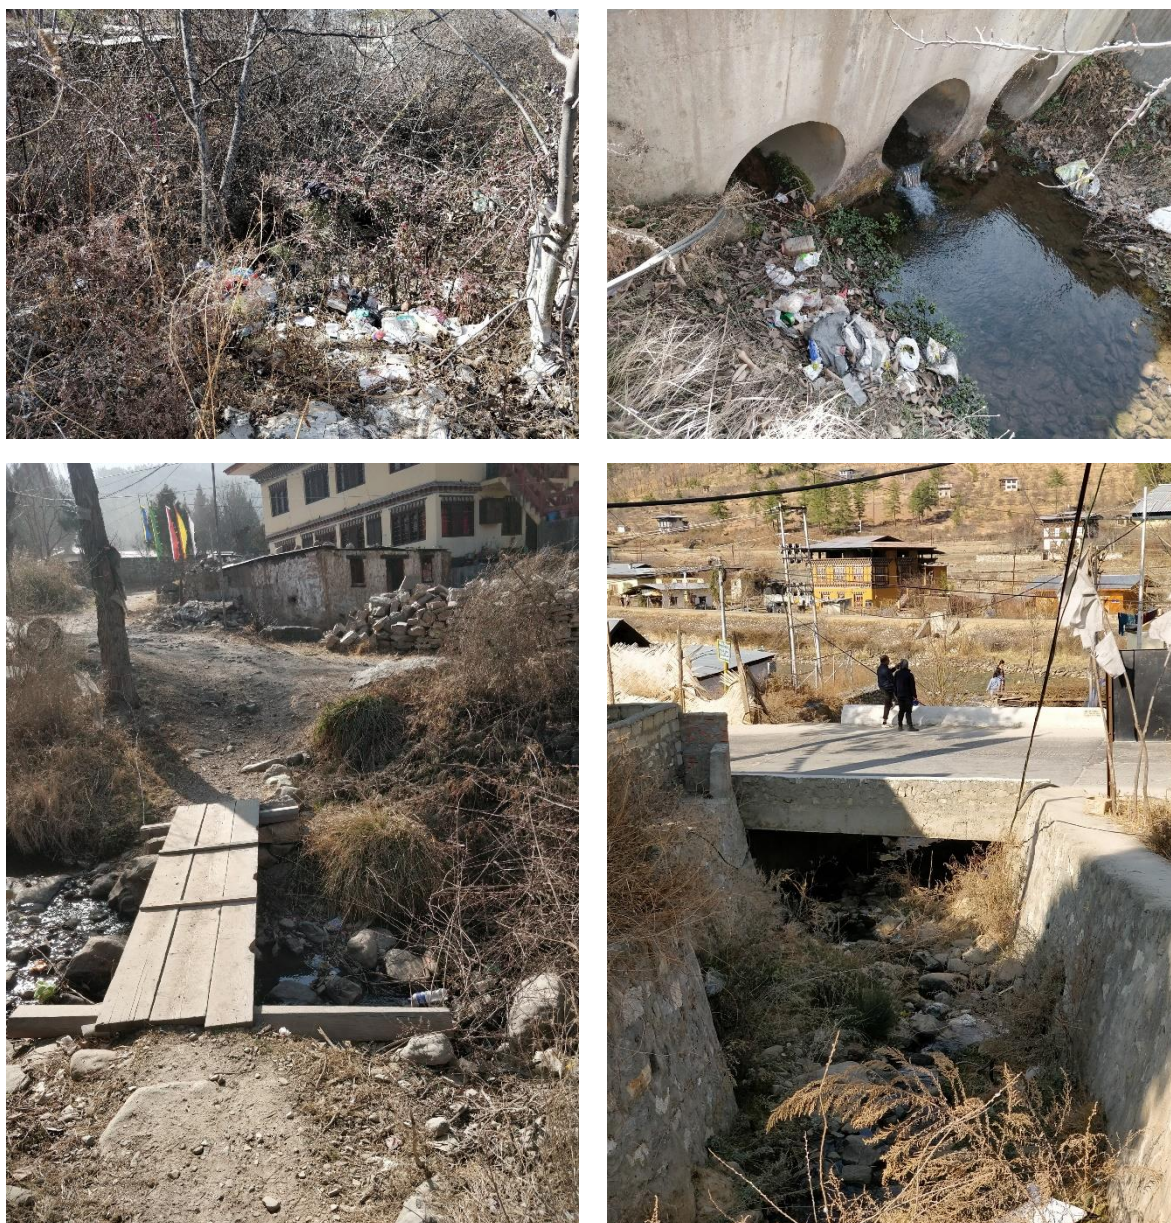
In the upstream portion dense bushes along both banks are recommended to be cleared immediately. Clearing of boulders is also recommended to increase conveyance capacity of the streams. Further towards downstream three-piped culvert layout with adequate opening but unnecessarily wide spacing has been observed. Clearing of shrubs and cleaning of dumped waste near stream mid-section is recommended. Mid portion of this streams is narrowed due to encroachment and settlement. In some portion cross drainage structures are recommended. Downstream portion is protected and stream passes through highway culvert which might have to be raised to maintain adequate flow section. Overall the channel sections seemed wide enough in the u/s and d/s portions with some substantial narrowing in the middle portion.

Figure 3.11: Dakhorong Chu

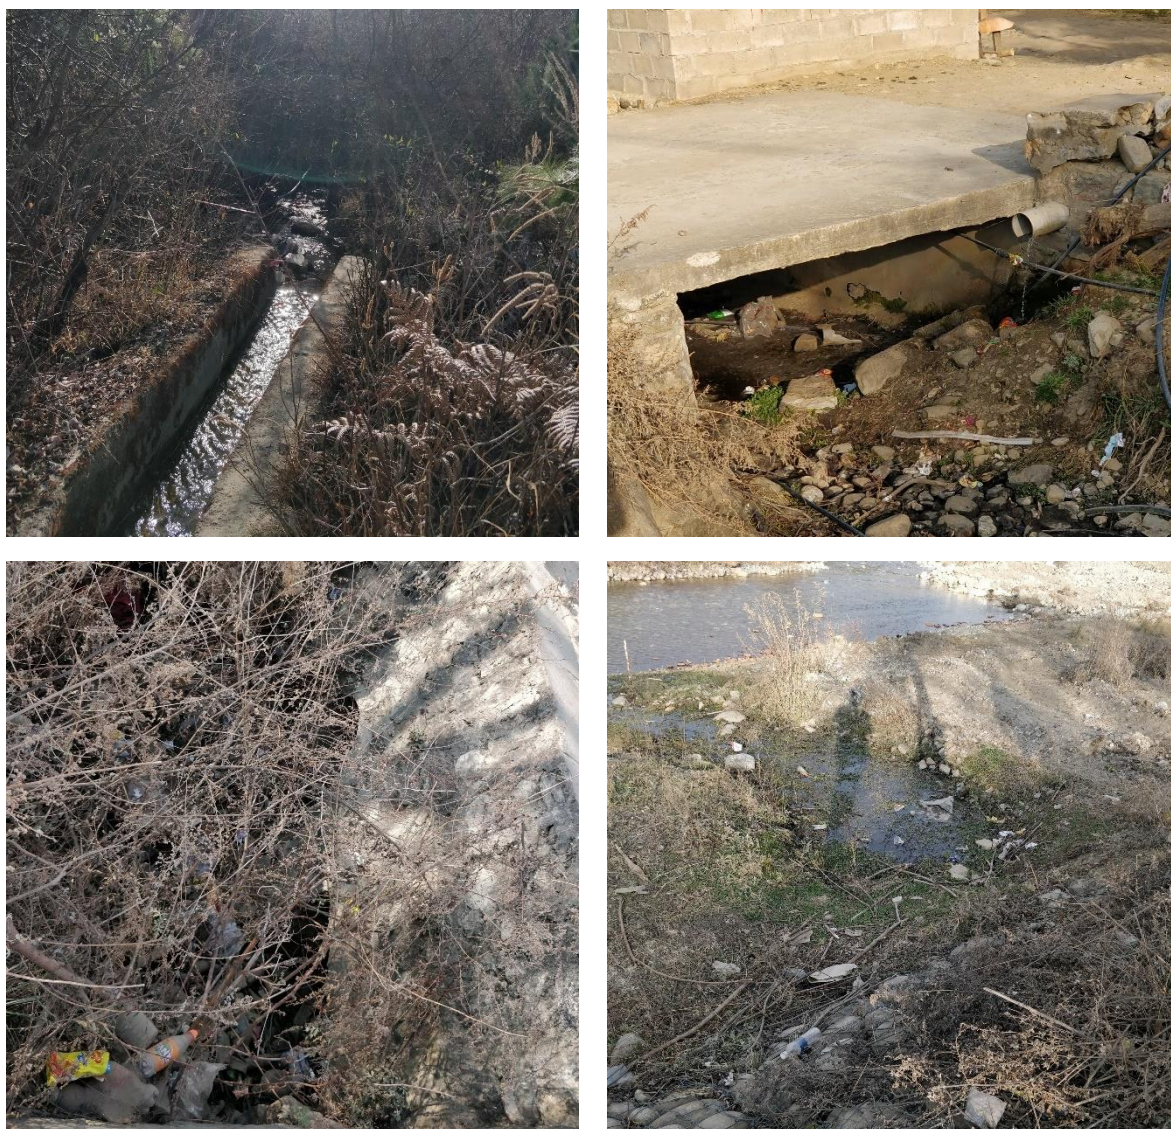
Substantial portion of u/s is protected along both banks due to settlements but section adequacy checking may be required. Excessive siltation from bank erosion and unplanned rural settlement make the mid portion of the channel narrowed. Some key locations are being obstructed by large boulders which affects smooth conveyance capacity. Dense bushes cleared and narrow culverts re-sectioned to increase conveyance. Though downstream portion of this stream is guided and regulated some unregulated land filling in downstream may be severely obstructed the flow which is recommended to be cleared immediately. A two-piped culvert blockage in d/s side causing flow obstruction at outfall and have to be cleared. D/s portion of outfall blocked as water seepages through geobags and slowly discharges into the Pa Chu.

Figure 3.12: Ngoborong Chu

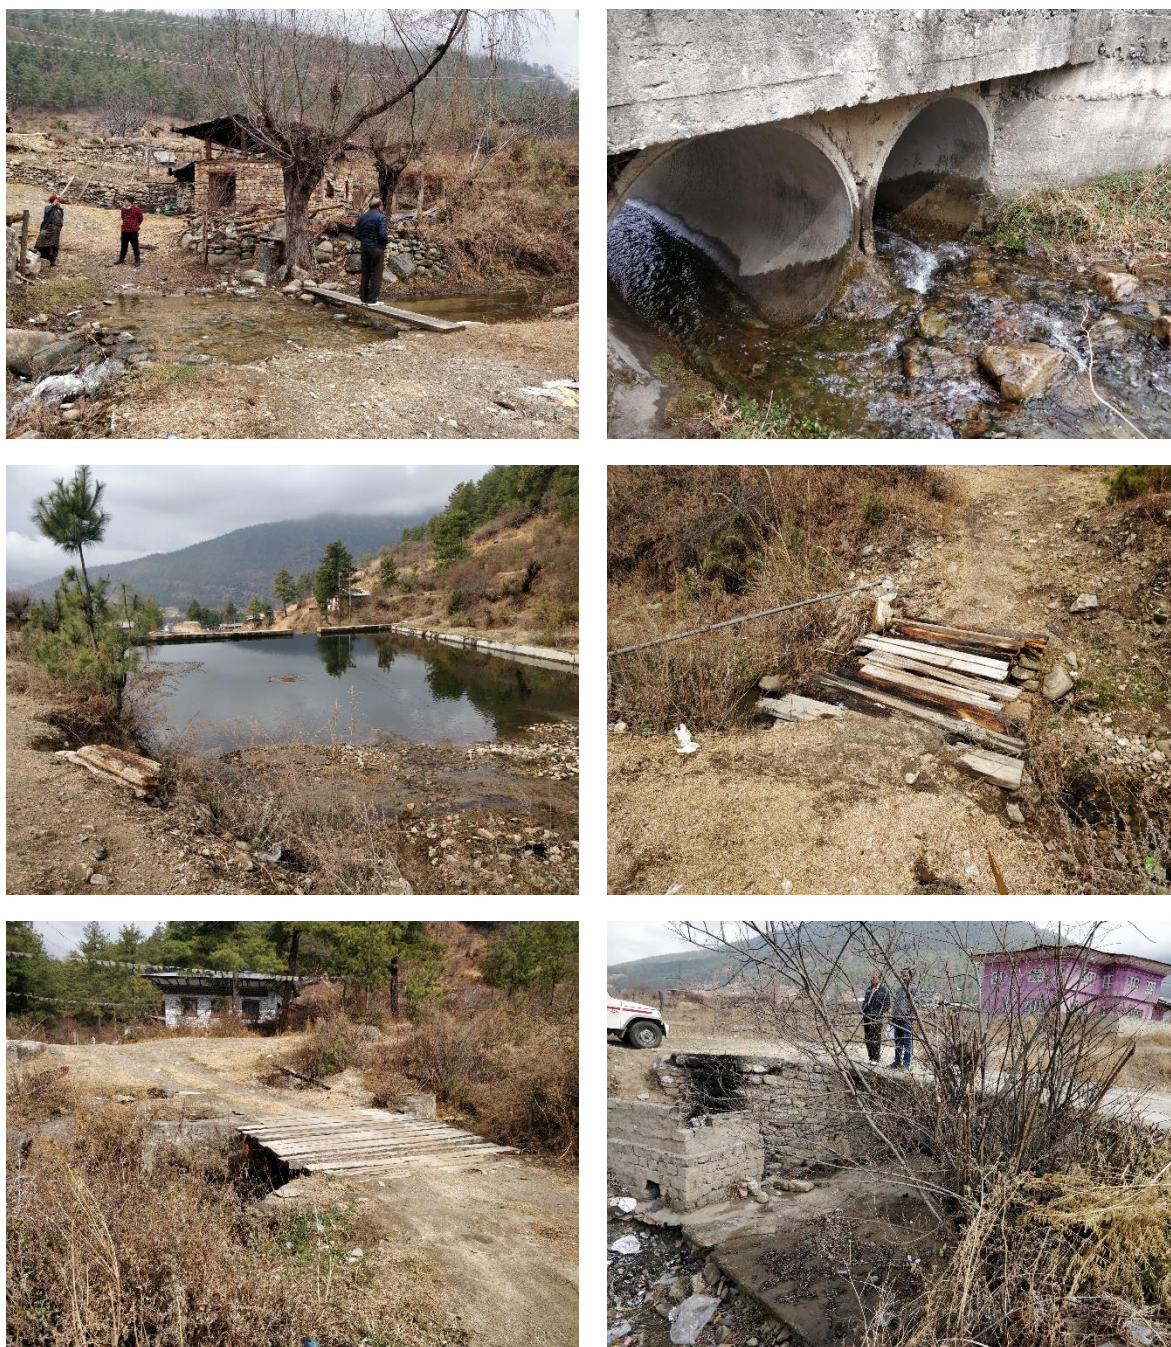
Upstream portion inaccessible due to dense forests. Rich dam, which was constructed for irrigation water diversion is silted up and almost non-functional. The depth of reservoir is insufficient so a deeper reservoir is recommended which would allow more storage as well as give incentive for fisheries practices. Siltation and unplanned settlement make stream section significantly narrower in d/s portion, which may need re sectioning furthermore the discharge point to Do Chu is wide but proper connection has to be established via re-sectioning of the u/s segments.

Figure 3.13: Ri Chu

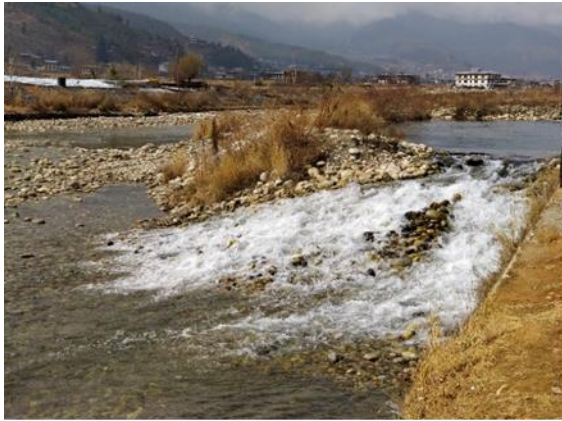
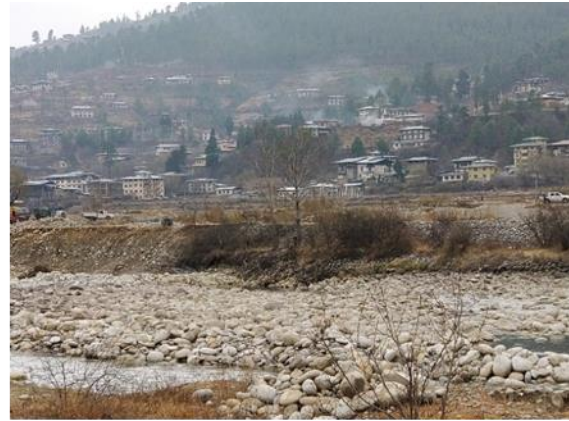
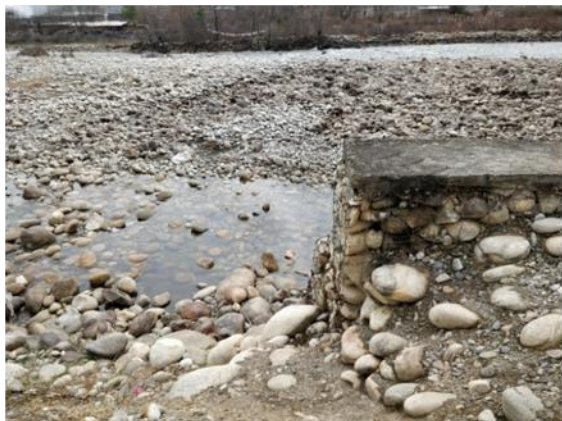
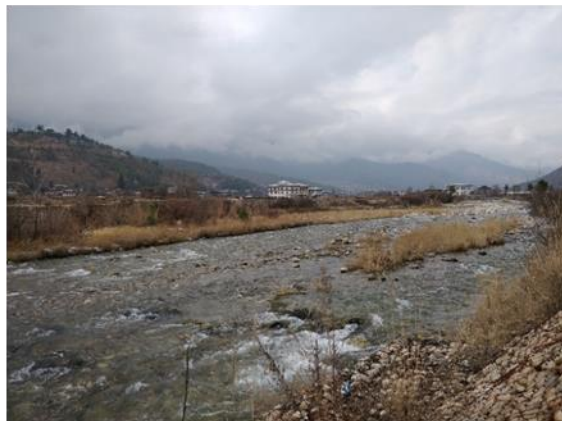
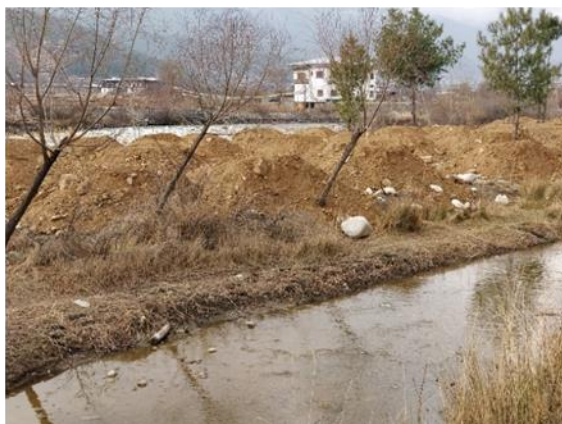
The bank protection structures and assessed the necessity of further protective measures that might be required along designated stretches. At some portion will be recommended for the necessary excavation works. The flowing nature and existing bed conditions will guide to suggest necessary excavation and re-sectioning works that might be required at certain portions.

Figure 3.14: Pa Chu

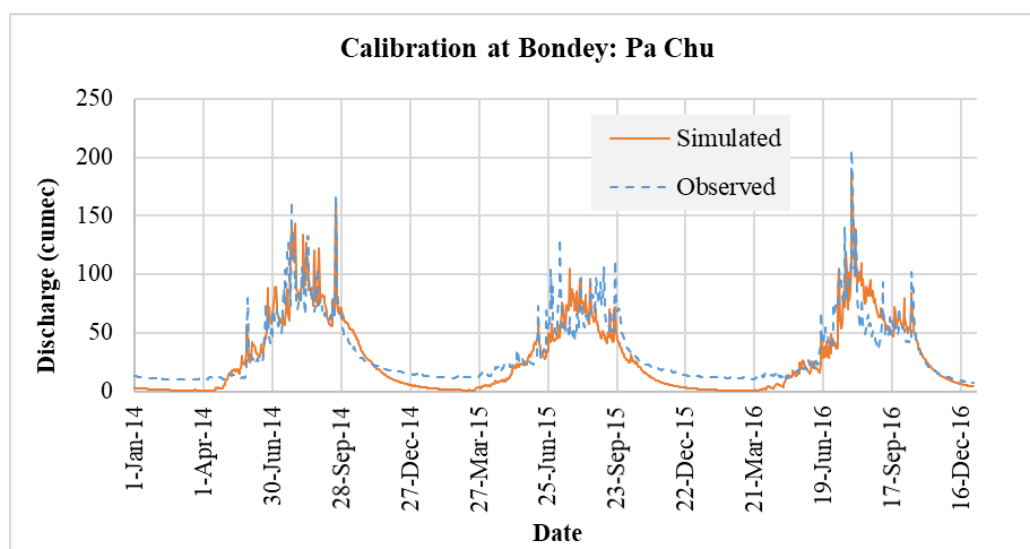
For visual comparison, daily observed and simulated streamflows were plotted for the calibration period (**Figure 4.5**) and the validation period (**Figure 4.6**). For both calibration and validation periods, the model could simulate the behavior of the observed flow. For most years, the peaks were well captured which is very important for flood impact assessment and design of flood management structures. For the dry season, the model slightly underestimates. During the validation period, dry season flow was simulated with good accuracy while the model overestimates for one year.

**Figure 4.5: Daily observed and simulated streamflow during the calibration period (2014 – 2016)**

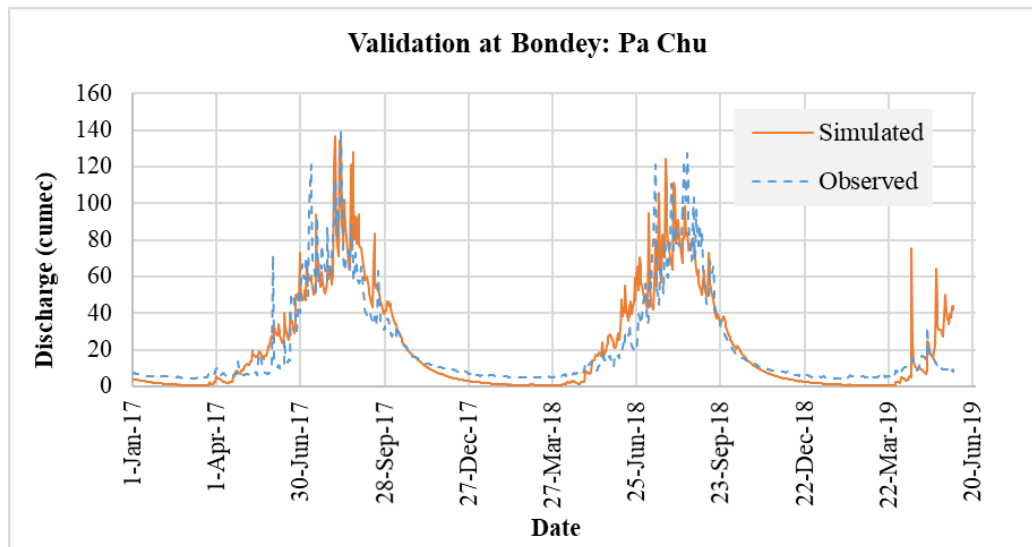
Figure 4.6: Daily observed and simulated streamflow during the validation period (2016 – 2019)

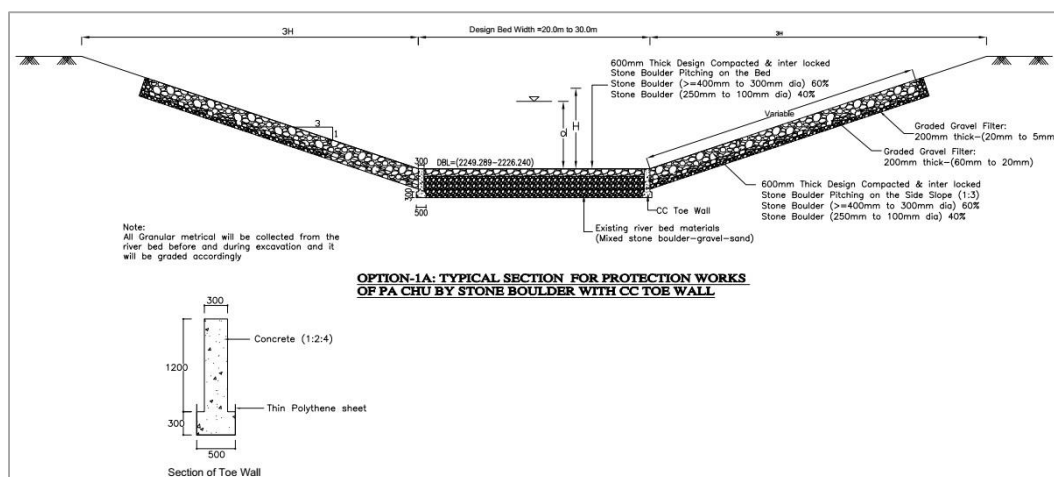
Figure 6.7: Pa Chu short-term option with 1:3 side slope and toe-wall

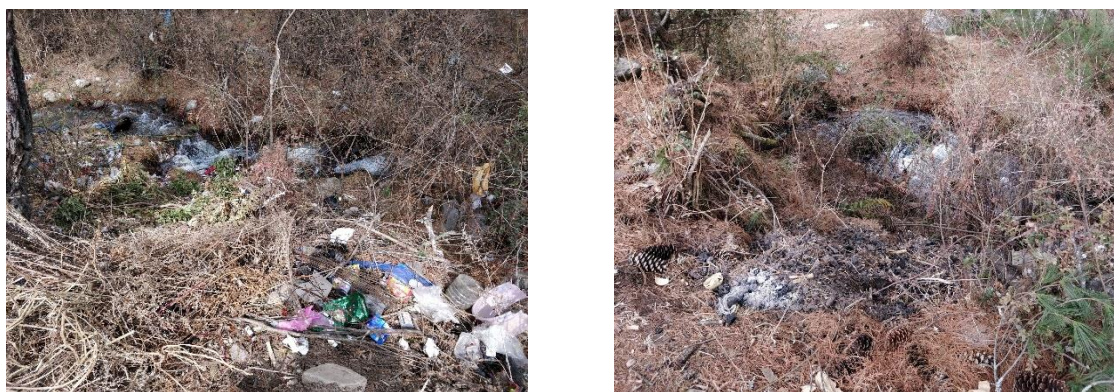
- Effluent from washroom/ labor shed toilets must not be disposed into the near streams (Chu) and should be handled properly.
- All vegetation or debris and wastes (**Figure 9.2**) should be cleaned up before removing the stones along the deepest point of the rivers/streams (Chu).

Figure 9.2: Debris and wastes at streams

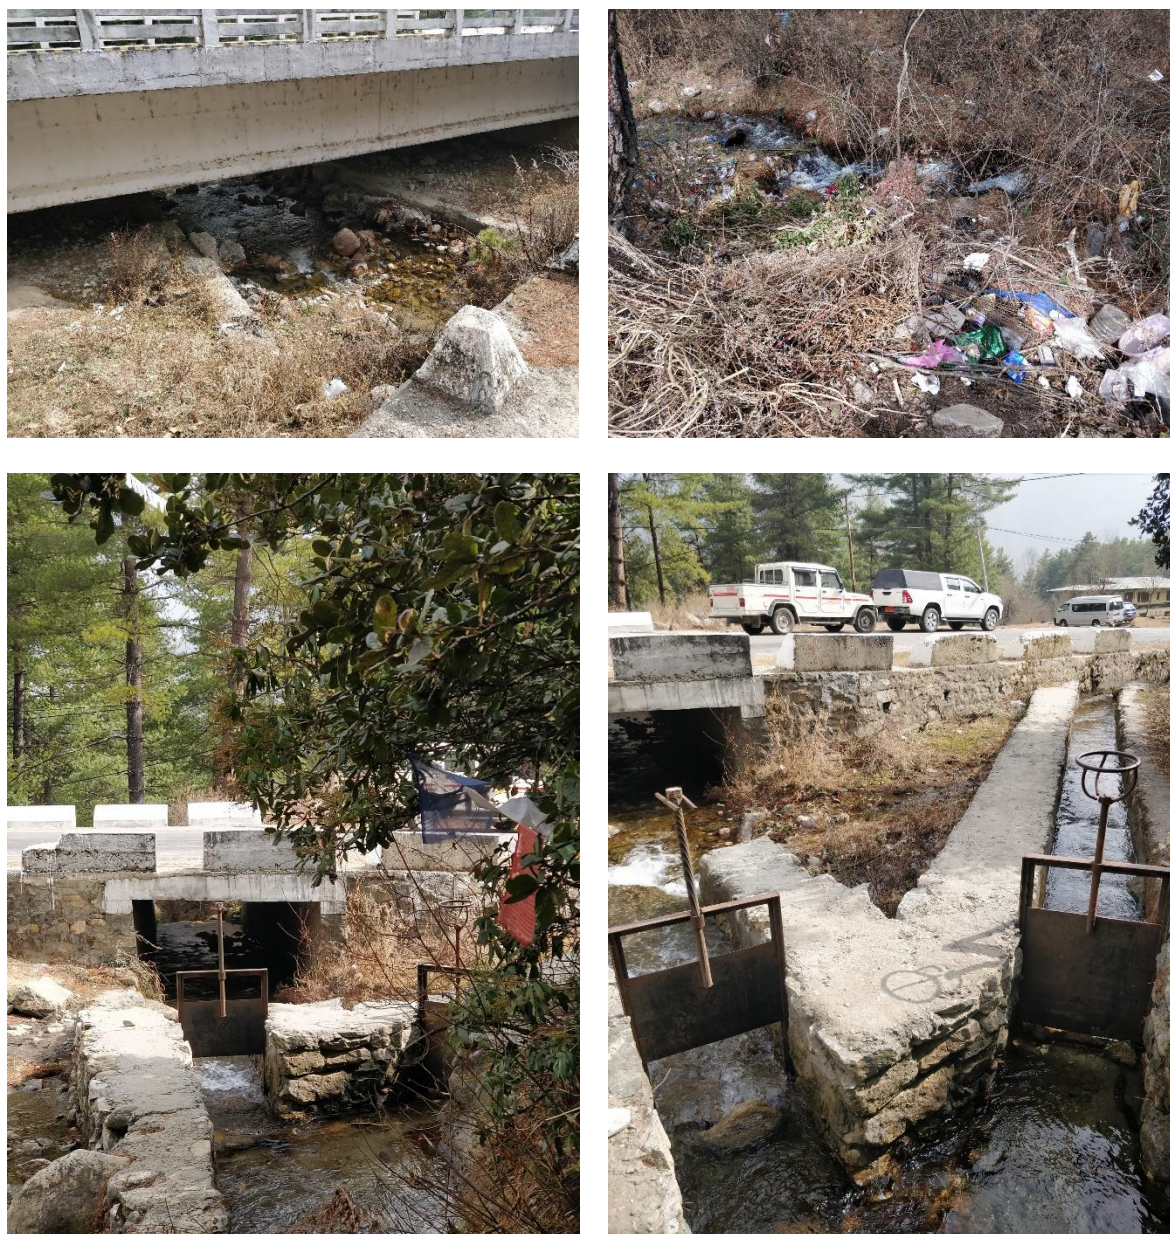
| Balakha Chu | | | | |
|---|---|---|--|---|
| 3 | 27.49730 | 89.32150 | Need to remove the boulders from the flow path | Need to remove the boulders from the flow path. |

Figure 1: Balakha Chu

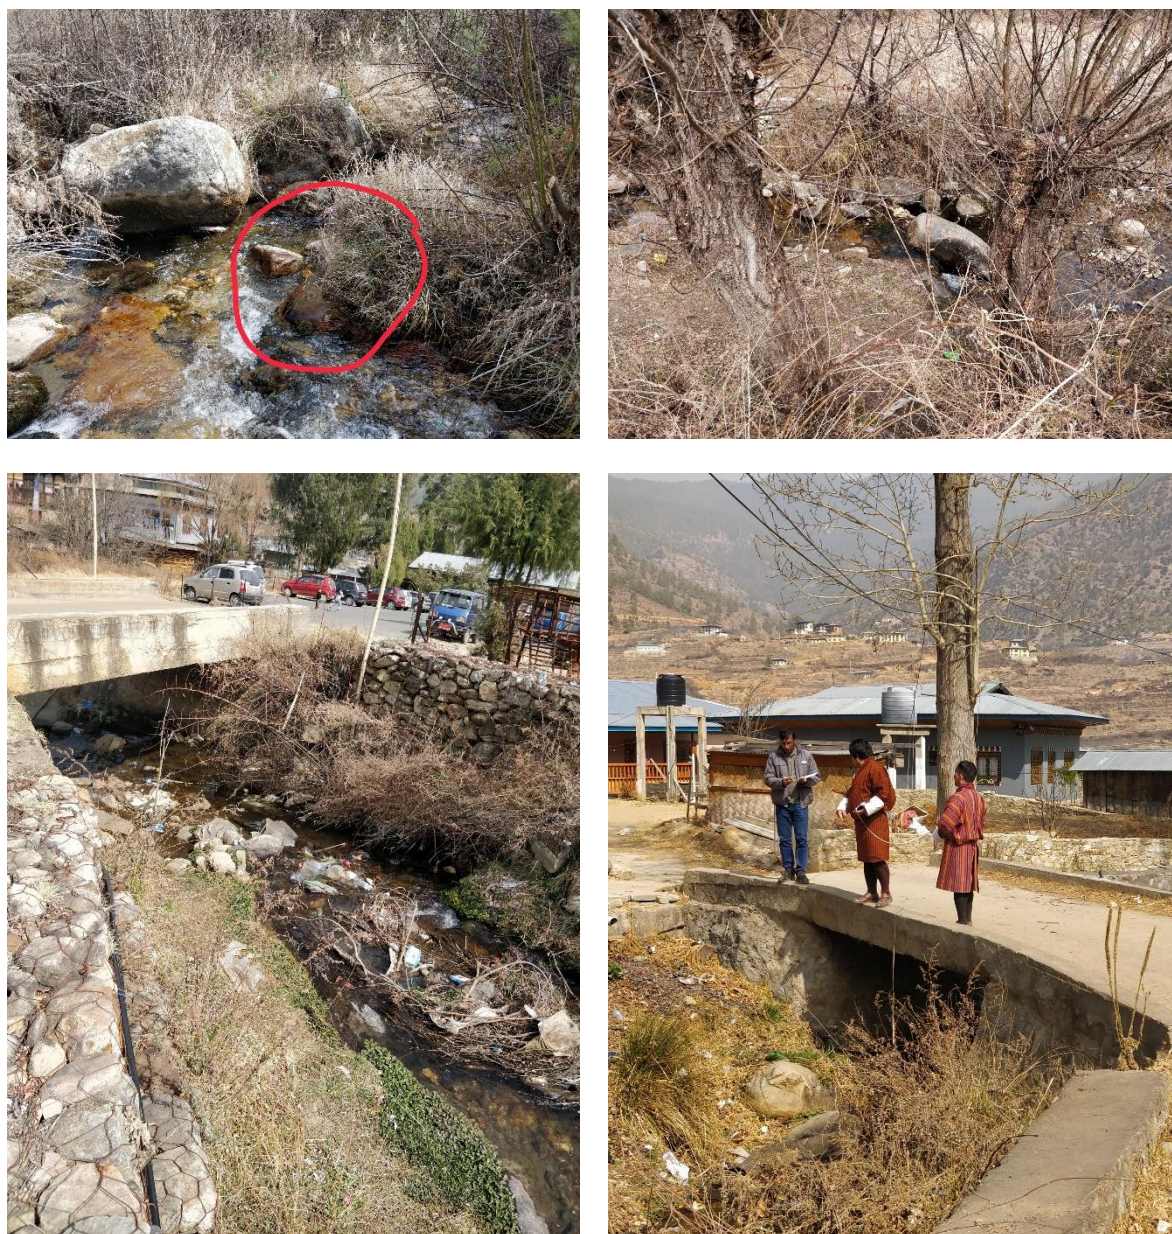
the channel to be able to allow passage of peak discharge is yet to be fulfilled after a thorough evaluation of the hydrodynamic model. Banks from mid to d/s portion were covered by dense bushes which can be a significant contributor to flow reduction. The section narrows quite a bit d/s due to unplanned development. This is presented in Table 2 and portrayed in Figure 2.

| Jew Chu | | | | |
|---|---|---|---|--|
| 15 | 27.39145 | 89.42845 | Narrow section | Recommend a guide wall in both sections with a box culvert. 20-30m of length. |

Figure 2: Jew Chu

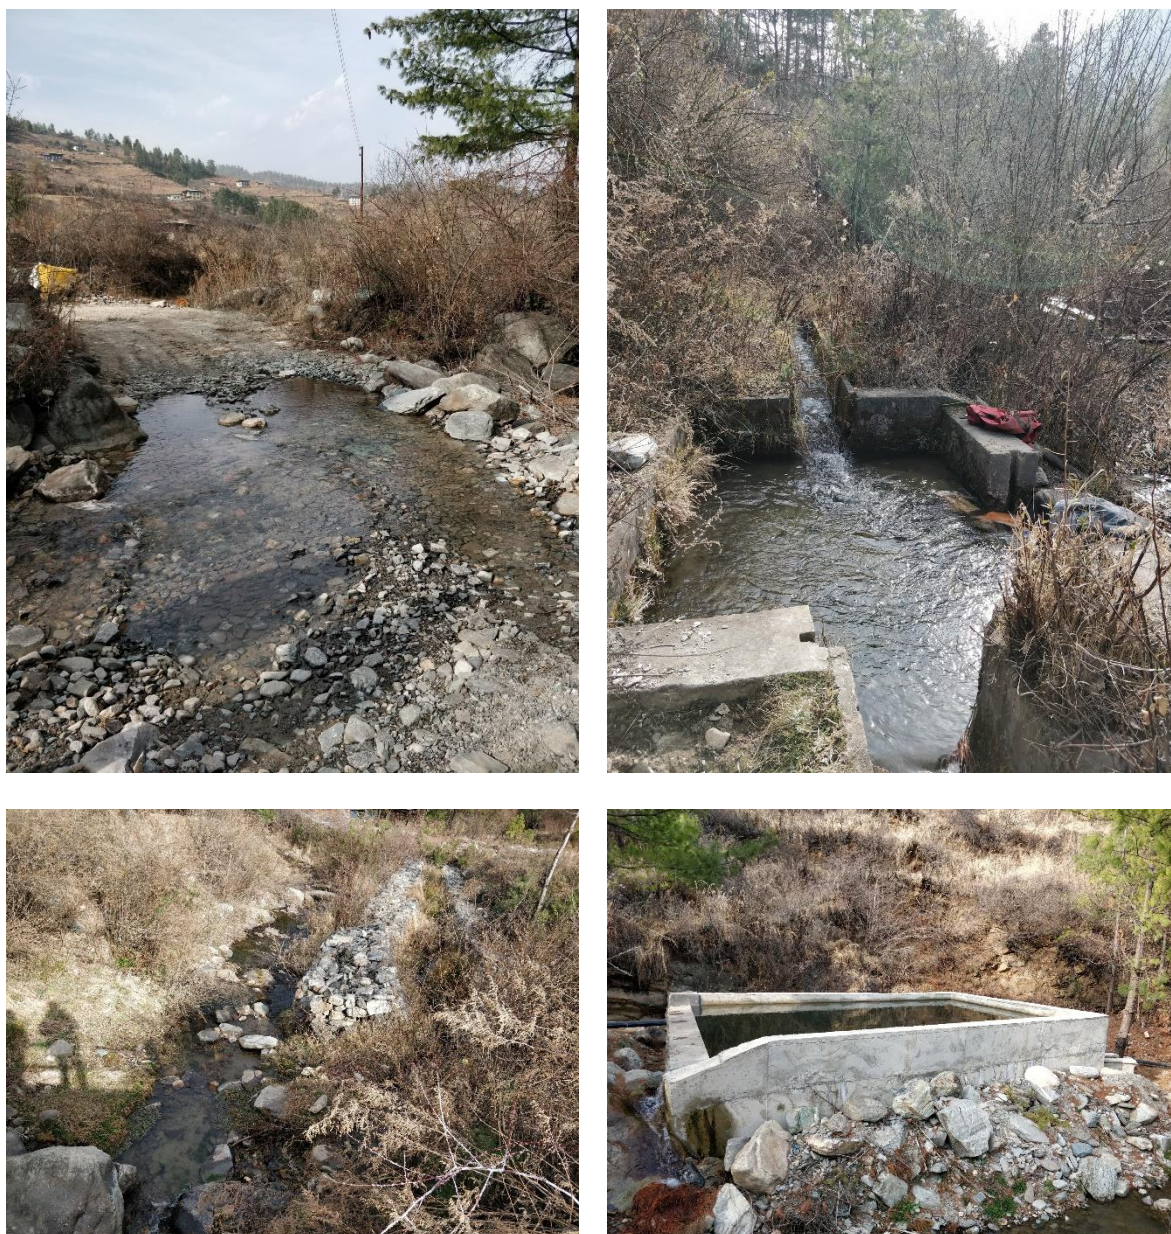
of dense bushes was noticed and these will be recommended for clearing to allow smooth passage of flow during monsoon onset. The presence of bushes calls for an unwarranted increase in the roughness coefficient of the banks and restrains flow thereby reducing velocity and causing the same amount of flow to require a greater section to be able to pass, thus ultimately causing flooding. Table 3 presents and Figure 3 illustrates Gatanarong Chu findings.

| Gatanarong Chu | | | | |
|---|---|---|---|--|
| 11 | 27.37956 | 89.46995 | Channel should be guided | Channel should be guided 150-200m of both sides of the retaining wall. It will also protect the encroachment. |

Figure 3: Gatanarong Chu

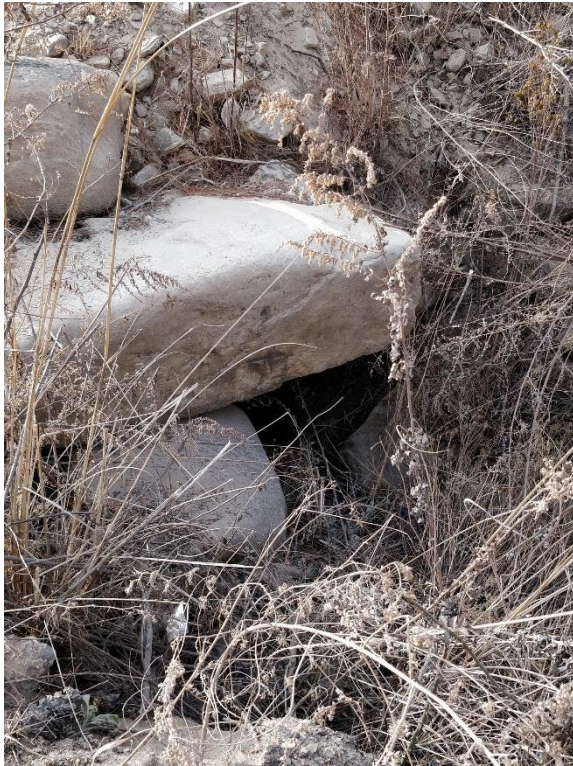
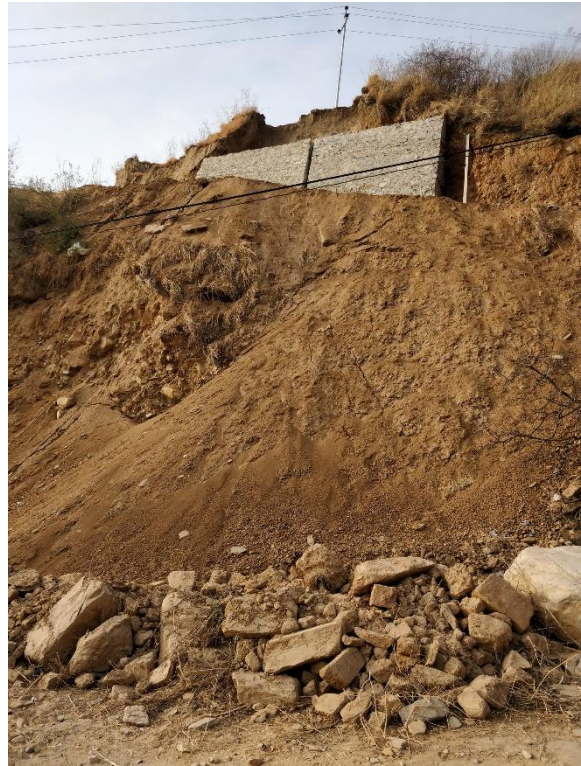
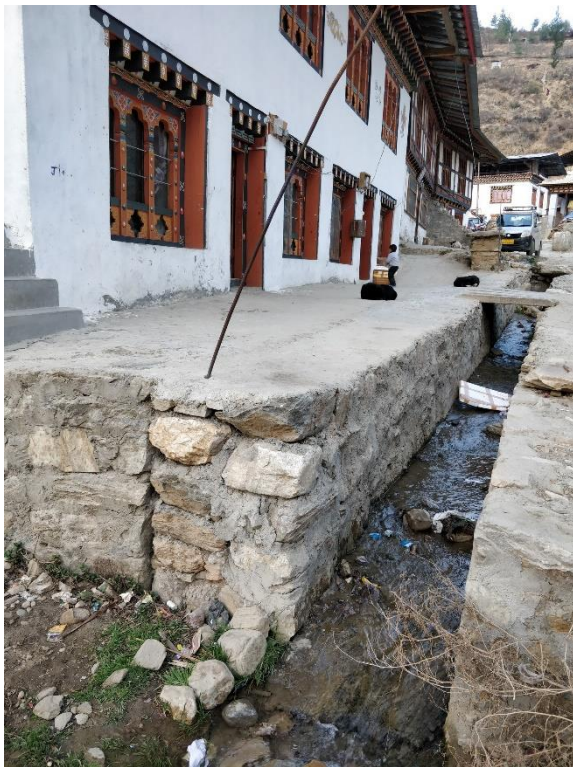
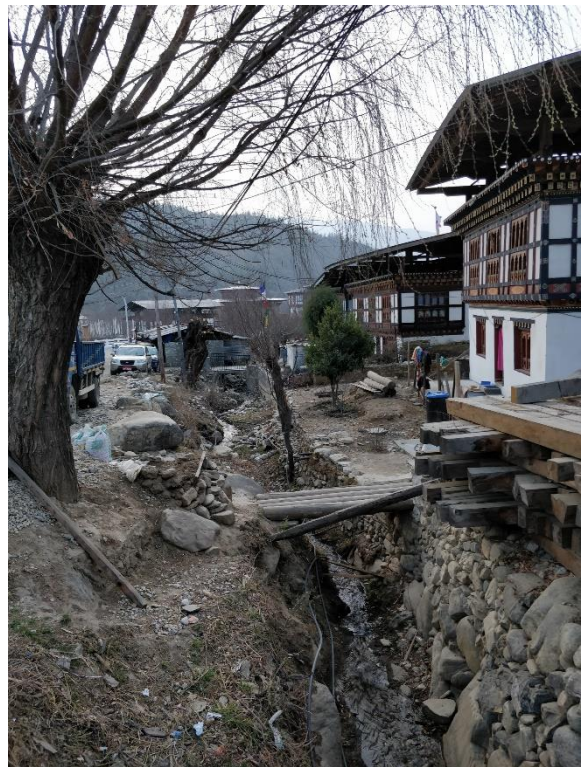
stream sections widen up further d/s near the outfall into the combined Pa Chu where it traverses under a highway bridge and falls into the river. Sections along this portion have to be cleared from debris to allow for smooth conveyance. Table 4 presents findings and Figure 4 shows the observed conditions along with Nephu Chu.

Figure 4: Nephu Chu

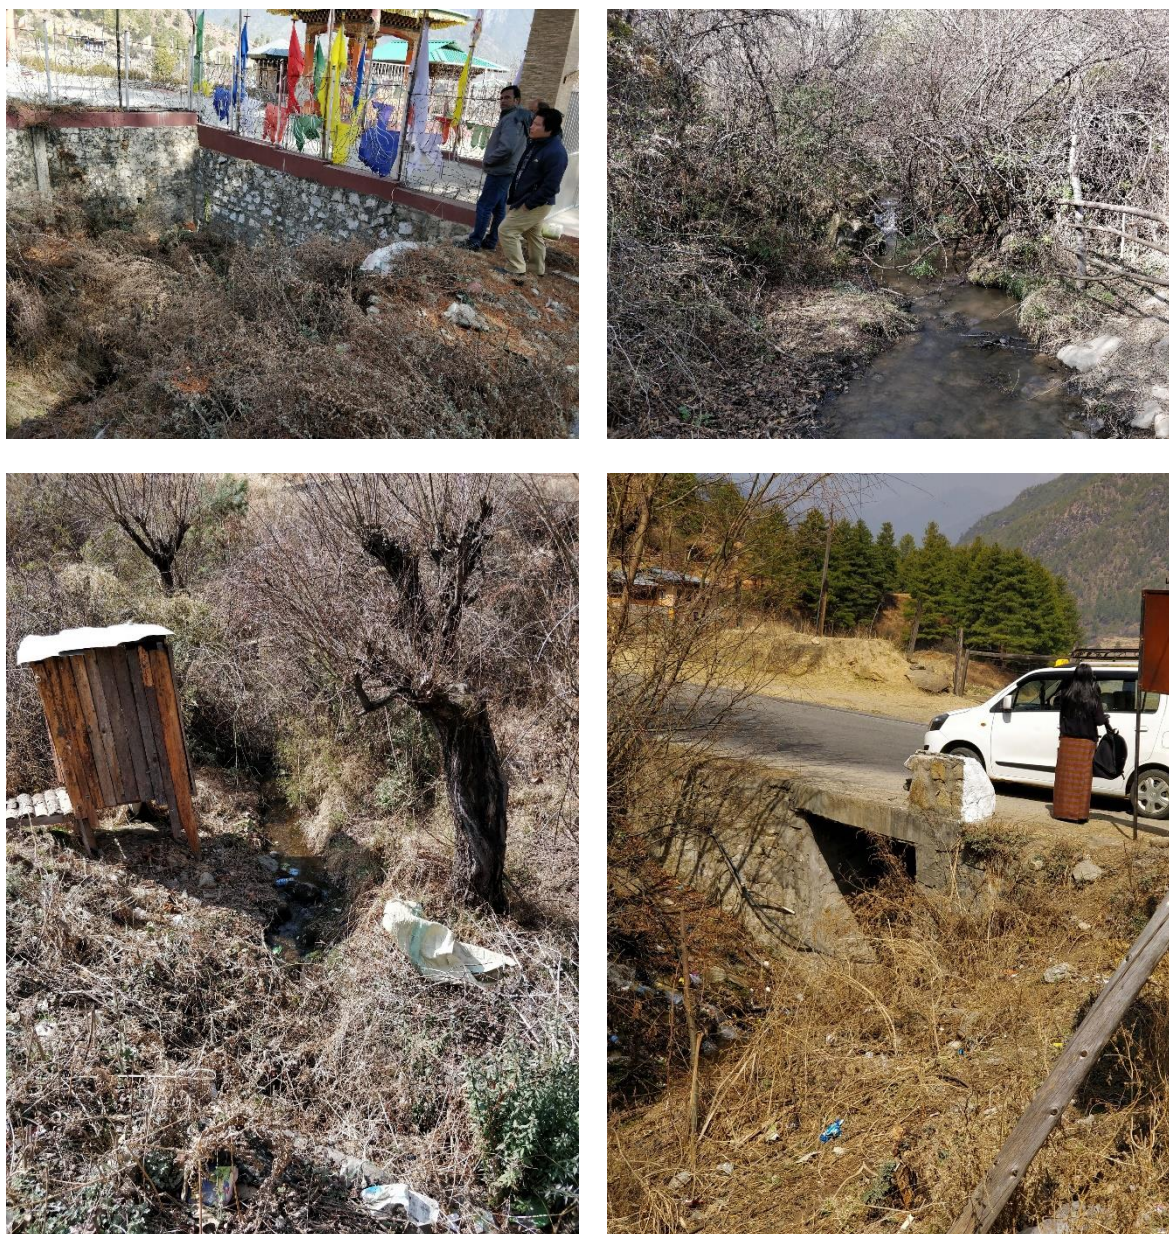
This stream discharges 6 cumec into the Pa Chu. U/s most accessible portion of the stream-side catchment housed a temporary stone grinding site which if left unchecked, has the potential to generate debris for the already narrow flow passage in the location. While moving further d/s on foot, the team witnessed the crisscrossing nature of the stream as it traversed both sides of the side-road through cross drainage piped culverts. These culverts were measured and initially deemed to be possessing a low diameter for flow passage. Flow passage naturally constricts a bit further d/s where the team came upon a construction site. This portion has to be widened via digging. Further d/s, the section widened up but along this passage, the flow path was severely constricted due to encroachment from a local resort named "Golden Roots". This resort took much of the adjacent flow path of the stream. This portion has to be demolished as soon as possible. Further d/s the section remains adequate apparently but accessibility is severely restricted due dense bushes. These have the potential to constrict flow substantially and thus have to be cleared. On a separate note, the presence of public restrooms along the bank will cause deterioration of stream thus river waters. The stream falls into Pa Chu after passing through a narrow highway culvert which will have to be widened. Table 5 presents findings and Figure 5 illustrates these observations.

| Satsam (North) Chu | | | | |
|---|---|---|---|---|
| 5 | 27.46885 | 89.34432 | Box culvert | The outfall of the stream. The depth of the box culvert is okay. The width can be increased slightly. Need to clean bush throughout the length of the stream. |

Figure 5: Satsam (North) Chu

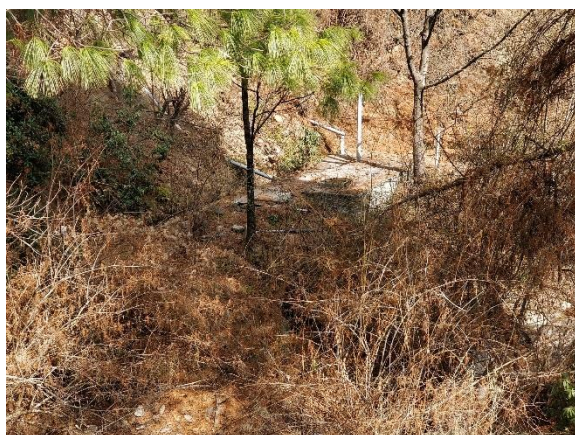
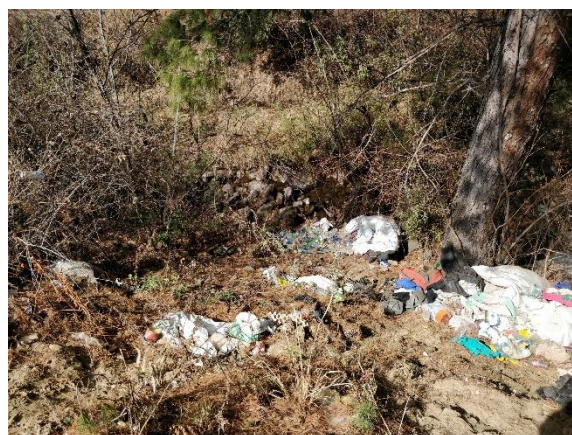
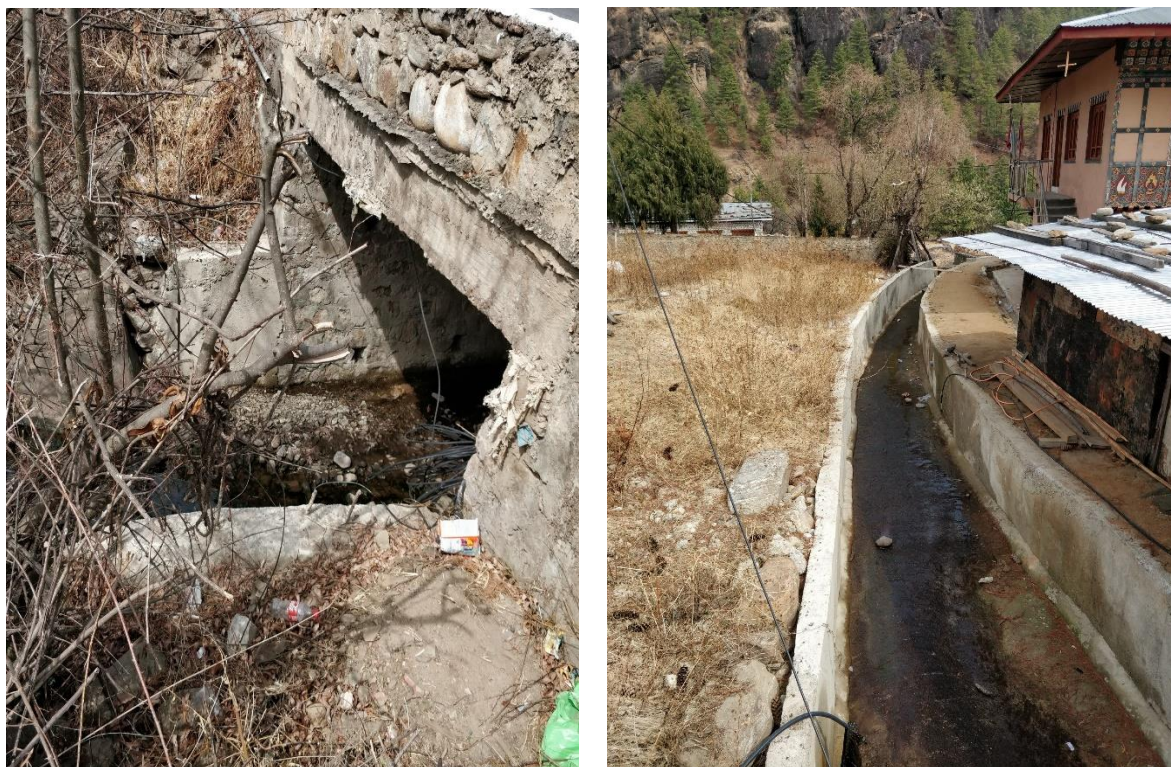
gets deeper as opposed to a relatively narrow width, barely visible due to dense bushes that have to be kept clear on a regular basis to reduce flow friction. Further d/s the team observed encroachment from another local resort and some small flow diversion structures. The d/s most portion of the channel passes under a highway culvert that has to be widened but is met with unfortunate narrowing through concrete channelization by locals. This will hamper flow passage to the Pa Chu and cause flooding during a heavy downpour. Table 6 presents and Figure 6 illustrates these findings.

| Satsam (South) Chu | | | | |
|---|---|---|---|---|
| 6 | 27.46481 | 89.35365 | Box culvert (2 nos) | Two different sill levels. The previously constructed culvert has a lower sill. Constriction at the down of the culvert. Recommendation: Replace the previous box culvert with a lower sill level. Width 3m & Depth 2m. |

Figure 6: Satsam (South) Chu

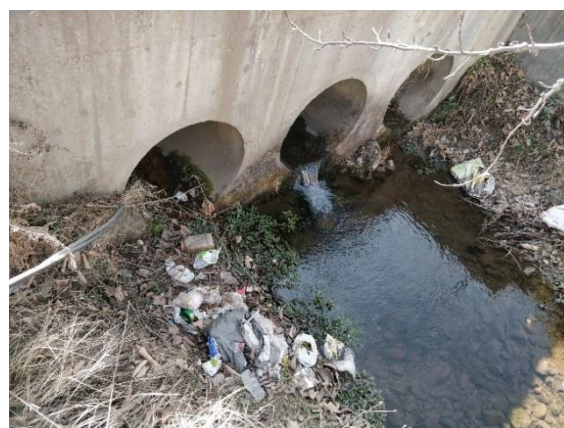
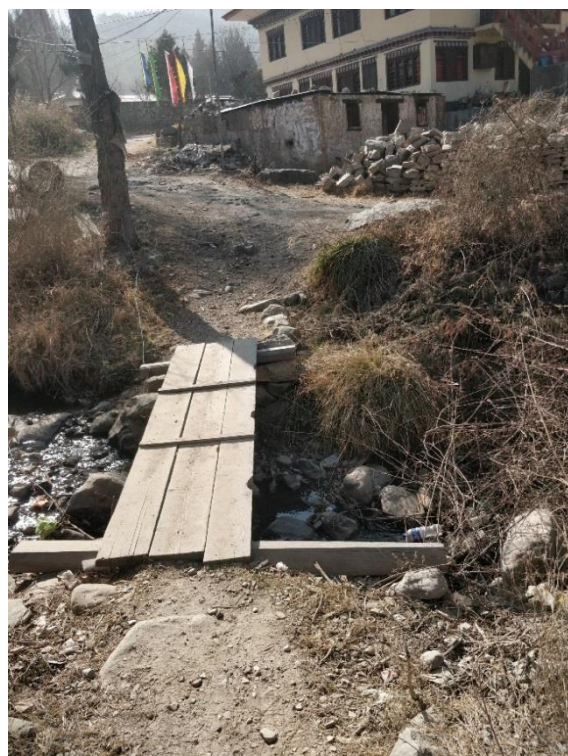
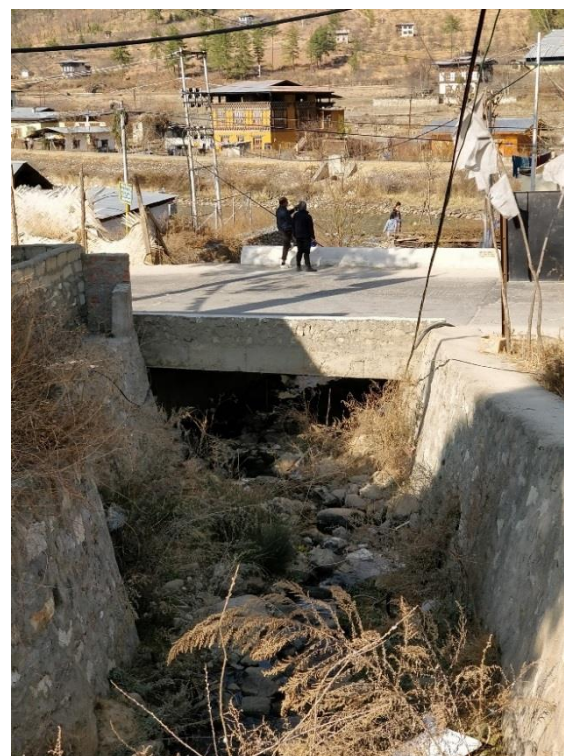
In the latter half of the day, the team then moved to the Dakhorong Chu which is on the smaller to medium size in capacity among the streams with a peak discharge of 6 cumec into the Pa Chu. The channel sections seemed wide enough in u/s and d/s portions with some substantial narrowing in the middle portion. U/s has dense bush along both banks that have to be cleared. Boulders placed at random locations along the bed will also have to be cleared up to an acceptable extent to allow smooth passage for flow. Along the flow path, there is a culvert opening with a three piped layout for flow passage. This setup although might be adequate dimension-wise, but might still obstruct high-velocity flow. A mixture of dense shrubs and waste dumping as the stream nears its mid-section will have to be cleared to allow flow. In the mid-portion the stream is narrowed down due to encroachment and settlement to a point where a small wooden plank would suffice for taking one step to cross the stream (Figure 7). These portions have to widen sufficiently and crossings such as these will have to be accommodated via culverts, dimensions of which will be finalized after hydrodynamic simulations and consultation with the design engineer. There are gabions and protective works along the banks, a trait again, of human settlements. The stream widens as it moves further d/s with protective works along both banks. Near d/s outfall it traverses under a highway culvert which might have to be raised to maintain adequate flow section for discharge into Pa Chu. Table 7 presents and Figure 7 illustrates Dakhorong Chu observations.

**Figure 7: Dakhorong Chu**

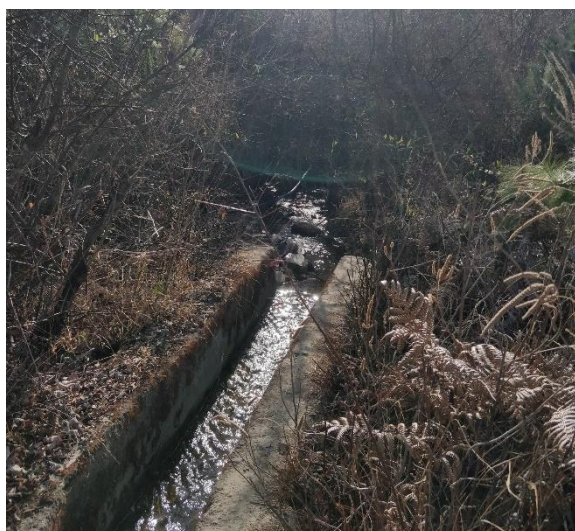
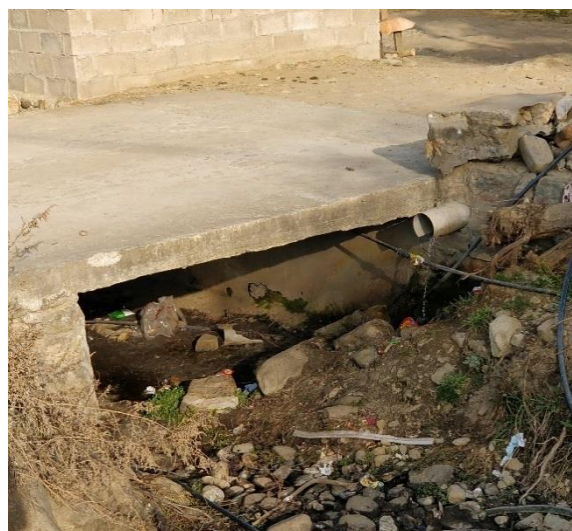
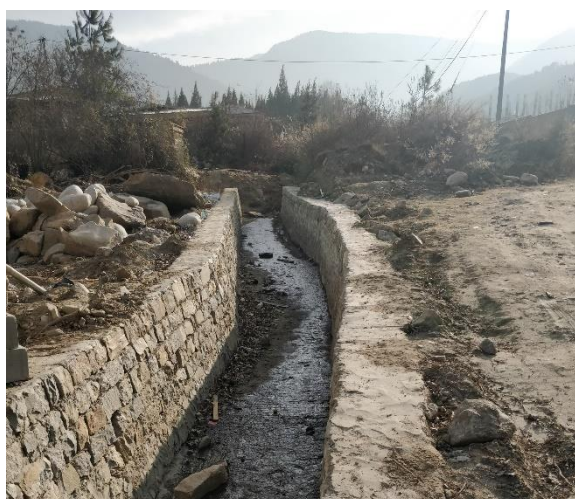
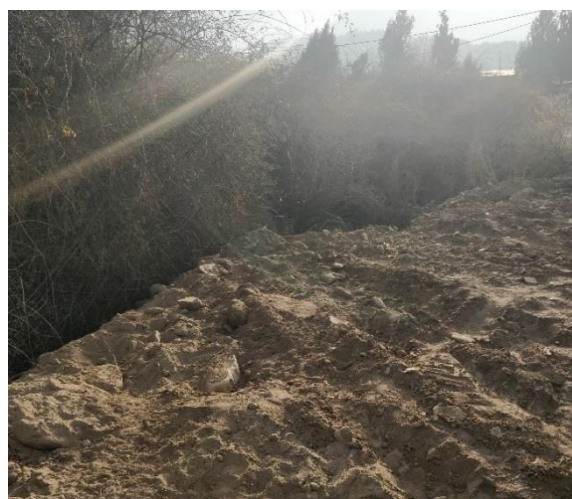
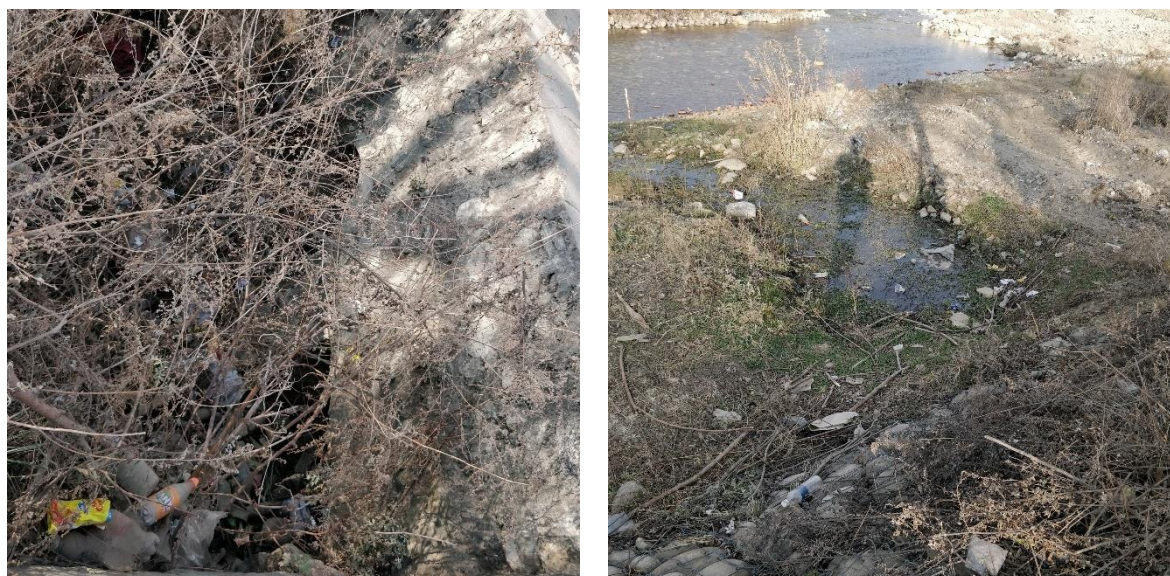
| Sl | Lat | Long | Observations | Remarks |
|---|---|---|---|--|
| 16 | 27.44139 | 89.38243 | Pipe culvert | One side of the culvert fall in the river. Culvert not functional, riverside end of the pipe is blocked. An irrigational channel passes over the stream just u/s of the culvert. The channel dimension is 2m x 0.5m at the upper segment of the culvert. Recommendation: Re-sectioning required. Need section drop to pass the irrigational canal. Pipe culvert should be replaced with a box culvert. Condition of stream outfall at the river needs to be checked. |

Figure 8: Ngoborong Chu
