Volume II: Main Report

Final Report

Preparation of Flood Management Plan for Paro Dzongkhag

June 2020

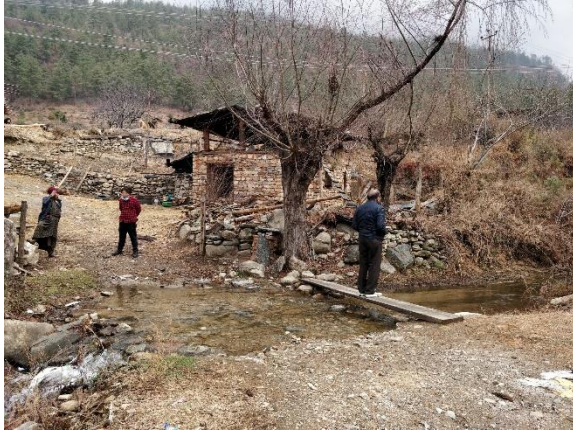
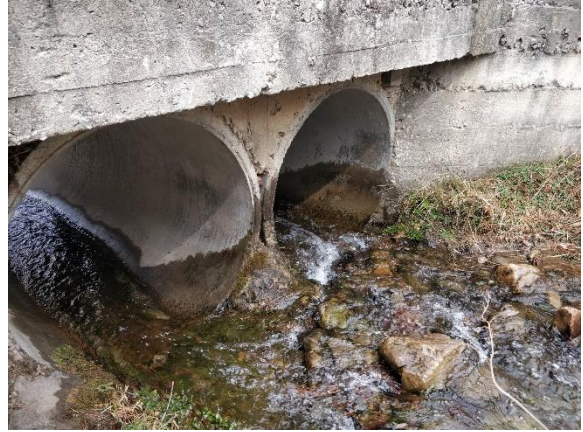
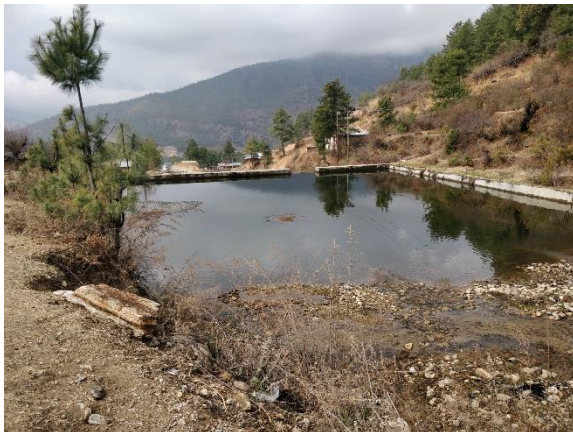
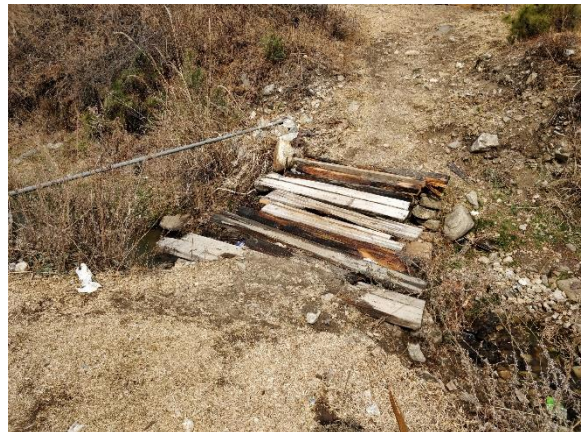
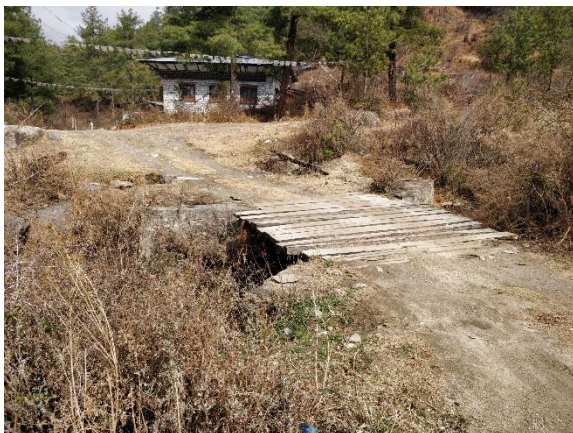
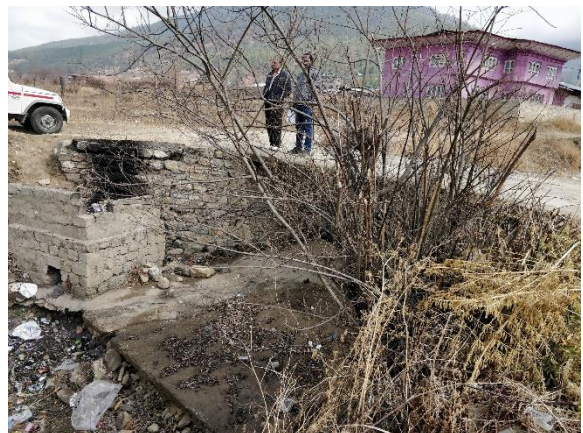
Figure 9: Ri Chu

During the morning on day 3, the team visited Ri Chu, the last of the 8 streams. With a peak discharge of 11 cumec, it is a prominent contributor to the flow of Do Chu which peaks at 60 cumec near outfall. It originates high in the mountains overlooking the Paro valley. U/s most portions are inaccessible by vehicle. The stream once visible appears narrow along with u/s segments with a very shallow bed level. This has to be re-sectioned to accommodate high-velocity flow during peak showers. Moving further d/s there is the Ri Chu Dam, a structure with u/s reservoir of insufficient depth as observed by the team members. A deeper reservoir would allow more storage as well as give incentives for fisheries practices. The stream section is significantly narrowed as we move d/s due to siltation and unplanned settlement. These have to be re-sectioned to allow flow. The team took measurements of the channel section as well as small culverts and other structures along the stream. The discharge point to Do Chu is the wide but proper connection has to be established via re-sectioning of u/s segments. Figure 9 illustrates this.

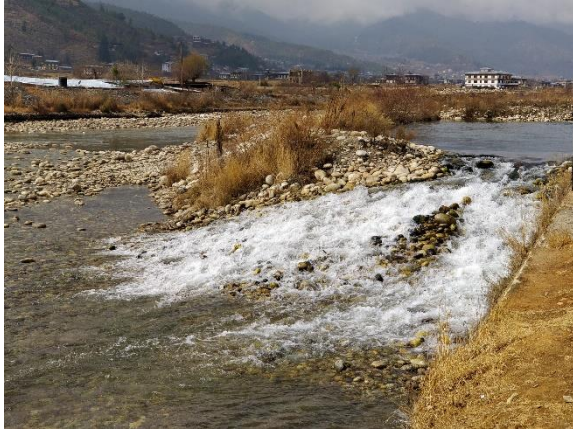
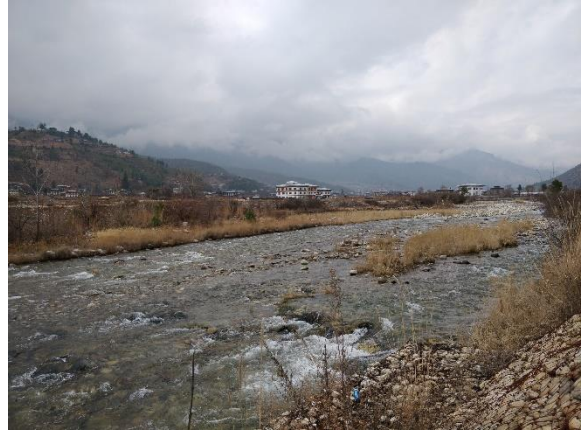
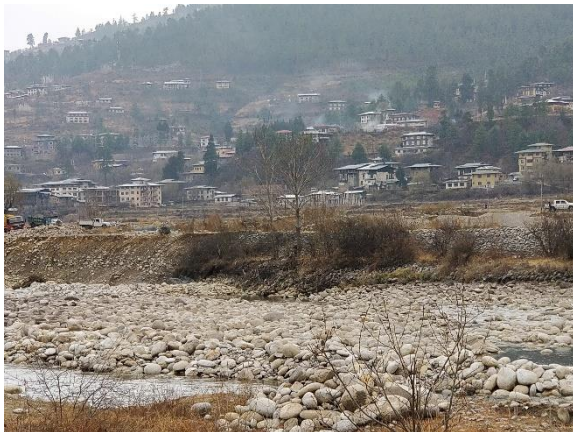
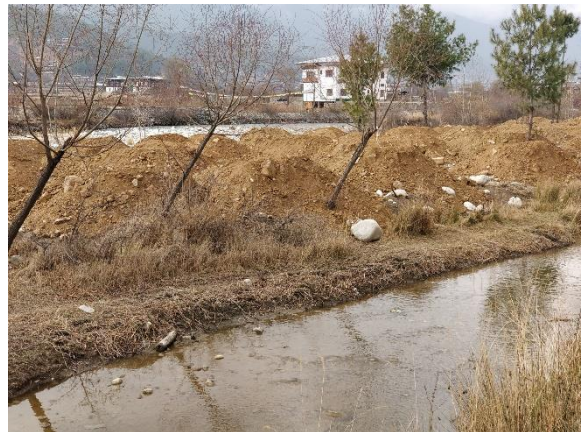
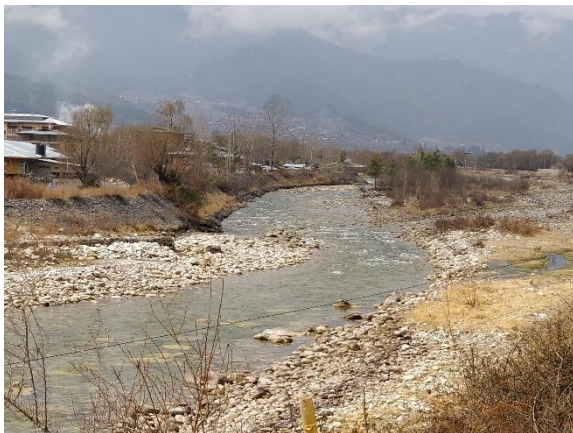
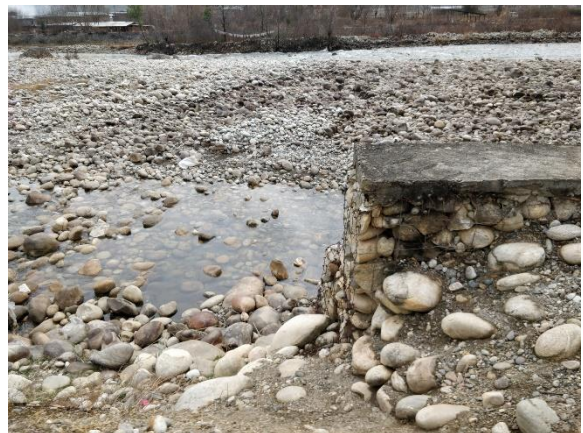
Figure 10: Pa Chu (Day 3)

With the observation of the streams completed, the team then moved along key locations along the Pa Chu River, marked from experience gained during reconnaissance visit. The team mainly observed the bank protection structures and assessed the necessity of further protective measures that might be required along designated stretches. The team also observed the flowing nature and made notes of the bed conditions so as to suggest necessary excavation works that might be required at certain portions. Table 10 presents and Figure 10 marks the Pa Chu observations.

| Pa Chu | | | | |
|---|---|---|---|---|
| 2 | 27.43499 | 89.40738 | Gabion failure | Gabion fails at the right bank. Input to water storage. |
| 3 | 27.43573 | 89.40657 | Start of gabion failure | Start of gabion failure at the right bank. Construction of new gabion is ongoing. |
| 5 | 27.43674 | 89.40512 | Start of right bank gabion failure | Soil dumps inside the river boundary. |
| 8 | 27.46961 | 89.35065 | Riverbank erosion | Riverbank erosion at the left bank due to the bending of the river. Around 100m down from this point. |

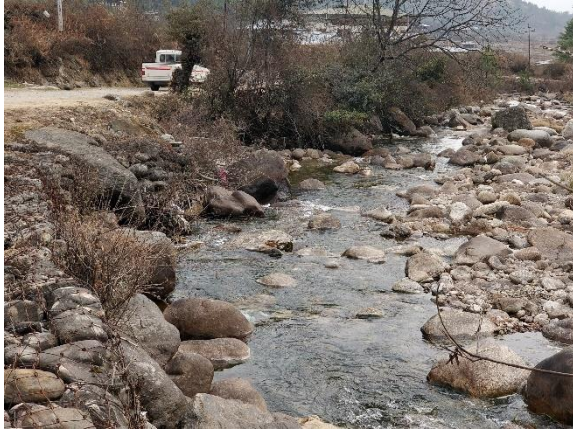
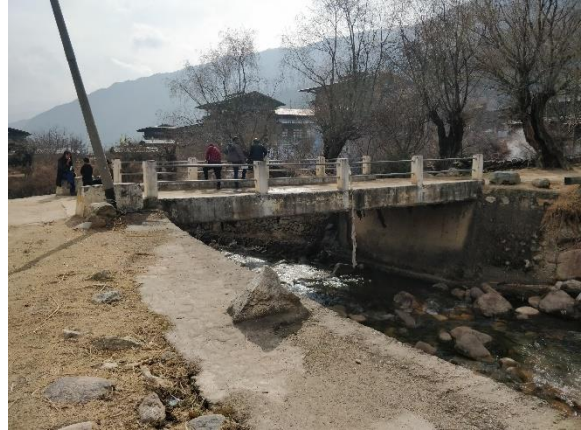
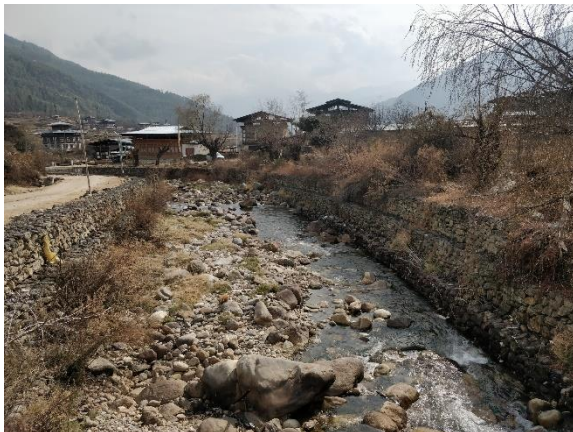
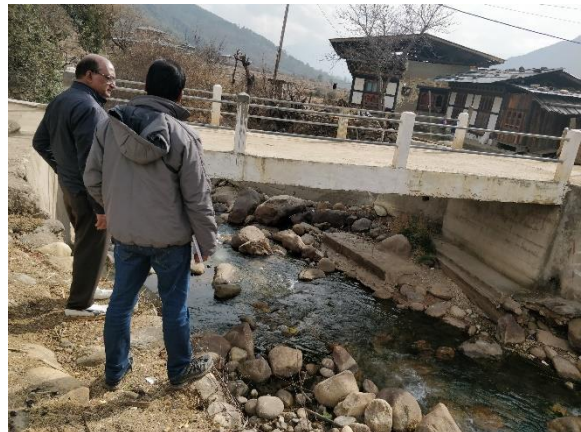
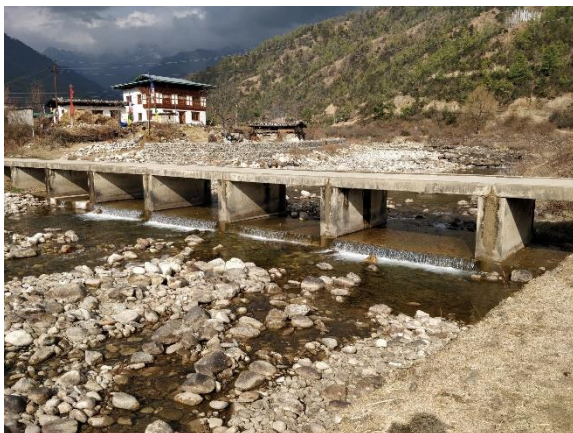
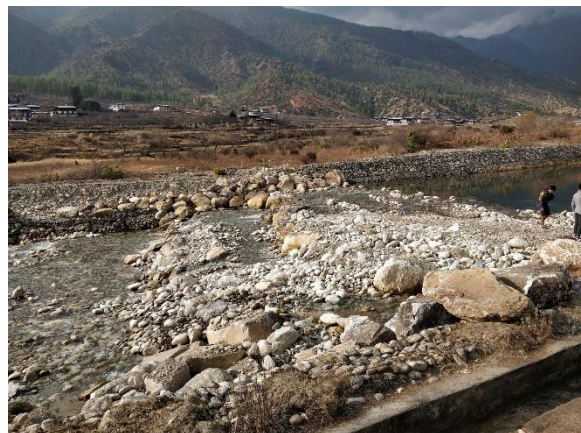
Figure 11: Do Chu

The team ended visits on day 3 via visiting Do Chu. The team then moved along key locations along the Do Chu River, marked from experience gained during reconnaissance visit. The team mainly observed the bank protection structures and assessed the necessity of further protective measures that might be required along designated stretches. The team also observed cross-river structures as well as the flowing nature and took measurements and made notes of the bed conditions so as to suggest necessary excavation works that might be required at certain portions. Table 11 presents and Figure 11 marks the Do Chu observations.

| Do Chu | | | | |
|---|---|---|---|---|
| 4 | 27.48805 | 89.43311 | Bridge | Submersible bridge. A 3m span bridge covering full length is recommended. |

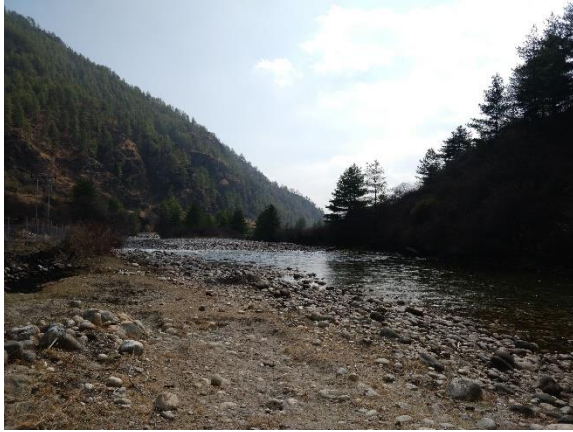
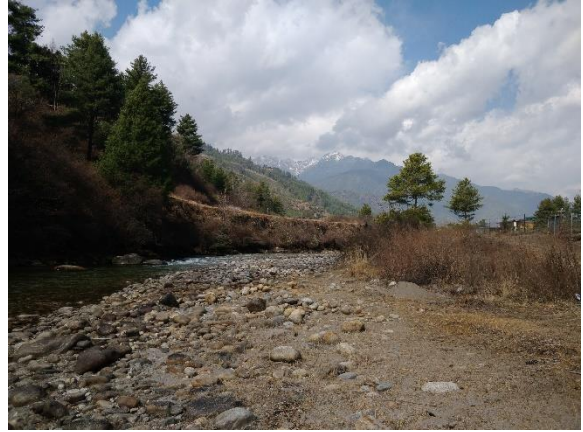
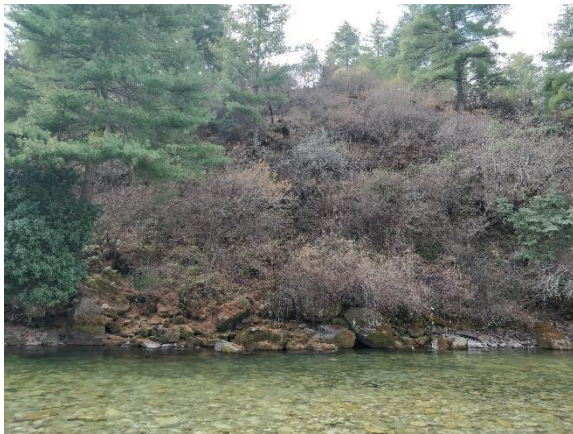
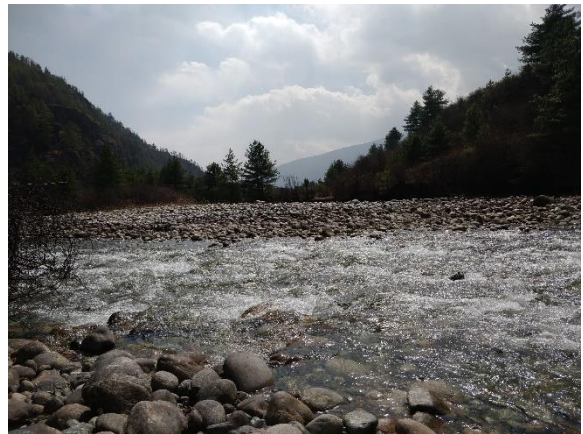
Figure 12: Pa Chu (Near Tiger's Nest)

The team visited key locations along with the Pa Chu on the final day of the visit. These visits included locations near the Tiger's Nest, along with mid to d/s segments of the stretch that meets Do Chu near Bondey and finally along with the combined Pa Chu near the Airport. Visit near the Tiger's Nest included observation of probable points of supercritical flow in coincidence with a sharp bend and subsequent high erosion probability at a large scale. Proper protection measures will have to be applied so that the energy of the flow is mitigated with as much ease as possible. This portion is highly prone to bank erosion. The next set of visits were concentrated along with the mid to d/s portion of the upper Pa Chu channel that meets Do Chu near Bondey. The team then moved along key locations along the section, and mainly observed the bank protection structures and assessed the necessity of further protective measures that might be required along designated stretches. The team also observed the flowing nature and made notes of the bed conditions so as to suggest necessary excavation works that might be required at certain portions. The final set of visits were made to the combined Pa Chu and Do Chu River near the international airport. The purpose of this segment of the visit was two folds. One was to observe and gather experience from the protection measures already in effect in that region and has been withholding flooding hazards for decades while simultaneously assess potential requirements of further measures. Figures 12 to 14 illustrate these observations and findings are presented in Table 11.
