**BANK PROTECTION AND  
RIVER TRAINING (AFPM)  
PILOT PROJECT  
FAP 21/22**

**TEST  
AND  
IMPLEMENTATION  
PHASE**

**PROGRESS REPORT  
NO. 21**

JULY TO SEPTEMBER 1998

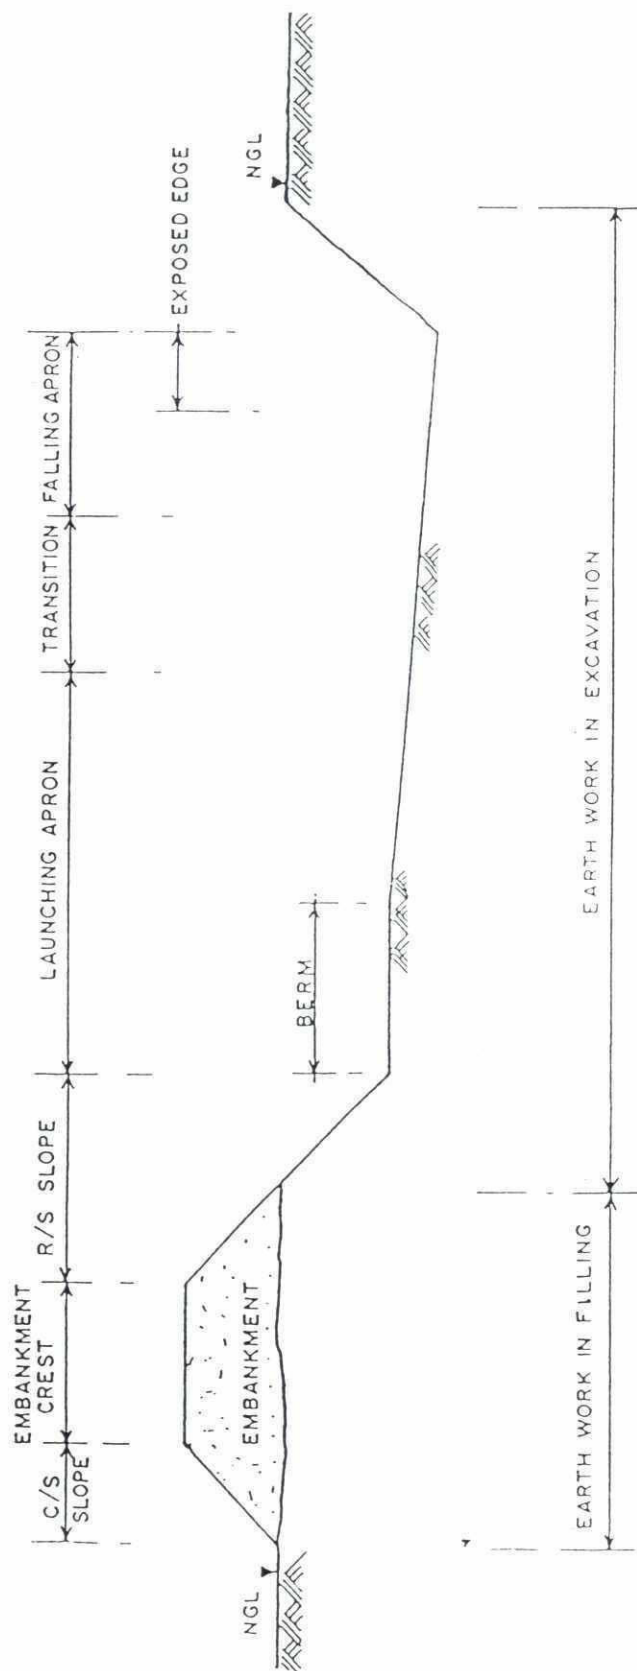
Figure 3: Definition Sketch of the Revetment Test Structure

Test Structure	A - end	A - 1	A - 2	B	C	D	E
	Rock mottress						
	In all sections Durba grass sods laid on Geo - jute soil cover

No damage of the Revetment Test Structure was reported. In July the process of sedimentation in front of the structure continued with maximum deposition of about 17.5 m along Section H-2. However, in August erosion started along the structure and maximum values of 6 m were observed at Section E-1 and H-1. This process continued also in September and maximum erosion of more than 3 m were recorded at Section D.

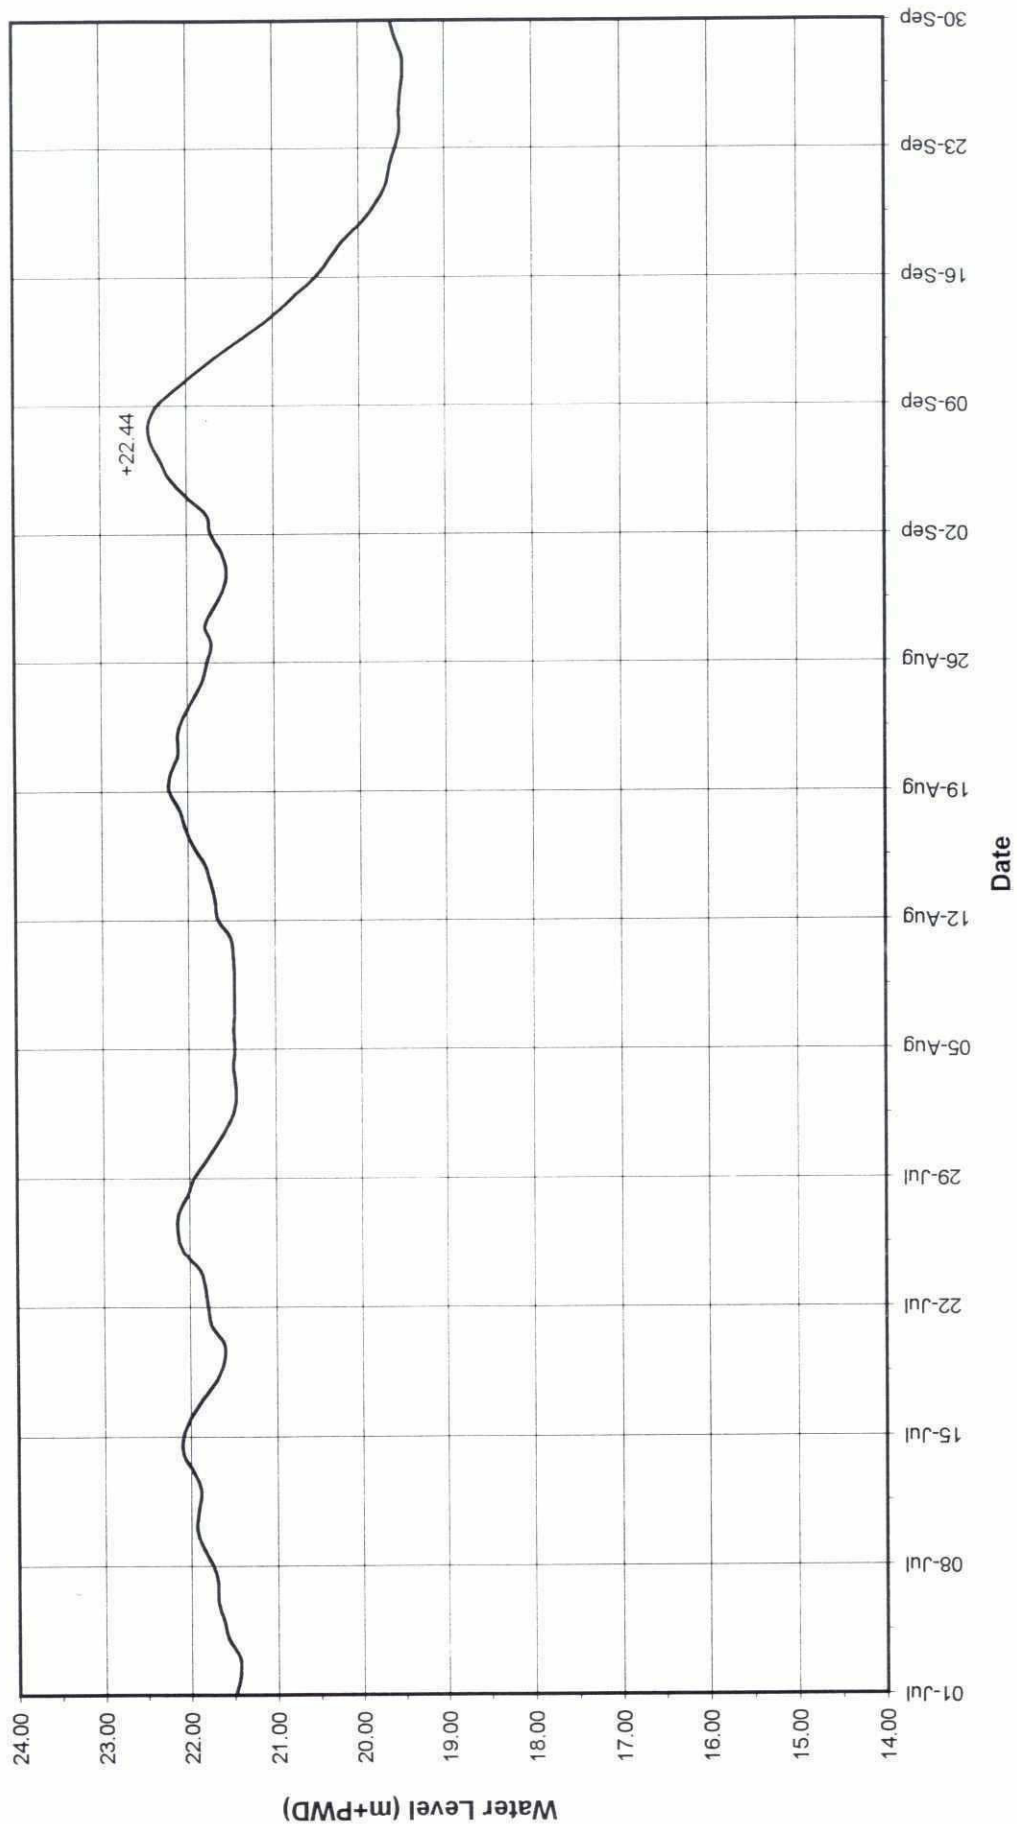
# **BANK PROTECTION TEST STRUCTURES - FAP 21** **WATER LEVEL AT KAMARJANI TEST SITE** **(July to September 1998)**

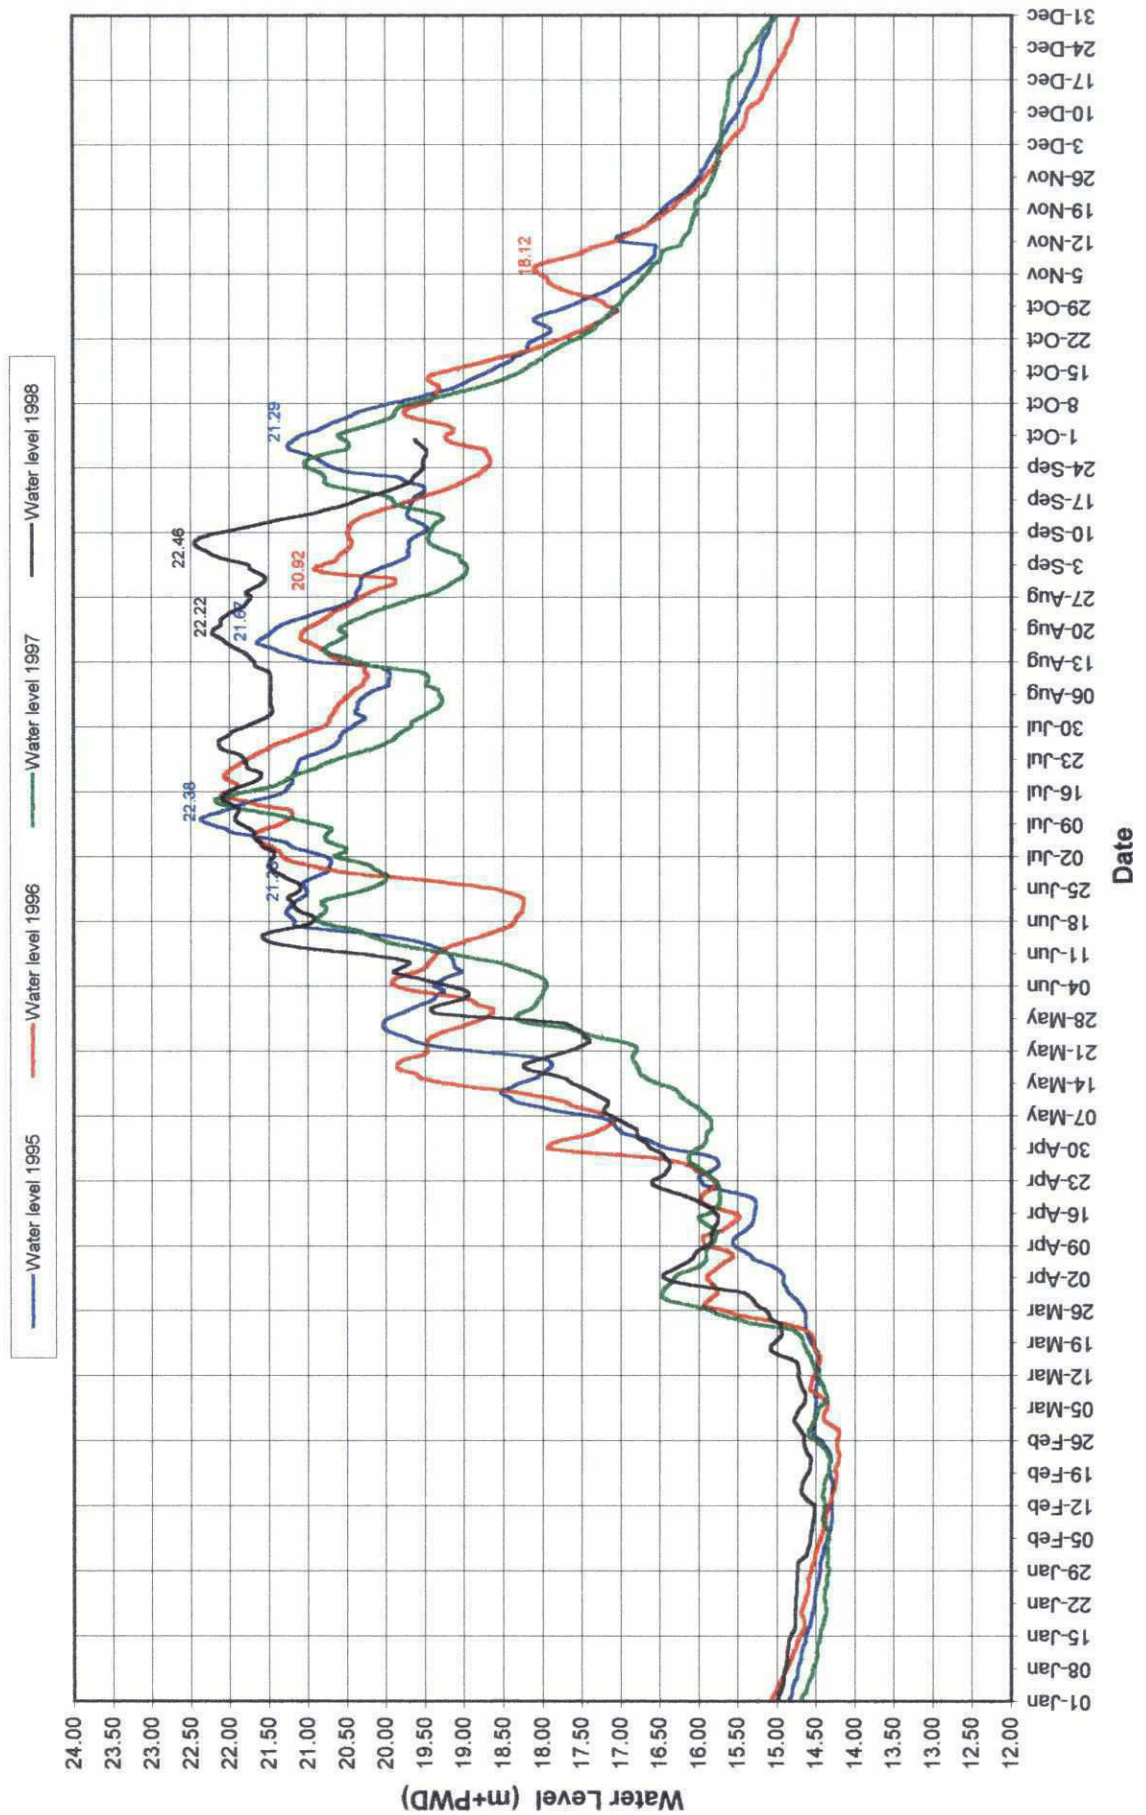
# **BANK PROTECTION TEST STRUCTURES - FAP 21** **WATER LEVEL AT KAMARJANI TEST SITE** **(January to December)**

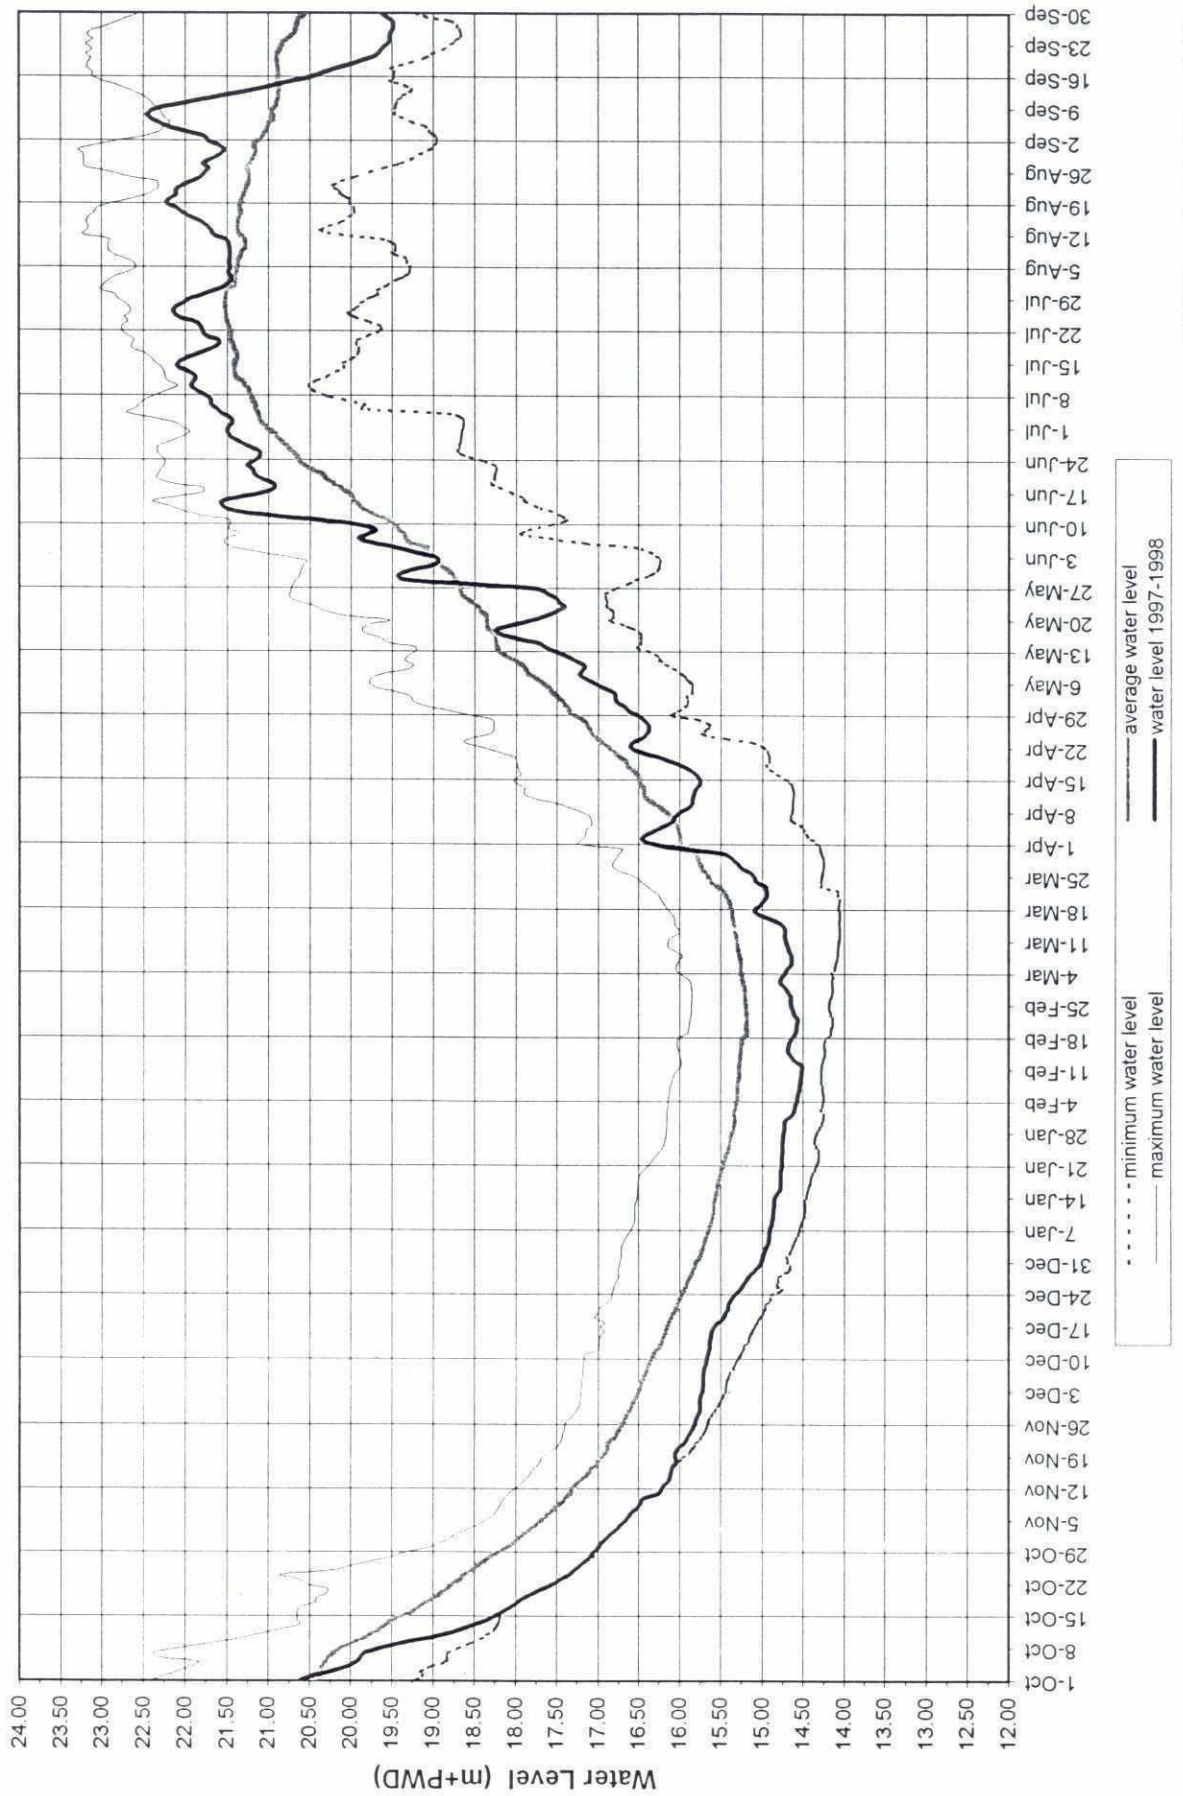
# **BANK PROTECTION TEST STRUCTURES - FAP 21** **BWDB WATER LEVEL FREQUENCY CURVES VERSUS ACTUAL FAP 21 WATER LEVEL** **AT KAMARJANI TEST SITE UP TO SEPTEMBER '98**

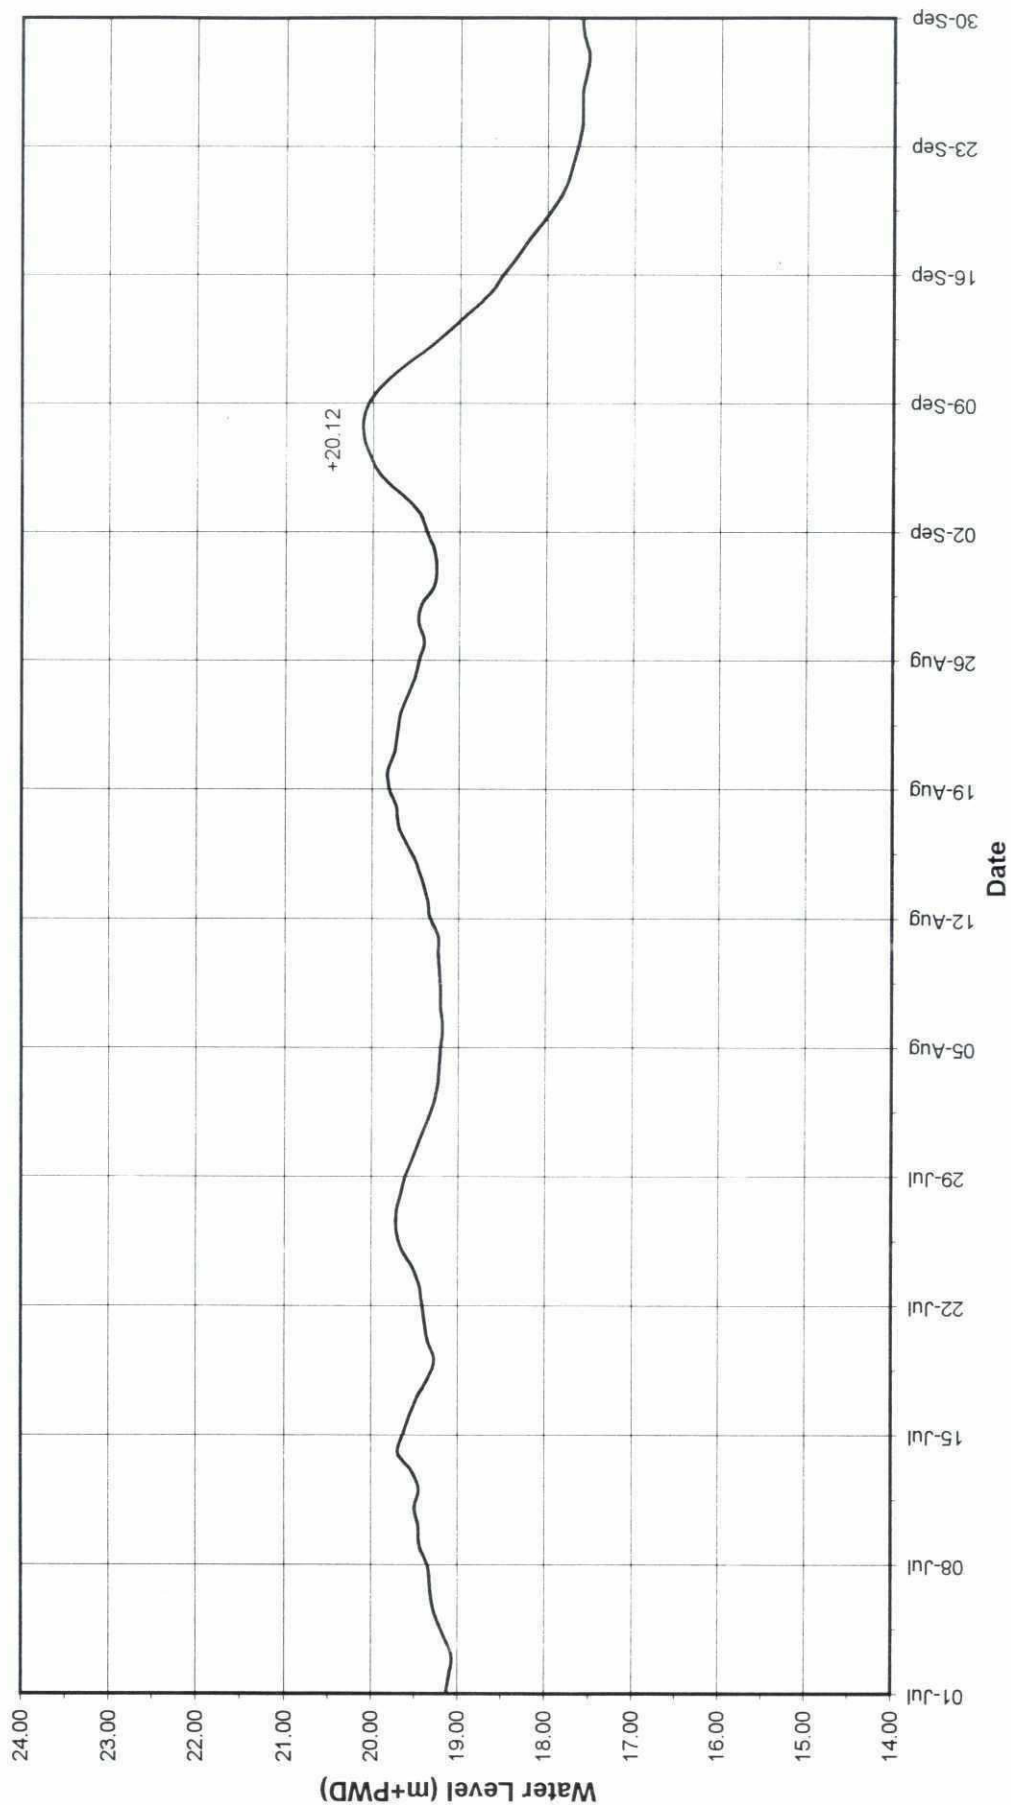
# **BANK PROTECTION TEST STRUCTURES - FAP 21** **WATER LEVEL AT BAHADURABAD TEST SITE** (July to September 1998)

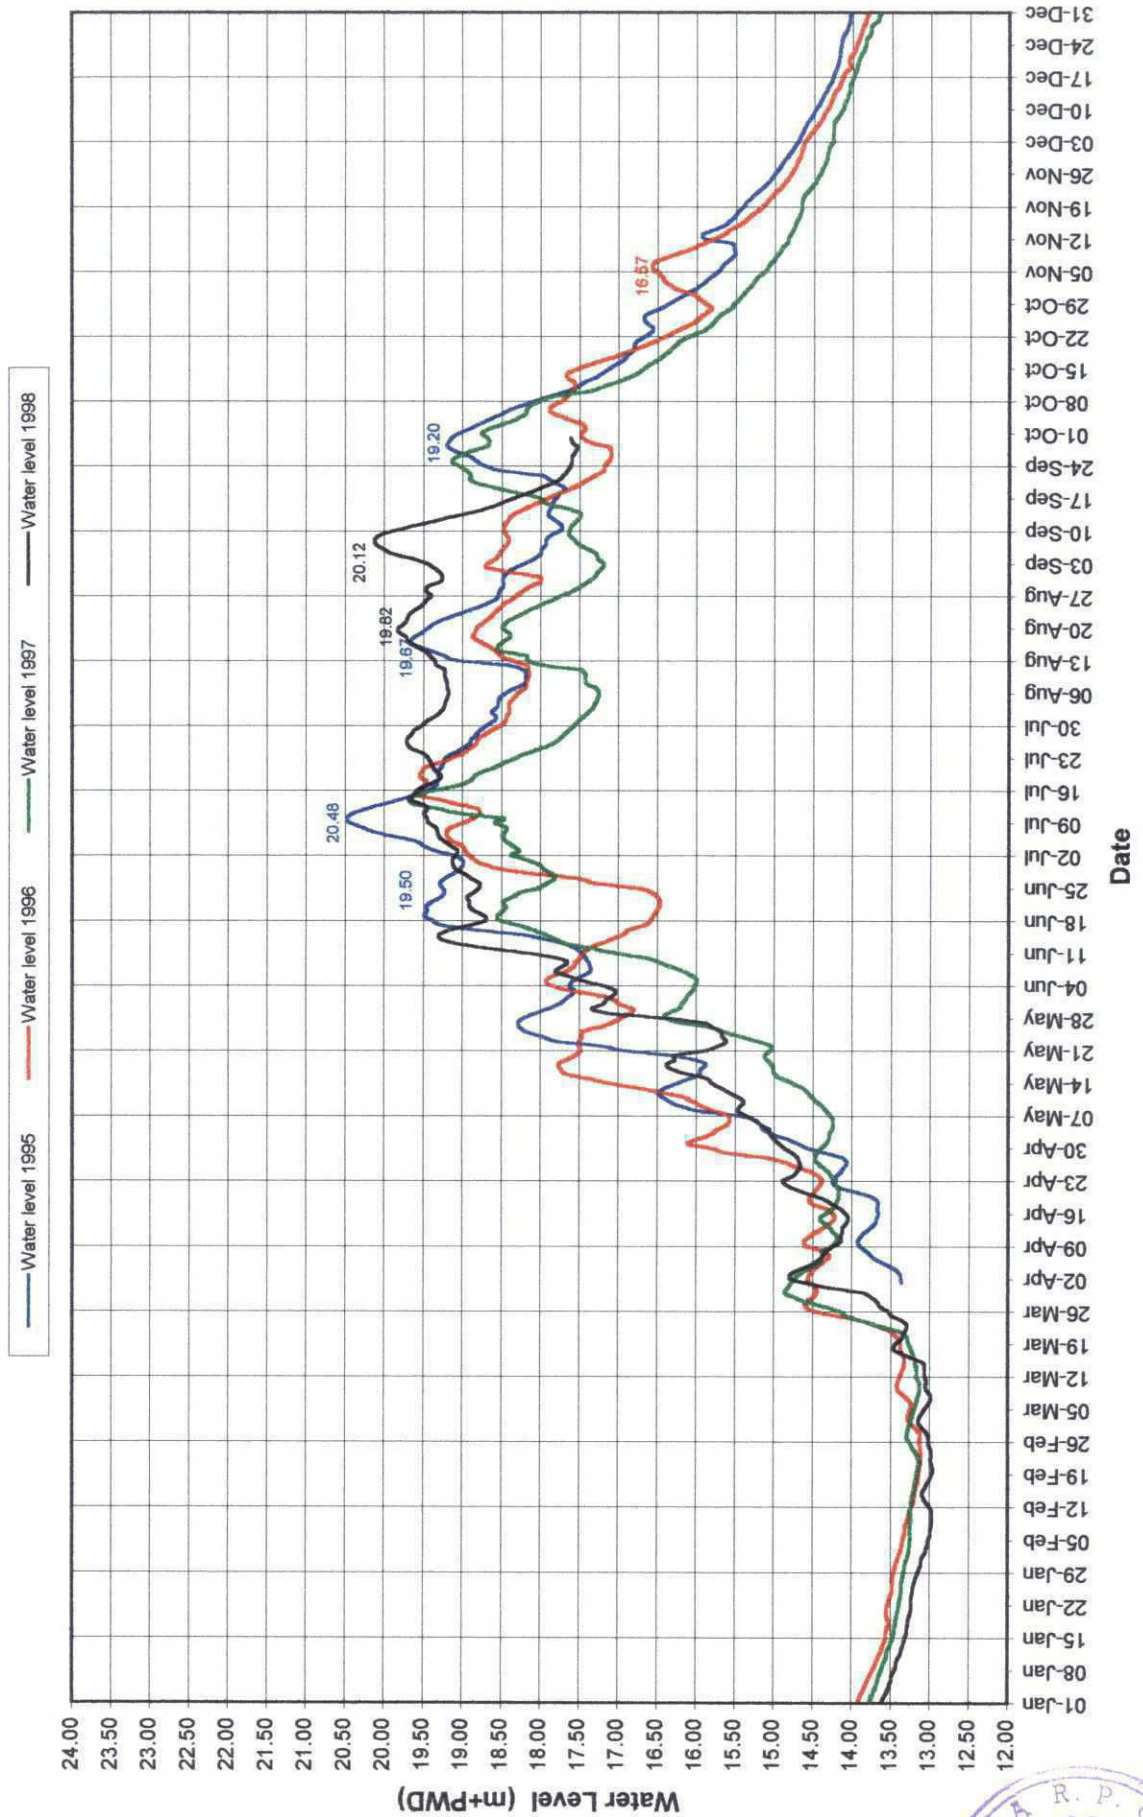
**BANK PROTECTION TEST STRUCTURES - FAP 21**  
**WATER LEVEL AT BAHADURABAD TEST SITE**  
**(January to December)**

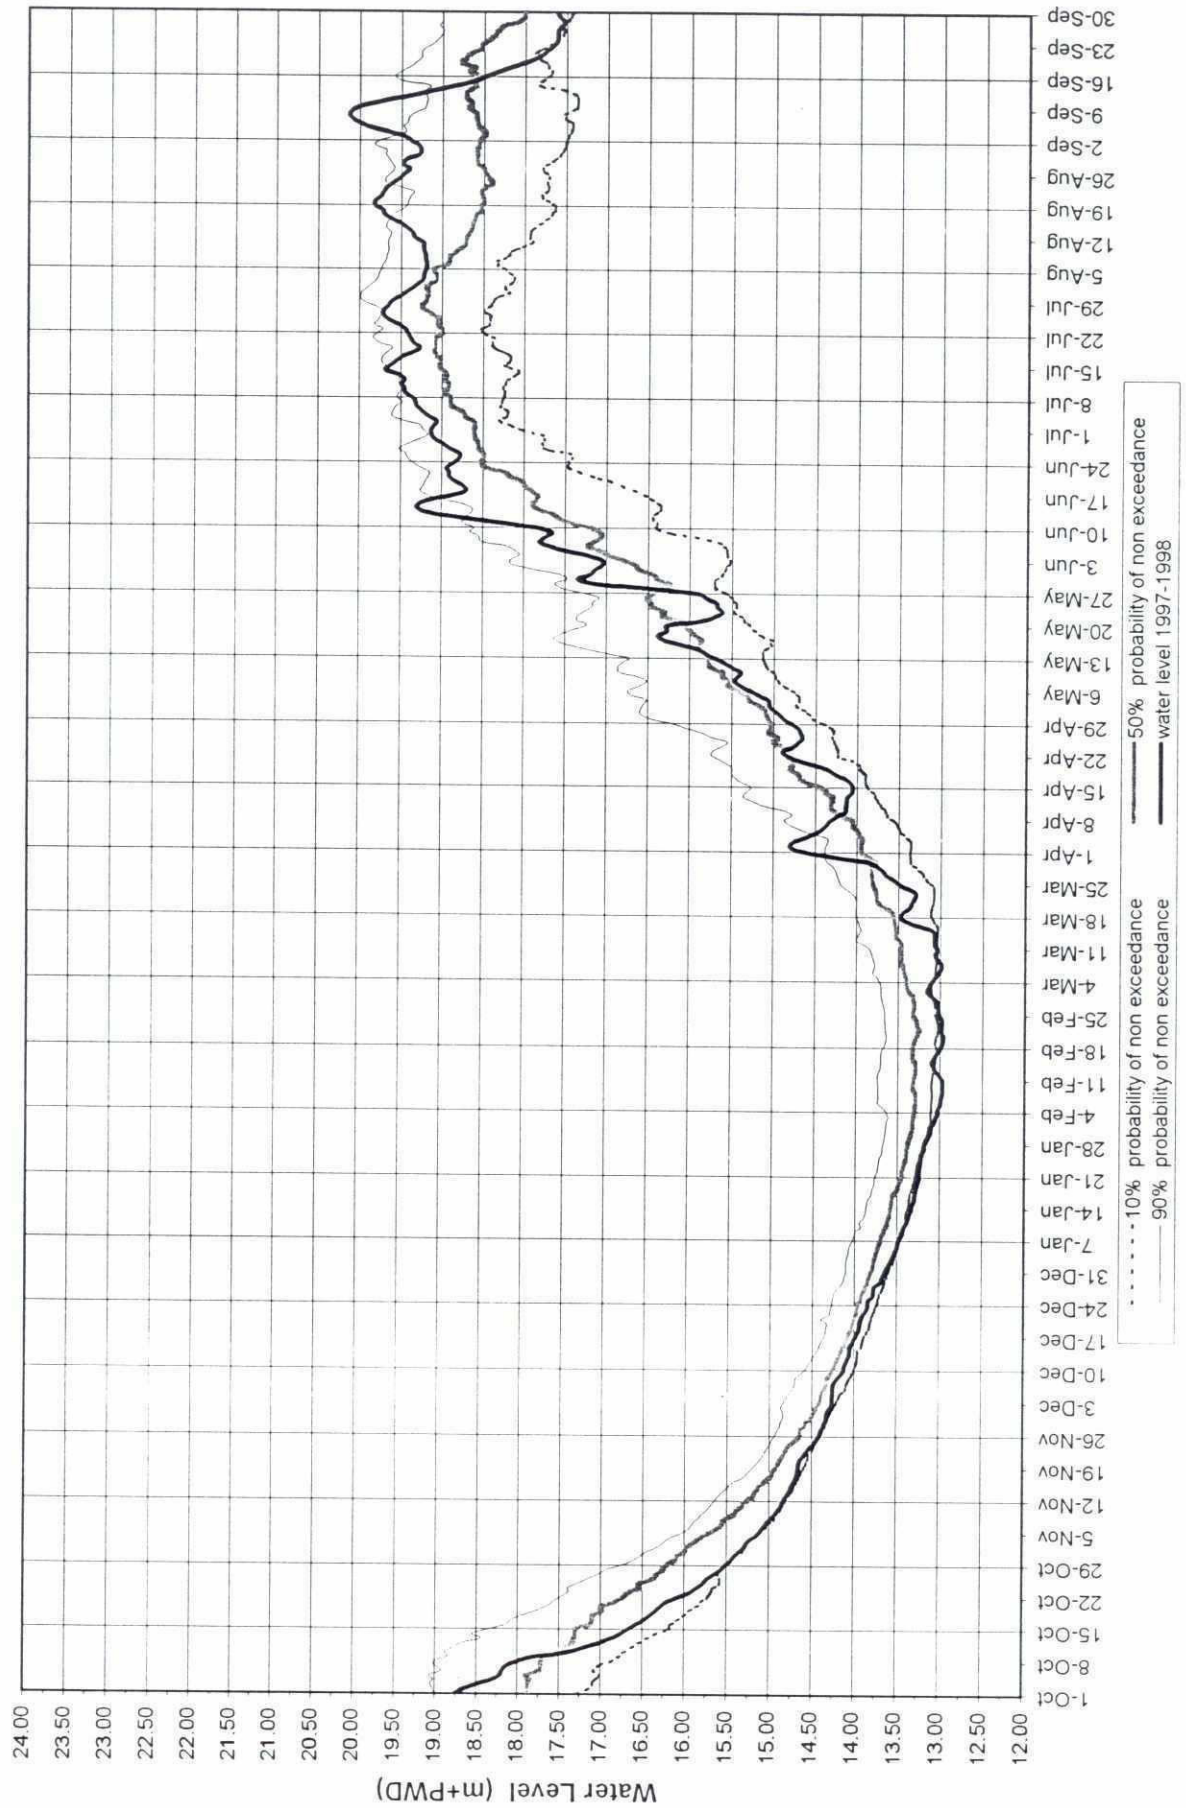
BWDB Data: Period of Record 1962 ~ 1994

**BANK PROTECTION TEST STRUCTURES - FAP 21**  
**BWDB WATER LEVEL FREQUENCY CURVES VERSUS ACTUAL FAP 21 WATER LEVEL**  
**AT BAHADURABAD TEST SITE UP TO SEPTEMBER '98**

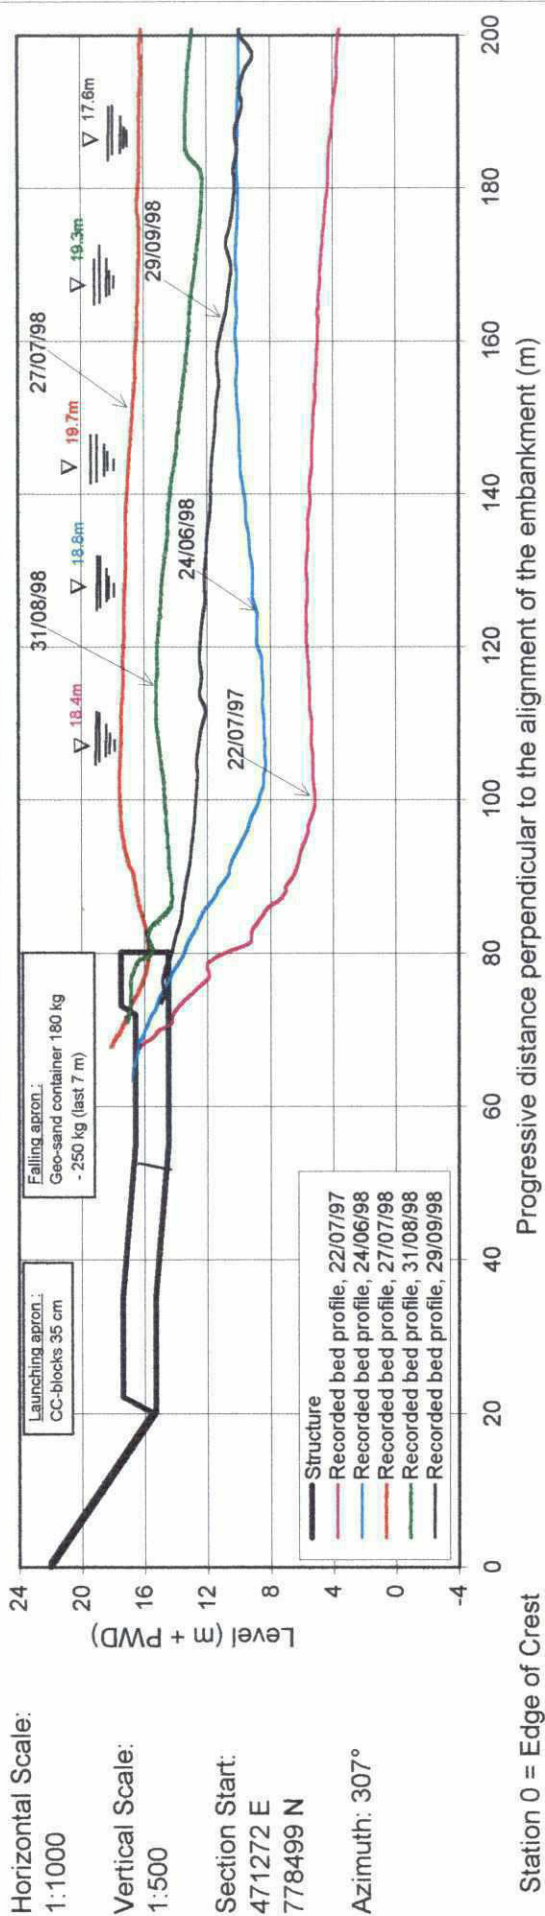
### Cross-Section B, July '97 to September '98

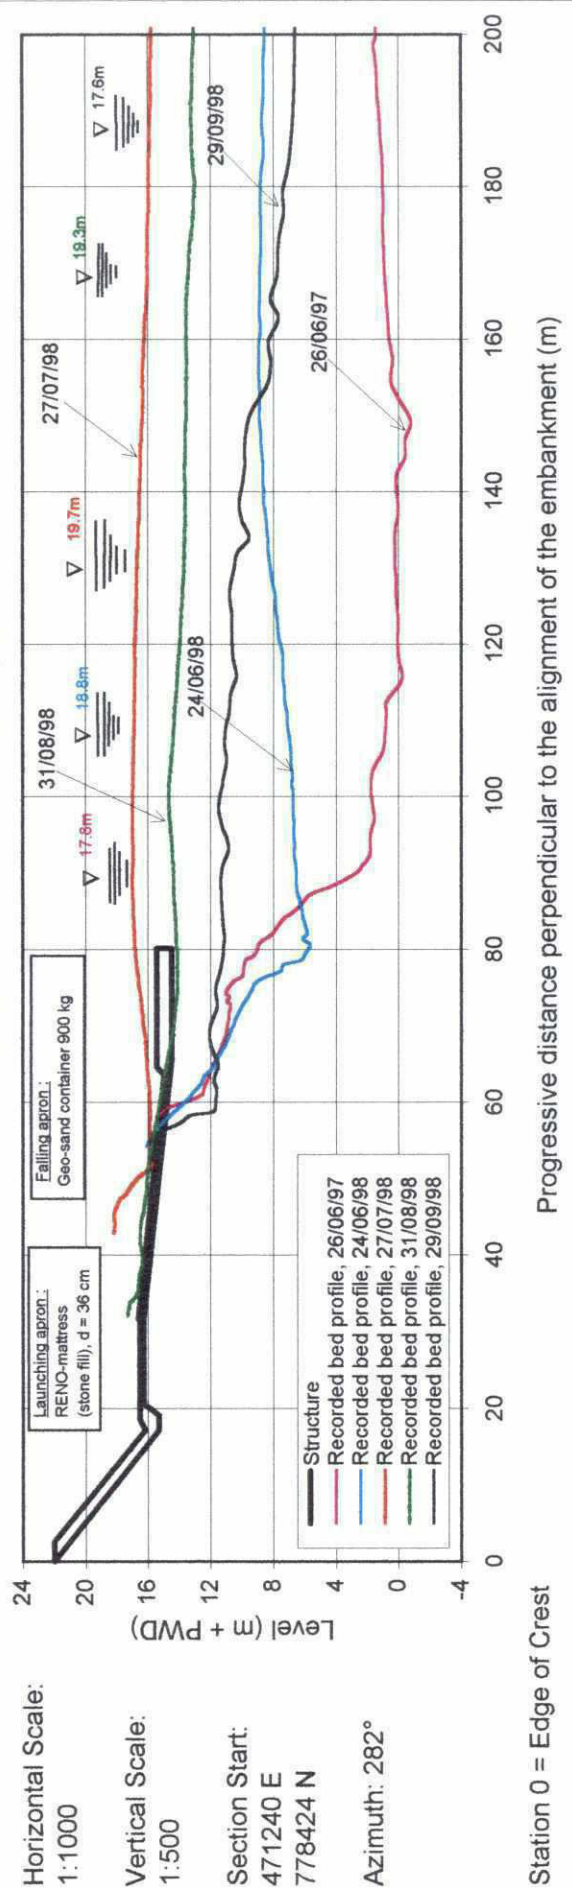
### Cross-Section C, June '97 to September '98

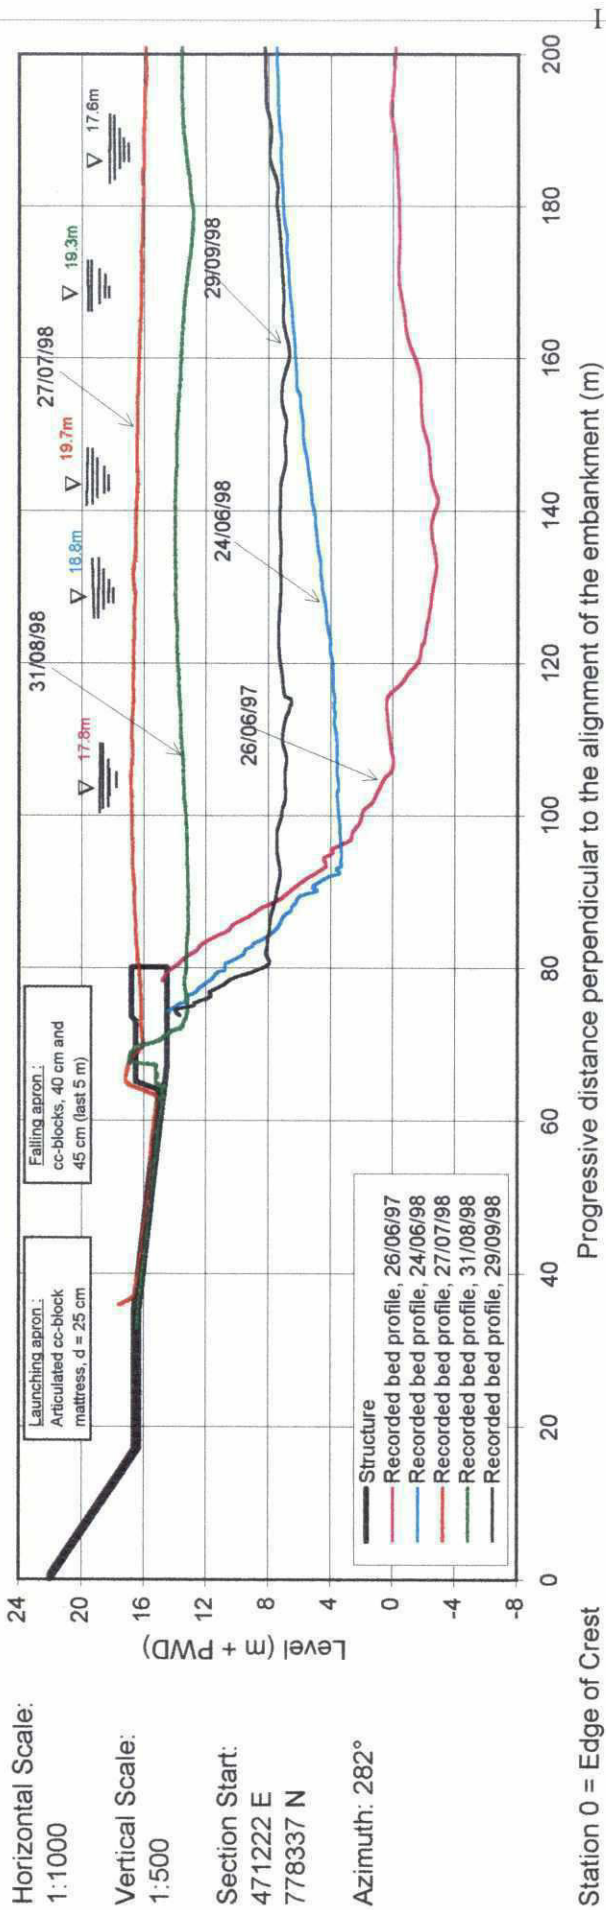
Cross-Section D, June '97 to September '98

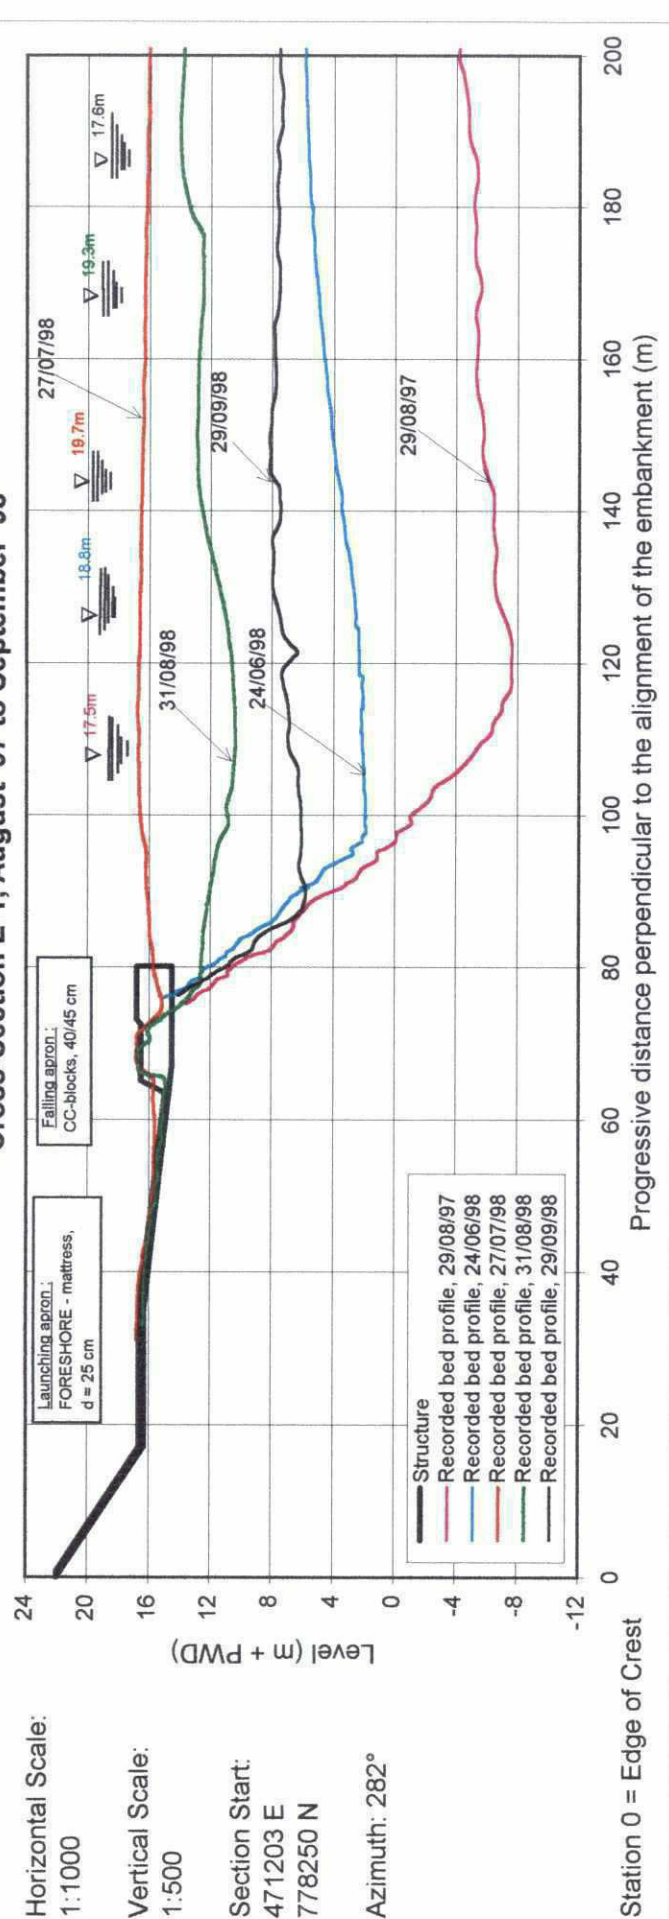
Cross-Section E-1, August '97 to September '98

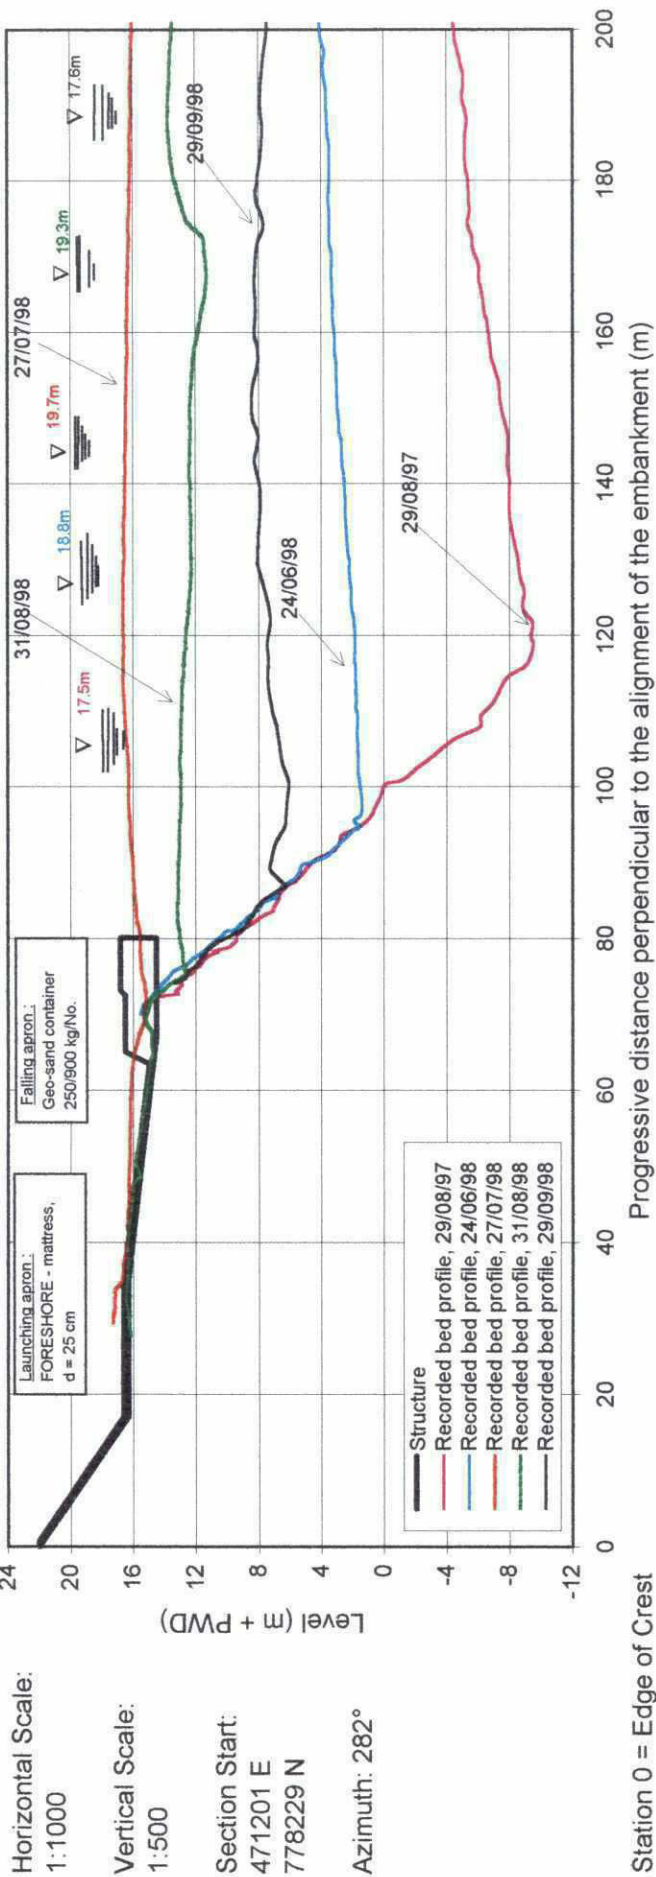
# Cross-Section E-2, August '97 to September '98

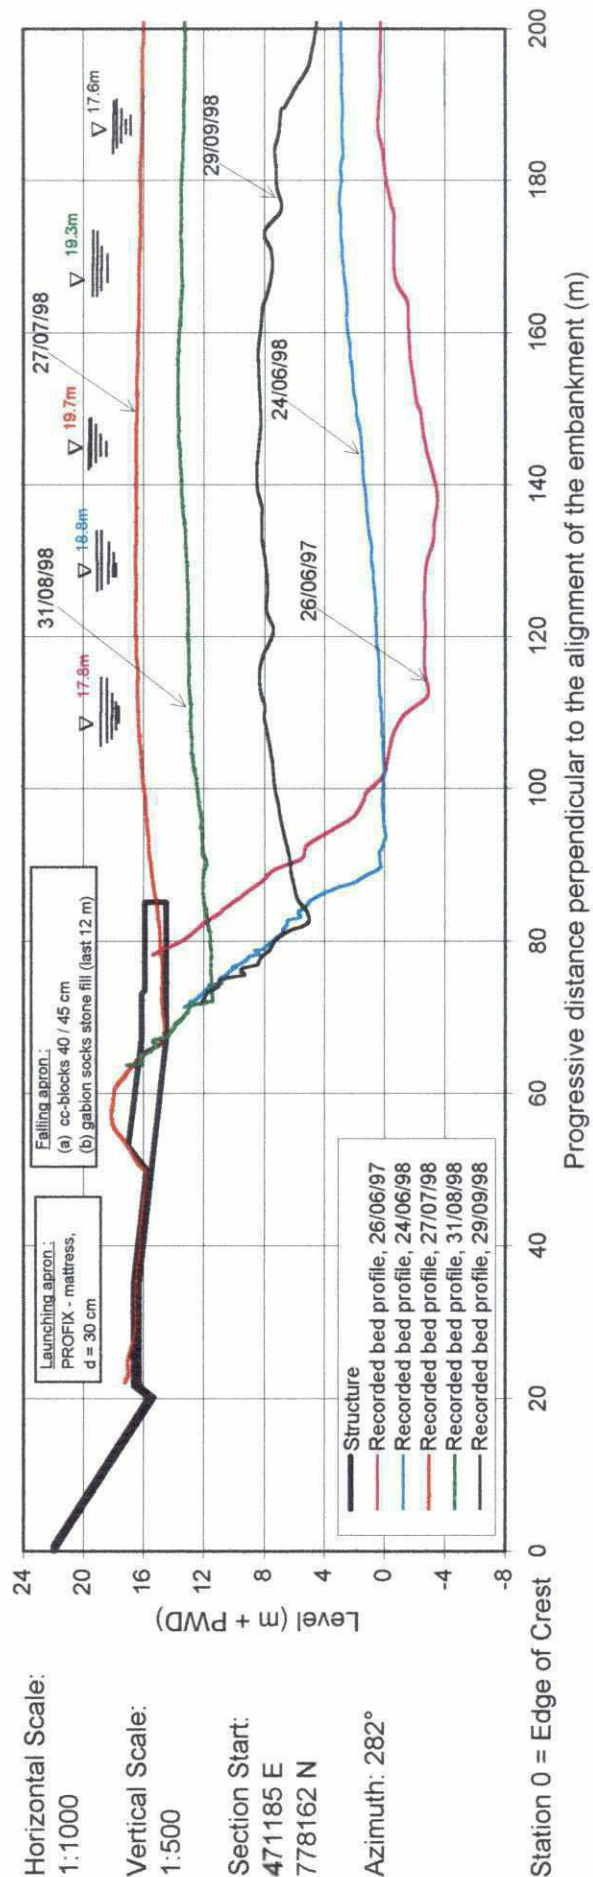
# Cross-Section F, June '97 to September '98

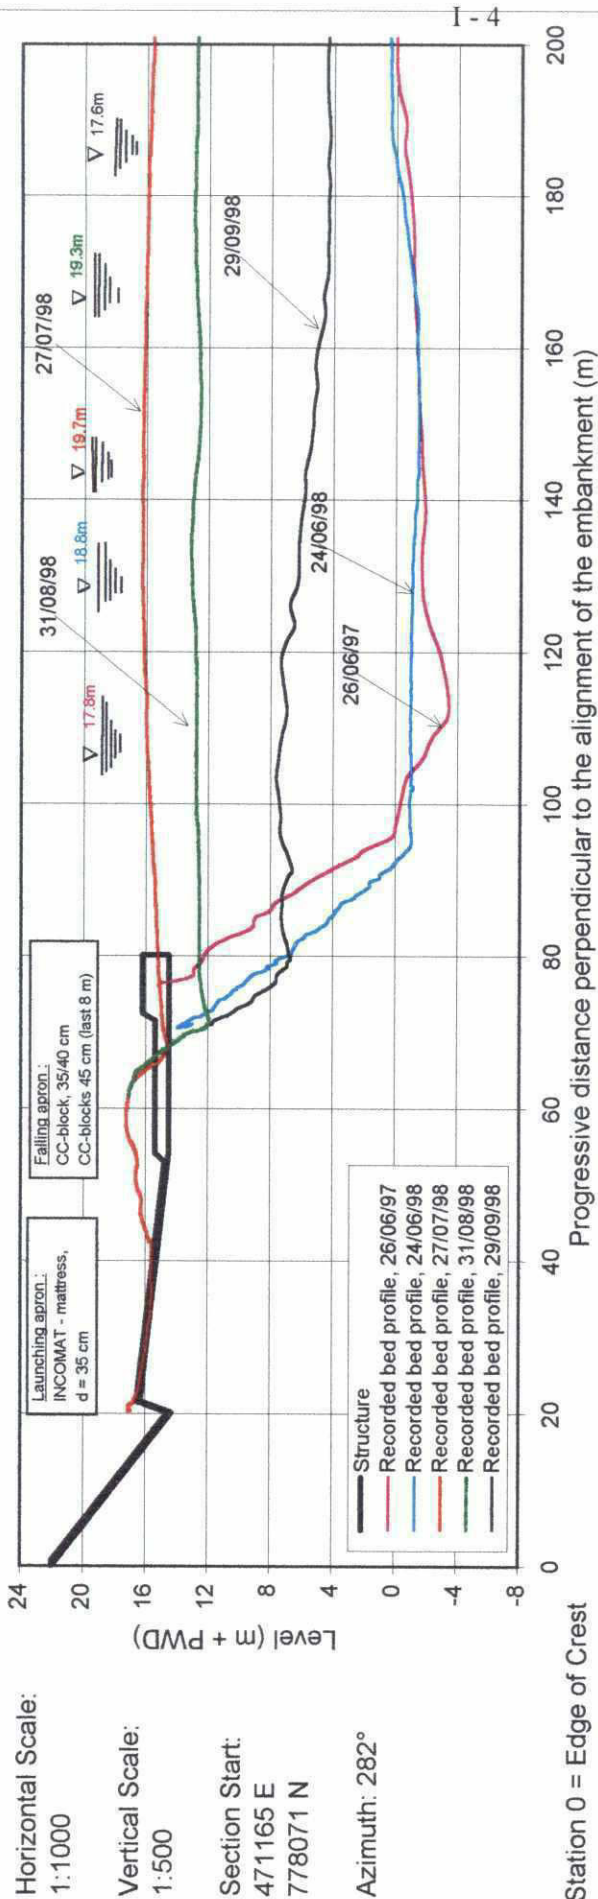
Cross-Section G, June '97 to September '98

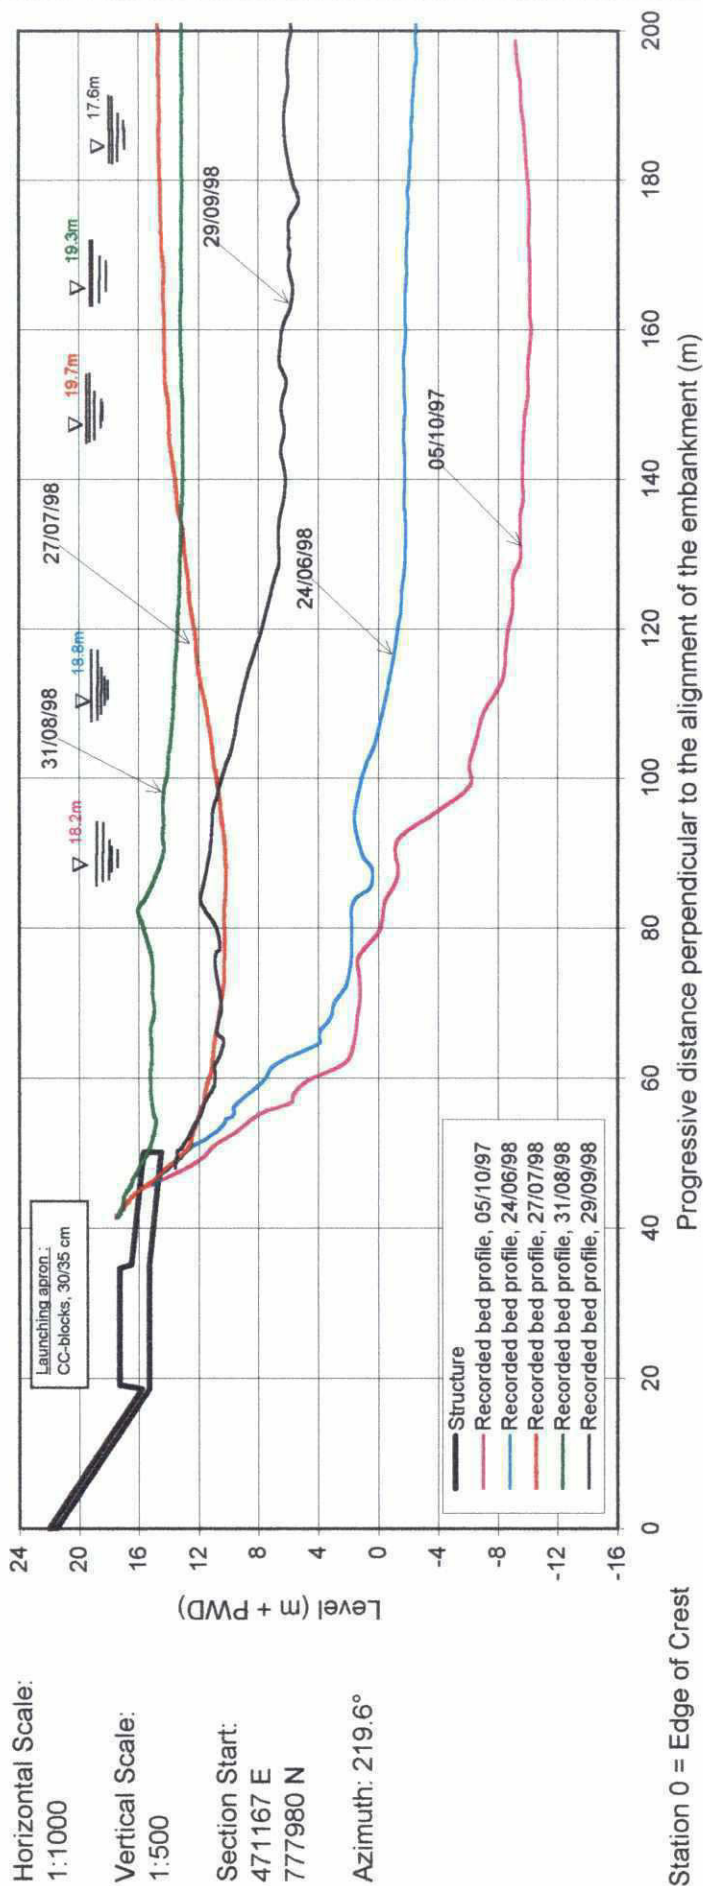
## Cross-Section H-2, October '97 to September '98
