**BANK PROTECTION AND  
RIVER TRAINING (AFPM)  
PILOT PROJECT  
FAP 21/22**

**TEST  
AND  
IMPLEMENTATION  
PHASE**

**PROGRESS REPORT  
NO. 21**

JULY TO SEPTEMBER 1998

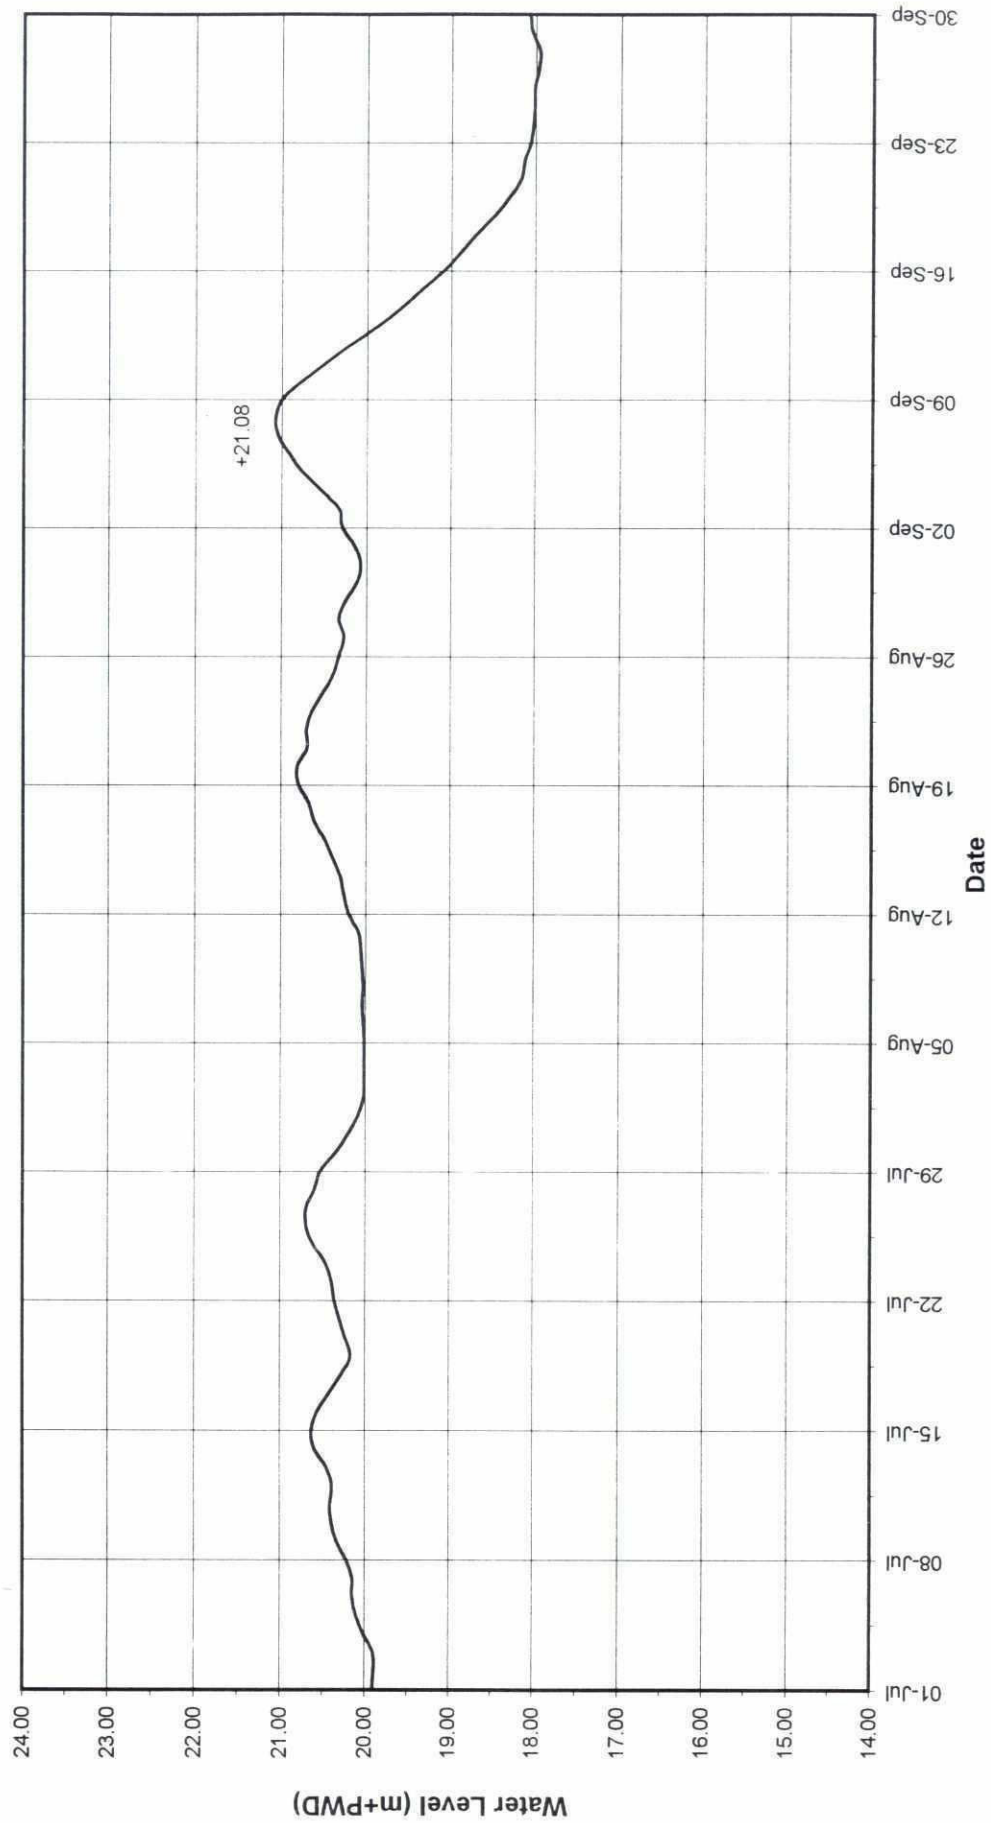
**RIVER TRAINING TEST STRUCTURES - FAP 22**  
**WATER LEVEL AT KATLAMARI TEST SITE**  
(July to September 1998)

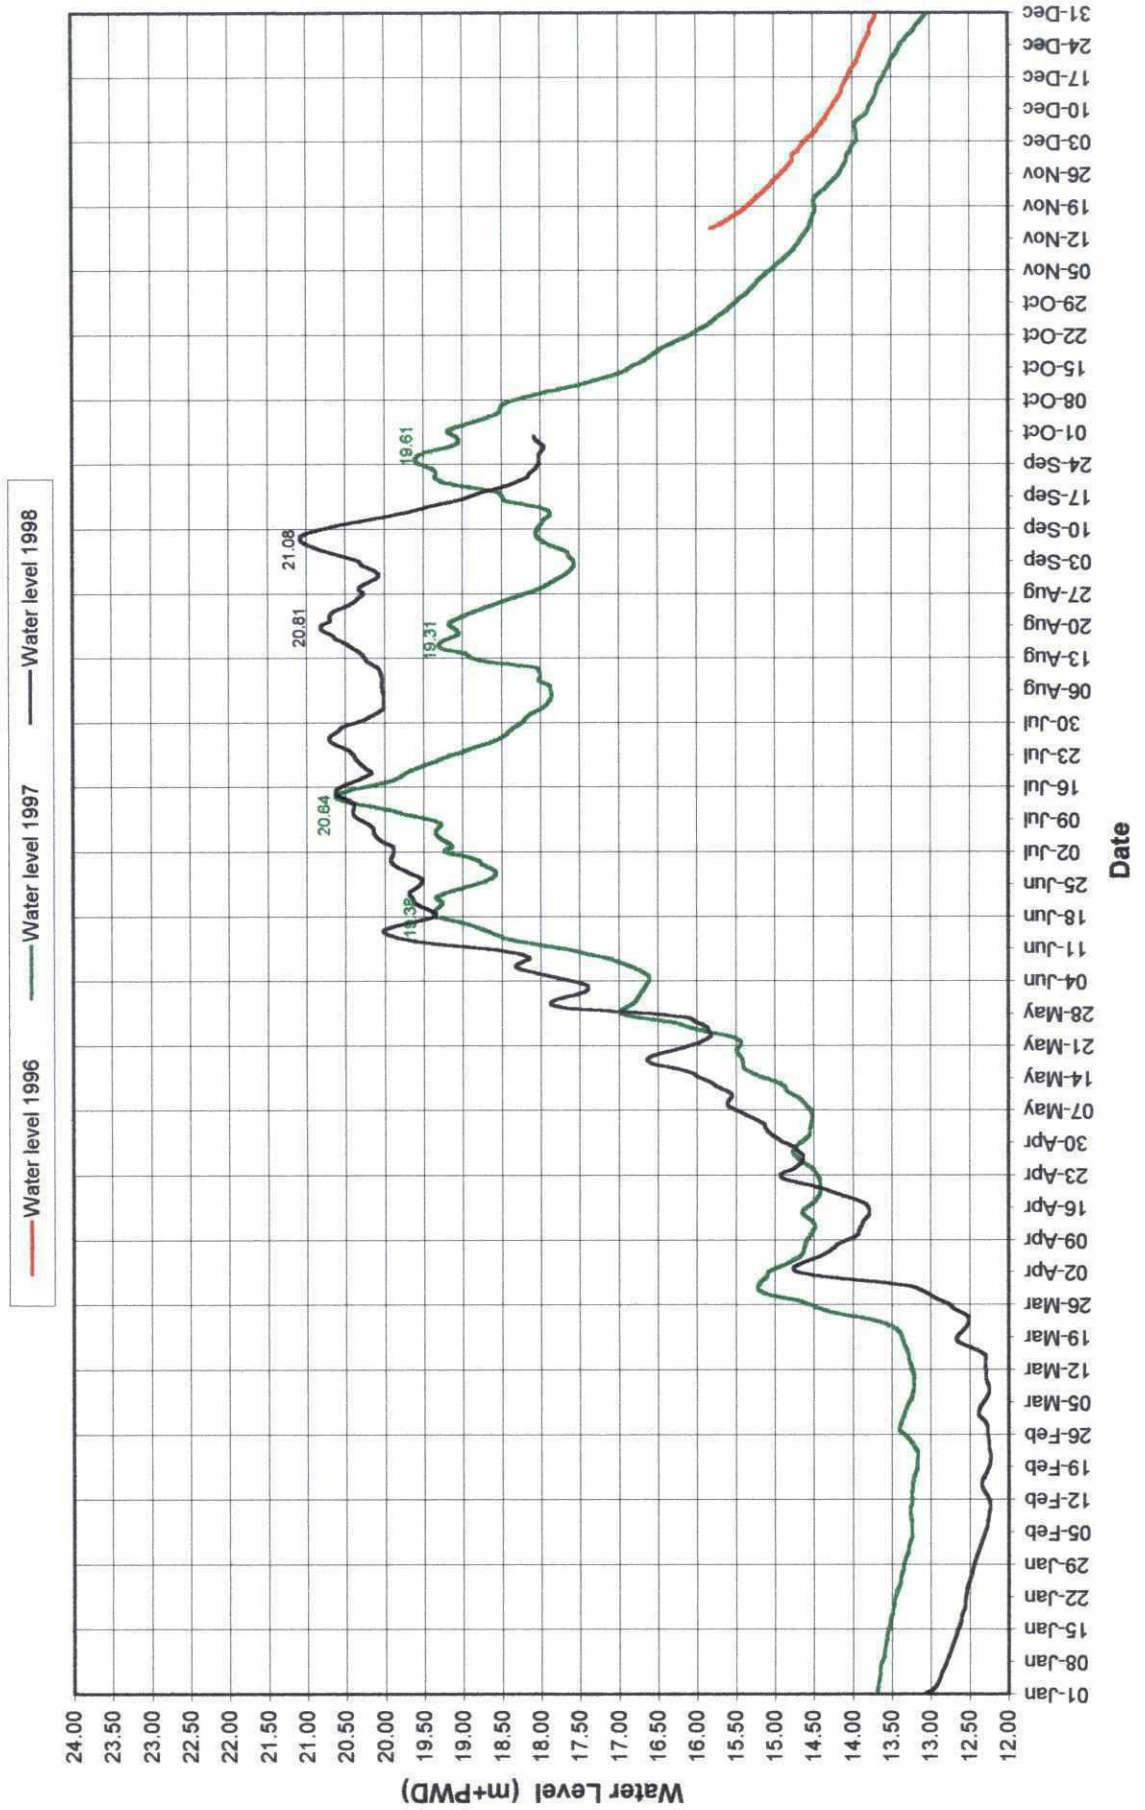
# **RIVER TRAINING TEST STRUCTURE - FAP 22** **WATER LEVEL AT KATLAMARI TEST SITE** **(January to December)**

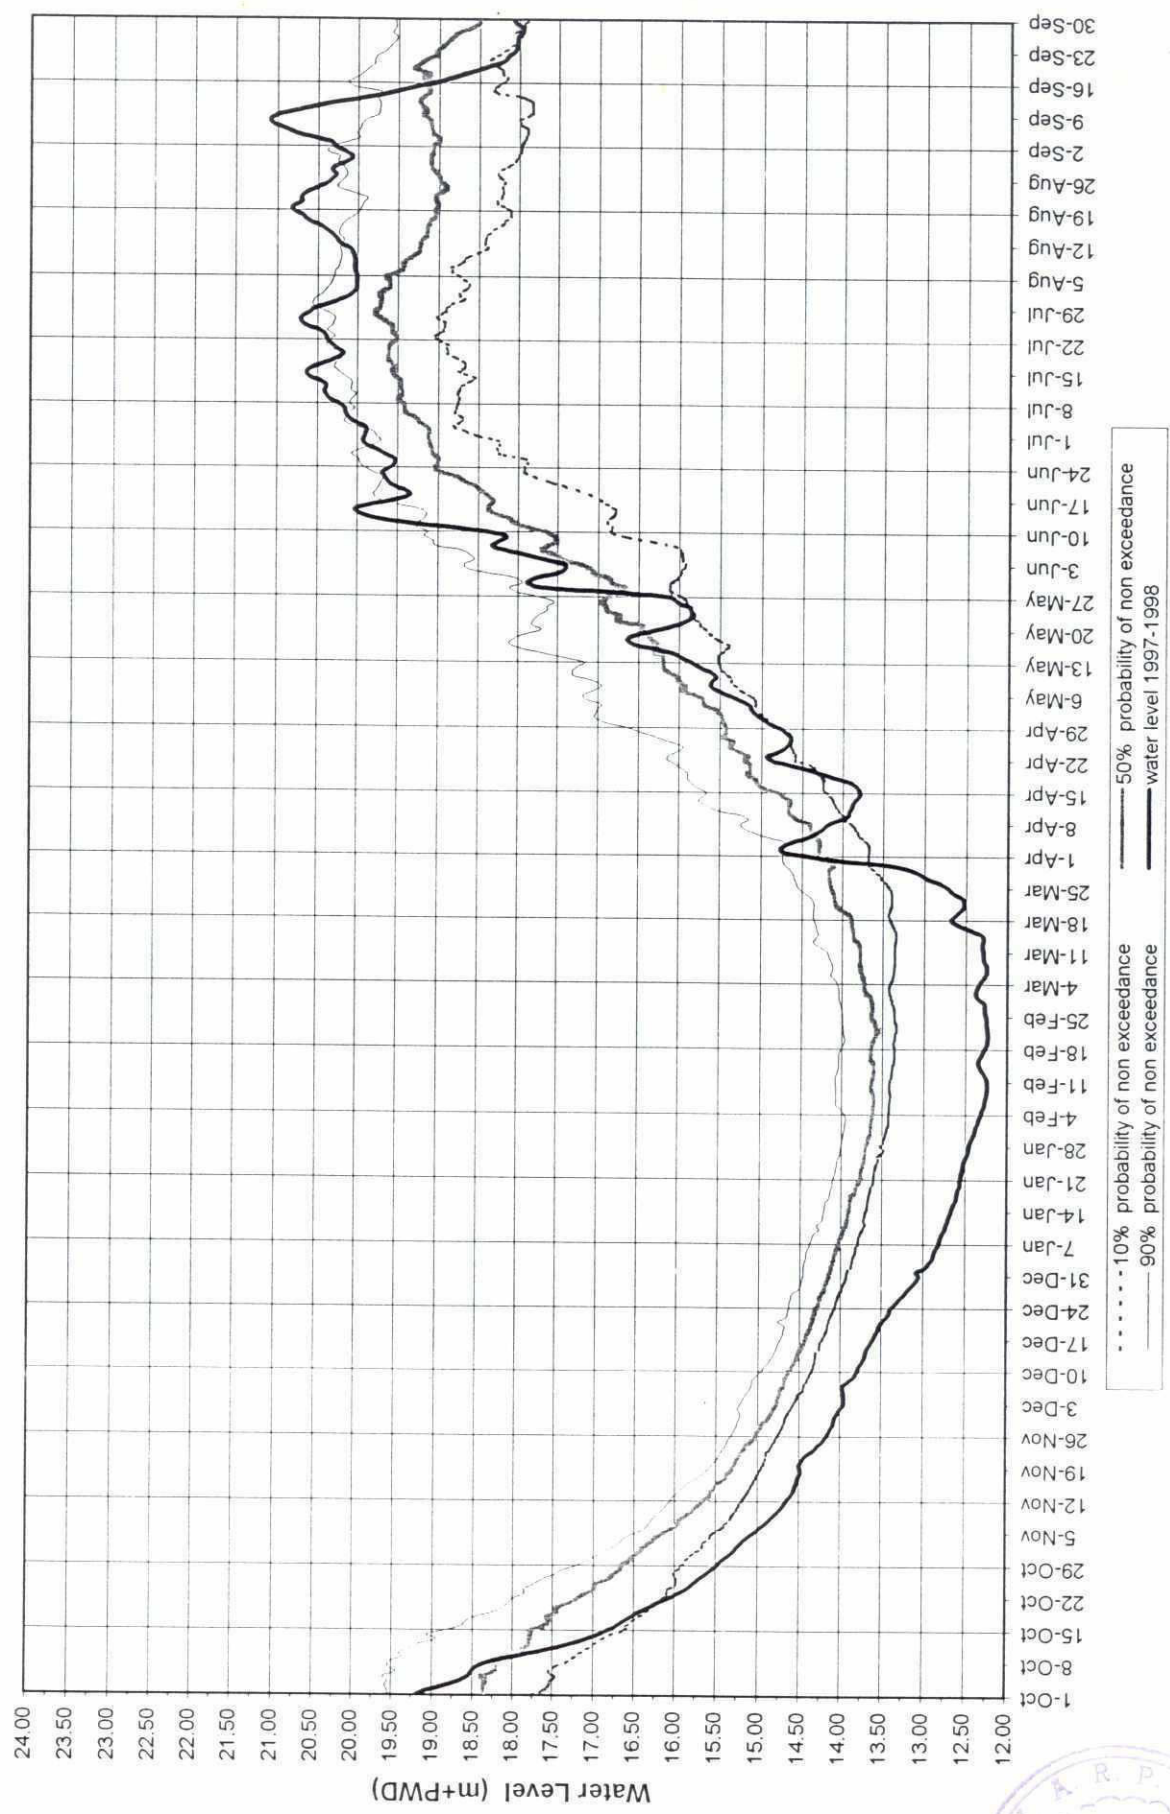
RIVER TRAINING TEST STRUCTURE - FAP 22  
ESTIMATED FROM BAHADURABAD WATER LEVEL FREQUENCY CURVES VERSUS  
ACTUAL FAP 22 WATER LEVEL AT KATLAMARI TEST SITE UP TO SEPTEMBER '98

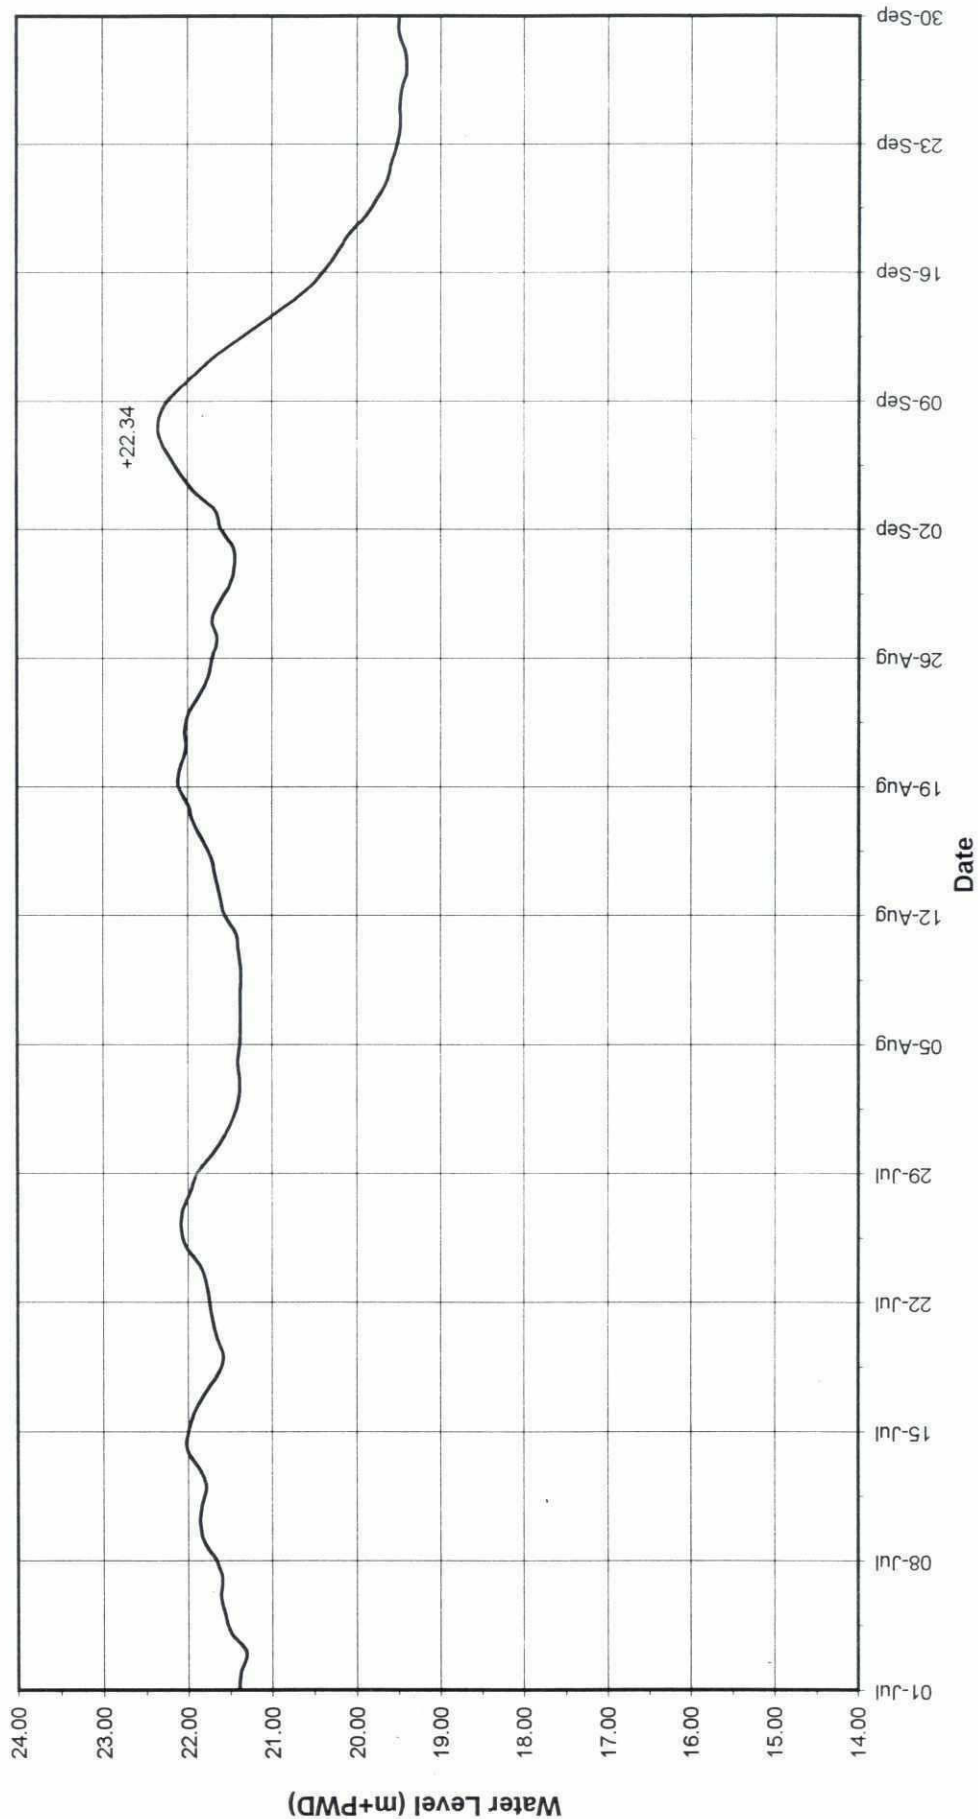
# RIVER TRAINING TEST STRUCTURES - FAP 22 WATER LEVEL AT KUNDARAPARA TEST SITE (July to September 1998)

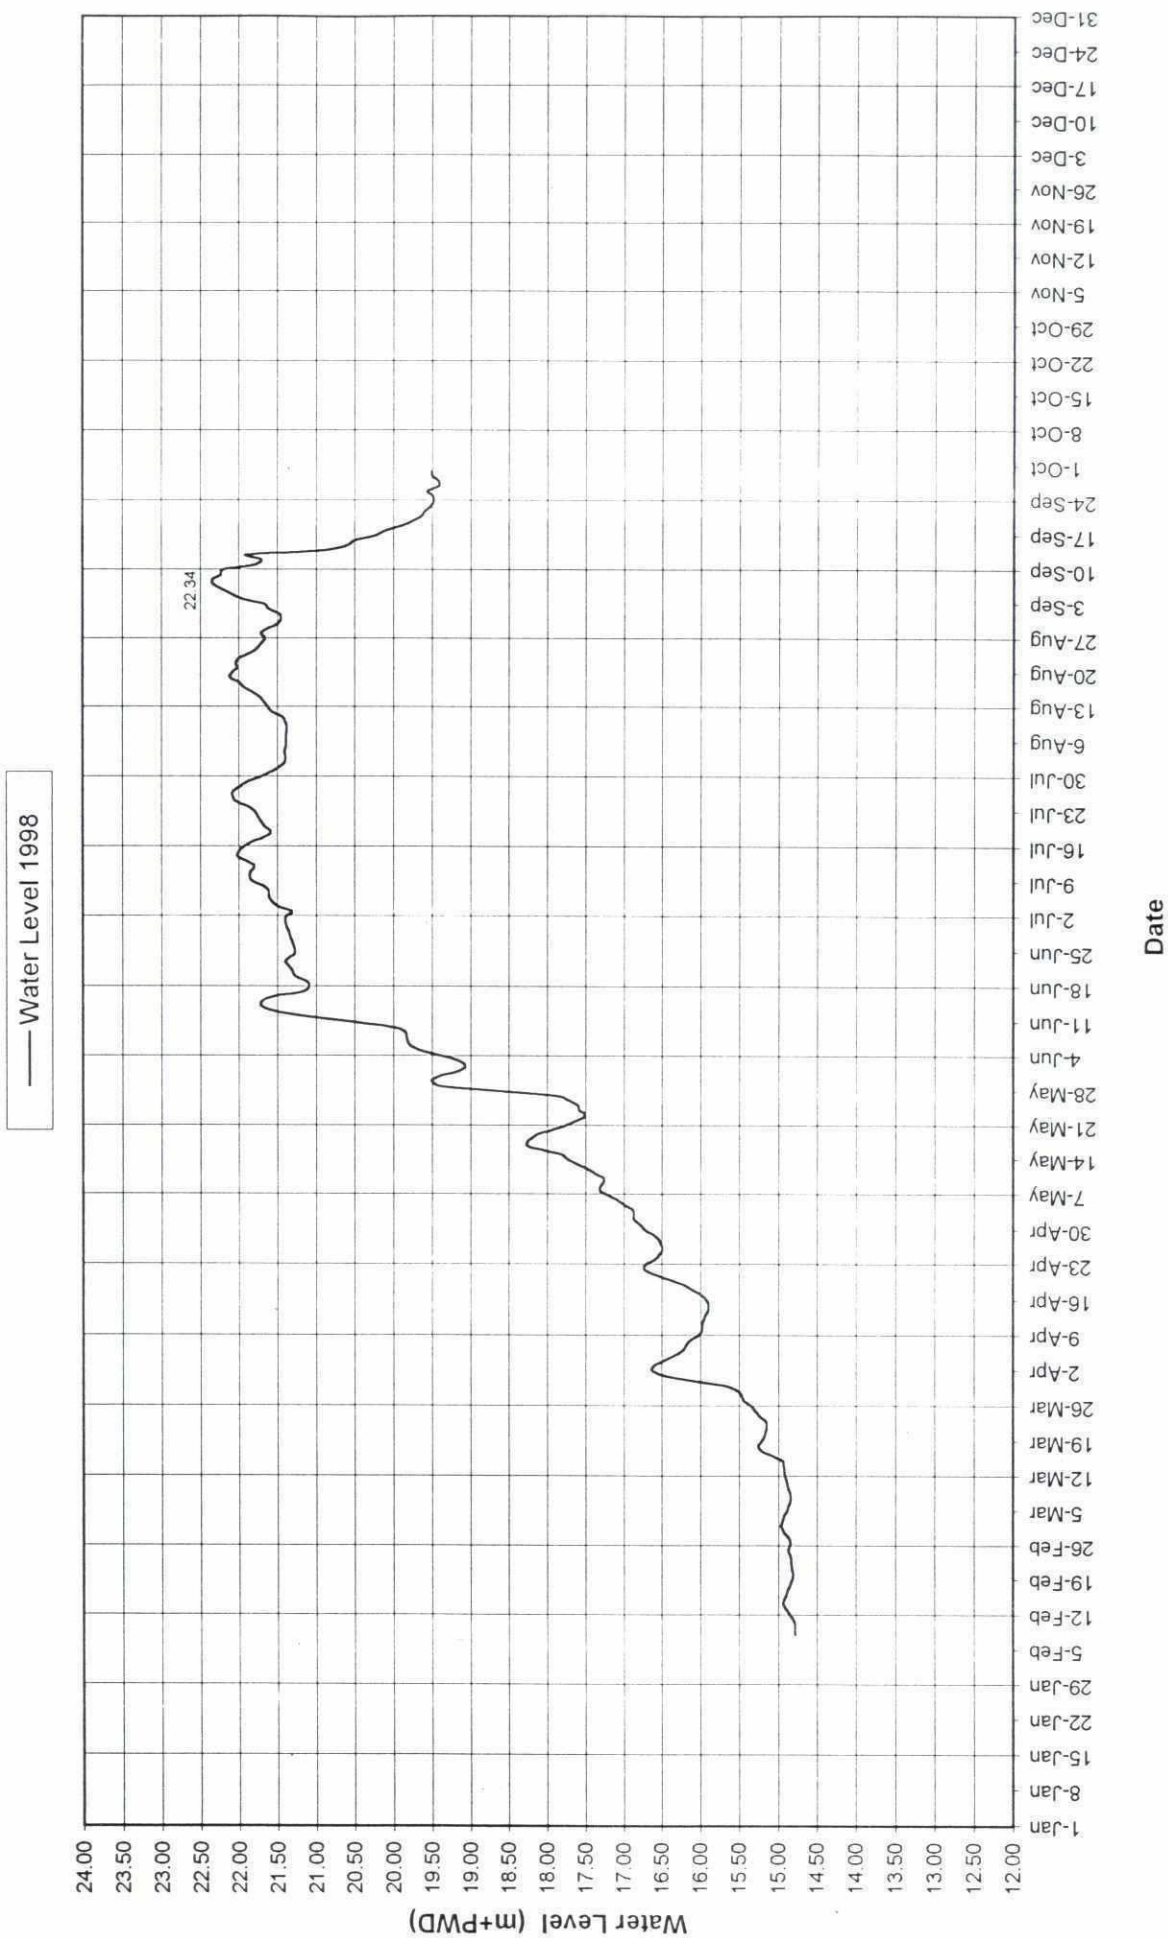
# RIVER TRAINING TEST STRUCTURE - FAP 22 WATER LEVEL AT KUNDARAPARA SITE (January to December)

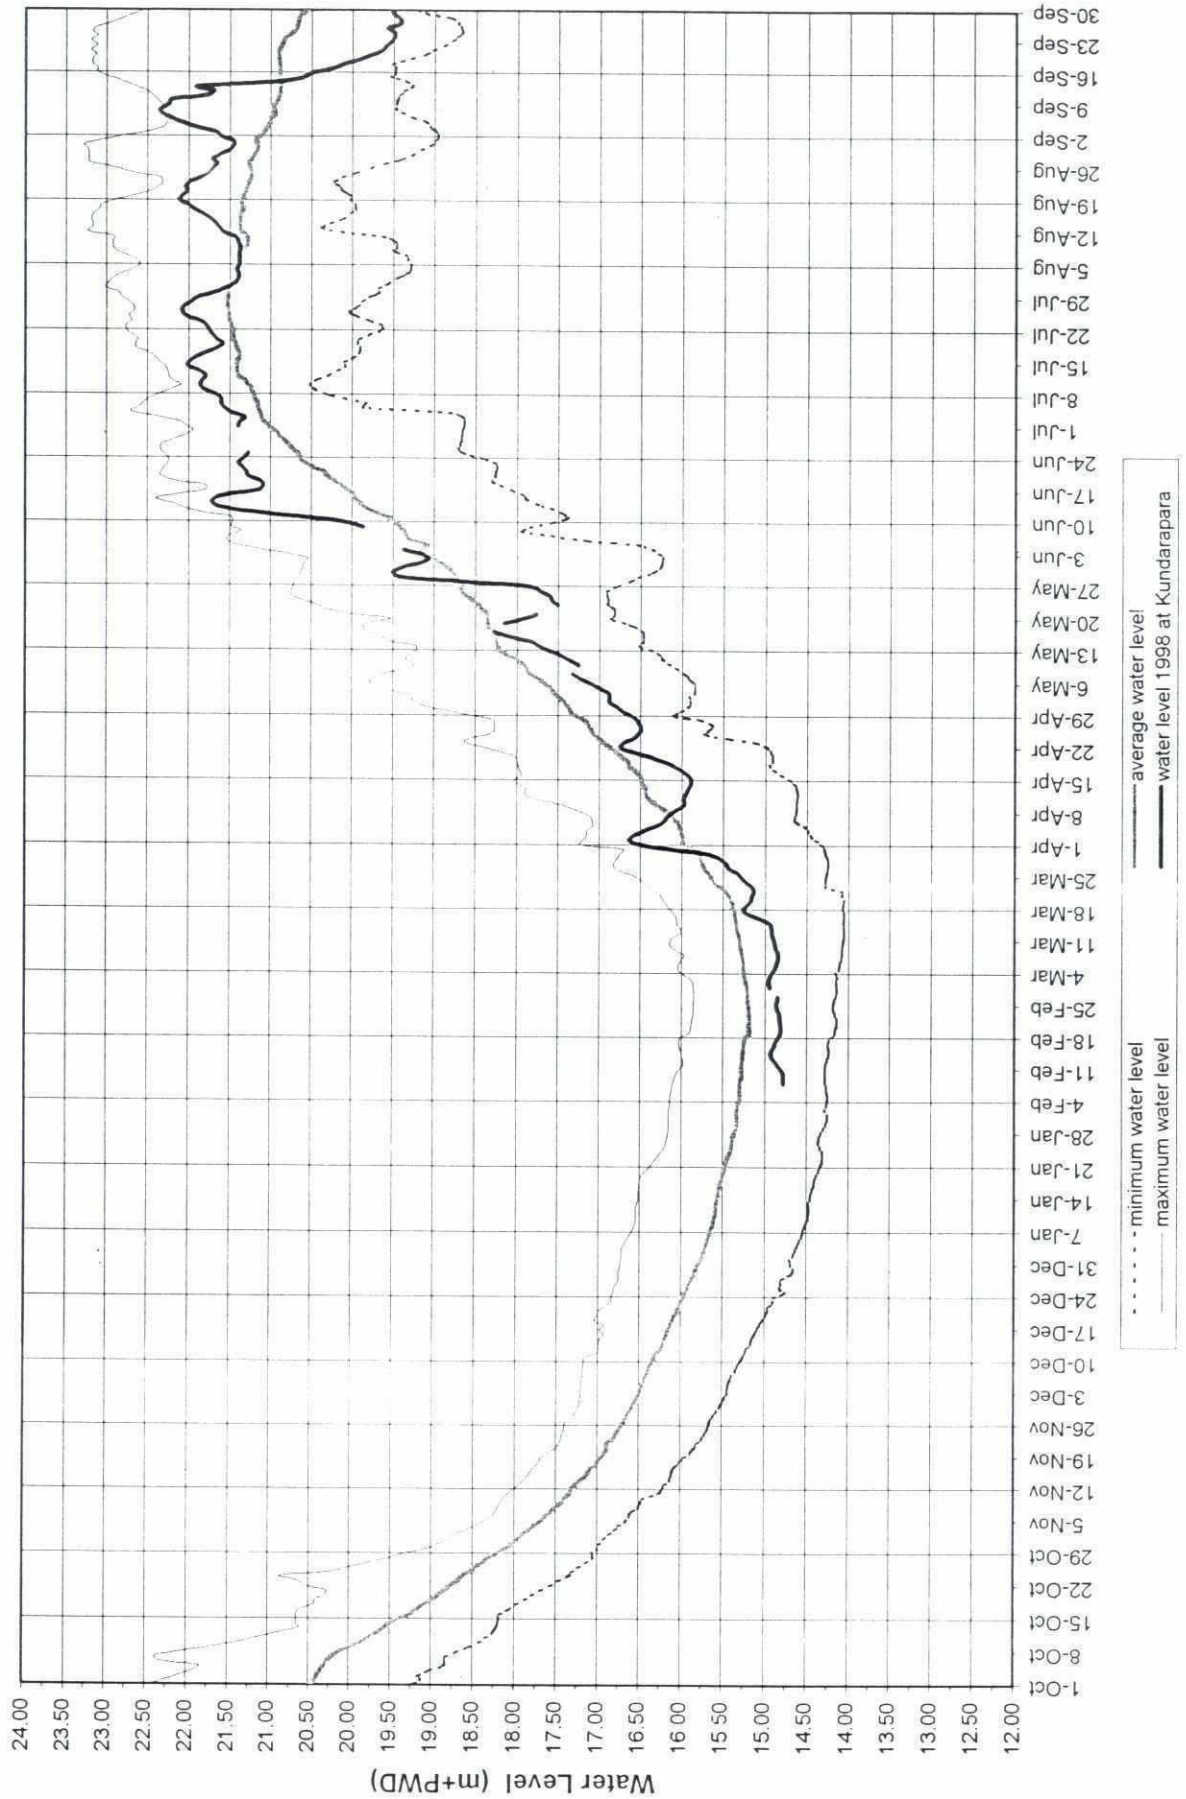
# RIVER TRAINING TEST STRUCTURES - FAP 22 BWDB WATER LEVEL FREQUENCY CURVES VERSUS ACTUAL FAP 22 WATER LEVEL AT KAMARJANI TEST SITE UP TO SEPTEMBER '98
