Final Research Report

THE PILOT PROJECT IN DIFFERENT AREAS OF BANGLADESH USING BAMBOO BANDALING STRUCTURES TO REDUCE RIVER BANK EROSION, LAND RECLAMATION AND INCREASE NAVIGATION

Prepared by River Research Institute

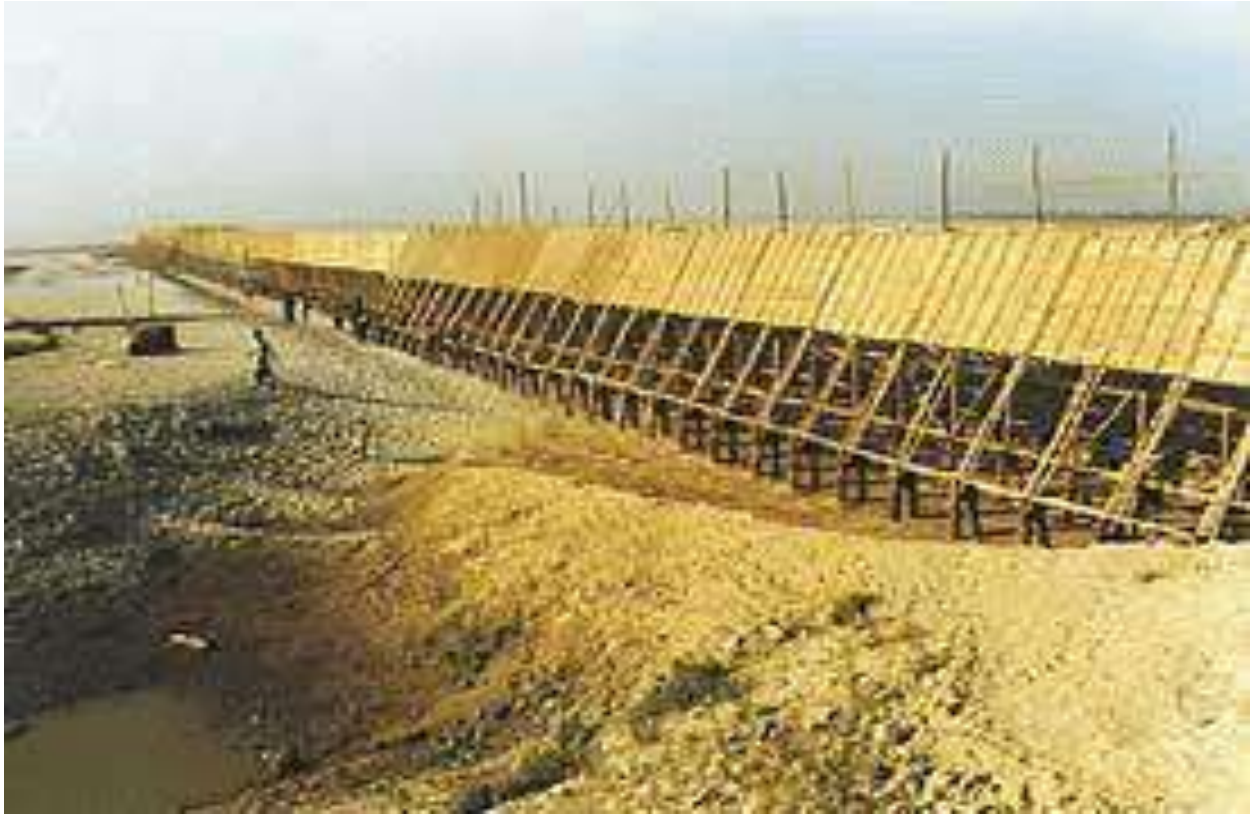
Figure 3.2 Typical bandal constructed alongside the river

A bandal structure physically appears as a vertical screen mounted on a frame. In general, the screen is made of bamboo mats and the frame consists of a series of bamboo sticks (Figure 3.2). As bamboos are locally available and low-priced labors are easily employable on site, bandal structures have achieved a wide use in some large braided and meandering rivers. According to the physical appearance, a bandal structure can be described as a combined structure of an impermeable groyne in the upper part and a permeable groyne in the lower part (Zhang et al., 2010). When the sediment-laden flow approaches a bandal structure, the low sediment-concentrated flow of the upper layer is diverted to the mainstream and is accelerated, resulting in mainstream bed degradation and increase of water depth. It is the mechanism for the navigability enhancement. On the other hand, the high sediment-concentrated flow of the lower layer passes through the bandal structure and sediment deposition occurs behind it due to the velocity reduction there (Rahman et al., 2004). As sediment deposits along the river bank, the risk of bank erosion is reduced and a new agricultural land is created. In other words, bandal is not only effective for the improvement of domestic navigation but also promising in farmland protection and disaster mitigation. Unfortunately, the performance of bandal is not always as efficient as desired according to analyses of field data obtained in major Bangladeshi Rivers (Rahman et al., 2003). In order to make full use of this indigenous method, there is a crucial need to combine updated insight of river dynamics with local indigenous knowledge and experiences. The structure having the similar functions as bandal structures is defined as bandal-like structure

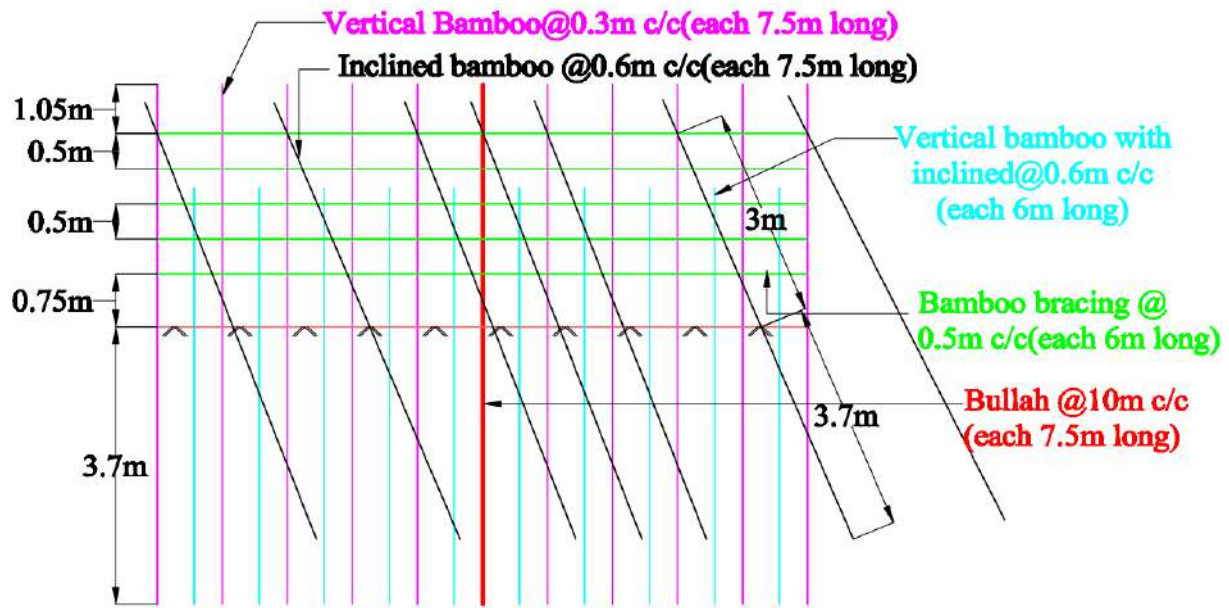
ONE SIDE ELEVATION OF BAMBOO BANDALS

Type of bamboo	: Barrack
Length of the Vertical main Bamboo pole	: ≥ 7.5 m
Length of Inclined bamboo	: ≥ 7.5 m
Length of Vertical bamboo with Inclined (Tie)	: ≥ 6 m
Length of the Horizontal Bamboo (Runner)	: ≥ 6 m
Inserted bamboo pole below the ground level	: 4.0 m
Bamboo pole above the ground level	: 3.5 m
Diameter of the bamboo	: 6 to 8 cm
Distance between vertical main bamboo	: 30 cm C/C
Distance between horizontal bamboo (runner)	: 50cm C/C
1st Horizontal bamboo above the ground	: 75 cm
Angle towards downstream (depending on situation especially flow condition, depth and width of the river)	: 30^0 to 45^0
Distance between main bamboo pole and tie bamboo	: 0.75 m
Distance between main bamboo pole and inclined bamboo	: 3 m at G.L.
Length of the Bullah	: 7.5 m
Spacing of the Bullah	: 10 m C/C
Diameter of the Bullah	: 10 to 13 cm

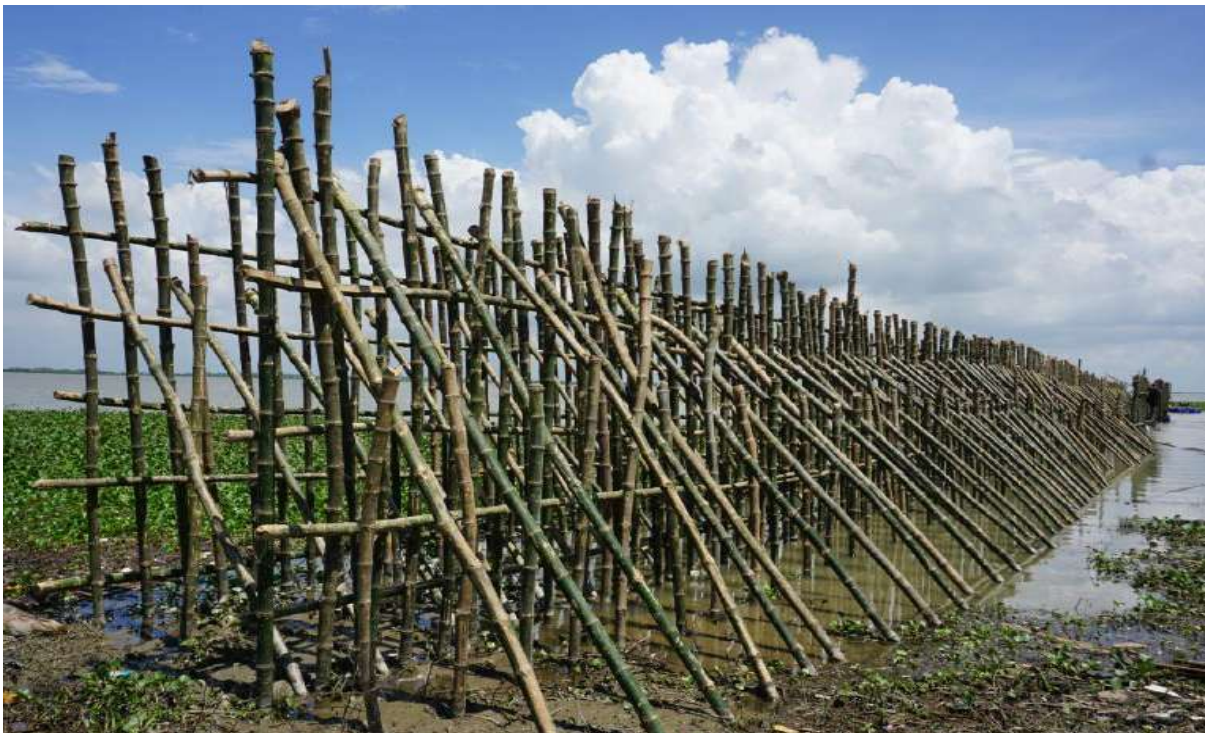
Figure 4.3 Constructed bandal structures at Enayetpur, Sirajgonj as per Design

Bandal type structures have been constructed in the selected erosion prone areas of the pre-considered rivers between January 2018 and June 2021. At every site a series of bandal type structures are constructed covering the erosion prone stretch of the river fully or partially. The design features of bandal type structure are shown in **Figure 4.2, 4.3** and **Table 4.2**.

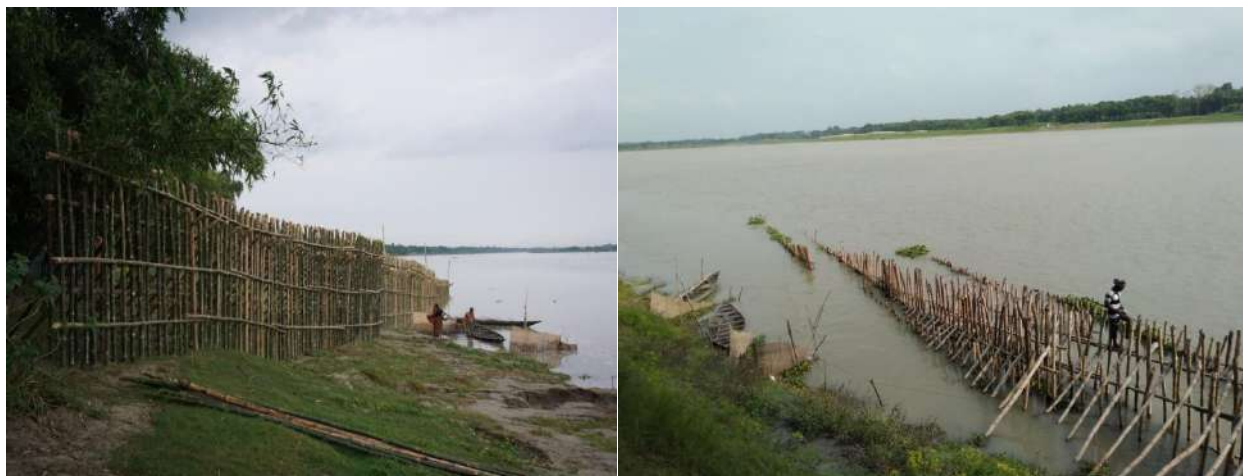
Figure 4.5 Bandal structures at u/s and d/s of Jhamshapur and Narua kheyaghat

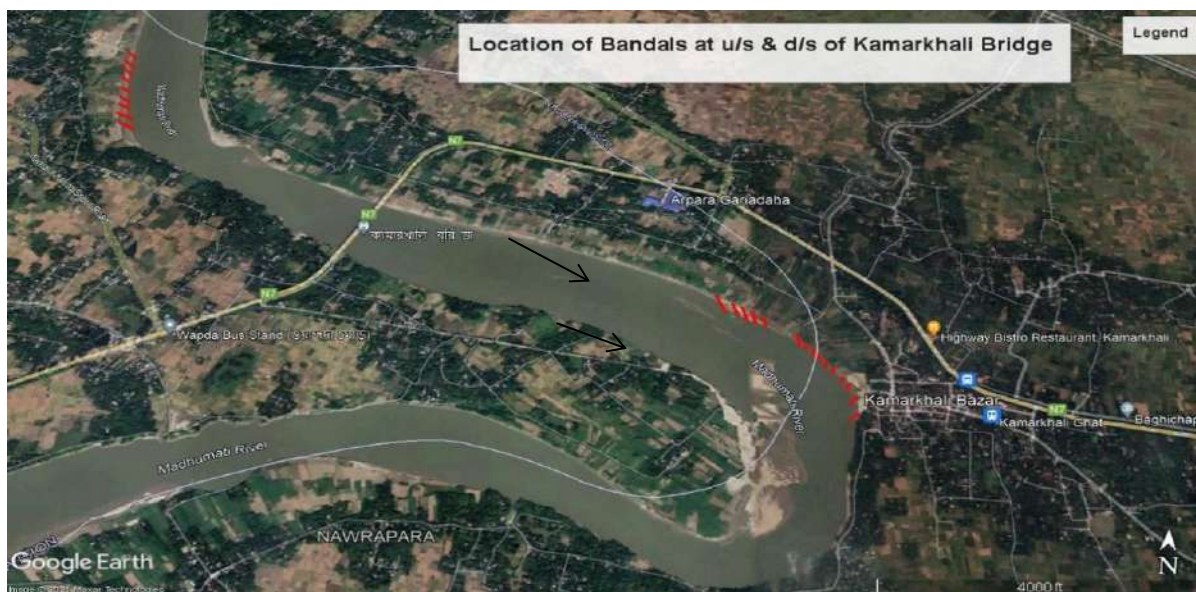
Figure 4.6 Location of the bandal structures at u/s & d/s of Kamarkhali Bridge

Bandal type structures have been constructed in the erosion prone area of the left and right bank of the Madhumati River at u/s & d/s of Kamarkhali bridge, Madhukhali upazila under Faridpur district in January 2019. 2000 meter bandal structures have been constructed at d/s of Kamarkhali bridge in the left bank near Kamarkhali Bazar and 650 meter bandal structures have been constructed at u/s of Kamarkhali bridge in the right bank of the Madhumati River. In total 2650 meter bandal structures have been constructed at u/s & d/s of Kamarkhali Bridge. The individual bandals are oriented at an angle of 30^0 - 35^0 towards downstream (Figures 4.6 and 4.7).

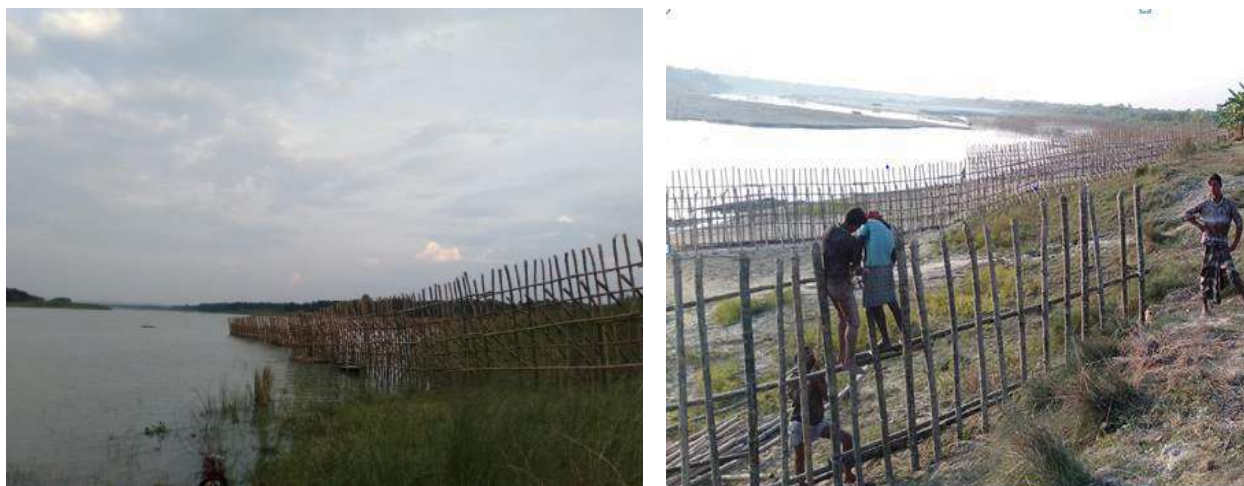
Figure 4.7 Bandal structures at u/s and d/s of Kamarkhali Bridge

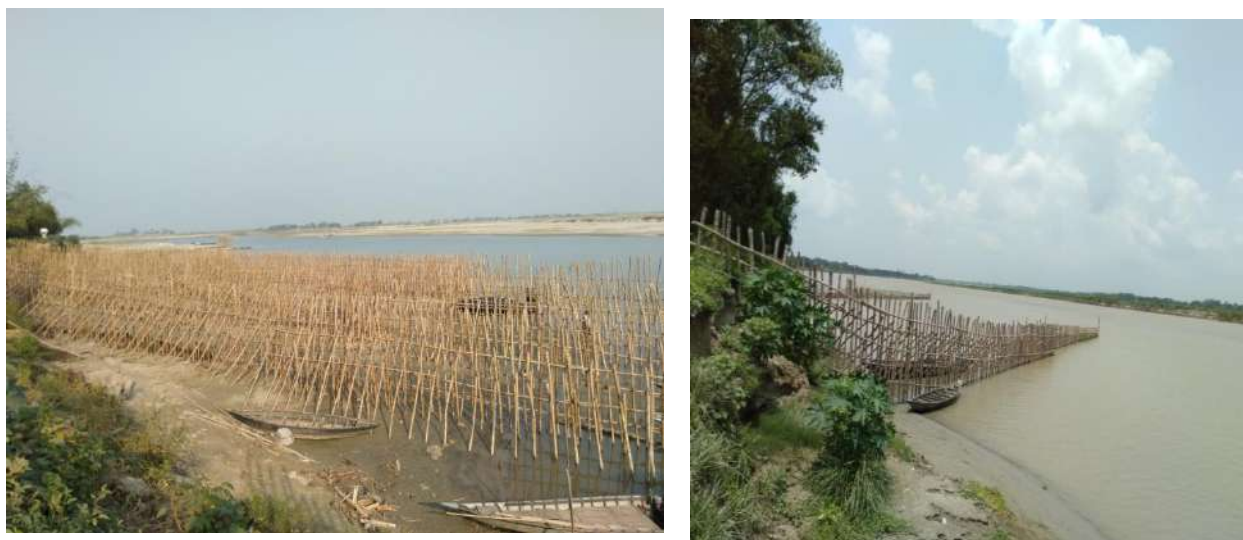
Figure 4.10 Bandal structures at u/s and d/s of Chandrapara Ghat, Sadarpur

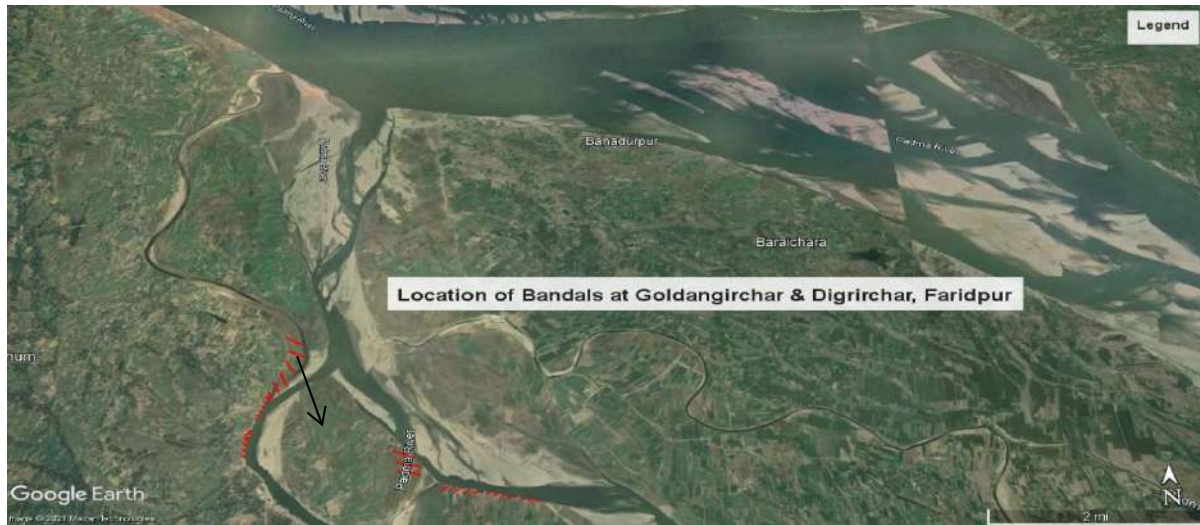
Figure 4.11 Location of the bandal structures at Goldangirchar & Digrirchar, Faridpur

Faridpur district in January 2021. Around 2800 meter bandal structures have been constructed at Goldangirchar and 1875 meter bandal structures have been constructed at Digrirchar under Faridpur sadar upazila. In total about 4375 meter bandal structures have been constructed at Goldangirchar and Digrirchar. Some bandals have been constructed as V-shape due to back flow effect at an angle 45° with the flow direction. The individual bandals are oriented at an angle of 30° - 40° towards downstream (Figures 4.11 and 4.12).

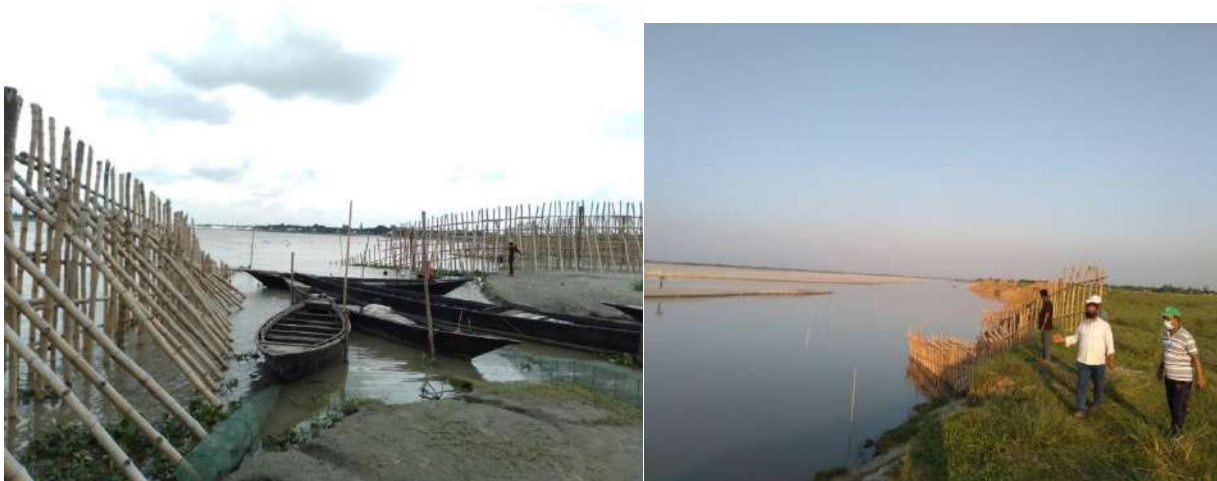
Figure 4.12 Bandal structures at Goldangirchar & Digrirchar, Faridpur

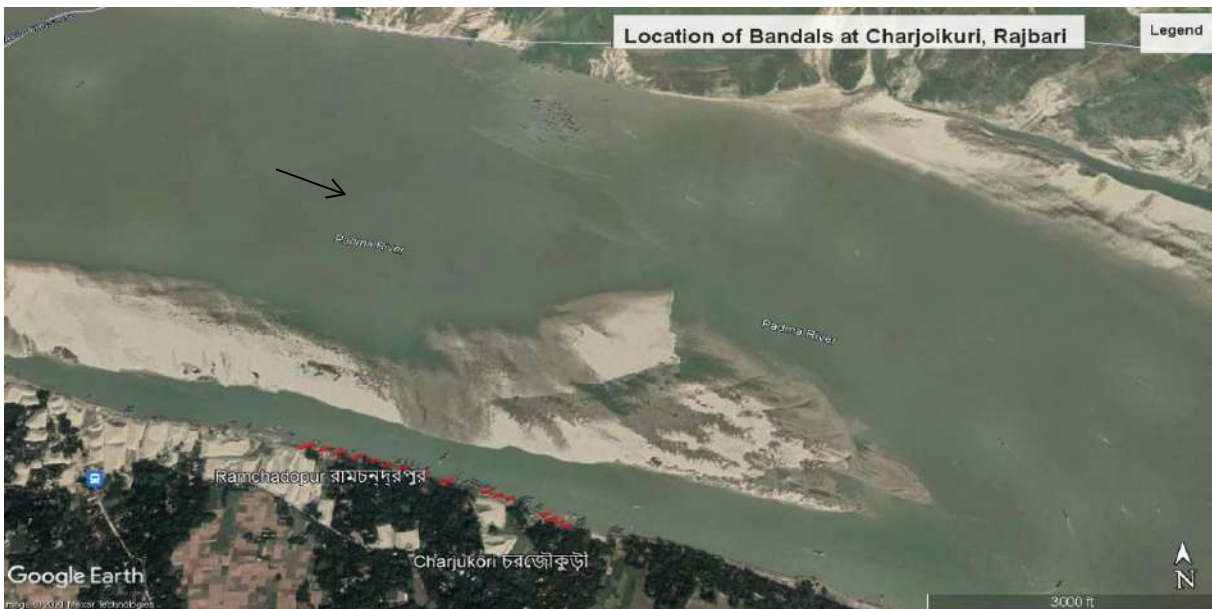
Figure 4.13 Location of the bandal structures at Charjoikuri, Rajbari

Bandal type structures have been constructed in the erosion prone area of the right bank of the Padma river at Charjoikuri, Rajbari sadar upazila under Rajbari district in January 2021. Around 1600 meter bandal structures have been constructed at Charjoikuri under Rajbari sadar upazila. The individual bandals are oriented at an angle of 30^0 - 40^0 towards downstream. Bandal type structures have been constructed from upstream to downstream (Figures 4.13 and 4.14).

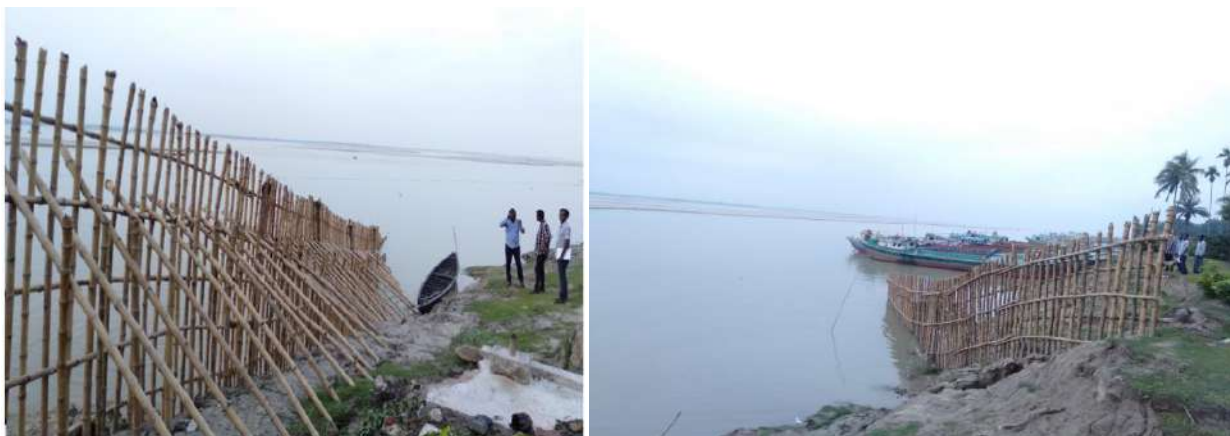
Figure 4.14 Bandal structures at Charjoikuri, Rajbari

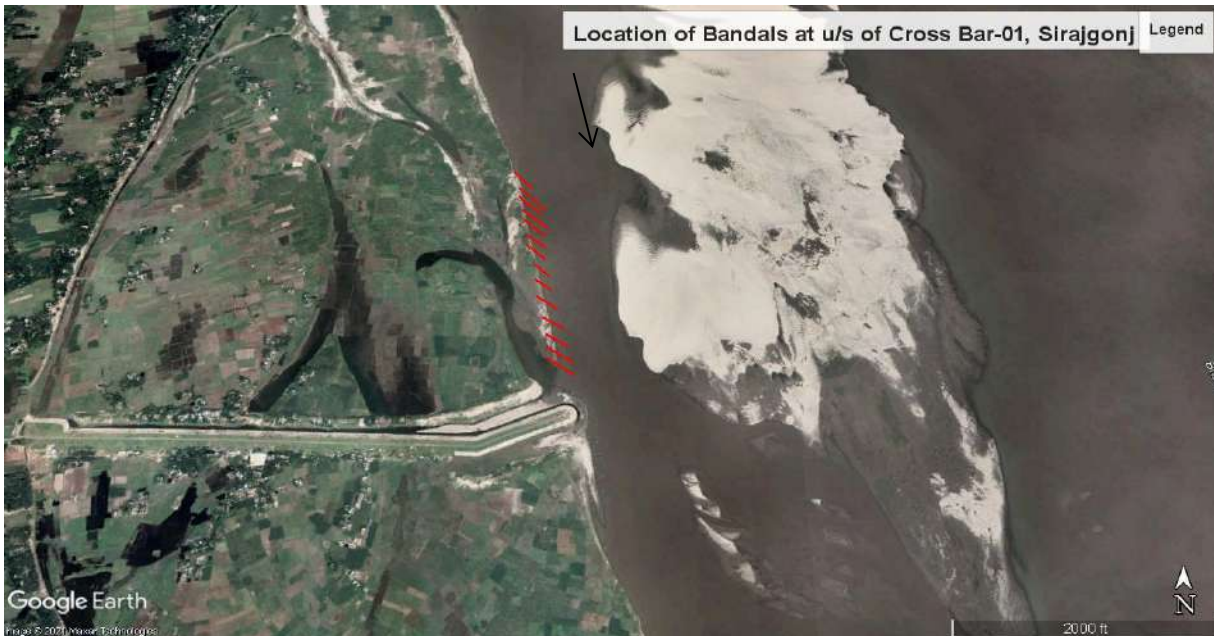
Figure 4.15 Location of the bandal structures at u/s of Cross Bar-01, Sirajganj

Bandal type structures have been constructed in the erosion prone area of the right bank of the Jamuna river at u/s of cross bar-01, Sirajgonj sadar upazila under Sirajgonj district in April 2021. Around 2600 meter bandal structures have been constructed at u/s of cross bar-01, Sirajgonj sadar upazila. The individual bandals are oriented at an angle of 30° - 40° towards downstream. Bandal type structures have been constructed from upstream to downstream (Figures 4.15 and 4.16).

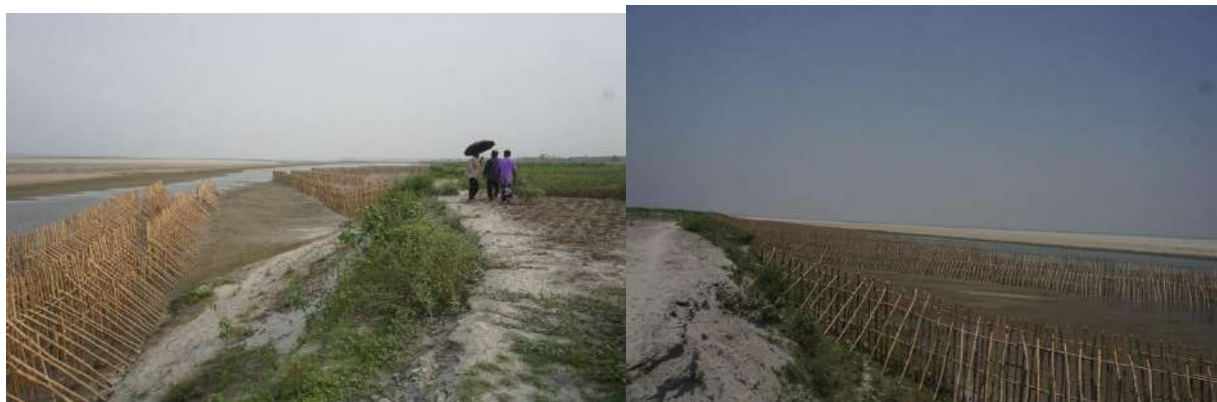
Figure 4.16 Bandal structures at u/s of Cross Bar-01, Sirajganj

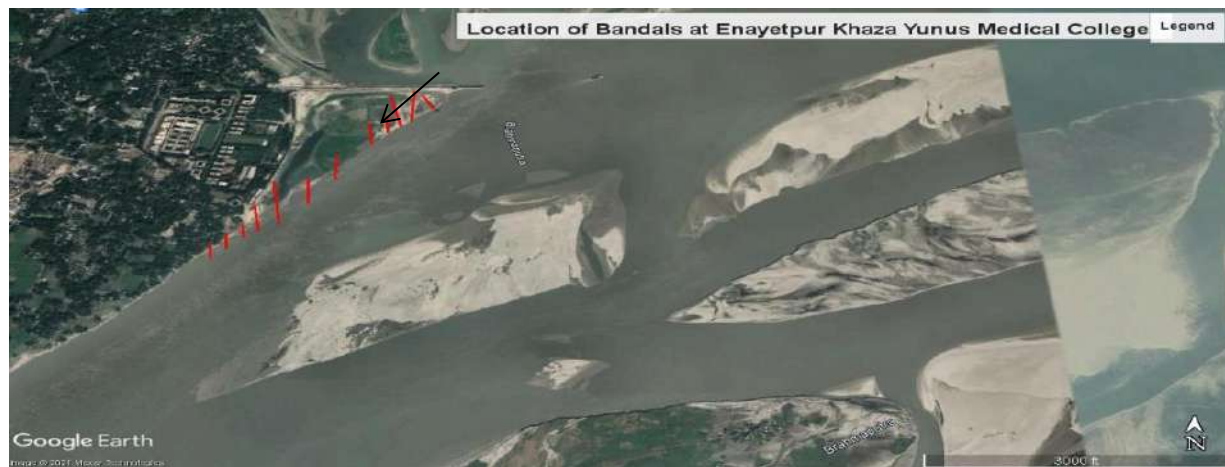
Figure 4.17 Location of the bandal structures at d/s of Enayetpur spur, Belkuchi

Bandal type structures have been constructed in the erosion prone area of the right bank of the Jamuna river at d/s of Enayetpur spur near Khaza Yunus Medical College, Belkuchi upazila under Sirajgonj district in March 2020. In the first year, 1700 meter bandal structures have been constructed at d/s of Enayetpur spur in the right bank of the Jamuna river. In the 2nd Year (January 2021), 1600 meter bandal structures have been constructed at d/s of Enayetpur spur near Khaza Yunus Medical College, Belkuchi upazila under Sirajgonj district. In total 3300 meter bandal structures have been constructed at d/s of Enayetpur spur near Khaza Yunus Medical College, Belkuchi upazila under Sirajgonj district. The individual bandals are oriented at an angle of 30^0 - 45^0 towards downstream (Figures 4.17 and 4.18).

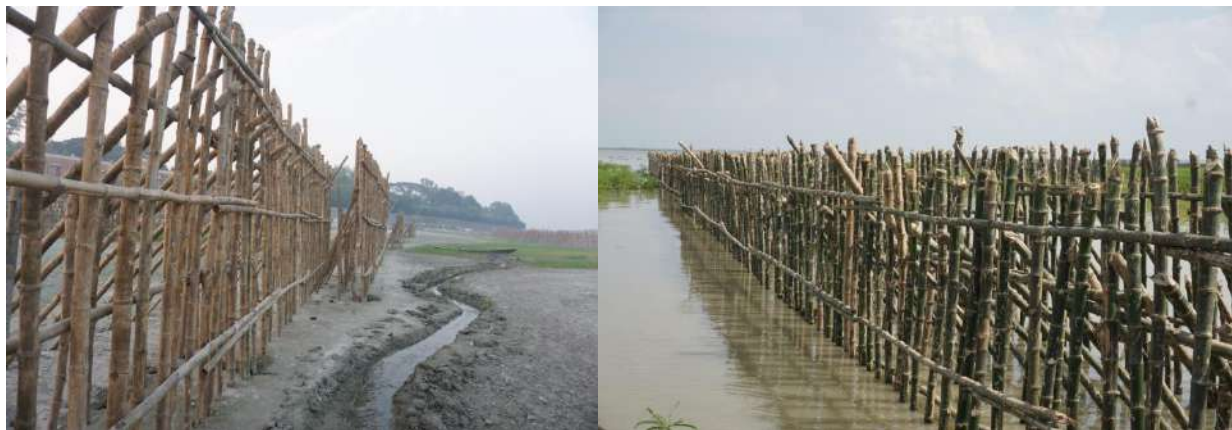
Figure 4.18 Bandal structures at d/s of Enayetpur spur, Belkuchi

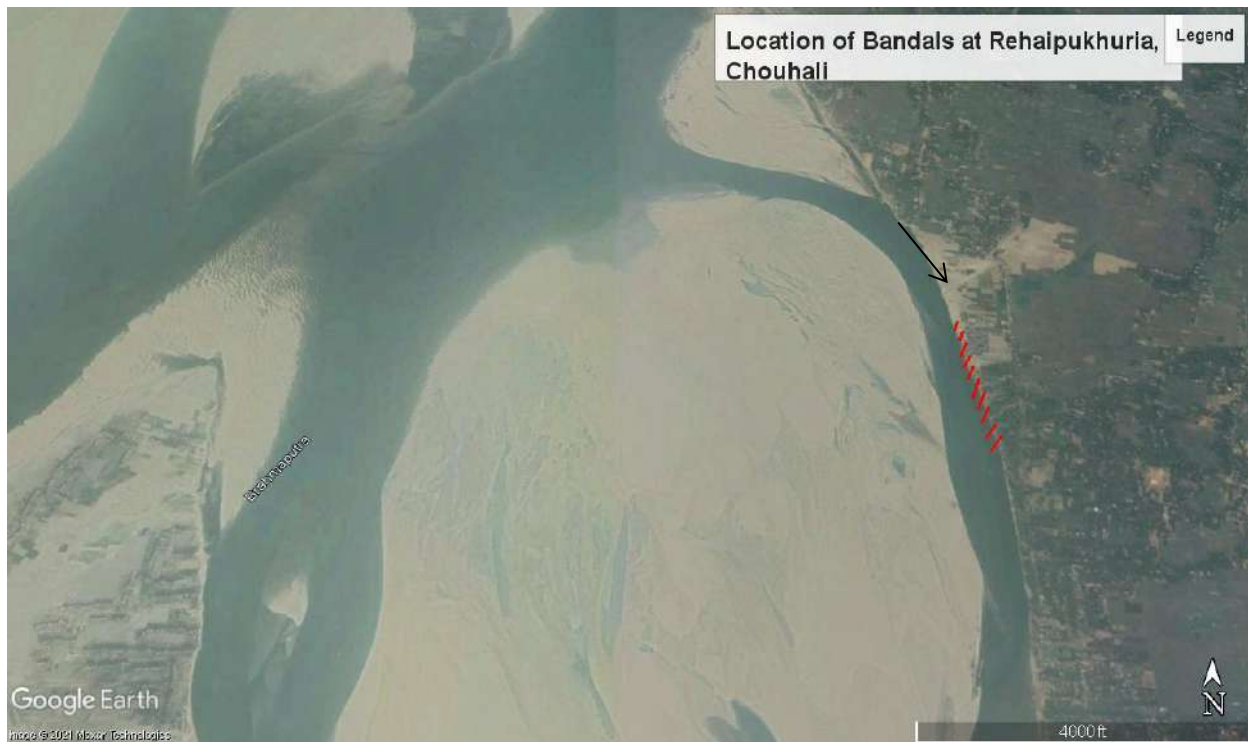
Figure 4.19 Location of the bandal structures at Rehaipukhuria, Chouhali

Bandal type structures have been constructed in the erosion prone area of the left bank of the branch channel of Jamuna river at Rehaipukhuria, Chouhali upazila under Sirajgonj district in March 2021. Around 2250 meter bandal structures have been constructed at Rehaipukhuria, Chouhali upazila. The individual bandals are oriented at an angle of 30° - 45° towards downstream (Figures 4.19 and 4.20).

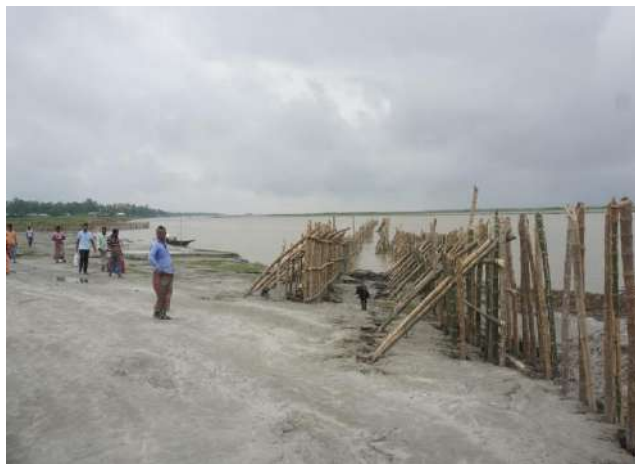
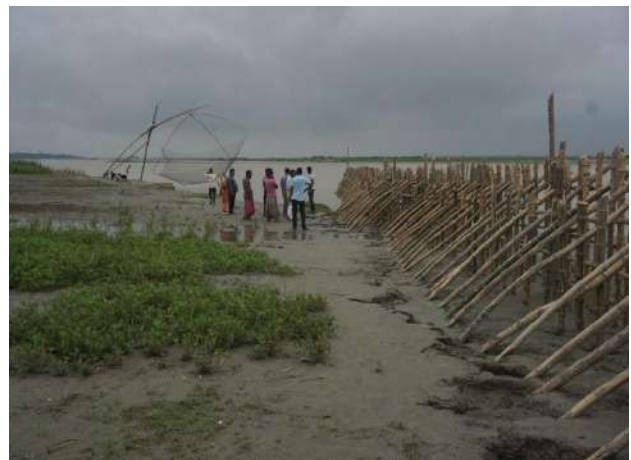
Figure 4.20 Bandal structures at Rehaipukhuria, Chouhali

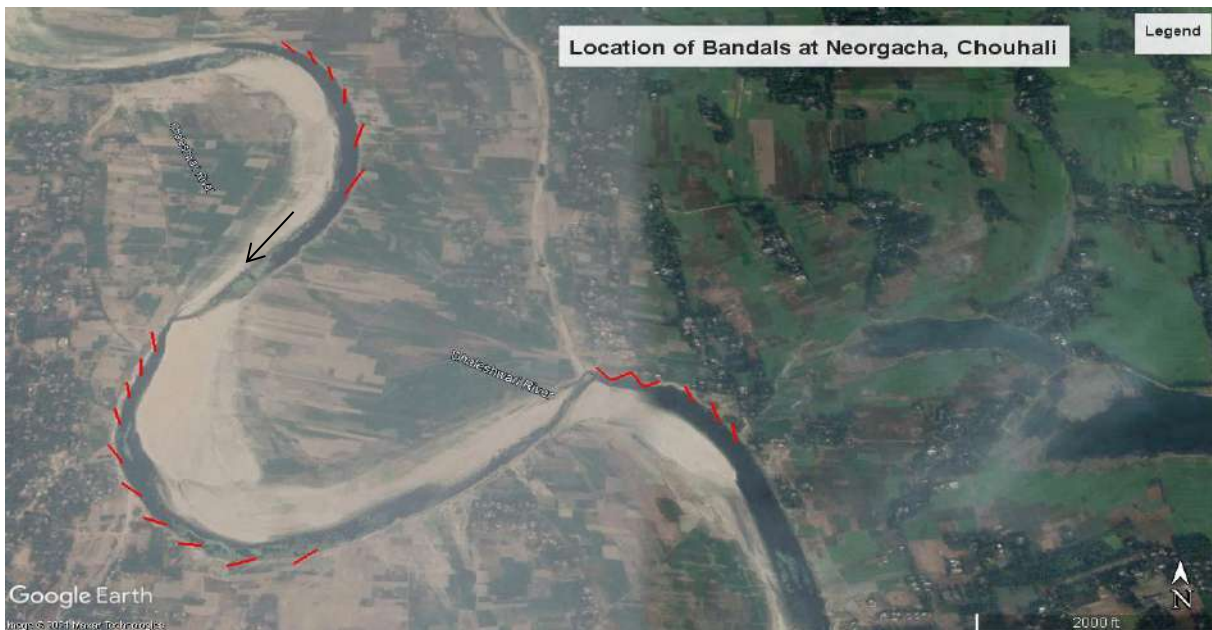
Figure 4.21 Location of the bandal structures at Neorgacha, Chouhali

Bandal type structures have been constructed in the erosion prone area of the left and right bank of the Dhaleshwari river at Neorgacha, Chouhali upazila under Sirajgonj district in January 2021. Around 2250 meter bandal structures have been constructed at Neorgacha, Chouhali upazila. Some bandals have been constructed as V-shape due to back flow effect at an angle 45° with the flow direction. The individual bandals are oriented at an angle of 30° - 45° towards downstream (Figures 4.21 and 4.22).

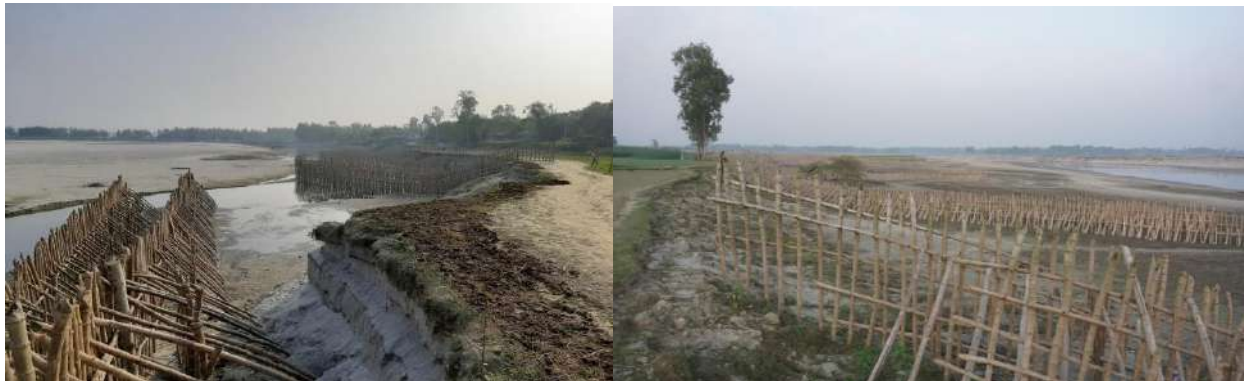
Figure 4.22 Bandal structures at Neorgacha, Chouhali

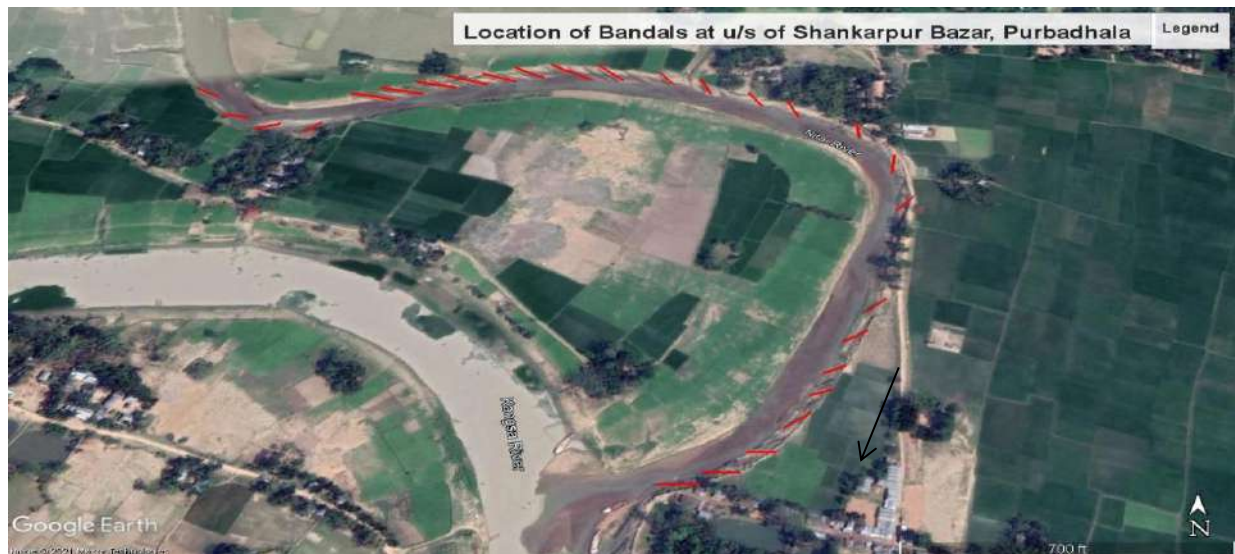
Figure 4.25 Location of the bandal structures at u/s of Shankarpur Bazar, Purbadhala

Bandal type structures have been constructed in the erosion prone area of the left and right bank of the Nitai river at u/s of Shankarpur Bazar, Purbadhala upazila under Netrokona district in March 2019. In the first year, 1500 meter bandal structures have been constructed at u/s of Shankarpur Bazar, Purbadhala upazila in the left bank of the Nitai river. In the 2nd Year (December 2020), 500 meter bandal structures have been constructed at u/s of Shankarpur Bazar, Purbadhala upazila in the left bank. In total 2000 meter bandal structures have been constructed at u/s of Shankarpur Bazar, Purbadhala upazila under Netrokona district. The individual bandals are oriented at an angle of 30^0 - 40^0 towards downstream (Figures 4.25 and 4.26).

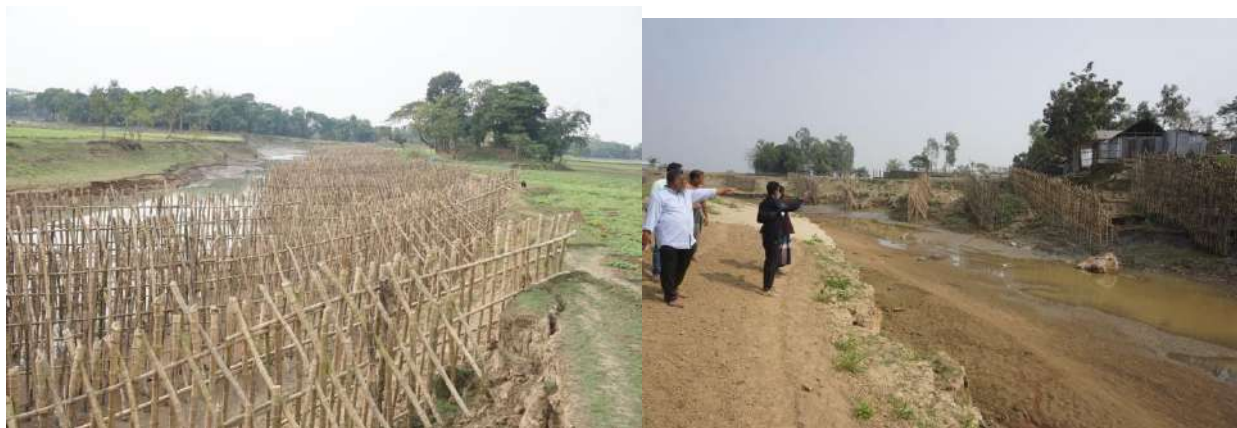
Figure 4.26 Bandal structures at u/s of Shankarpur Bazar, Purbadhala

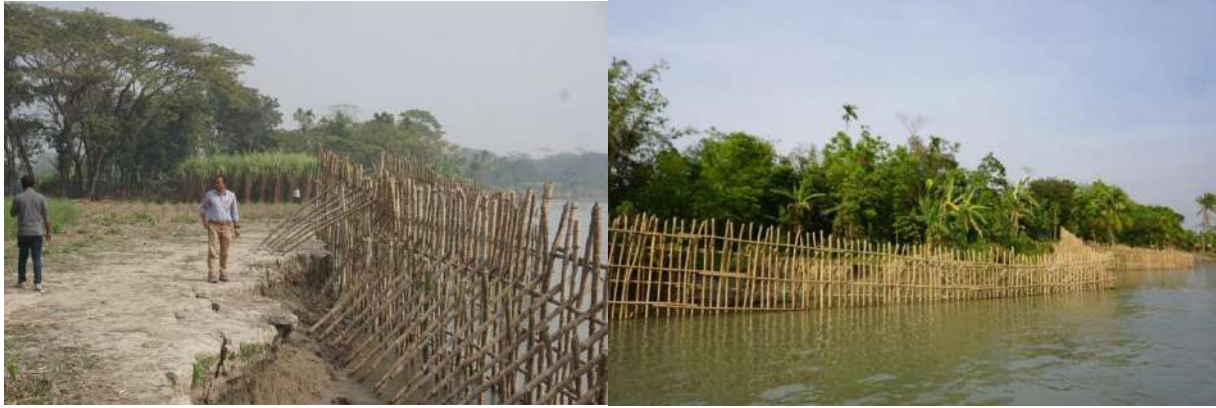
Figure 4.28 Bandal structures at u/s & d/s of Doarika Bridge, Babuganj

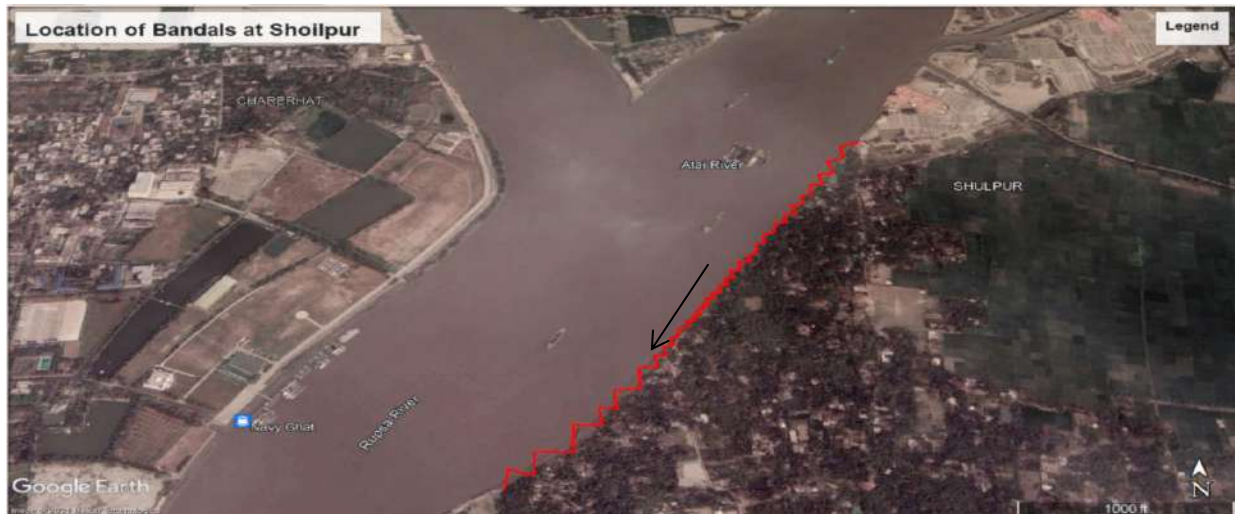
Figure 4.29 Location of the bandal structures at Shoilpur, Rupsha, Khulna

Bandal type structures have been constructed in the erosion prone area of the left bank of the Atai and Rupsha river at Shoilpur, Rupsha upazila; Laskarpur-Madhupur, Terokhada upazila and Ambaria, Digholia upazila under Khulna district in February 2020. Total 3800 meter bandal structures have been constructed at Shoilpur, Rupsha upazila; Laskarpur-Madhupur, Terokhada upazila and Ambaria, Digholia upazila under Khulna district. The Atai and Rupsha rivers are tidally affected. In this case, V-shape bamboo bandalling structures have been constructed with 45° angles with the flow direction. The new arrangement is facilitated with both the flood and ebb tide from u/s to d/s and vice versa. There is an arrangement at the u/s for flow entry and flow out and also the same arrangement in the d/s to ensure the flood and ebb tide (Figures 4.29, 4.30, 4.31, 4.32, 4.33 and 4.34).

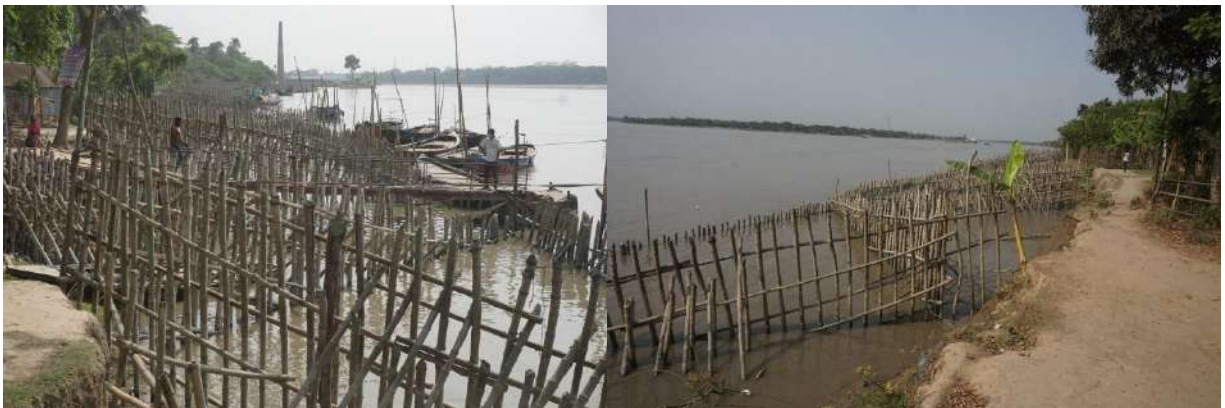
Figure 4.30 Bandal structures at Shoilpur, Rupsha, Khulna

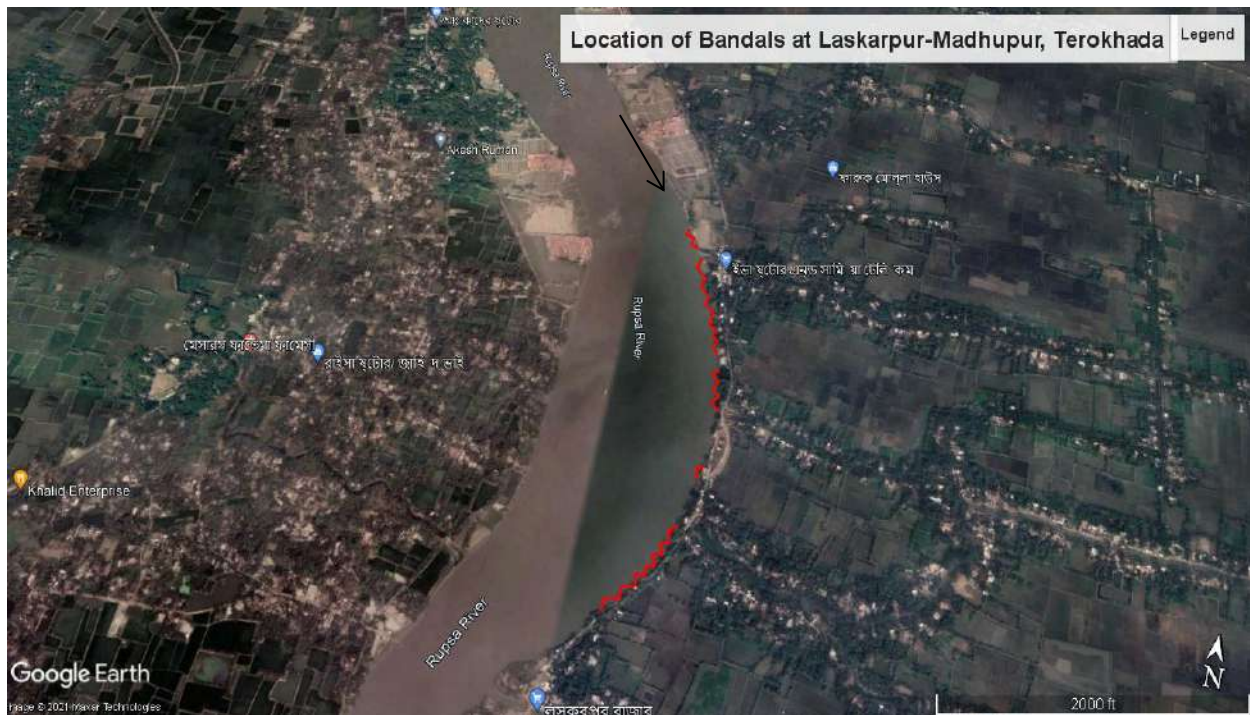
Figure 4.31 Location of the bandal structures at Laskarpur-Madhupur, Terokhada, Khulna

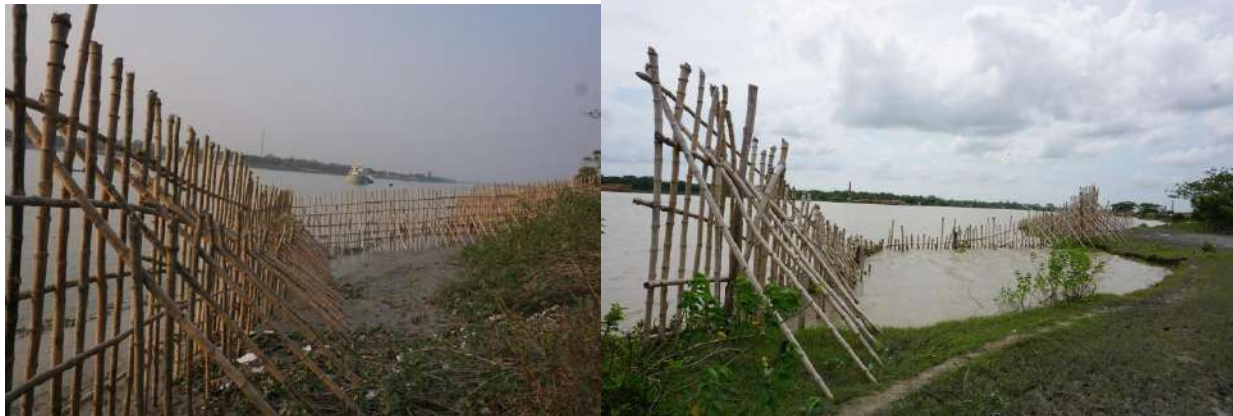
Figure 4.32 Bandal structures at Laskarpur-Madhupur, Terokhada, Khulna

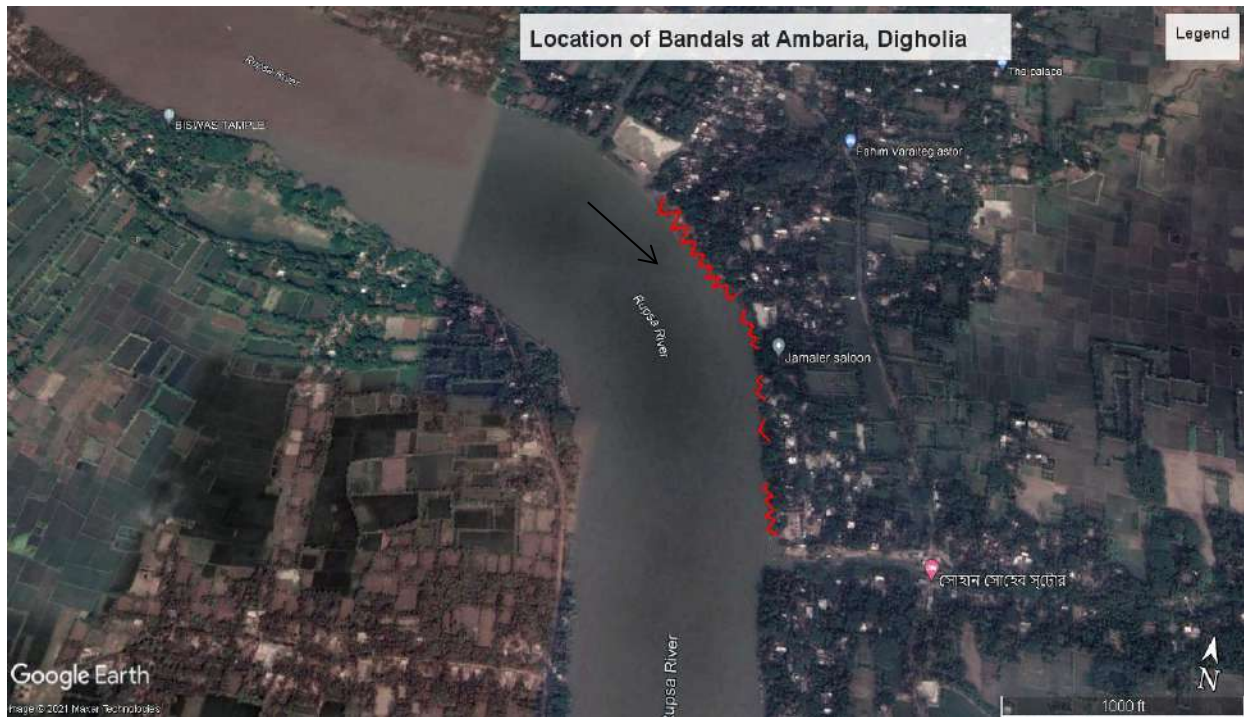
Figure 4.33 Location of the bandal structures at Ambaria, Digholia, Khulna

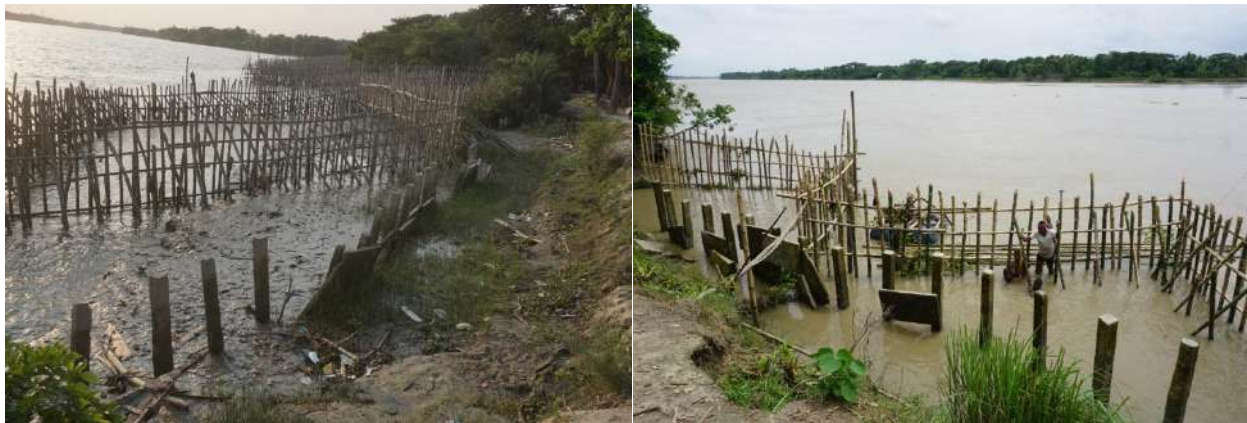
Figure 4.34 Bandal structures at Ambaria, Digholia, Khulna

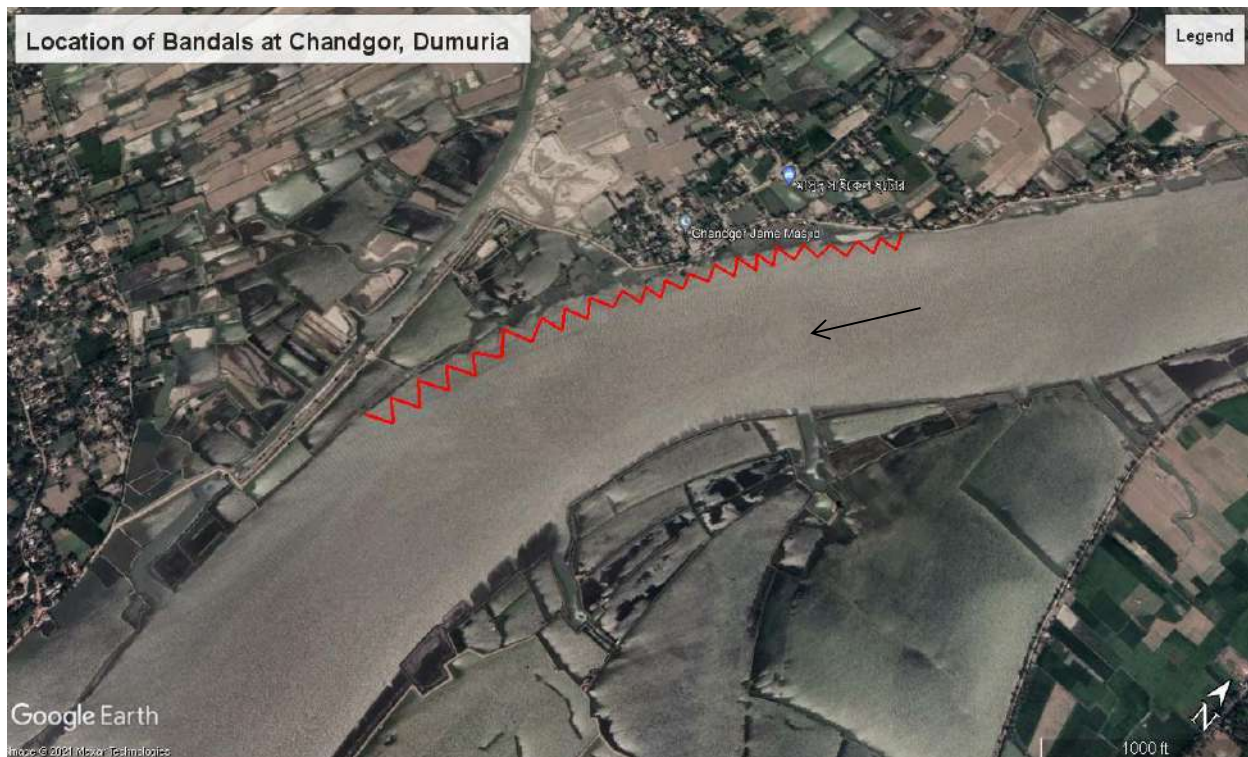
Figure 4.35 Location of the bandal structures at Chandgoar, Dumuria, Khulna

Bandal type structures have been constructed in the erosion prone area of the right bank of the Bhadra river at Chandgoar and left and right bank of the Bhadra river at Kharnia Bazar, Dumuria upazila under Khulna district in January 2020. 1750 meter bandal structures have been constructed at at Chandgoar and 1750 meter bandal structures have been constructed at Kharnia Bazar, Dumuria upazila under Khulna district. Total 3500 meter bandal structures have been constructed at Chandgoar and Kharnia Bazar, Dumuria upazila under Khulna district. The Bhadra river is tidally affected. In this case, V-shape bamboo bandalling structures have been constructed with 45° angles with the flow direction. The new arrangement is facilitated with both the flood and ebb tide from u/s to d/s and vice versa. There is an arrangement at the u/s for flow entry and flow out and also the same arrangement in the d/s to ensure the flood and ebb tide (Figures 4.35, 4.36, 4.37 and 4.38).
