Final Research Report

THE PILOT PROJECT IN DIFFERENT AREAS OF BANGLADESH USING BAMBOO BANDALING STRUCTURES TO REDUCE RIVER BANK EROSION, LAND RECLAMATION AND INCREASE NAVIGATION

Prepared by River Research Institute

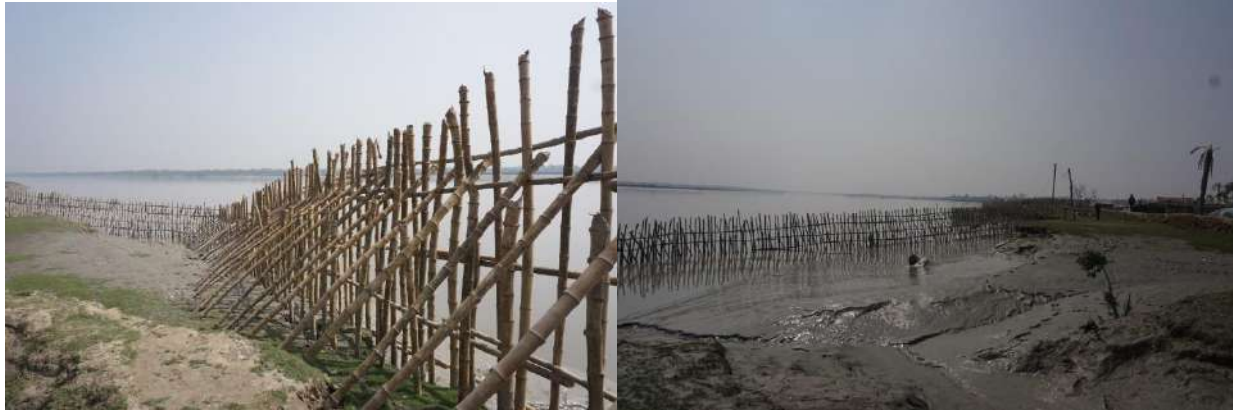
Figure 4.36 Bandal structures at Chandgoar, Dumuria, Khulna

Bandal type structures have been constructed in the erosion prone area of the right bank of the Bhadra river at Chandgoar and left and right bank of the Bhadra river at Kharnia Bazar, Dumuria upazila under Khulna district in January 2020. 1750 meter bandal structures have been constructed at at Chandgoar and 1750 meter bandal structures have been constructed at Kharnia Bazar, Dumuria upazila under Khulna district. Total 3500 meter bandal structures have been constructed at Chandgoar and Kharnia Bazar, Dumuria upazila under Khulna district. The Bhadra river is tidally affected. In this case, V-shape bamboo bandalling structures have been constructed with 45° angles with the flow direction. The new arrangement is facilitated with both the flood and ebb tide from u/s to d/s and vice versa. There is an arrangement at the u/s for flow entry and flow out and also the same arrangement in the d/s to ensure the flood and ebb tide (Figures 4.35, 4.36, 4.37 and 4.38).

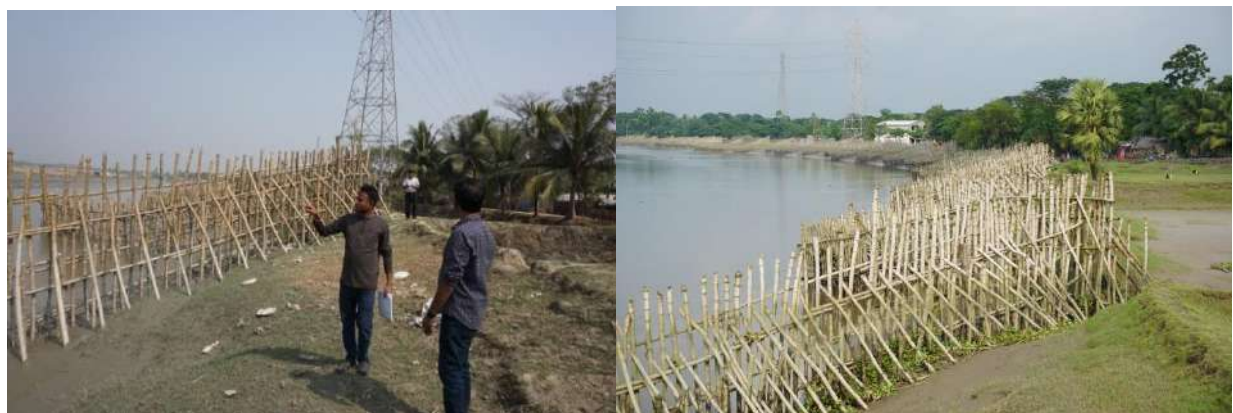
Figure 4.38 Bandal structures at Kharnia Bazar, Dumuria, Khulna

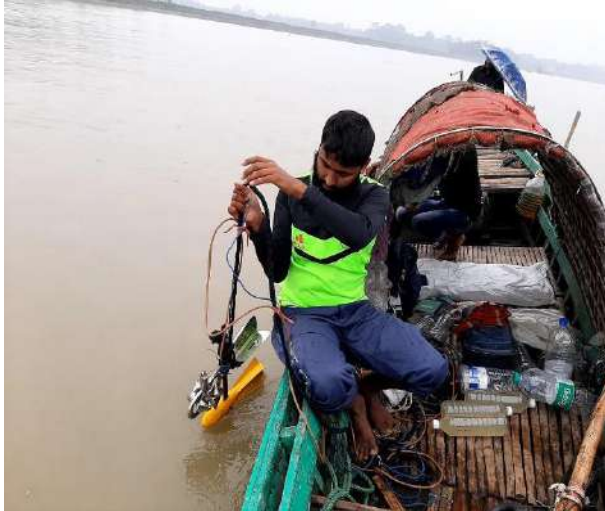
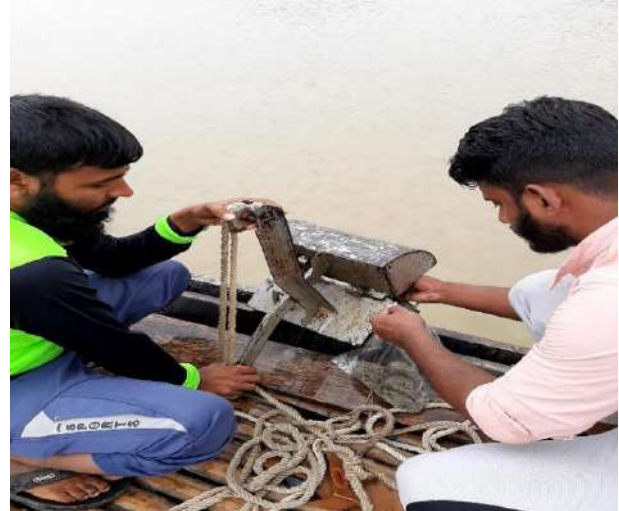
Figure 4.39 Survey in rivers

Bathymetry data, bank line data, discharge, velocity and water level data were collected from the study areas before and after construction of bandal structures at different sites. WinProfile bathymetric Survey Software has been used for data collection. The position (x, y) received from the GPS is in WGS-84 ellipsoid were later converted to Universal Transverse Mercator (UTM) by the data acquisition software. Electronic Total Station (TS) has been used to Survey the bank part of the river shallow depths, bank slope & bank part. Universal Cup type current metre has been used to take velocity measurement. Velocity has been measured using three point measurement method at 0.2d, 0.6d and 0.80d point. However, where the depth is below 1.50m that vertical velocity have taken only 0.6d point. One fiber Gauge has been installed at Survey site near discharge location and observation Water Level (WL) at one hour interval during the Survey time. X-Section survey done by bathymetric & topographic Survey work and combined both data by AutoCAD software. Then generate X-Section graph by excel software. Sediment Concentration data are collected and also Soil boring is done for some sites to investigate soil strata condition. Water quality data for different sites has been collected and are tested to examine adverse impact if any for river water. The data and satellite images were used to detail analysis for effectiveness and impact of bamboo bandal type structures. Detailed data collection from Padma at C & B Ghat Faridpur and at Rajbari, from Jamuna at Eunus Ali Medical College, Sirajgonj, from Sughandha river at Barisal, from Kagshu river at Purbadhala, Netrokona. Also data are collected from Gorai at Narua, Baliakandi, from Modhumati at Kamarkhali, Modhukahli, Faridpur, from Arial Khan at Chandrapara, Sadarpur, Faridpur, from Vodra river at Kharnia Bazar, Dumuria, Khulna, from Rupsha at Shoilpur, Khulna, from Jamuna branch channels at Rehipukuria, Dewangonj, Chowhali, Sirajgonj.

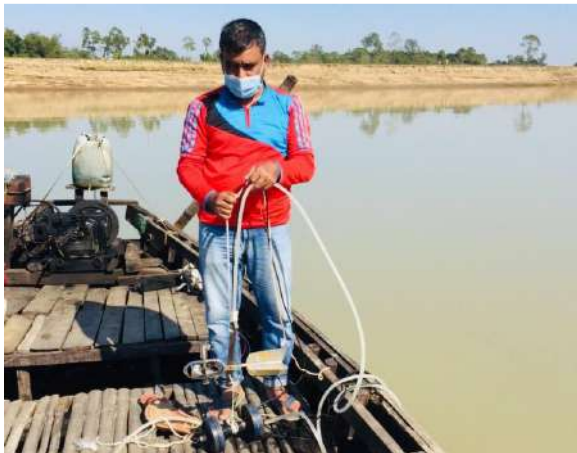
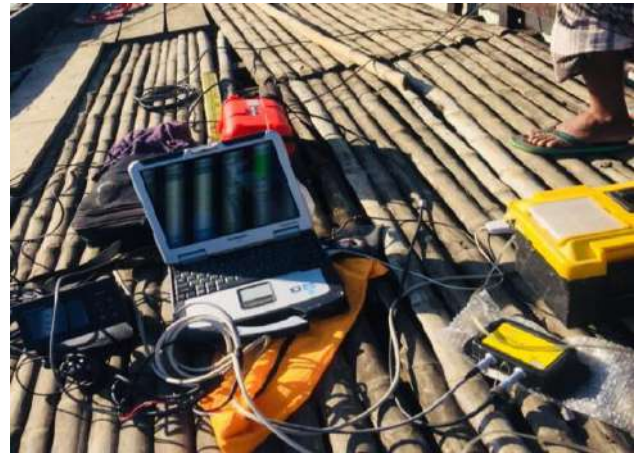
Figure 4.40 Survey in rivers

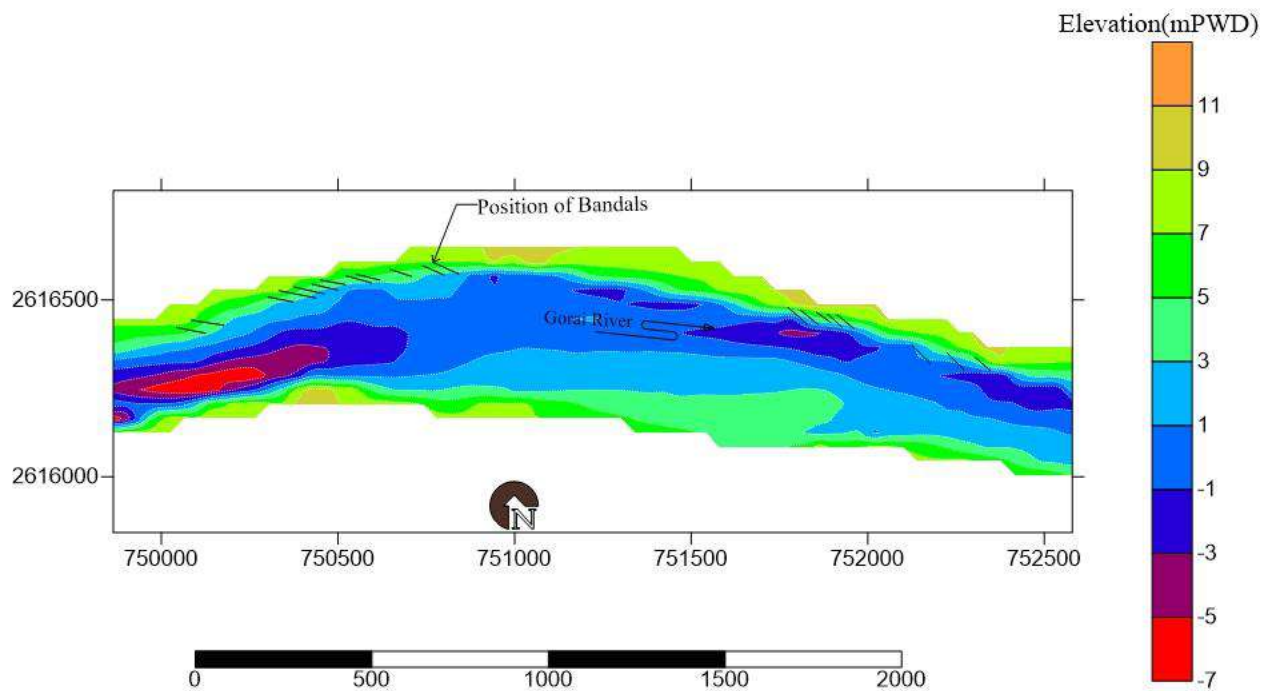
From figures 5.1 and 5.2, it is revealed that the left bank of the Gorai River is shifted towards the right (river side) during the last three years. The constructed bandal structures near the Jamshapur kheyaghat functioned well to river bank erosion protection through near bank sedimentation. It is evident from the figure 5.3 so that there is about more than 40 meters sedimentation towards the horizontal direction and about more than 3 meters sedimentation in the vertical direction near the left bank. Some Bamboo Bandal Structures since 2019 but no pre data taken. From actual field condition and photograph huge sedimentation recorded since 2019. It is seen from photographs smaller local scour occurred around the tip of the structures due to the higher velocity and the vertical vortex formed at the upstream area of structure caused by the downward flow. At the upstream of the river reach, there is less sedimentation due to beginning thrust of flowing water pressure, but there is river bank erosion protection. This position will be improved if bamboo bandaling structures are constructed in further upstream of this reach. At the remaining downstream of the river reach (Narua kheyaghat); there is also less sedimentation due to steep slope of the river reach, but river bank erosion protection. It is also mentioned that even in opposite side of the bandal structures, there is little bit bank erosion due to constrict of the flow area and higher velocity at the right bank. At Kheyaghat huge geo bag were failing to protect nearby roads bazar and mosque, but bamboo bandal has protected the geo bag to function properly and steep bank becomes mild one.

Figure 5.1 Bed elevations of the Gorai River in November 2020

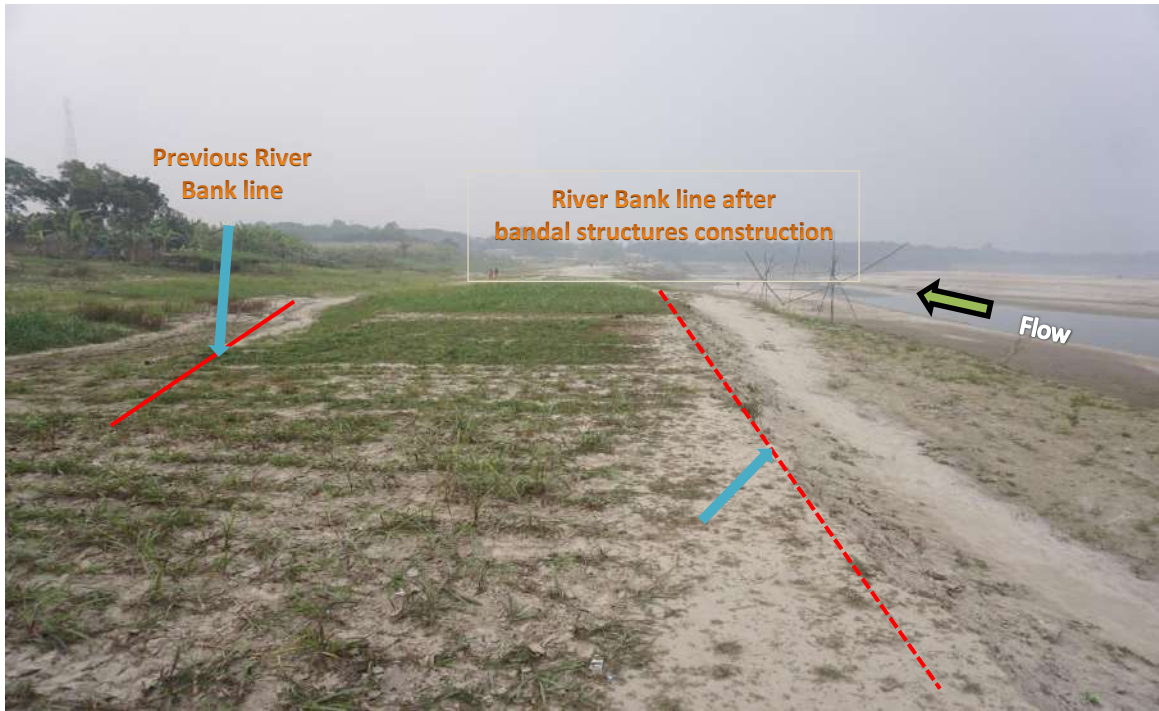
Figure 5.7 Sediment depositions on river bank induced by bandal-like structures at the left bank of Madhumati River (d/s of Kamarkhali Bridge)

From figures 5.4 and 5.5, it is revealed that the right bank of the Madhumati River is shifted towards the left (river side) at u/s of Kamarkhali Bridge and left bank of the Madhumati River is shifted towards the right (river side) at d/s of Kamarkhali Bridge during the last three years. The constructed bandal structures at the u/s of Kamarkhali Bridge as well as at the d/s of Kamarkhali Bridge functioned well to river bank erosion protection through near bank sedimentation. It is evident from the figures 5.6 and 5.7 so that there is about more than 50 meters sedimentation towards the horizontal direction and about more than 3 meters sedimentation in the vertical direction near the right and left bank respectively. Bamboo Bandal Constructed during 2019 and no pre data was taken. Actually sedimentation is huge as in field visible in photograph. It is seen from photographs smaller local scour occurred around the tip of the structures due to the higher velocity and the vertical vortex formed at the upstream area of structure caused by the downward flow. At the upstream of the river reach, there is less sedimentation due to beginning thrust of flowing water pressure, but there is river bank erosion protection. This position will be improved if bamboo bandalling structures are constructed in further upstream of this reach. At the remaining downstream of the river reach (d/s of Kamarkhali Bazar); there is also less sedimentation due to steep slope of the river reach, but river bank erosion protection. It is also

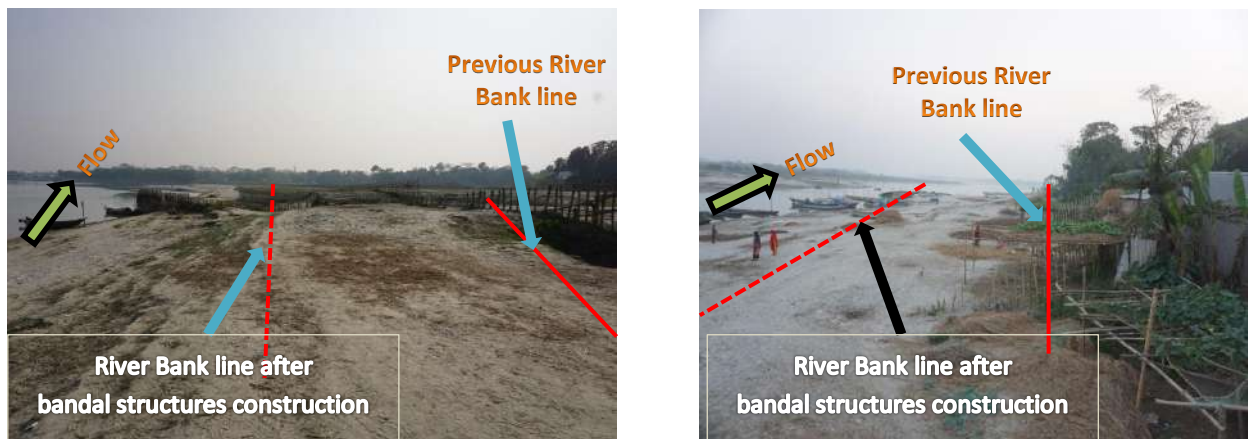
Figure 5.10 Sediment depositions on river bank induced by bandal-like structures at the right bank of Arial Khan River (u/s of Chandrapara ghat)

From figures 5.8 and 5.9, it is revealed that the right bank of the Arial Khan River is shifted towards the left (river side) at u/s of Chandrapara ghat during the last three years. From figure 5.11, it is revealed that the left bank of the Arial Khan River is shifted towards the right (river side) at d/s of Chandrapara ghat in some area but erosion occurred in the left bank in some area due to damaging of the bandal structures during the last one year due to insufficient bandals. The constructed bandal structures at the u/s of Chandrapara ghat functioned well to river bank erosion protection through near bank sedimentation. It is evident from the figures 5.10 and 5.12 so that there is about more than 50 meters and 30 meters sedimentation towards the horizontal direction and about more than 3 meters sedimentation in the vertical direction near the right and left bank respectively. At Balshar ghat, u/s of Chandrapara bandal constructed during 2019 but no pre data was taken. Actual field condition and photograph taken reveal huge sedimentation. Later during 2020 loop cut opened with consequence of bandal impact. Afterwards some dredging for lake formation at u/s of Chandrapara during 2021. It is seen from photographs smaller local scour occurred around the tip of the structures due to the higher velocity and the

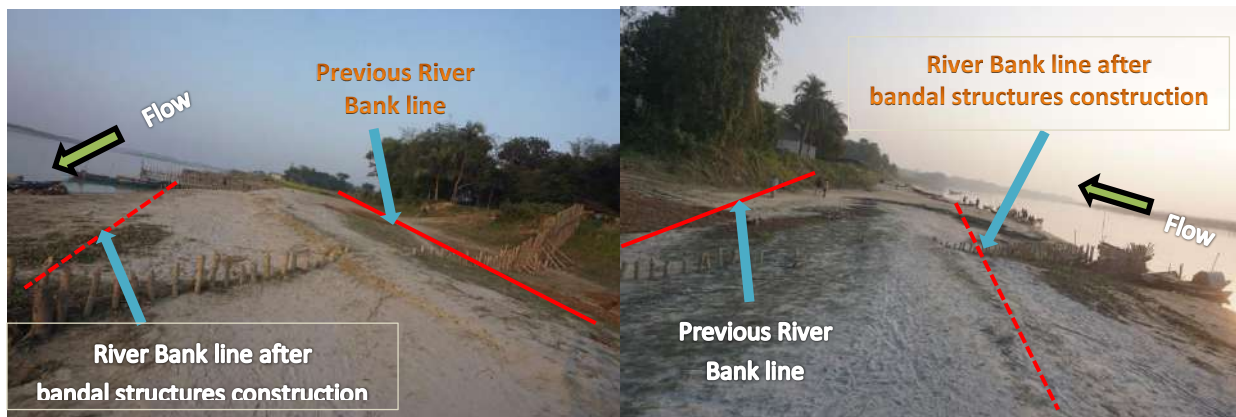
Figure 5.12 Sediment depositions on river bank induced by bandal-like structures at the right bank of Arial Khan River (d/s of Chandrapara ghat)

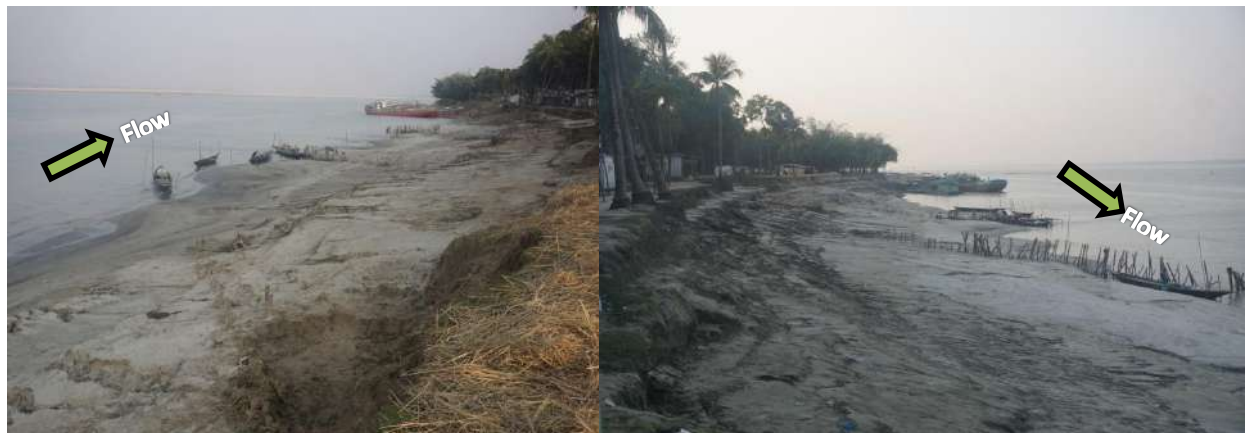
Figure 5.18 Sediment depositions on river bank induced by bandal-like structures at the right bank of Padma River (Charjoikuri)

From figure 5.17, it is revealed that the left bank of the Padma River is shifted towards the left (river side) during the last one year. The constructed bandal structures near the Charjoikuri functioned well to river bank erosion protection through near bank sedimentation. It is evident from the figure 5.18 so that there is about 1 meter sedimentation in the vertical direction near the right bank of Padma River in Charjoikuri. It is seen from photographs the bamboo bandals are cutup by local people for their vessel movement. If the bandal structures were there, it would be a desirable level of sedimentation and bank protection.

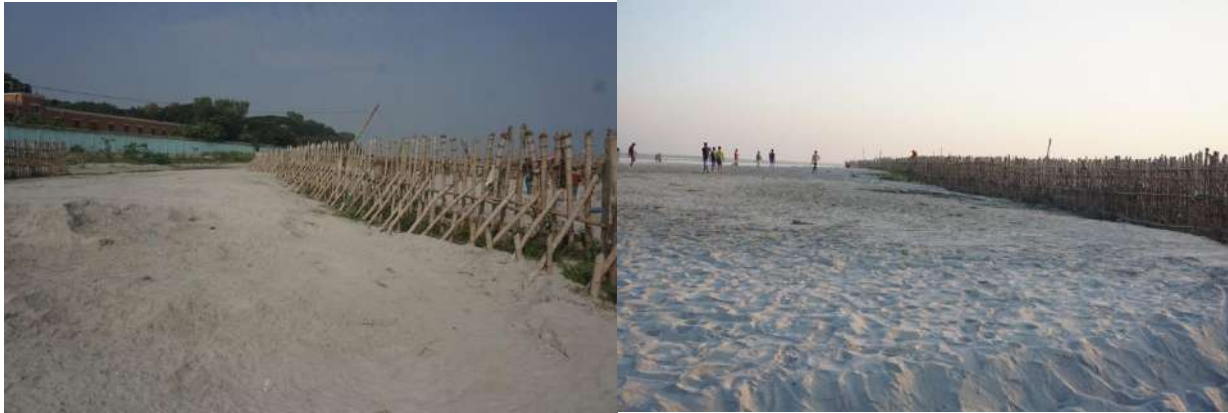
Figure 5.20 Sediment depositions on river bank induced by bandal-like structures at the right bank of Jamuna River (d/s of Enayetpur Spur)

From figures 5.19 and 5.20, it is revealed that the right bank of the Jamuna River is shifted towards the right (river side) during the last one year. The constructed bandal structures near the Khaja Eunos Ali Medical College, Enayetpur functioned well to river bank erosion protection through near bank sedimentation. It is evident from these figures so that there is about more than 50 meters sedimentation towards the horizontal direction and about more than 1 meter sedimentation in the vertical direction near the right bank of Jamuna River. Here land up liftation is remarkable but some reclaimed land is eroded later due to some improper measure taken by Khaja Eunos Ali Medical College. From figures 5.21 and 5.22, it is revealed that there is about more than 20 meters sedimentation towards the horizontal direction and about more than 1 meter sedimentation in the vertical direction near the left bank of Jamuna River in u/s of these bandals at Rehaipukhuria, Chouhali. But d/s of these bandals, there is some erosion occurred and damaged the bandals due to oblique flow. From figure 5.23, it is revealed that there is about more than 40 meters sedimentation towards the horizontal direction and about more than 1 meter sedimentation in the vertical direction near the right bank of Jamuna River in u/s of Cross bar-01, Sirajganj. It is seen from photographs smaller local scour occurred around the tip of the structures due to the higher velocity and the vertical vortex formed at the upstream area of structure caused by the downward flow. At the upstream of the river reach, there is less sedimentation due to beginning thrust of flowing water pressure, but there is river bank erosion protection. This position will be improved if bamboo bandalling structures are constructed in further upstream of this reach.

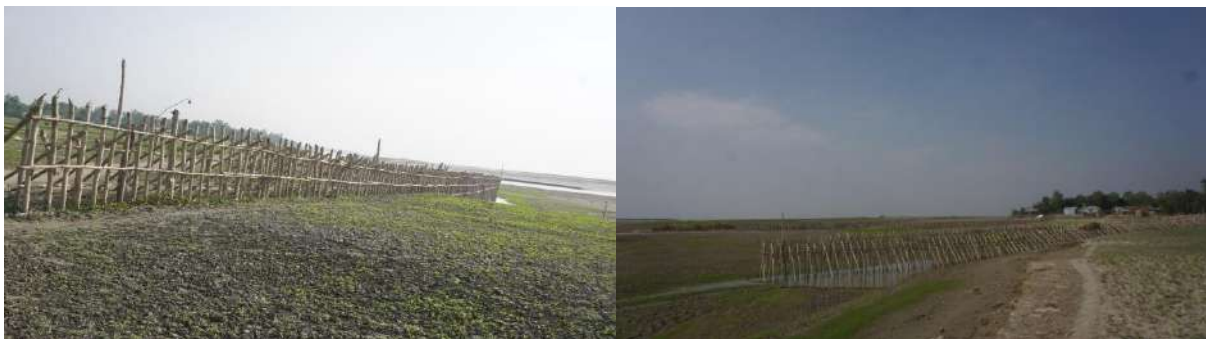
Figure 5.22 Sediment depositions on river bank induced by bandal-like structures at the left bank of Jamuna River (Rehaipukhuria, Chouhali)

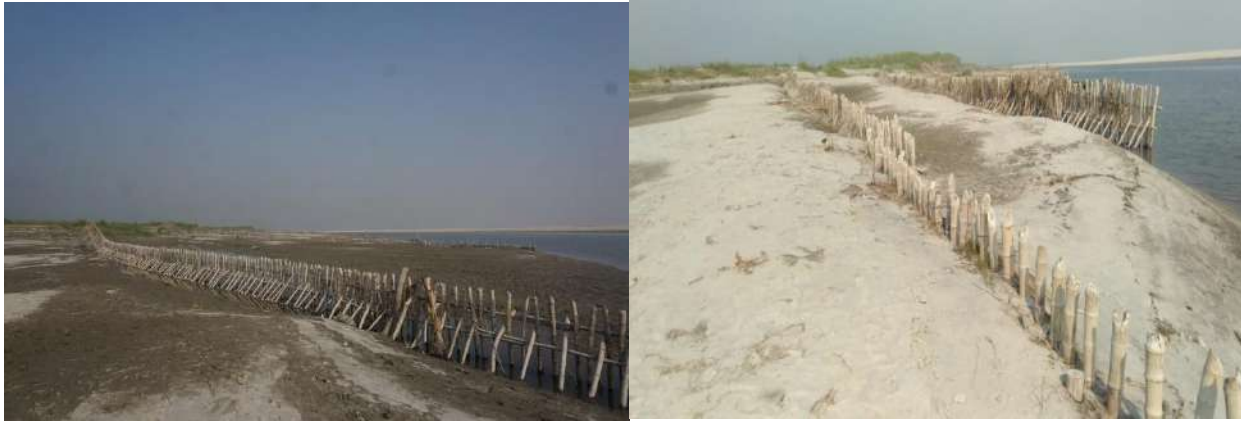
Figure 5.23 Sediment depositions on river bank induced by bandal-like structures at the right bank of Jamuna River (u/s of Cross bar-01, Sirajganj)

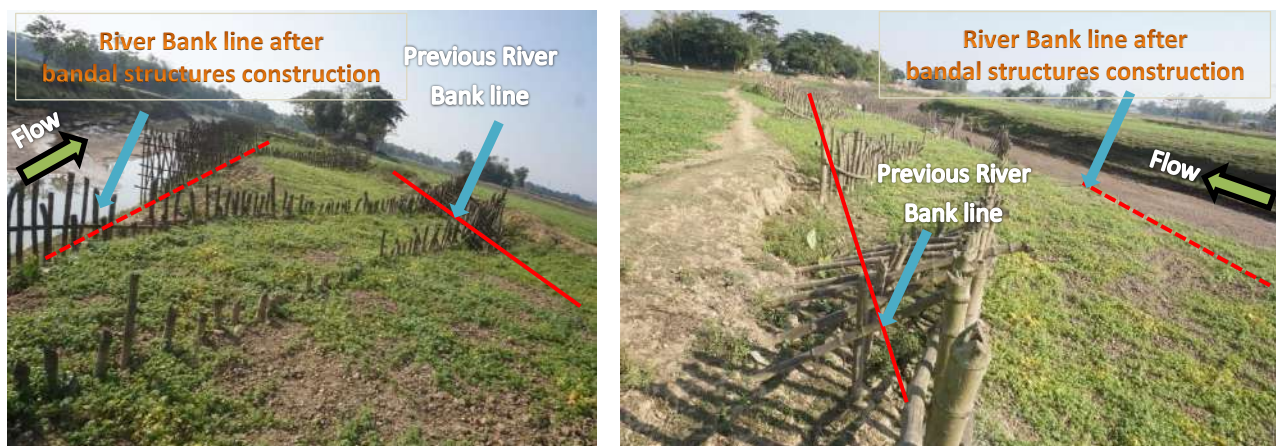
Figure 5.31 Sediment depositions on river bank induced by bandal-like structures at the Nitai River (u/s of Shankarpur Bazar, Purbadhala)

From figures 5.29, and 5.30, it is revealed that the right bank of the Nitai River is shifted towards the river side during the last one year. The constructed bandal structures near the Shankarpur Bazar functioned well to river bank erosion protection through near bank sedimentation. It is evident from the figure 5.31 so that there is about more than 10 meters sedimentation towards the horizontal direction and about more than 2 meters sedimentation in the vertical direction near the bank. and important bazar, village roads and two important village residential area are protected from river erosion. Also tendency for Nitai to meet with Kangsa at upstream of Shankarpur Bazar was protected to save huge area from disaster. It is seen from photographs smaller local scour occurred around the tip of the structures due to the higher velocity and the vertical vortex formed at the upstream area of structure caused by the downward flow. At the upstream of the river reach, there is less sedimentation due to beginning thrust of flowing water pressure, but there is river bank erosion protection. This position will be improved if bamboo bandalling structures are constructed in further upstream of this reach. At the remaining downstream of the river reach; there is also less sedimentation due to absence of protective measures, but river bank erosion protection. It is also mentioned that even in opposite side of the bandal structures, there is little bit bank erosion due to constrict of the flow area and higher velocity.

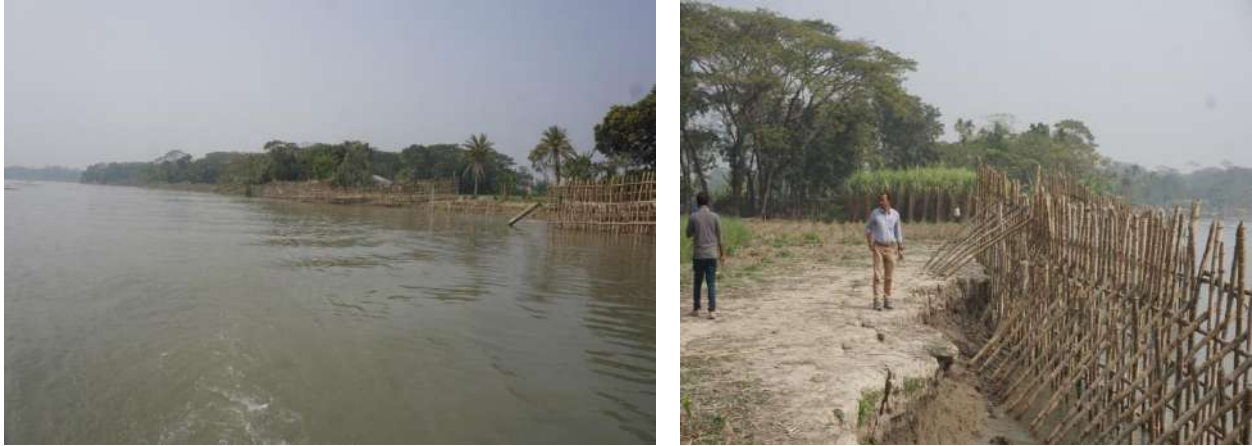
Figure 5.33 Bank erosion induced by instability of the of soil condition in Sugandha River (u/s & d/s Doarika Bridge, Babuganj)

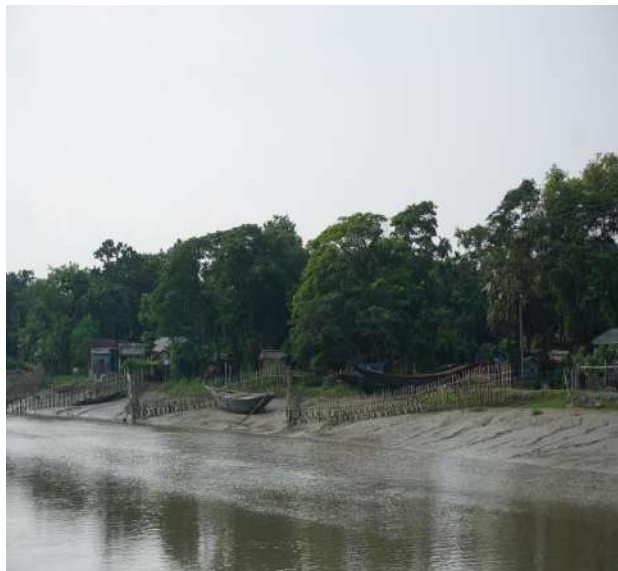
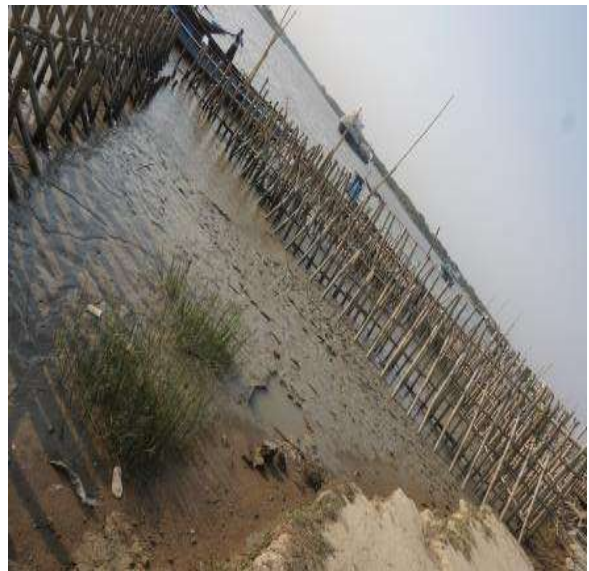
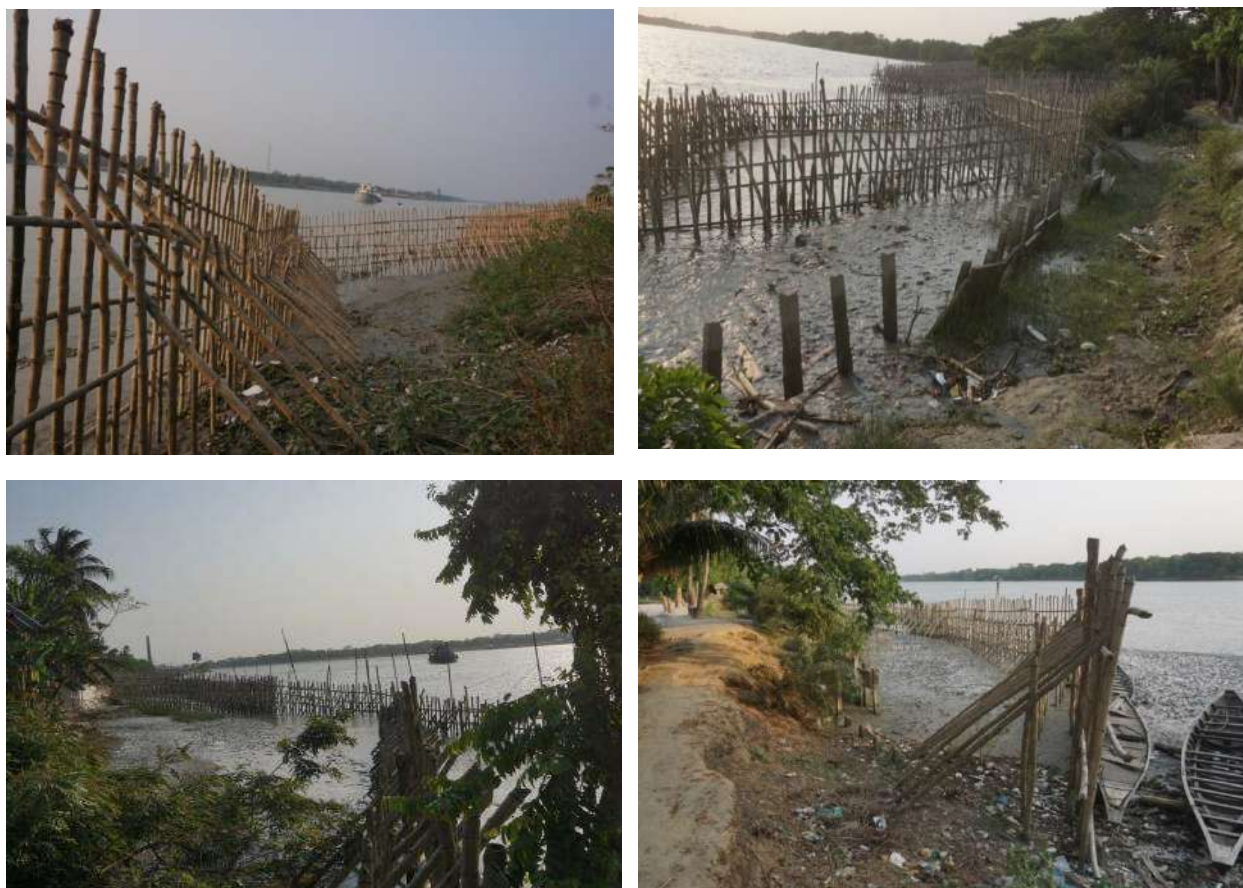
Figure 5.35 Sediment depositions on river bank induced by bandal-like structures at the Rupsha-Atai Rivers

From figures 5.34 and 5.35, it is revealed that the right banks of the Rupsha-Atai River are shifted slightly towards the river side during the last two years. The constructed bandal structures near the Shoilpur ghat, and Ambaria School functioned well to river bank erosion protection through near bank sedimentation. It is evident from these figures so that there is about more than 5 meters sedimentation towards the horizontal direction and about more than 0.5 meter sedimentation in the vertical direction near the right bank. It is seen from photographs the deposited sediment is very fine particles. Due to finer particles it is washed out during wave action. Sediment deposition is little bit because the velocity of these rivers is comparatively low.

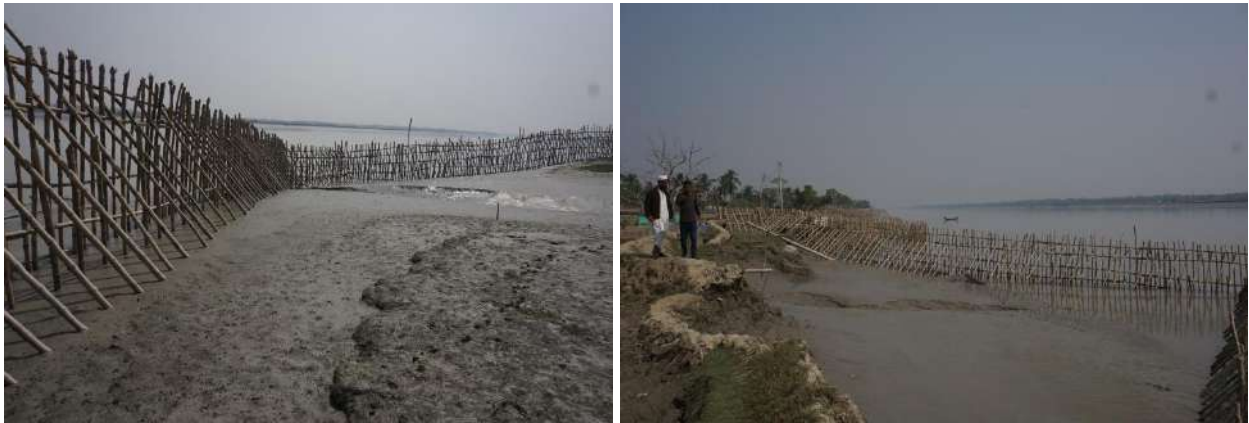
Figure 5.37 Sediment depositions on river bank induced by bandal-like structures at the Bhadra River (near Chandgoar, Dumuria)

From figures 5.36 and 5.37, it is revealed that the right bank of the Vadra River near Chandgoar is shifted slightly towards the river side during the last two years. The constructed bandal structures functioned well to river bank erosion protection through near bank sedimentation. It is evident from these figures so that there is about more than 10 meters sedimentation towards the horizontal direction and about more than 1 meter sedimentation in the vertical direction near the right bank. It is seen from photographs the deposited sediment is very fine particles. Due to finer particles it is washed out during wave action. From figures 5.39 and 5.40, it is revealed that the left bank of the Vadra River near Kharnia Bazar is shifted towards the right side during the last three years. The constructed bandal structures functioned well to river bank erosion protection

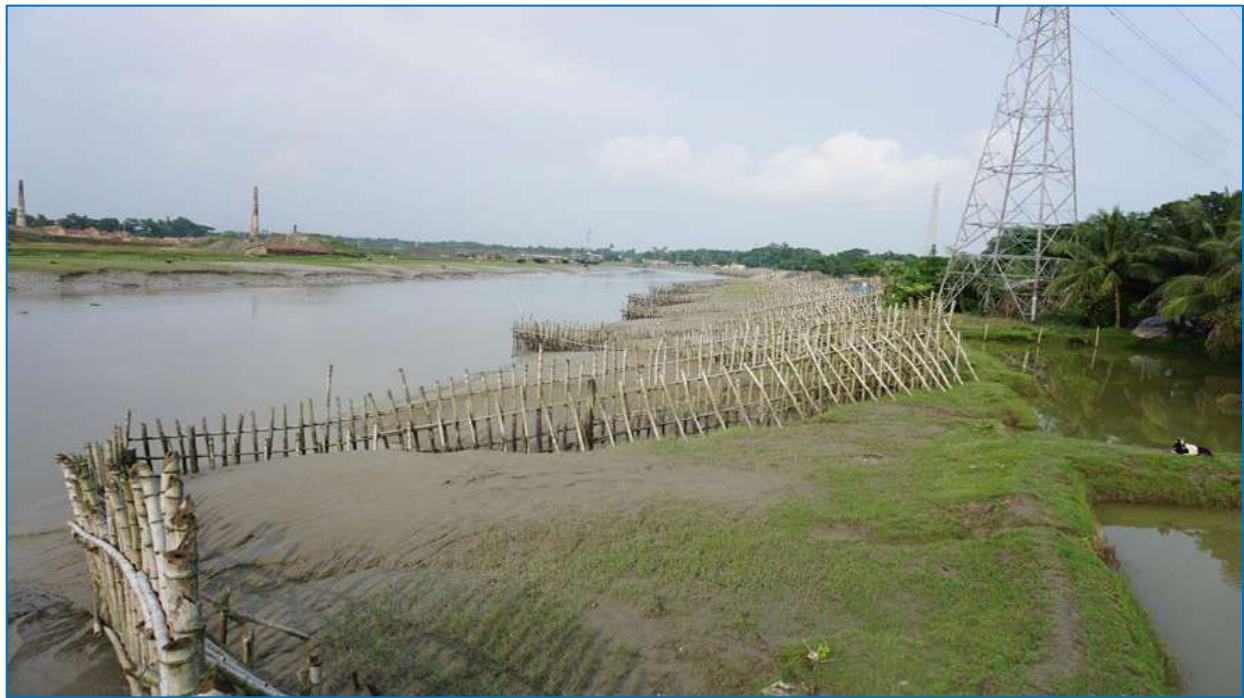
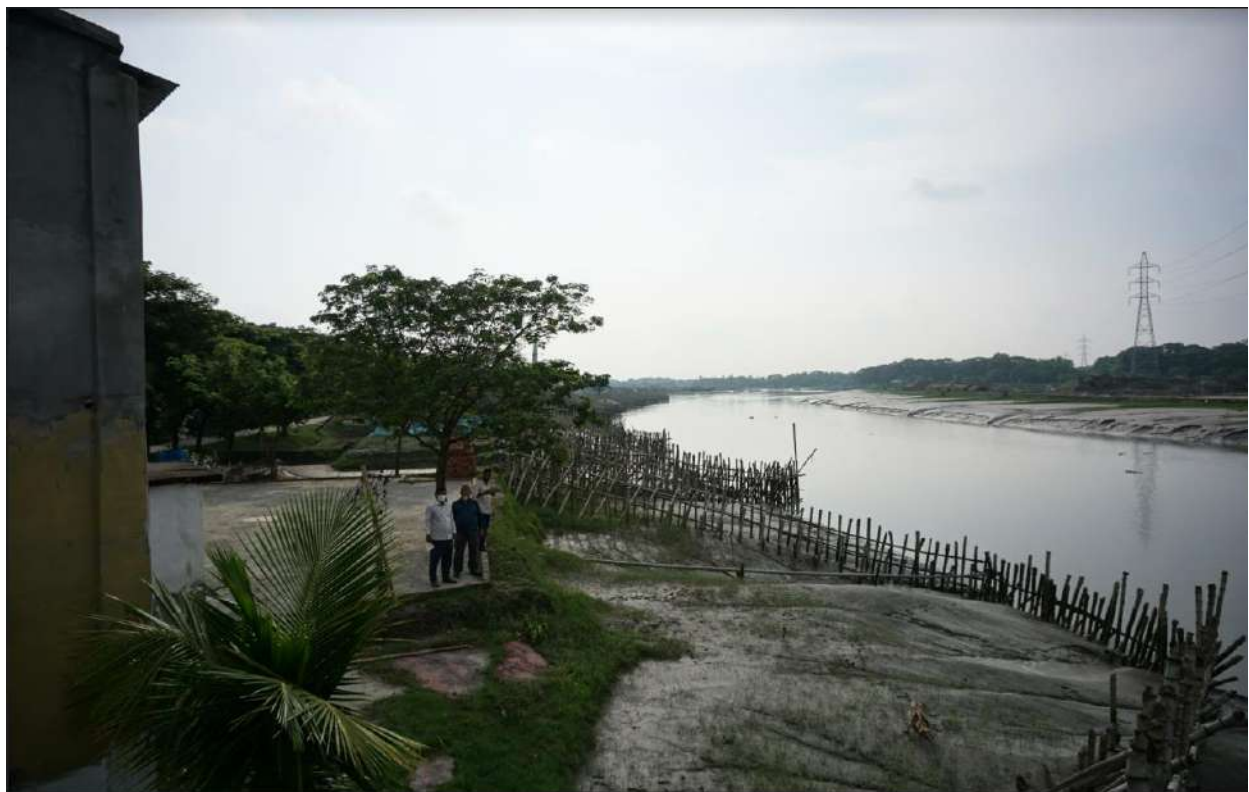
Figure 5.40 Sediment depositions on river bank induced by bandal-like structures at the Bhadra River (Kharnia Bazar, Dumuria)

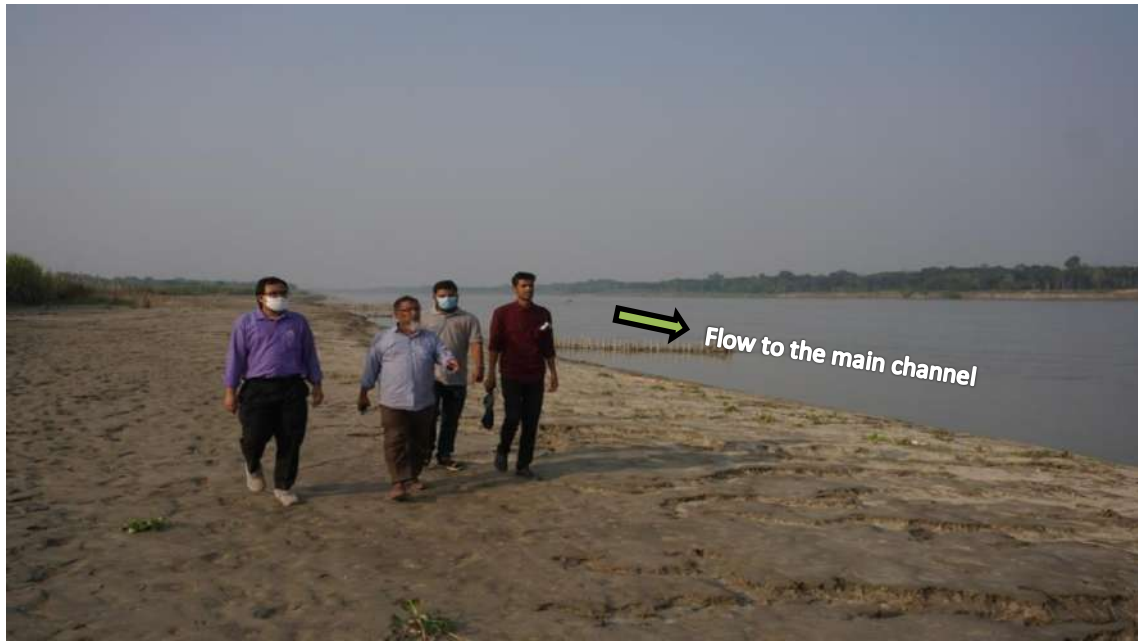
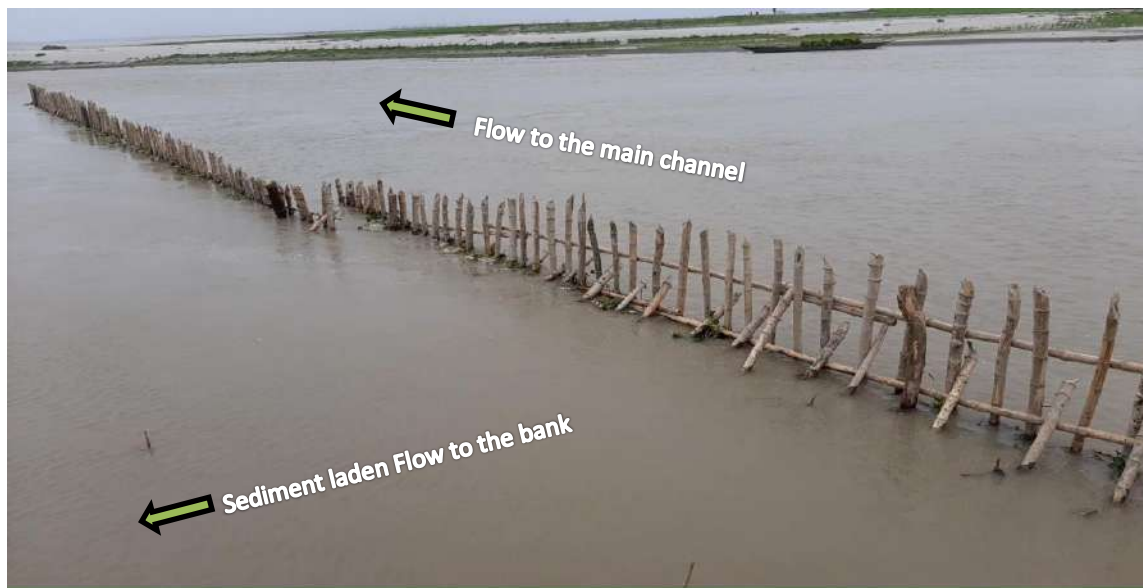
From the field investigations it is seen that, bandal type structures are suitable for all kinds of rivers such as flashy, tidal, non-tidal, braided and meandering except the tidal rivers such as Sandha, Sugandha, etc where water contains minimum sediment with finer particles, bed and bank material is very unstable and the bank slope is very steep and there is deep channel near bank even during dry season i.e. high water level near bank even in dry season for which bandal structures can't be entered sufficiently into the river. Moreover, some bandal structures have failed due to oblique flow that has come from the main channel and damaged the bandal structures. At C & B Ghat in Faridpur sadar upozilla, river bank is consist of loose sand with low SPT value and there were deep channel immediate after the bank. Even with these unfavorable conditions, bandal performance was satisfactory as flow was diverted with big bandals from upstream and there was no more oblique flow. Also BIWTA did some dredging work at opposite bank. Again in Atai river at Ambaria, bandal performance is very good. Where as, in the same river at Madhupur-Laskarpur bandal failed as there is a organic soil layer at 25-30 feet depth for which river bank is automatically eroded. On the other hand bed soil at Ambaria, Khulna and at Nitai, Netrokona is too hard to drive bamboo but output is fantastic. For rivers in Khulna, water level decrease sufficiently during ebb-tide to favor bamboo drive but for river in Barishal little water decrease during ebb-tide for which unfavorable situation for bamboo drive. So in Sugandha river at Barishal bamboo failed due to high water level for which bandal was not long enough into the river and loose bank and bed soil accelerated bank failure. For alluvial river, there are always key locations for bamboo bandaling but for tidal river due to two directional flow, selection of key location is difficult. So not only flow condition but also bank and bed soil condition have to be considered for proper functioning of bandal structures. As we experienced sudden bank failure during bamboo drive and also we observed bamboo sink even with self weight in Sugandha at Barishal. Similarly in Atai at Madhupur-Laskarpur, Khulna during bamboo driving organic layer of bed soil eject chemical to harm skin of the labour. Again steep bank should converted to mild one through earth work. So before bamboo bandal structures flow pattern of rivers, bank and bed soil condition, bank slope condition have to be studied properly to select location and layout angel of bandals. There should be sufficient bandals for proper output. Some vegetation in some cases specially for tidal rivers well helpful to grab the sediment. Some times geo bag beside the bandal in the river can give good result. Actually combination of measures like bandal, geo bag, dredging will give good result.

Figure 5.41 Higher flow velocity deviated to the main channel by bandal-like structures

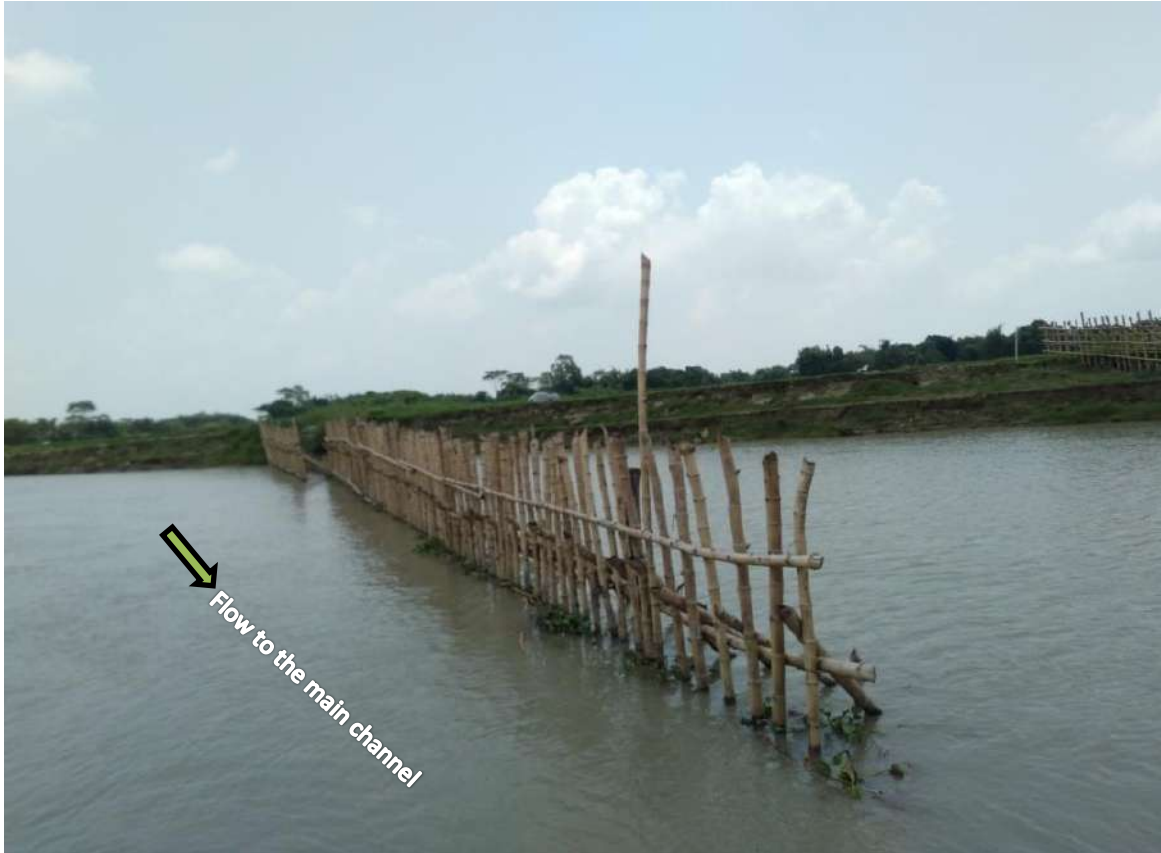
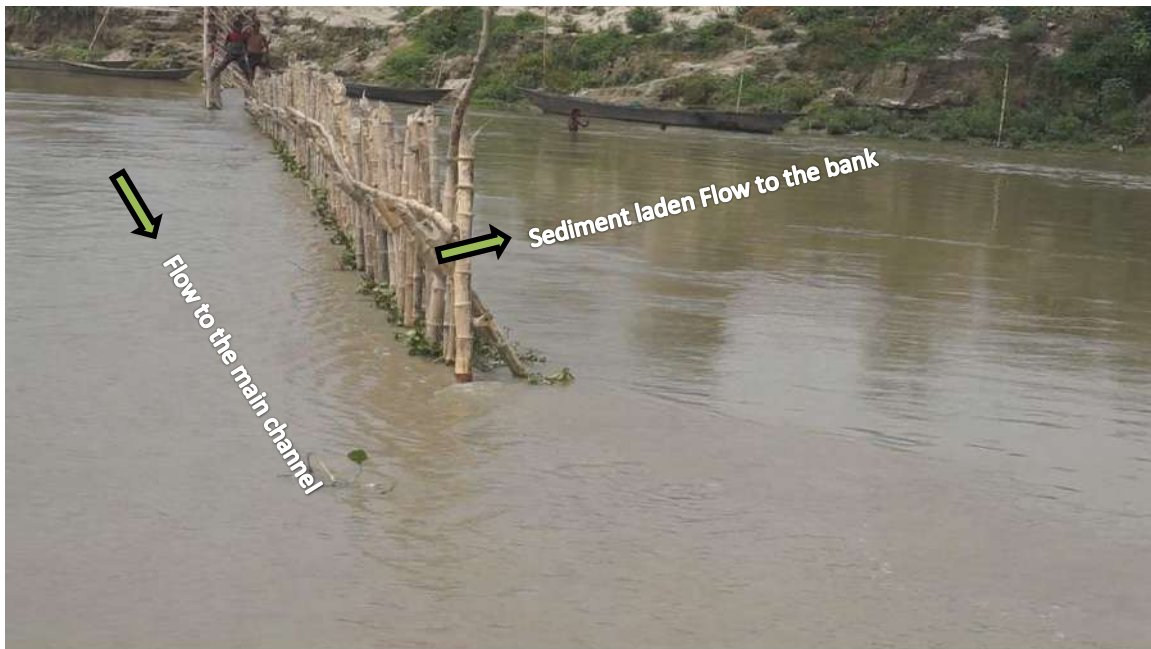
Figure 5.42 Higher flow velocity deviated to the main channel by bandal-like structures

In the case of bandal type structures, it is seen that the higher flow velocity deviated from the structures to the main channel which is more effective than the impermeable groynes case (Figures 5.41 and 5.42). Due to the influence of the bandal type structures diverting the flow from bank to the main channel, the effect of flow on bed near the structure is minimized. This point is an important characteristic of the bandal type structures utilization in which the energy of the flow at the lower part is also reduced by the presence of piles which causes disturbances in flow patterns which affects the erosion/deposition process over there. There was a considerable pressure different between the upstream and downstream side of the bandal type structures (Figures 5.43). Bank line shifting and sediment deposition induced by bandal type structures are shown in the following figure. (Figure 5.44 and 5.45)

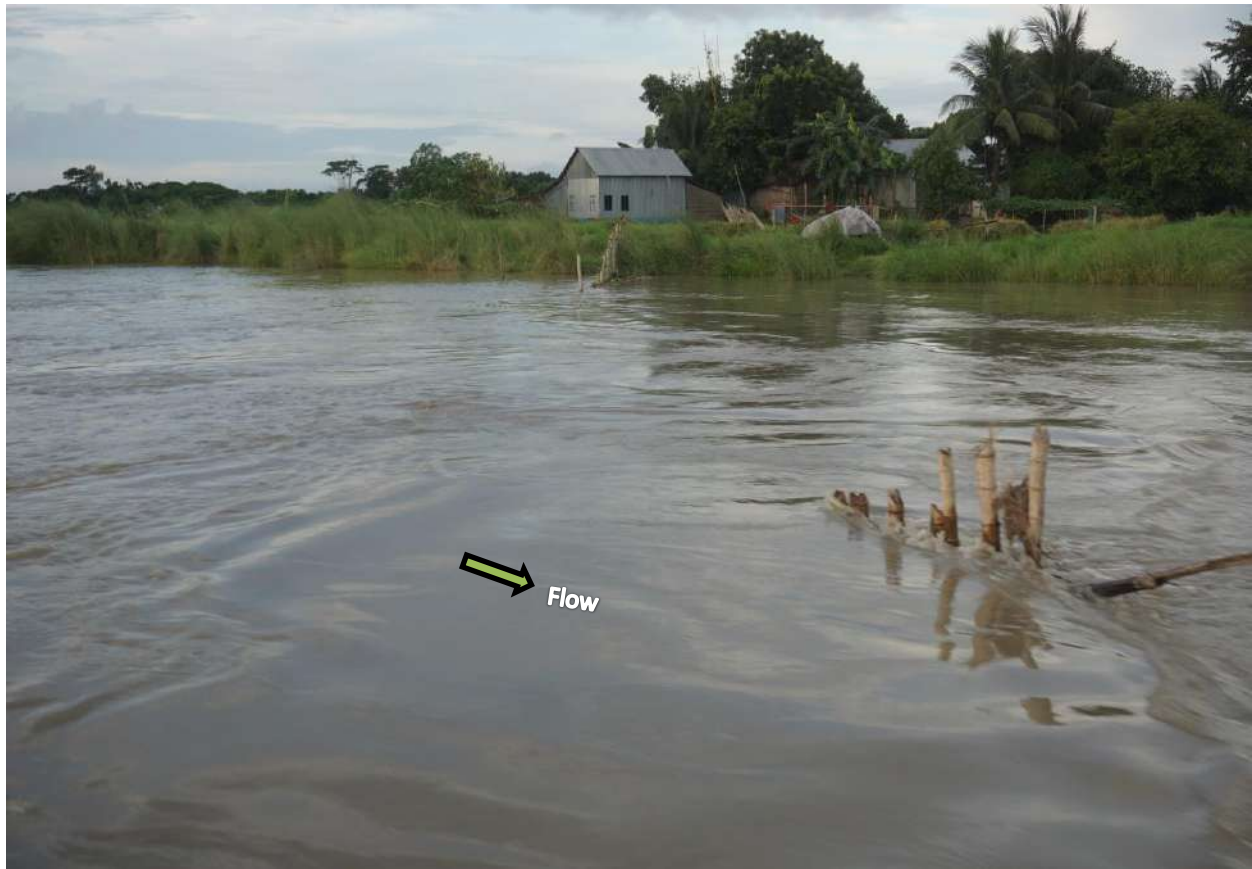
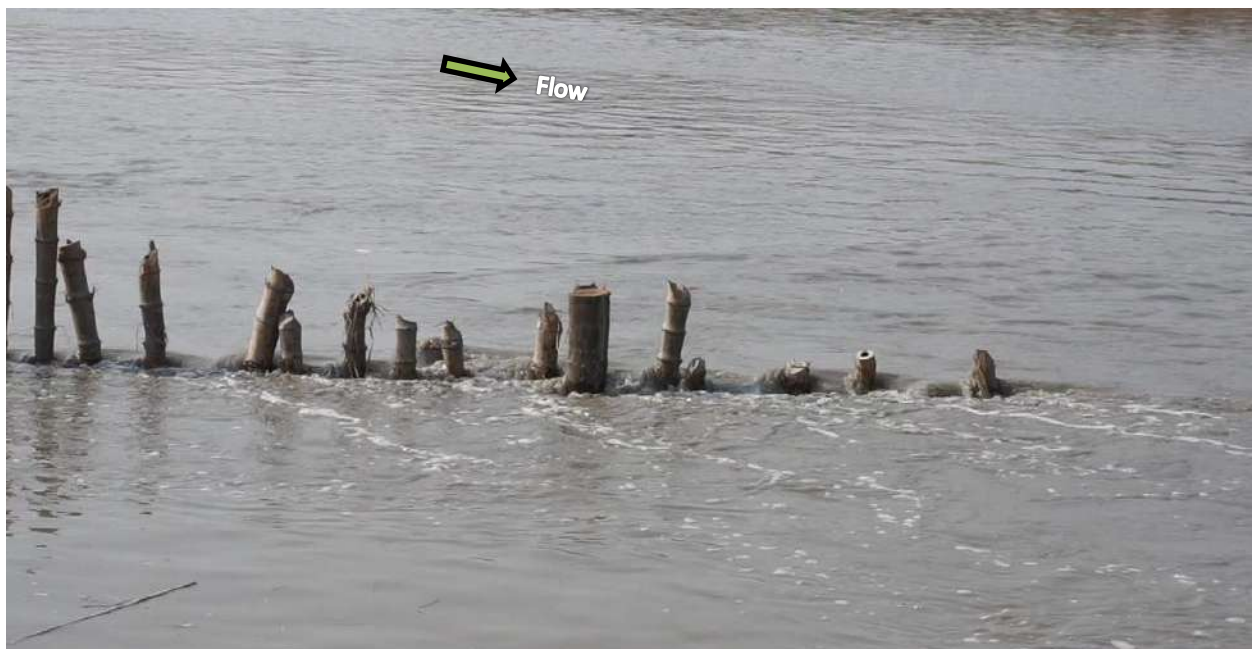
Figure 5.43 Pressure difference between the upstream and downstream side of the bandal-like structures
