Final Research Report

THE PILOT PROJECT IN DIFFERENT AREAS OF BANGLADESH USING BAMBOO BANDALING STRUCTURES TO REDUCE RIVER BANK EROSION, LAND RECLAMATION AND INCREASE NAVIGATION

Prepared by River Research Institute

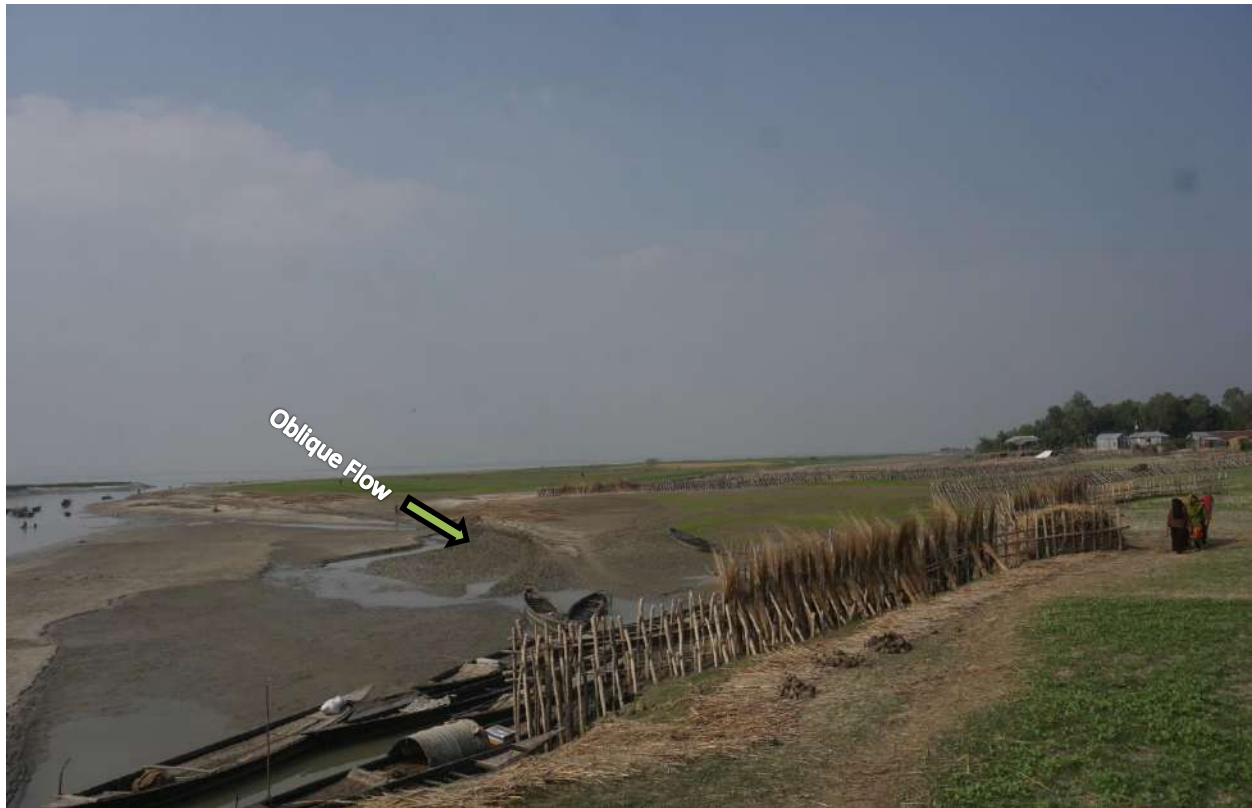
Figure 5.46 Oblique flow from main channel hit to the bandal-like structures in Jamuna River

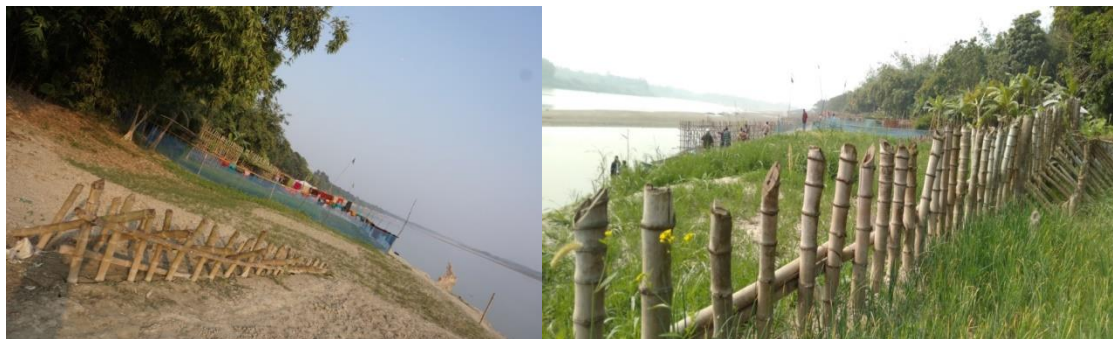
Sediment depositions on river bank induced by bandal-like structures at the left bank of Gorai River

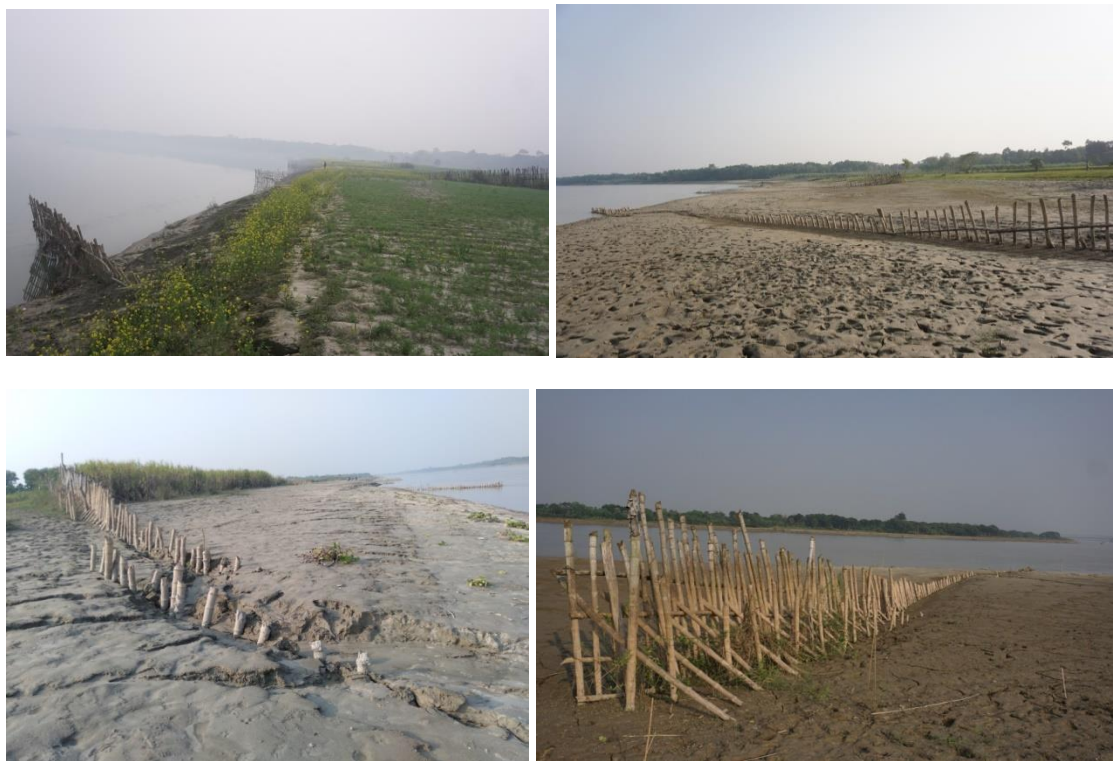
Sediment depositions on river bank induced by bandal-like structures at the right bank of Madhumati River (u/s of Kamarkhali Bridge)

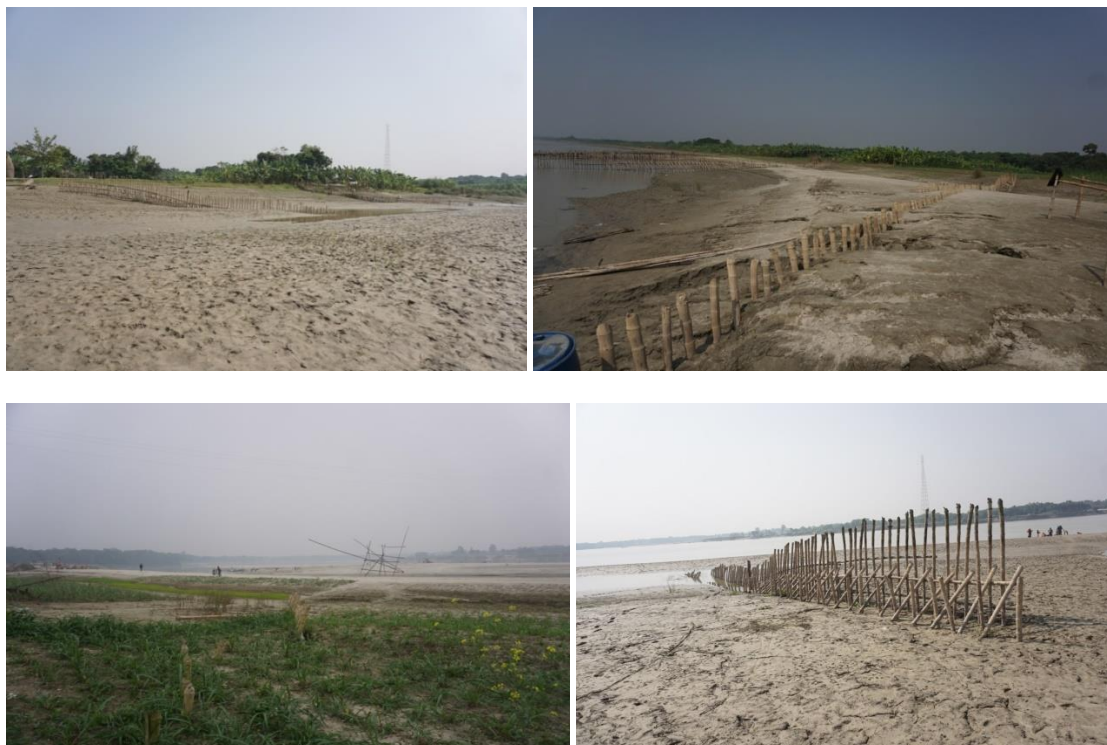
Sediment depositions on river bank induced by bandal-like structures at the left bank of Madhumati River (d/s of Kamarkhali Bridge)

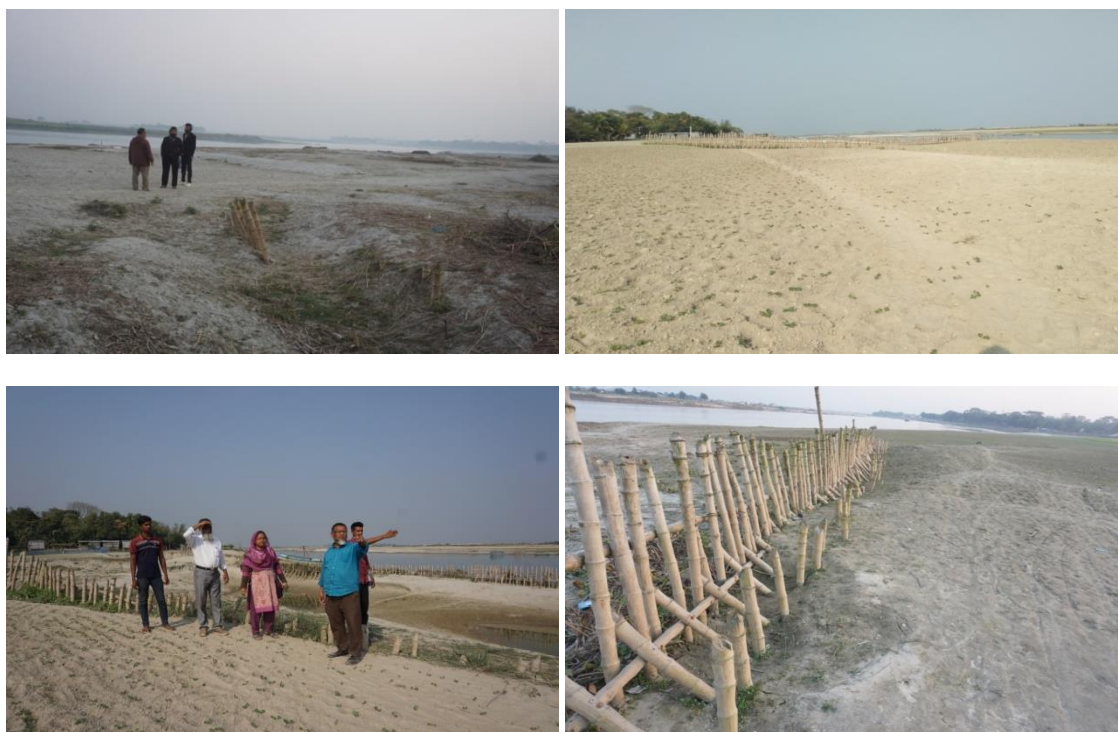
Sediment depositions on river bank induced by bandal-like structures at the right bank of Arial Khan River (u/s of Chandrapara ghat)

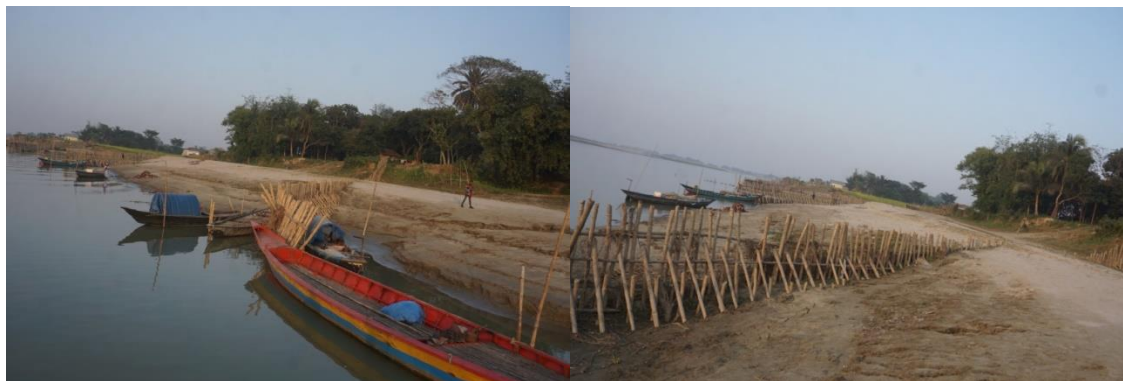
Sediment depositions on river bank induced by bandal-like structures at the right bank of Arial Khan River (d/s of Chandrapara ghat)

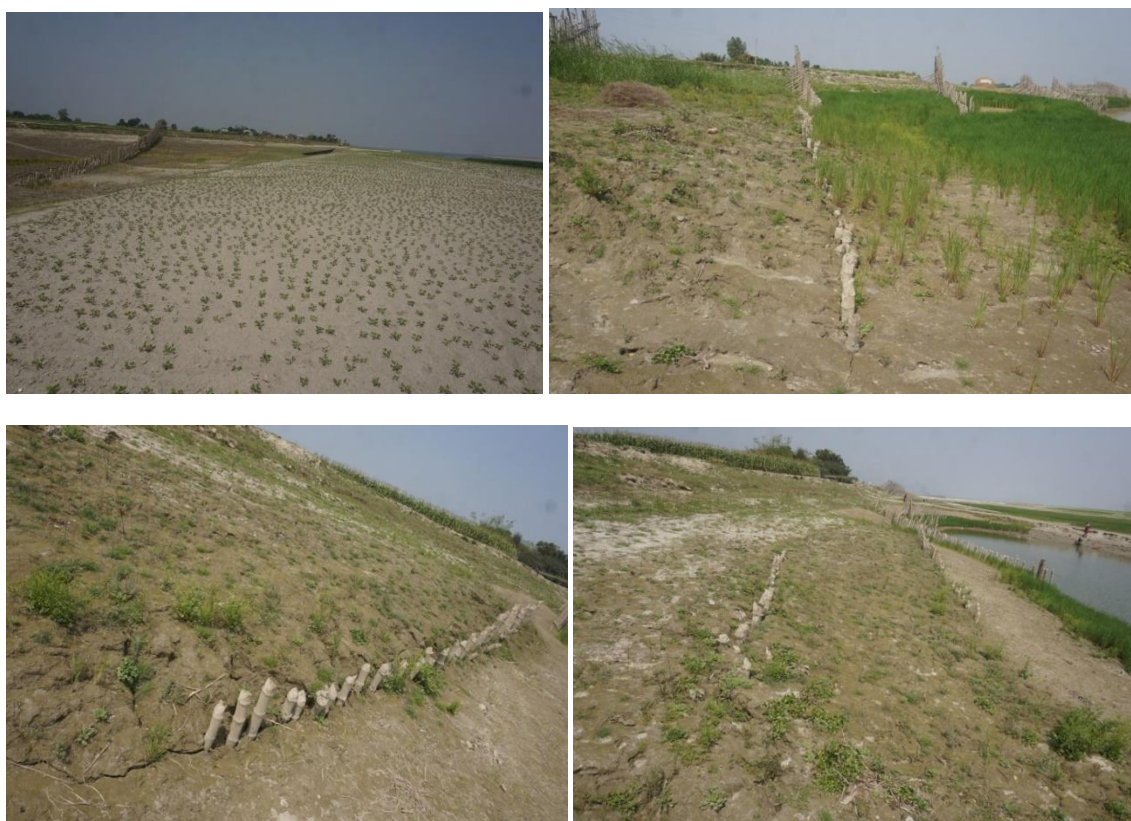
Sediment depositions on river bank induced by bandal-like structures at the right bank of Padma River (u/s of C & B ghat, Goldangirchar)

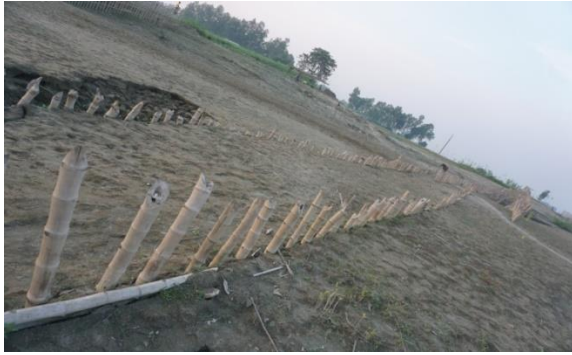
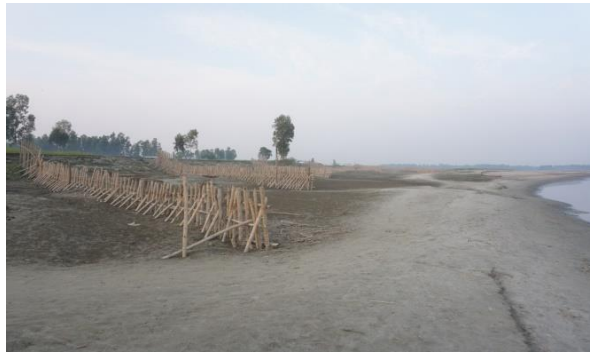
Sediment depositions on river bank induced by bandal-like structures at the left and right bank of Dhaleshwari River (Neorgacha, Chouhali)

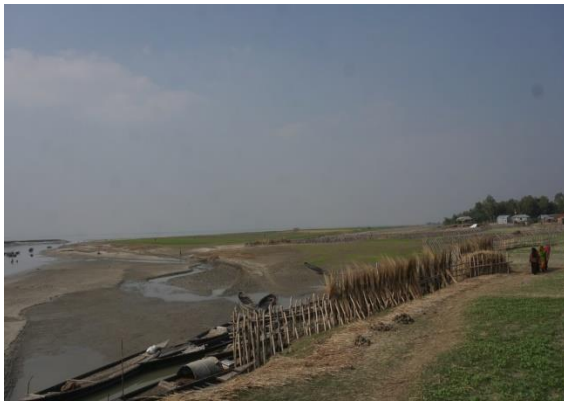
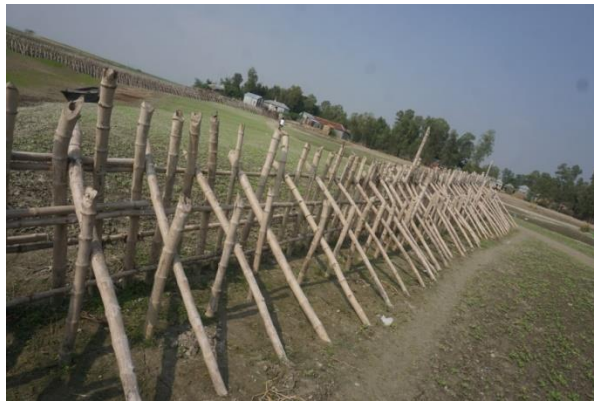
Sediment depositions on river bank induced by bandal-like structures at the left bank of Jamuna River (Rehaipukhuria, Chouhali)

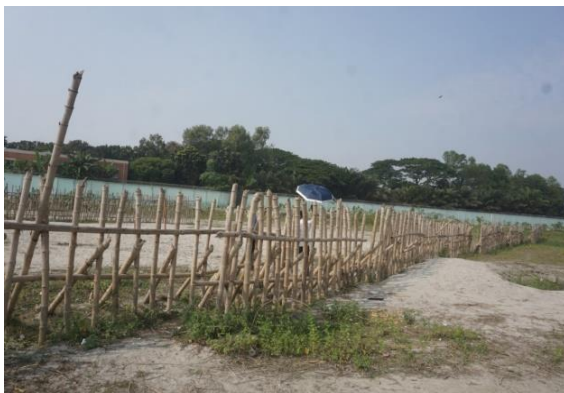
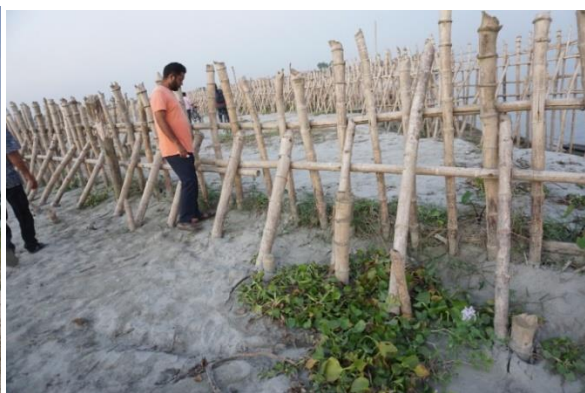
Sediment depositions on river bank induced by bandal-like structures at the right bank of Jamuna River (d/s of Enayetpur Spur)

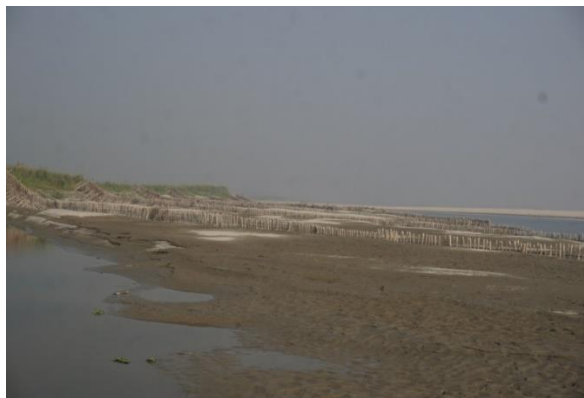
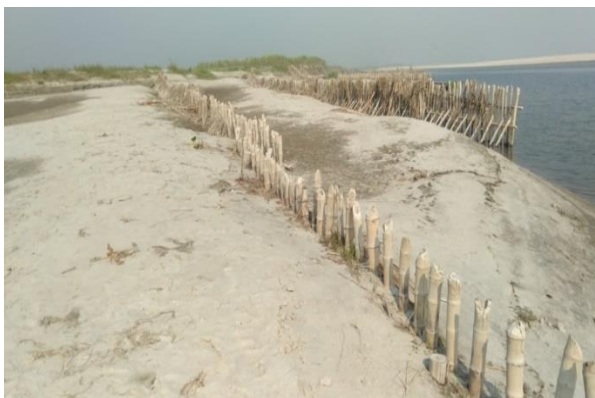
Sediment depositions on river bank induced by bandal-like structures at the right bank of Jamuna River (u/s of Cross bar-01, Sirajganj)

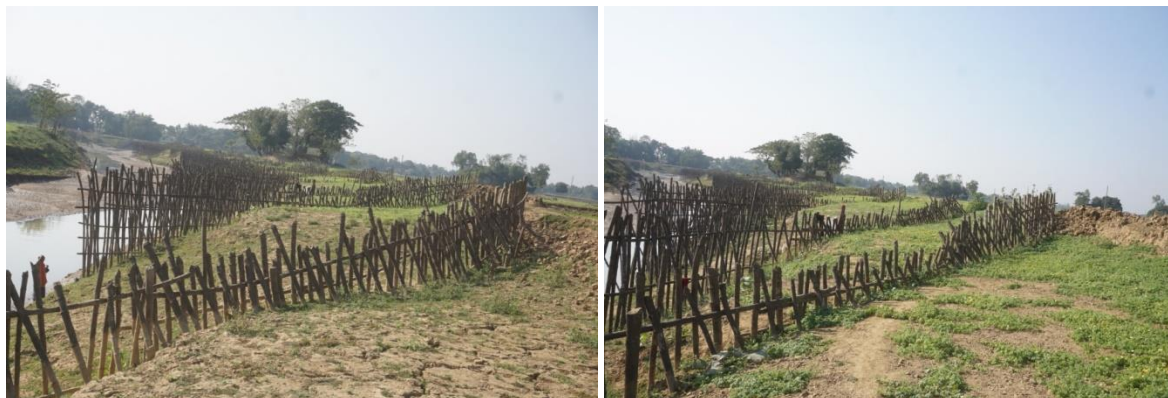
Sediment depositions on river bank induced by bandal-like structures at the Nitai River (u/s of Shankarpur Bazar, Purbadhala)

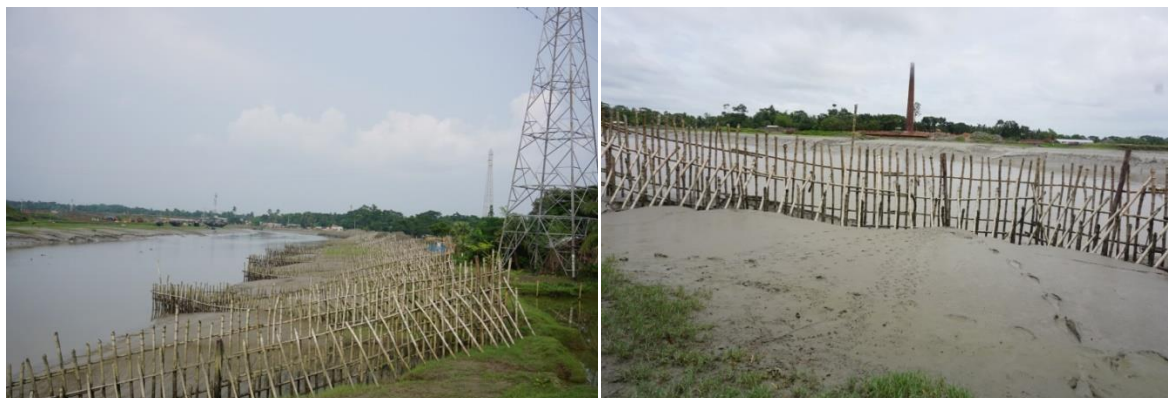
Sediment depositions on river bank induced by bandal-like structures at the Bhadra River (Kharnia Bazar, Dumuria)

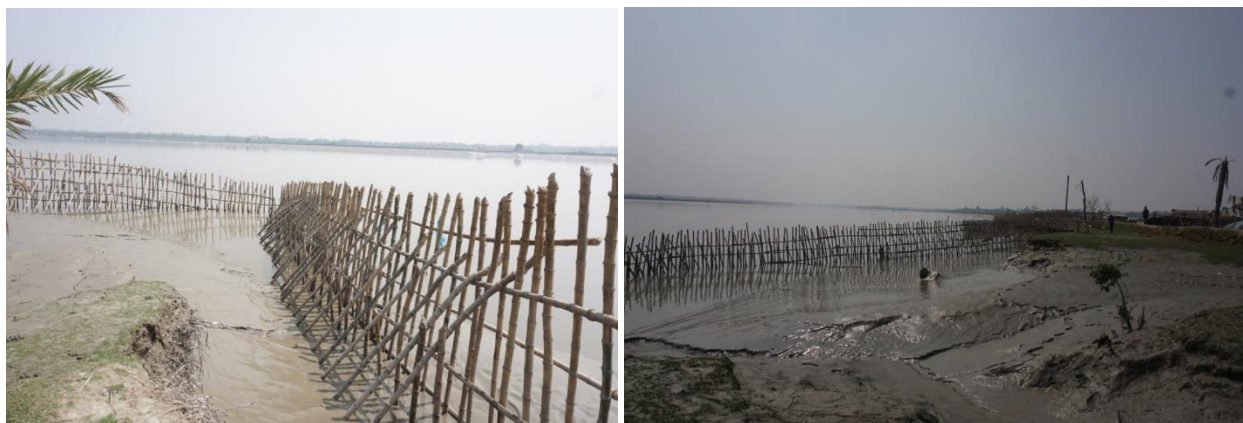
Sediment depositions on river bank induced by bandal-like structures at the Bhadra River (near Chandgoar, Dumuria)

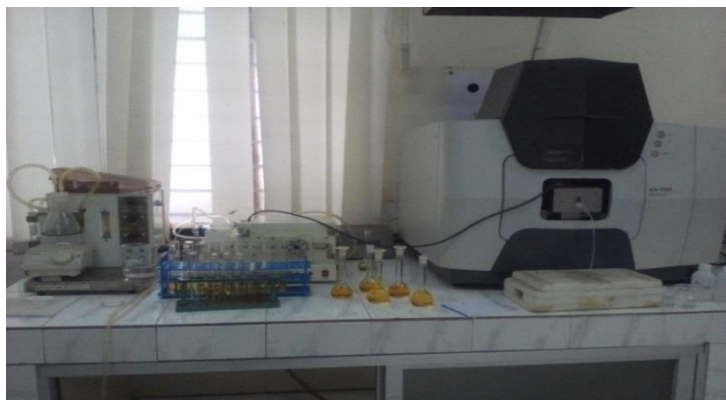
Lead, Cadmium, Chromium, Nickel, Copper, Zinc, Arsenic, Calcium (Ca), and Magnesium (Mg) in water samples were determined with an atomic absorption spectrophotometer (AAS) (Model: AA-7000, Shimadzu) followed by APHA 3111, which was calibrated using certified reference material (CRMs) (APHA, 1998).

Atomic absorption spectrophotometer

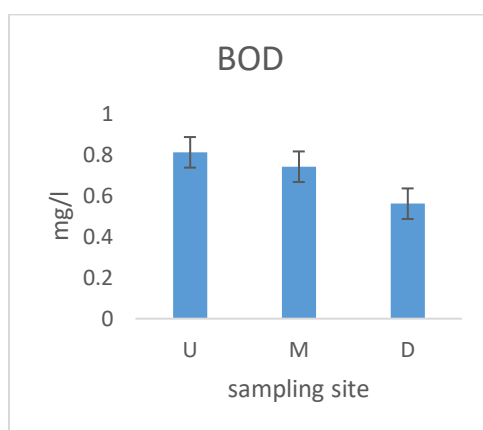
In this river sampling was also carried out for two sessions. The highest concentration of BOD (1.30 mg/l) was found in the upstream in the second phase of the experiment and the lowest concentration (0.43 mg/l) was detected in the downstream during after bandaling at the second session of experiment. The highest average concentration was found in the upstream and the lowest was in the downstream for this river (Fig. 3).

Fig.3. Showing the average concentration of BOD of the river Baliakandi (2019-2020).

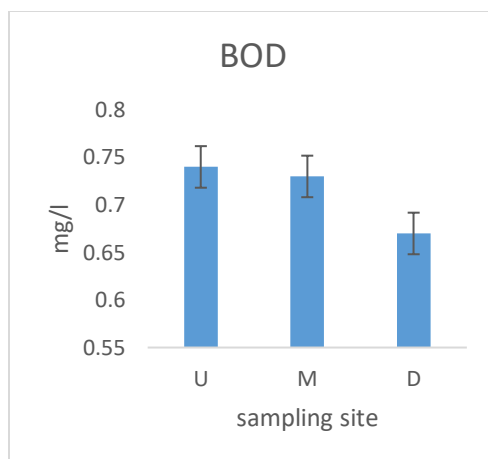
A total of eight phases of experiments were done in this river. The highest concentration (1.2 mg/l) of BOD was detected at downstream during before bandaling of seventh phase of the experiment and the lowest concentration (0.31 mg/l) was also found at downstream during after bandaling period of second phase. The highest average concentration was found in the upstream and the lowest was in the downstream for this river (Fig. 4).

Fig. 4. Showing the average concentration of BOD of the river Sugondha (2019-2020).

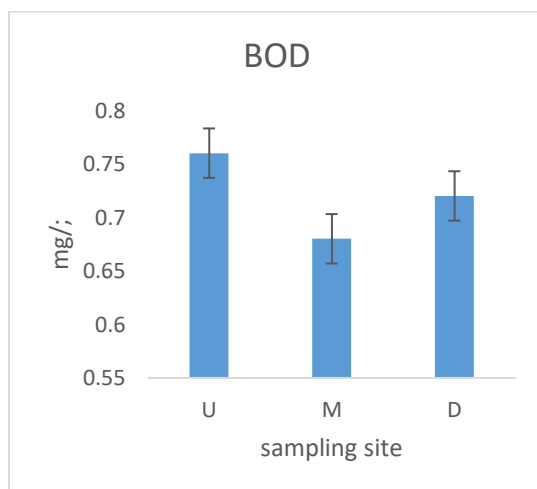
A total of eight phases of experiments were done in this river. The highest concentration (1.2 mg/l) of BOD was detected at upstream during after bandaling of first phase of the experiment and the lowest concentration (0.41 mg/l) was also found at the middle during after bandaling period of second phase. The highest average concentration was found in the upstream and the lowest was in the middle for this river (Fig. 5).

Fig. 5. Showing the average concentration of BOD of the river Kongsho (2019-2020).

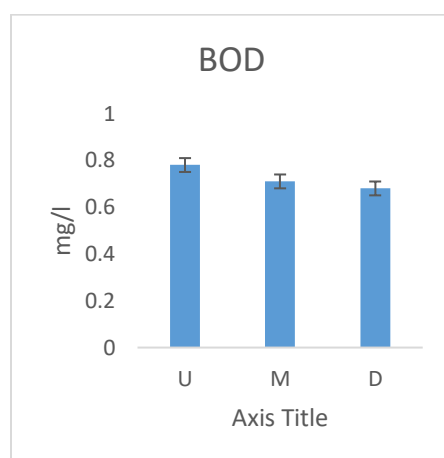
A total of eight phases of experiments were done in this river. The highest concentration (1.3 mg/l) of BOD was detected at upstream during after bandaling of seventh phase of the experiment and the lowest concentration (0.41 mg/l) was also found at the downstream during after bandaling period of third phase. The highest average concentration was found in the upstream and the lowest was in the downstream for this river (Fig. 6).

Fig. 6. Showing the average concentration of BOD of the river Bhadra (2019-2020).

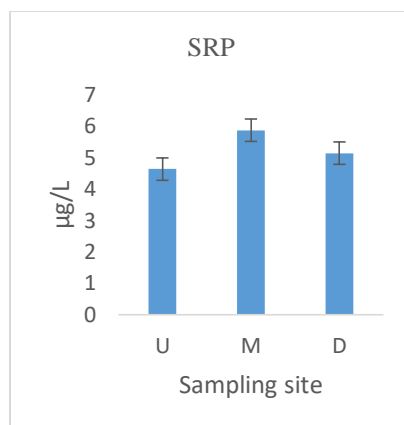
Sampling was carried out only for two sessions in this river. The highest concentration of SRP (10.93 $\mu\text{g/l}$) was found in the downstream in the second phase during before bandaling of the experiment and the lowest concentration (1.30 $\mu\text{g/l}$) was also detected in the downstream during after bandaling at the first session of experiment. The highest average concentration of SRP (5.87 $\mu\text{g/l}$) was found in the middle and the lowest (4.36 $\mu\text{g/l}$) was found in the upstream for this river (Fig. 8).

Fig. 8. Showing the average concentration of SRP of the river Arialkha (2019-2020).

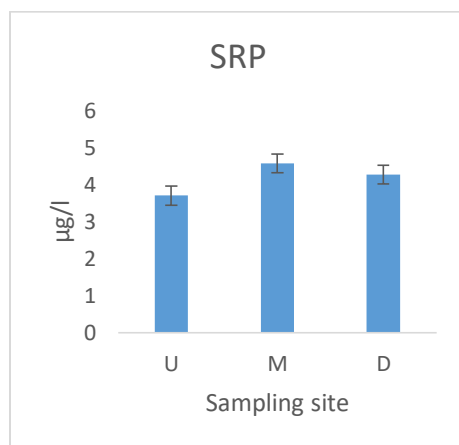
In this river sampling was also carried out for two sessions. The highest concentration of SRP (5.10 µg/l) was found in the middle during after bandaling in the first phase of the experiment and the lowest concentration (2.55 µg/l) was detected in the downstream during after bandaling at the first phase of the experiment. The highest average concentration of SRP (4.56 µg/l) was found in the middle during after bandaling and the lowest (3.70 µg/l) was also found during after bandaling in the downstream for this river (Fig.9).

Fig. 9. Showing the average concentration of SRP of the river Baliakandi (2019-2020).

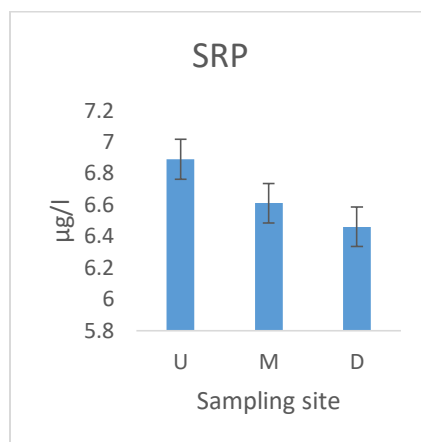
A total of eight phases of experiments were done in this river. The highest concentration (14.87 $\mu\text{g/l}$) of SRP was detected at upstream during after bandaling of fifth phase of the experiment and the lowest concentration (2.37 $\mu\text{g/l}$) was also found at upstream during before bandaling period of sixth phase. The highest average concentration of SRP (6.89 $\mu\text{g/l}$) was found in the upstream and the lowest (6.46 $\mu\text{g/l}$) was in the downstream for this river (Fig. 10).

Fig. 10. Showing the average concentration of SRP of the river Sugondha (2019-2020).

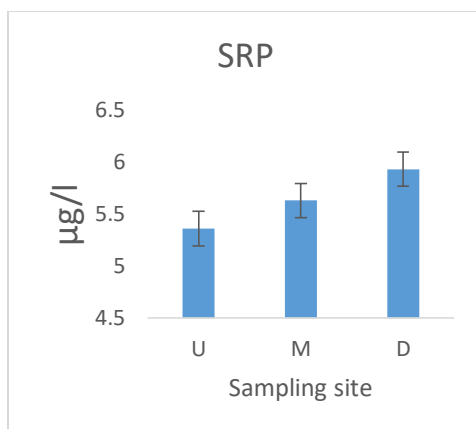
A total of eight phases of experiments were done in this river. The highest concentration (14.59 $\mu\text{g/l}$) of SRP was found at the middle during before bandaling of fourth phase of the experiment and the lowest concentration (1.20 $\mu\text{g/l}$) was also found at the upstream during before bandaling period of the third phase of the experiment. The highest average concentration of SRP (5.93 $\mu\text{g/l}$) was found in the downstream and the lowest concentration (5.36 $\mu\text{g/l}$) was in the upstream for this river (Fig. 11).

Fig. 11. Showing the average concentration of SRP of the river Kongsho (2019-2020).

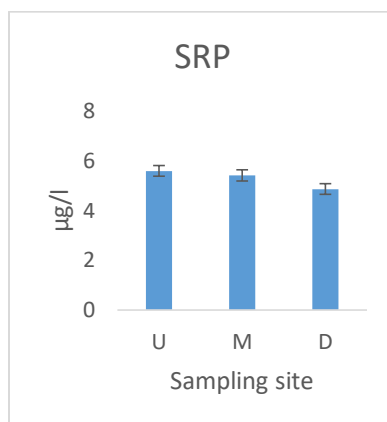
A total of eight phases of experiments were done in this river. The highest concentration (11.56 µg/l) of SRP was detected in the middle during before bandaling of fourth phase of the experiment and the lowest concentration (1.09 µg/l) was found at the downstream during after bandaling period of sixth phase. The highest average concentration of SRP (5.58 µg/l) was found in the upstream and the lowest concentration (4.85 µg/l) was detected in the downstream for this river (Fig. 12).

Fig. 12. Showing the average concentration of SRP of the river Bhadra (2019-2020).

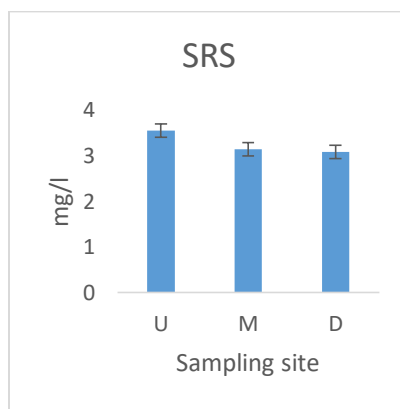
The concentration of SRP was the highest in the downstream (12.23 mg/l) during after bandaling at the eighth phase of the experiment and the lowest concentration (0.23 mg/l) was also found during before bandaling at the downstream during the fourth phase of the sampling. The highest average concentration of SRP (3.55 mg/l) was found in the upstream and the lowest (3.09 mg/l) was detected in the downstream for this river (fig. 13).

Fig. 13. Showing the average concentration of SRS of the river Padma (2019-2020).

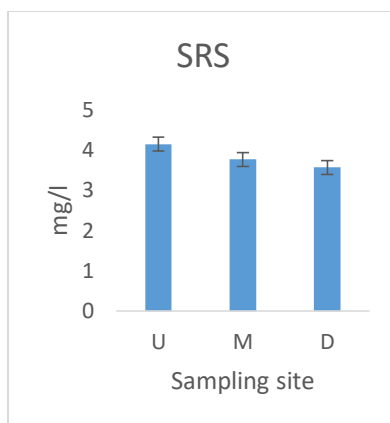
Sampling was carried out only for two phases in this river. The highest concentration of SRP (6.88 mg/l) was found in the upstream in the second phase during before bandaling of the experiment and the lowest concentration (1.48 mg/l) was also detected in the upstream during after bandaling at the first session of experiment. The highest average concentration of SRP (4.15 mg/l) was found in the upstream and the lowest concentration (3.57 mg/l) was found in the downstream for this river (Fig. 14).

Fig. 14. Showing the average concentration of SRS of the river Arialkha (2019-2020).

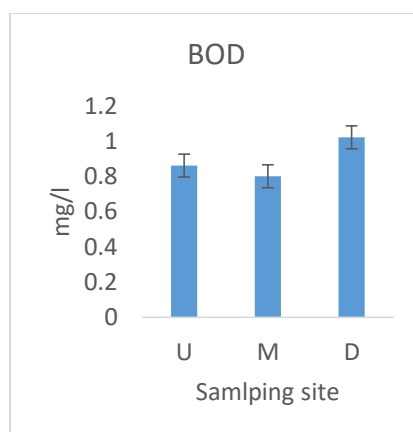
concentration (1.02 mg/l) was found in the downstream and the lowest (0.80 mg/l) was in the middle for this river (Fig. 3).

Fig.3. Showing the average concentration of BOD of the river Baliakandi (2020-2021).
