BANGLADESH FLOOD ACTION PLAN

OPERATION AND MAINTENANCE STUDY

FINAL REPORT

VOLUME 2
Case Studies

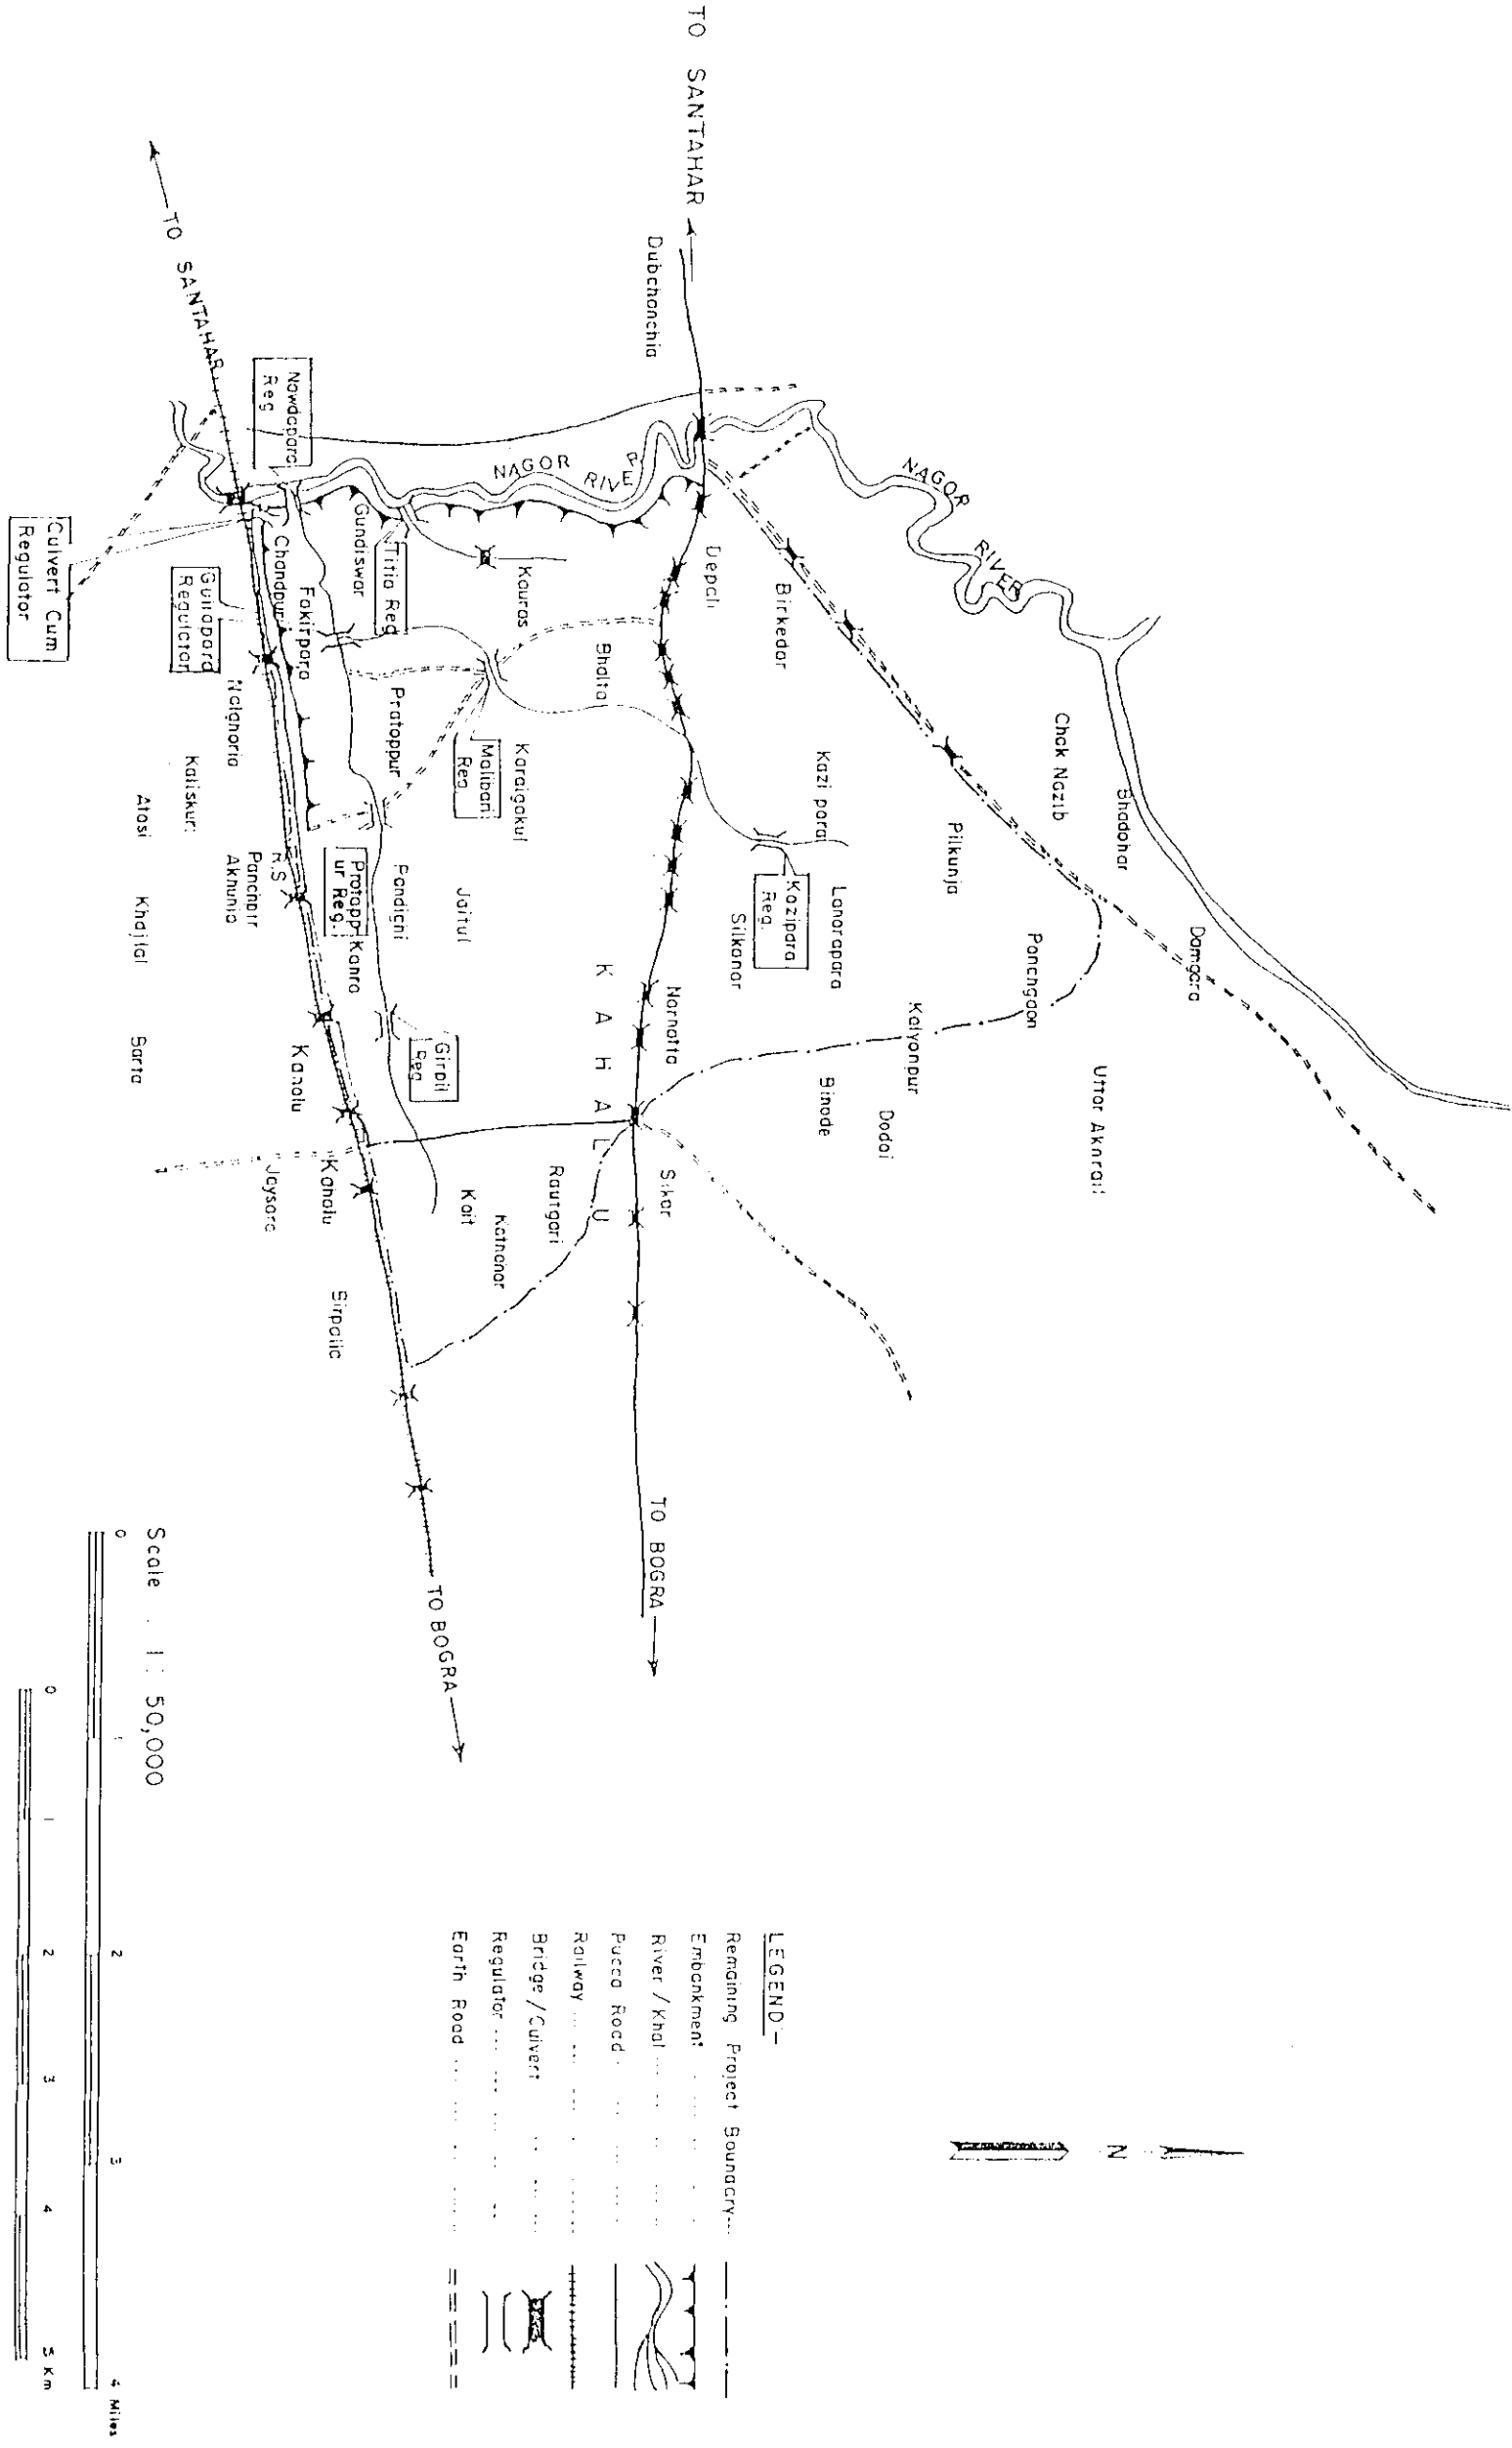
Figure 6.1 Protappur Irrigation Project - Key Features

Embankment is severely eroded due to continued public cut/breach and backflow in Nagor river. Project requires major replanning exercise on whole Atrai Basin before any major works are contemplated. To keep the remainder of the project in running order in the meantime excavation of the Hulhulia Khal and repair and maintenance of those regulators (except the one at Domdoma) not threatened by erosion have become urgent.

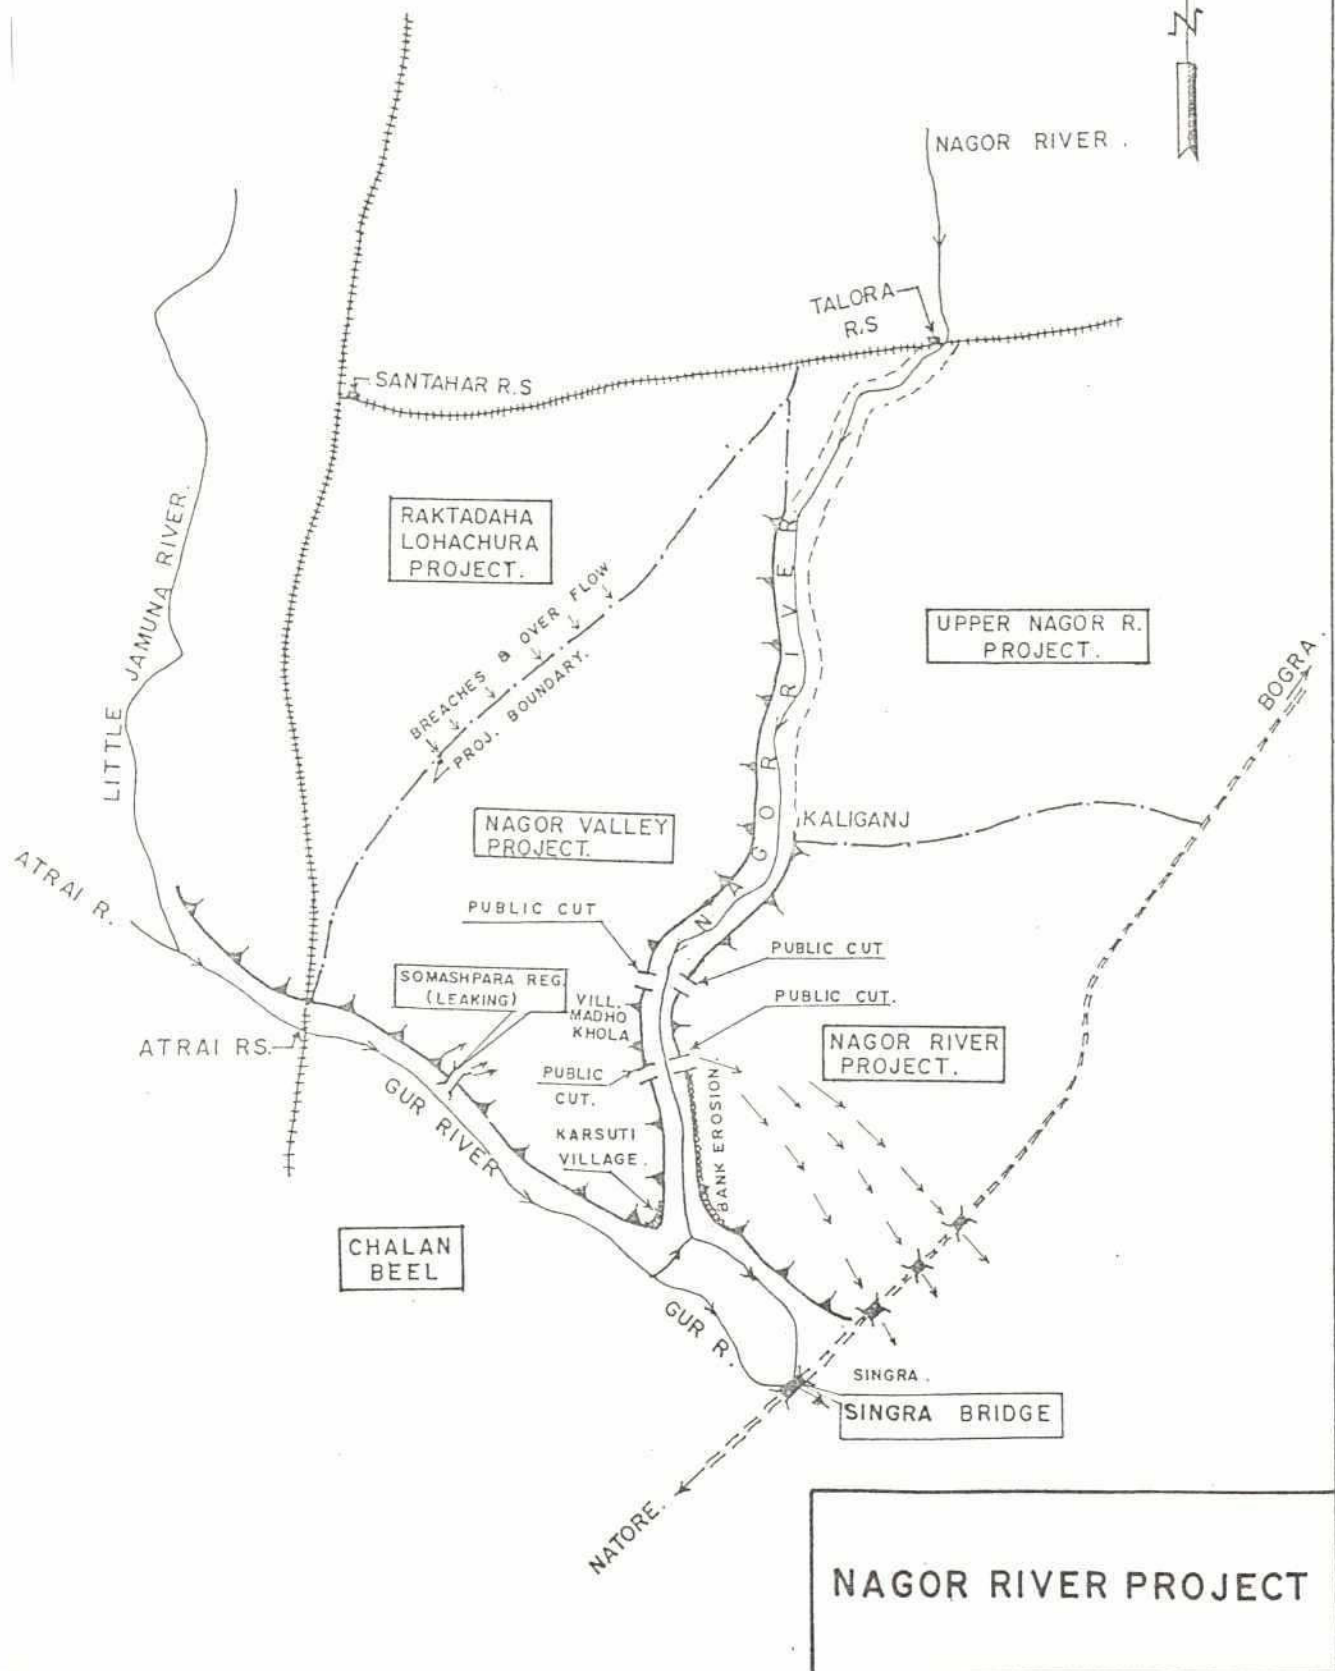
Figure 7.2 Nagor River Project showing typical monsoon water flows between projects within the Nagor river system.

Since then this phenomenon of public cuts has taken place every year at these places. The public cuts both in Nagor Valley and Nagor River projects have damaged the Aman crops in Nagor River Project every year. Moreover, the public cuts in the Nagor River embankment have created a serious threat to the very existence of the project embankment, as the entire Nagor river flow is diverted into the Nagor River Project through these cuts causing a back flow of Gur river water into the Nagor river for a length of about 2 km from its confluence with the Gur. The Nagor river bed is very flat and its slope in this reach is only 4cm/km (EIP, 1988, P-9). This back flow has created a strong upstream current in Nagor river, causing severe erosion of 2 km of the project embankment. Figure 7.2 shows the now usual system of flood flows with the cuts.

many places due to wave cut and erosion during the 1987 and 1988 floods. The top width of embankment was found to be less than the designed width of 12 ft. (3.7m) and the side slopes are damaged. The embankment has practically zero set back distance from the river throughout its length.

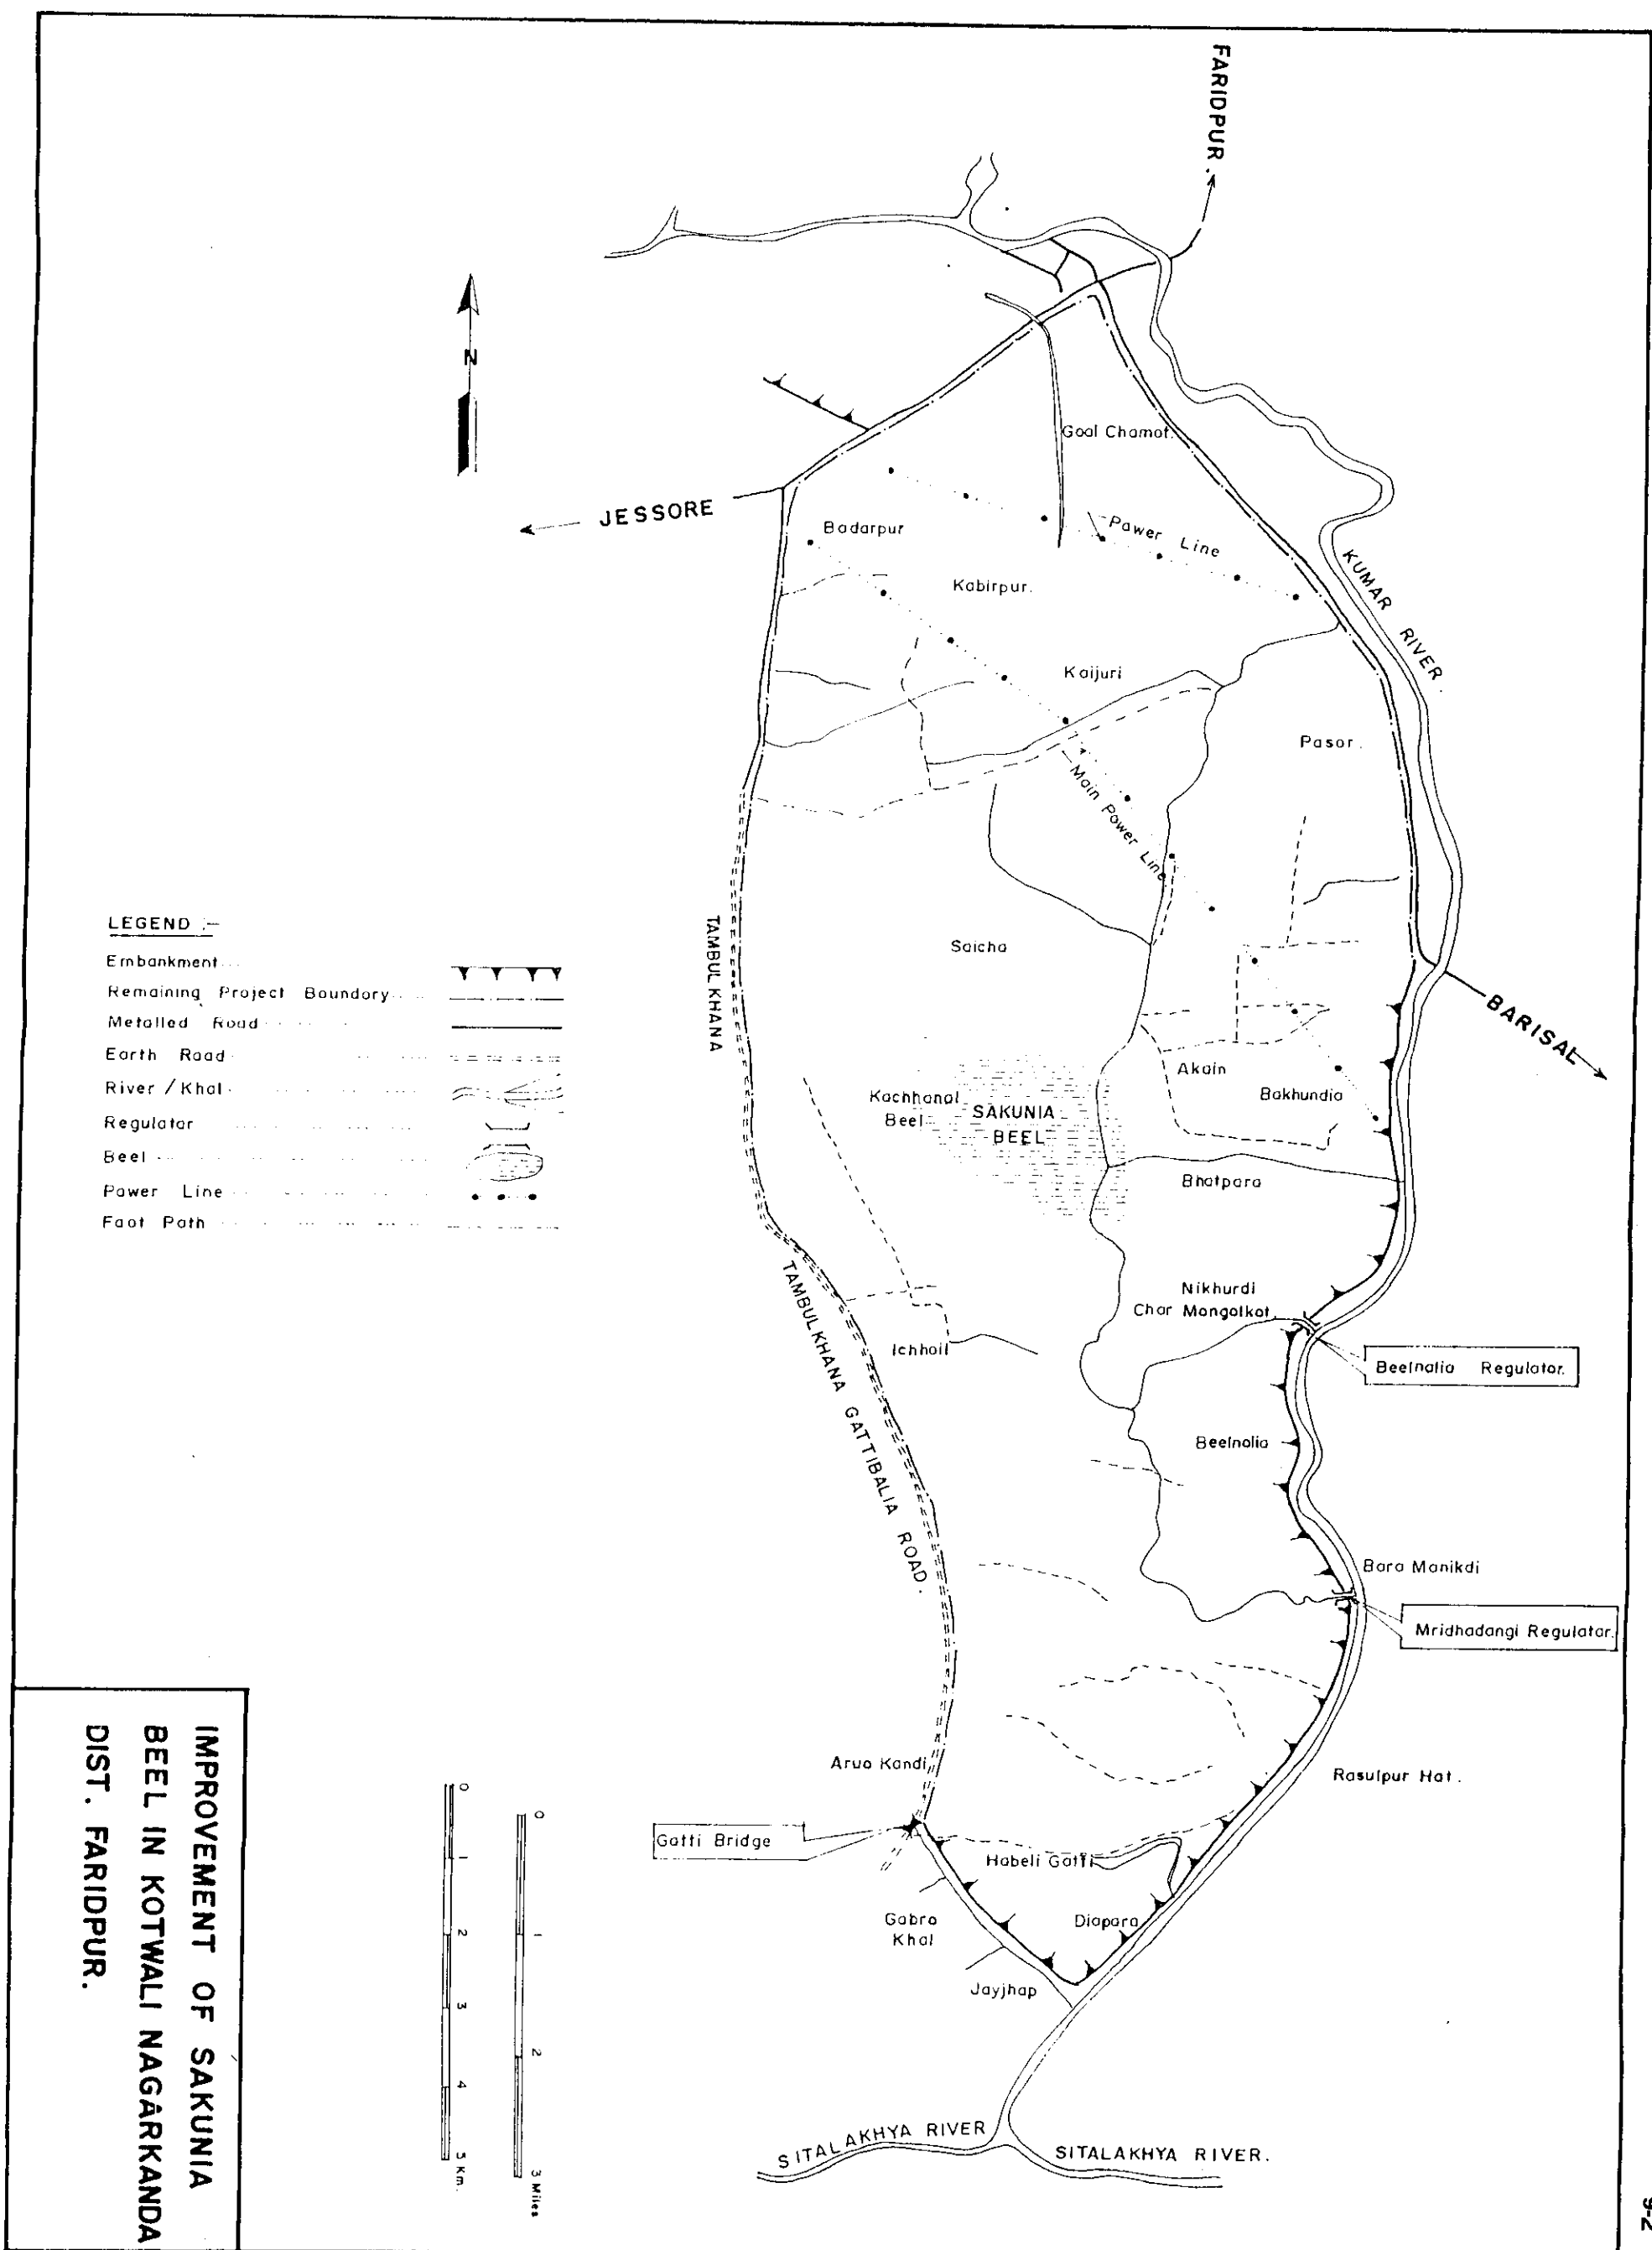
Figure 9.1 Sakunia Beel Project - Key Features

Reconstruction of the embankment damaged and breached in 1988 by pressure of internal water is still required. Repair of one regulator with a cracked wing wall. Drainage congestion problems because khals need re-excavation.

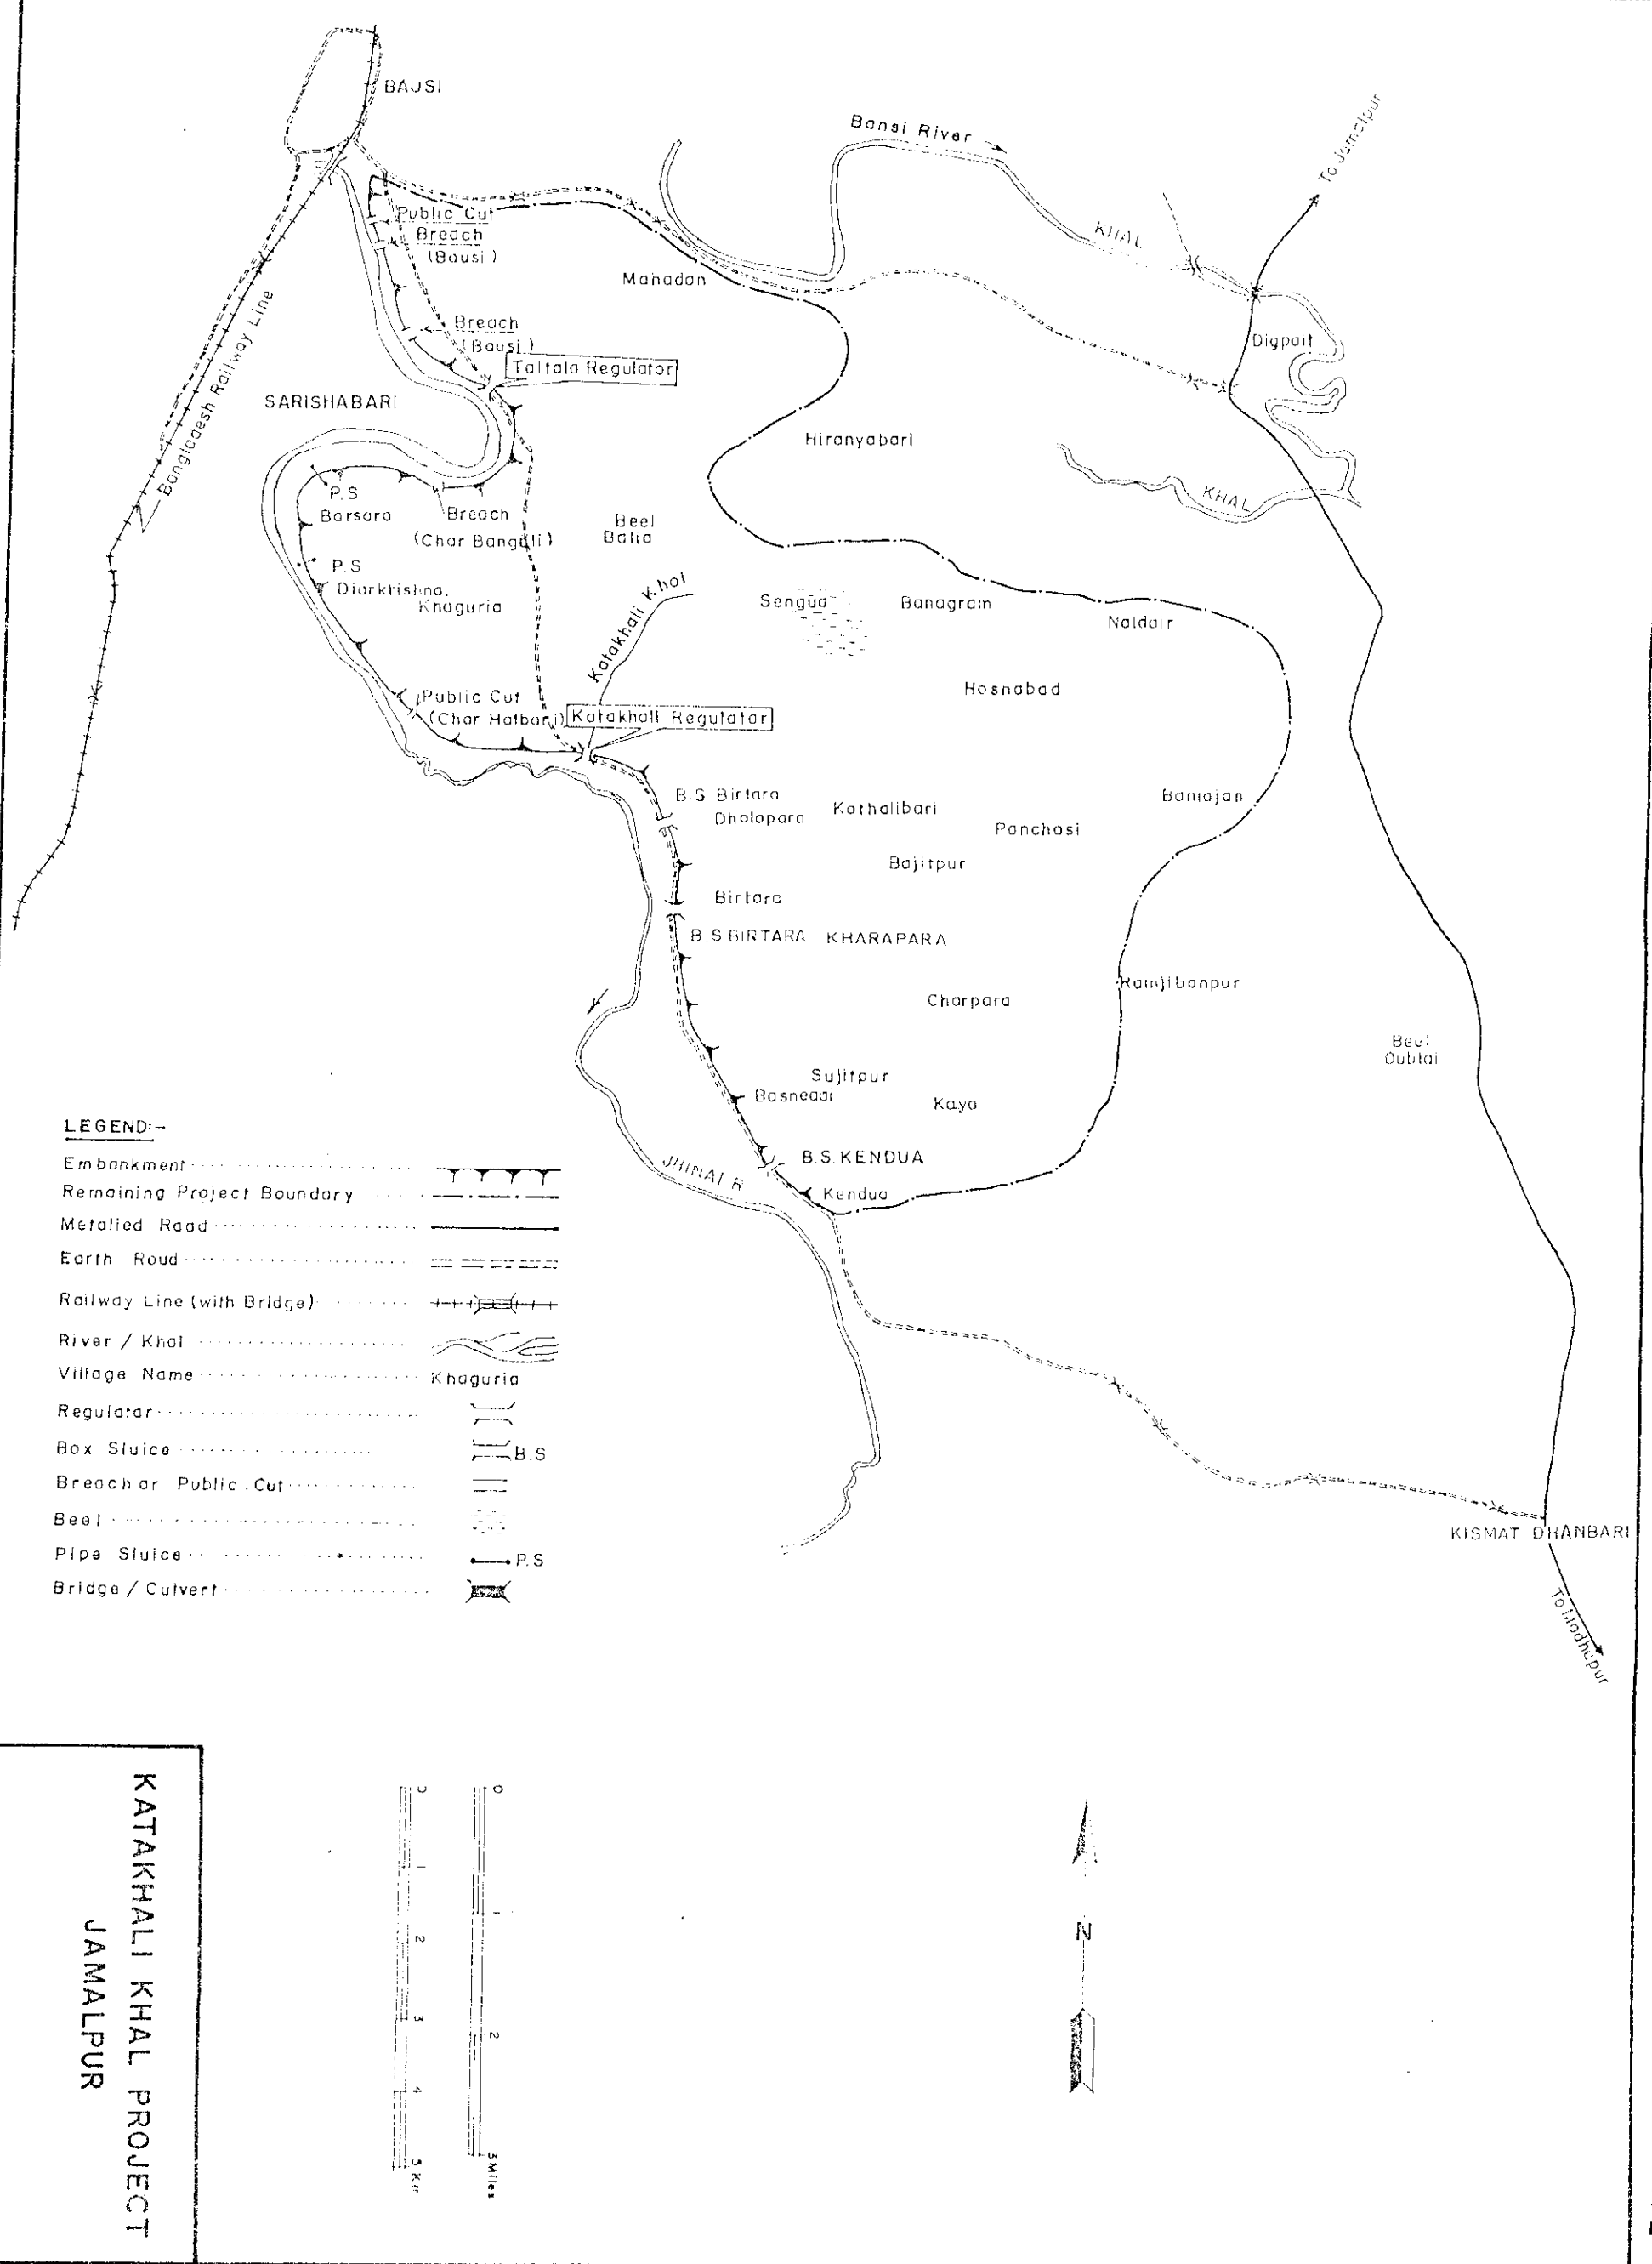
Figure 11.1 Katakhal Khal Project - Key Features

Repair of breaches dating back to 1988 and of public cuts made in 1991 to drain out early rainwater. Resectioning of northern part of embankment where there are many raincuts. Maintenance of earthworks around regulators and box sluices.

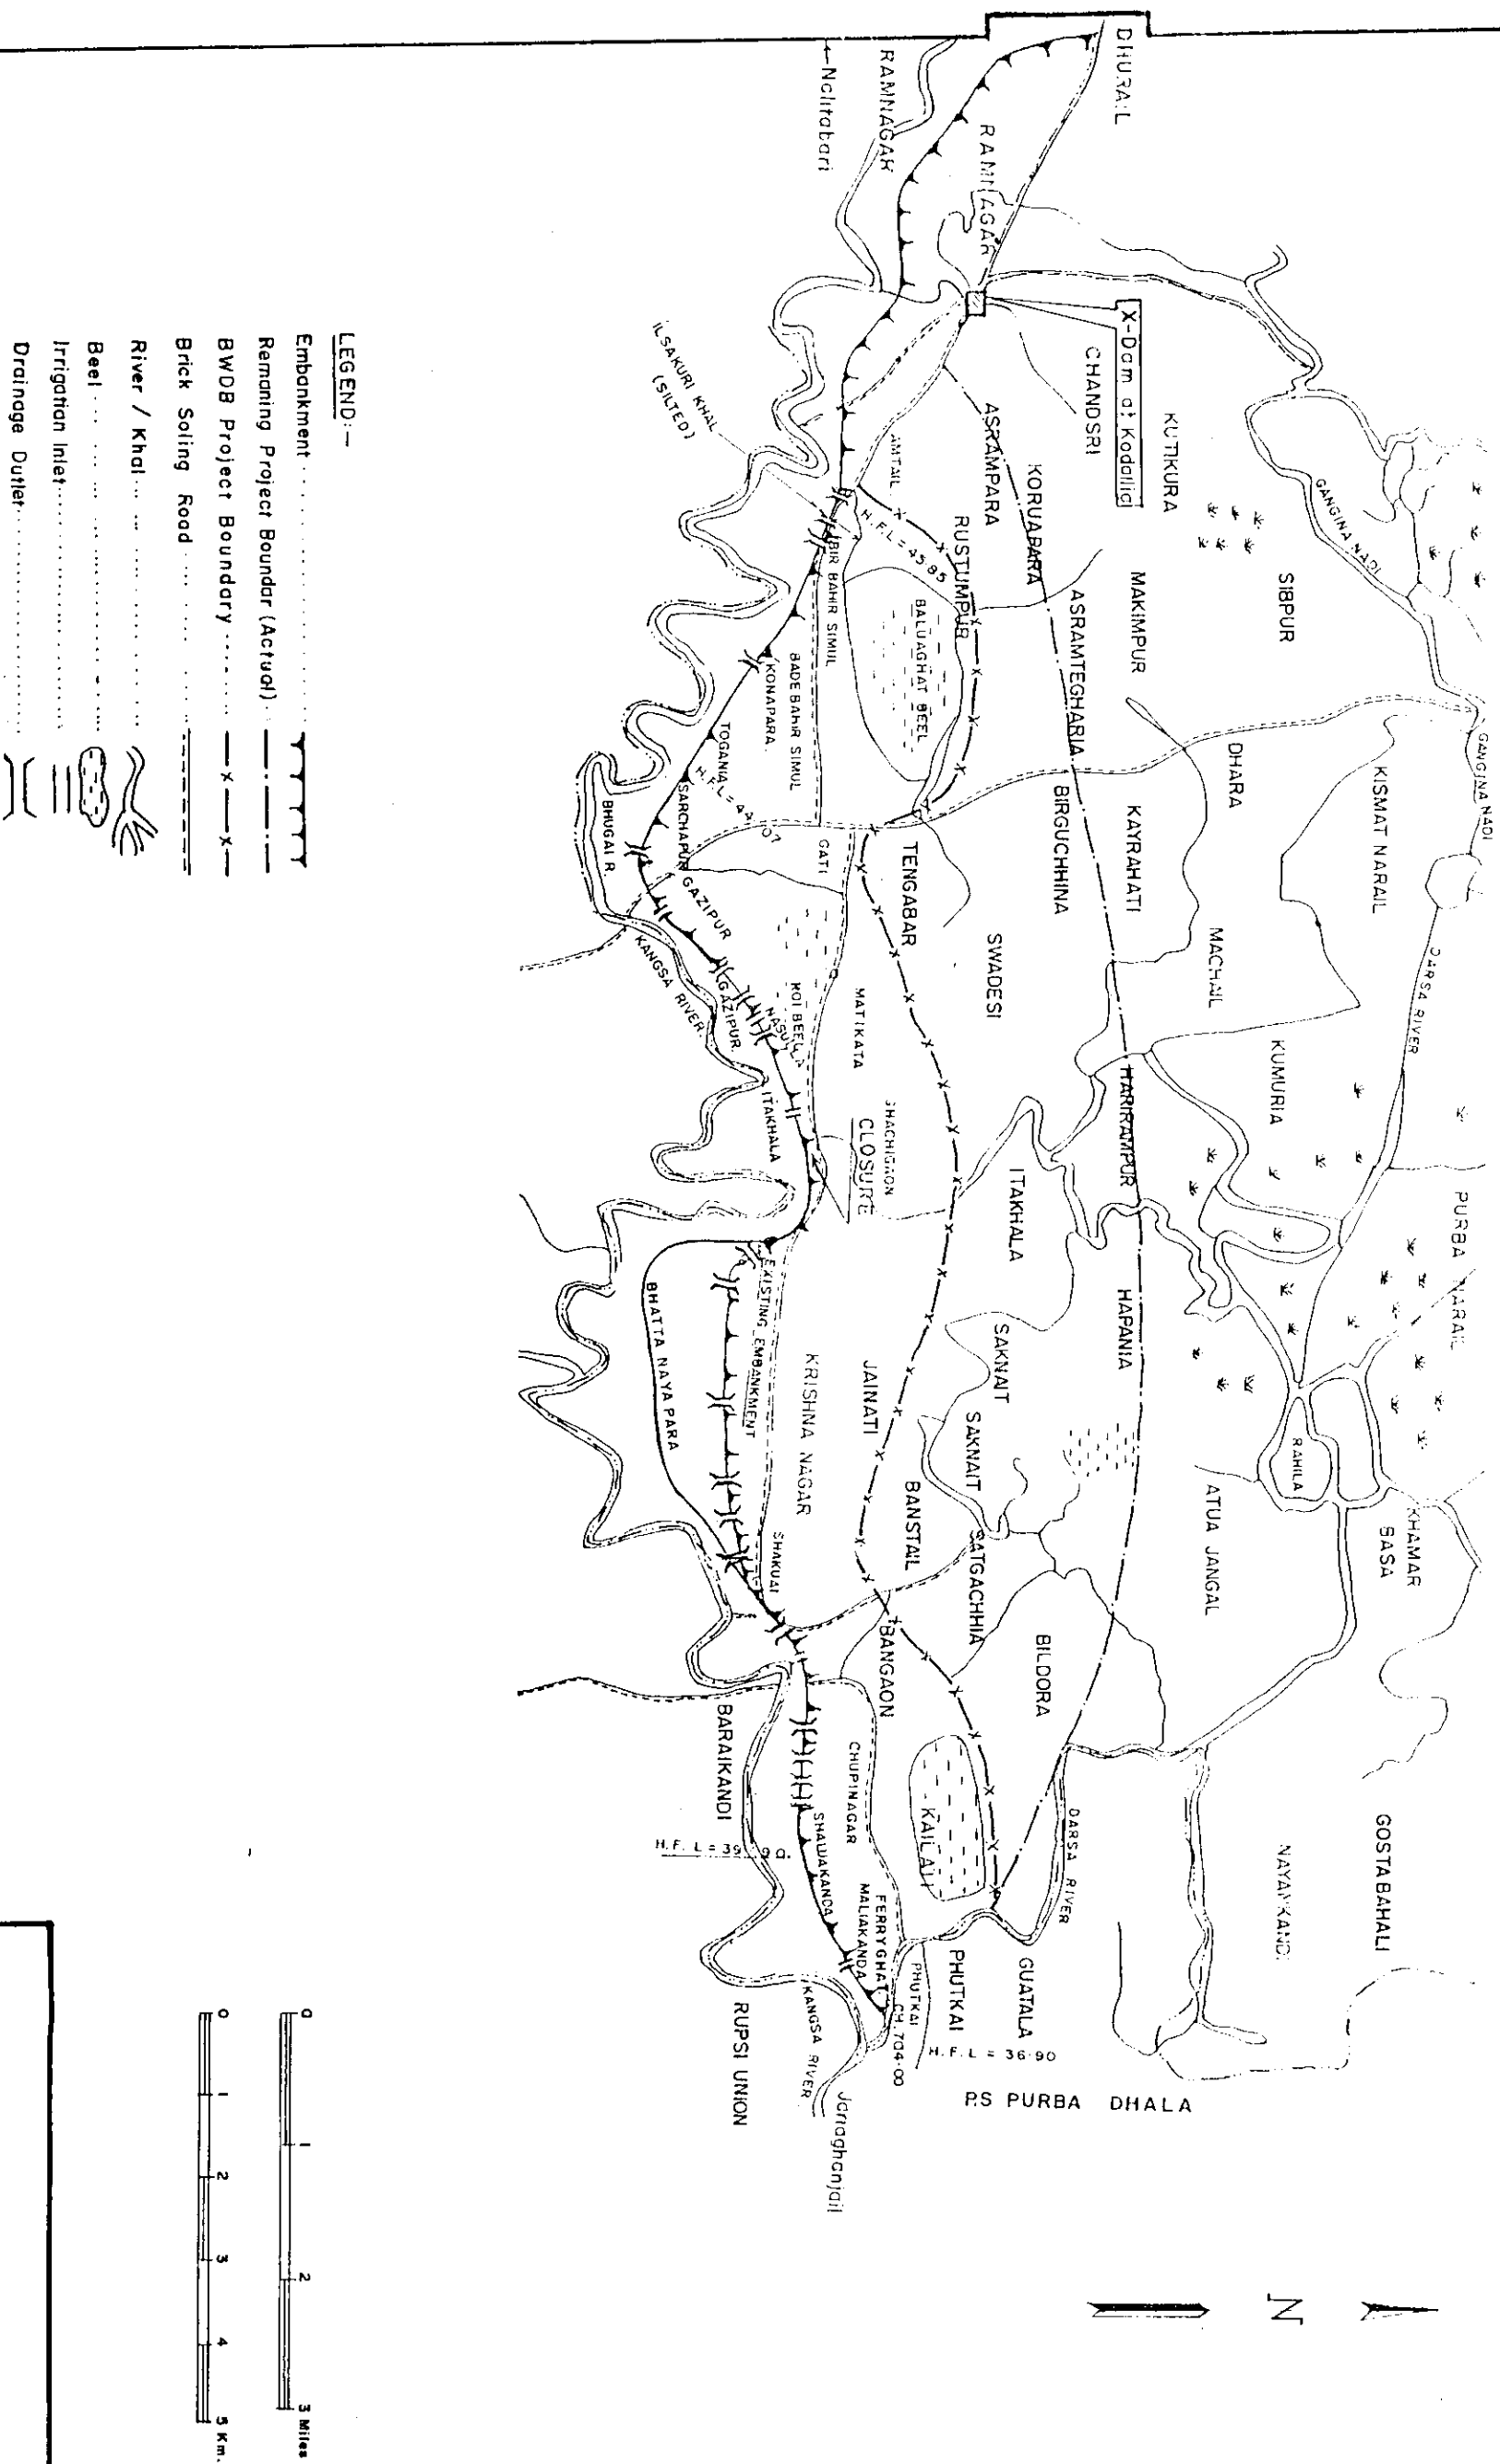
Figure 14.1 Konapara Embankment - Key Features

Despite complete resectioning in 1989 much of the embankment is in poor shape and still requires extensive work.

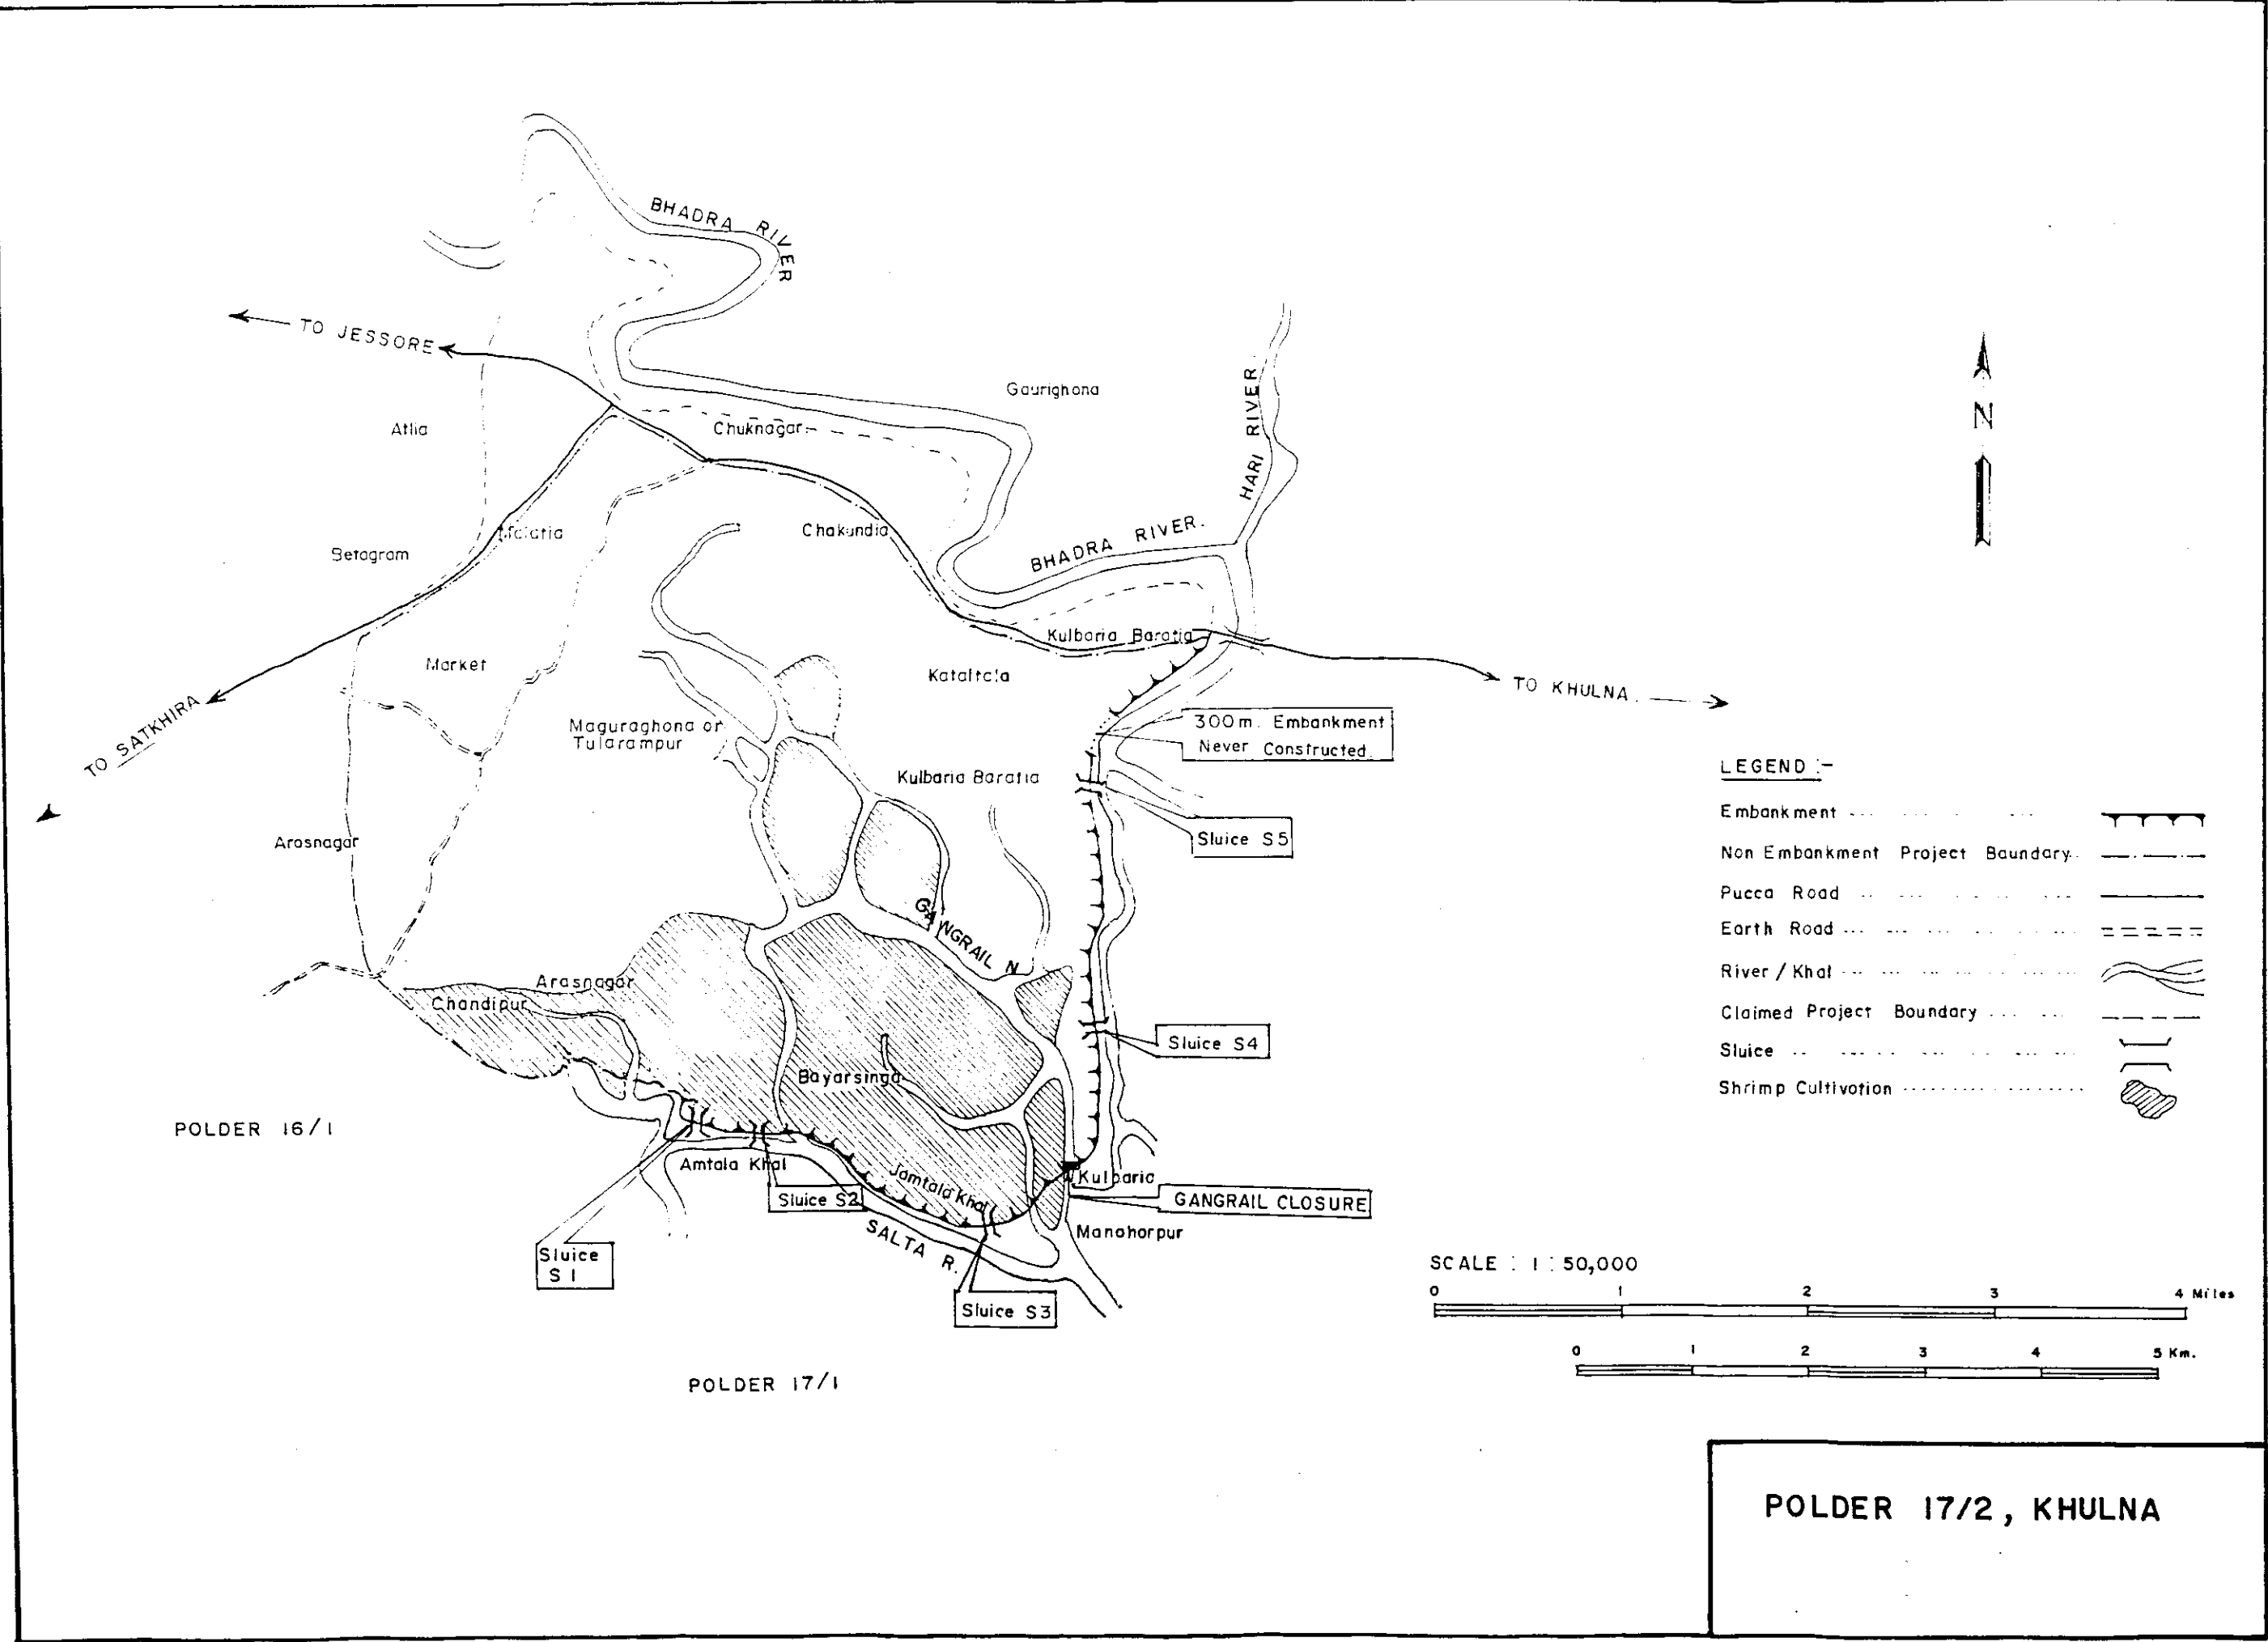
Figure 15.1 Polder 17/2 - Key Features

Project works completed, after three failures to close Gangrail river, in 1983/4. However, numerous private inlets for controlling saline water used in shrimp cultivation mean the intention of excluding saline water was not achieved, although saline water is now managed by private entrepreneurs.

The embankment and structures were completed in 1970-71 (local information and dates inscribed in sluices). About 300m length of the embankment was never constructed along the distributary of the Bhadra river on the north-eastern side of the project area (see Figure 15.1). This area was under homesteads and the residents argued that the land was high enough to be above flood risks, and that they did not wish to lose their homes. The land dispute raised by the households there appeared to have been overcome by a compromise between them and the then BWDB officials for the Project. Water level at high tide remains 0.3-0.6m (1-2 ft) lower than the river bank at that site, but the natural levee might be overtopped by an unusually high tide during the monsoon.
