**BANK PROTECTION AND
RIVER TRAINING (AFPM)
PILOT PROJECT
FAP 21/22**

**EXTENDED STUDIES ON
RECURRENT MEASURES
(FAP 22)**

**KATLAMARI TEST SITE
IMPACT AND BEHAVIOUR
DURING MONSOON 1997**

AUGUST 1998

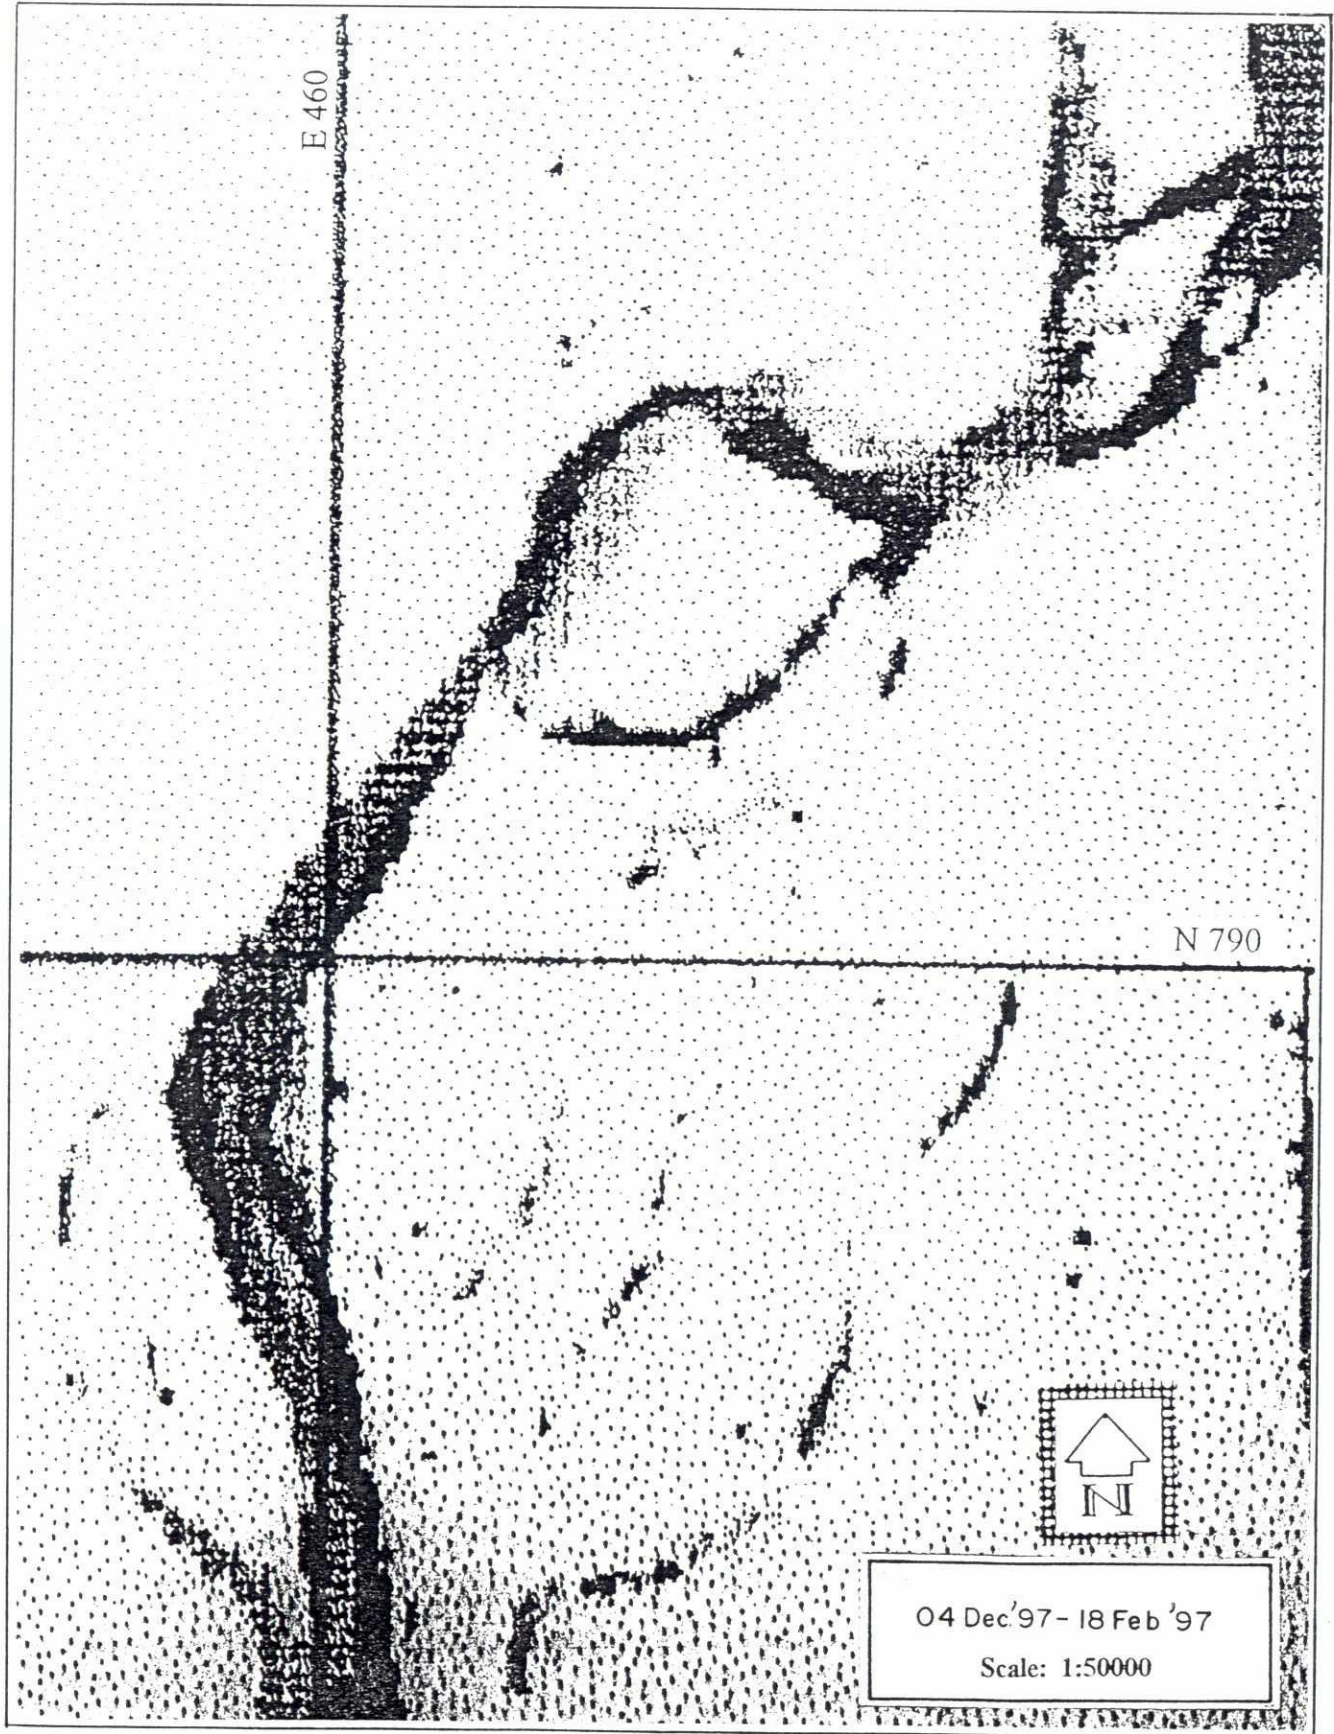
Fig. 5.6: Difference map from February to December 1997
(from LANDSAT TM)

The bathymetric surveys of FAP 21/22 can illustrate the changes with time from downstream from Ratanpur to near Fulchhari Ghat. Fig. 5.3 provides the impression about the changes from the off-take to Ratanpur. The changes of the planform of the Fulchhari channel during the monsoon is clearly visible from Fig. 5.6.

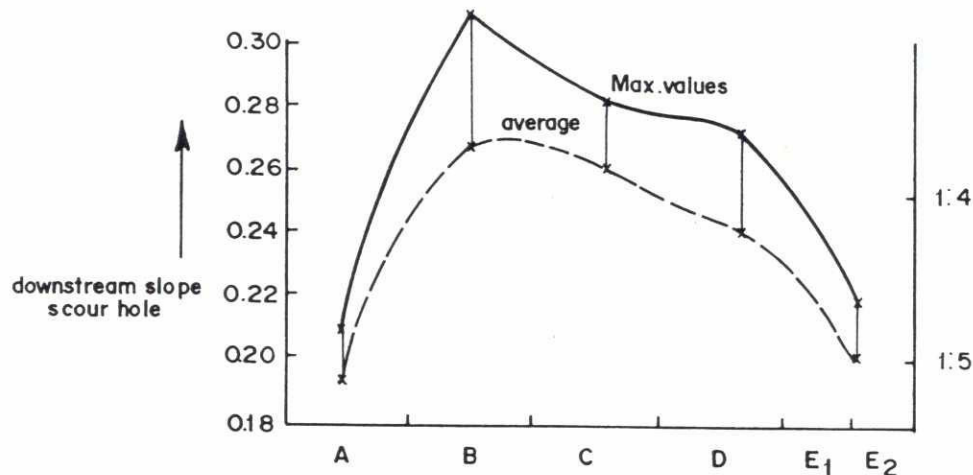
Fig. 6.3: Downstream slope behind the bandals

The length of the scour hole varied with the depth (and the slope) and was usually within 20m. As a maximum 28m (downstream from bandal Section C) was observed. This was dangerous in view of the anchoring system of the ropes of Section C which were fixed at 20m from the bandals at a level of 15 m+PWD. Downstream from the scour hole accretion was observed (see Fig. 6.8).

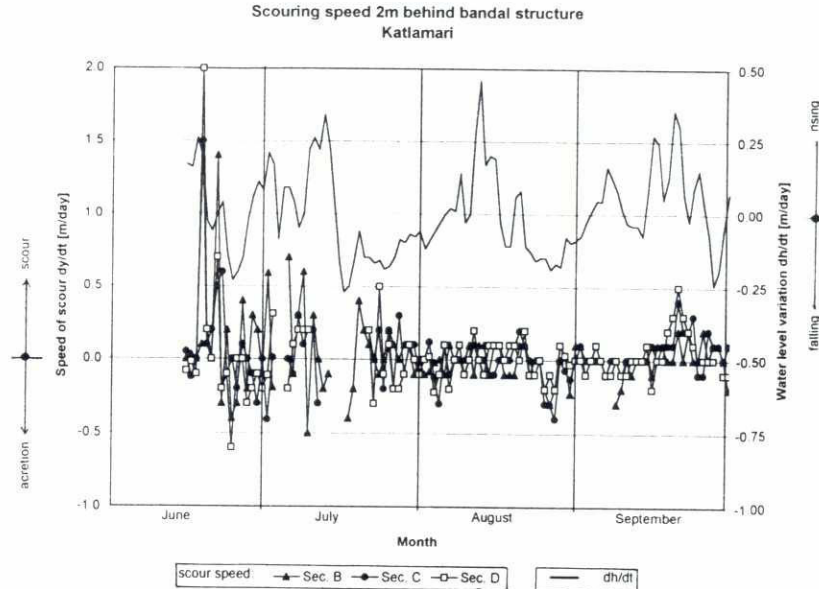
Fig. 6.6: Speed of scour

The speed of erosion and sedimentation can be seen from the time series of $y(t)$ as plotted in Fig. 6.6.

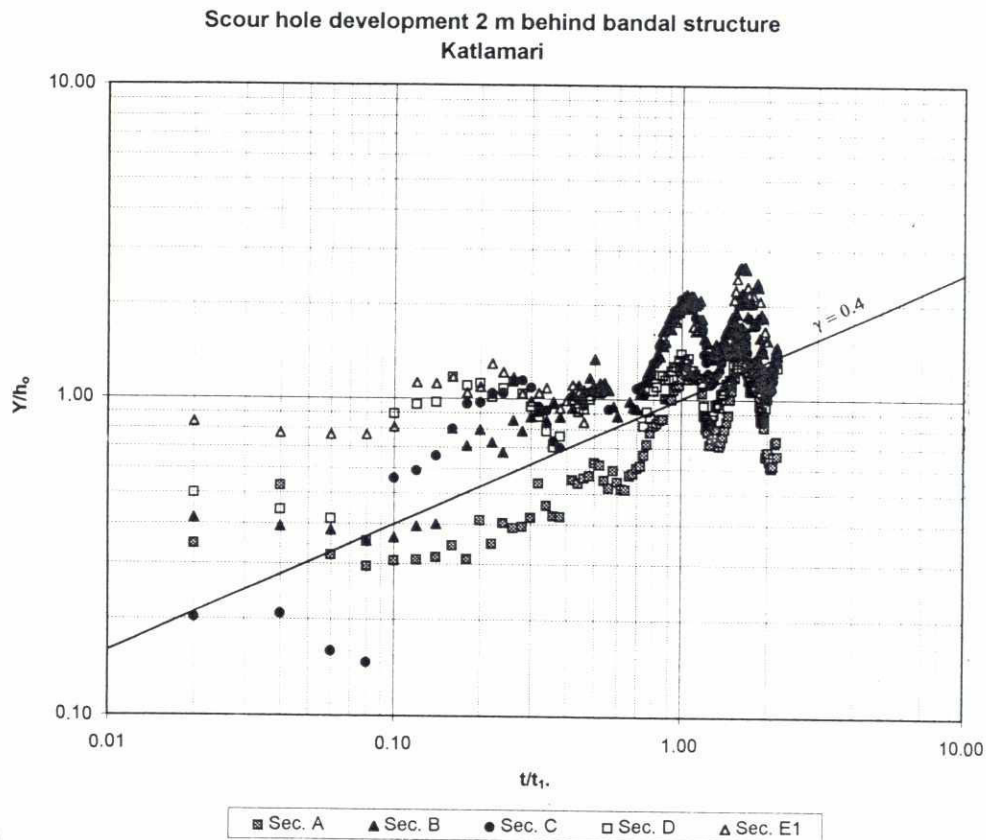
Fig. 6.8: Scour depth / water depth ratios versus time

There are, however, reasons to increase the α value somewhat. The relative turbulence is higher than expected. The detailed velocity measurements in the scour hole were executed as 3 series of 10 seconds per point. The variation between the series is an indication (not a determination) of the turbulence. From these figures relative turbulence values of about 30% seem likely. This leads to α values of 1.9 instead of the estimated 1.75 value. Another estimate comes from earlier model investigations [20p.50] where for a case without sill and without bed protection an α - value of 2.0 is indicated. With this value t_l becomes 50 days and $y_m = 5.1$ m. This seems perfect, assuming that the $\gamma = 0.4$ value of equation (1) is correct. This has been verified in the following figure.

From Figure 6.8 the following can be observed:

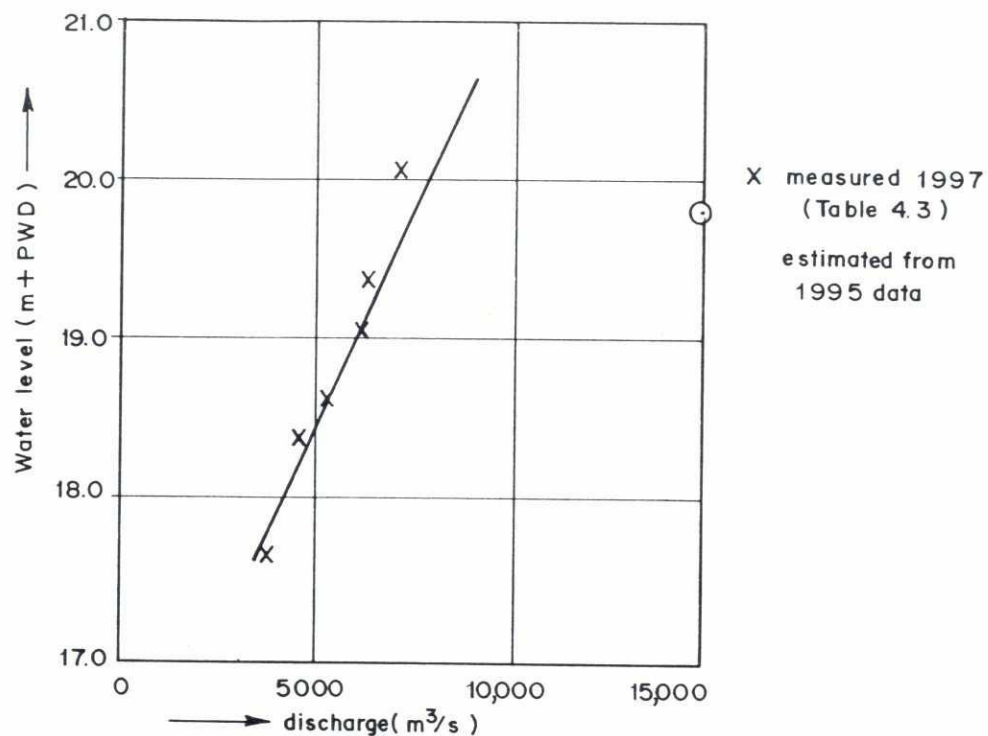
Fig. 6.10: Stage discharge in the Fulchari channel

From the Figures 6.10 and 6.11 it can be concluded that the stage-discharge curve changed considerably between 1995 and 1997. However, the main changes were caused by considerable accretion in the Fulchari channel (especially at the entrance). As a consequence, the wet cross-section decreased, by which the discharges reduced without appreciable changes in the flow velocities.

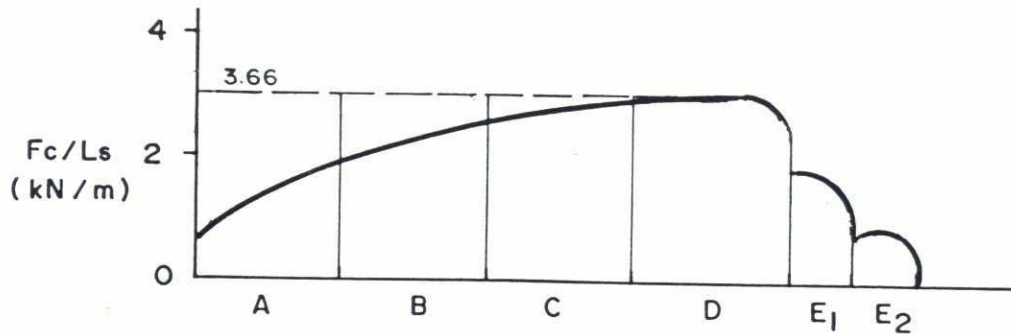
Fig. 6.12: Horizontal distribution of flow induced load

The distribution indicates in Fig. 6.12 that as soon as a more detailed flow pattern is available, load reduction can be applied. Because of the flexibility of the structure the extra 50% load due to dynamic effects can be reduced till say 20%.

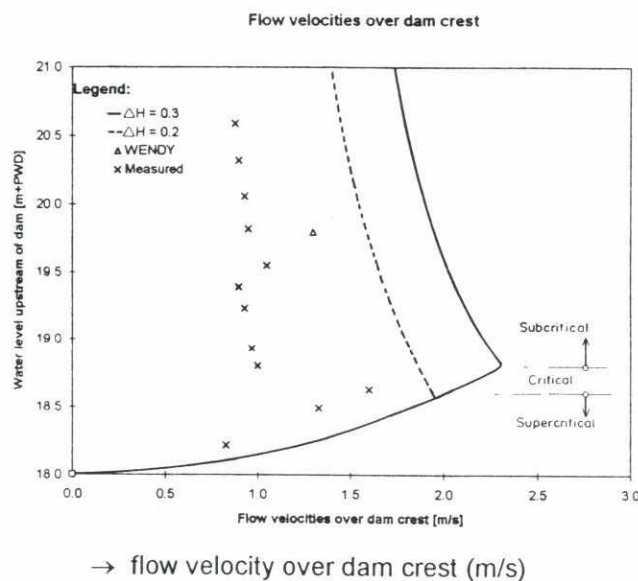
Fig. 6.19: Flow velocities over dam crest

The figure shows that the velocities were increasing when water levels were rising from 18.0 m+PWD (being the dam crest level) till 18.8 m+PWD. At that moment the head over the dam (ΔH_1) was maximum (about 90% of the total head ΔH), while the velocities and consequently the head losses (ΔH_2) in the channel were still small (about 10% of the total head). With increasing water levels the discharge increased and therefore the velocities and head losses in the Katlamari channel increased. This implies that from the total head (ΔH) less was available for the dam and the crest velocities were decreasing.
