**BANK PROTECTION AND
RIVER TRAINING (AFPM)
PILOT PROJECT
FAP 21/22**

**TEST
AND
IMPLEMENTATION
PHASE
FAP 21**

**REPORT ON
MONITORING AND ADAPTATION
AT
BAHADURABAD TEST SITE**

MONSOON 1997

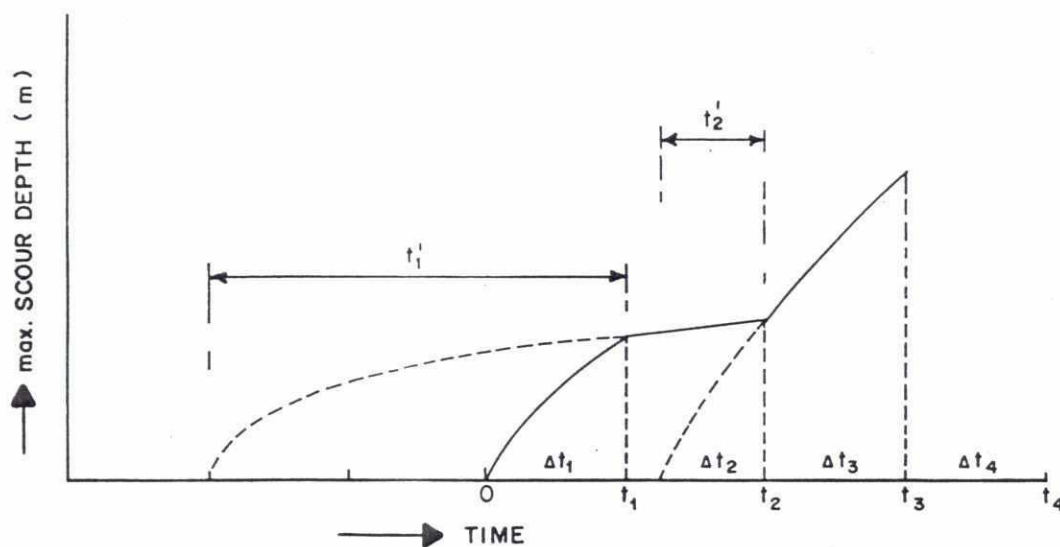
Sketch: Principle of the calculation time dependent development of the maximum scour depth

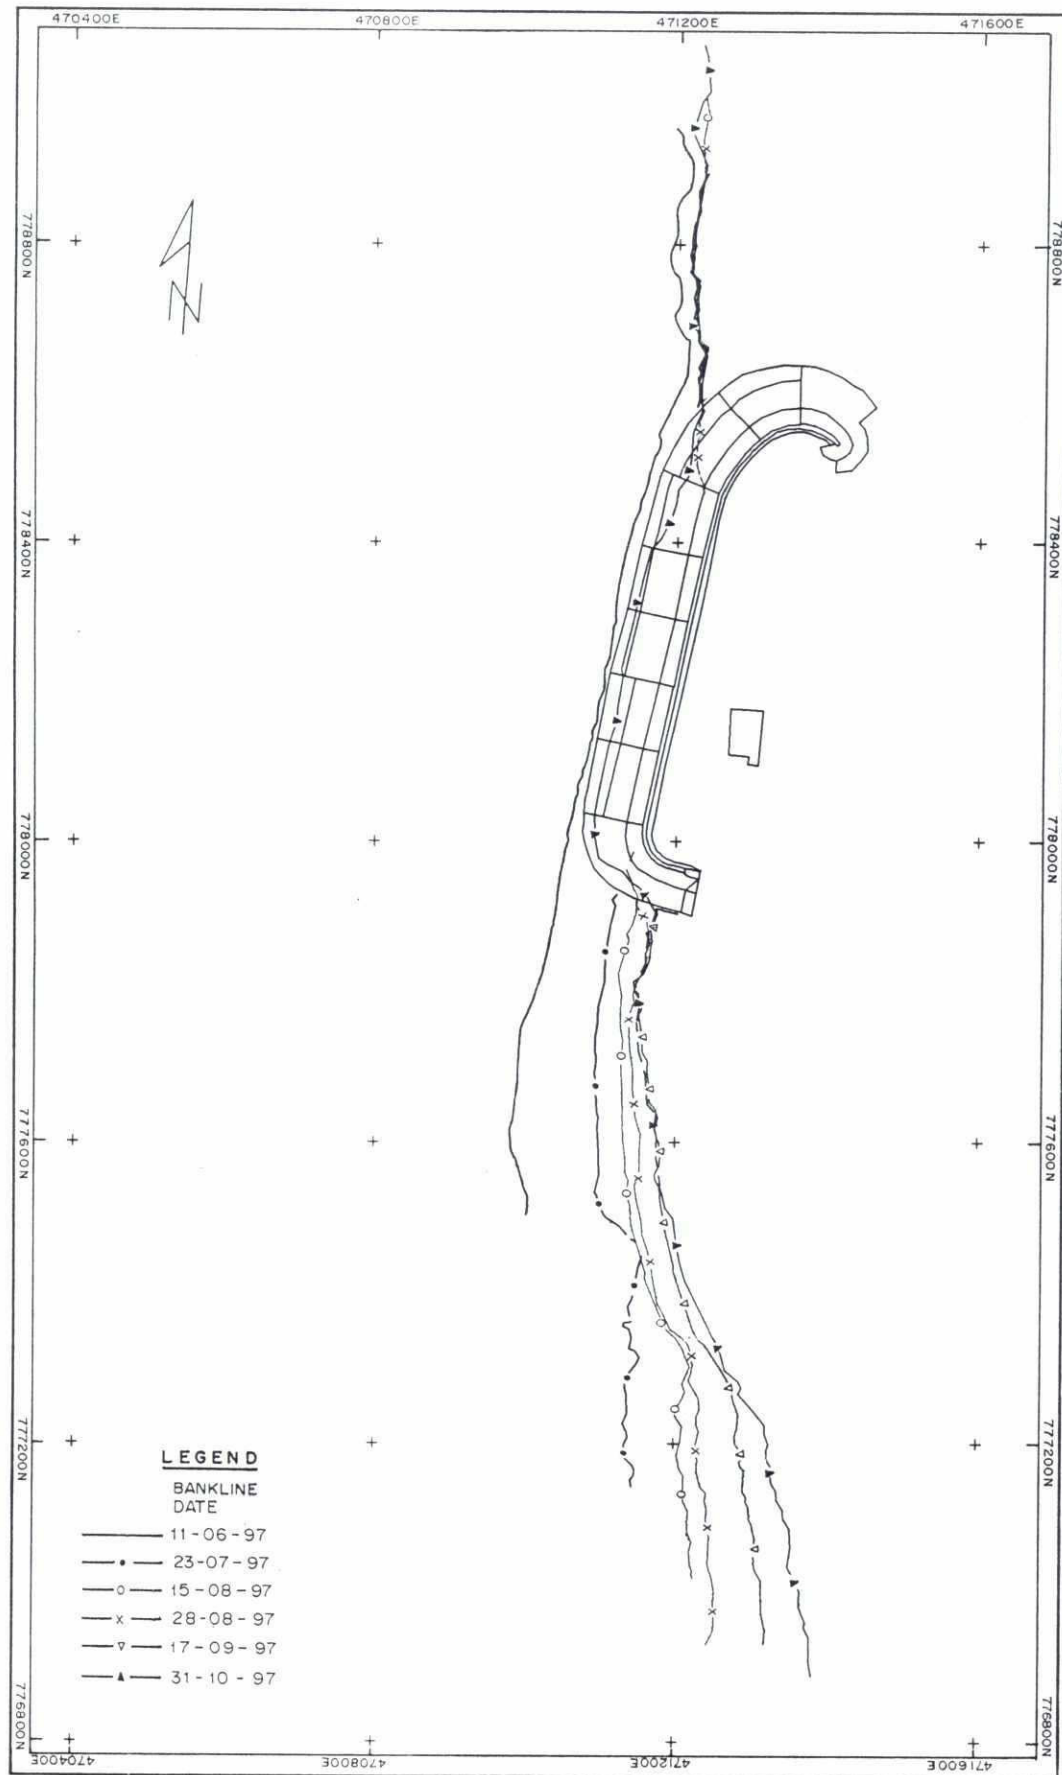
FIG. 4.1

The bank line started to erode in spring 1997 when the water level started to rise. On June 11 the cofferdam protecting the revetment structure still functioned, but after its breach on June 20 the test structure came under flow attack. During the first half of July strong bank erosion had been observed downstream from Section H. This erosion stopped on July 18 after the second flood peak. Between June 11 and July 23 the bank had been eroded over a distance of about 100 m at an average rate of about 2 m per day. Later it continued at a lower rate of 1 to 1.5 m/day up to September 17, then it stopped. The bank erosion shifted about one kilometre in downstream direction during September (see Fig. 4.1). Downstream from Section H an embayment developed during this monsoon more or less as assumed in the design of the test structure.

Bank erosion during monsoon 1997

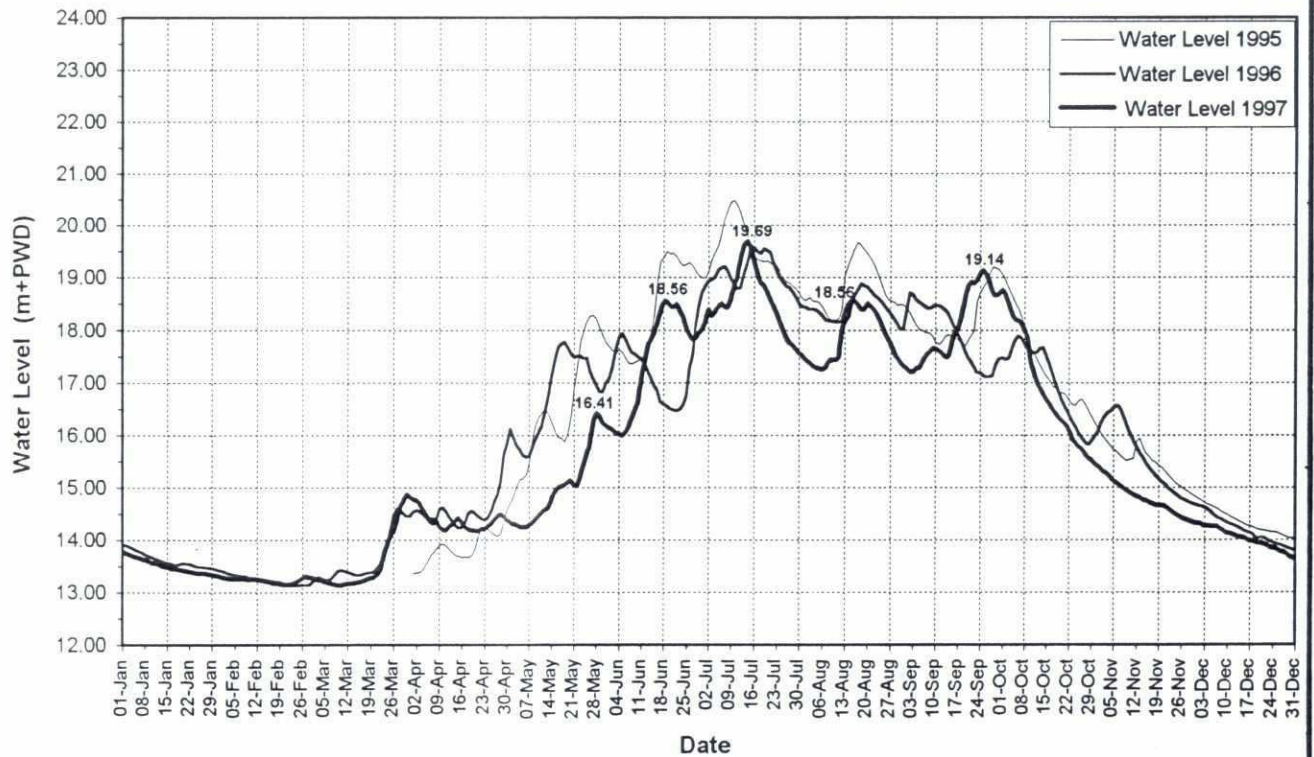
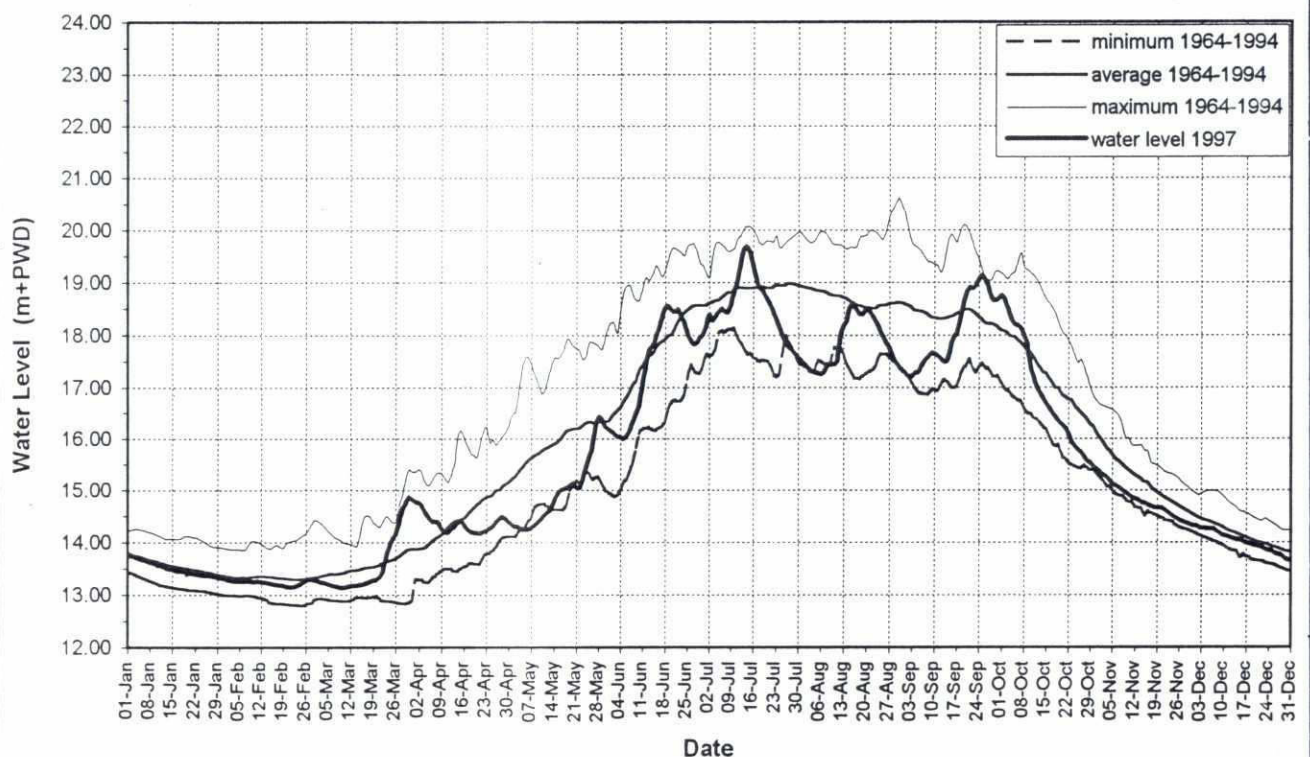
FIG. 4.2

level at the staff gauges is scheduled normally at 8.00, 13.00 and 17.00 hours daily. In general, the readings from 8.00 hours were used as a daily averaged value presented in hydrographs (see Fig. 4.2). The accuracy of the reading is estimated at ± 0.01 m.

Hydrograph in 1995, 1996 and 1997

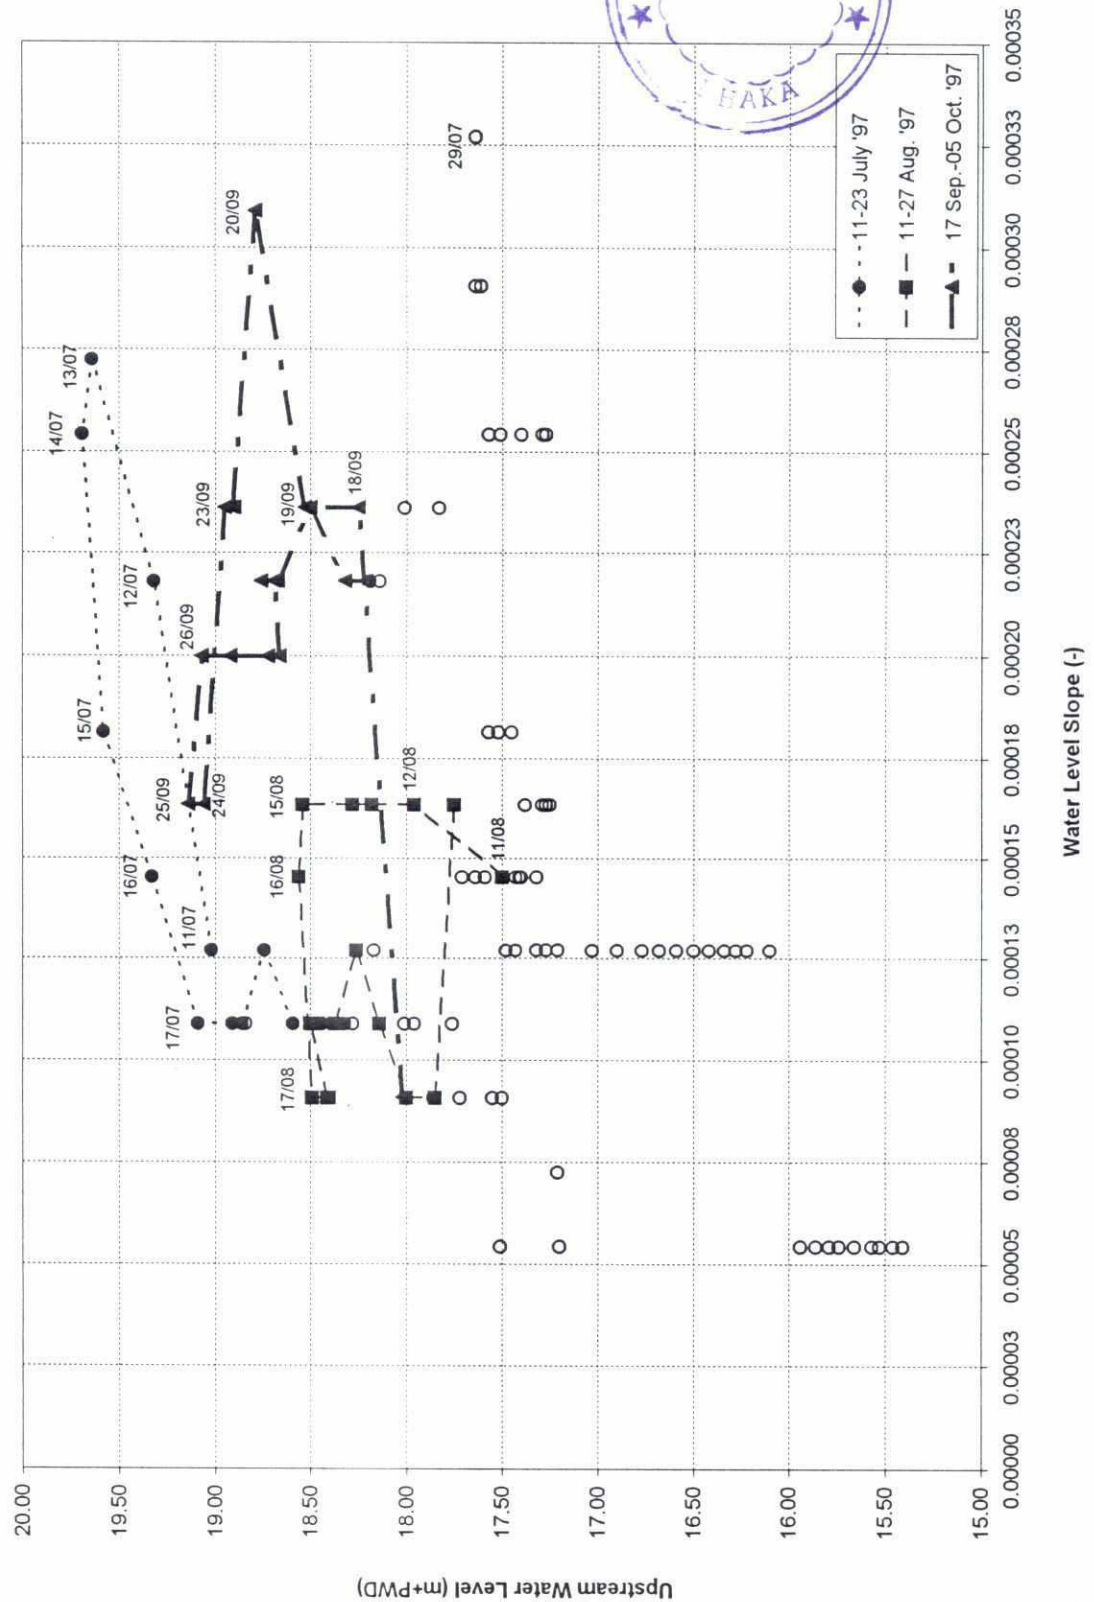
FIG. 4.4

The water level gradient is the difference in the upstream and the downstream water level divided by the distance between the staff gauges along a flow line which is about 550 m. The water level gradients during the monsoon have been presented as function of the water level in Fig. 4.4. This graph shows that the water level gradient was higher before the peak on July 14 than after this peak for the same water level. This tendency is clearly shown because that peak flow had a single peak. However, it is less clear for other peakflows because these flows had multiple peaks. The flood wave had a steep front followed by the recession limb with lower gradients.

The flow velocity U has been estimated from float trackings and from a relationship with the local slope. It has been observed various times that after a flood peak the flow velocities reduce considerably. Then also the water level slope reduces. The relationship is shown in Fig. 4.4.

BAHADURABAD TEST SITE
Water level slope as function of the
water level in 1997

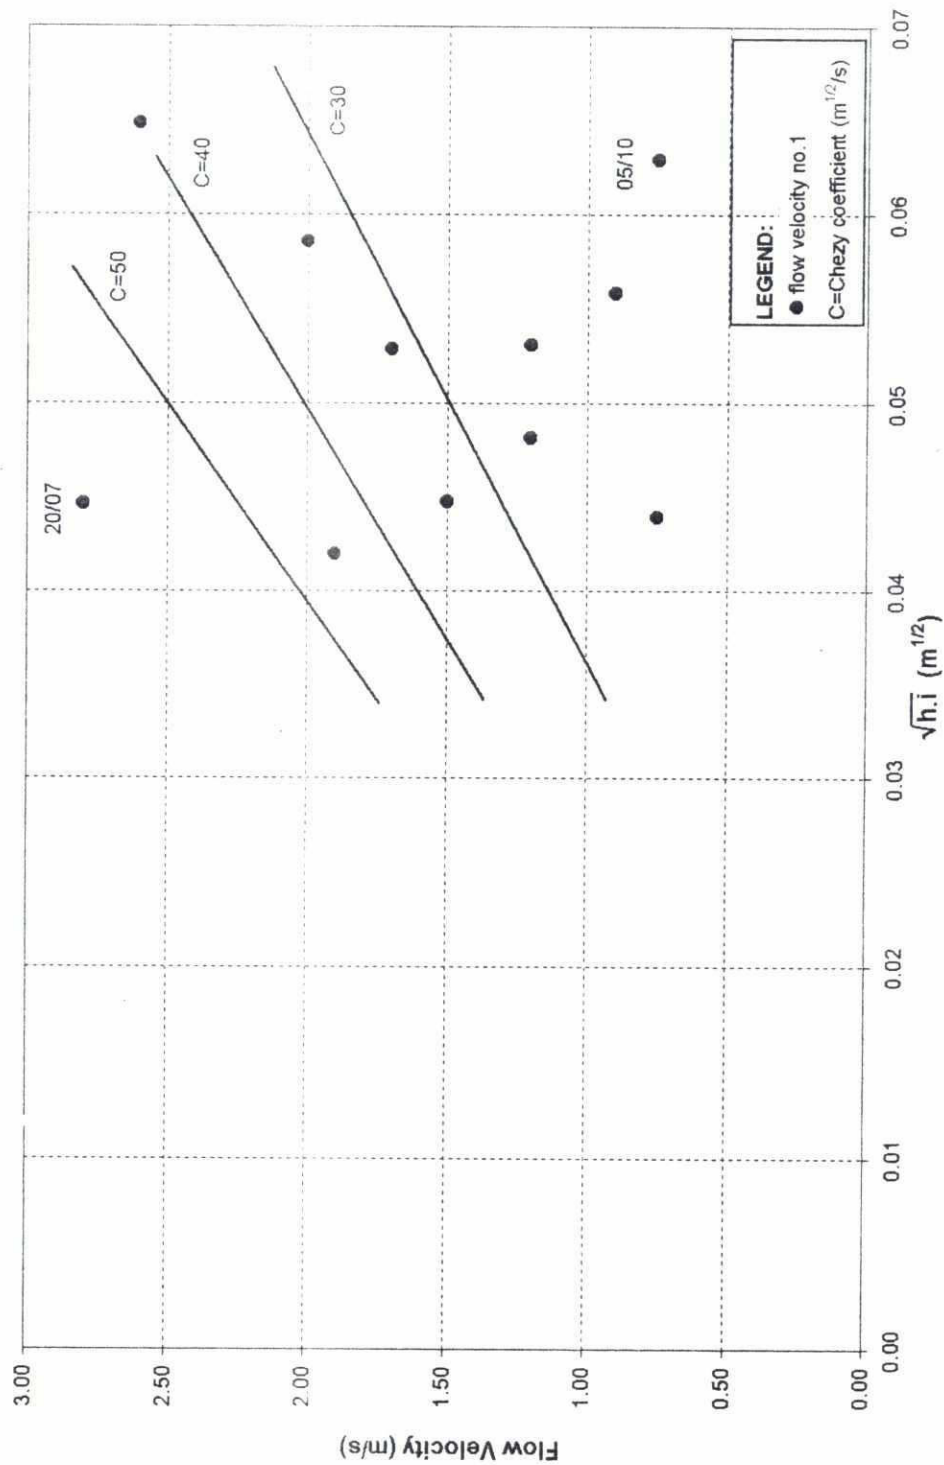
FIG. 4.5

In the graph of Fig. 4.5 the flow velocity has not been measured at the same time as the water level readings along the flow line between the staff gauges, therefore the relationship is not accurate and the values of the Chezy coefficients are probably too low. However, this graph explains that the high flow velocities occurred before the flood peak and as soon as the water level recedes the flow velocities reduce strongly. This has been observed several times by the monitoring team.

Application of the Chezy formula

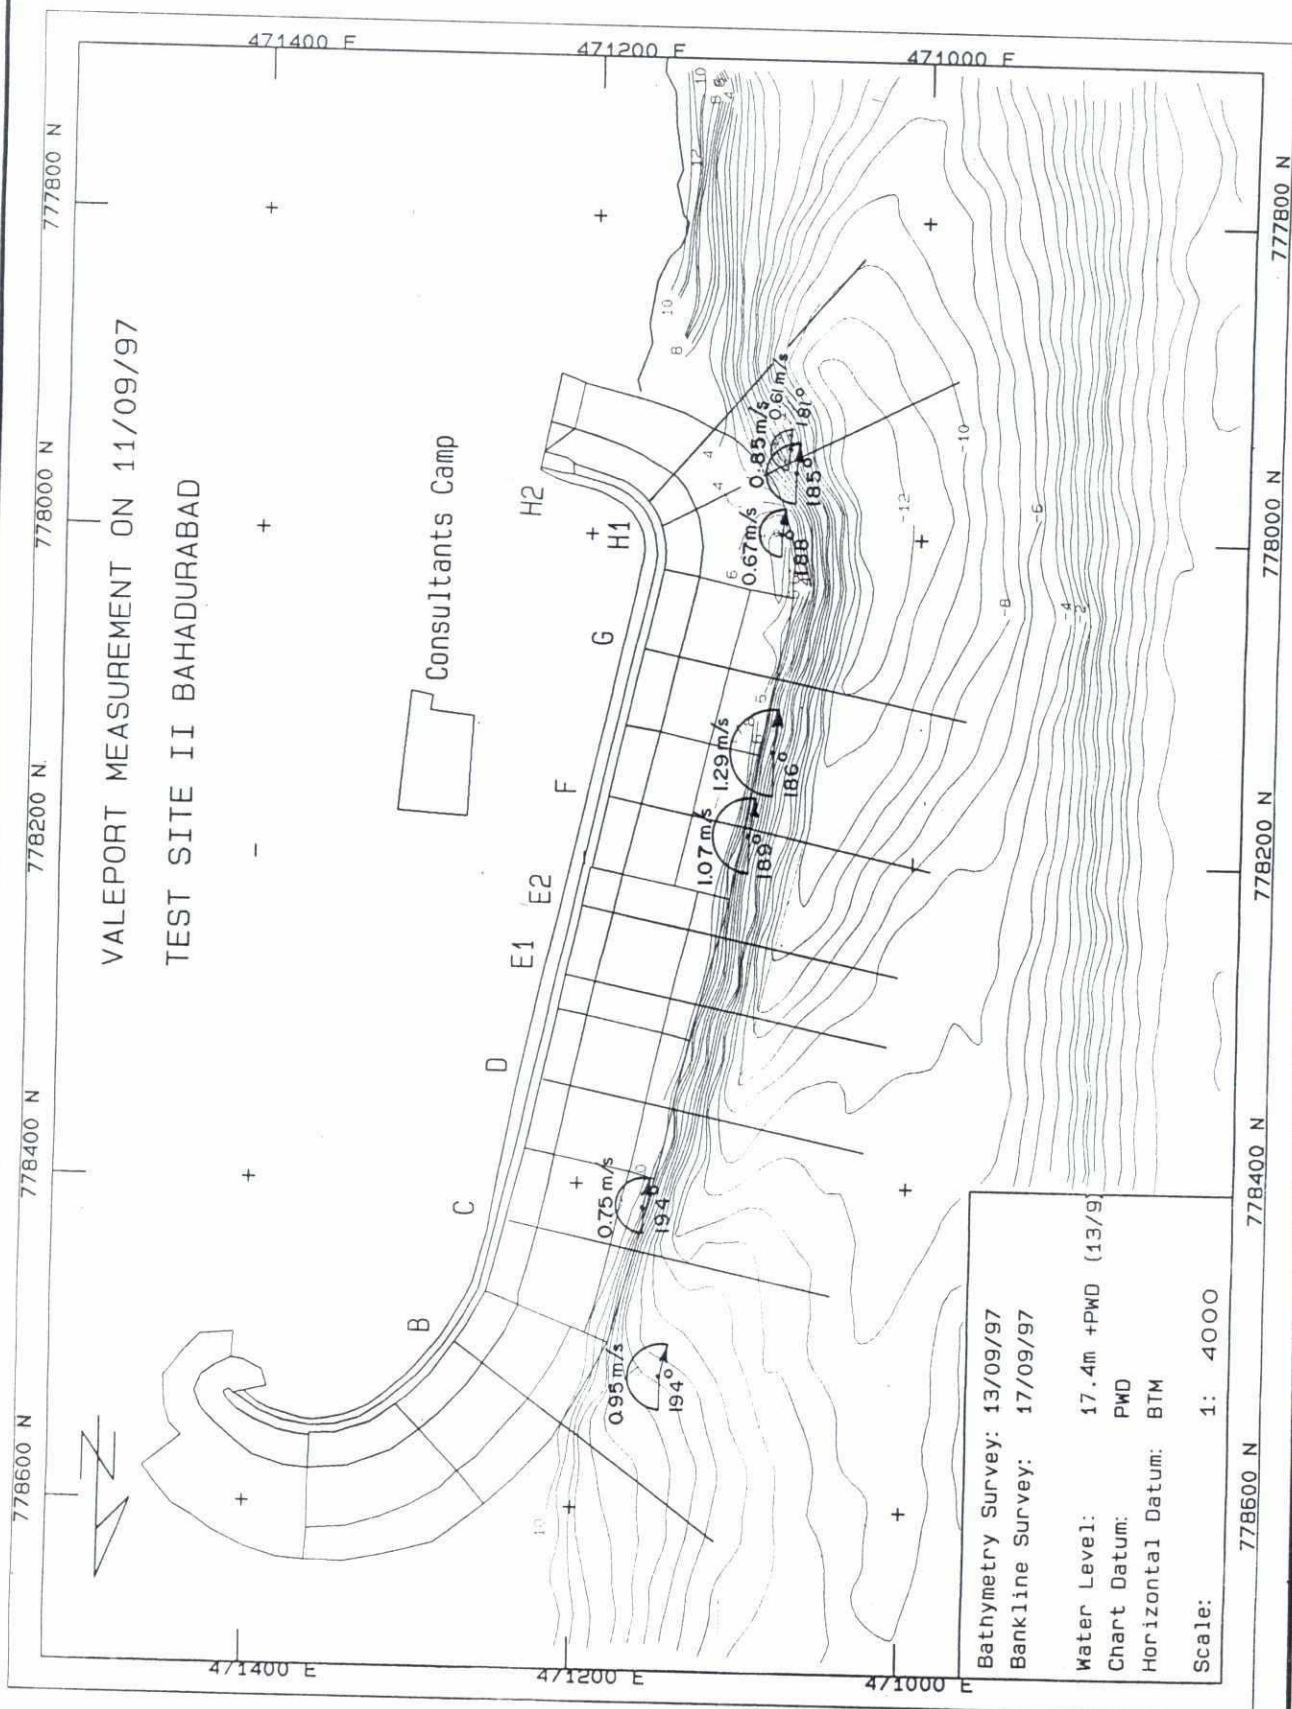
FIG. 4.6

Flow velocities have been measured by Valeport velocity meter in the vicinity of the test structure only on September 11. They were rather low that day, see the depth averaged flow velocity in Fig. 4.6. The standard deviation of the slowly accelerating flow along the edge of the falling apron varied from 0.06 to 0.09 \bar{u} in Sections B to G and 0.2 to 0.3 \bar{u} at the downstream termination in Section H, where flow separation occurs (\bar{u} = the local depth averaged flow velocity).

BAHADURABAD TEST SITE
Depth averaged flow velocities on
September 11, 1997

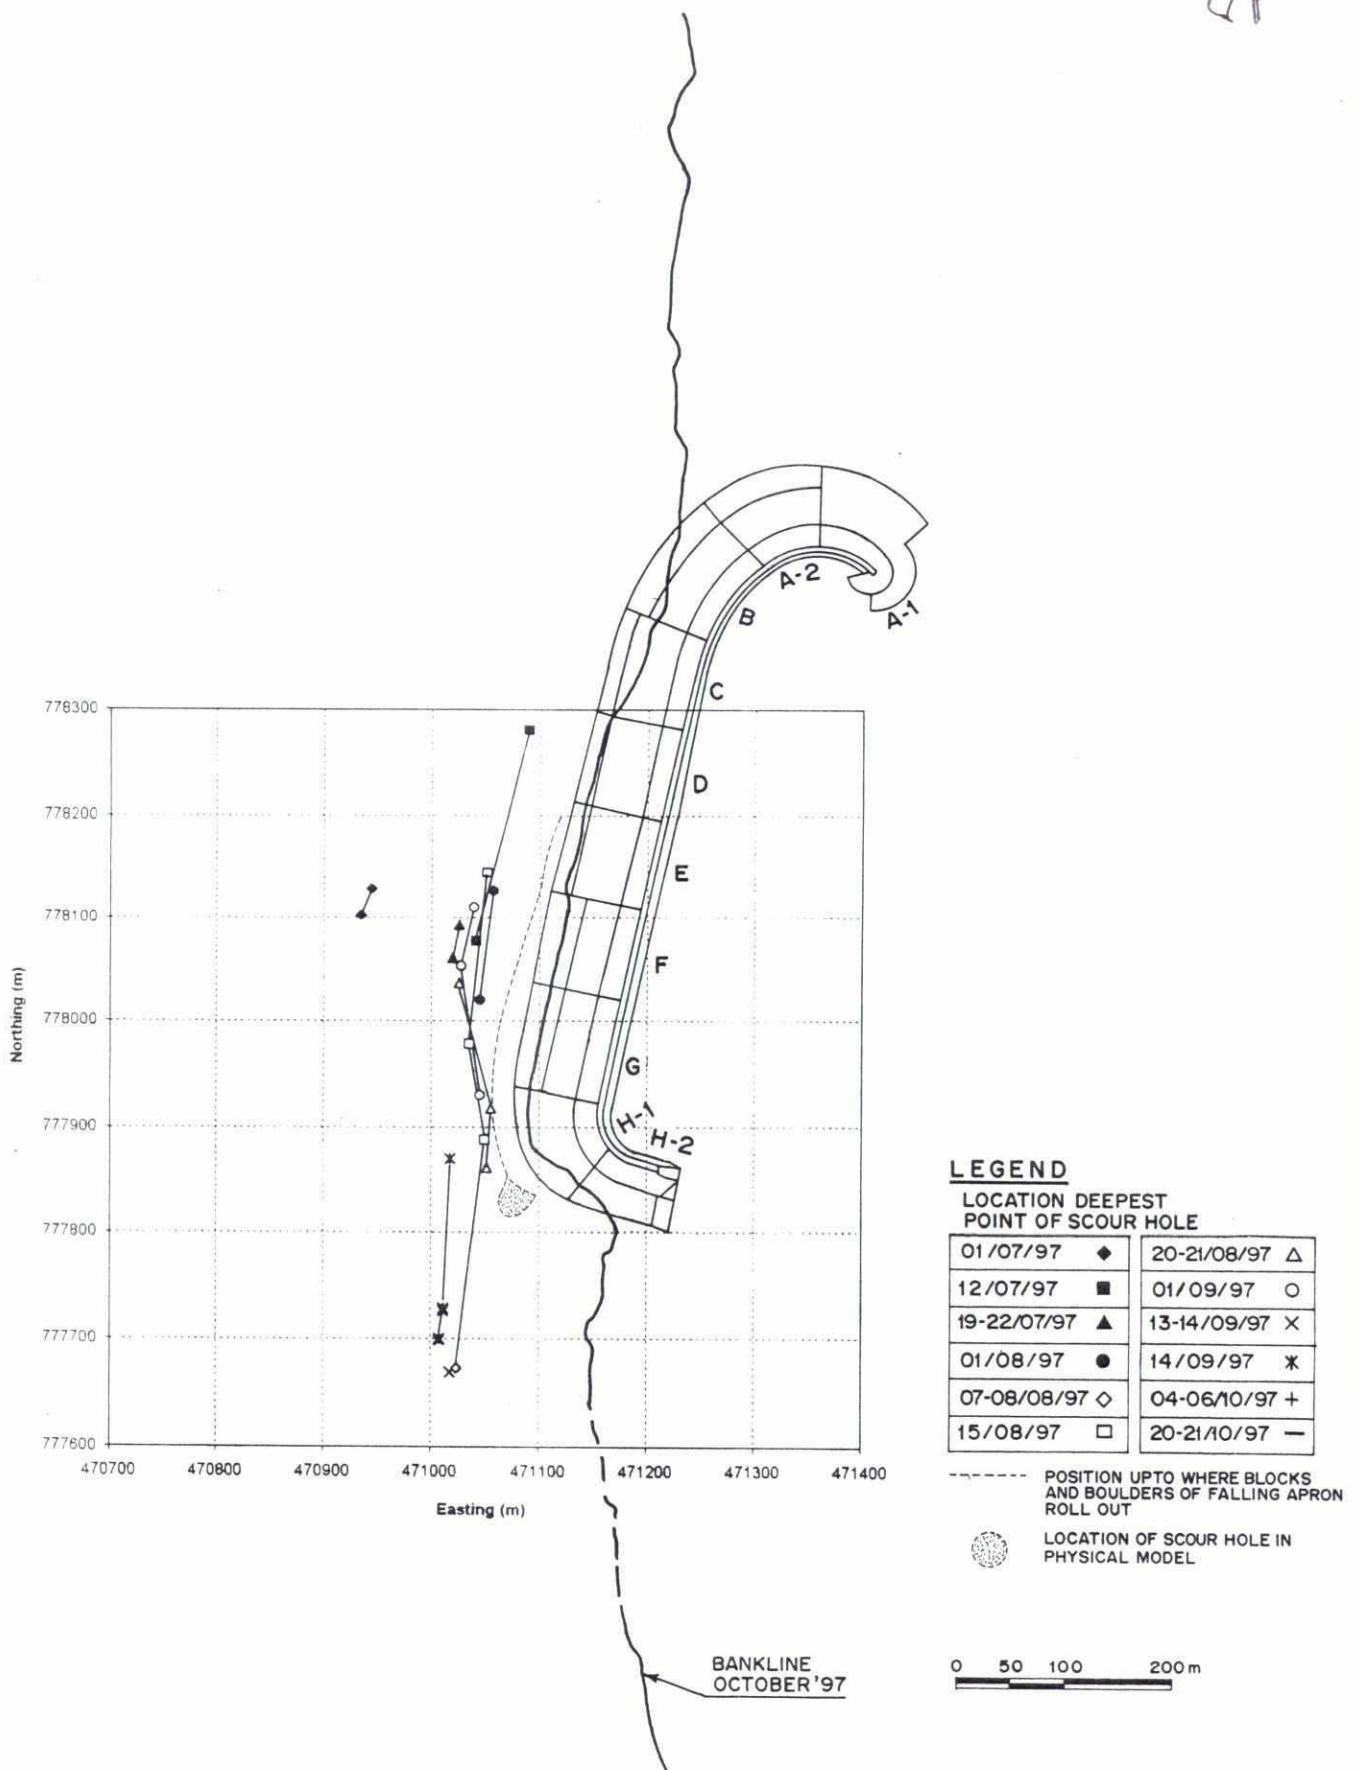
FIG. 4.22

The location of the deepest point of the scour hole has been determined from bathymetric maps. In some surveys the scour hole has an elongated flat bottom, which is indicated by two or more points connected by a line in Fig. 4.22. In general this deepest point shifted in downstream direction during the monsoon.

BAHADURABAD TEST SITE
 Location deepest point in scour hole at
 Bahadurabad

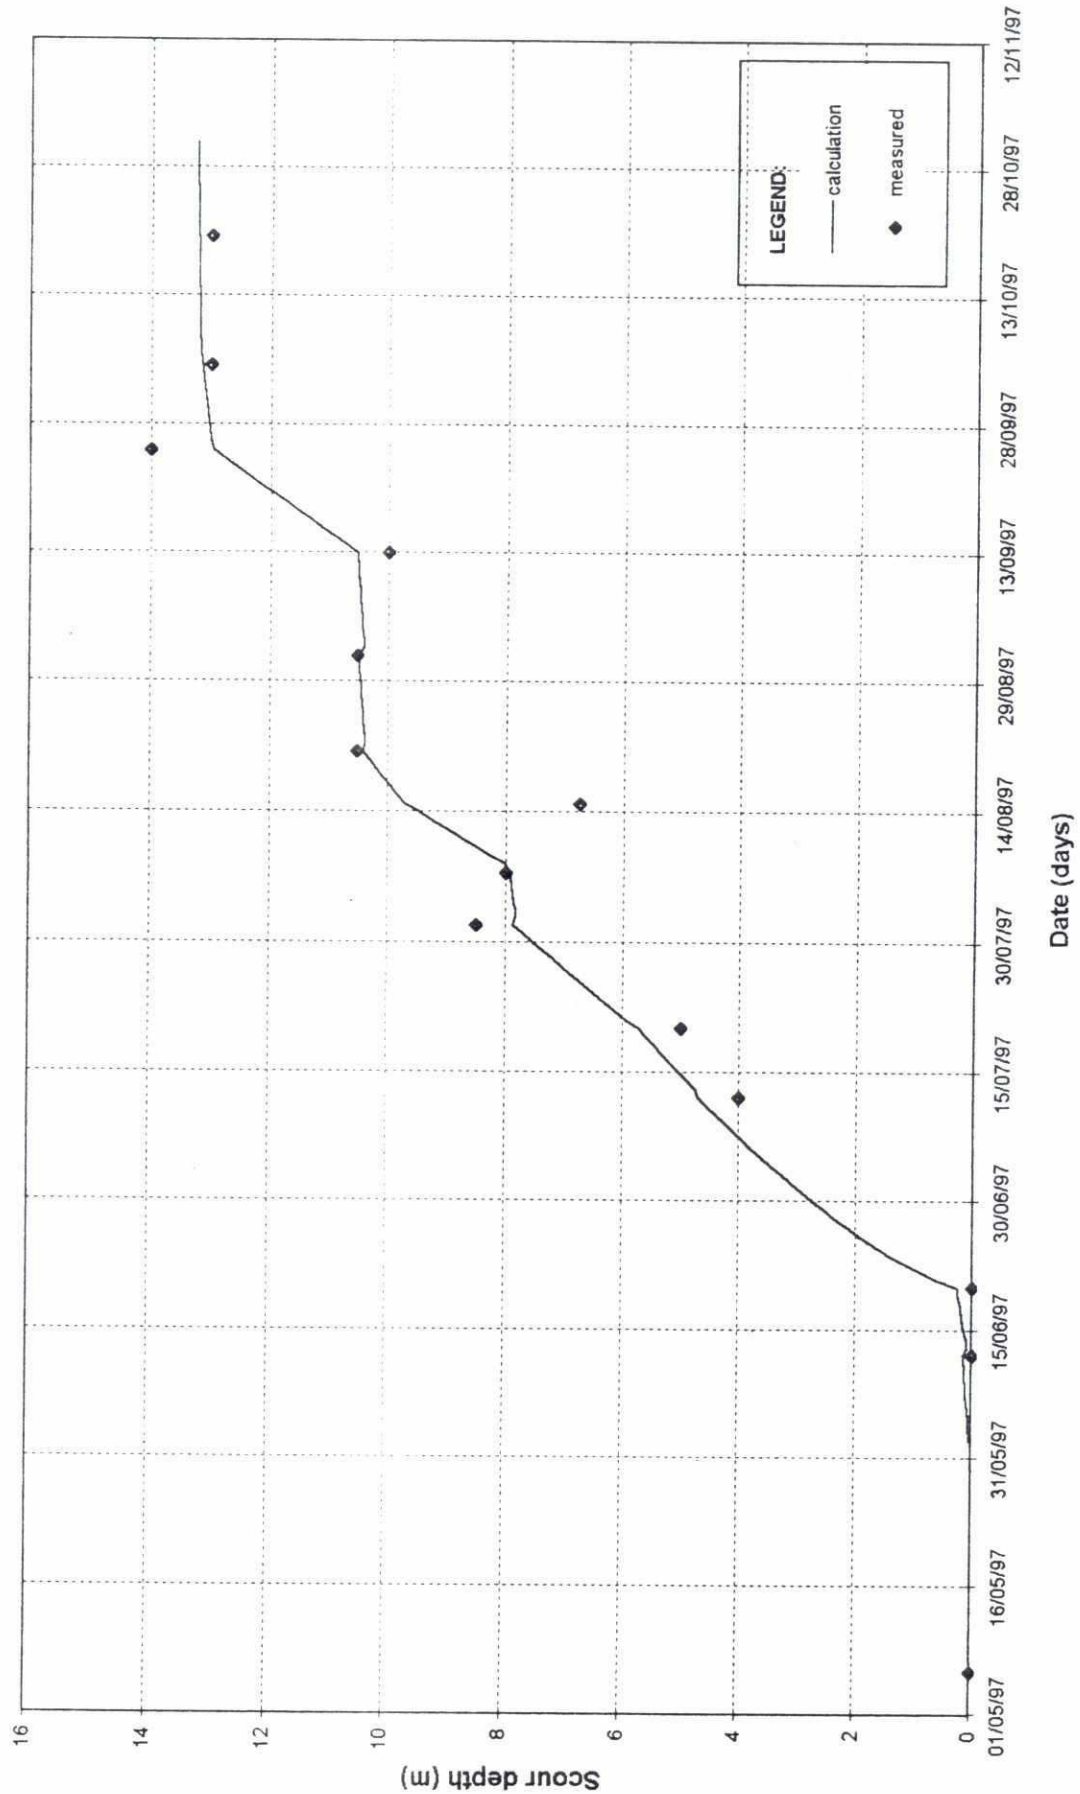
FIG. 4.24

The results of the calibration of this calculation method on the maximum scour depth near the downstream termination are shown in Fig. 4.24, using the calculation method as indicated in the following sketch. The value of the parameter $\alpha \cdot u$ is one of the most important parameters for the calibration. The parameter α increased from 1.2 in June to 2 in August and September. It is recommended to develop this method further with other calibrations. This will present a better knowledge of the values of these coefficients and their physical meaning.

In the Jamuna river $\frac{B}{B-b} u$ is considered as the increased flow velocity near the structure. At the time the maximum scour depth had been reached end of August and September 1997 the coefficient was $K = 2.5$ to 3.5 . The upper value is a safe first estimate for the design of this type of structures. In the initial stage in June and July the scour hole developed slowly and the observed scour depth was not the equilibrium depth. The value of coefficient K was low, between 1 and 2. In the final stage end of September and October the scour hole was too large for the actual flow conditions and started to sediment. In that stage large values of $K = 4$ to 5 have been calculated from the measurements.

BAHADURABAD TEST SITE
 Calculation maximum scour depth
