BANK PROTECTION AND  
RIVER TRAINING (AFPM)  
PILOT PROJECT  
FAP 21/22

CURRENT MEASUREMENTS  
AT KAMARJANI AND BAHADURABAD  
JULY AND AUGUST 1996

DECEMBER 1996

JAMUNA TEST WORKS CONSULTANTS, JOINT VENTURE  
CONSULTING CONSORTIUM FAP 21/22

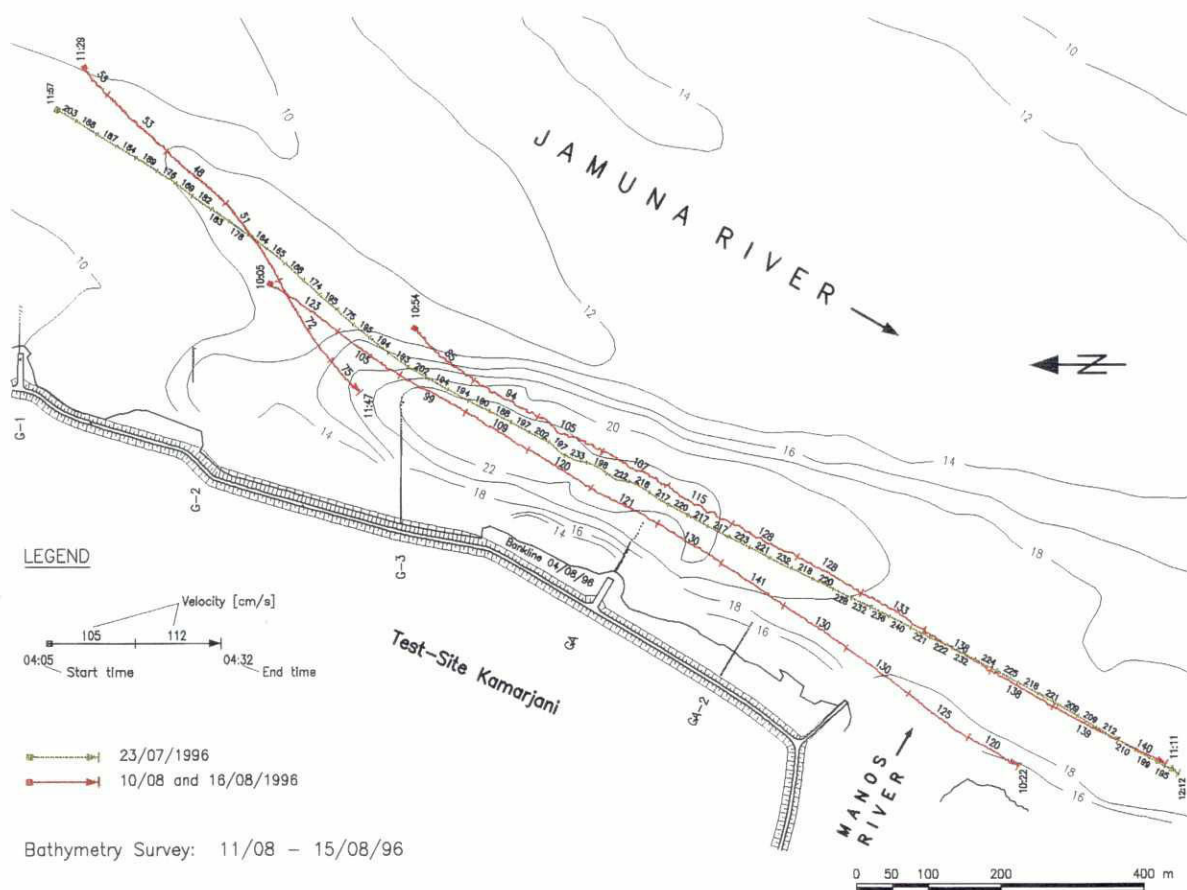
The current conditions recorded on the 23/07, 27/07 and 30/07 in 1.5 m depth are shown in annex 7. Outside the groyne fields the current velocities shortly after the high water passed on the 23/07/96, were significantly higher than those recorded in August. To demonstrate this, selected drifter tracks from annexes 3 and 7 were compiled in figure 17. The main flow attack was on G-3 and downstream, where the highest current velocities were recorded.

Fig. 17: Drifter Tracks measured in 1.5 m Depth in July and August 1996 at Kamarjani Test Site.

The current velocities were, despite of strong variations within single flow tracks, almost twice as high in July than in August. This causes multiple sediment transport which is according to hydrodynamic and physical laws stating a potential function between current velocity and drag force.

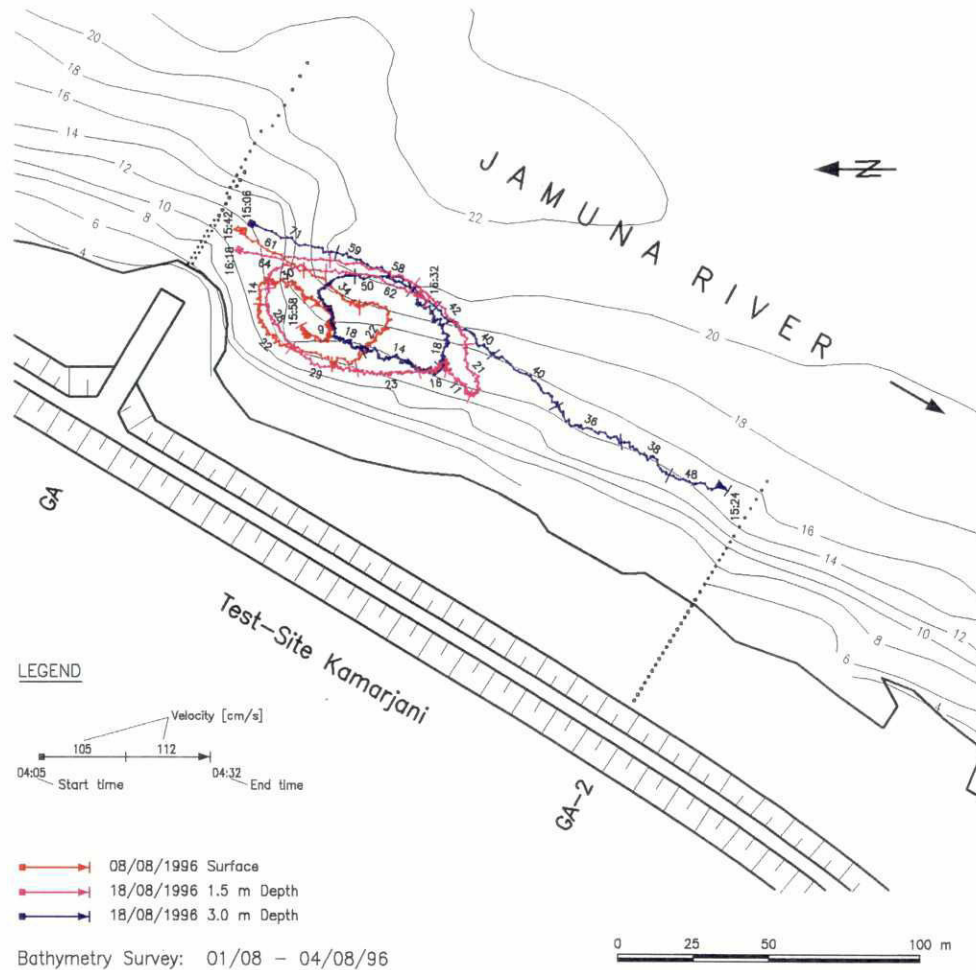
Fig. 18: Drifter Tracks recorded on the Surface (08/08/96), in 1.5 m and 3 m Depth (18/08/96).

The eddy current on the 08/08/96 was of lesser intensity and centred closer to GA than those recorded on the 18/08/96 at a 80 cm lower water level. This means that the return currents are intensified at higher water levels and exceed the critical velocity. This leads to leeward erosions threatening the structure's stability.

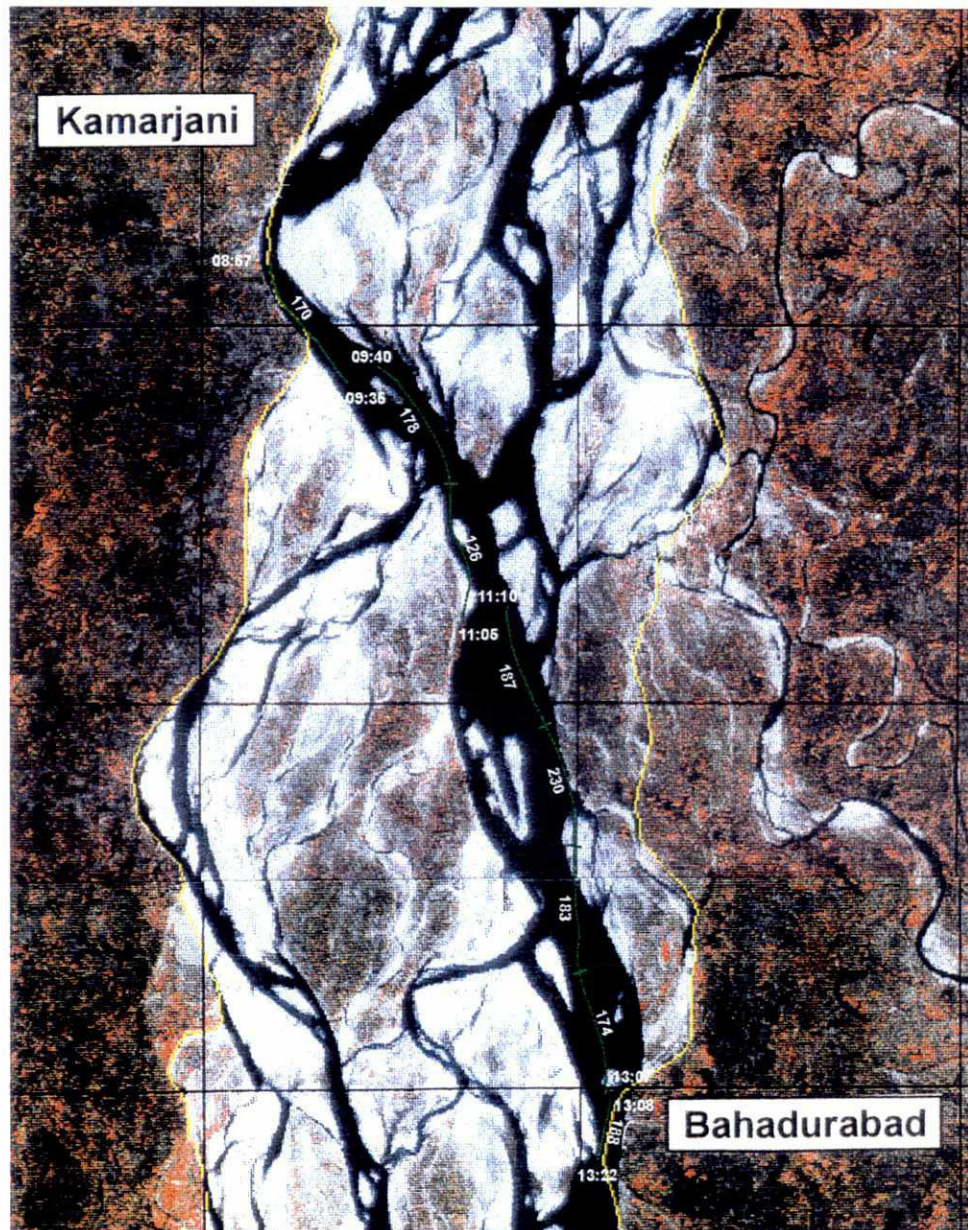
The complexity of the highly braided river system is documented by the satellite picture from January 1996 (fig. 22). On the 19/08/96 a DGPS drifter buoy following the talweg in 3 metres depth was tracked from Kamarjani to Bahadurabad. The flow track is shown in figure 22. The high velocities (in cm/s) indicate the vigorous morphologic activity of the Jamuna River during the monsoon season.

Fig. 22: Drifter Track from Kamarjani to Bahadurabad in 3 m Depth on the 19<sup>th</sup> August 1996;  
Satellite Picture from January 1996

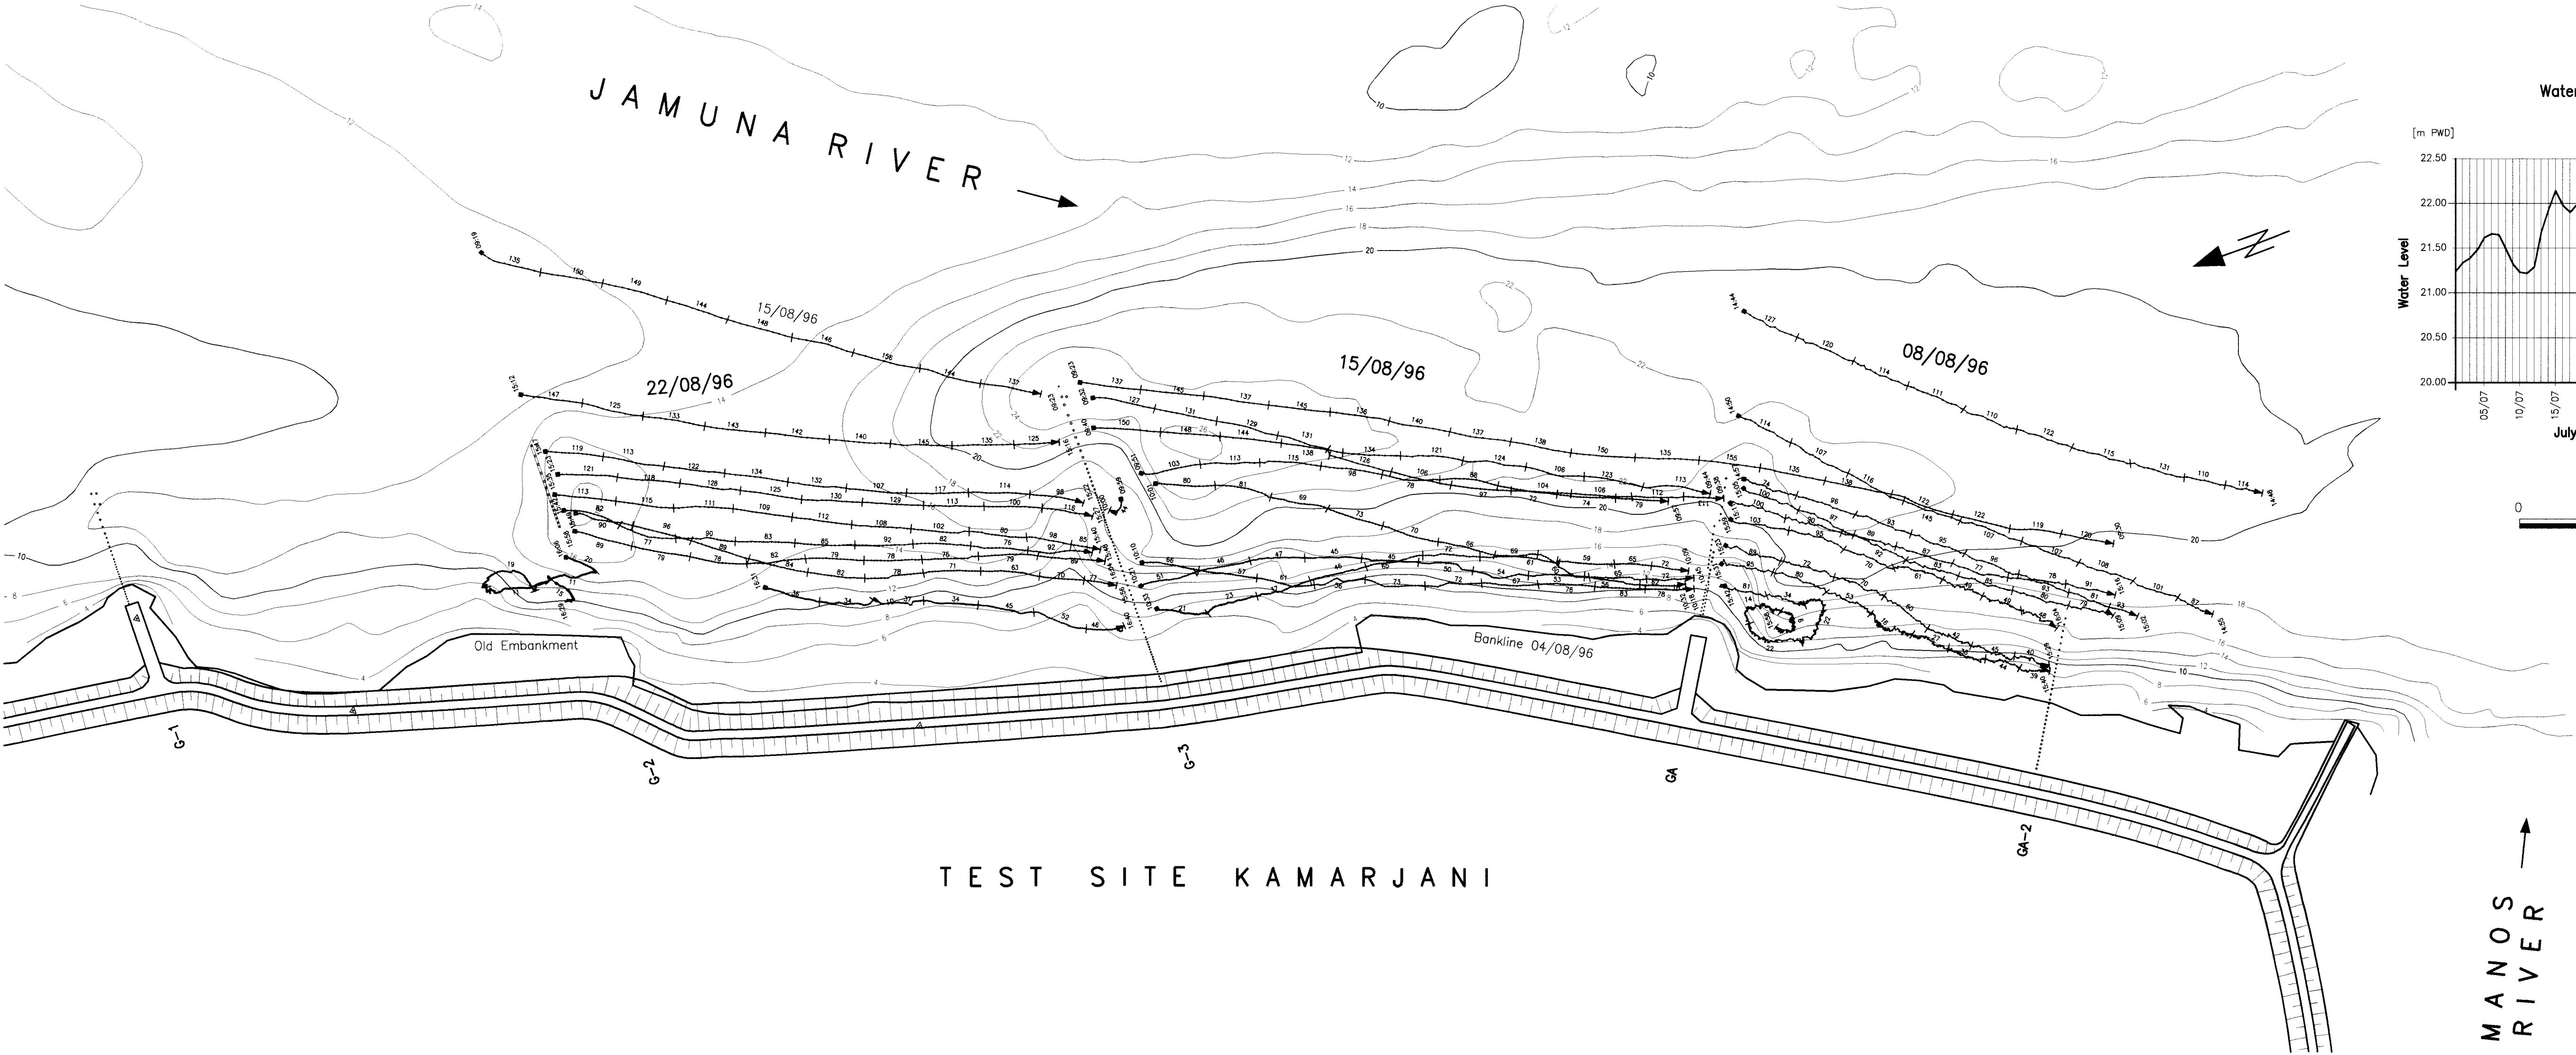
Even after the passage of the high water in mid July relatively high current velocities were recorded between the 24/07 and 27/07/96 (annex 5). The water levels were +21.65 m PWD and +21.25 m PWD with a falling trend. The main flow attack was at the head of groyne G-3. Further upstream the velocities were generally about  $v = 2$  m/s, depending on the varying turbulent velocities. This is the cause for the deep scour of 23 m depth (26 metres below CD; CD = 24 metres below PWD), located downstream of G-3. The continuously intensive flow attack holds the danger of receding scour action against the groyne head and threatening the stability of the structure. An evidence of this is the close succession of the depth contours downstream and parallel to G-3 (annex 5). In the upper region of the groyne field G-3/GA the current conditions are characterized by high turbulences which are indicated

by the intersecting flow tracks and by the varying velocities in each track. These distinctive intersecting vortex trails leading away from the head of G-3 can be observed on location.

The grade of deceleration caused by groyne G-3 on the current velocities evidently depends on the grade of permeability (annex 5). It is important to note that no return currents occur downstream of the foot of G-3, owing to groyne G-3 being fully permeable. Return currents, however, can be observed downstream of the cofferdam at G-1 and downstream of the remains of the old embankment at G-2. These return currents are stable eddies of velocities up to  $v = 30$  cm/s, which is enough to transport the fine non-cohesive bed material. Investigations by HJULSTRÖM (1935)<sup>1</sup> have shown that a current velocity of about  $v = 20$  cm/s is sufficient to erode loose, fine sand with a grain size up to  $d = 0.2$  mm (fig. 14).

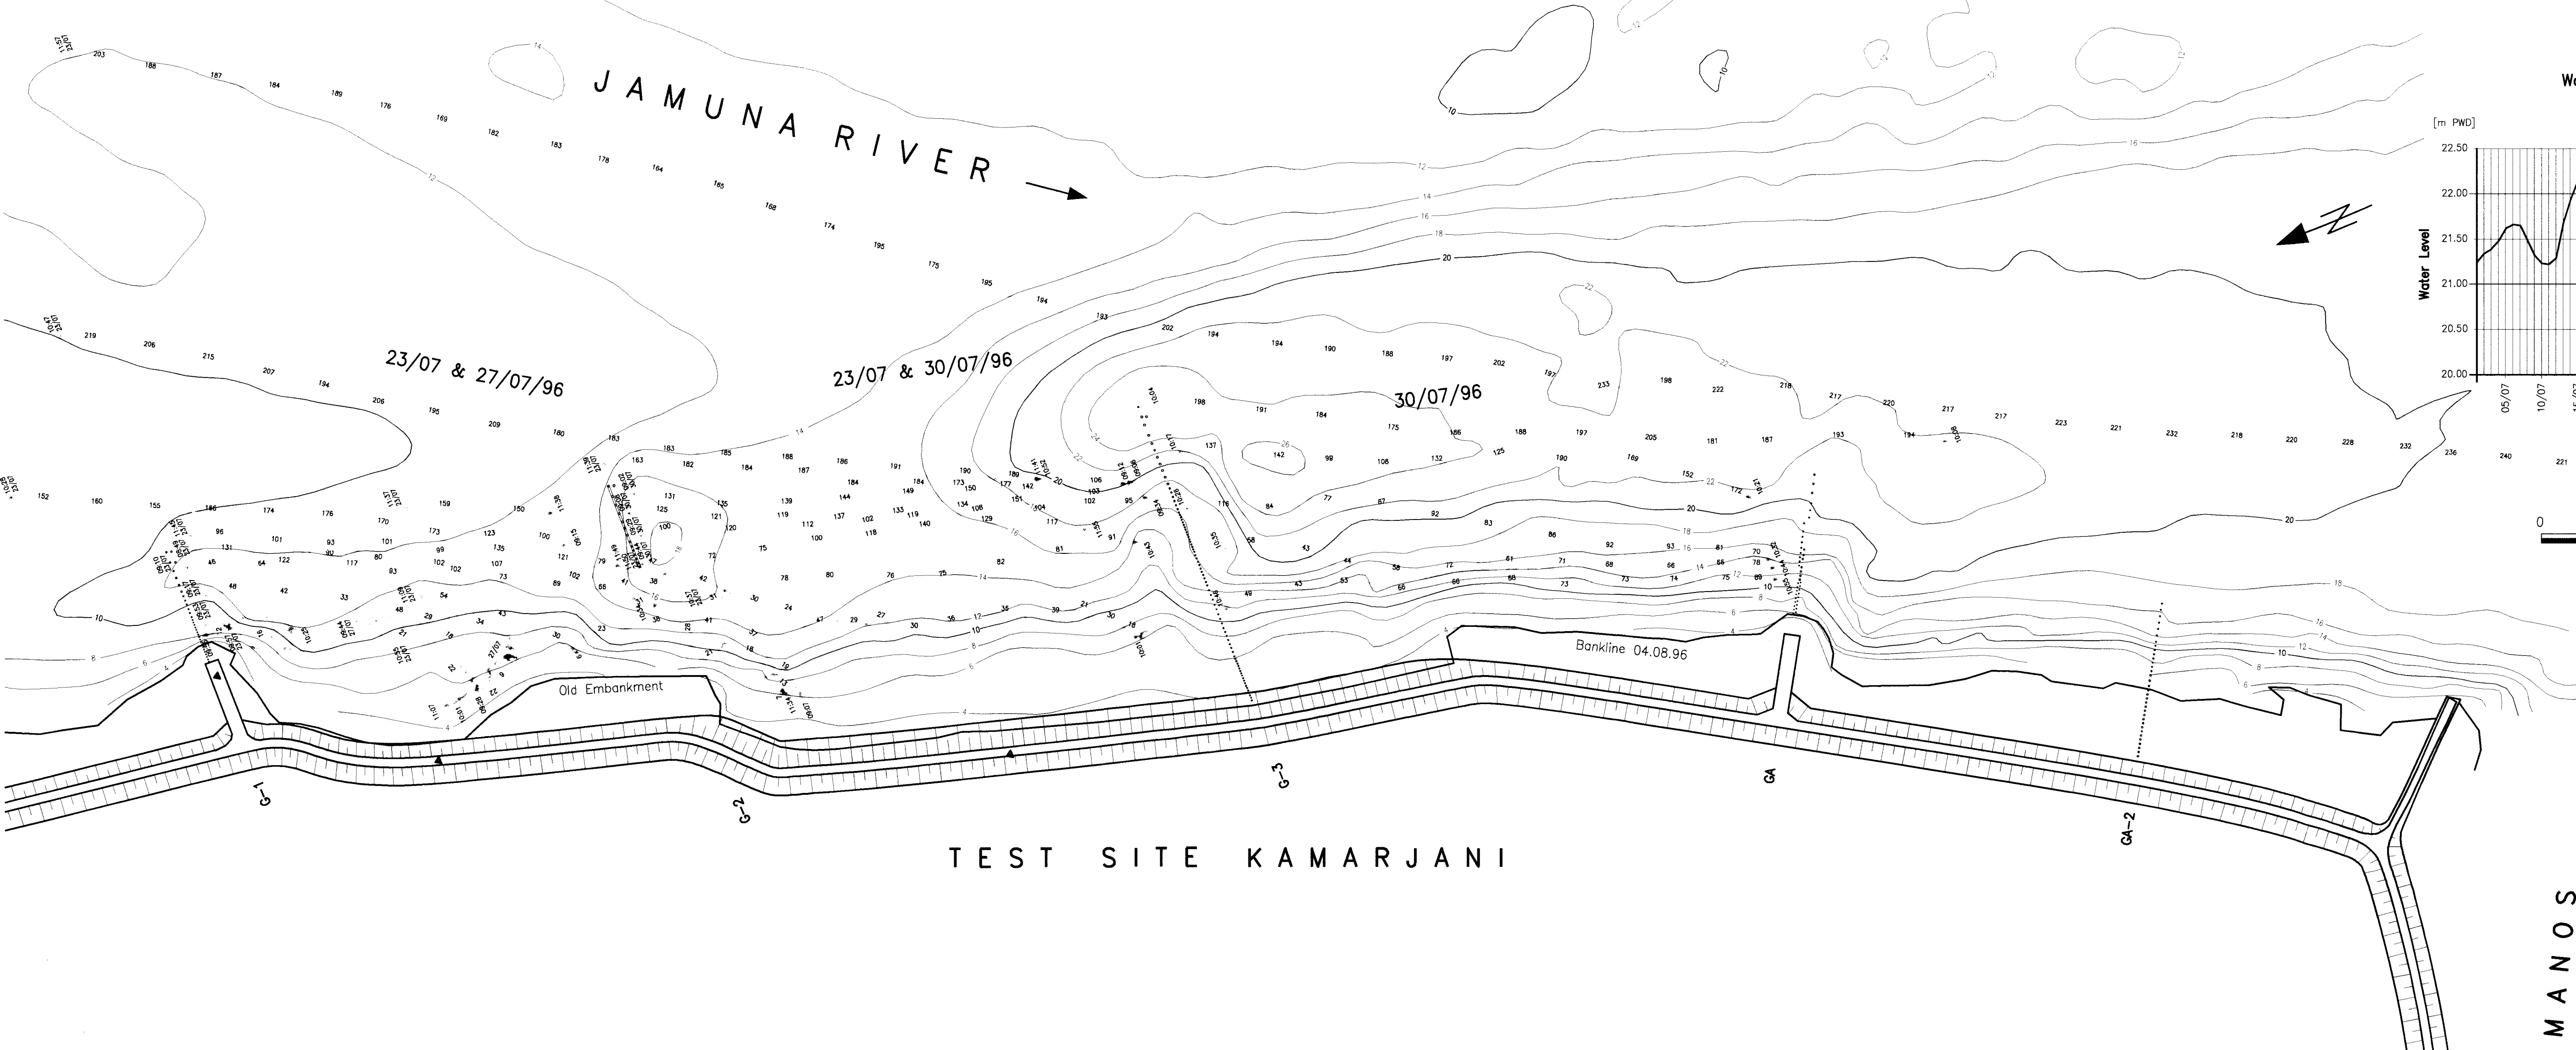
**ANNEX 6**

The surface current patterns described above and in annex 5 are generally verified in annex 6 in a reduced manner. The velocities decrease notably the further the tracks are inside the groyne field. The most turbulent currents are found in the groyne field G-3/GA. The rapid changes of direction and velocity are demonstrated by the measurements carried out on the 15/08/96 (middle groyne field in annex 6). The four drifter tracks were recorded within half an hour, yet the successive velocities differ up to several decimetres. Of interest are also the return currents immediately downstream of the lesser permeable part of G-3.

Significantly calmer conditions can be found in the groyne field G-2/G-3. The stream lines are roughly parallel and hardly intersect. The stem of flow caused by G-3 can be seen by comparing the

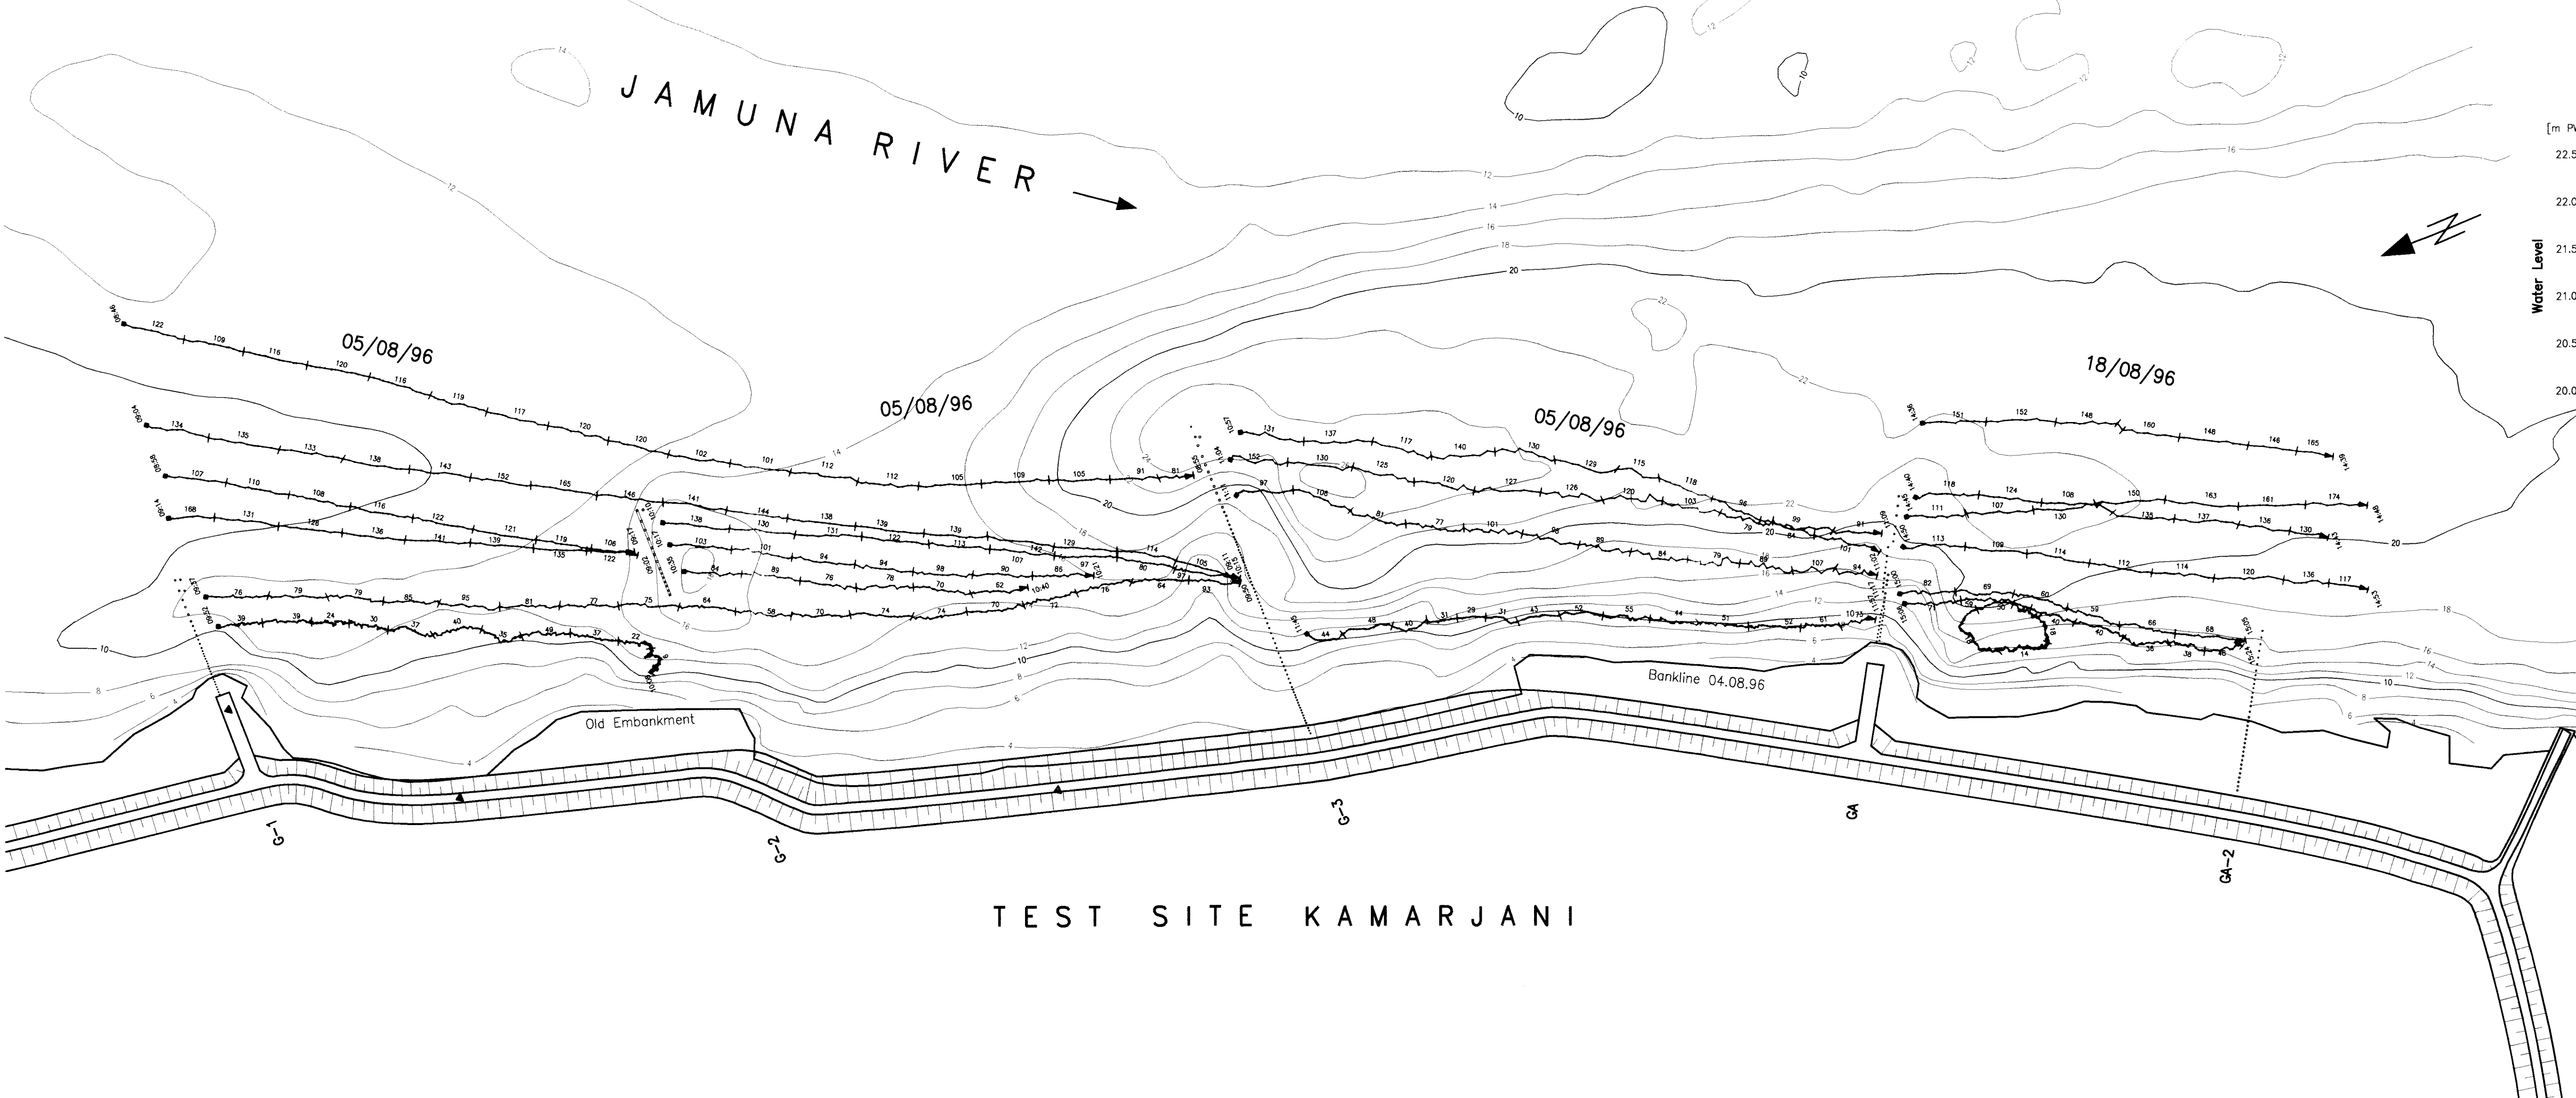
On the 31/07/96 the highest and most turbulent currents were again measured in the lower part of the groyne field G-3/GA, as shown by the clear differences of velocity and direction of the flow tracks (annex 9). The highest velocities were recorded in the area of the head scour downstream of G-3. The part of G-3 with the closer pile distances stems the flow velocities upstream of G-3 and causes a calm zone leeward in which return currents can be observed.

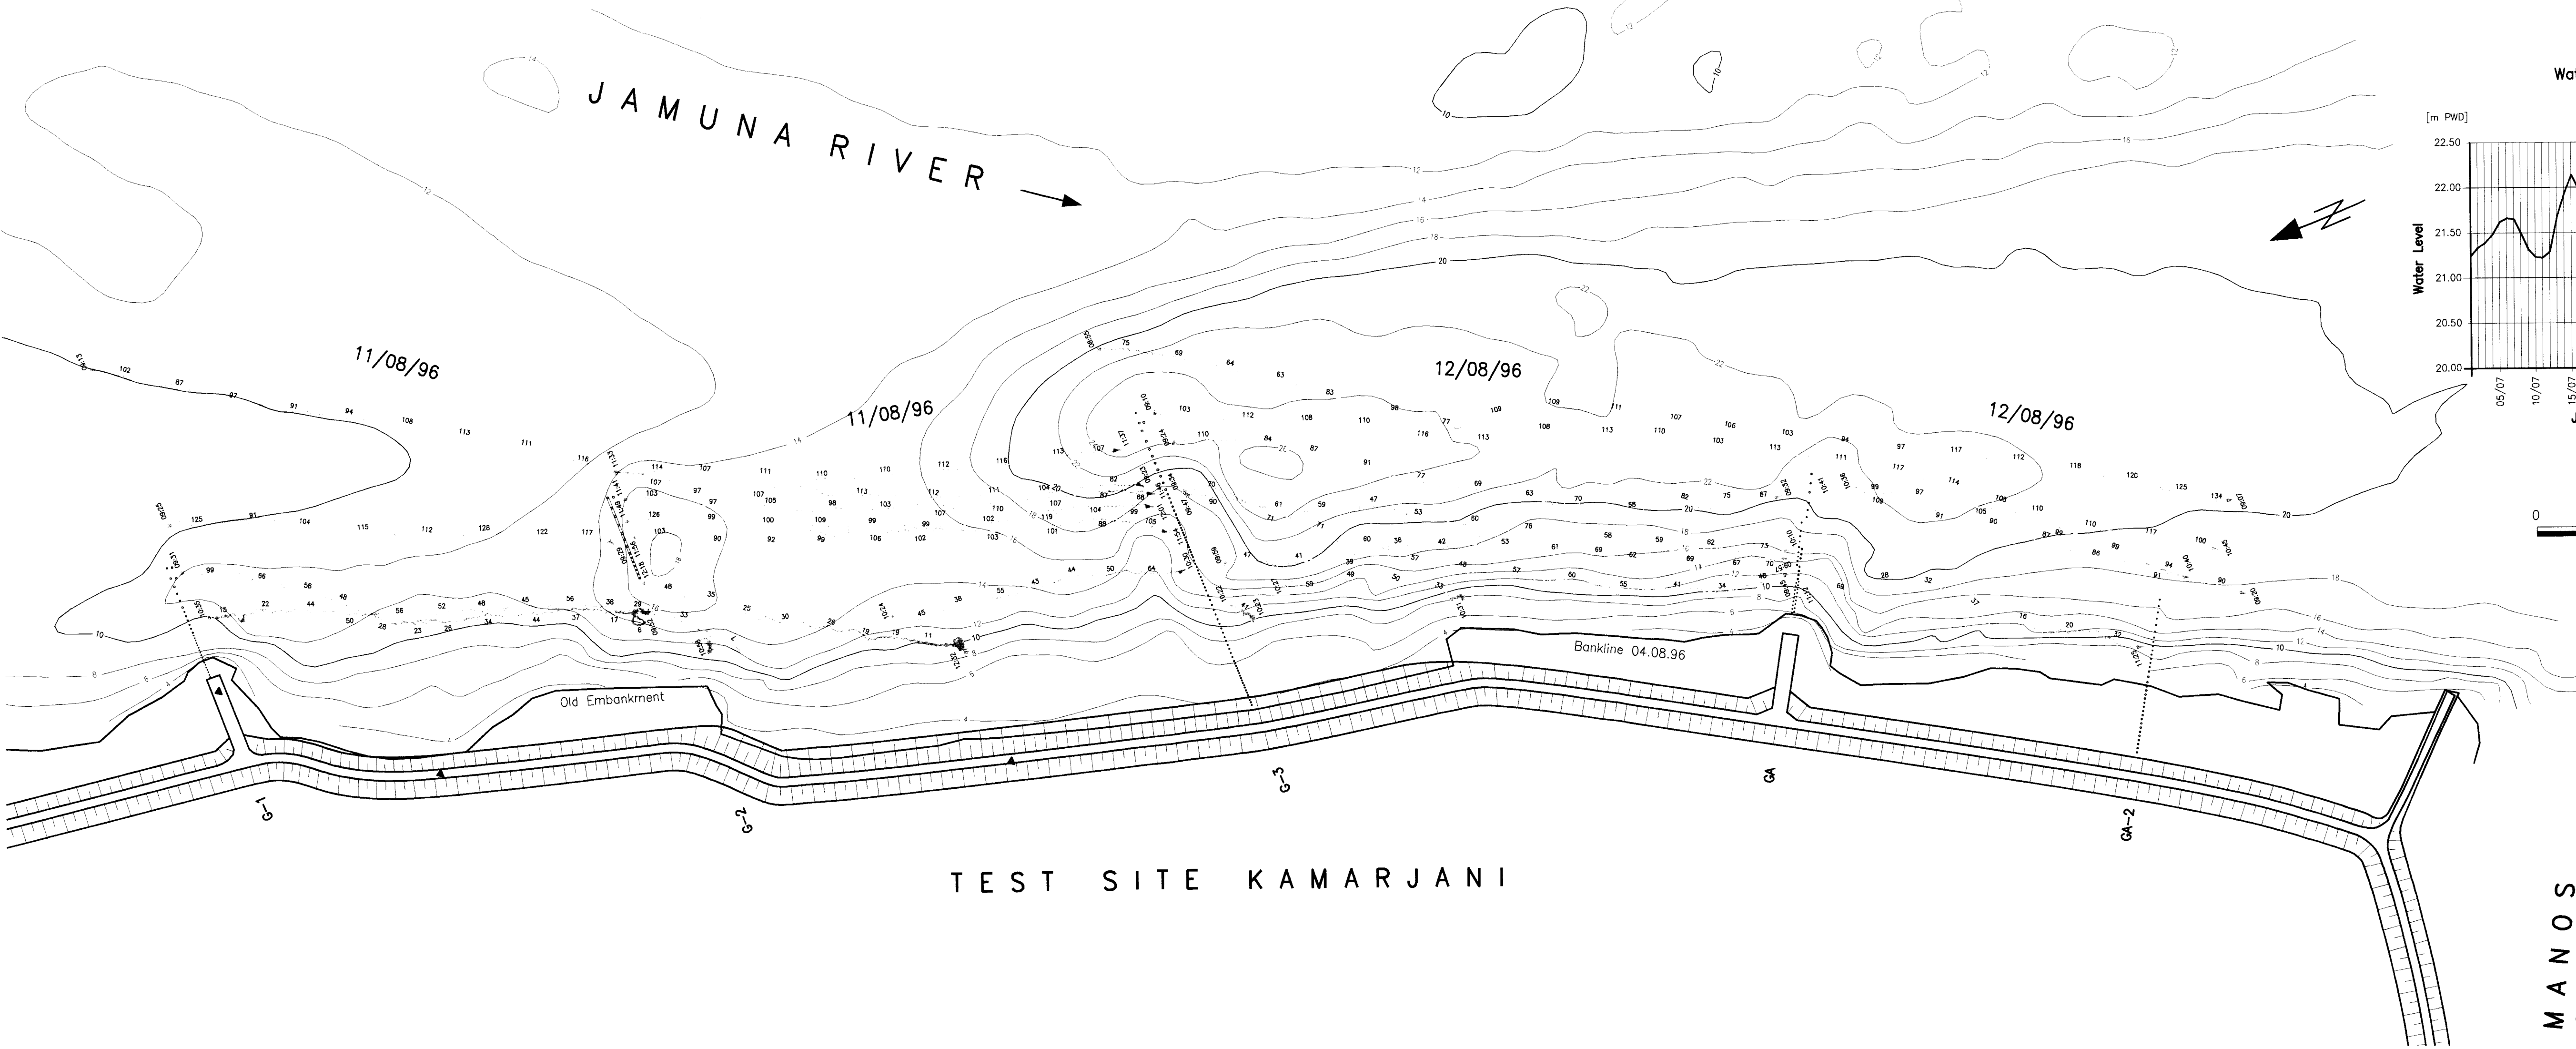
The above described current conditions at test site Kamarjani are confirmed by the measurements from the 02/08/96 and 11/08 & 12/08/96 (annex 12). The currents with strongly altering directions were also recorded downstream of groyne G-3 with slightly reduced intensity. The velocities are lower owing to the falling water level. A comparison of the absolute velocities of the tracks recorded outside the groyne field G-3/GA demonstrates this (annexes 11 & 12). The current attack must be accordingly higher during higher discharge periods, which would explain the scours extending from downstream of the head of G-3. In the groyne field G-1/G-2 there is a recognisable trend to form return currents along the bankline.
