**BANK PROTECTION AND
RIVER TRAINING (AFPM)
PILOT PROJECT
FAP 21/22**

**REPORTS ON SUB-WATER INVESTIGATIONS
OF FALLING AND LAUNCHING APRONS:
A. VISUAL INSPECTION BY DIVING, AND
B. SIDE SCAN SONAR SURVEY
AT
TEST SITE II - BAHADURABAD**

FEBRUARY AND MARCH, 1999

JAMUNA TEST WORKS CONSULTANTS, JOINT VENTURE
CONSULTING CONSORTIUM FAP 21/22

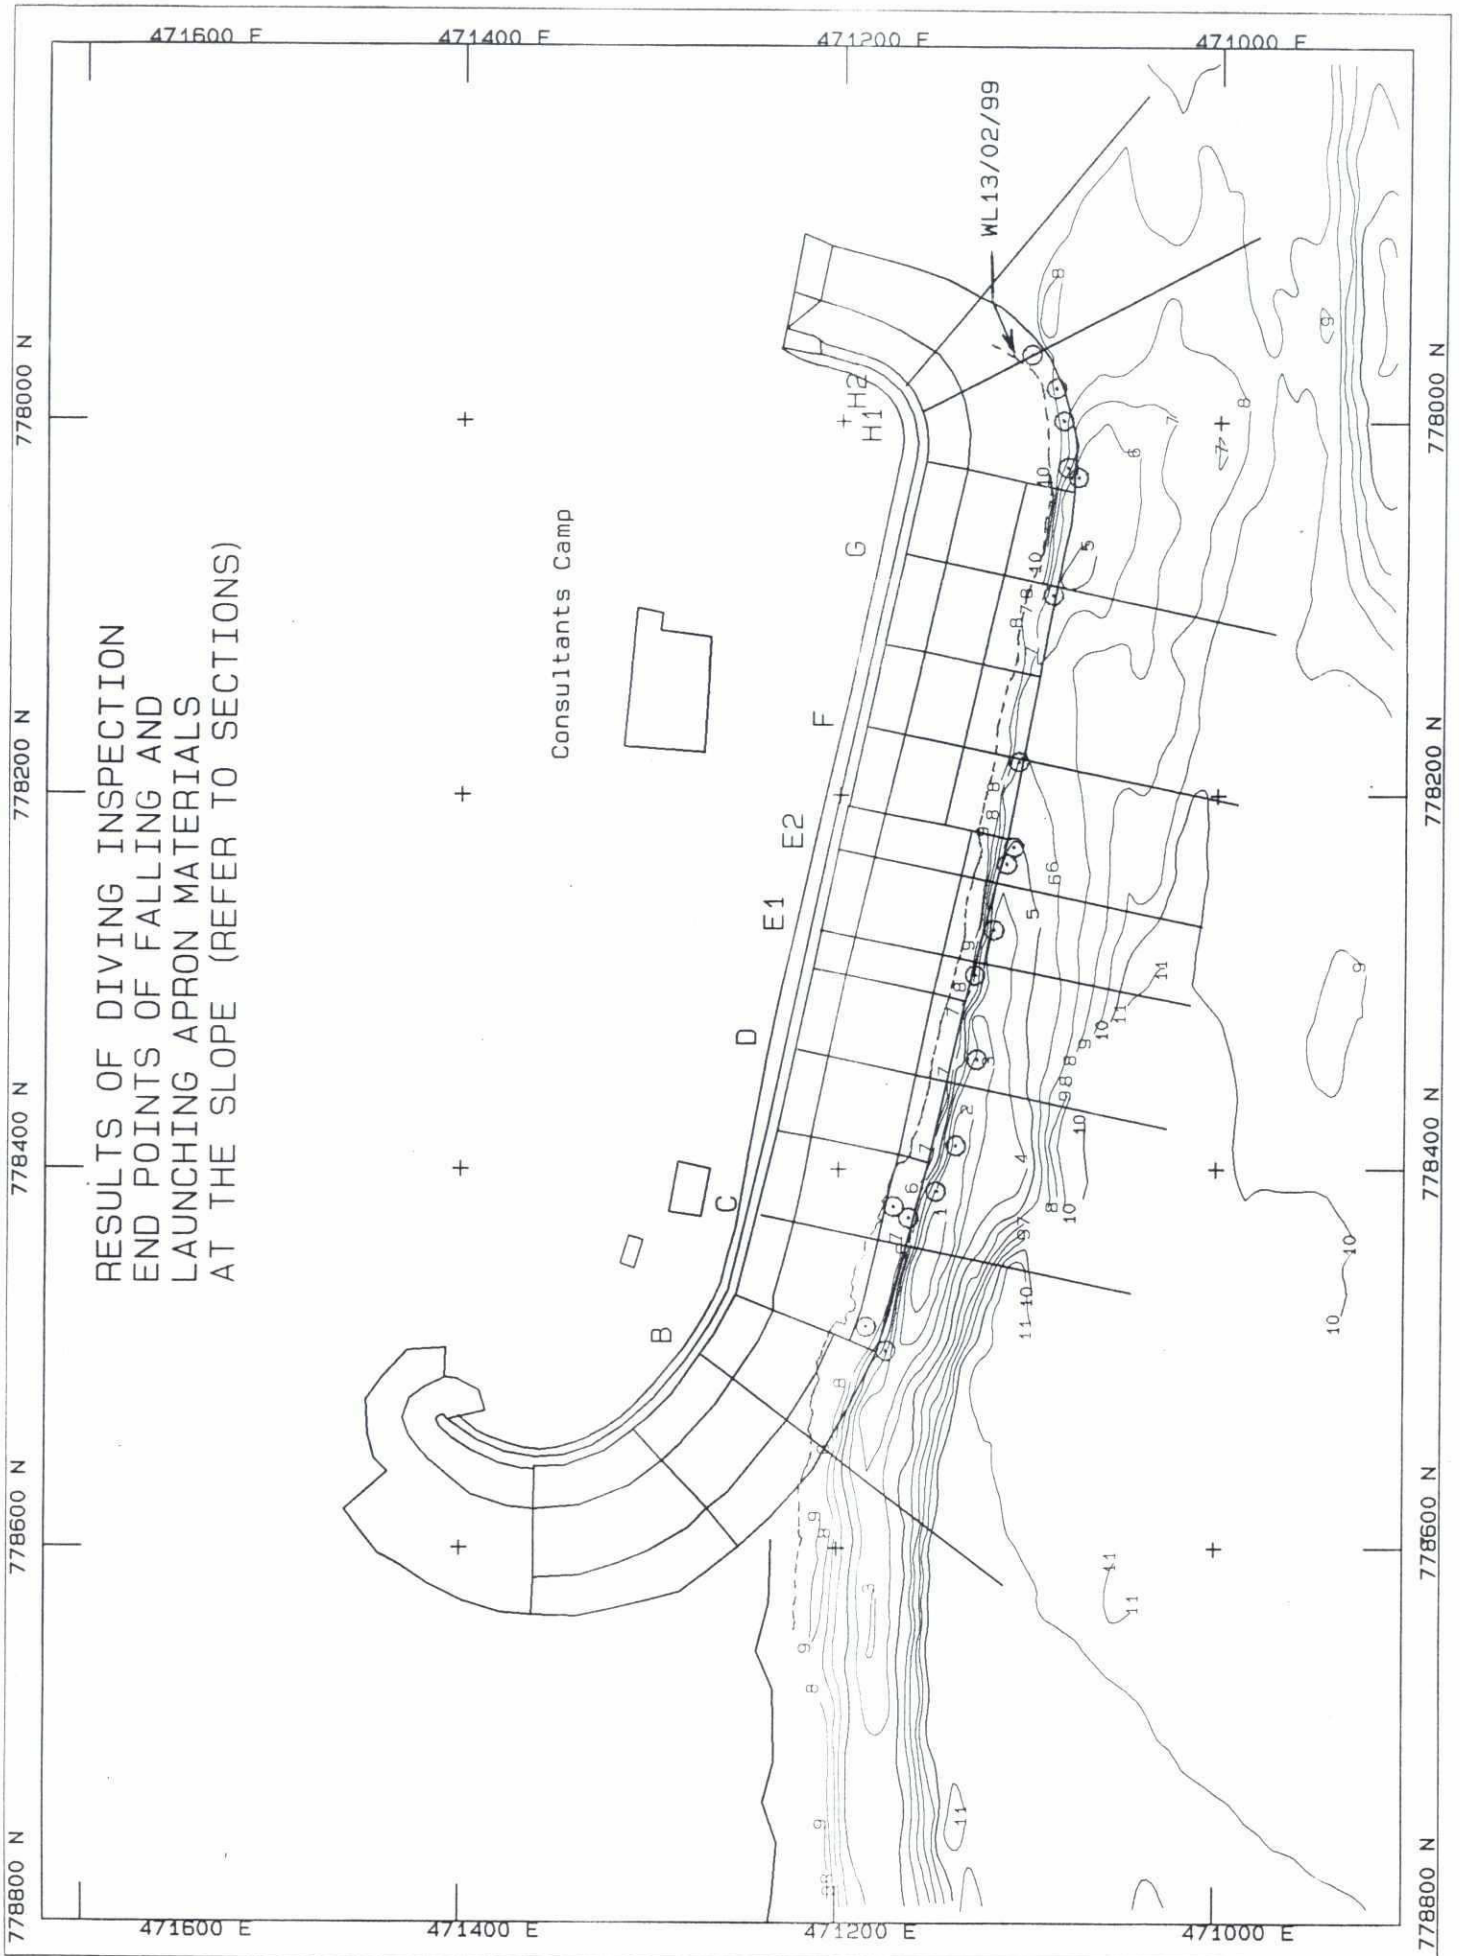
Results of Inspection by Diving
Bahadurabad Test Site
Upstream Transition of X_sec: B [16/02/99]

Existence of cc-blocks was found approx. 10 m from waterline. The blocks were scattered and did not form the slope, also nor in evenline. The slope is covered by thick deposit of clayee loam at the beginning of section B. Slightly upstream of the section start of a scour hole was located. Approximately the hole is 3 m x 3 m x 1.5 m in size at water depth of 4 m.

Geo-sand container was found in Section B as continuous cover over bed material up to 15 m from waterline. The bags were intact, undulating in slope. Scattered cc-blocks were also found in this section up to 24 m from waterline. Rest of the slope was composed of soil and hard clayee soil lumps.

REMARKS: The scattered cc-blocks found at the bottom of the slope are the remaining ones in the stack yard at natural cofferdam after the structure section. With the first disappearance of the cofferdam by erosion of the river, probably the blocks settled directly at that location.
