**BANK PROTECTION AND
RIVER TRAINING (AFPM)
PILOT PROJECT
FAP 21/22**

**FINAL PROJECT
EVALUATION REPORT**

- Annex 10: The Revetment Test Structure; Monitoring Report**
- Annex 11: The Revetment Test Structure; Evaluation of Hydraulic Loads and River Response**

DECEMBER 2001

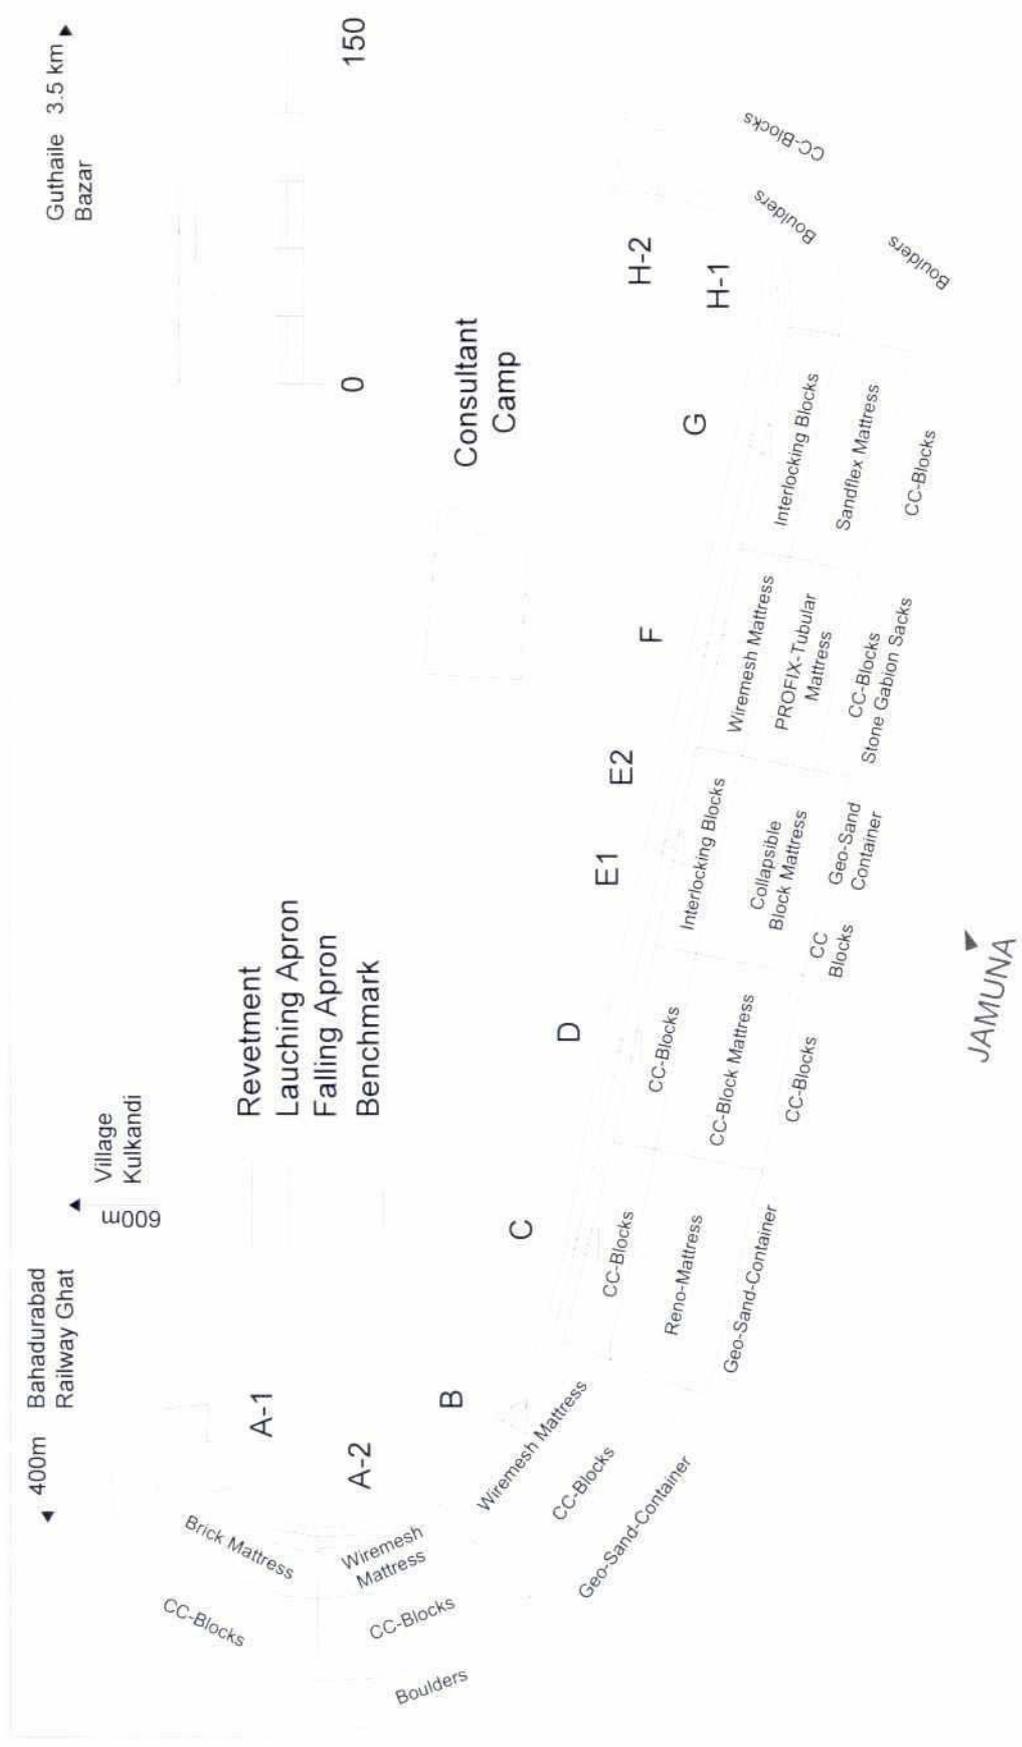
Fig. 1.3-2: Layout of Revetment Test Structure

The final layout of the structure is presented in Fig. 1.3-2. The total length of the structure is 662.5 m split up into 10 sections, each consisting of a sloped embankment revetment, a launching apron and a falling apron. For the construction of the individual sections different material had been used for the cover layer and filter layer of the embankment revetment as well as for launching and falling aprons (Fig. 1.3-2).

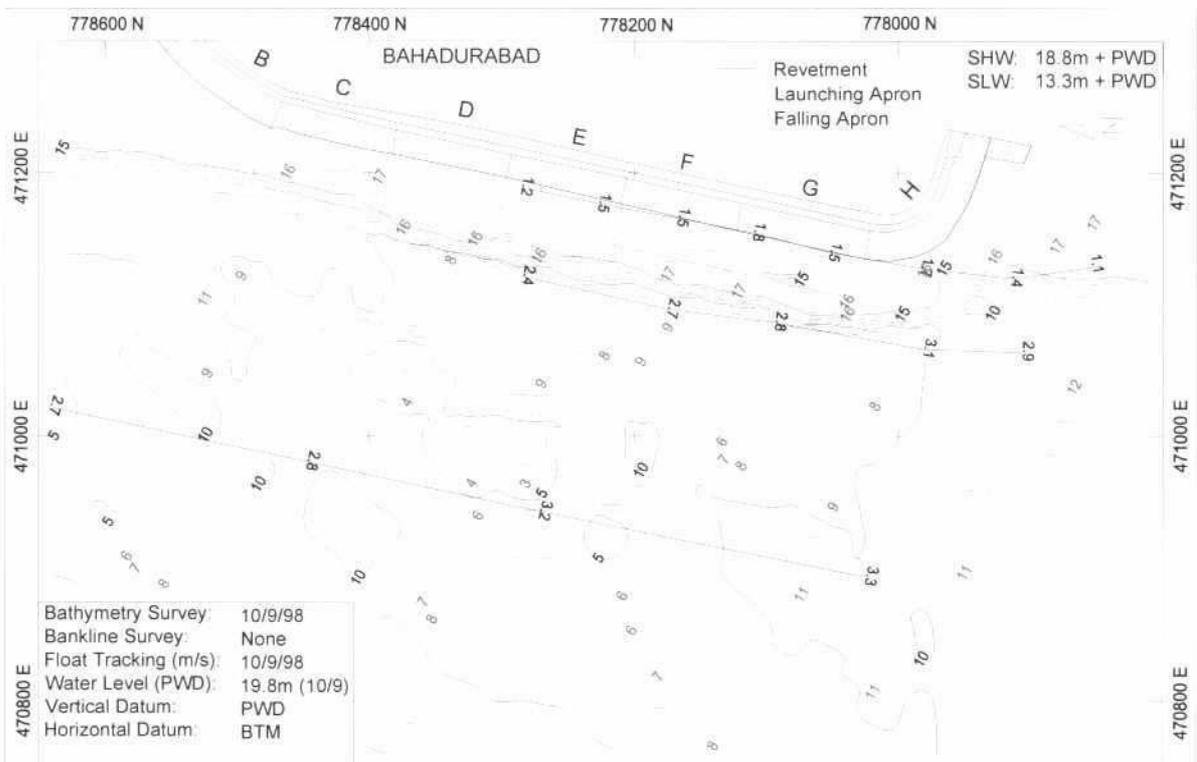
Fig. 4.2-15: Bathymetry in September 1998

The highest water level at Bahadurabad during the total monitoring period was recorded on September 07 and 08, 1998 at 20.12 m+PWD. Two days later a survey of the test site was carried out (Fig. 4.2-15). Although the river channel was silted up in the previous two months (Fig. 4.2-13 and Fig. 4.2-14), high flow velocities of about 1.5 m/s were recorded over the launching apron.

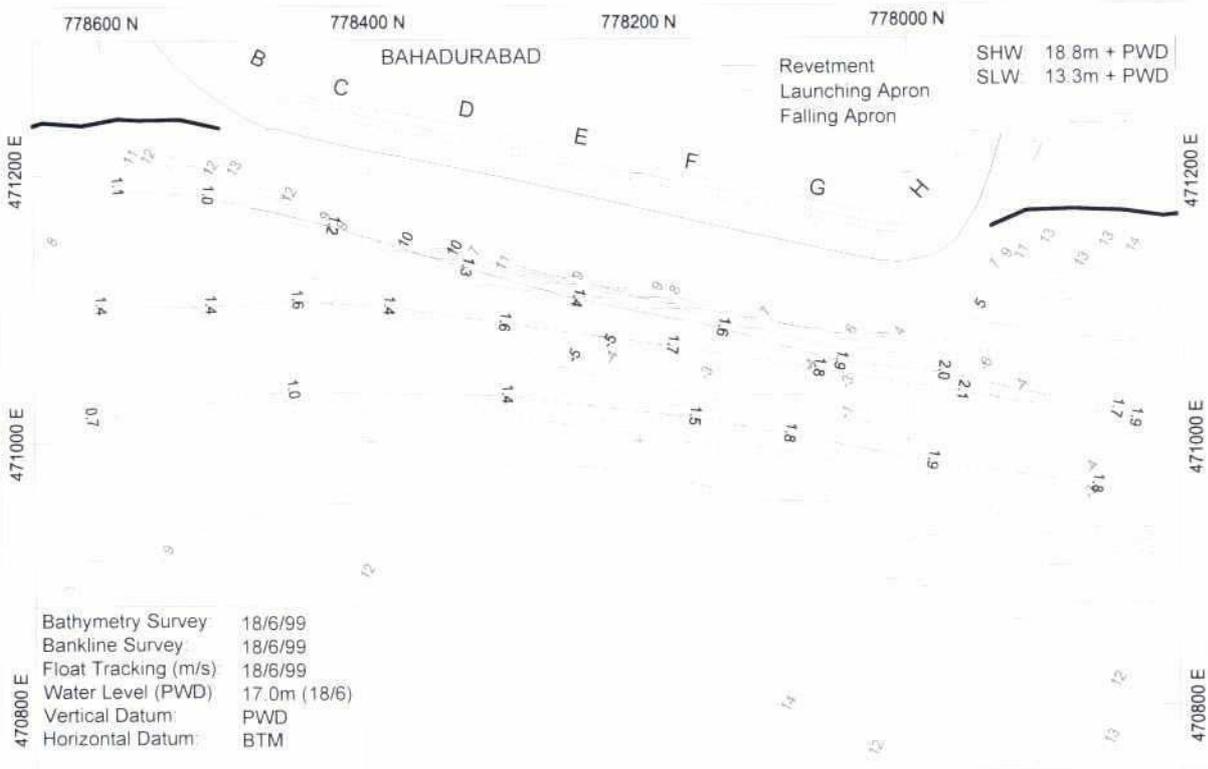
Fig. 4.2-20: Bathymetry and flow in June 1999

In June 1999 less flow velocities were measured in front of the structure (Fig. 4.2-20). But downstream from Section H the backflow along the bank and the eddies were present again in that area, which was surveyed on June 28 (Fig. 4.2-21).

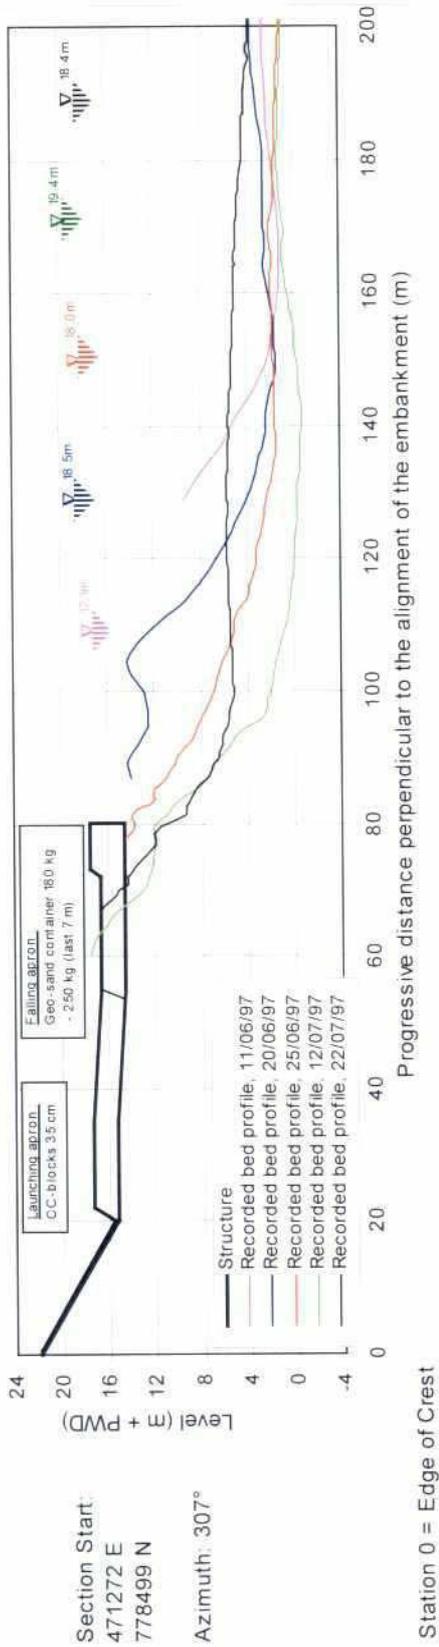
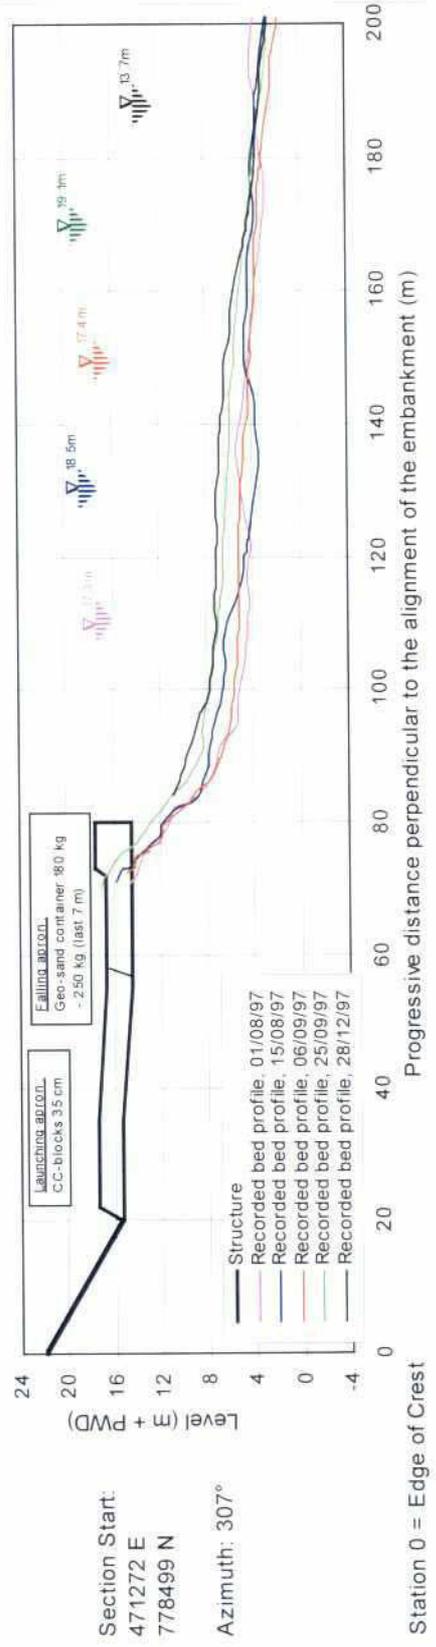
Fig: 4.3-1: Bathymetry cross section B in 1997

Already during the first two months after completion all falling aprons along Section B to H-1 started to function. Along Section C to H-1 the falling aprons launched to a slope inclination of 1V:2H as it was designed. The slope inclination at Section B was found as 1V:3H.

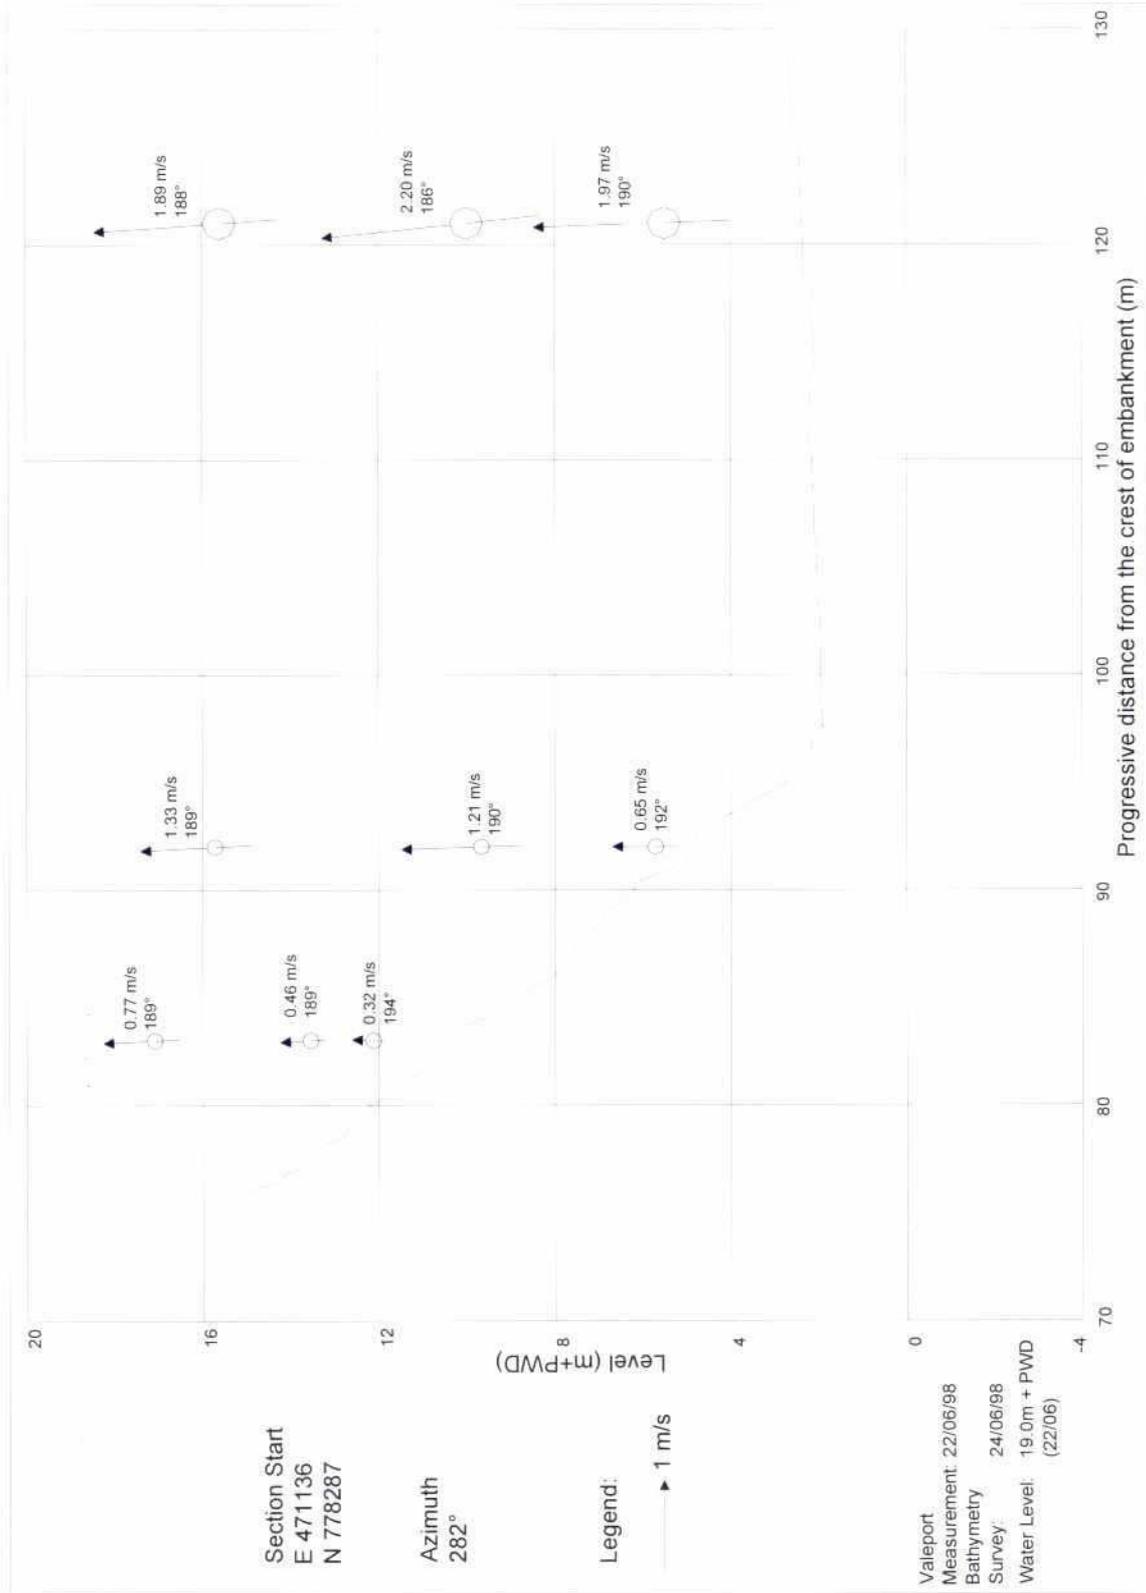
Fig. 4.4-7: Current point measurement at Section E-1

The results are presented together with the bathymetric cross section in Fig. 4.4-7 and Fig. 4.4-8. The significant reduction of the flow velocity above the falling apron could be surveyed along Section E-1.

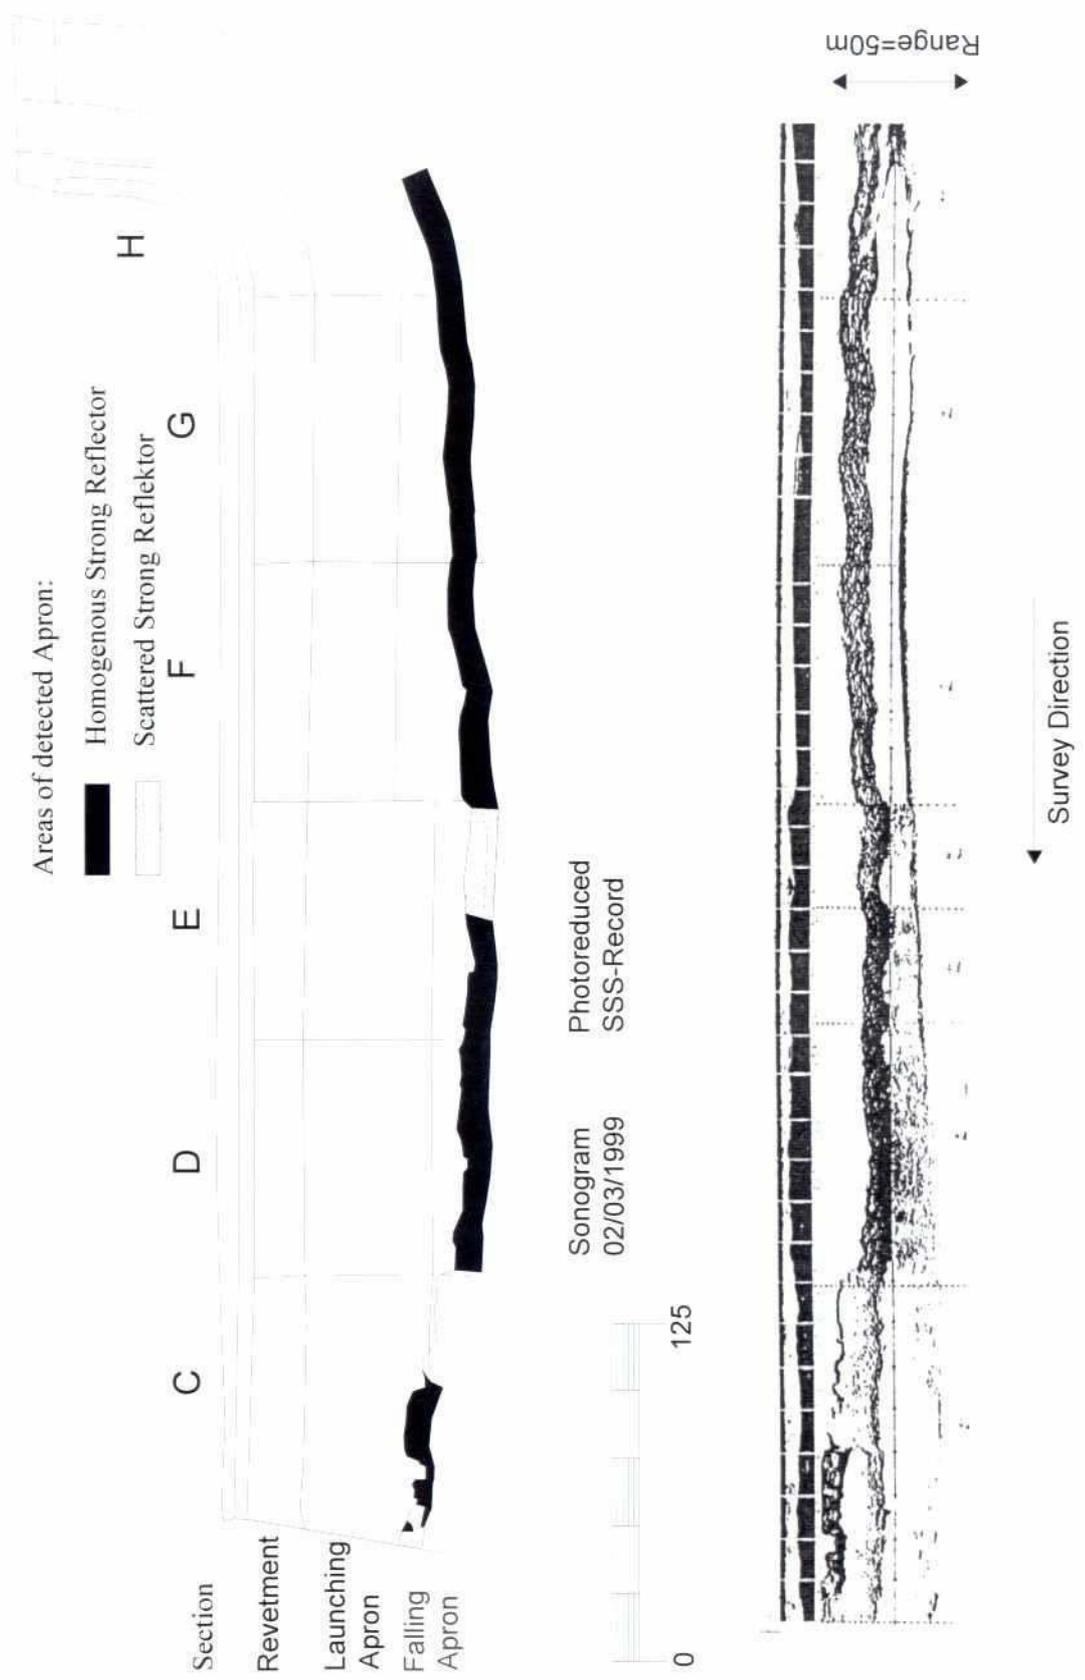
Fig. 5.1-2: Side Scan Sonar Coverage March 1999

Another side scan sonar inspection was done in March 1999 (Fig. 5.1-2). Since the riverbed at that time was between 0 to 5 m+PWD due to sedimentation, only the slope of the falling aprons could be investigated.

A comparison of the reflection between the slopes at Section D and E-1 with the Section F to H shows a more scattered strong reflection at the latter sections, which implies more sedimentation on these slopes.

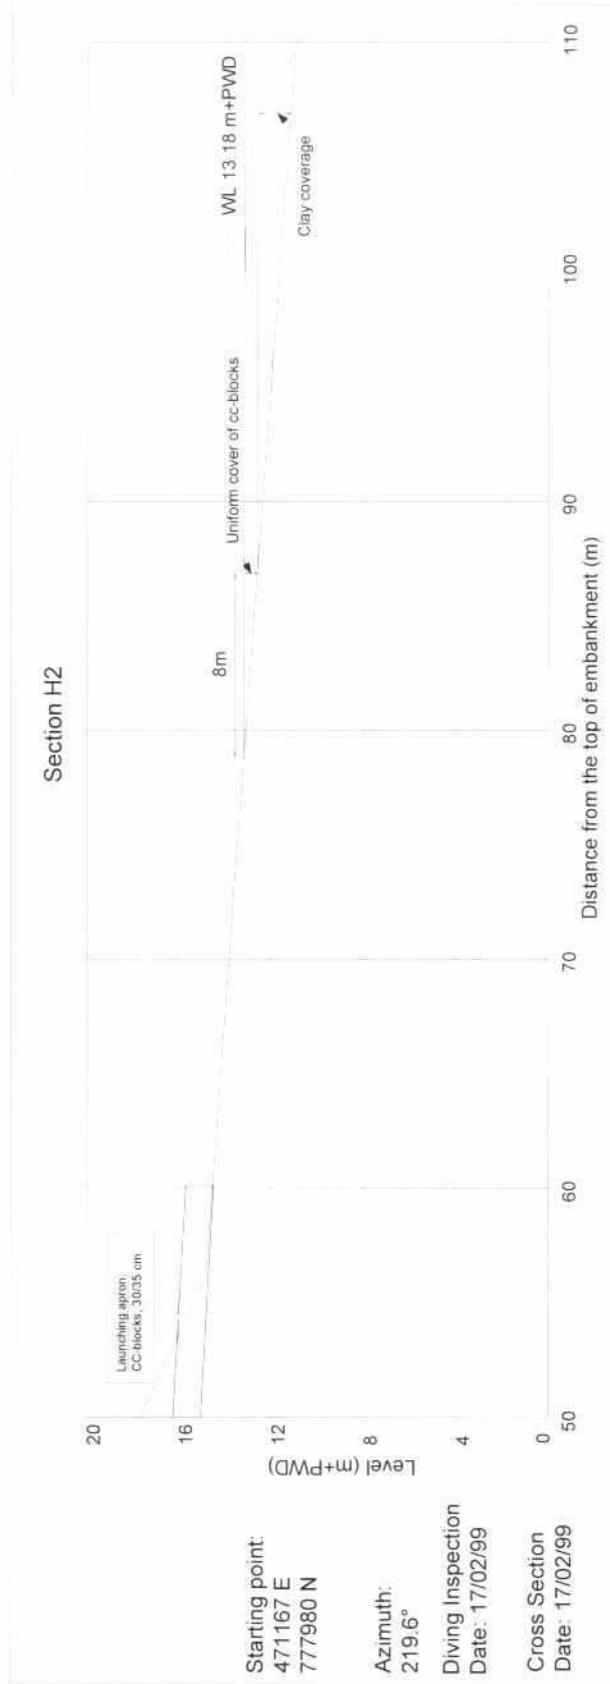
Fig. 5.3-6: Diving inspection at Section H2

Scattered blocks were found up to a distance of 15 m from the waterline. A lot of gaps between the blocks were found. Sited sand of 1 m width in longitudinal direction was found in some parts.

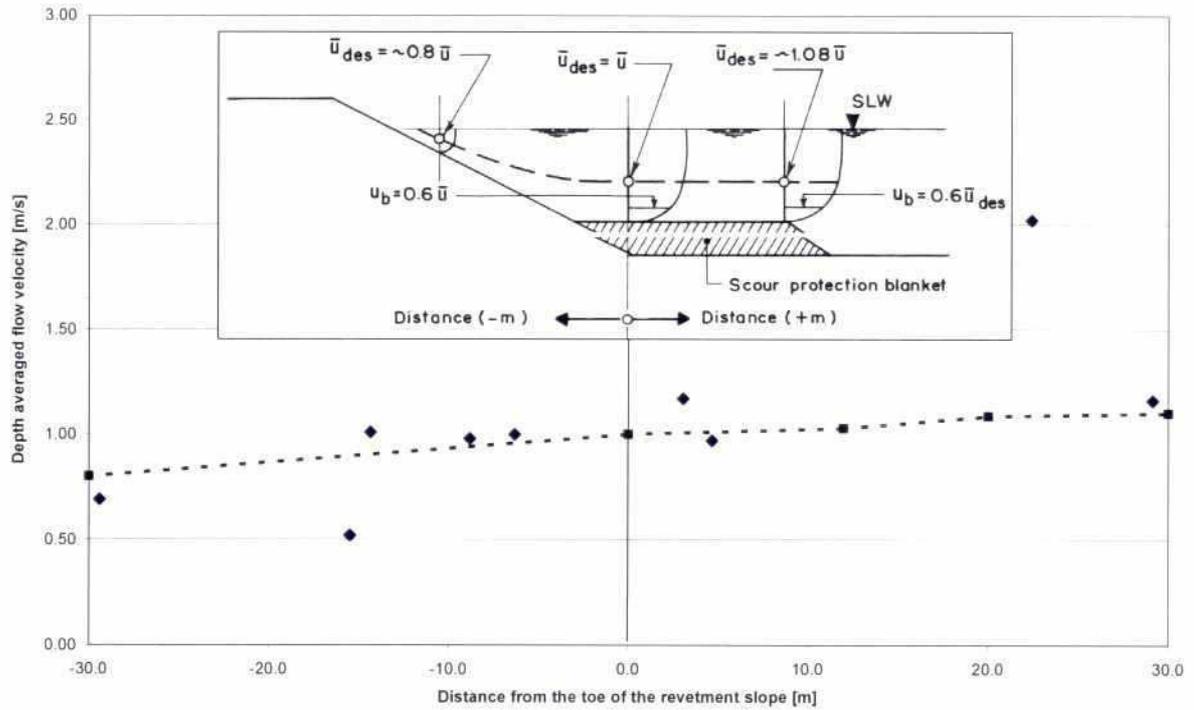
Fig. 4.3-7: Calculated depth averaged flow velocities from measurements and design velocity distribution along the revetment slope

The depth averaged flow velocity along the revetment slope for the same data is given in Fig 4.3-7. The assumed dependency between flow velocity and the distance from the toe of the revetment slope (see Annex 8, Subsection 2.4.5) is well represented by the measurements, even the cross-section differed from the assumed design cross-section.

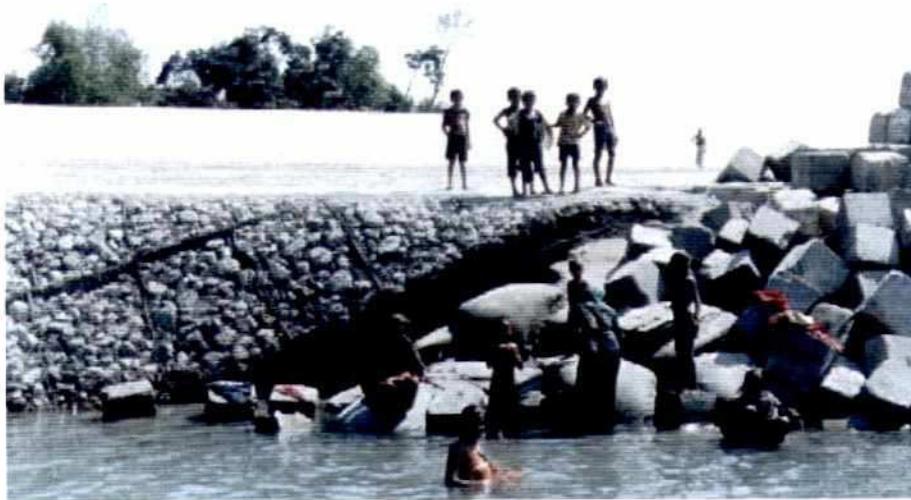
Due to the efficiency of the falling aprons the launching aprons were not subjected to erosion. Only the edge of the articulating Reno mattresses in Section C started to launch early in the 1997 monsoon season (see Photo 5.2-1 and 5.2-2). On July 11, 1997 an erosion of 1.5 m had been observed. The mattress system did perform well. Due to sharp bending, the wiremesh boxes lacing wire of a few cages broke up and some boulders fell out. This is to be seen as an executional short fall. The Reno mattresses articulated over a length of about 8 m (perpendicular to the structure crest) under a steep slope of 1V:0.9H. It is concluded that Reno mattress systems are well applicable, but the proper closing of the wiremesh boxes must be carried out with highest attention.

Photo 5.2-2: Transition Section C/D on February 18, 1998; Section C: Launching apron; Section D: Falling apron; Water level at 13.00 m+PWD

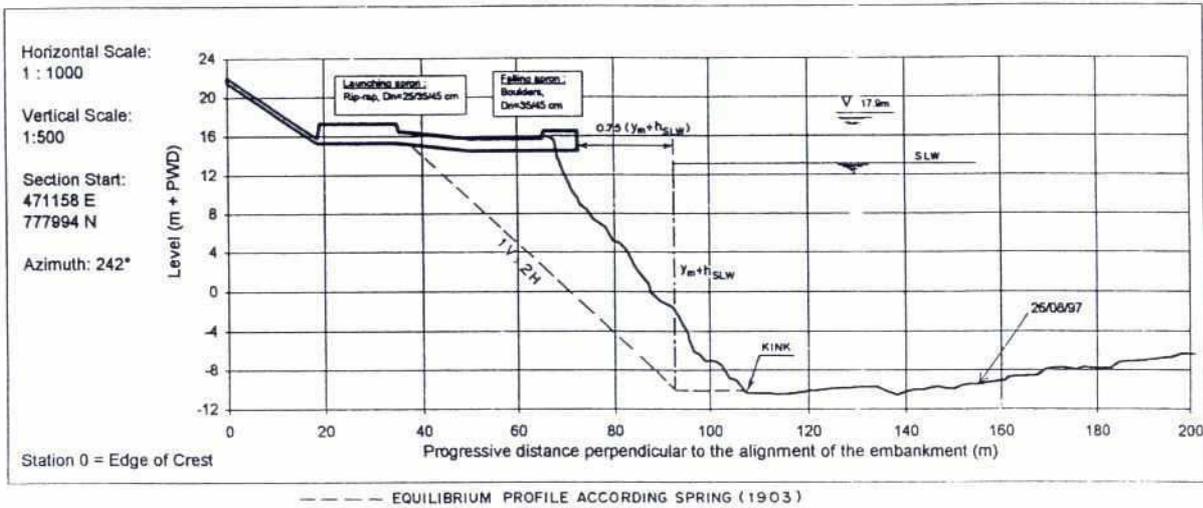
Fig. 5.3-3: Cross-section H-1 on August 26, 1997

A kink in the depth measured in cross-section surveys indicates a certain coverage down to this kink, (see example in Fig. 5.3-3). This is caused by the slowly eroding surface formed by the falling

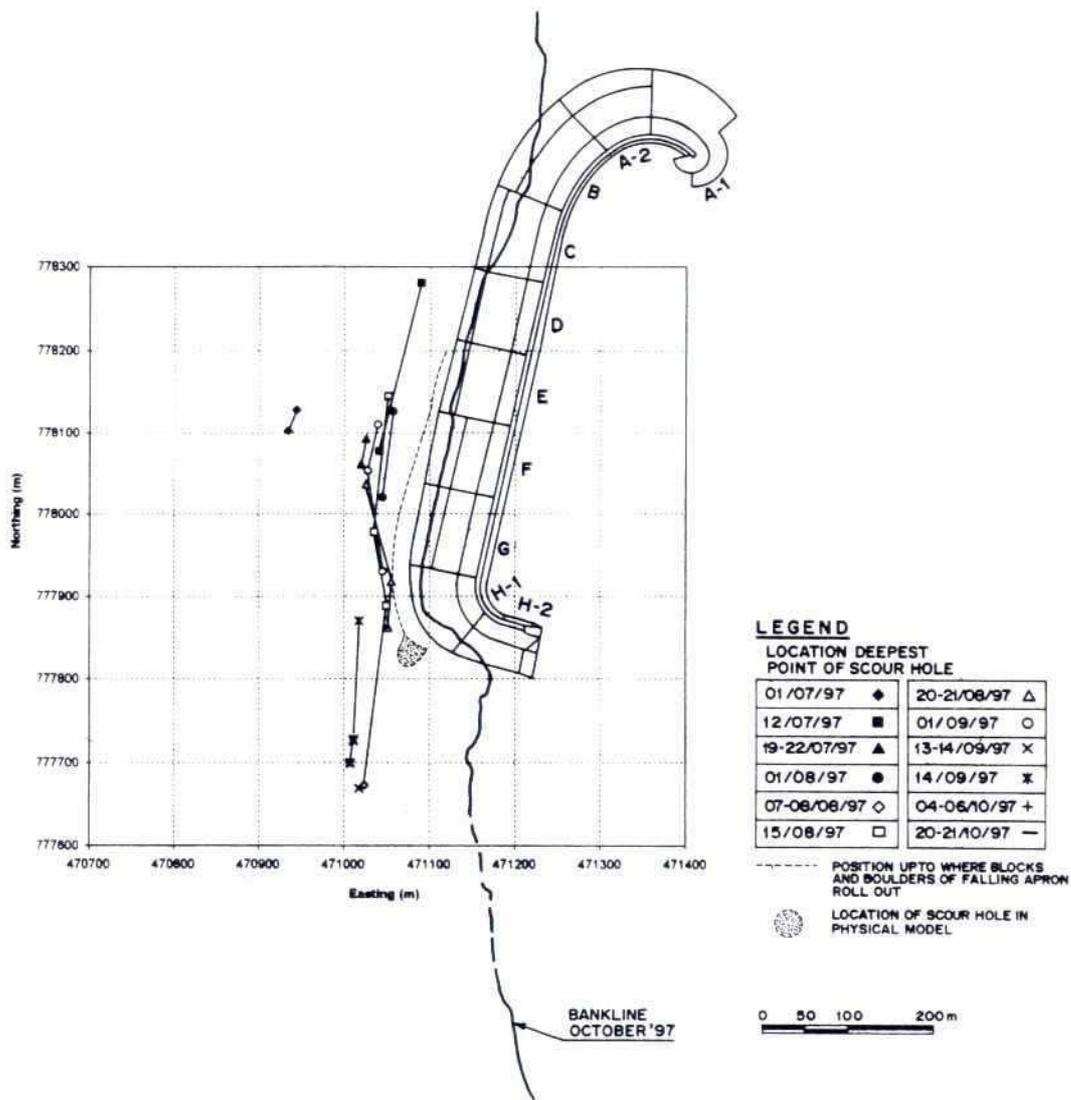
Fig. 7.2-1: Location of the deepest point in the scour hole 1997

The location of the deepest point of the scour hole has been determined from bathymetric maps. In some surveys the scour hole had an elongated flat bottom, which is indicated by two or more points connected by a line in Fig. 7.2-1. In general, this deepest point moved in downstream direction during the 1997 and 1998 monsoon floods. In the following this will be analysed more in detail.

During June and July 1997 the scour hole developed at some distance from the falling apron with the deepest points in front of Sections D to F. When the scour hole became fully developed in August and September 1997 the deepest point of the scour hole shifted towards the falling apron in front of Sections G and H. The eddy with return current downstream from Section H started to develop during those months. In September the scour hole reached its maximum size and in October 1997 it started to silt up. The location of the deepest point did not move anymore.

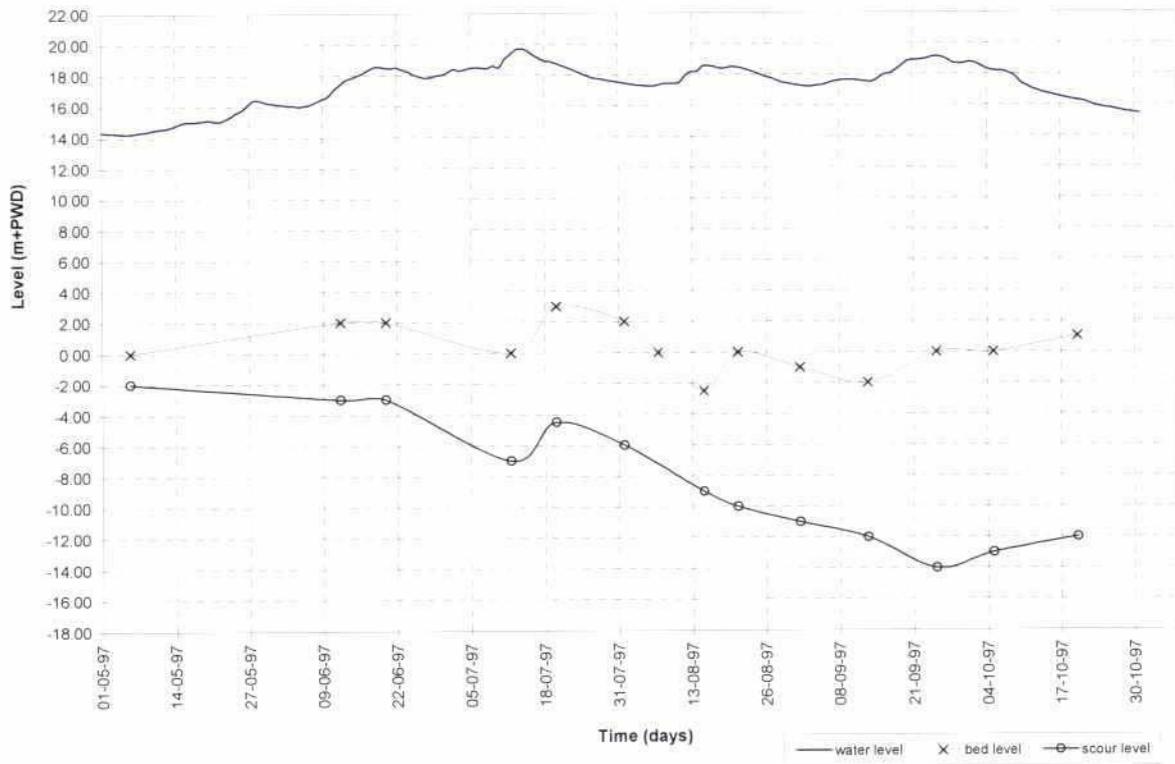
Fig. 7.3-1: Development of bed level and scour depth in 1997

The depth of the scour hole in front of the revetment structure gradually increased from 2 m in May 1997 to 14 m at the end of September 1997 at an average rate of 0.1 m/day. This erosion rate is similar to the falling rate of the falling apron in Section F (see Section 5.3). The gradually increasing scour depth is different from the quick development of the local scour holes near the Kamarjani groynes in the 1995 monsoon (erosion rates of 0.3 m/day). The slow erosion rate of the scour hole near the revetment structure has possibly reduced considerably the risk of sudden large slides.
