**MES II  
MEGHNA ESTUARY STUDY**

TECHNICAL NOTE MES-039

**HAIMCHAR & KHORKI EROSION CONTROL PILOT SCHEMES**

June 2001

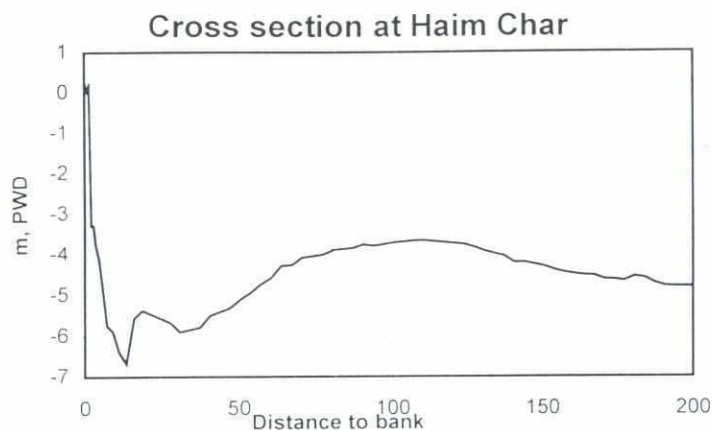
**Fig- A4, Cross-section at Haimchar, December 1998**

The slope of the bank is almost vertical above the high waterline. The underwater slope is maximum 33 degrees, where a safe angle would be 12.1 degrees.

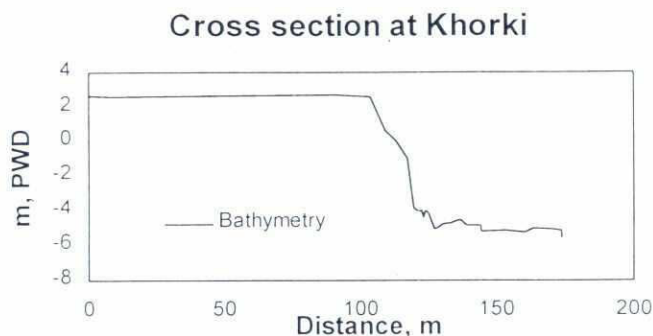
Fig- B4. Cross section at Khorki

The pilot was not located at a point with the deepest scour hole as can be seen from the cross section in Fig-1.12. The maximum depth was 6 meters. The under water slope angle was 45 degrees, which indicates a very instable point. A safe angle would be 11.7 degrees.

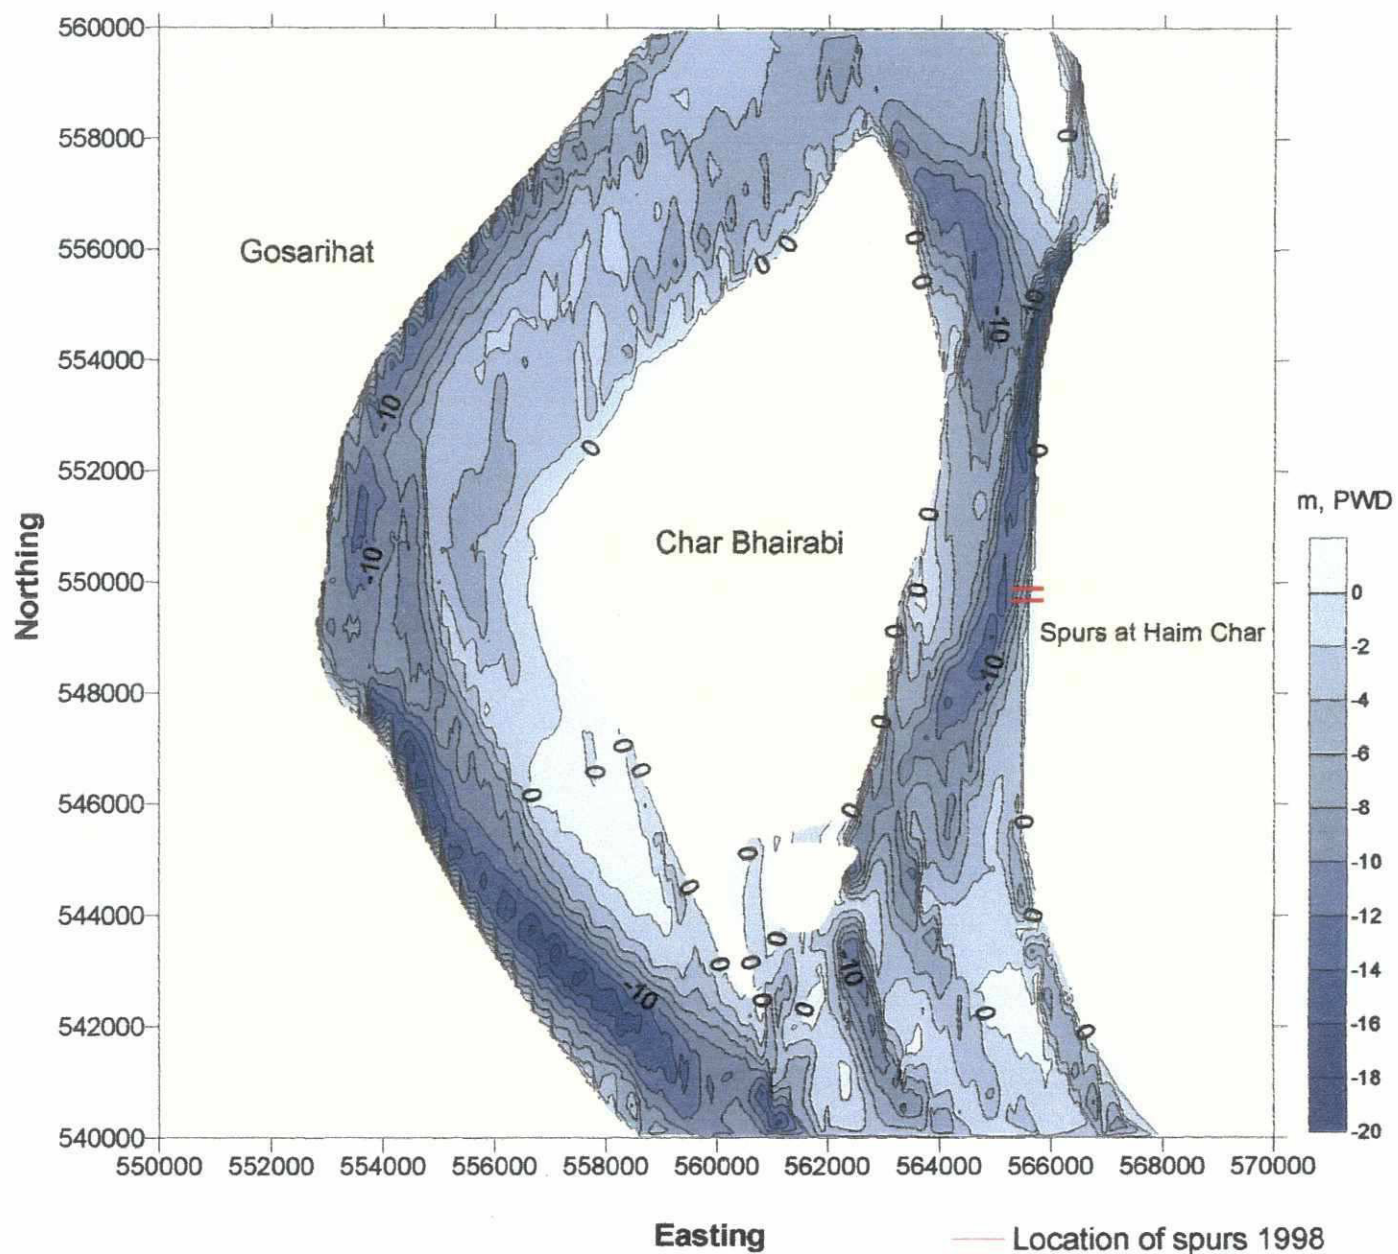
Figure A5 : Accretion/erosion (bathymetric change) map for area 1

The bathymetric changes in the 1997 - 2000 period are shown in Fig- A5. The eastern part of the East channel has deepened more than five meters. Locally, in the western part of the East channel some accretion has occurred.

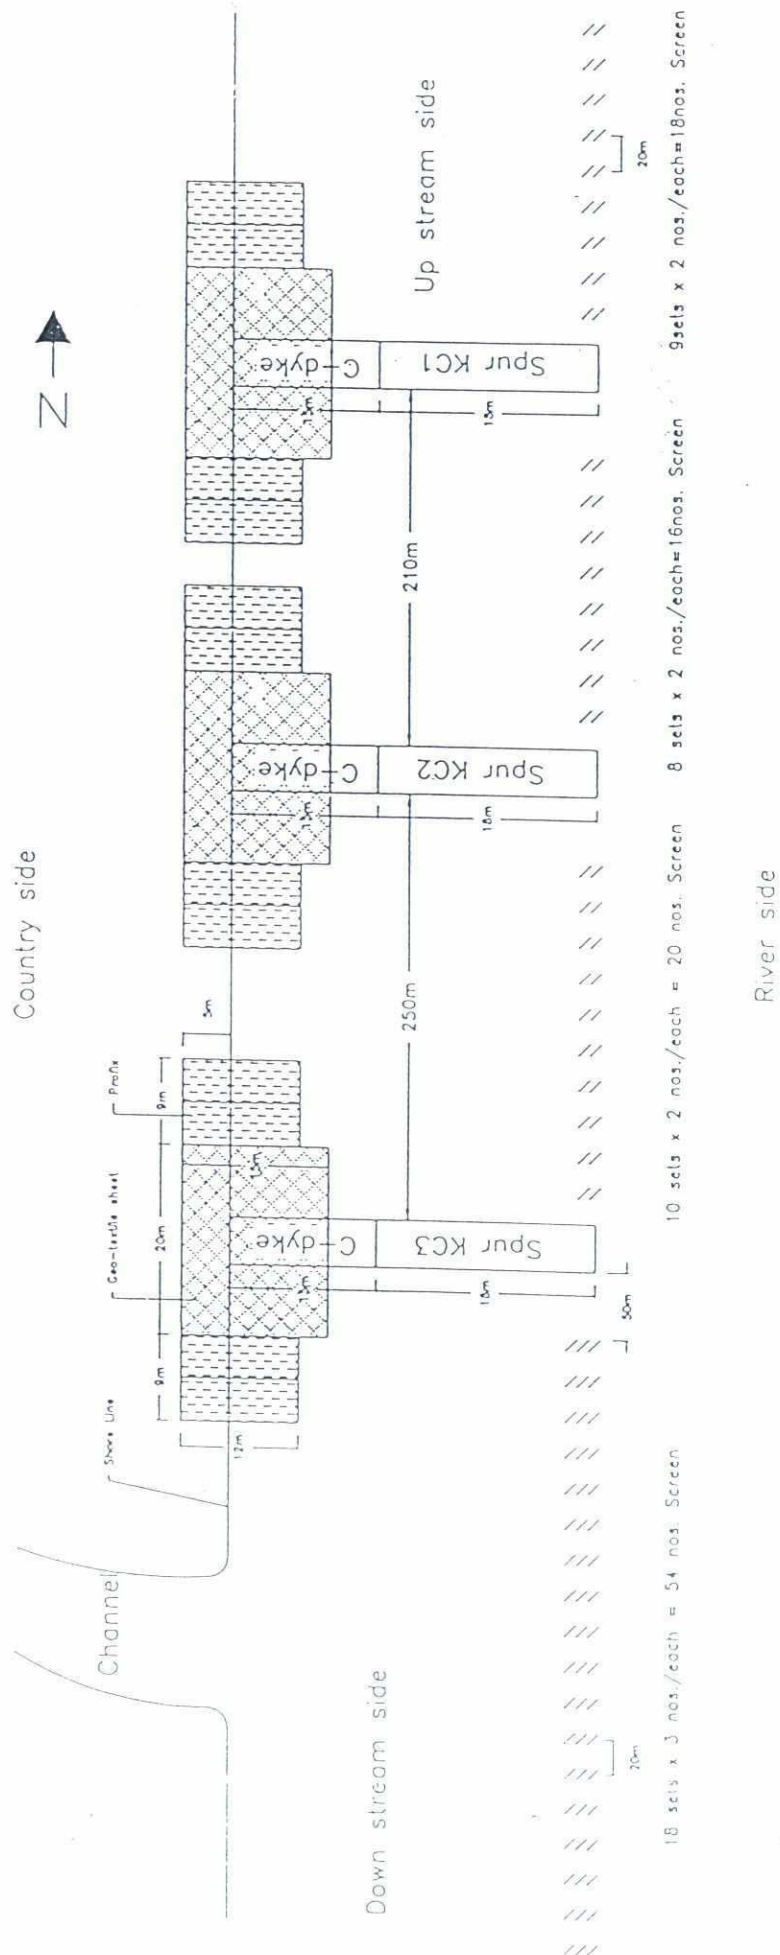
Figure - 2.1

Design and design consideration of Bottom Vane Screens was same as used at Haimchar. The screen array was planned as per Fig-2.1 on arbitrary basis. However since flow velocity and erosion condition was severe near and to downstream of spur KC3 an array of 54 screens consisting of each set of 3 screens in parallel line is placed to combat the situation there.

Design considerations for design of spur, bed mattress, screen and profix were same as at Haimchar site. 3 nos. of permeable spurs each of length 18 meters and 108 nos. of submerged Bottom Vane screens were decided to be installed arbitrarily as per plan shown in Fig-2.1. It was expected that design criteria will come out from the monitoring reports of the pilot scheme.

Bed mattress was designed similar as used at Haimchar site. However, since earth-filled gunny bags did not prove to be durable as ballasting materials at Haimchar, concrete blocks of size 40 cm x 40 cm x 40 cm were used here. The bed mattress at shore side was extended upto 5 meters inside the shore (Fig-2.1).

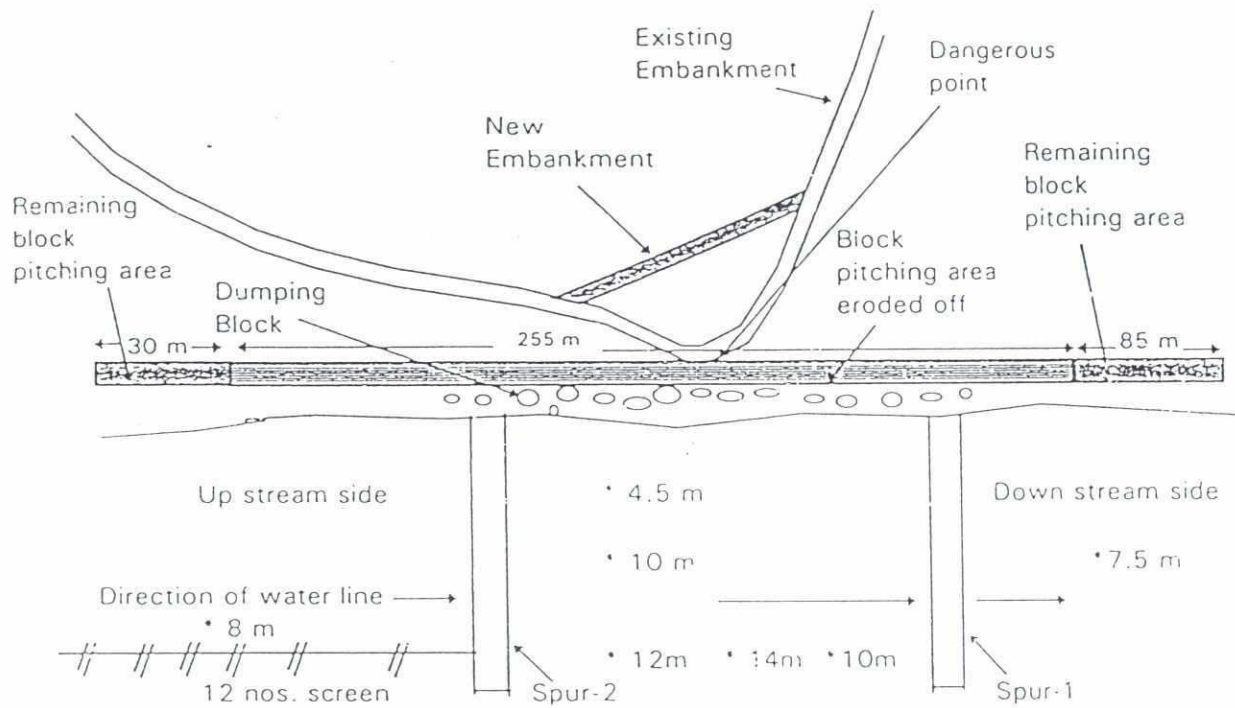
Figure - 11

Chandpur BWDB executed 370 m of block pitching in the entire project area in June and July 1998 (Fig-11, 13 & Picture 5).

- Turbulence and a change in flow direction is observed on the water surface when it passes the downstream location of the spur indicating existence of the spur under water.
- But in the upstream location of the spur no change of water flow direction or any turbulence is observed on the water surface.
- 255 meter out of the 370 m length of block pitching done by the Chandpur BWDB has slid down (Fig- 11 & Picture 7).
- Bottom levels were measured at some locations as shown in Fig-12 & 13.

# Monitoring September 16-19, 1998

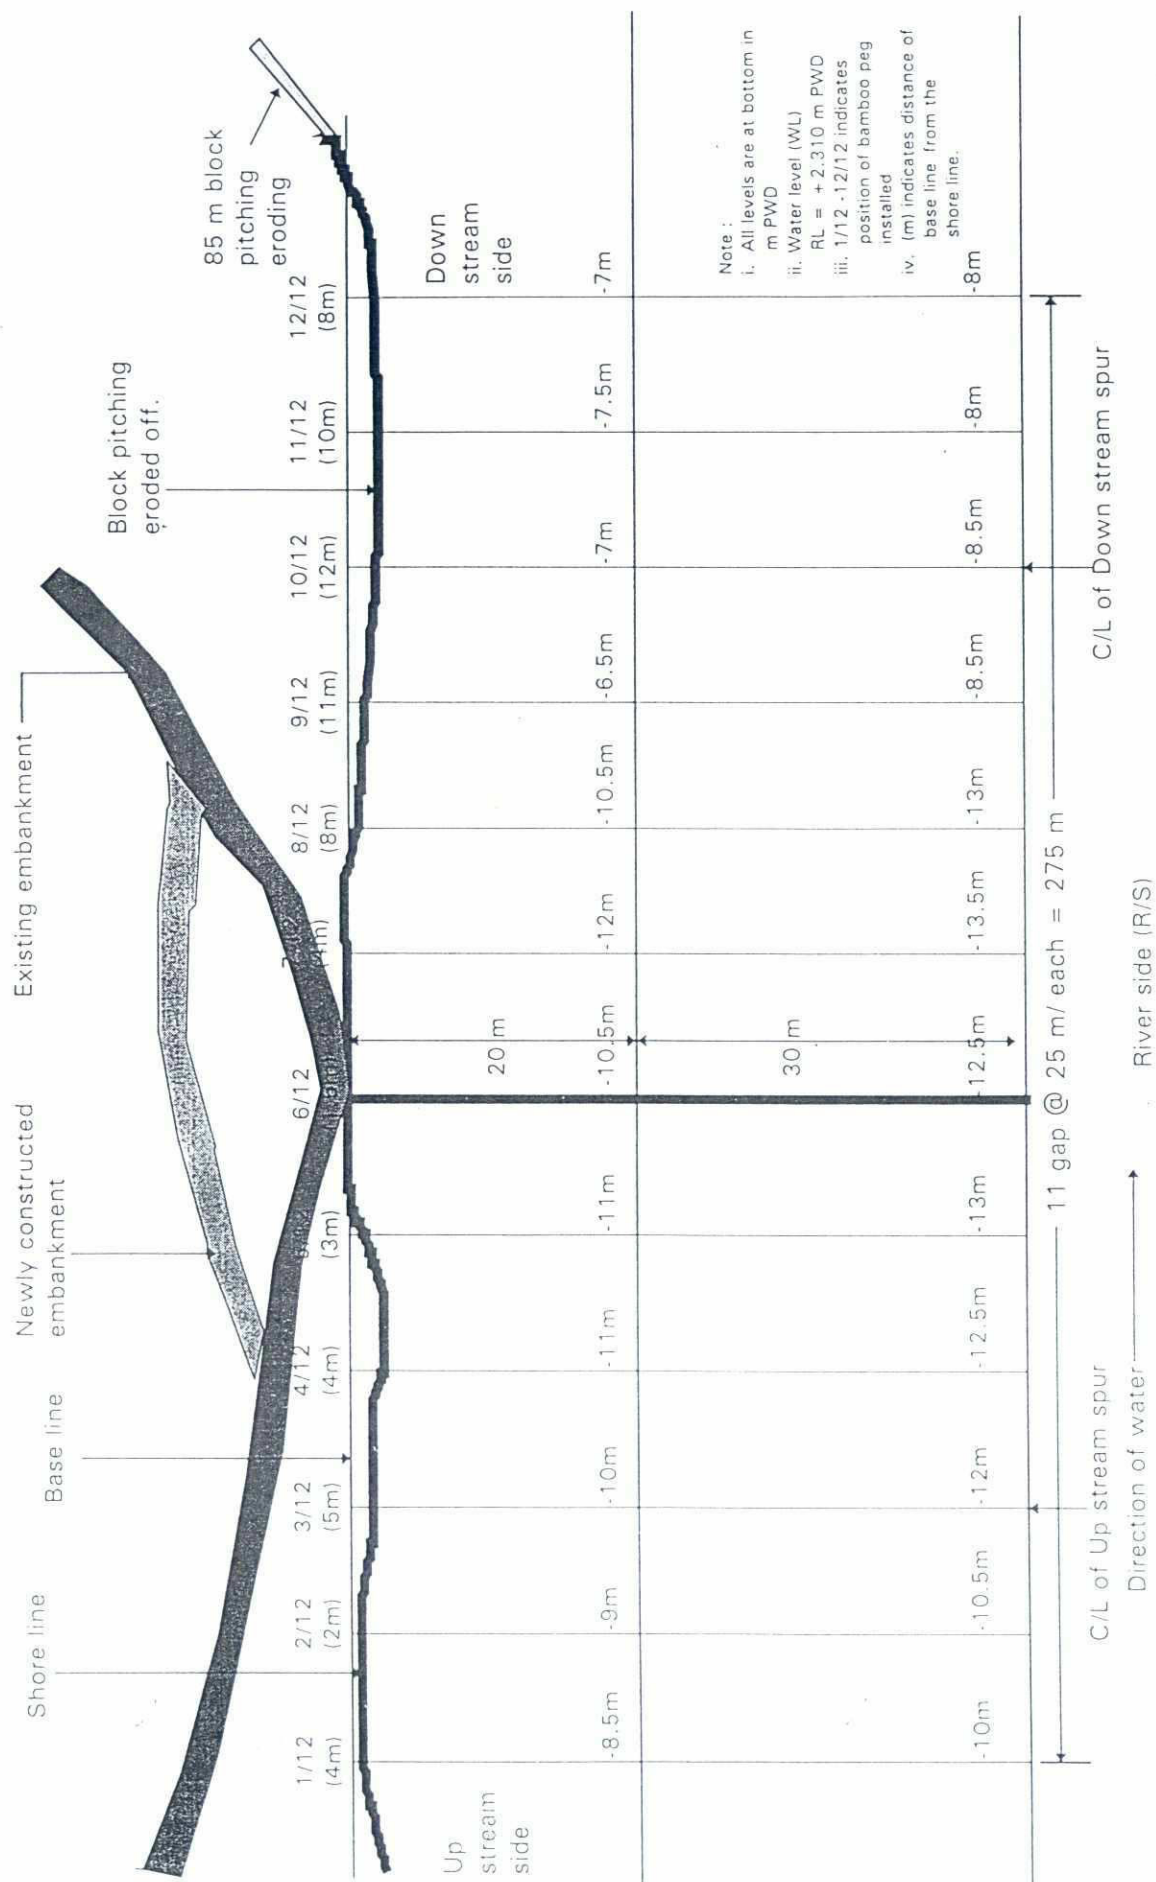
Figure - 12

- The remaining length of 30 meter of the upstream block pitching by the BWDB as recorded from September 16 to 19, 1998 has slid (Fig-12 & Picture 8).
- 85 meter length of block pitching on the downstream side has slid.
- The erosion area started from the downstream spur towards the north.
- Turbulence of water movement on top of the bottom vane screen area was recorded.

Sounding Report of Haimchar Site, Chandpur as on 25.09.98

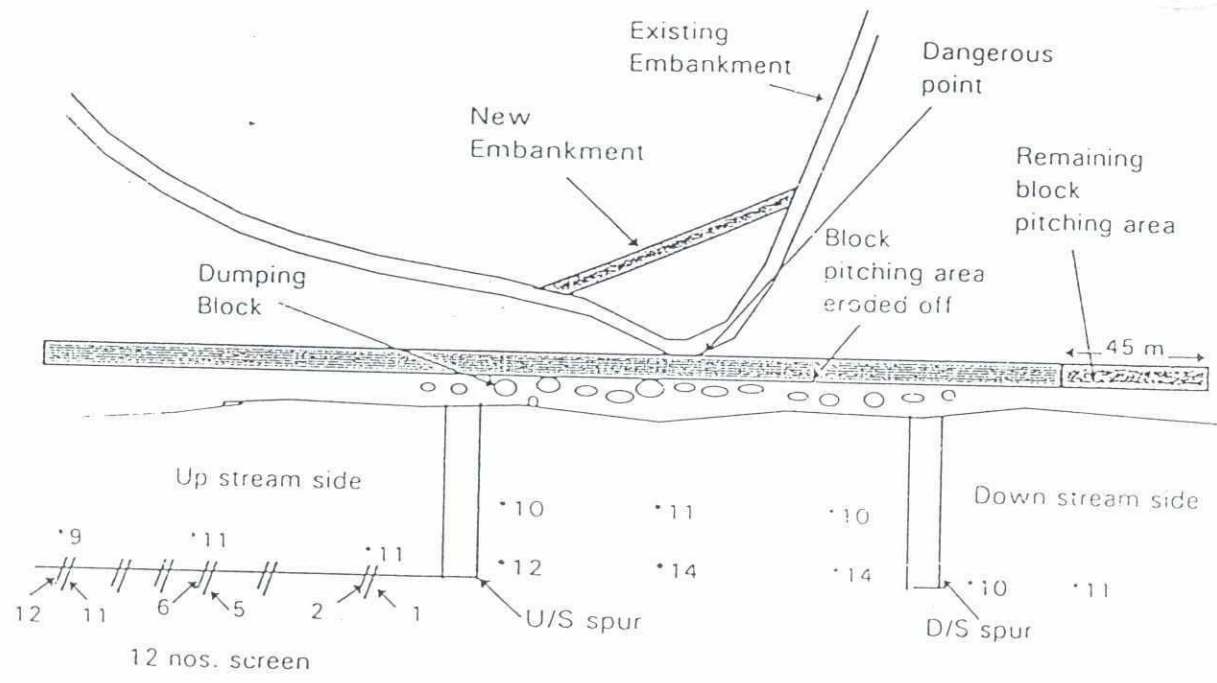
Figure - 13

From September 24 to 26, 1998 the following observations were recorded at site (Fig-13).

Monitoring September 24-26, 1998

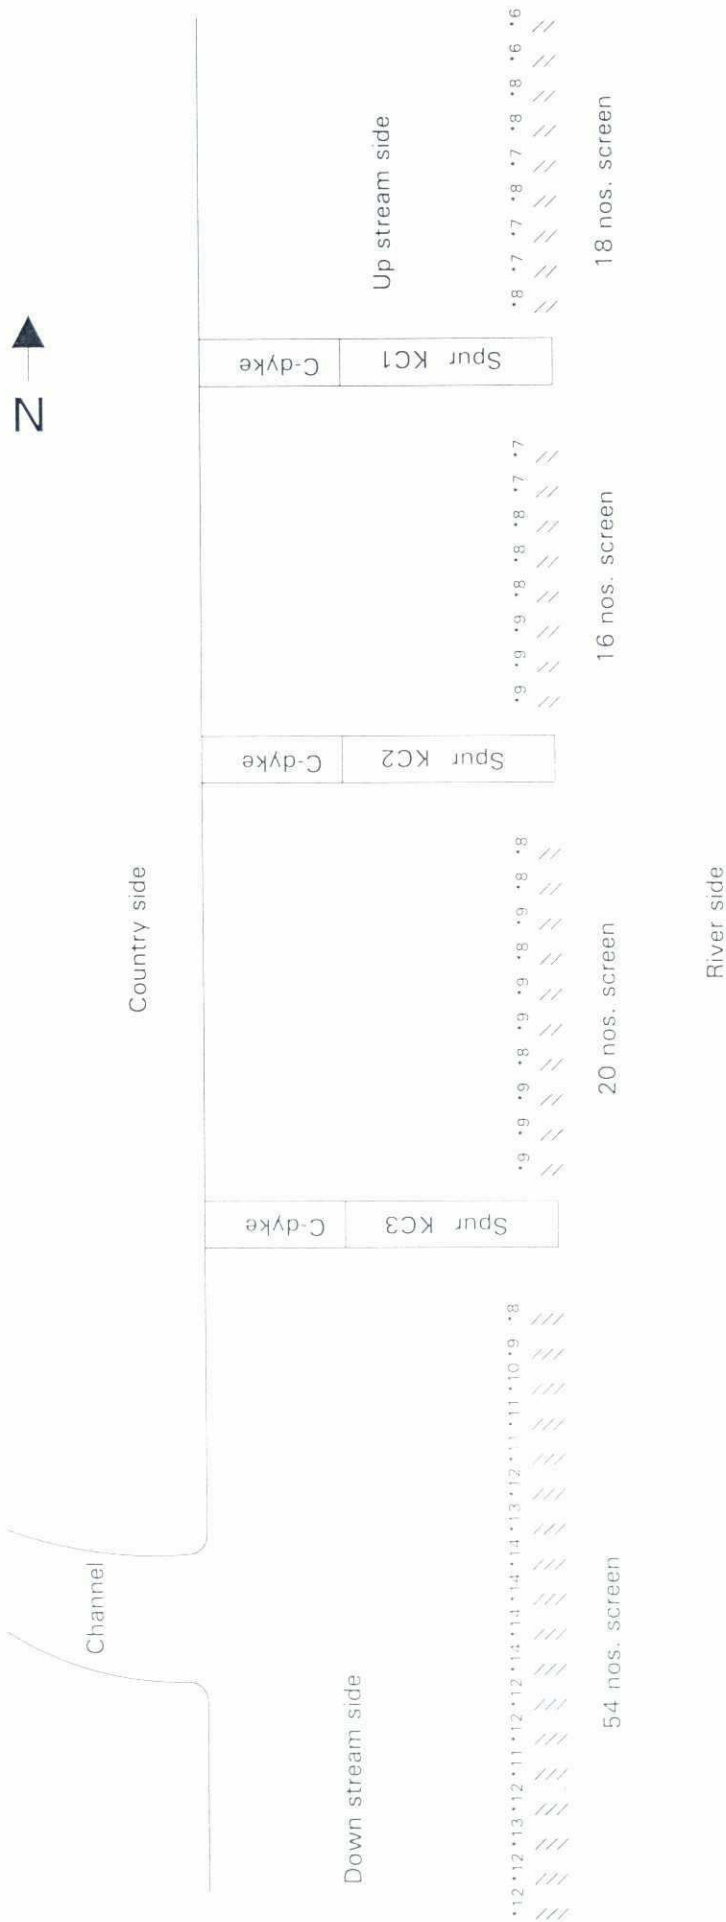
During high tide the water levels were recorded as shown in Fig-16.

Figure 16: Monitoring November 15, 1998

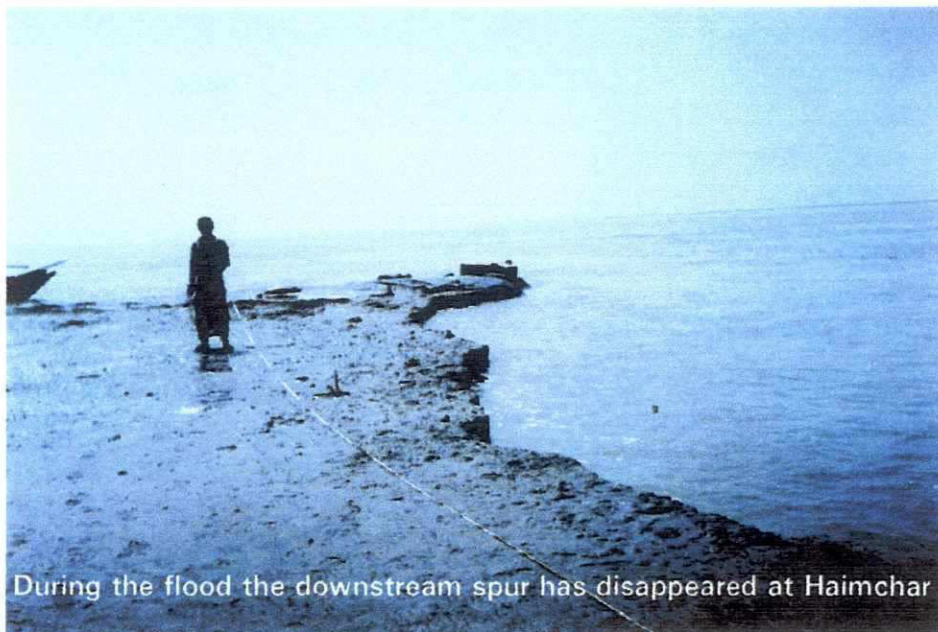
Picture 9 Haimchar

During the flood the downstream spur has disappeared at Haimchar

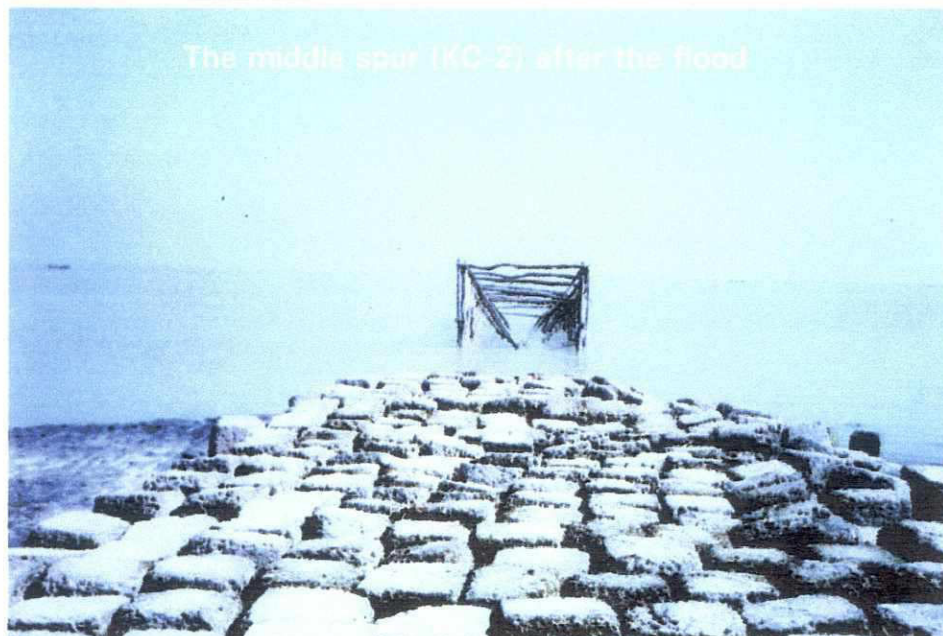
Picture 11 Khorki

Both spurs were found OK (Picture 11). Siltation was observed on the geotextile bed mattresses around the spurs. The Profix was in place.

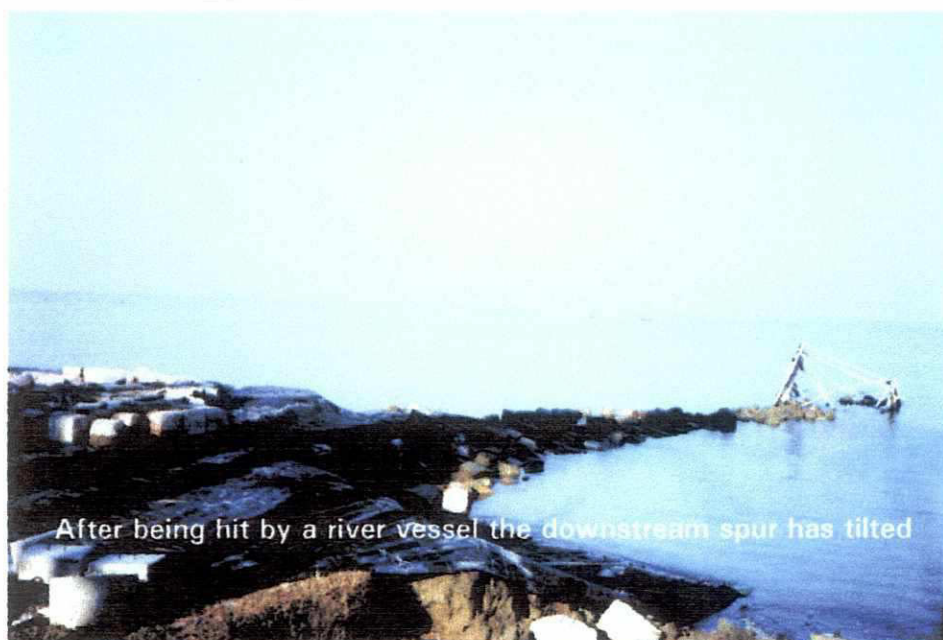
Picture 12 Khorki

It was hit by a big river vessel and was tilted towards north (Picture 12). But the spur as a unit was in position. However some of its bullahs and bamboos were damaged. Bank erosion downstream of spur 3 has reached up to the spur. 2 nos. of Profix blankets were washed away exposing the river bank slope near the spur.

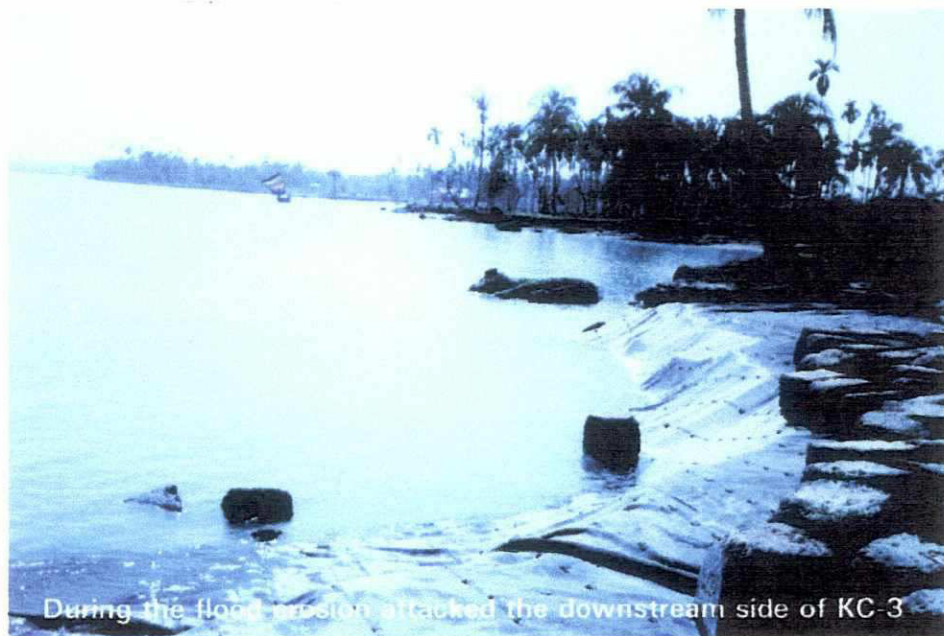
Picture 13 Khorki

30 meters downstream of spur KC-3, 13 meters erosion was recorded (picture 13). No shoreline regression was observed in between the spurs KC-1, KC-2 and KC-3. In picture 14 the unharmed shoreline upstream of the upstream spur (KC-1) is shown. The siltation pattern at the upstream side of the middle spur (KC-2) can be seen in picture 15. Siltation is visible at the upstream side of the downstream spur (KC-3, Picture 16).

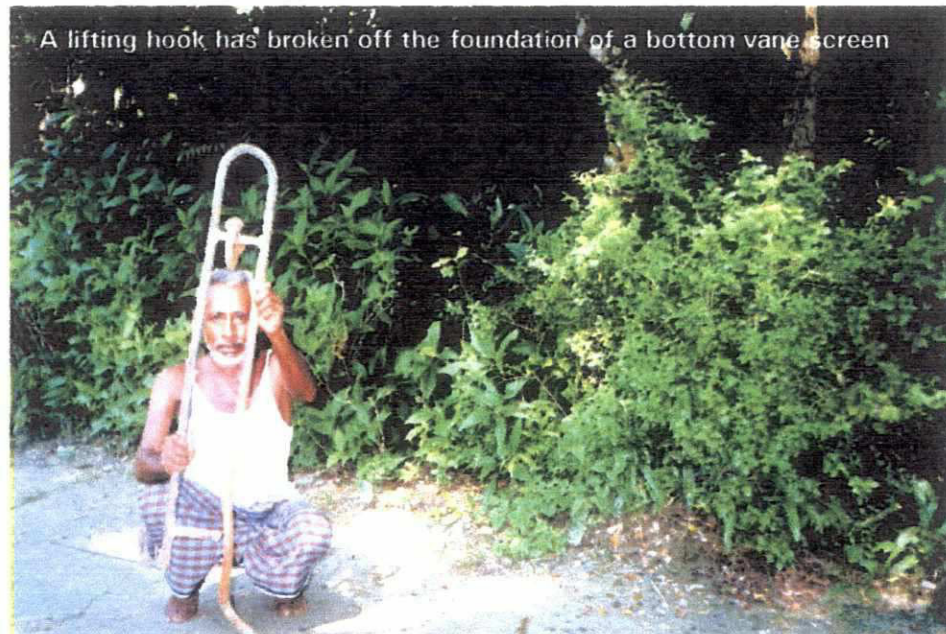
Picture 17

One screen was disconnected from the riverbed on November 15th 1998. The one meter long lifting hook was separated from the anchor slab (Picture 17). The top float pipe was flattened. It might have been hit by a river vessel which might have dragged the screen causing failure of the lifting hook.

- The anchor blocks were designed with attachment of 1 m ling lifting hook (Fig-7). The Bottom Vane Screens are attached to this hook. During installation also these hooks are used for shifting purpose of the blocks. Thus the hooks are subjected to force in various directions. Failure of these hooks was observed during monitoring period (Picture-17). The lifting hooks of the anchor slabs need to be strengthened to handle the pulling force in all directions.

- The length of the lifting hook has to be reduced from 100 cm to 60 cm.
- Failure of anchor hook of RCC beam attached to bottom vane screens has been observed during monitoring period (Fig-14). The anchor hooks at both ends of the R.C.C. beam need to be strengthened.
