# ASSESSMENT OF THE POSSIBILITY OF EROSION OF TANGAIL TOWN AND ITS ADJACENT AREA BY THE RIVER JAMUNA AND ITS PROBABLE REMEDIAL MEASURE

**RESEARCH REPORT**  
**REPORT NO. RES-4 (2001)**

**JUNE 2001**

**RIVER RESEARCH INSTITUTE, FARIDPUR**  
**Ministry of Water Resources**  
**Government of the People's Republic of Bangladesh**

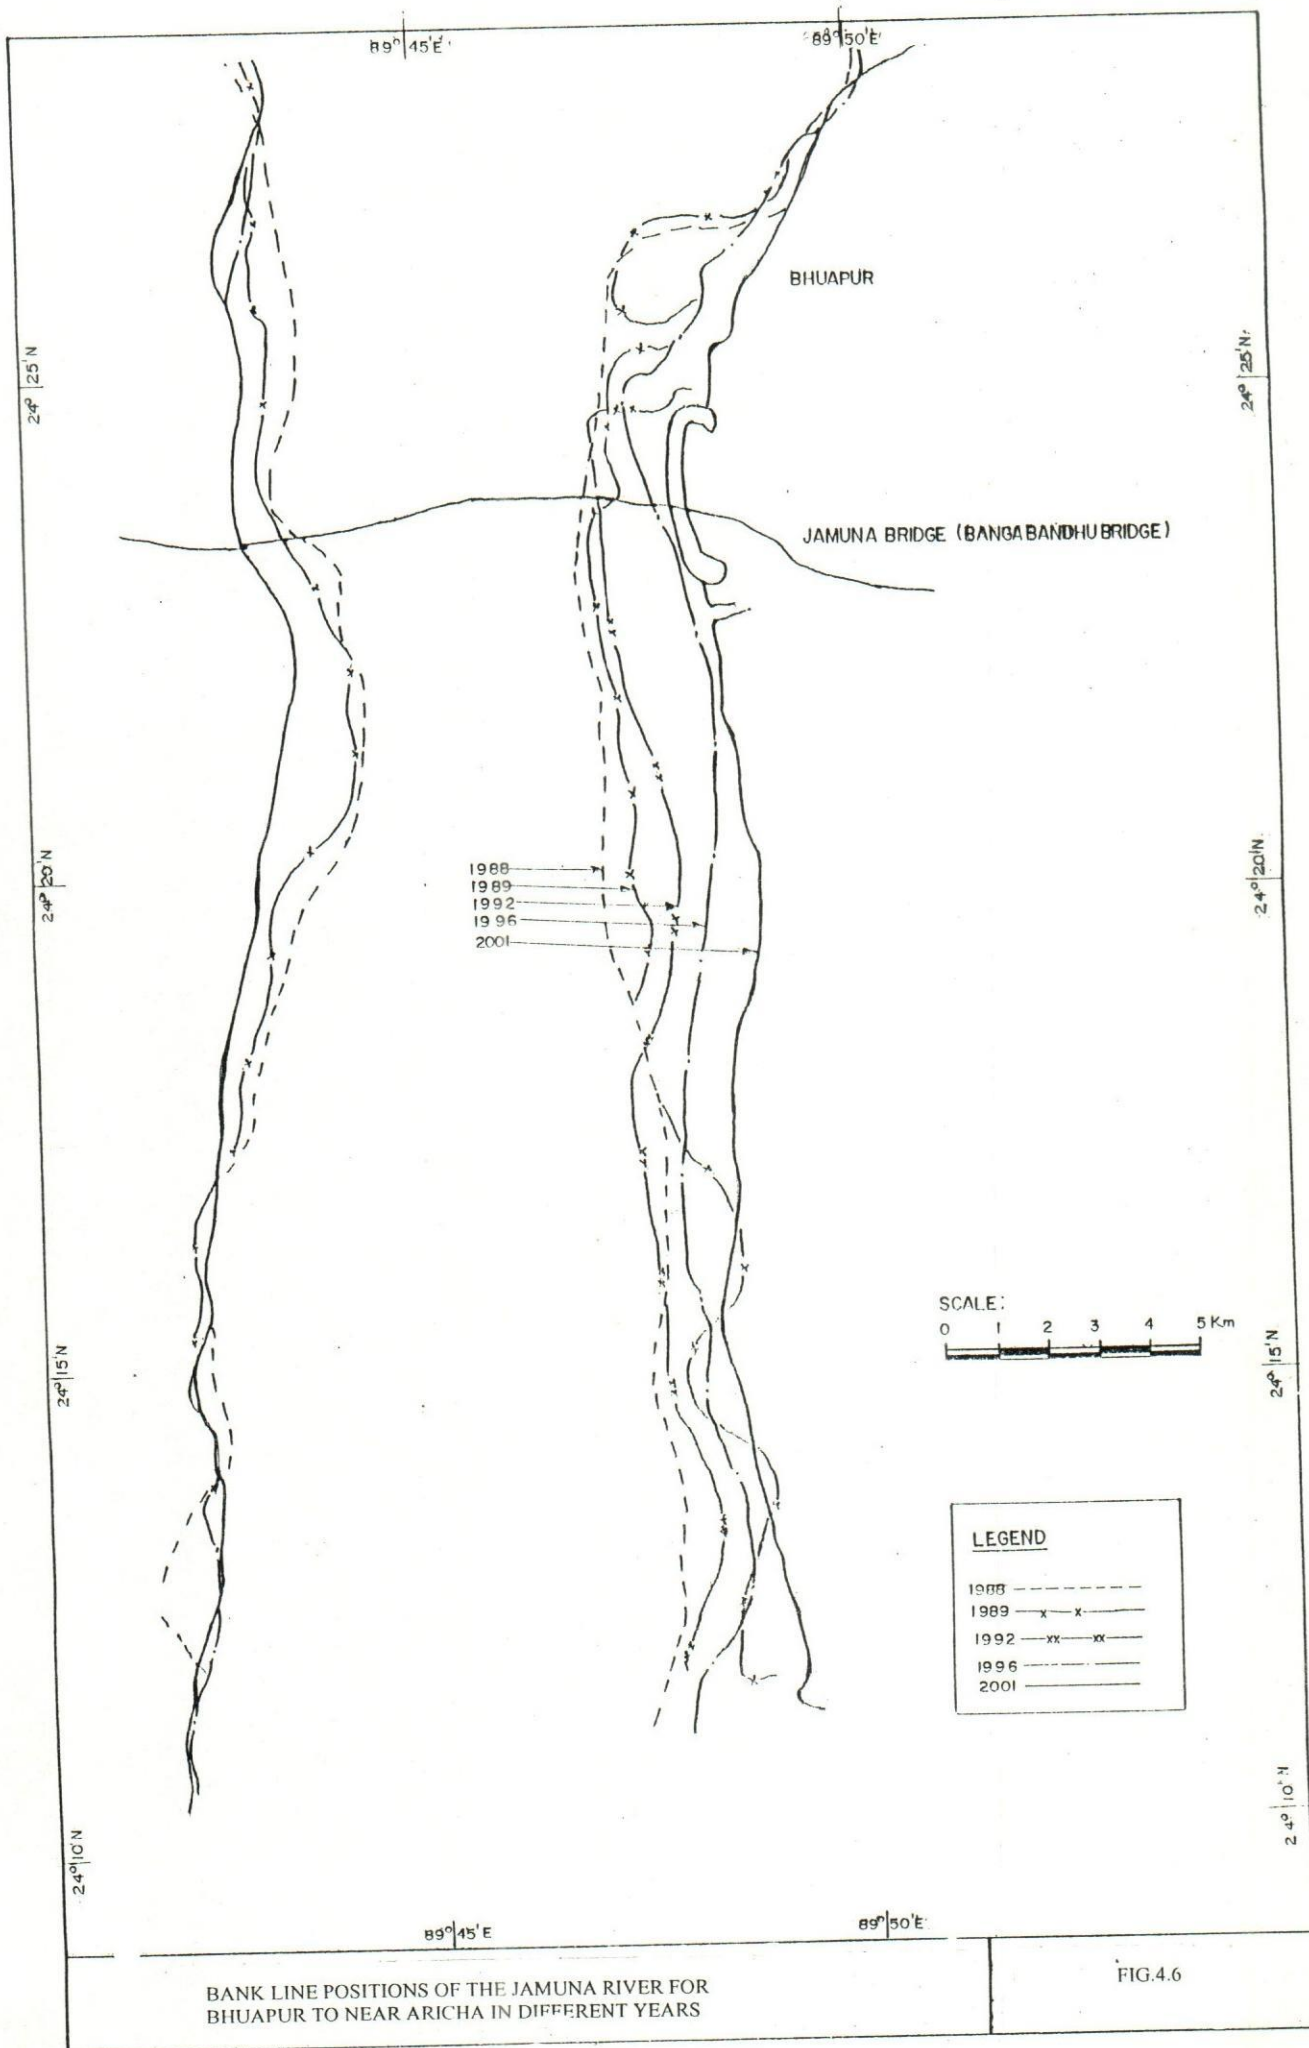
FIG.4.6

Maximum bank erosion rate along the left bank in other years was found in the order of 400-550 m/year for the same river reach (Fig.4.6). Comparing the bank erosion rates in normal flood year with that of high flood year it can be concluded that bank erosion with high discharge is much higher and erosion rate is strongly related with the river discharge in the Jamuna river. From Fig.4.5 & 4.6 it is observed that high bank erosion may occur even in convex bank and straight bank. Usually it is believed that high bank erosion occurs in concave bank. But in the Jamuna, highly braided river severe bank erosion can be occurred in

straight bank also. It is clear from the bank line maps of different years as shown in Fig.4.5 & Fig.4.6.

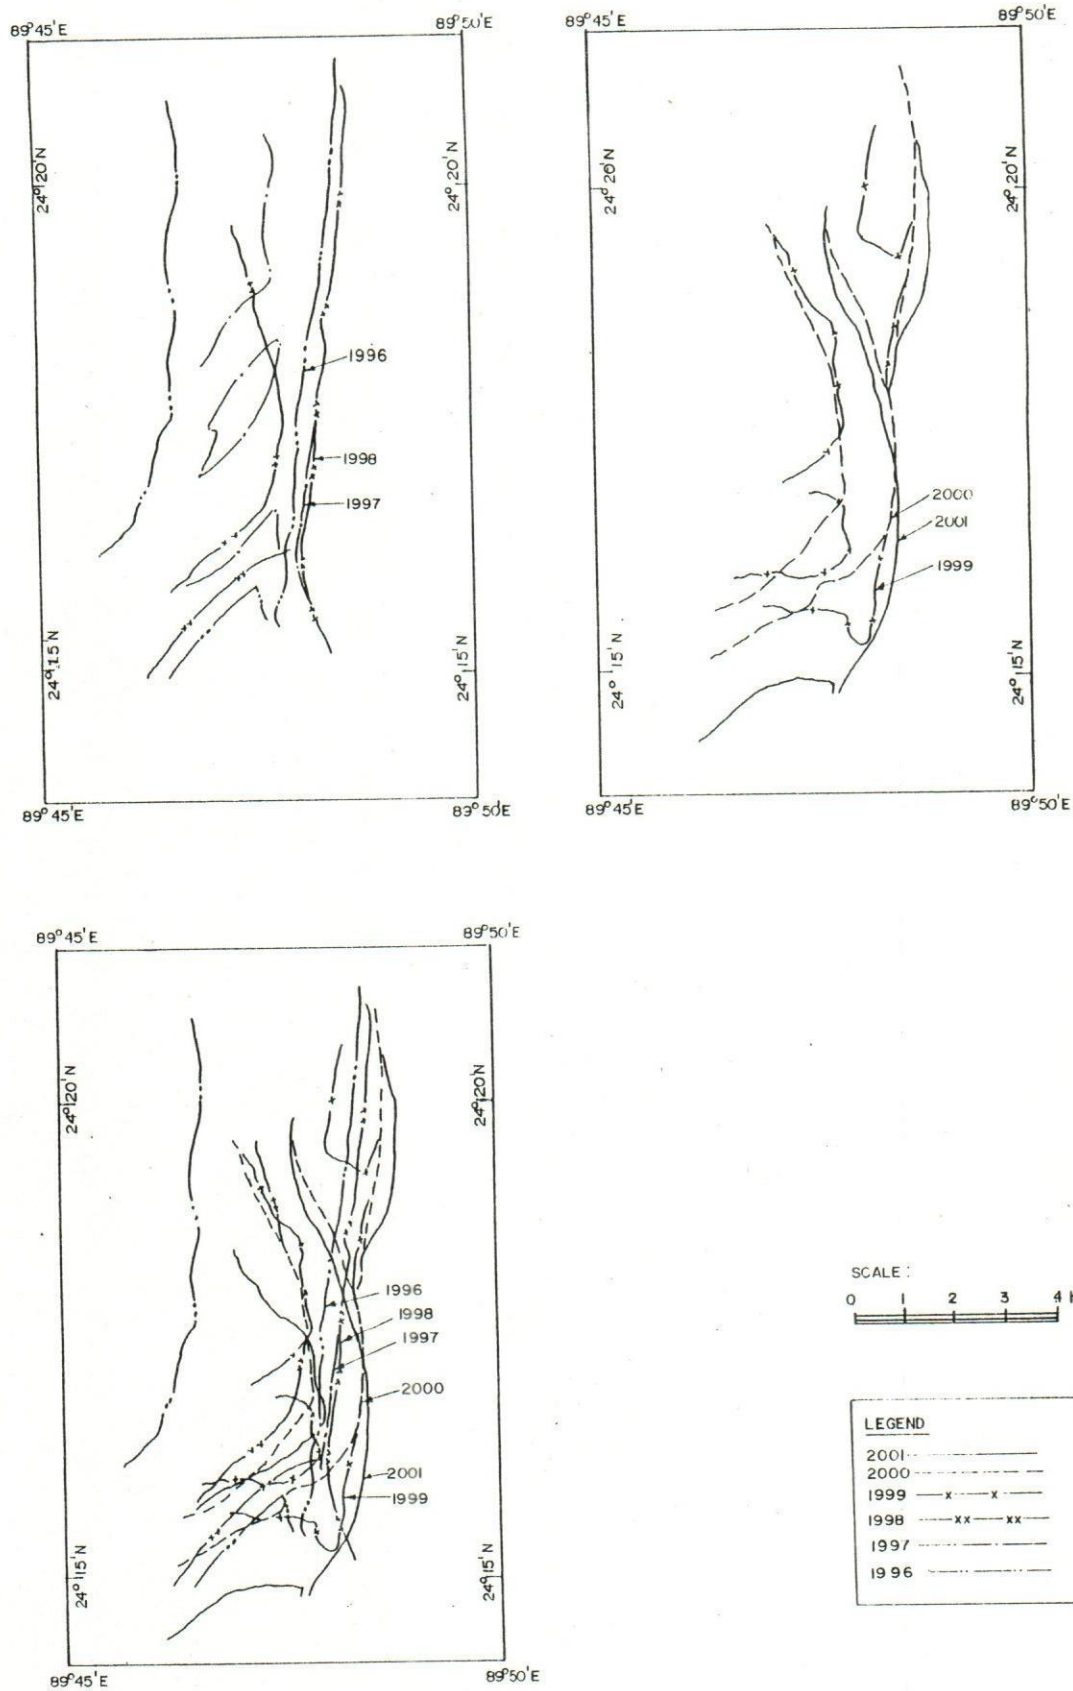
FIG.4.7

Typical bend evolution immediately at the u/s of Tangail town is shown in Fig.4.7. In this figure the upper left figure gradual development of the bend from 1996 to 1998 is shown and in the upper right figure development from 1999 to 2001 is shown. Combination of the above figures is shown in bottom figure.

TYPICAL BEND EVOLUTION IN THE JAMUNA RIVER AT THE D/S OF BANGABANDHU BRIDGE (ALONG LEFT BANK)

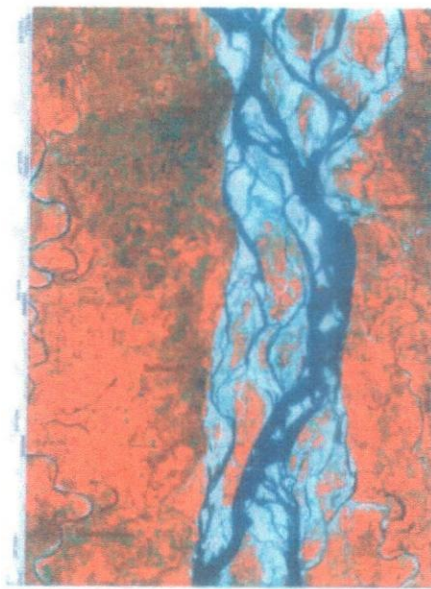
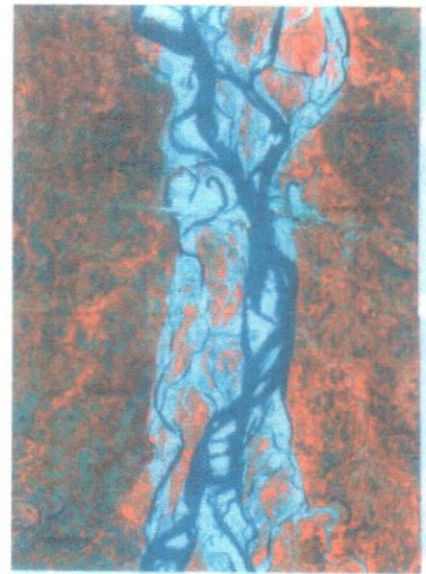
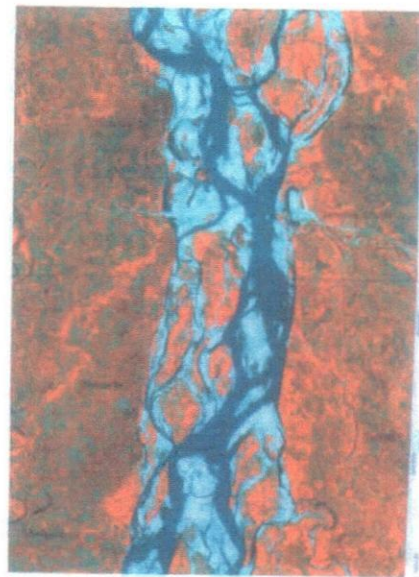
Fig.4.8 Planforms of the Jamuna river in 1996, 1997 & 1998

From satellite images of the year 1973 to 2001 (Fig.4.8 & Fig.4.9) for the study reach it is appeared that in 1973 the main channel of the river at the d/s of Bangabandhu bridge was near the East bank but in 1980 the main channel shifted towards the West bank. Again in 1986 the main channel changed its position and moved to the East bank and from then the main channel remains close to the East bank up to 1998. After 1998 the main channel showed a tendency to gradual movement towards the inside of the river. From Fig.4.9 it can be seen that in 1999 the main channel at the d/s of Bangabandhu bridge bifurcated and this situation remains up to 2000. But in 2001 the main channel divided into three channels. Though from
