Investigation of Geotechnical Reasons for Bank Failure on Daulatdia and Paturia Side of Padma River of Bangladesh.

June 2020

RIVER RESEARCH INSTITUTE, FARIDPUR

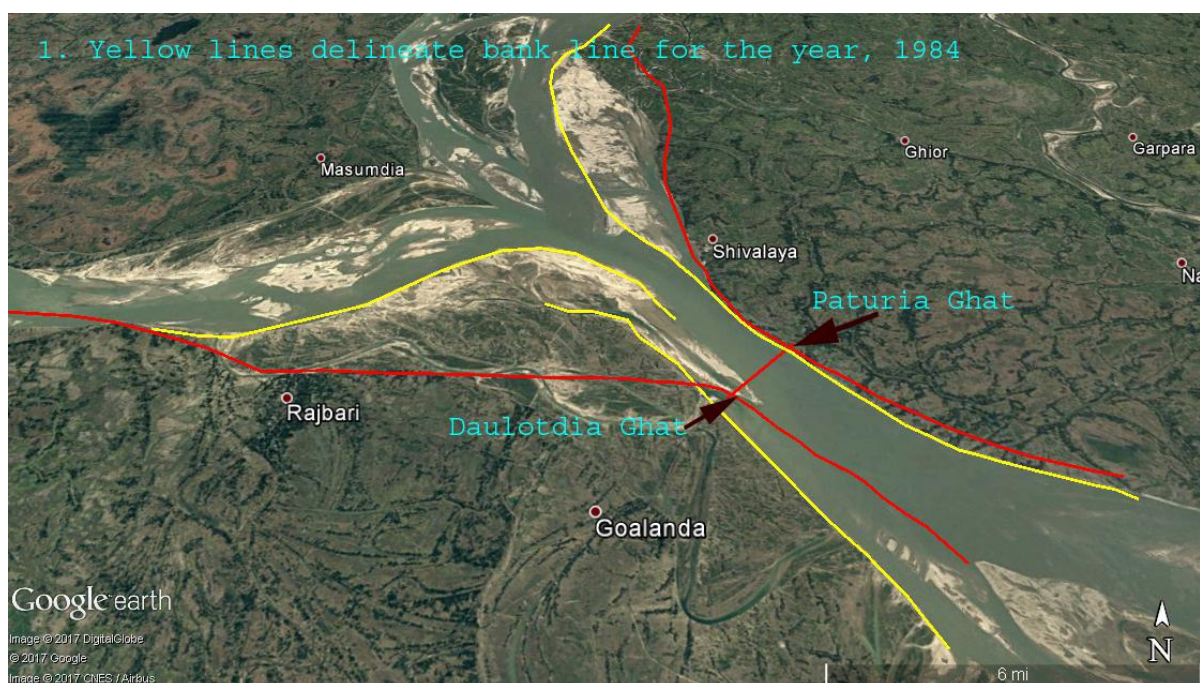
Figure 1.3: Historical Google earth Pro image of Padma river around Daulatdia–Paturia Ghat, 1984

Historical map of satellite images of Google earth Pro. show up that the bank erosion of Daulatdia Ghat of Goalanda at Rajbari district is more worsen than that of Paturia ghat of Manikgonj district of Padma river. In the satellite image, it is found that Padma river has not been shifted profoundly at Paturia from 1984 to till date. But the Padma river has shifted significantly at the Daulatdia ghat and silted up. At that side, it has reclaimed land as a char. People are residing on that char as their livelihood. The image photo has been shown in Fig-1.3 & Fig-1.4 respectively.

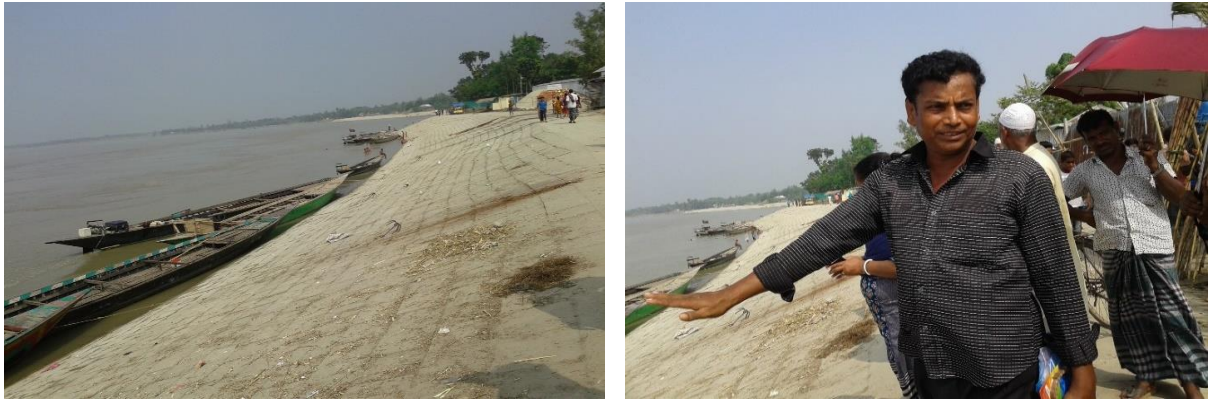
Figure 3.4: Discussion with local people at Jafargonj side of Shibaloy Upazila

Finally, in a question of protection of the river bank they explained their opinion that after construction of Jamuna Bridge at Jamuna River, flow has been lessened of the river. They also commented that river bank can be protected through dumping concrete block and river dredging. The research team has physically observed that the soils at Jafargonj side are light brown color clay on the upper layer and the bed materials are sandy clay.

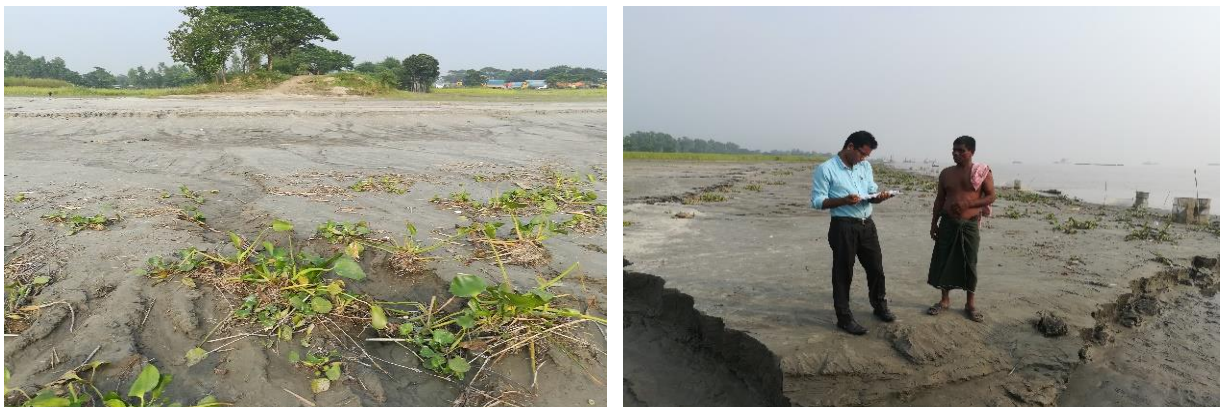
Figure 3.5: Site selection and questionnaire survey at Daskandi, Shibaloy, Manikgonj

The research team has visited then Daskandi of Shibaloy thana and asked some questions to the local people which has been shown in Fig-3.5. They told that the char has developed due to siltation and all the soils here are silt and clay and the sand layer may be obtained below 20 feet of this layer. In a question of a comparison of bank failure at Daulatdia ghat of Rajbari district and the Paturia ghat of Manikgonj district, they answered that the bank failure is massive at the Daulatdia ghat of Rajbari district than the Paturia ghat of Manikgonj district.

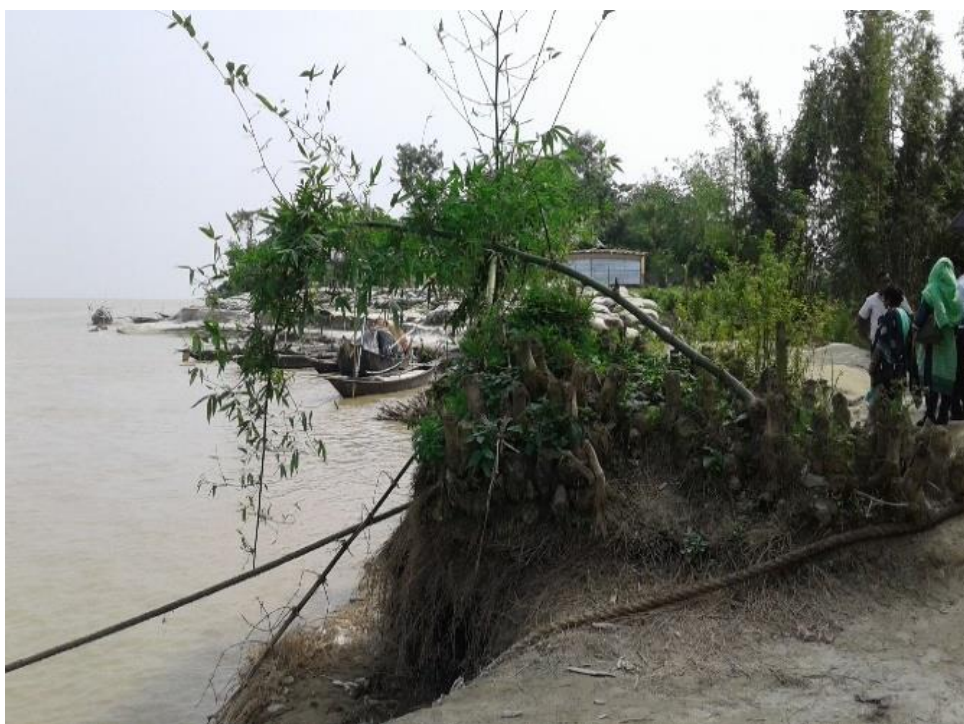
Figure 3.11: Questionnaire survey at erosion prone area, Bahir Char Daulatdia, Goaland, Rajbari

Then the team has visited the location Char Bahirdia Daulatdia, union: Daulatdia, Goalanda, Rajbari adjacent to the ferry ghat which has been shown in Fig-3.11 & 3.12 respectively. The research team asked the people about bank failure. They said that the extensive failure occurs in the month of mid-June to August but the water pressure increases in August. The failure increases when water level rises and the decreases when water level decreases. The bank failure is more at the site of ferry ghat which has been shown in Fig-3.13. The bank failure has been occurred since two years long (2016-2017) and 1.5km failed from the existing river. A question about bank erosion of last ten years,

Finally, in a question of protect the river bank in the ferry ghat area, they recommended in a word that it should be done through river training work permanently and dumping geo-bag and block through proper design with the help of government. Erosion prone area and instant protection has been shown in the table.

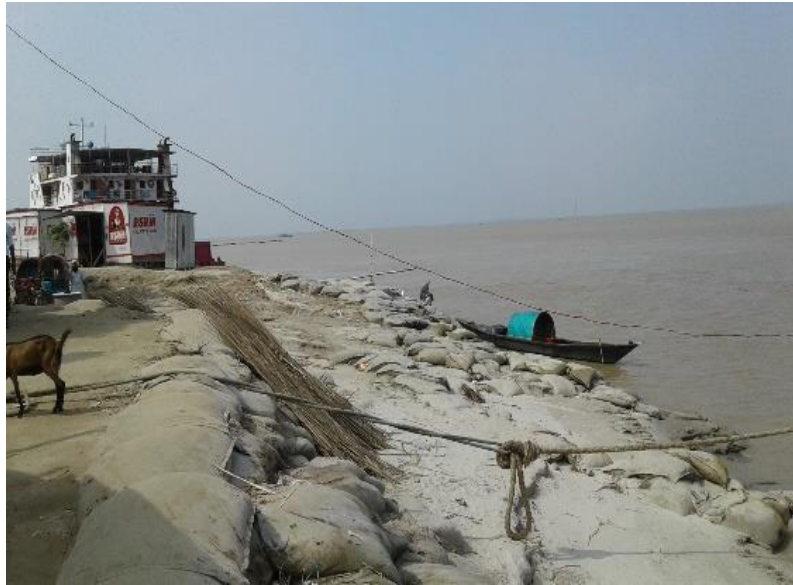
Figure 3.12: Protection work to safe Daulatdia ferry ghat through geo-bag dumping

The BWDB official added that the failure has been increased since 2(two) years. In a question of bank protection they said that BWDB instantly has would protect the ferry ghat as well as bank side on the river through dumping geo-bag.

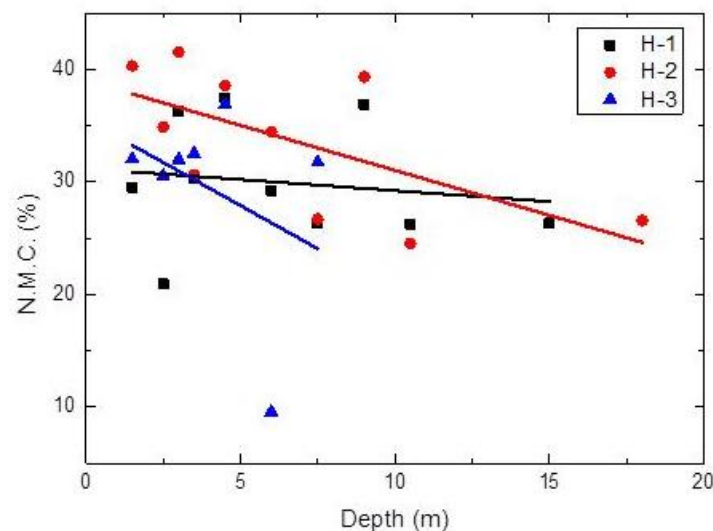
Figure 4.1: Natural moisture content (N.M.C) vs. depth graph for soil of Daskandi at Paturia side

In the location of Paturia side, it has been observed that natural moisture content has been lessened with the increases of depth. The soil strata has been varied from cohesive layer to non-cohesive layer and their particle sizes has been varied from small to high trend.

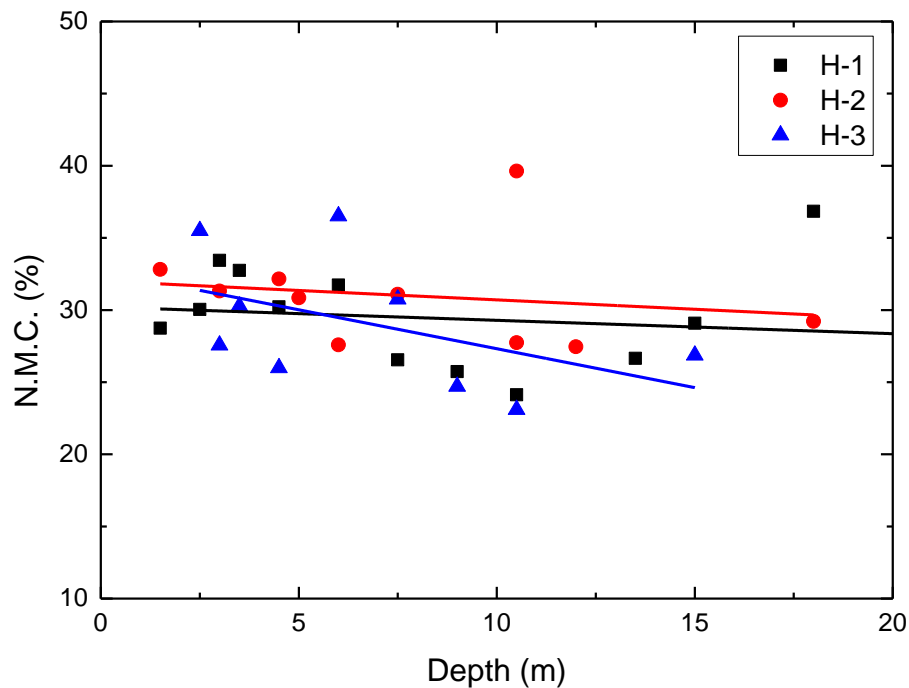
Figure 4.3: Natural moisture content (N.M.C) vs. depth graph for soil of CharBahirdia at Daulatdia side

In the location of Daulatdia side, it has been observed that natural moisture content has been lessened with the increases of depth except in location Afsarsheikher Para. The soil strata has been varied from cohesive layer to non-cohesive layer and their particle sizes has been varied from small to high trend at CharBahirdia and Launchghat however, the soil strata i.e cohesive up to the depth 1.5m and the deposit below up to the depth of exploration consists of non-cohesive strata with variable particle sizes.

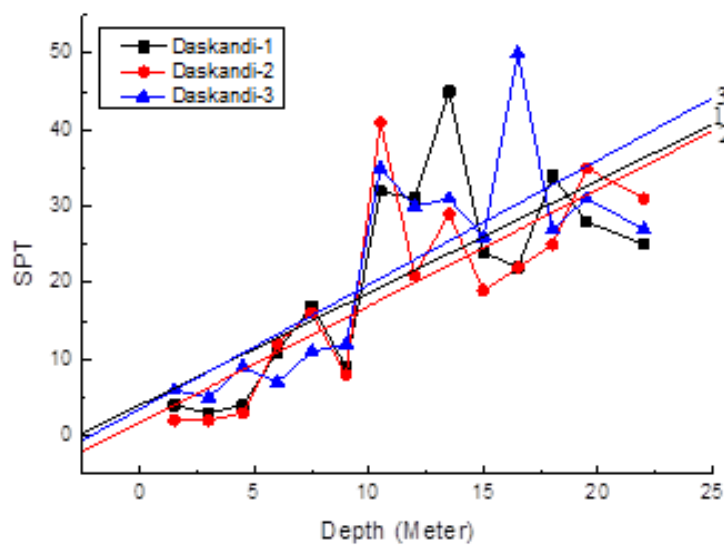
**Figure 4.6:** Standard Penetration Resistance-N (SPT) value vs. depth for soil of Daskandi at Paturia side

Figure-4.6 represents the variation of SPT value with depth. From the graph it is found that SPT values increase with depth in all the holes; however, SPT decreases several times in all the holes as observation states. After analyzing the bore holes of Daskandi at Paturia side, it is decided that these SPT variations have followed the natural moisture content, density, plasticity, particle size, stiffness, age of deposition and other geotechnical properties. By analyzing the soil profile it is also observed that the same depth of the study area does not contain the same soil layer as their ground level is not homogeneous in mPWD.

In hole no.1 –no.3 of Daskandi site, it has been found that cohesive soil layers are up to the depth of about (0-6) m and the layers are non-cohesive up to the depth of exploration. The ground level varies from (6.667-7.617) mPWD where the ground water level varies from (3.3528-3.9624)m on date 30.01.18-01.02.18 at 9hrs. The SPT values are (2-11) for

cohesive soils where the SPT values are (9-45) for non-cohesive soils. The consistency of cohesive soils varies from very soft to stiff and the plasticity varies from low to high plasticity. The clay particle varies from (6-31)%, silt particle varies from (64-84)% and sand particle varies from (4-16)% for cohesive soils. The density index of non-cohesive soils varies from loose to dense and the plasticity is non-plastic. The clay particle varies from (0-1)%, silt particle varies from (7-79)% and sand particle varies from (19-93)%. The cohesion varies from (0-76)kN/m² and the angle of internal friction varies from (12-21)degree. The permeability varies from (1.08E-04-8.27E-02)mm/sec. The specific gravity varies from 2.599-2.715. The pH values vary from (7.72-8.14). The moisture content varies all about (9-42)%.

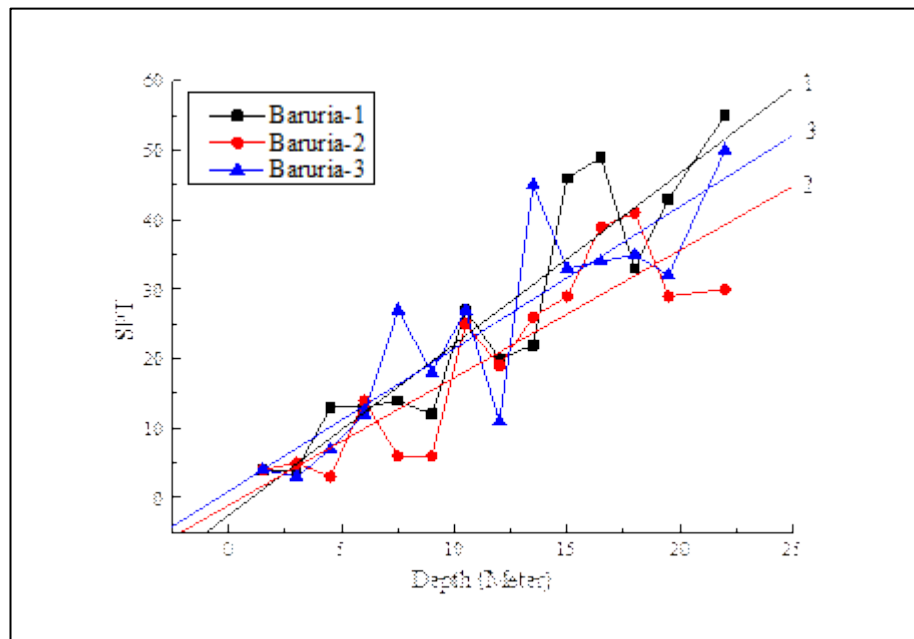
Figure 4.7: Standard Penetration Resistance-N (SPT) vs. depth graph for soil of Baruria site at Paturia side

Figure-4.7 represents the variation of SPT value with depth. From the graph it is found that SPT values increases with depth in all the holes however, SPT fluctuates several times in all the holes as investigation states. After analyzing the bore holes of Baruria at Paturia side, it is decided that these SPT variation has been followed the natural moisture content, density, plasticity, particle size, stiffness, age of deposition and other geotechnical properties. By analyzing the soil profile it is also observed that the same depth of the study area does not contain same soil layer as their ground level is not homogeneous in mPWD.

In hole no.1 –no.3 of Baruria site, it has been found that cohesive soil layers are up to the depth of about (0-9)m and the layers are non-cohesive up to the depth of exploration. The ground level varies from (6.935-9.492)mPWD where the ground water level varies from (3.048-3.6576)mPWD on date 02.02.18-04.02.18 at 9hrs. The SPT values are (3-12) for cohesive soils where the SPT values are (5-55) for non-cohesive soils. The consistency of cohesive soils varies from very soft to stiff and the plasticity varies from medium compressibility to high plasticity. The clay particle varies from (6-40)%, silt particle varies

from(56-84)% and sand particle varies from (2-20)% for cohesive soils. The density index of non-cohesive soils varies from loose to dense and the plasticity is non-plastic. The clay particle varies from(0-1)%,silt particle varies from(8-20)% and sand particle varies from(80-91)%.The cohesion varies from (5-19) kN/m² and the angle of internal friction varies from (15-18)degree. The permeability varies from (1.56E-04-6.68E-02)mm/sec. The specific gravity varies from 2.55-2.693. The pH values varies from (7.90-8.04).The mica contents about 8.5%(M-2%,B-5%,C-1.5%). The moisture content varies all about (20-43)%.

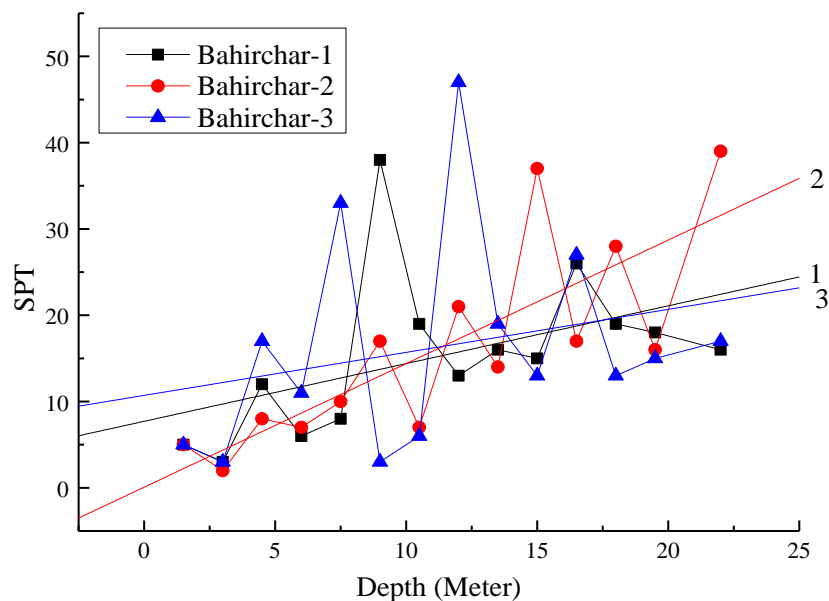
Figure 4.8: Standard Penetration Resistance-N (SPT) vs. depth graph for soil of CharBahirdia at Daulatdia side

Figure-4.8 represents the variation of SPT value with depth. From the graph it is found that SPT values increases with depth in all the holes however, SPT fluctuates several times in all the holes as investigation states. After analyzing the bore holes of CharBahirdia at Daulatdia side, it is decided that these SPT variation has been followed the natural moisture content, density, plasticity, particle size, stiffness, age of deposition and other geotechnical properties. By analyzing the soil profile it is also observed that the same depth of the study area does not contain same soil layer as their ground level is not homogeneous in mPWD.

In hole no.1 –no.3 of CharBahirdia site, it has been found that alternate layer of cohesive and non-cohesive soil layers are up to the depth of about (0-9)m and the layers are non-cohesive up to the depth of exploration. The ground level varies from (7.219-8.241)mPWD where the ground water level varies from (3.048-4.572)m on date 05.02.18-07.02.18 at

9hrs. The SPT values are (2-6) for cohesive soils where the SPT values are (3-39) for non-cohesive soils. The consistency of cohesive soils varies from very soft to medium stiff and the plasticity varies from low compressibility to high plasticity. The clay particle varies from (3-9)%, silt particle varies from (68-88)% and sand particle varies from (5-27)% for cohesive soils. The density index of non-cohesive soils varies from very loose to dense and the plasticity is non-plastic. The clay particle varies from (0-1)%, silt particle varies from (7-25)% and sand particle varies from (48-92)%. The cohesion varies from (3-4)kN/m² and the angle of internal friction varies from (5-20)degree. The permeability varies from (7.5E-05-1.67E-02)mm/sec. The specific gravity varies from 2.623-2.77. The pH values varies from (8.01-8.57). The mica contents about (8-10)% (M-2-3%,B-5%,C-1-2%). The moisture content varies all about (12-40)%.

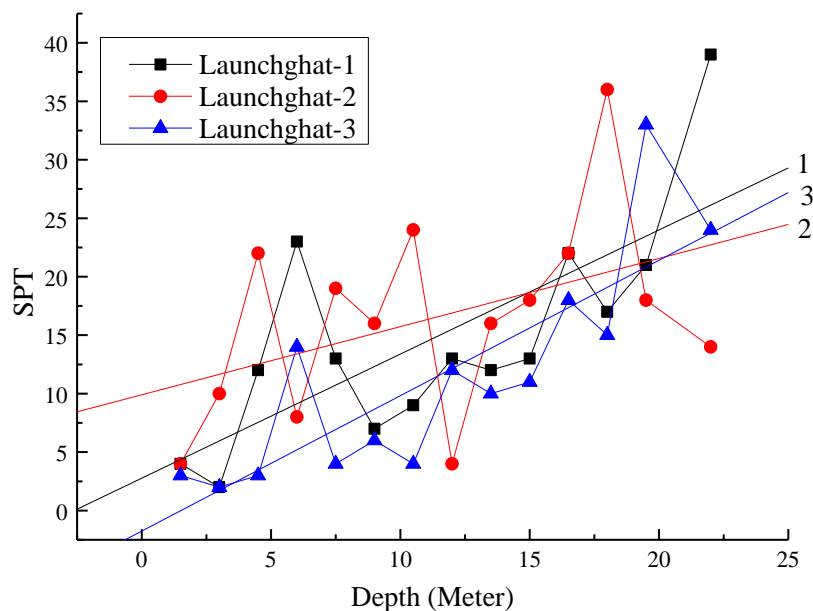
Figure 4.9 Standard Penetration Resistance-N (SPT) vs. depth graph for soil of Launchghat at Daulatdia side

Figure-4.9 represents the variation of SPT value with depth. From the graph it is found that SPT values increases with depth in all the holes however, SPT fluctuates several times in all the holes as investigation states. After analyzing the bore holes of Launchghat at Daulatdia side, it is decided that these SPT variation has been followed the natural moisture content, density, plasticity, particle size, stiffness, age of deposition and other geotechnical properties. By analyzing the soil profile it is also observed that the same depth of the study area does not contain same soil layer as their ground level is not homogeneous in mPWD.

In hole no.1–no.3 of Launchghat site, it has been found that alternate layer of cohesive and non-cohesive soil layers are up to the depth of about (0-12)m and the layers are non-cohesive up to the depth of exploration. The ground level varies from (6.753-9.526) mPWD

where the ground water level varies from (2.7432-5.7912)m on date 08.02.18-10.02.18 at 9hrs. The SPT values are (3-14) for cohesive soils where the SPT values are (3-39) for non-cohesive soils. The consistency of cohesive soils varies from soft to stiff and the plasticity is medium. The clay particle varies from (10-18)%, silt particle varies from (75-79)% and sand particle varies from (8-18)% for cohesive soils. The density index of non-cohesive soils varies from very loose to dense and the plasticity is non-plastic. The clay particle varies from (0-2)%, silt particle varies from (7-64)% and sand particle varies from (18-93)%. The cohesion varies from (1-25)kN/m² and the angle of internal friction varies from (4-31)degree. The permeability varies from (4.8E-05-8.27E-02)mm/sec. The specific gravity varies from 2.646-2.70. The pH values varies from (7.71-8.70). The mica contents about (8-10)% (M-4-5%, B-2-3%, C-2%). The moisture content varies all about (16-44)%.

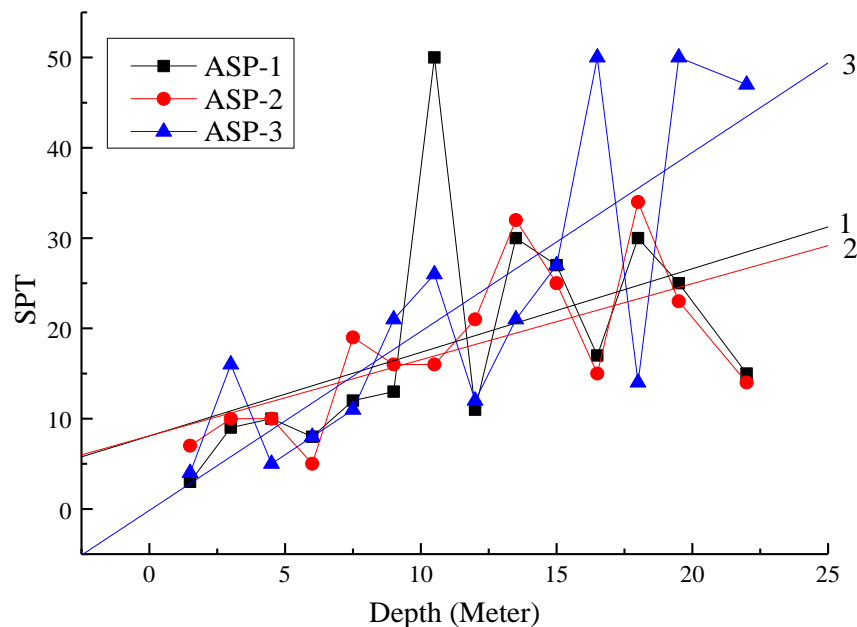
Figure 4.10: Standard Penetration Resistance-N (SPT) vs. depth graph for soil of Afsarsheikher Para at Daulatdia side

Figure-4.10 represents the variation of SPT value with depth. From the graph it is found that SPT values increases with depth in all the holes however, SPT fluctuates several times in all the holes as investigation states. After analyzing the bore holes of Afsarsheikher Para at Daulatdia side, it is decided that these SPT variation has been followed the natural moisture content, density, plasticity, particle size, stiffness, age of deposition and other geotechnical properties. By analyzing the soil profile it is also observed that the same depth of the study area does not contain same soil layer as their ground level is not homogeneous in mPWD.

In hole no.1 –no.3 of Afsarsheikher Para site, it has been found that cohesive soil layer is up to the depth of about (0-2) m and the layers after that are non-cohesive up to the depth of exploration. The ground level varies from (7.353-8.073) mPWD where the ground water level varies from (4.2672-6.4008)m on date 10.02.18-12.02.18 at 9hrs. The SPT values are (3-7) for cohesive soils where the SPT values are (5-50) for non-cohesive soils. The consistency of cohesive soils varies from soft to medium stiff and the plasticity is medium. The clay particle varies from (9-18)%,silt particle varies from(66-84)% and sand particle varies from (4-16)% for cohesive soils. The density index of non-cohesive soils varies from loose to dense and the plasticity is non-plastic. The clay particle varies from(0-1)%,silt particle varies from(3-76)% and sand particle varies from(23-97)%.The cohesion varies from (0-6)kN/m² and the angle of internal friction varies from (17-24)degree. The permeability varies from (7.15E-05-8.07E-02)mm/sec. The specific gravity varies from (2.663-2.721). The pH values varies from (8.10-8.42).The mica contents about (6-12)% (Where, Muscovite-(1-5)%,Biotite-(3-6)%,Chlorite-(1-2)%). The moisture content varies all about (7-34)%.

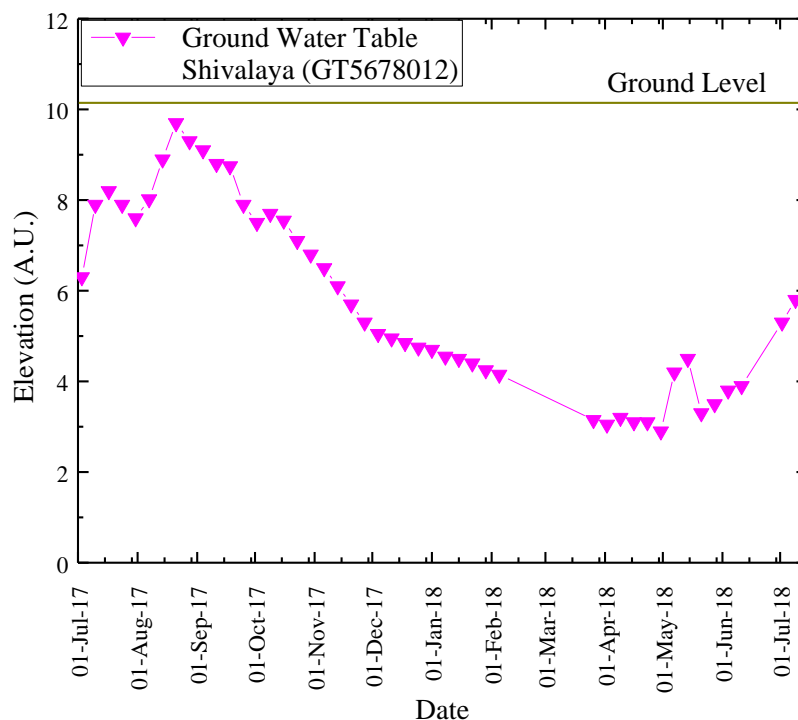
Figure 4.11: Graph showing the variation of Ground Water Level from July'17 To July'18 at Paturia side of Padma River (Source: BWDB)

In figure-4.11 ground water level with time has been presented. From this graph it has been observed that ground water level is adjacent to ground level on the mid of August'17

and then the ground water level has been decreased up to April. The level has been raised after then.

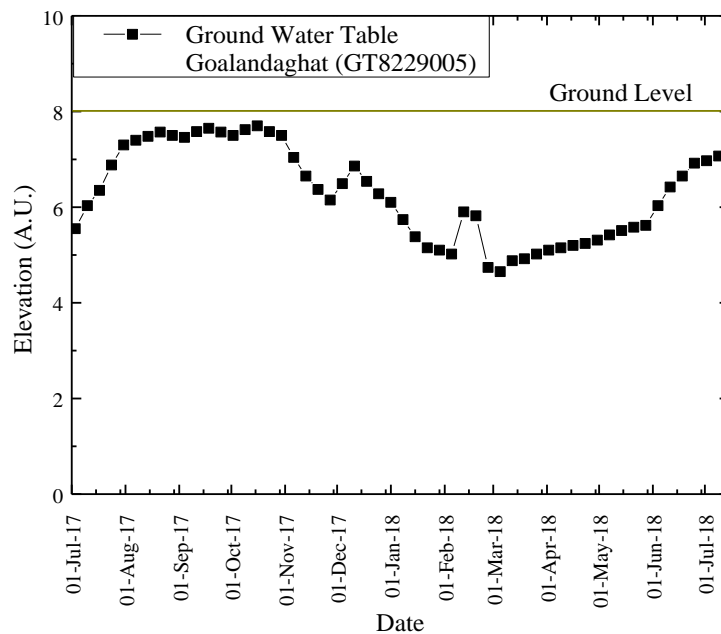
Figure 4.12: Graph showing the variation of Ground Water Level from July'17 To July'18 at Daulatdia side of Padma River (Source: BWDB)

In figure-4.12 ground water level with time has been presented. From this graph it has been observed that ground water level is adjacent to ground level on the mid of August'17 to mid of October'17 and then the ground water level has been decreased up to April'18. The level has been raised after then.

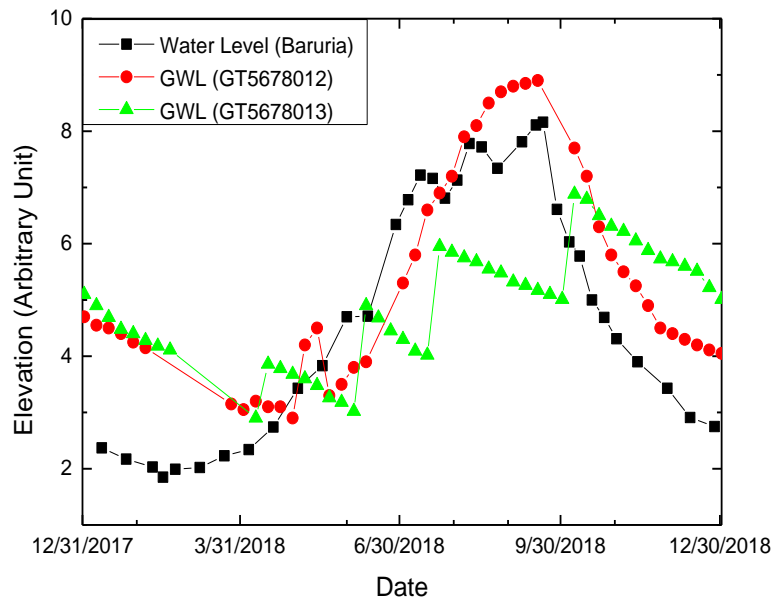
Figure 4.13: Graph represents the surface water level (SWL) of Baruria and ground water level (GWL) of 2 stations of Shivalaya, Manikganj with time (Source: BWDB).

In figure-4.13 the variation of ground water table of two stations of Shivalaya of Manikgonj and the surface water level of Baruria of Paturia side of Manikgonj on March'2017 to March'2018 have been shown in the graph. In the graph it has been found that ground water level changes with the change in surface water level. In the month of mid of March surface water level is lower where it has been gradually increased after then. The increasing trend of water level is up to the month of September'18. The water level has been decreased rapidly up to the month of December'18. On the other hand, the ground water level decreases up to May'18 and gradually increases up to the month June'18 and then rapidly increases up to the mid of September,18 and then decreased rapidly up to the month of November'18 and gradually decreased up to the month December,18.

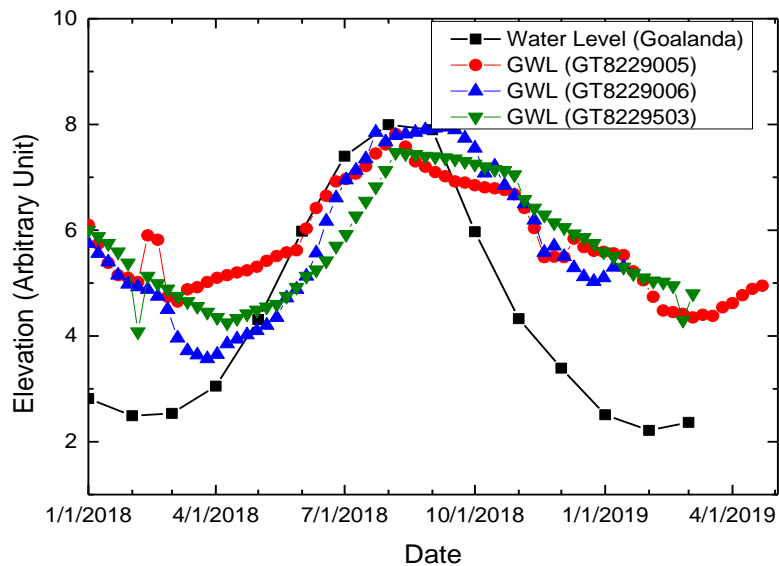
Figure 4.14: Surface water level (SWL) of Goalandaghat and ground water level (GWL) of 3 stations of Goalandaghat, Rajbari with time (Source: BWDB).

In Figure-4.14 the variation of ground water table of three stations of Goalanda of Rajbari and the surface water level of Goalanda of Daulatdia side of Rajbari on January'2018 to April'2019 have been shown in the graph. In the graph it has been found that ground water level changes with the change in surface water level. In the month of March surface water level is lower where it has been gradually increased after then. The increasing trend of water level is up to the month of September'18. The water level has been decreased rapidly up to the month of December'18. On the other hand, the ground water level decreases up to April'18 and gradually increases up to the month June'18 and then rapidly increases up to the mid of September,18 and then decreased gradually decreased up to the month March'19.

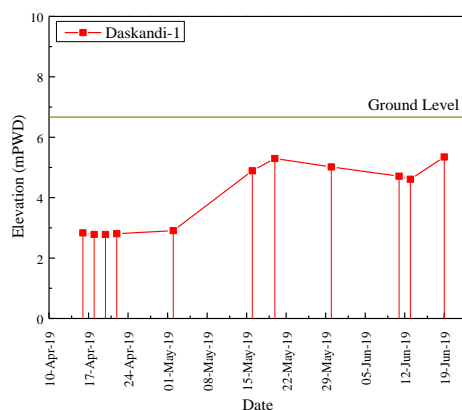
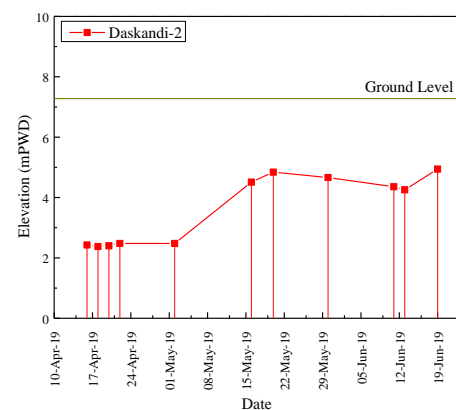
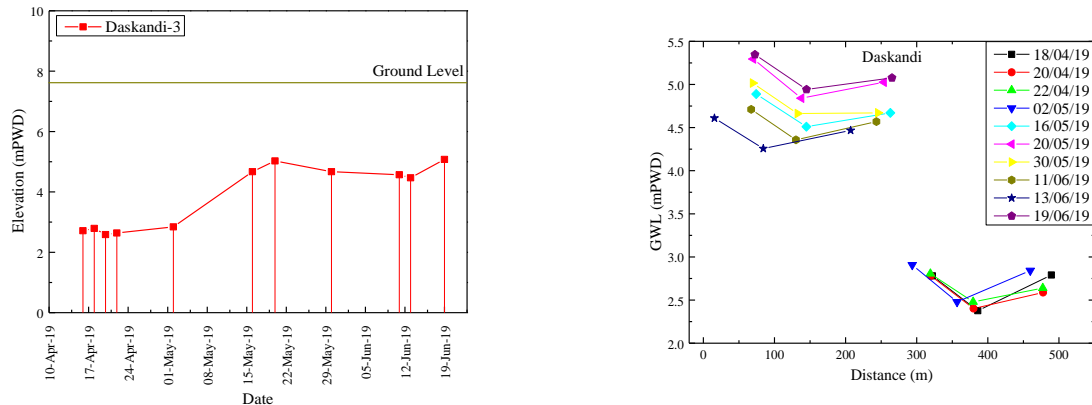
Figure 4.15: Graph showing the ground water level of three holes of Daskandi at Paturia side from April to June'2019

From Figure-4.15 it has been observed that ground water level of different holes at Daskandi of Paturia side has been varied at the same time as the bank line is altered and another is, as soil profile is not homogeneous due to various coordinates. As a result, gradient is different from one to another. Here it is remarkable that the increasing and decreasing tendency is comparable.

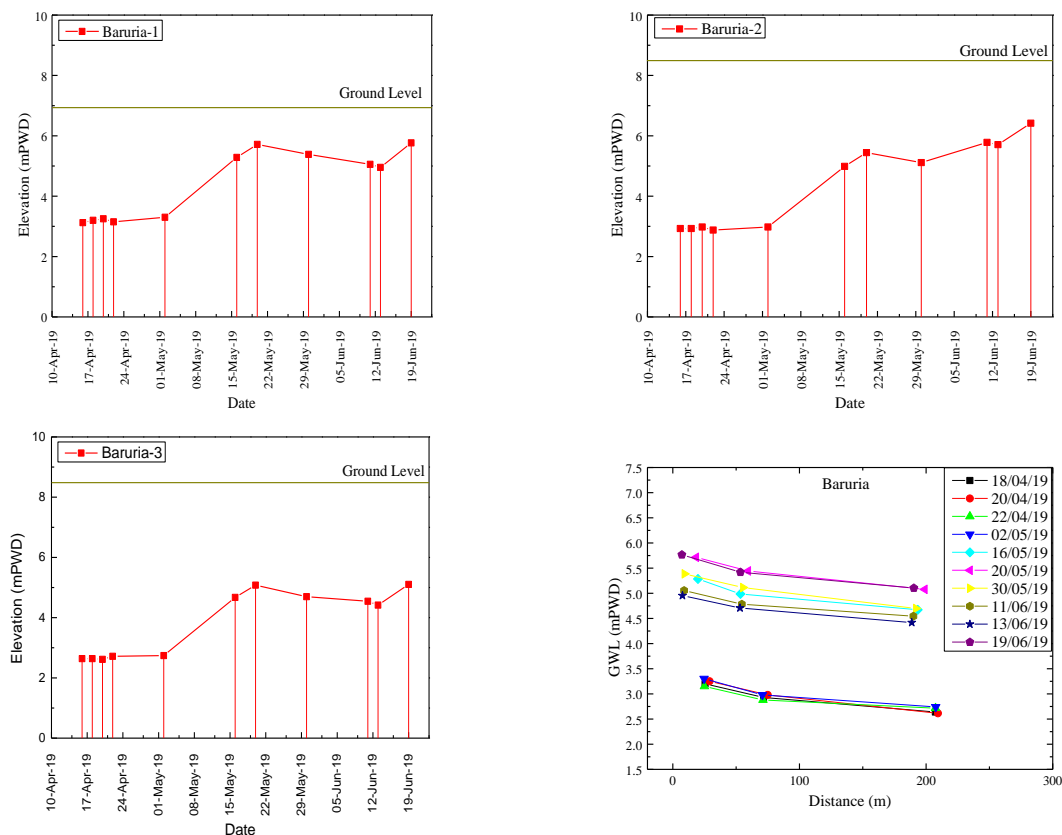
Figure 4.16: Graph showing the ground water level of three holes of Baruria at Paturia side from April to June' 2019

From Figure-4.16 it has been observed that ground water level of different holes at Baroria of Paturia side has been varied at the same time as the bank line is altered and another is, as soil profile is not homogeneous due to various coordinates. As a result, gradient has differed from one to another. Here it is remarkable that the increasing and decreasing tendency is comparable.

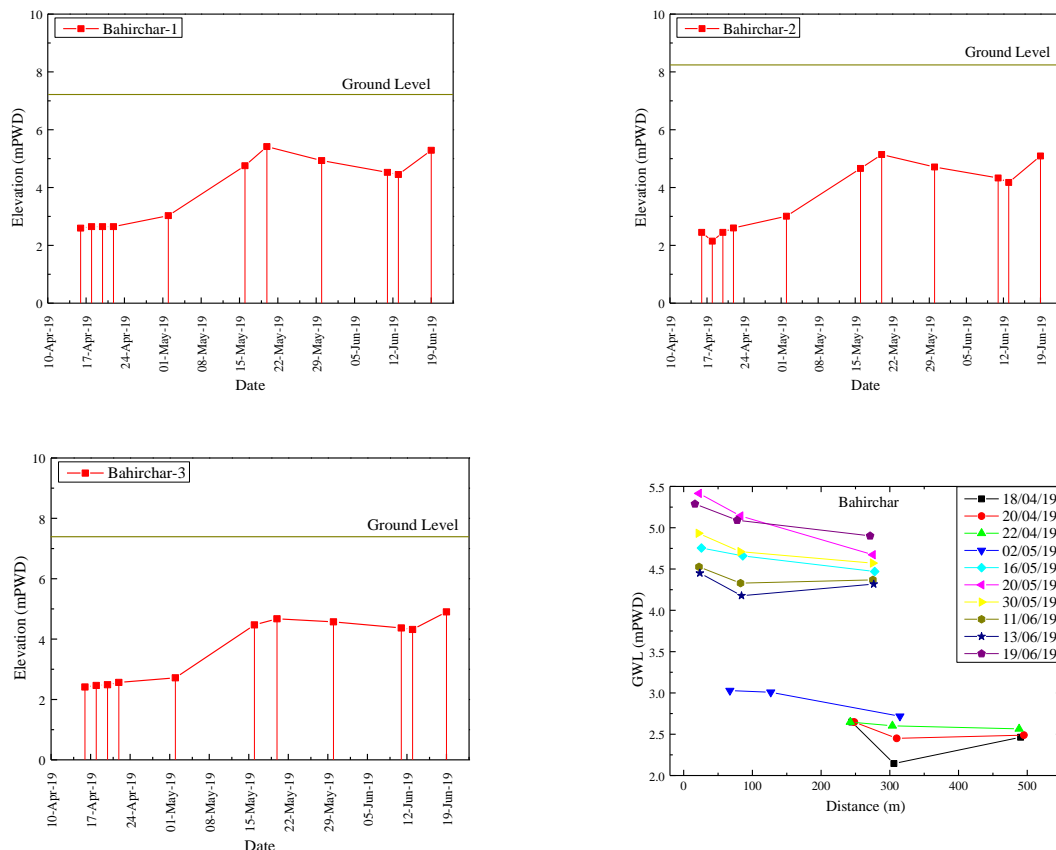
Figure 4.17: Graph showing the ground water level of three holes of CharBahirdia at Daulatdia side from April to June'2019

From Figure-4.17 it has been observed that ground water level of different holes at CharBahirdia of Daulatdia side has been varied at the same time as the bank line is altered and another is, as soil profile is not homogeneous due to various coordinates. As a result, gradient is different from one to another. Here it is remarkable that the increasing and decreasing tendency is comparable.

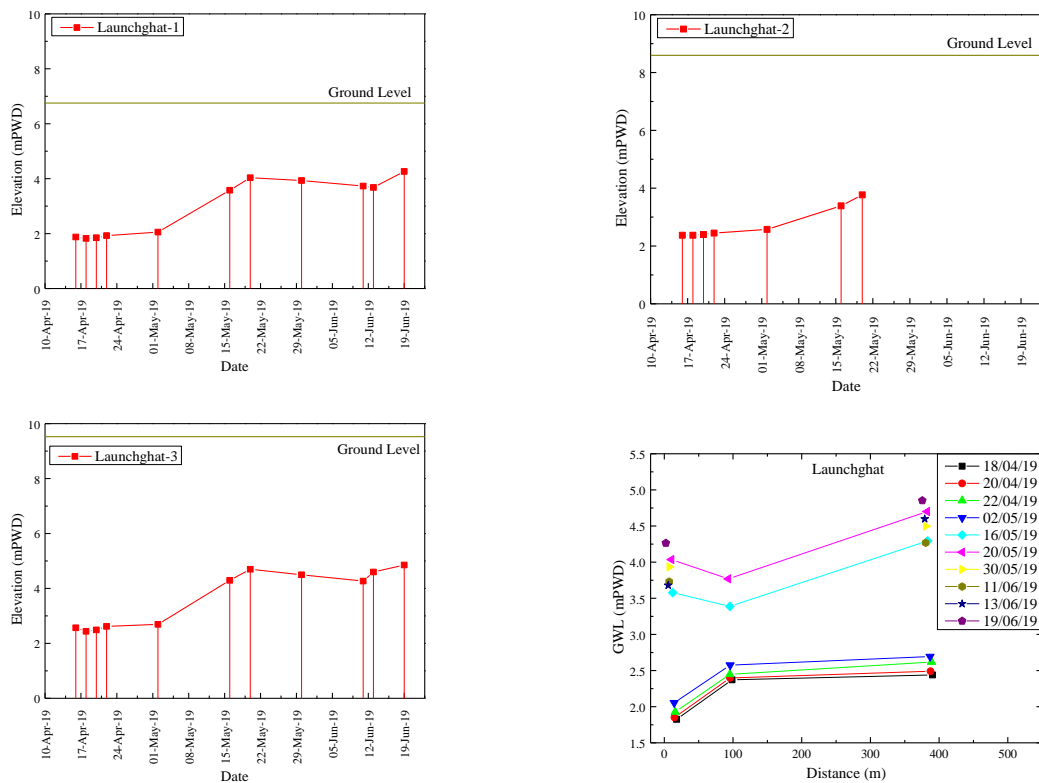
Figure 4.18: Graph showing the ground water level of three holes of Launchghat at Daulatdia side from April to June'2019

From Figure-4.18 it has been observed that ground water level of different holes at Launchghat of Daulatdia side has been varied at the same time as the bank line is altered and another is, as soil profile is not homogeneous due to various coordinates. As a result, gradient is different from one to another. Here it is remarkable that the increasing and decreasing tendency is comparable.

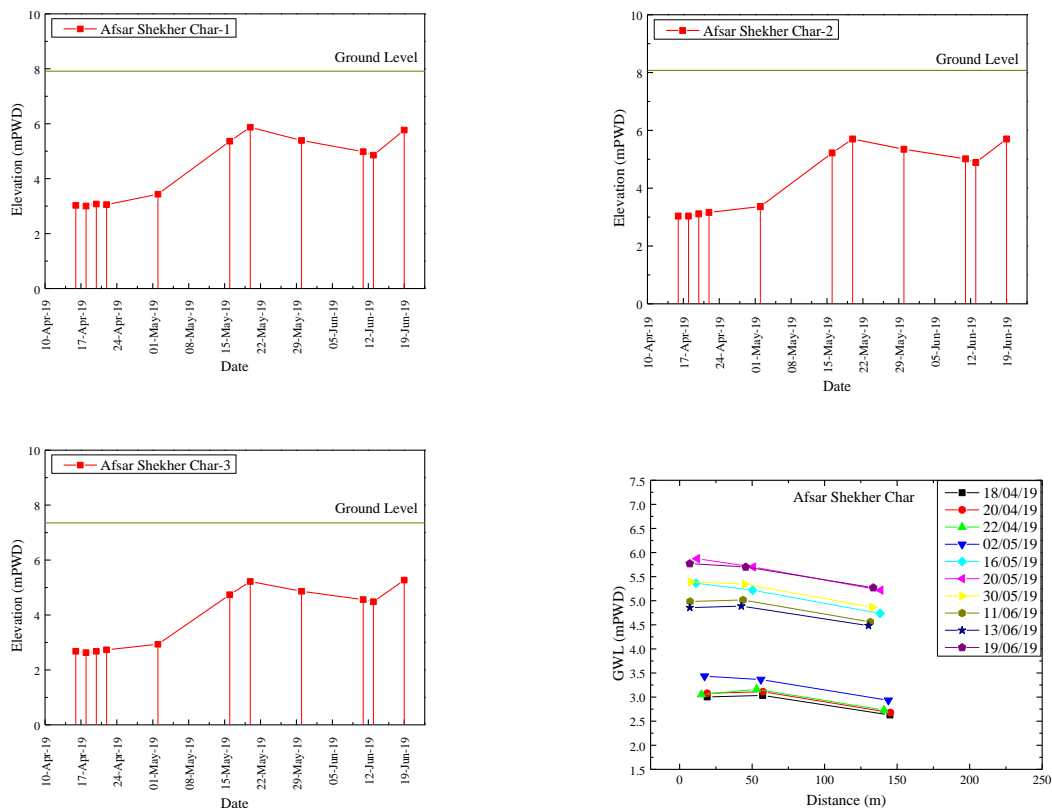
Figure 4. 19: Graph showing the ground water level of three holes of Afsarsheikher Para at Daulatdia side from April to June'2019

From Figure-4.19 it has been observed that ground water level of different holes at Afsarsheikher Para of Daulatdia side has been varied at the same time as the bank line is altered and another is, as soil profile is not homogeneous due to various coordinates. As a result, gradient is different from one to another. Here it is remarkable that the increasing and decreasing tendency is comparable.

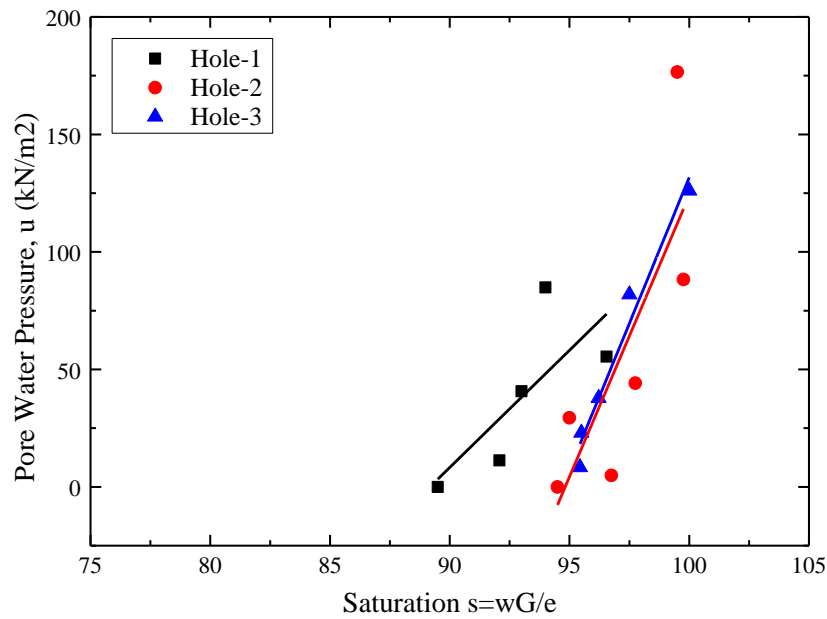
Figure 4.22: Graph showing the effect of saturation on pore prerssure at Baruria of Paturia side of Padma river

In Figure-4.22 the pore water pressure has been plotted with its respective saturation. The data have been considered here on the month of February'18. From fig it is observed that the pore water pressure has been increased with the increases of saturation. It is mentionable that the data would become changed monthly as the location is situated on the river bank and the distance of the holes adjacent to the bank line. The saturation becomes full when the soil is submerged. The saturation has been increased I,e, from 88% to 100% in accordance with its soil properties as it depends on specific gravity as well as void ratio of the soils and its density. Their corresponding pore water pressures have been increased from 0 to 170kN/m² accordingly. However, the saturation at hole no.-1 of Baruria site is slightly dissimilar in comparison with other two holes. It has also been happened due to its soil layers and properties and its ground water level as well as coordinates. In here the ground water level has been changed in accordance with surface water level. Here it is remarkable that reduced level was not existed at the alike coordinate and ground level. That's why the soil layer was not homogeneous however, the location was identical.

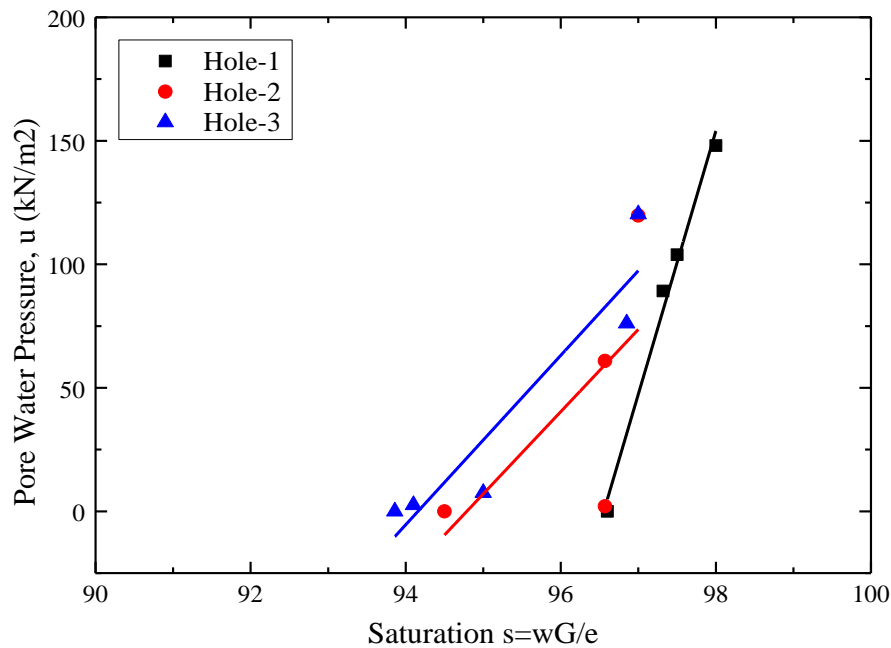
Figure 4.24: Graph showing the effect of saturation on pore pressure at Launchghat of Daulatdia side of Padma river

In Figure-4.24 the pore water pressure has been plotted with its respective saturation. The data have been considered here on the month of February'18. From figure it is observed that the pore water pressure has been increased with the increases of saturation. It is mentionable that the data would become changed monthly as the location is situated on the river bank and the distance of the holes adjacent to the bank line. The saturation becomes full when the soil is submerged. The saturation has been increased i.e from 93% to 97% in accordance with its soil properties as it depends on specific gravity as well as void ratio of the soils and its density. Their corresponding pore water pressures have been increased from 0 to 163kN/m² accordingly. However, the saturation at hole no.-1 of Launch Ghat site has been varied in comparison with other two holes. The variation has been occurred especially here as the hole was very close to bank line. In addition the soil layers, soil properties and its ground water level as well as coordinates were also differed. The most important effect was the ground water level has been changed in accordance with surface water level. Here it is remarkable that reduced level was not existed at the alike coordinate and ground level. That's why the soil layer was not homogeneous however, the location was identical.

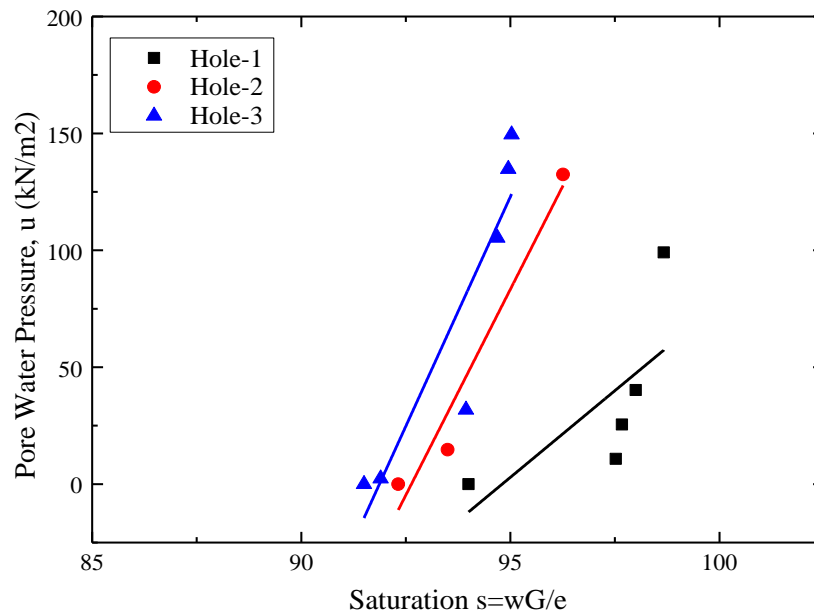
Figure 4.25: Graph showing the effect of saturation on pore pressure at Afsarsheikher Para of Daulatdia side of Padma river

In Figure-4.25 the pore water pressure has been plotted with its respective saturation. The data have been considered here on the month of February'18. From figure it is observed that the pore water pressure has been increased with the increases of saturation. It is mentionable that the data would become changed monthly as the location is situated on the river bank and the distance of the holes adjacent to the bank line. The saturation becomes full when the soil is submerged. The saturation has been increased, e from 91% to 98% in accordance with its soil properties as it depends on specific gravity as well as void ratio of the soils and its density. Their corresponding pore water pressures have been increased from 0 to 164 kN/m² accordingly. However, the saturation at hole no.-1 of Afsarsheikherchar site is slightly different in comparison with other two holes. Here one reason is the hole-No.1 is very adjacent to bank line and another reason is soil layers and its properties. As a result, saturation increased as well as ground water and water level. It is noticed that the ground water level has been changed in accordance with surface water level. Here it is remarkable that reduced level was not existed at the alike coordinate and ground level. That's why the soil layer was not homogeneous however, the location was identical.

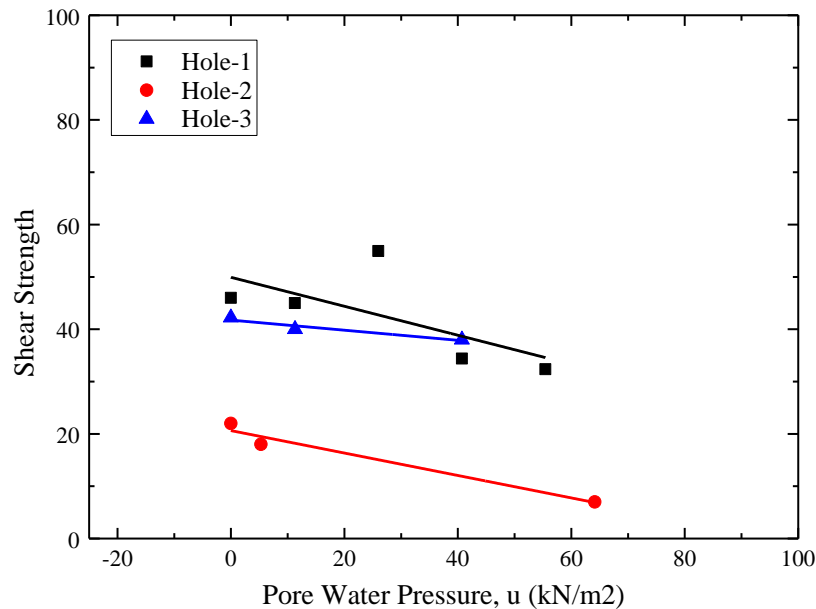
Figure 4.26: Graph showing the effect of pore pressure on shear strength at Daskandi of Paturia side of Padma river

In Figure-4.26 Shear strength has been plotted with corresponding pore pressure. From the graph it is observed that shear strength decreases with the increases of pore water pressure in different pattern in three holes. Such as shear strength of the soils of hole no-1 is more than that of hole no.-2 and hole no.-3 is more or less constant with the increases of pore pressure. The shear strength of the soil of hole no.-2 is less than that of other two holes. Here it is noticed that reduced level was not existed at the alike coordinate and ground level. That's why the soil strength is not homogeneous however, the location was identical.

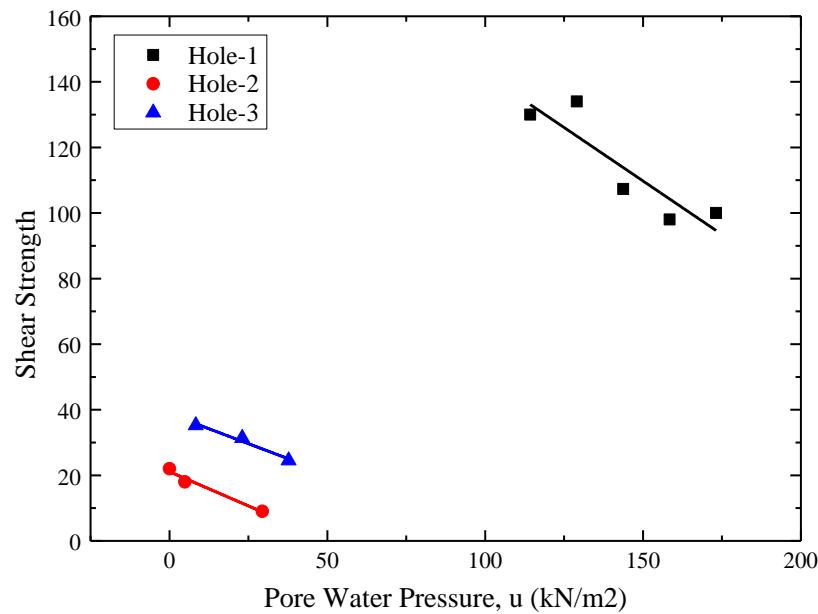
Figure 4.27: Graph showing the effect of pore pressure on shear strength at Baruria of Paturia side of Padma river

In Figure-4.27 Shear strength has been plotted with corresponding pore pressure. From the graph it is observed that shear strength decreases with the increases of pore water pressure in different pattern in three holes. Such as shear strength of the soils of hole no-1 decreases rapidly with the increases of pore water pressure whereas this tendency is slow in case of hole no. 2 & 3. This rapid tendency is due to high percentage of saturation limit. The shear strength of the soil of hole no.-3 is more than that of other two holes. Here it is noticed that ground level was not existed at the alike coordinate and ground level. That's why the soil strength is not homogeneous however, the location was identical.
