Investigation of Geotechnical Reasons for Bank Failure on Daulatdia and Paturia Side of Padma River of Bangladesh.

June 2020

RIVER RESEARCH INSTITUTE, FARIDPUR

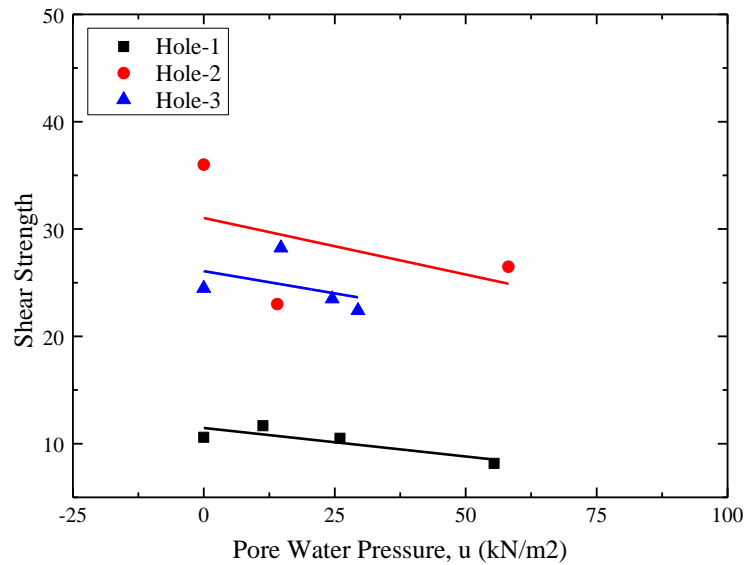
Figure 4.28: Graph showing the effect of pore pressure on shear strength at CharBahirdia of Daulatdia side of Padma river

In Figure-4.28 Shear strength has been plotted with corresponding pore pressure. From the graph it is observed that shear strength decreases with the increases of pore water pressure in both the holes. Shear strength of the soils of hole no-1 is less than that of hole no.-2 and hole no.-3. The shear strength of the hole no.-3 has been varied in a certain limit and the strength is more in hole no. 2. Here it is noticed that reduced level was not existed at the alike coordinate and ground water level as well as water level. That's why the soil strength is not homogeneous however, the location was identical.

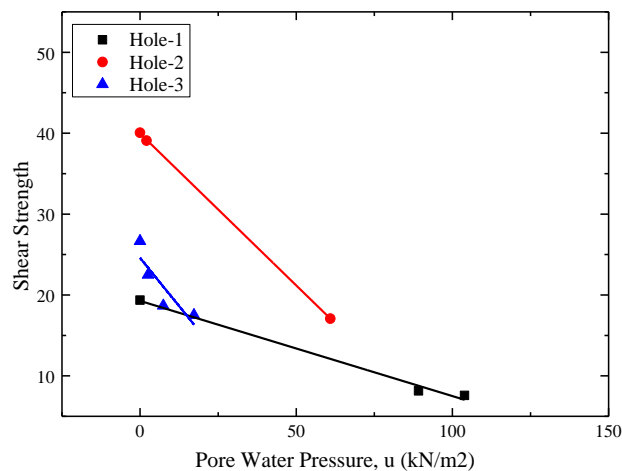
Figure 4.29: Graph showing the effect of pore pressure on shear strength at Launchghat of Daulatdia side of Padma river

In Figure-4.29 Shear strength has been plotted with corresponding pore pressure. From the graph it is observed that shear strength decreases with the increases of pore water pressure in both the holes. Shear strength of the soils of hole no-1 is less than that of hole no.-2 and hole no.-3. The shear strength of the hole no.-3 has been varied in a certain limit and the strength is more in hole no. 2. Here it is noticed that ground level was not at the alike coordinate and ground water level as well as water level. That's why the soil strength is not homogeneous however, the location was identical.

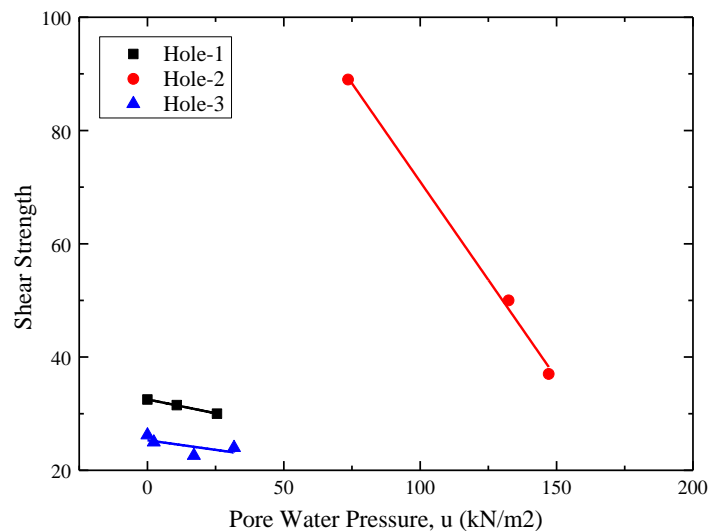
Figure 4.30: Graph showing the effect of pore pressure on shear strength at Afsarsheikher Para of Daulatdia side of Padma river

In Figure-4.30 Shear strength has been plotted with corresponding pore pressure. From the graph it is observed that shear strength decreases with the increases of pore water pressure in both the holes. Shear strength of the soils of hole no.-1 and hole no.-3 are less than that of hole no.-2. The shear strength of the hole no.-2 has been varied rapidly with pore pressure. The variation of particle sizes of the soils effects the pore pressure as well as shear strength. The ground level was not existed at the alike coordinate and ground water level as well as water level. That's why the soil strength is not homogeneous however, the location was identical.
