**BANK PROTECTION AND
RIVER TRAINING (AFPM)
PILOT PROJECT
FAP 21/22**

**TEST
AND
IMPLEMENTATION
PHASE
FAP 21**

**REPORT ON
MONITORING AND ADAPTATION
AT
BAHADURABAD TEST SITE**

MONSOON 2000

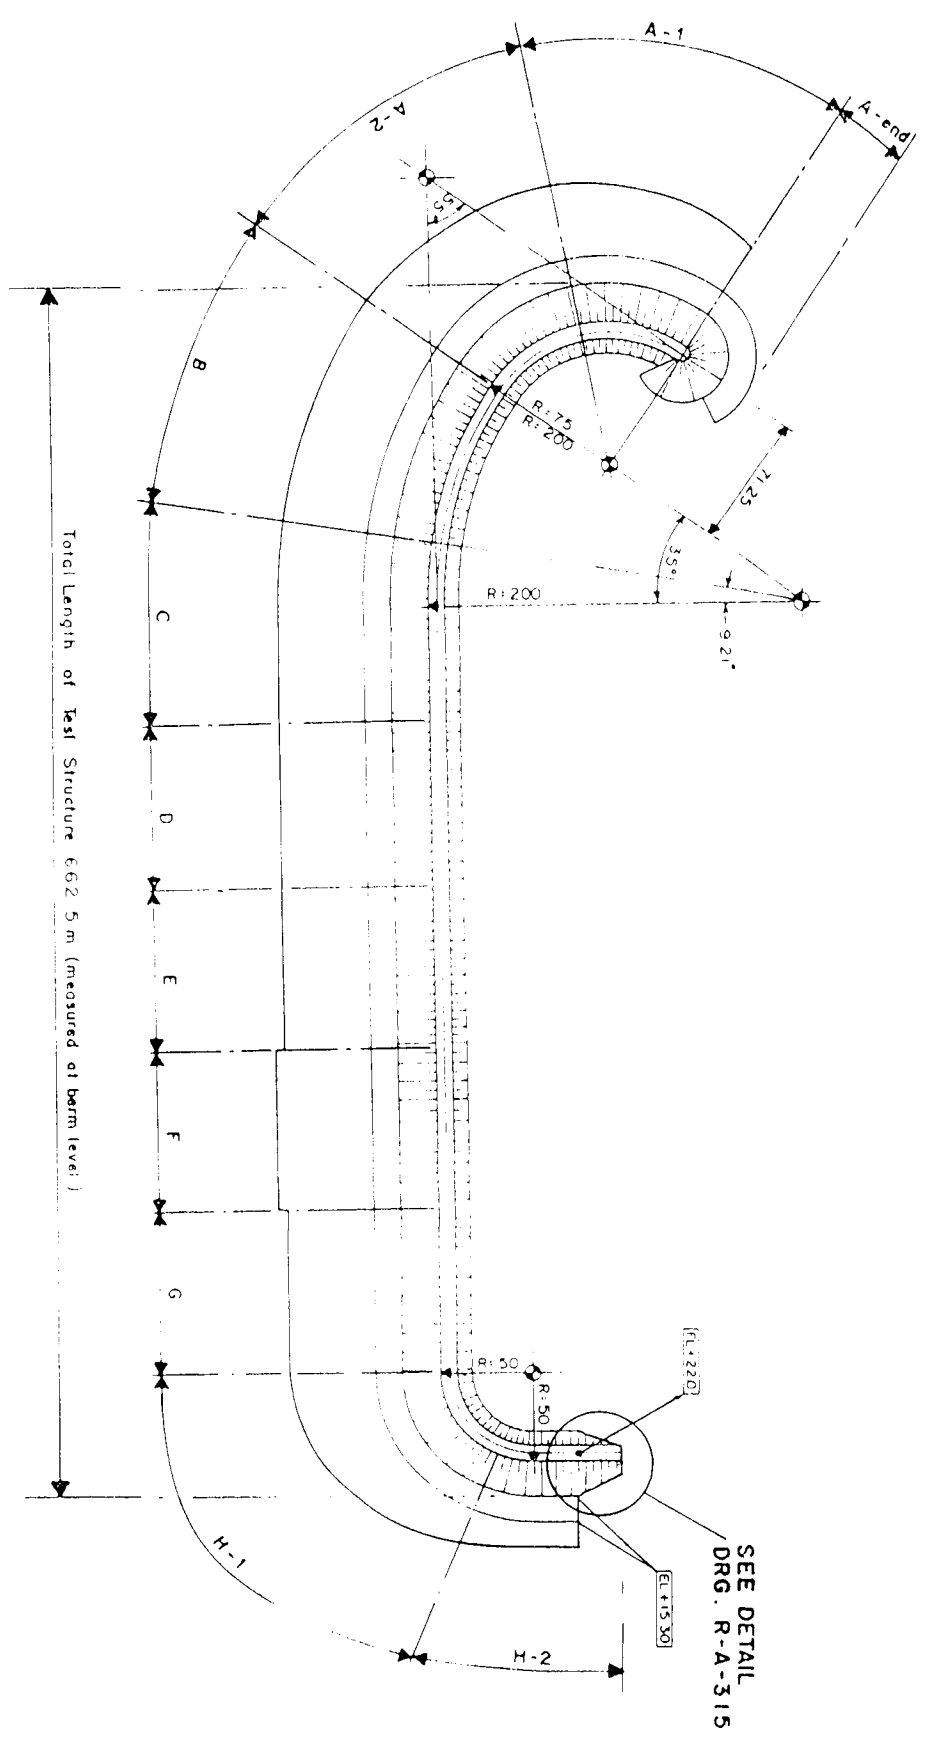
TEST SITE II - BAHADURABAD
DESIGNATION OF DESIGN SECTIONS
AND MATERIALS

Total Length of Test Structure 662.5 m (measured at berm level)

Test Structure	A-end	A-1	A-2	B	C	D	E	F	G	H-1	H-2	H-2(end)
Land sided slope	Brick mattress d: 15cm	Brick mattress d: 15cm	Wiremesh mattress d: 23/36cm with stone fill (D ₅₀ : 15cm)	Wiremesh mattress d: 23/36cm with stone fill (D ₅₀ : 15cm)	CC blocks D _h : 30cm	CC blocks D _h : 30cm	Interlocking CC blocks (step top type)	Wiremesh mattress d: 36cm with stone fill	Wiremesh mattress (type: groove type) with stone fill	Rip-rap Grade C (D ₅₀ : 20cm) Top 20cm with stone pitching (d: 30cm)	Rip-rap Grade C (D ₅₀ : 20cm) Top 20cm with stone pitching (d: 40cm)	As H-2 Rip-rap E+F 80cm on 20cm
Approximate length along toe of upper slope (at berm level)	~ 87.40	~ 74.70	~ 74.70	~ 99.10	~ 93.20	88.0	90.0	88.0	~ 100.0	~ 82.75	~ 97.60	~ 20.0
Revelment above berm level (+15.5m to +22.0m PWD)	Brick mattress d: 15cm	Brick mattress d: 15cm	Wiremesh mattress d: 23/36cm with stone fill (D ₅₀ : 15cm)	Wiremesh mattress d: 23/36cm with stone fill (D ₅₀ : 15cm)	CC blocks D _h : 30cm	CC blocks D _h : 30cm	Interlocking CC blocks (step top type)	Wiremesh mattress d: 36cm with stone fill	Wiremesh mattress (type: groove type) with stone fill	Rip-rap Grade C (D ₅₀ : 20cm) Top 20cm with stone pitching (d: 30cm)	Rip-rap Grade C (D ₅₀ : 20cm) Top 20cm with stone pitching (d: 40cm)	As H-2 Rip-rap E+F 80cm on 20cm

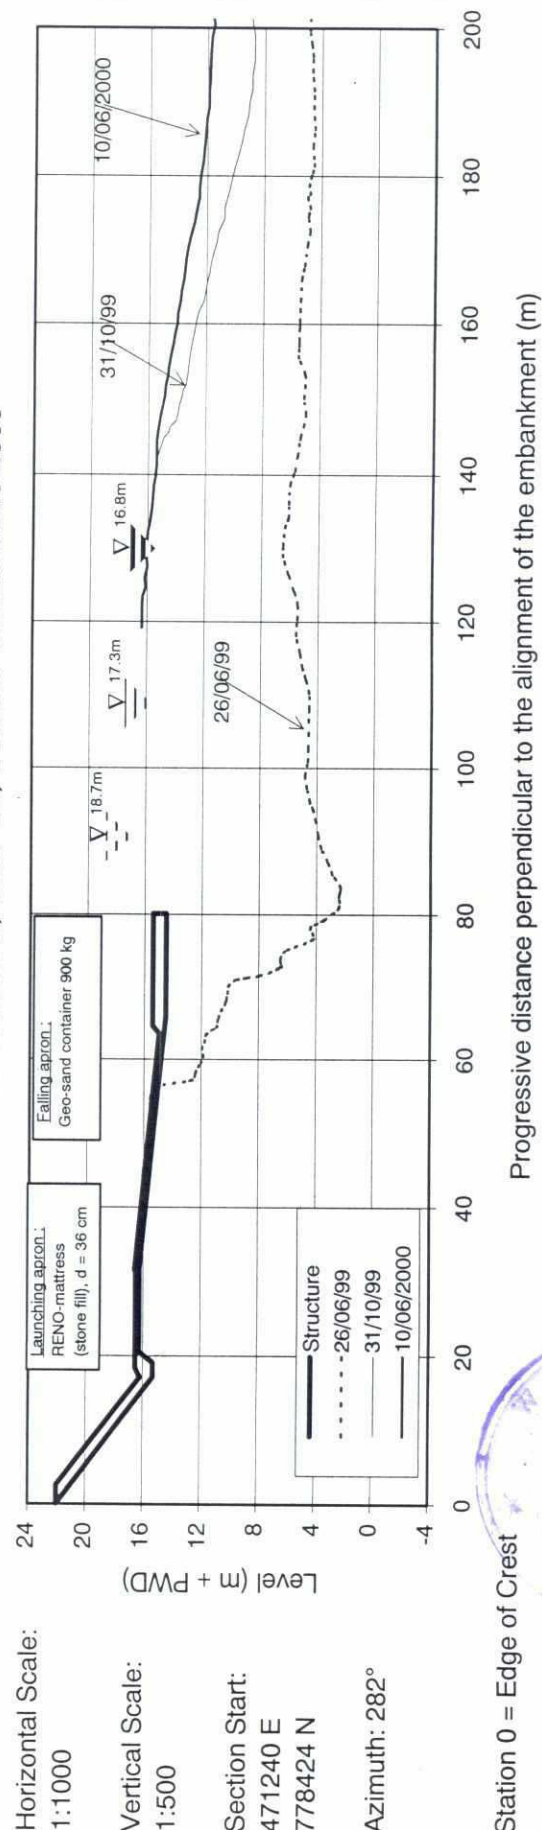
Cross-Section D, June '99, October '99 and June 2000

778424 N

Azimuth: 282°
