**BANK PROTECTION AND
RIVER TRAINING (AFPM)
PILOT PROJECT
FAP 21/22**

**REPORT ON
MONITORING AND ADAPTATION
AT
BAHADURABAD TEST SITE**

MONSOON 1999

MARCH 2001

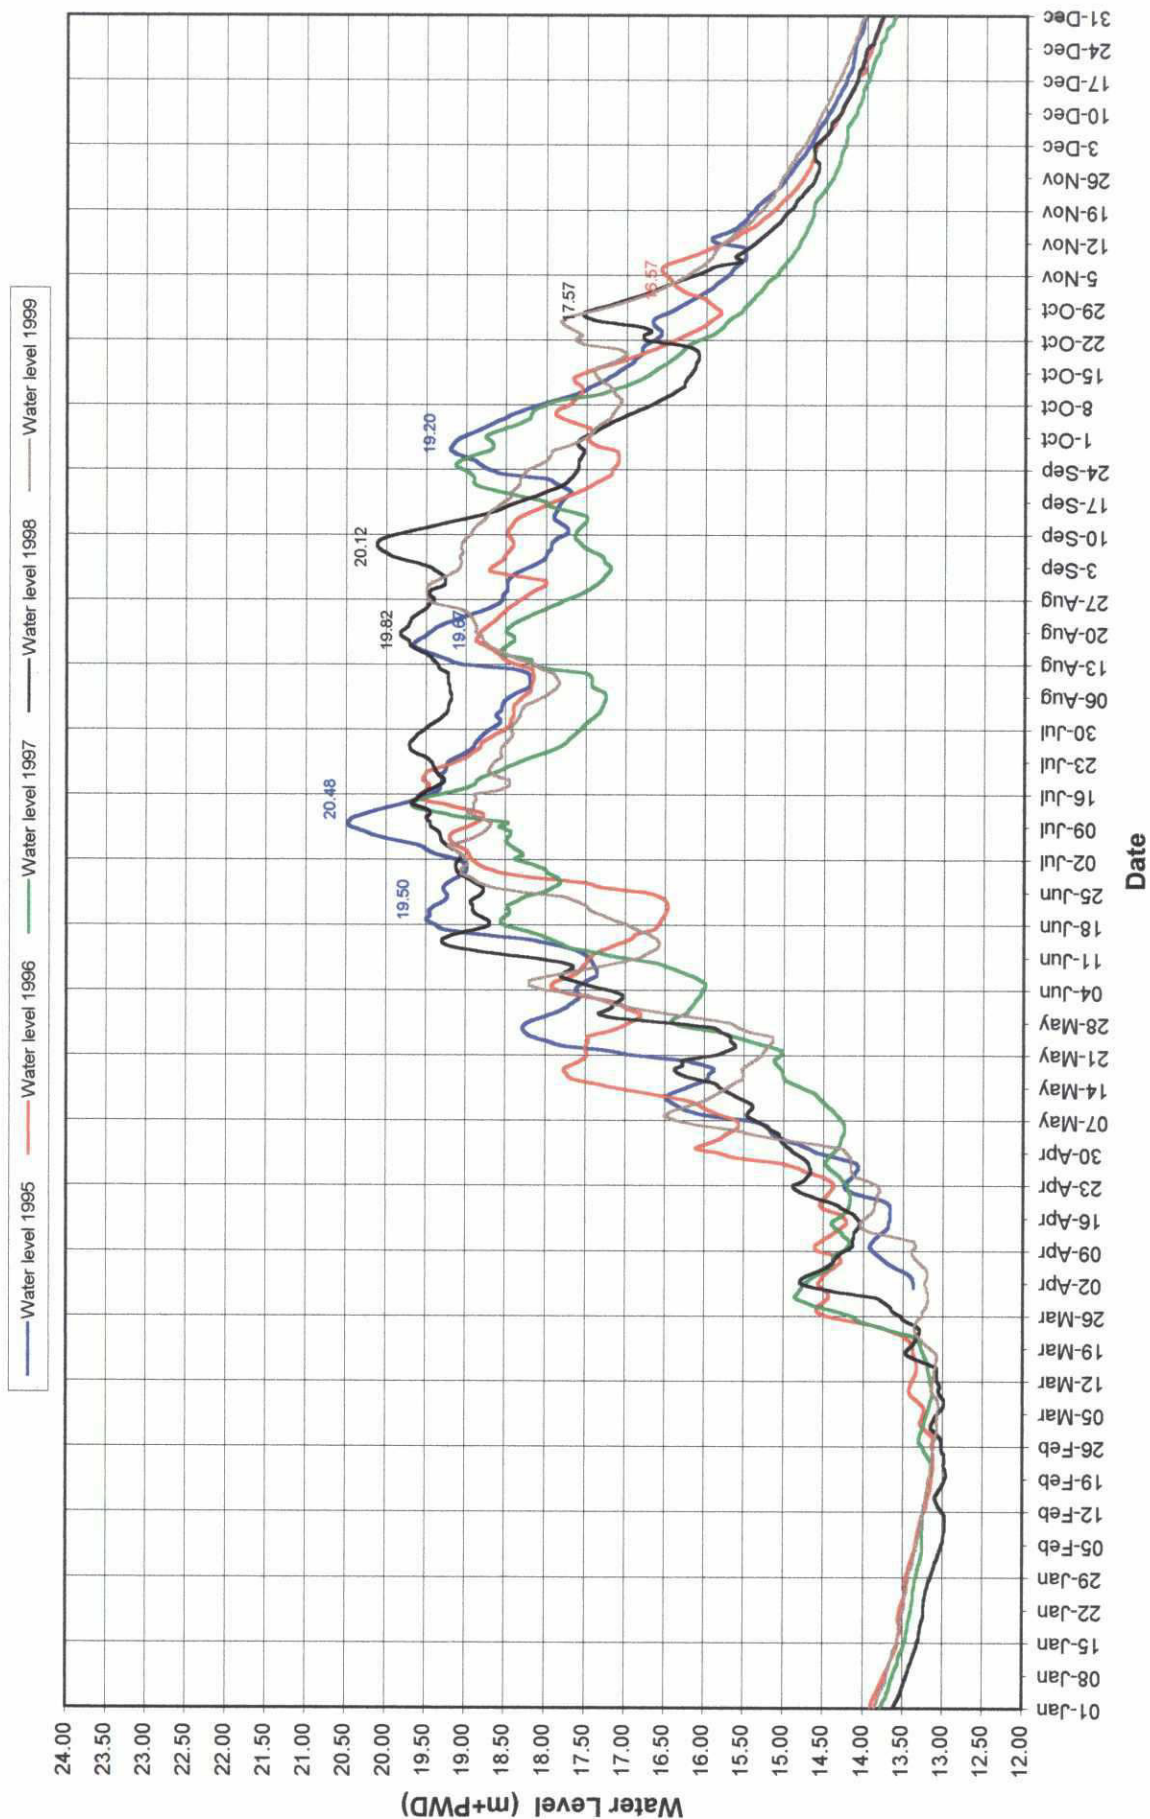
BANK PROTECTION TEST STRUCTURES - FAP 21 **WATER LEVEL AT BAHADURABAD TEST SITE** **(January to December)**

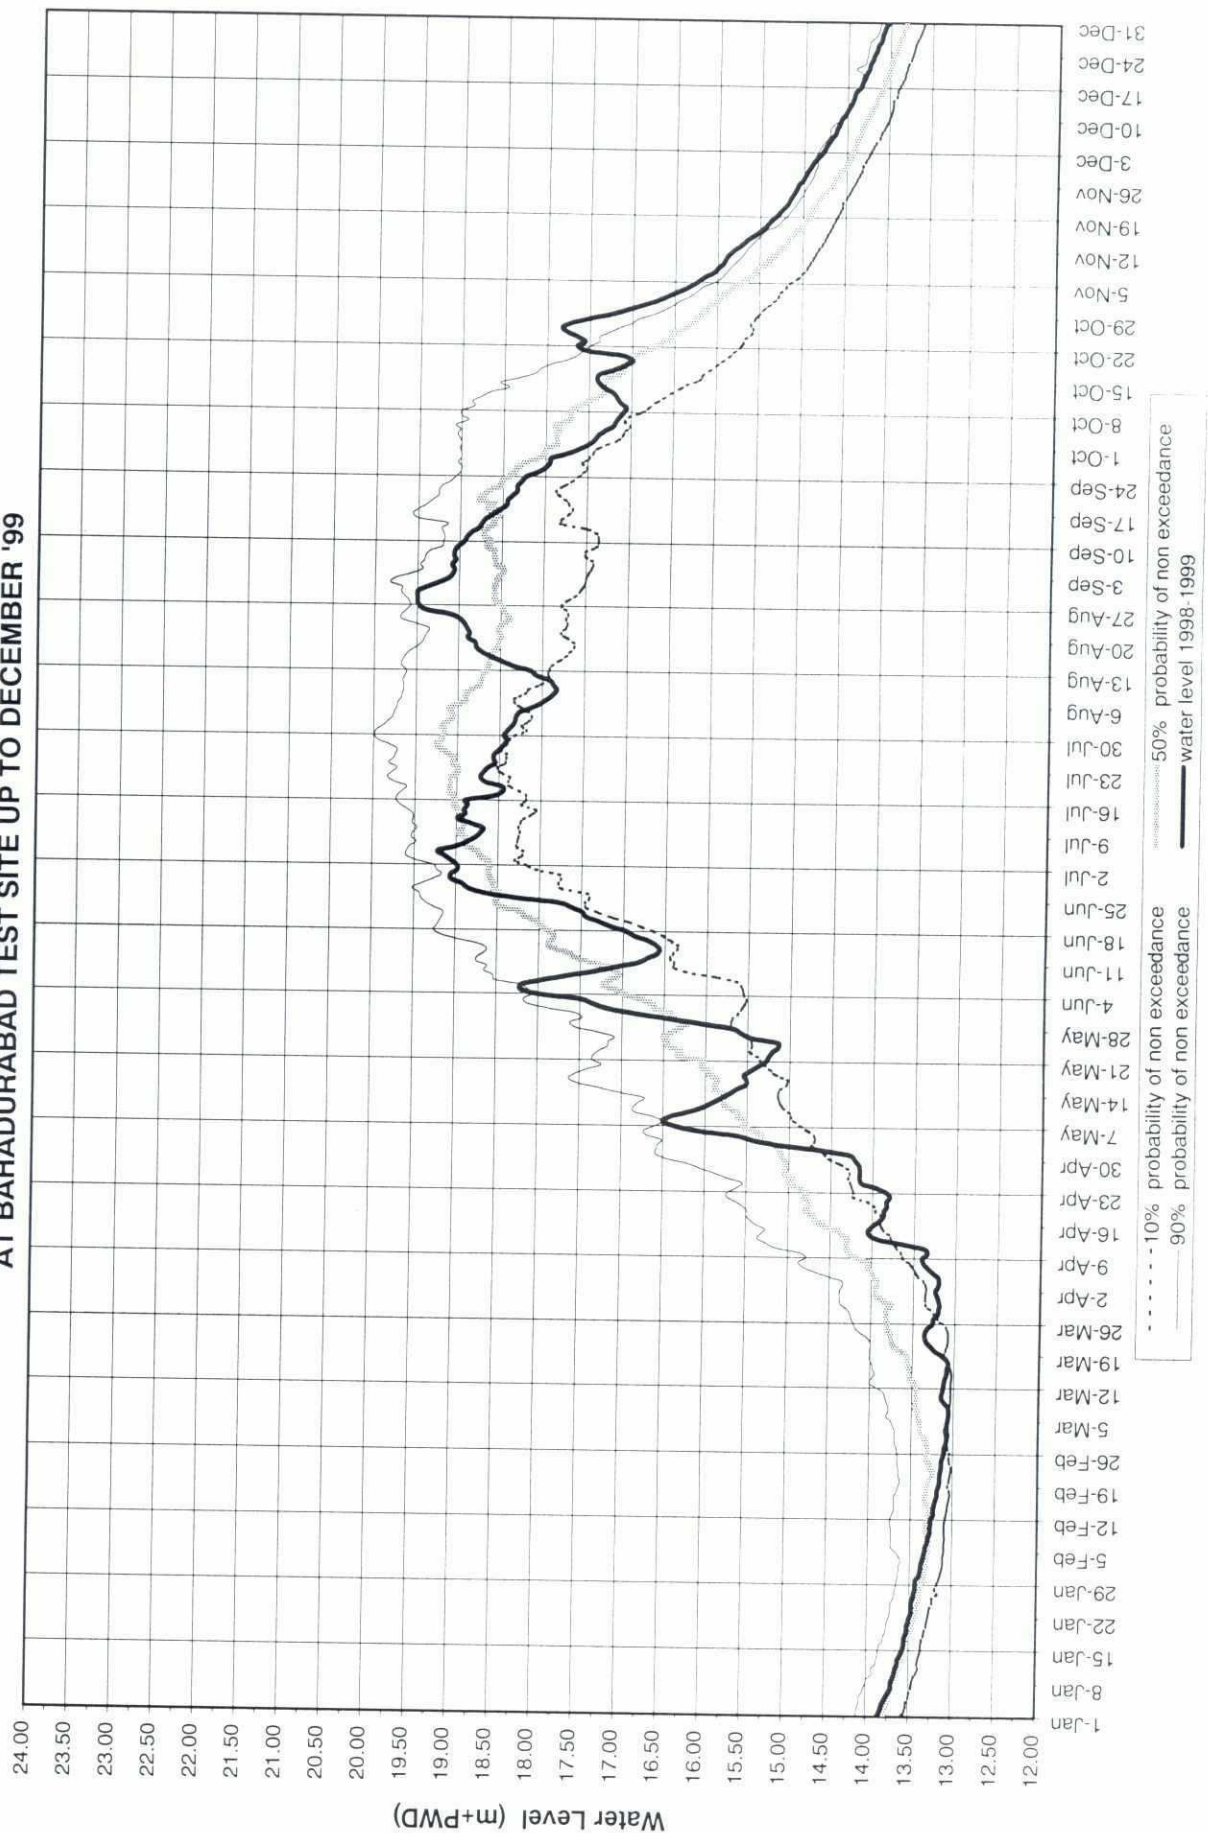
BANK PROTECTION TEST STRUCTURES - FAP 21 **BWDB WATER LEVEL FREQUENCY CURVES VERSUS ACTUAL FAP 21 WATER LEVEL** **AT BAHADURABAD TEST SITE UP TO DECEMBER '99**

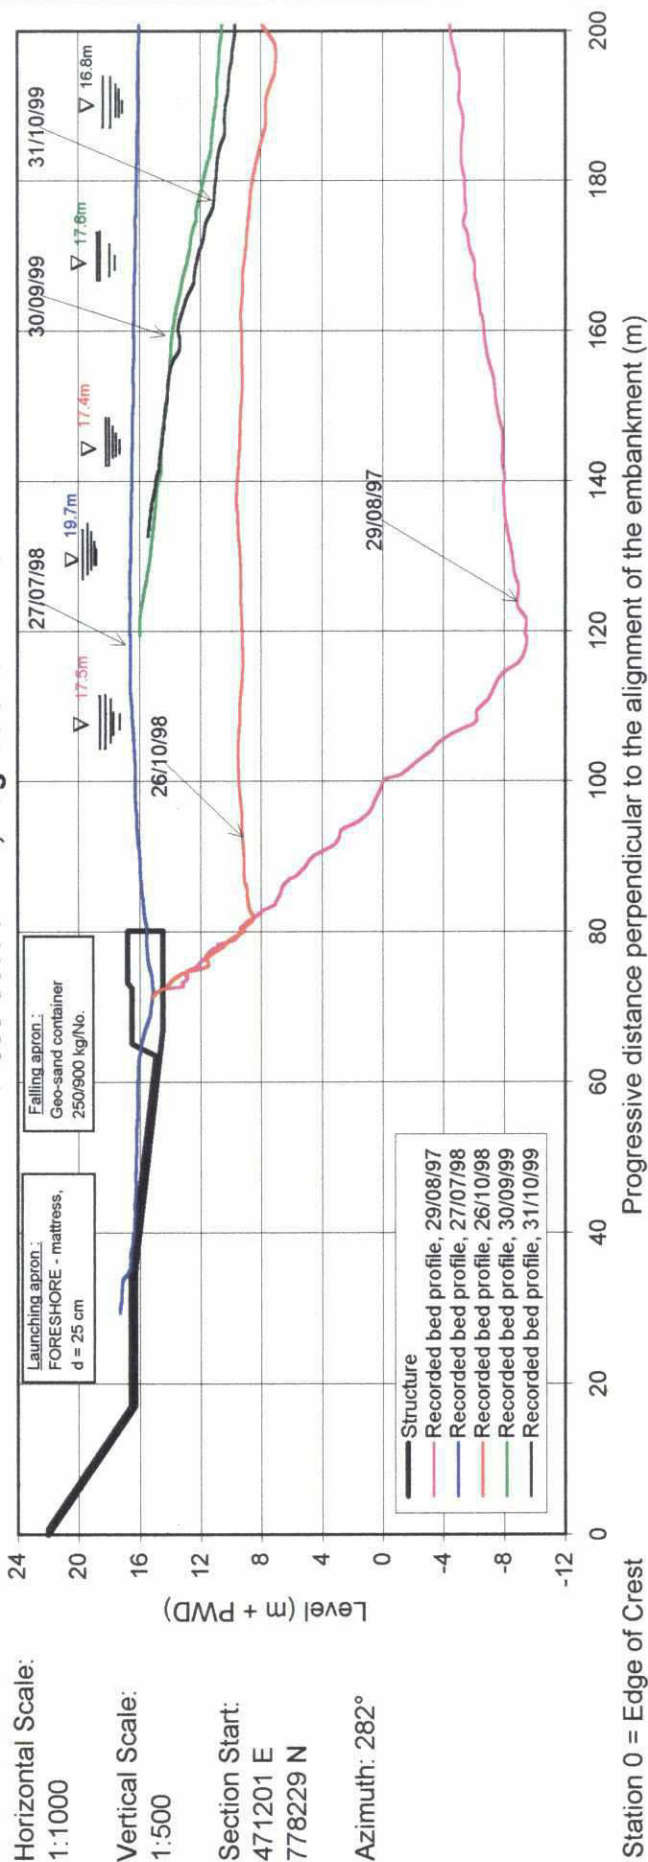
Cross-Section E-2, August '97 to October '99

Section Start:
471201 E
778229 N

Azimuth: 282°

During the flood season 1998 no significant damages of the test structure had been observed. However, again rain-cuts beneath the filter layer caused some deformations/settlements of the cover layer in Section E-2 (see Subsection 2.3-1 and Section 2.4).

To stabilise the slope of the revetment above the berm in Section E-2 the cover layer and filter layer had to be removed. The rain-cuts were filled up and the composite geotextile filter, which had been placed with the wrong side up during the construction phase, was replaced now with the right dark/coarse side down. On that a 5 cm thick filter layer of khoa was placed and finally the cc-slabs.

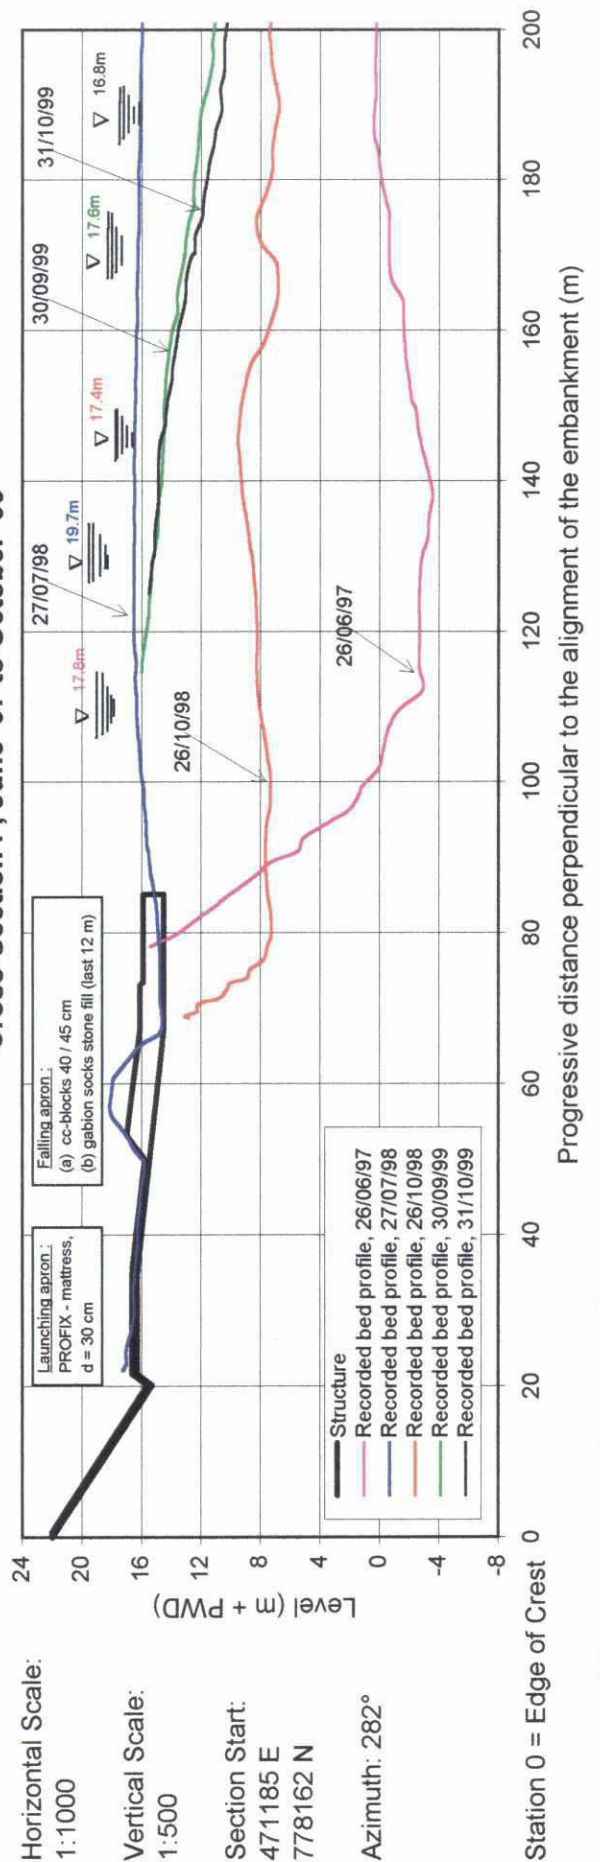
Cross-Section F, June '97 to October '99

Horizontal Scale:
1:1000

Section Start:
471185 E
778162 N

Azimuth: 282°

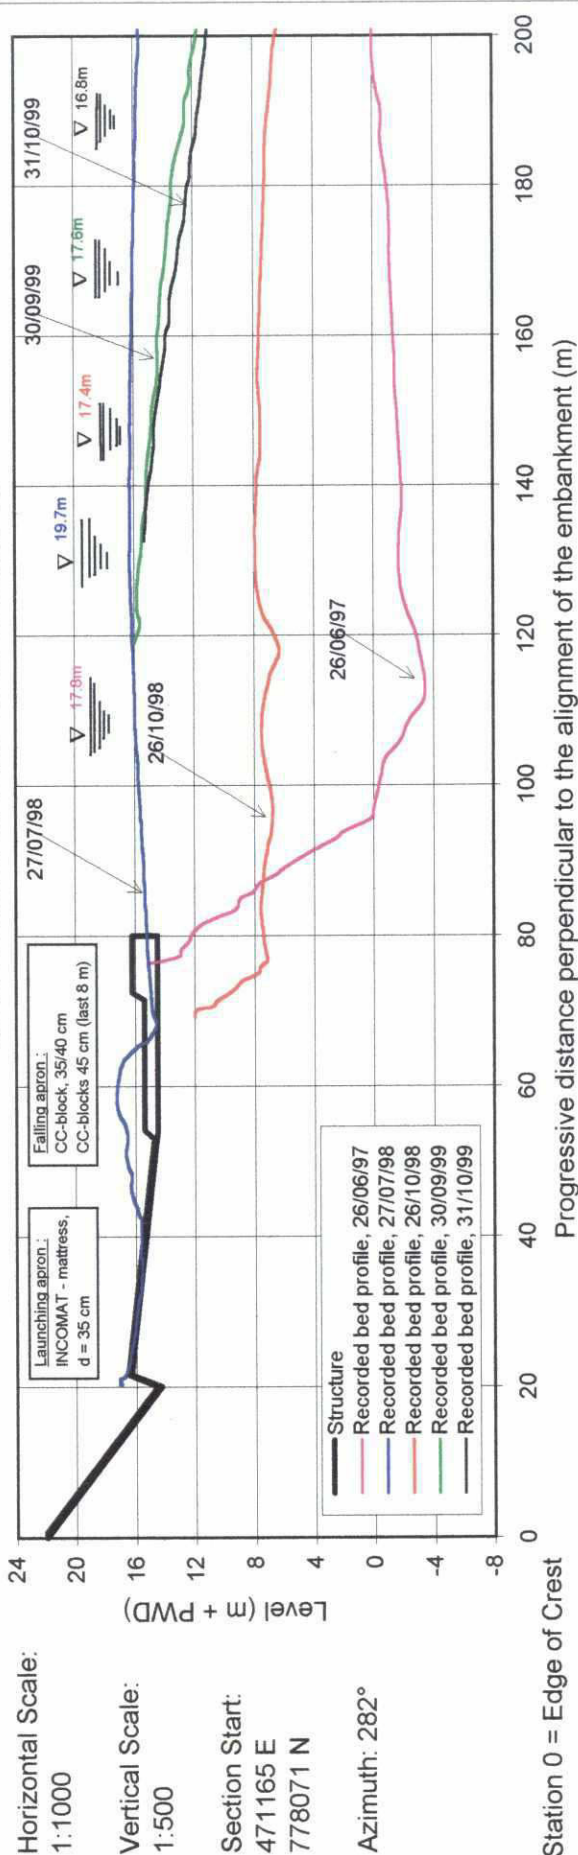
Cross-Section G, June '97 to October '99

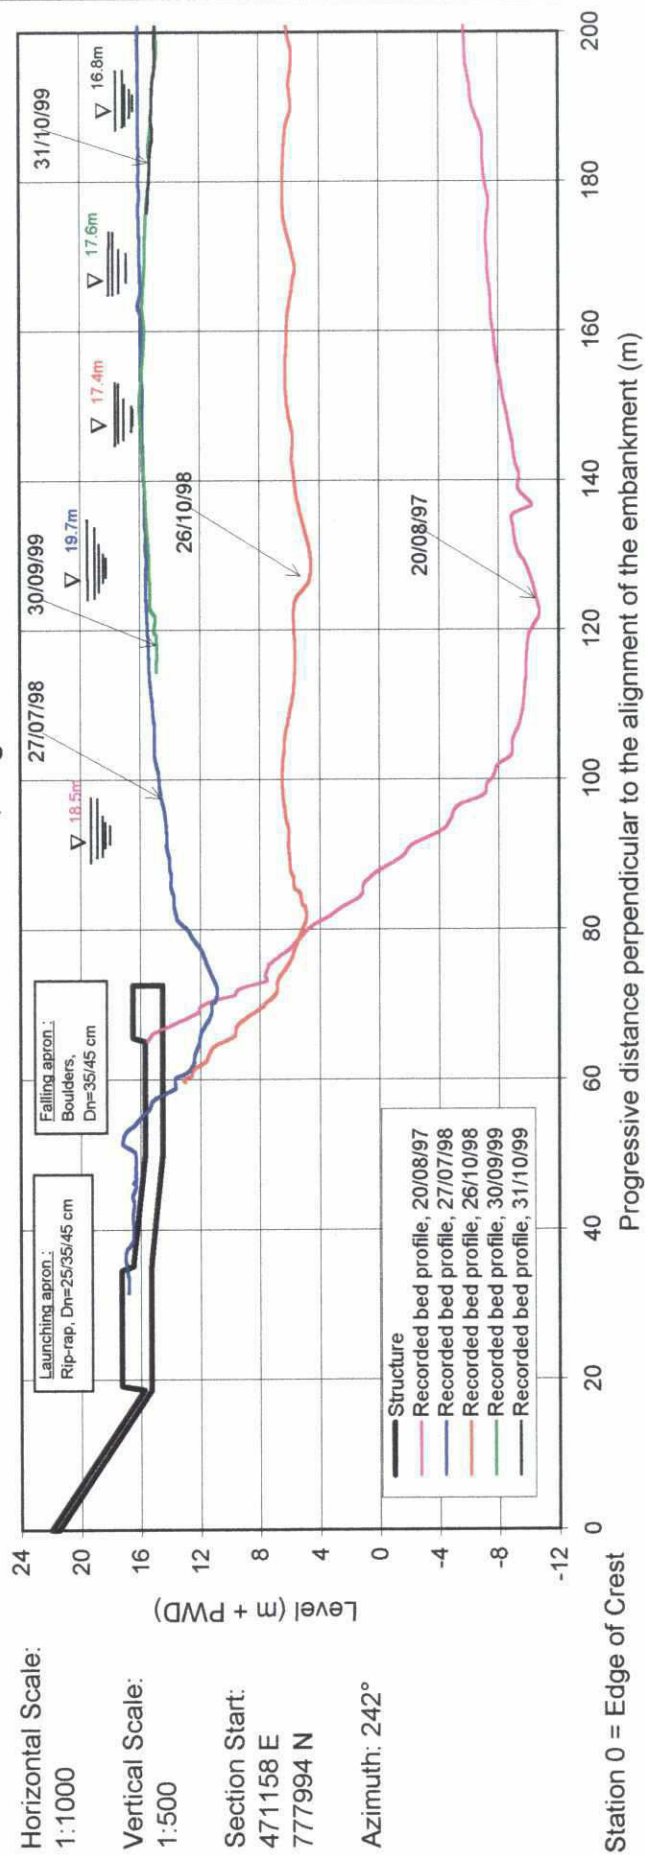
Cross-Section H-1, August '97 to October '99
