**BANK PROTECTION AND
RIVER TRAINING (AFPM)
PILOT PROJECT
FAP 21/22**

**REPORT ON
MONITORING AND ADAPTATION
AT
BAHADURABAD TEST SITE**

ANNEXES

MARCH 1999

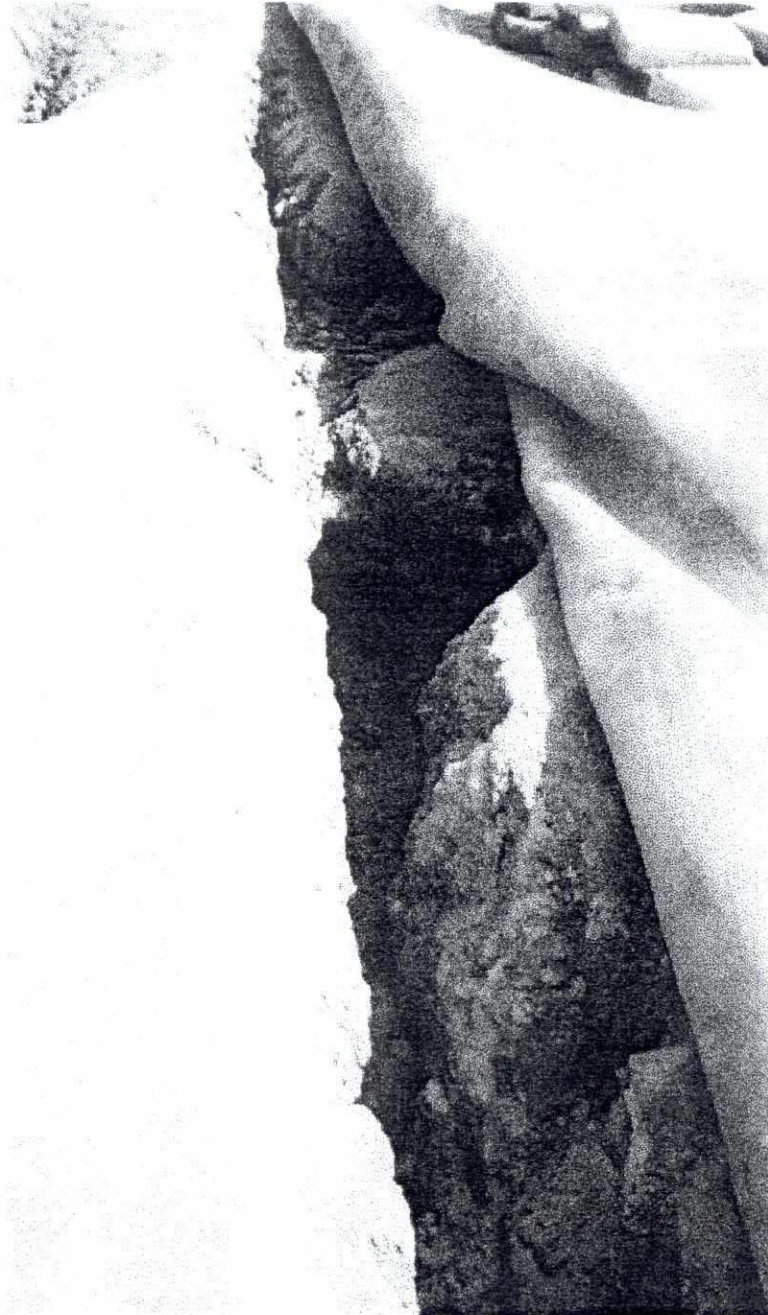
Soil migration below composite geo-filter
J 9014 HaTe (placed wrongly – upside down)

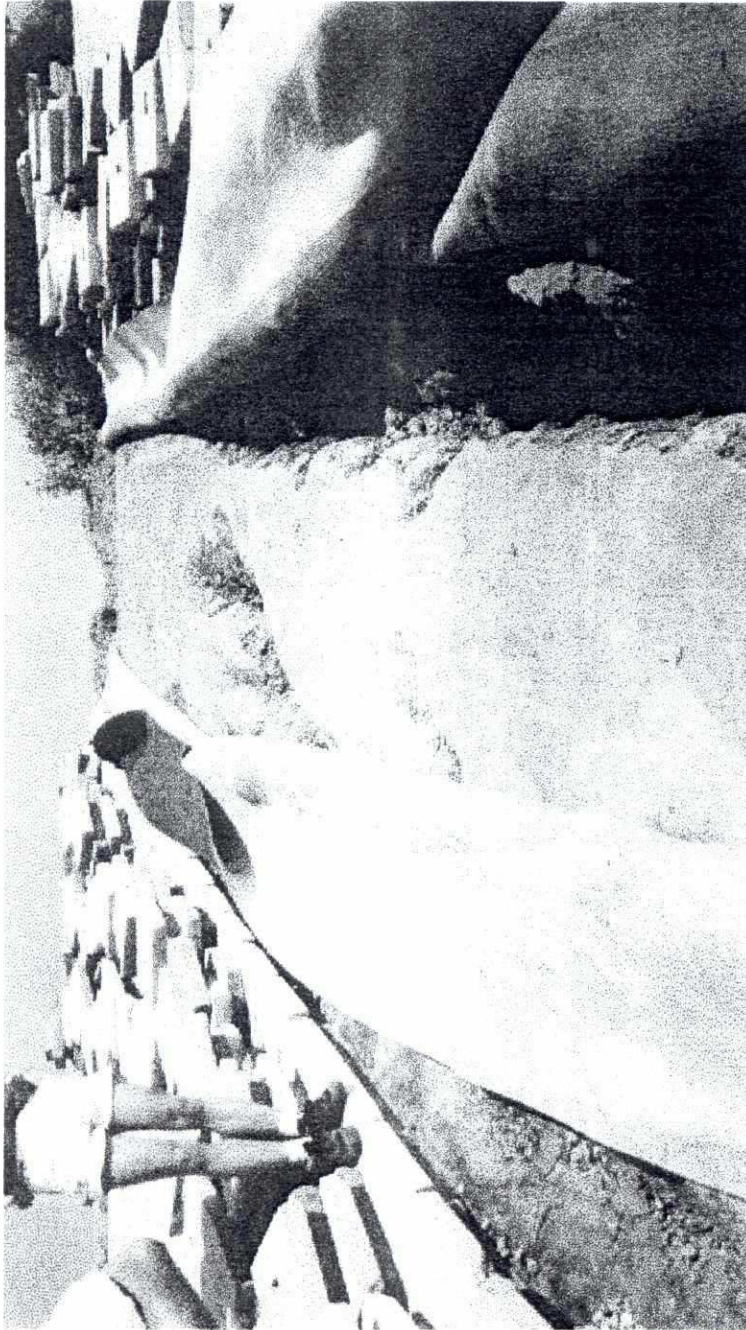
- 5 Section E-2:
- Ship-Lap type cc-slabs on composite geo-filter
 - soil migration from crest to toe of slope

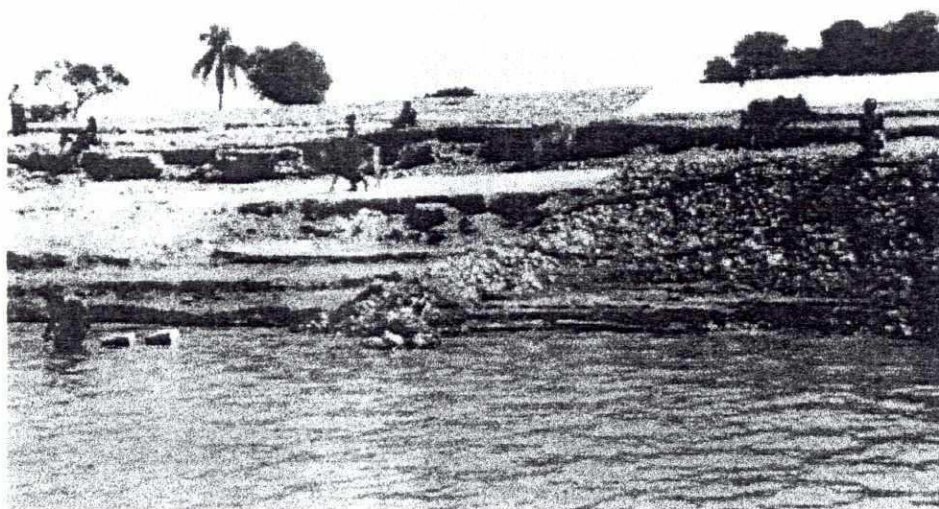
VISUAL OBSERVATION (continued)		Date: 19.02.1998
Observed Area	Comments	Photographs No.
Falling apron	The falling apron completely eroded to its full extend on a length of 30 m along the waterline. But after the erosion took place some significant sedimentation especially around the bankline took place as only at some points the remaining parts of the falling apron can be seen. In those exposed areas the geo-sand containers have been cut or removed by local people. If and to which extend the underwater slope is now protected by the vanished material has to be taken from the result of the Side Scan Sonar Survey (<i>see Special Notes / Comments</i>), however, the river bed slope has remained quite stable during the past months. Beside this survey it has been successfully tried to locate / identify some cc-blocks under water at a distance of up to 5 m from the waterline using a bamboo stick.	273 / 2A 273 / 1A

273/1A: View at bank-/ waterline transition Section B/C (21.02.98; W.L. = 12.97 m PWD)

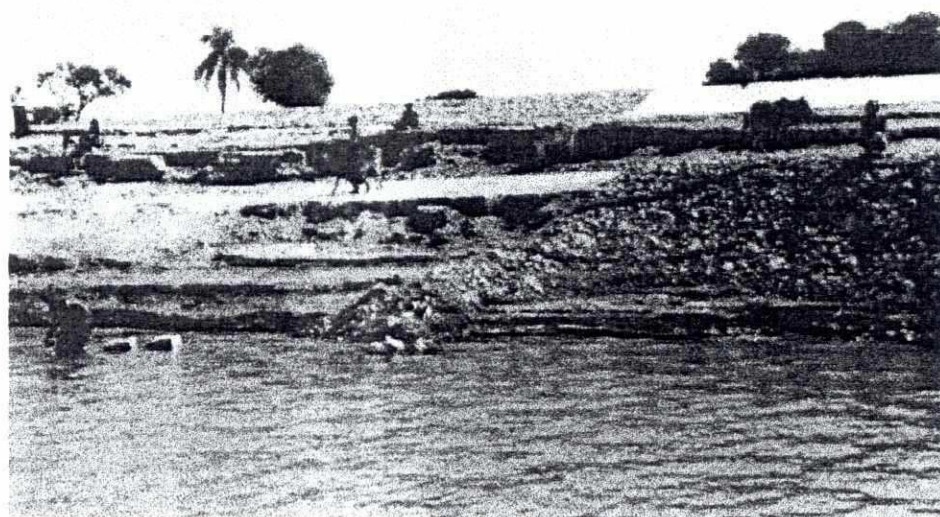
273/1A: View at bank-/ waterline of Sectin B/C (21.02.98; W.L. = 12.97 m PWD)

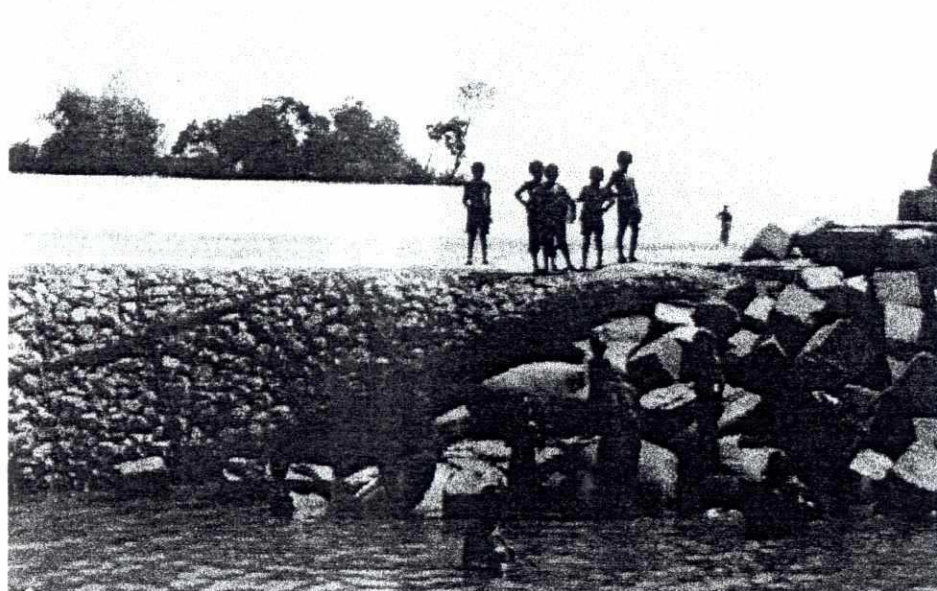
Observed Area	Comments	Photographs No.
Launching apron / transition between launching and falling apron	The wiremesh is of very good quality (imported RENO-mattress) and of the type used in Sections A-2 and B. Corrosion is not apparent. Nevertheless some single cages around the waterline seem to have burst due to too heavy stresses. But it also has to be considered that one or two of them have been opened by local people to get access to the stone filling. If and to which extend the mattresses can be found on the underwater slope might be taken from the result of the Side Scan Sonar Survey (<i>see Special Notes / Comments</i>).	273 / 1A 273 / 0A 271 / 36 271 / 31
Falling apron / exposed edge of falling apron	Only a couple of geo-sand containers are left and can be seen at the transition to Section D on a length of some 5 m along the waterline. If and to which extend the underwater slope is now protected by the vanished material has to be taken from the result of the Side Scan Sonar Survey (<i>see Special Notes / Comments</i>). Beside this survey it has been successfully tried to locate / identify some geo-sand containers under water at a distance of up to 5 m from the waterline using a bamboo stick. No ongoing erosion has been detected so far, and the river bed slope remained reasonable stable during the past months.	271 / 31

271/31: View at bank-/ waterline transition Section C/D (21.02.98; S.L.=12.97 m PWD)

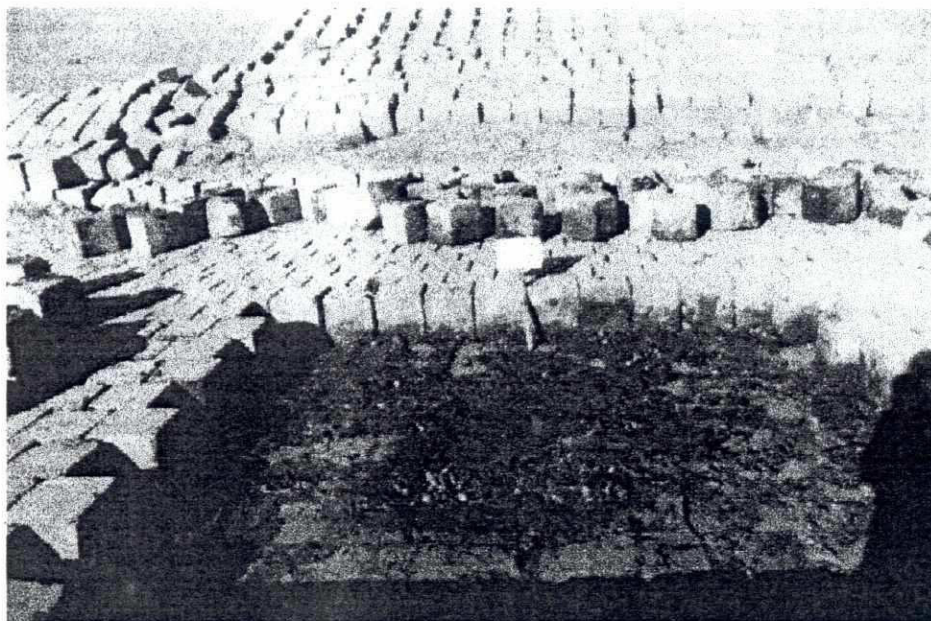
272/31: Sight on inspected area Section D before removing geotextile (19.02.98)

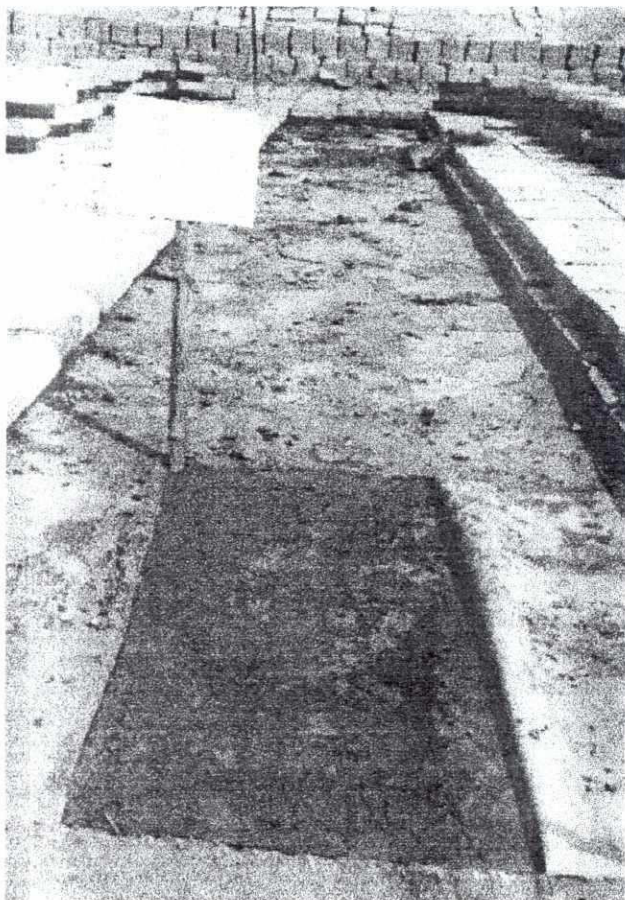
Result of Physical Inspection:	
After removing the cc-slabs only at the toe of the revetment obvious depression could be seen through the geotextile. The geotextile was opened there and at the top of the slope by cutting three sides with a knife leaving a connection at the right side in flow direction. It was then lapped over to give sight on the subsoil. At the top location some minor drainage channels channels of 2-3 mm in depth could be observed. The location at the toe on the other hand showed some depression. The area was of around 40 cm in square size with a depth of up to 4 cm and in an overall wet condition. The depressed location was refilled and compacted before Section E-1 was set into original condition by overlapping with an additional sheet of geotextile filter material.

272/18: Inspected area at top of E-1
(18.02.98)

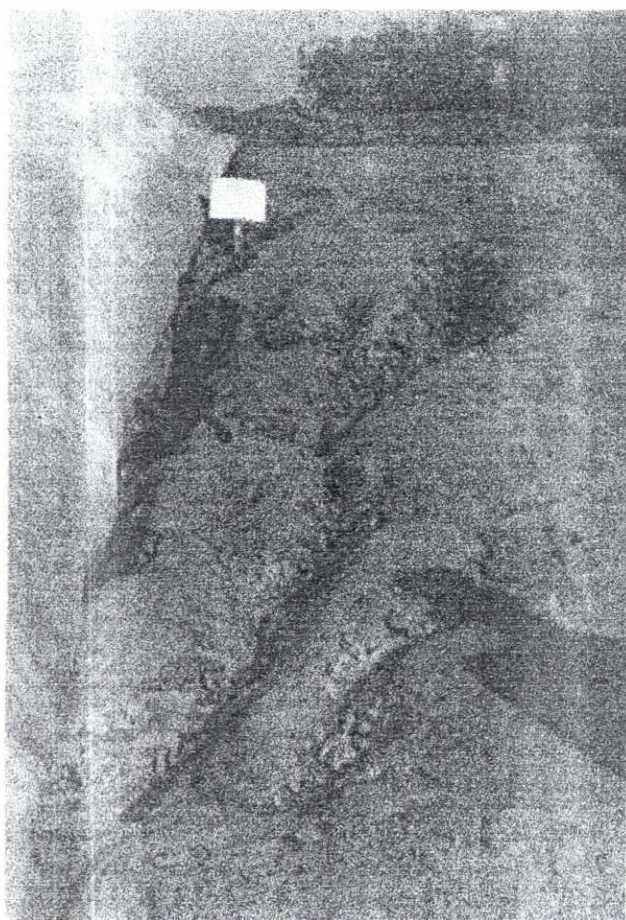
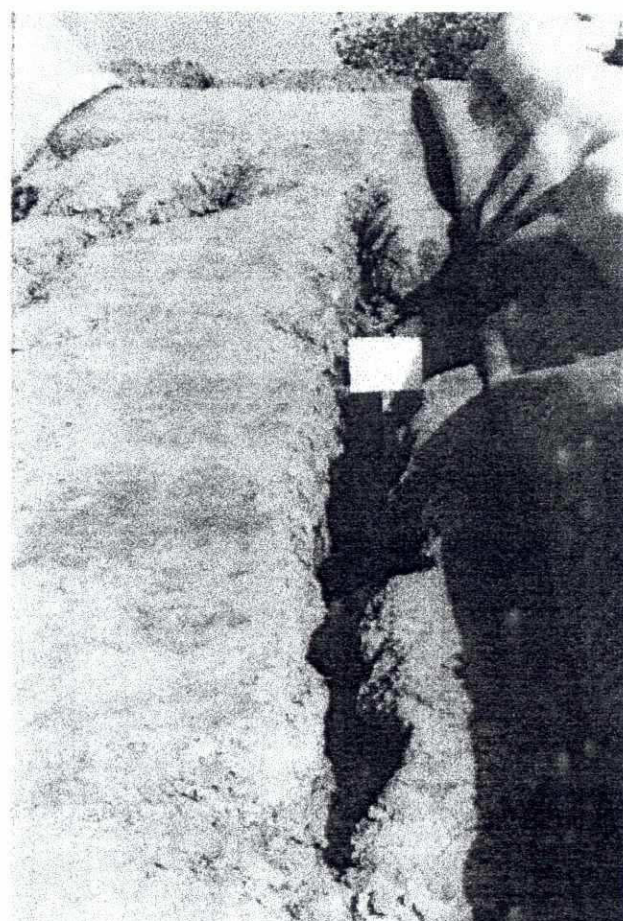
Section E-2 was provided with a composite geotextile filter, particularly suitable for soils susceptible to downslope migration which was however placed with the wrong side down, keeping the coarse fibre layer at the top side. It can only be assumed that this supported the appearance of the rain-cuts which have been observed at two occasions (June 15th and 19th&20th) during massive continuous rainfall (117 mm).

In addition to those assumptions it must be said again that due to laying the cc-slabs not in parallel rows with staggered joints between the layers the impact of heavy rain falls occurring each monsoon might have had an impact. Due to the false laying there are joints running every 220 mm (width of one slab) from top of the embankment to the toe of the slope giving the water the chance of fast infiltration and run off in between the slabs. To know in which condition the geotextile is after the last monsoon season in terms of permeability two soil samples one from the upper part and one from the lower part have been taken for analysis. The results are shown under Laboratory Tests further down of this assessment sheet.

Both pictures: Sight on rain-cuts Section E-2 (19.02.1998)

To stabilize the slope excessive repair work has been done in Section E-2 by removing all cc-slabs, cutting and removing the geotextile, excavating the whole slope to a depth of 20 cm, refilling the rain-cut channels true to slope, attaching a granular filter (as done in Section G), replacing the geotextile with the right dark/coarse side down and finally placing the cc-slabs in parallel rows with staggered joints between the layers on top.

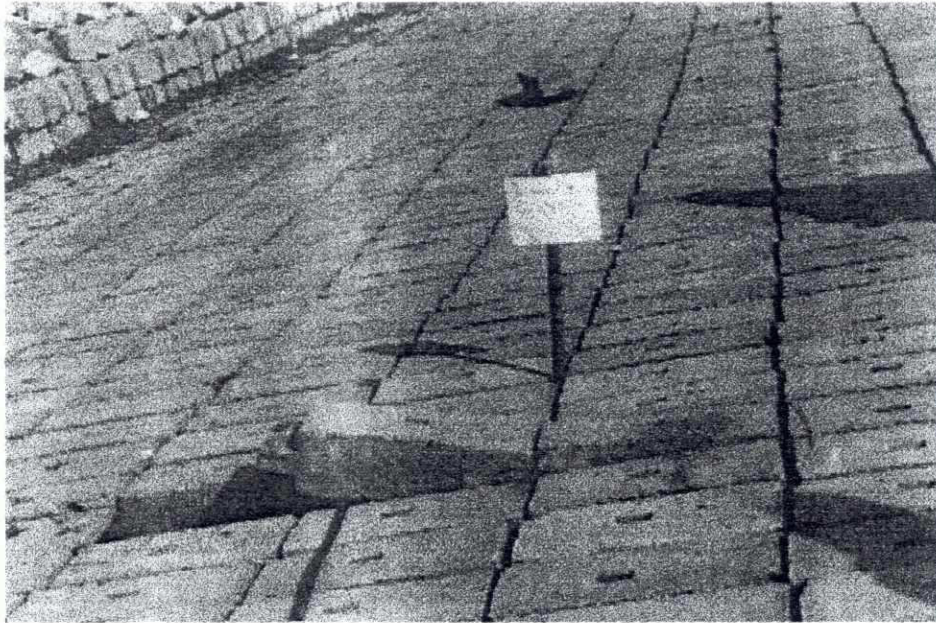
PHYSICAL INSPECTION OF FILTER BEHAVIOUR		Date: 16.02.98
Selection of Location:		Photographs No.
There was no obvious upheaval or depression to be seen in Section G. Therefore the location for inspecting the geotextile and the underlying subsoil has been chosen around the position where the highest waterlevel has left a mark on the revetment above berm level. So any differences between the water covered area and the dry area of the revetment (only exposed to rain and waves) can be detected after removing the cover layer of interlocking cc-slabs off the geotextile. Size and exact location of the inspected area can be seen in Figure 21-13 attached to this assessment sheet.		272 / 4 272 / 5
Result of Physical Inspection:		
First the cover layer was removed. The inspected area was at an overlapping joint of the geotextile. The geotextile was cut with a knife at three sides leaving a connection at the right side in flow direction. The geotextile was then lapped over to give sight on the underlying subsoil which was in a good and overall moist condition. No differences were detected between the water covered and the dry area of the revetment. The opened area was set into original condition after inspection by overlapping with an additional sheet of geotextile filter material.

272/4: Section G before inspection (16.02.1998)

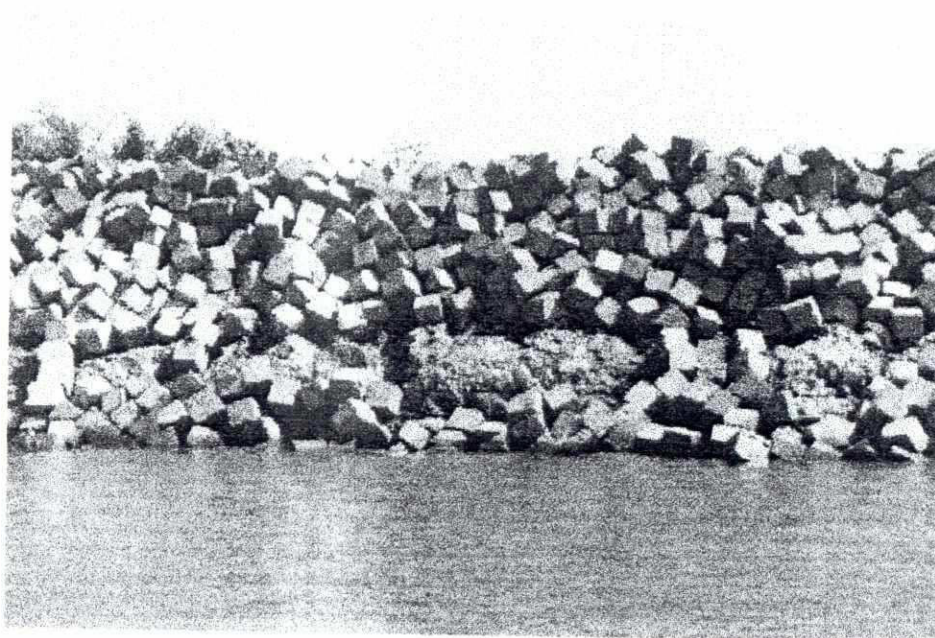
Observed Area	Comments	Photographs No.
Revetment above berm level	No severe attack of the river on this segment of Section G occurred during the flood season of 1997. No visible changes / damages could be observed. But as in sections E-1 and E-2 the cc-slabs have not been laid in parallel rows with staggered joints between the layers. With this not only flow attack but also heavy rain falls occurring each monsoon might have a greater impact on the structure than they should.	272 / 4
Launching apron	Some slight sedimentation can be found on the Incomat mattress. The collapsible block mattress itself is in very good condition. Only a minor number (2-3) of blocks show some damage which presumably relate either to the fact that during high water levels small boats with bamboo sticks for maneuvering have been used in this area or to the cutting by local people to get access to the filling.	
Transition between launching apron and falling apron	No visible changes / damages could be observed as this segment is covered by the end of the launching apron material and a part of the falling apron which still exists to some extent.

271/22: View at bank-/ waterline of Section G (21.02.98; W.L. = 12.94 m PWD)
