MEGHNA ESTUARY STUDY

TECHNICAL NOTE MES-025

MONITORING OF HAIMCHAR EROSION CONTROL WORKS

MONITORING OF KHORKI EROSION CONTROL WORKS

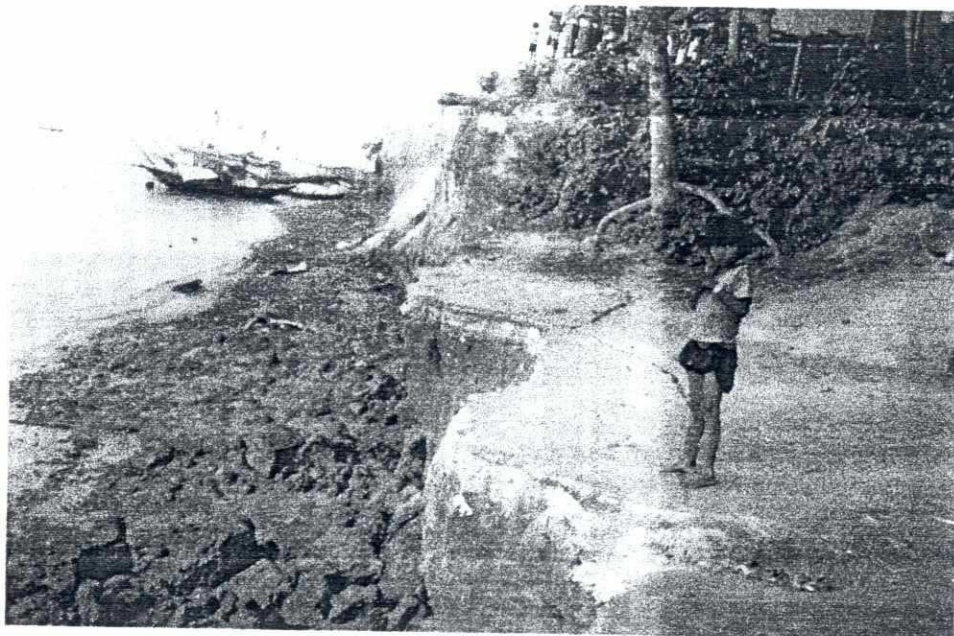
Picture 1 Erosion pattern before execution of the work at Haimchar

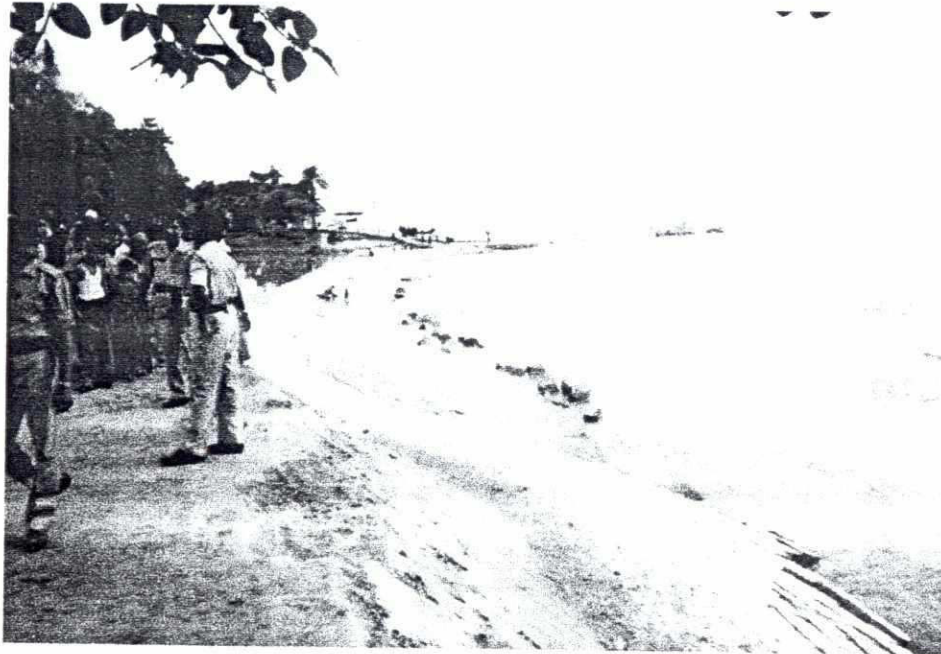
Picture 4 Block pitching performed by the Chadpur BWDB near the downstream spur

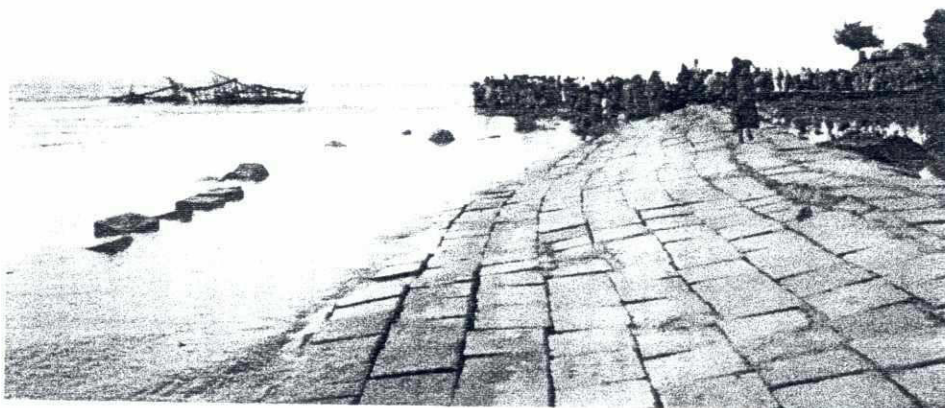
Picture 5 Block pitching performed by the Chadpur BWDB near the upstream spur

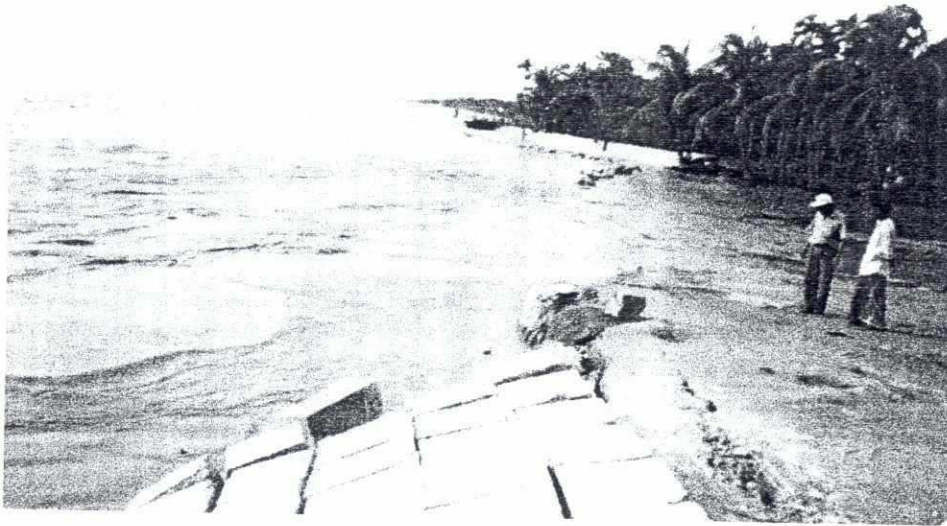
Picture 7 Blocks are sliding down near the upstream spur which has dissapeared

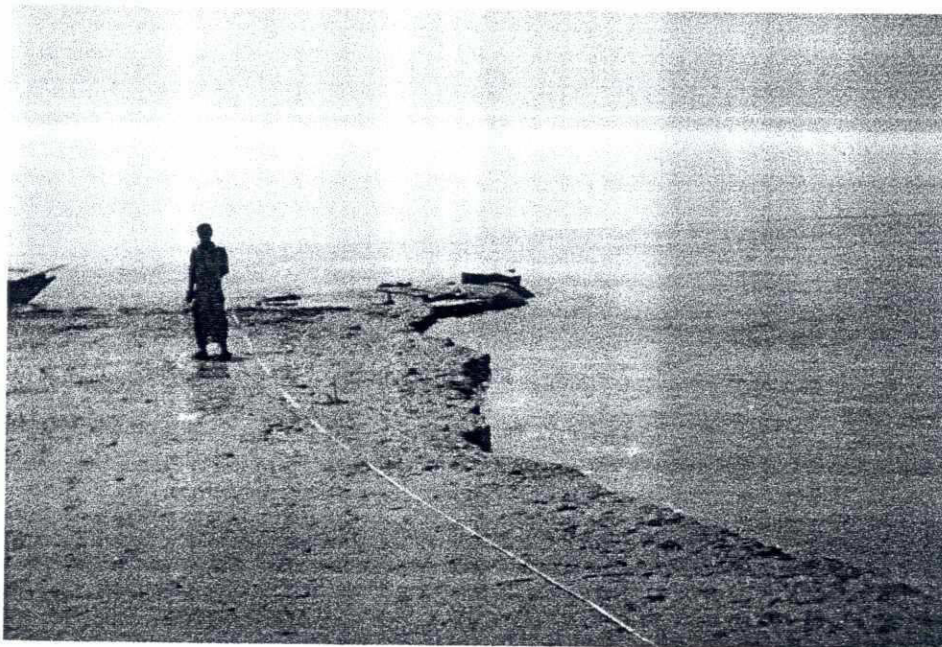
Picture 9 During the flood the downstream spur has disappeared at Haimchar.

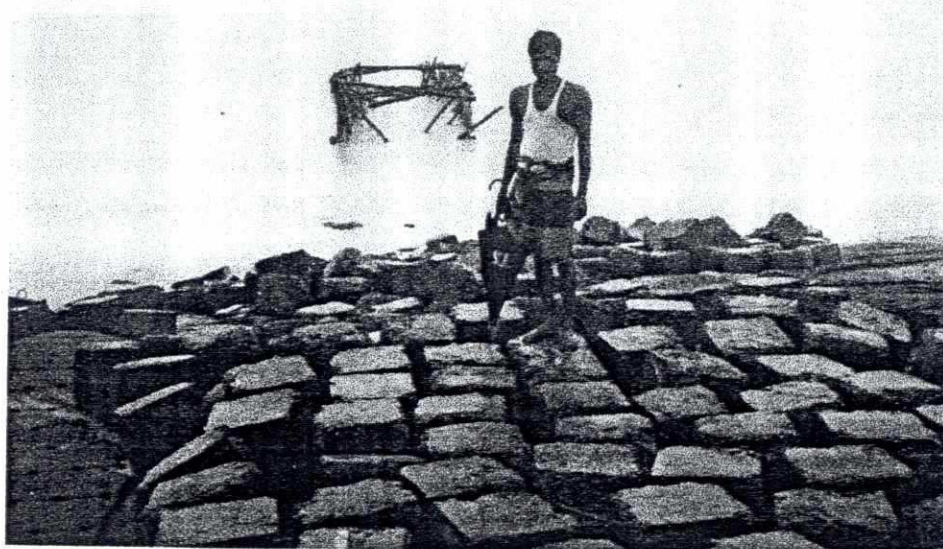
The spur caissons were prepared the same way as in Haimchar. Length of each spur caisson was 18 meters. The caissons were filled with concrete blocks up to 2 meters height. The connecting dykes were built out of dumped concrete blocks (picture 10).

Picture 10 The downstream spur (KC-3) after construction.

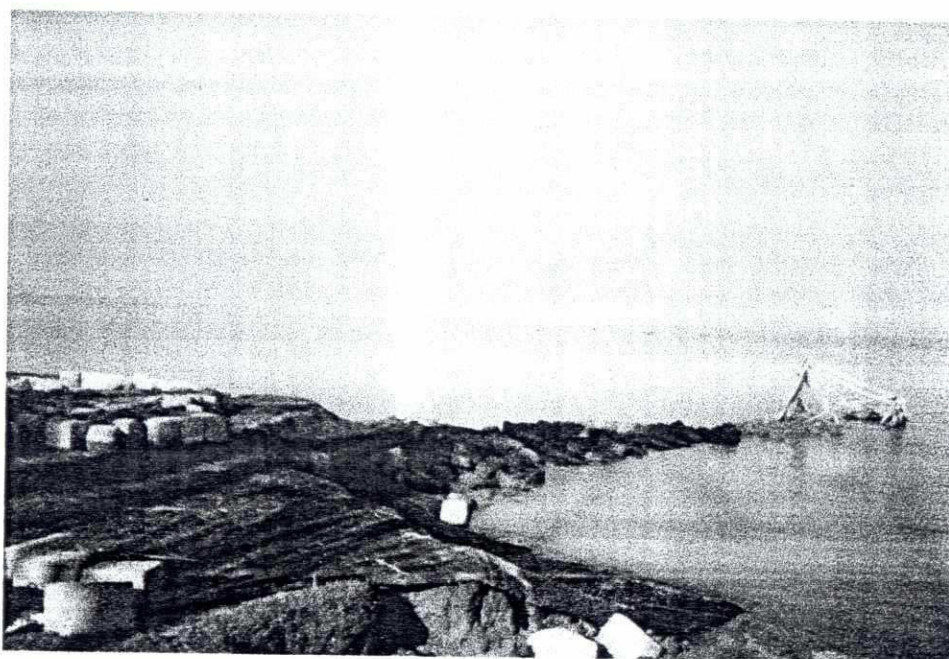
It was hit by a big river vessel and was tilted towards north (picture 12). But the spur as a unit was in position. However some of its bullahs and bamboos were damaged. Bank erosion downstream of spur 3 has reached up to the spur. 2 nos. of Profix blankets were washed away exposing the river bank slope near the spur.

Picture 12 After being hit by a river vessel the downstream spur has tilted.

- b) The design of the spur needs to be changed to be more stable to resist the strong current force.
- c) The size of the bed protection mattress has to be increased in order to reduce the number of overlaps; the currents may sweep up the edges, exposing the foundation material to scour. The length of the overlap should also be increased taking into account the accuracy of the installation as well as movement due to settlement after installation.

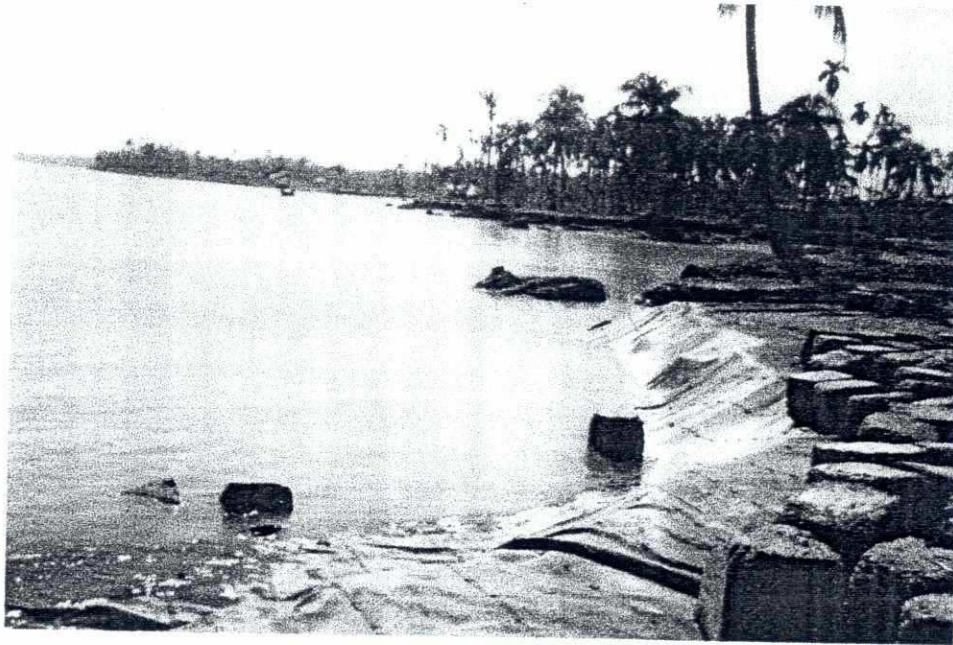
30 meters downstream of spur KC-3, 13 meters erosion was recorded (picture 13). No shoreline regression was observed in between the spurs KC-1, KC-2 and KC-3. In picture 14 the unharmed shoreline upstream of the upstream spur (KC-1) is shown. The siltation pattern at the upstream side of the middle spur (KC-2) can be seen in picture 15. Siltation is visible at the upstream side of the downstream spur (KC-3, picture 16).

Picture 13 During the flood erosion attacked the downstream side of KC-3.

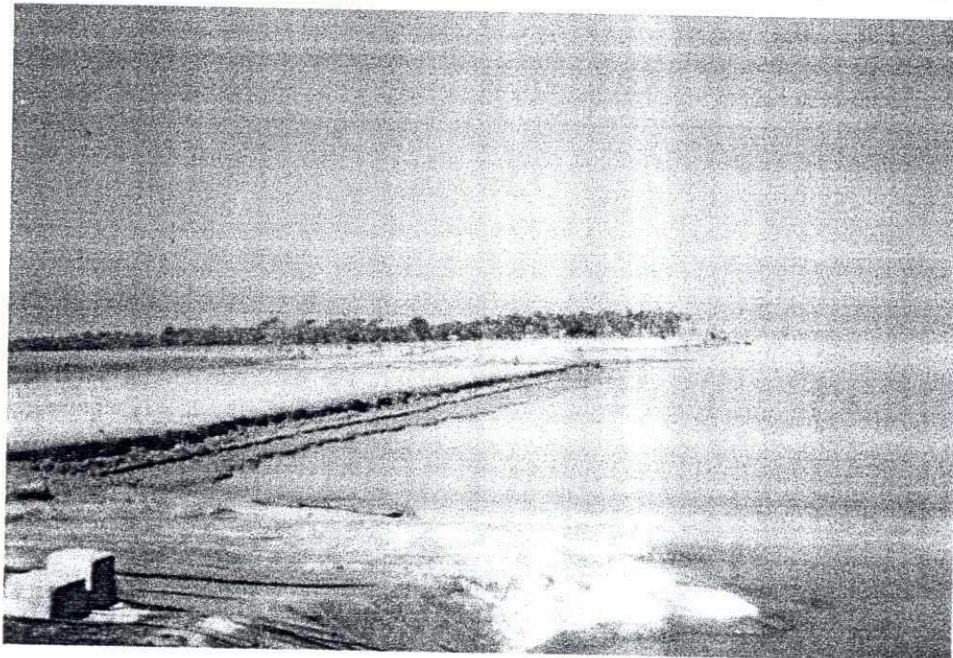
Picture 14 The unharmed shoreline upstream of the upstream spur (KC-1).

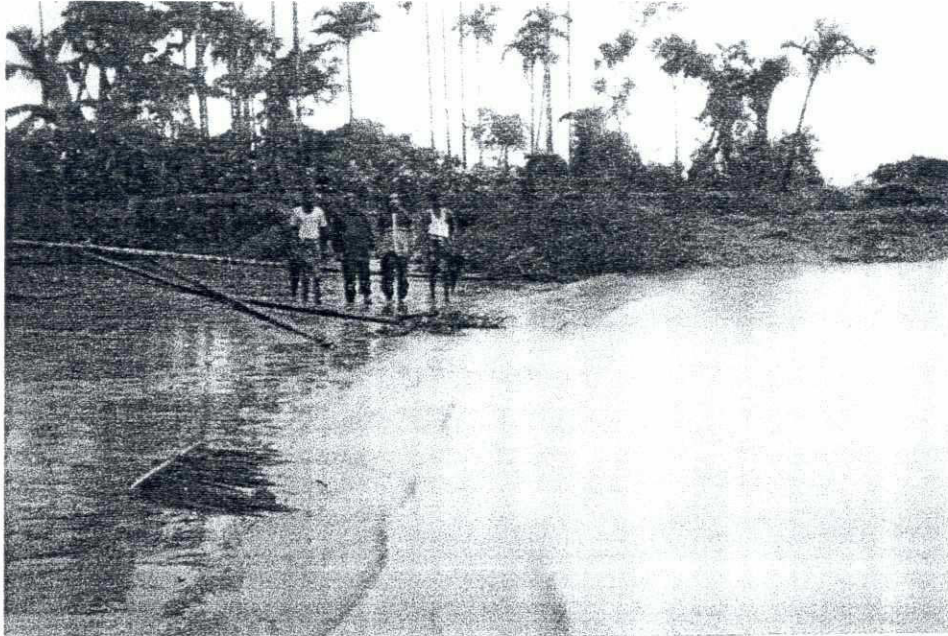
Picture 15 Siltation pattern at the upstream side of the middle spur (KC-2)

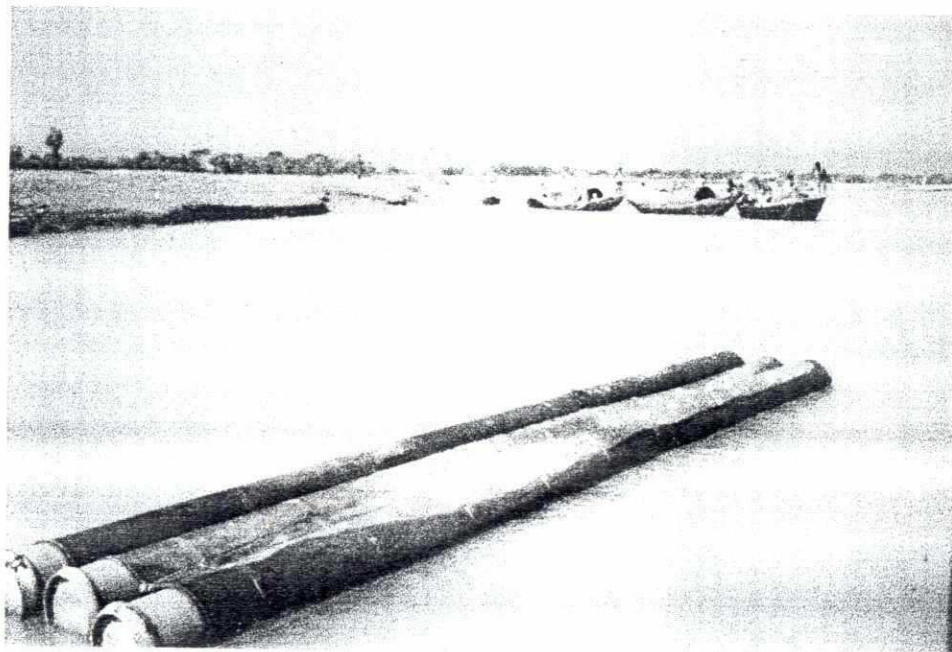
One screen was disconnected from the riverbed on November 15th 1998. The one meter long lifting hook was separated from the anchor slab (picture 17). The top float pipe was flattened. It might have been hit by a river vessel which might have dragged the screen causing failure of the lifting hook (picture 18).

Picture 18 The PVC float pipes of this bottom vane screen, which is disconnected from the anchor slab, are squeezed due to a hit of a river vessel. The edges of the geotextile shifted away from the edges of the floats.

- k) The length of the lifting hook has to be reduced from 100 cm to 60 cm.
- l) The sealing method of the PVC float pipes needs improvement. The end seals were attached to the float pipes through double welding. The outer seal plate was reinforced through fiber-reinforced polyester resin (FRP) system. It is recommended that both the inner and outer end seal plates will be double welded and further reinforced by the FRP system to increase the strength of the float pipes.
